Former Doble U.S. Army Reserve Center

Adaptive Reuse Conditions Report

Phase I – Senior Activity Center

City of Portsmouth, NH

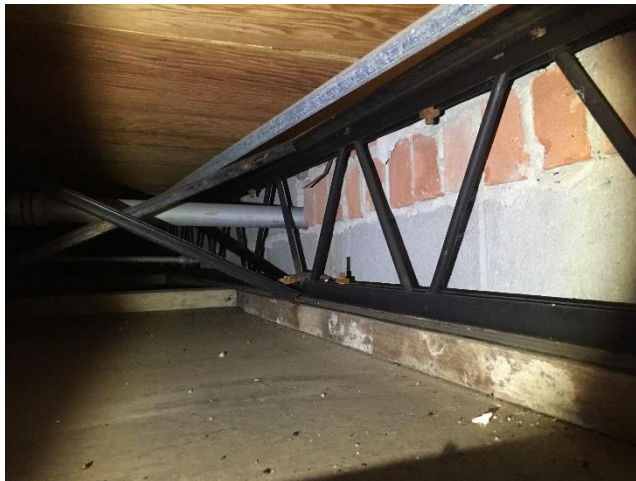
Figure 3: Open-Web Steel Truss System (Typ.)

The roof is supported by three sections of steel open-web joists that span from the perimeter walls to the corridor walls (Figure 3). Joists are orientated perpendicular to the east-west building plane (long length). The primary joist sections (2) span from the north and south perimeter walls to the main corridor CMU walls. A shorter truss section spans the corridor supported by the interior corridor walls. Field verification of the joist-to-joist connections is required for any structural modifications.

The open-web joists are set at 24-inches on center and are approximately 10-inches wide in section. Steel cross-bracing (bridging) connects joists to resist lateral (bending) stresses. Structural roof decking consists of plywood panels and timber planking connected to the joist flanges.

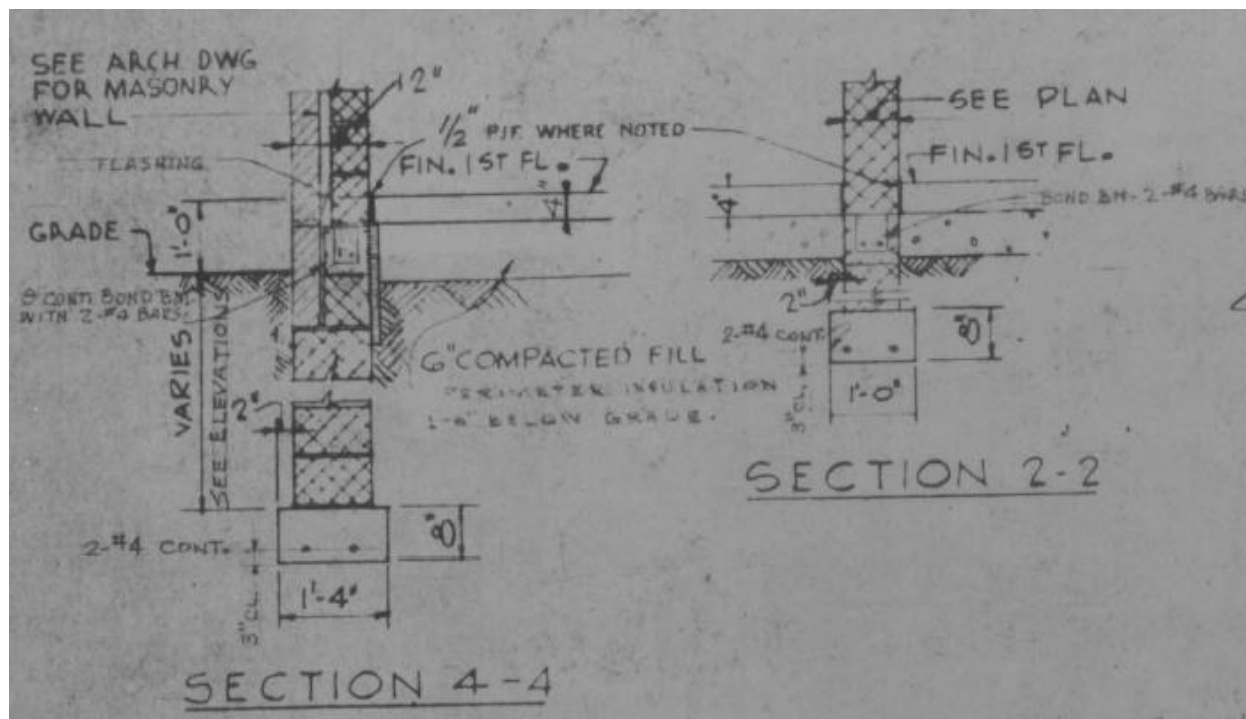
Figure 4: Design Details for Perimeter and Interior Walls and Foundations (c. 1955)

The original design drawings identify perimeter and interior shallow foundation systems. The perimeter system consists of a steel reinforced cast-in-place concrete spread footing and CMU stem wall with a steel-reinforced grade bond beam (Figure 4). This system extends the perimeter of the building and is located below the two corridor walls extending the length of the main building.

Typical of structures constructed in this circa (1950's), the existing structures likely do not meet current IBC design requirements for snow, wind, and earthquake loads. Structural modifications would be required to comply with current building standards.

Prior to adding any loads to the existing structure wall or roof systems, a rigorous structural evaluation should be completed by a licensed Professional Structural Engineer. This includes developing a model of the existing structures to determine the structural integrity as it exists. Additional structural engineering is necessary to accommodate building modifications and associated increases in loading.

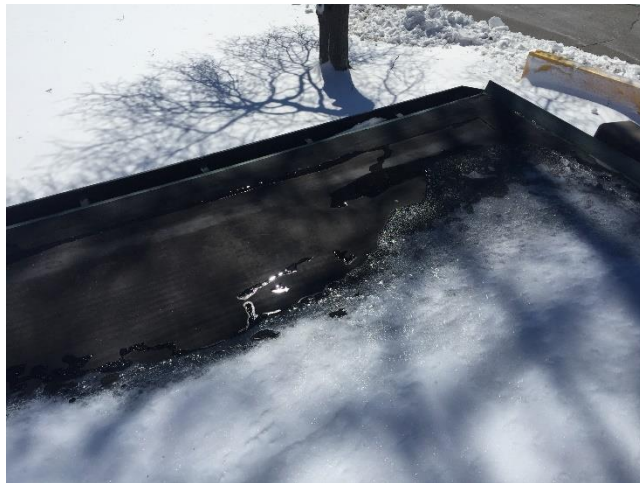
Figure 5: Rubber-Membrane Roofing System

applied to rigid insulation board (Figure 5). Drainage of the low-pitch roofs is provided by gutter and downspout systems. Condition of the roof membrane appears satisfactory and evidence of leakage is not evident.

Adding roof-mounted equipment (HVAC equipment, solar-panels, etc.) to the existing roofing systems is not recommended. Increased loading resulting from equipment weight and snow-drift loads will require a structural analysis. Considering the existing open-web roof joist system, it is presumed that structural modifications will be required to support any additional loading.

Future replacement of the membrane roofing system should include additional rigid insulation. Ideally, the new insulation value will surpass the existing building code minimum requirements. Inspection of the existing plywood and timber plank decking system should also be completed to determine if replacement or repair is necessary.

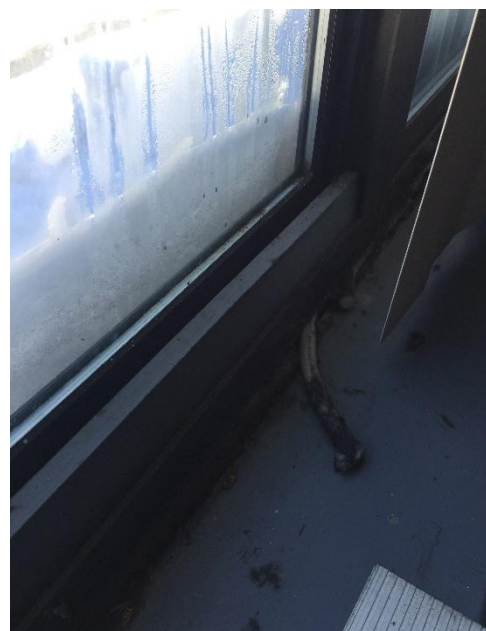
The original windows have been replaced with operating aluminum clad, double-pane units. Based on the window design and condition, the units were installed in the 1990s. Issues with the existing windows include failed seals (as evidenced by condensation between glazing), poor weather-sealing to masonry opening, and inoperability of sliding units (Figure 6).

Figure 6: Window with Failed Seals (Typ.)

Replacement of all windows in the main building is recommended. Future uses of the Assembly Hall should be determined prior to investing in new window systems.

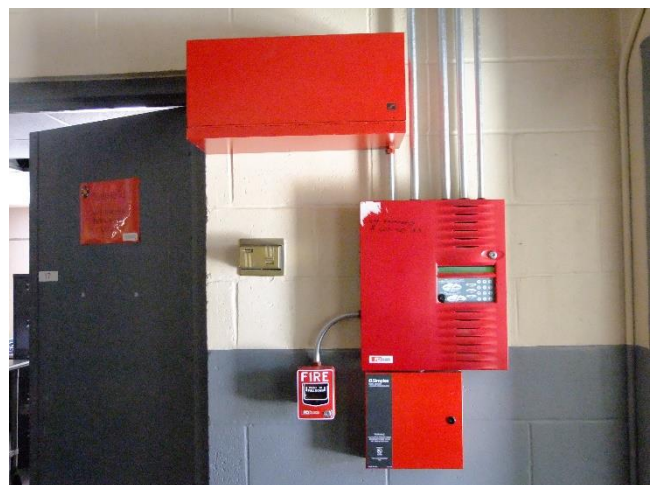
Figure 7: Fire Alarm Panel

Fire detection and notification systems within the building consisted of manual pull alarms, heat detectors, and smoke detectors in each room. Detectors are integrated and connected to a fire alarm panel, Simplex Model 2080-9024, at the west entrance (Figure 7). Notification devices (horn and strobes) are located throughout the corridors. It could not be determined if the alarm system is integrated with a central control.

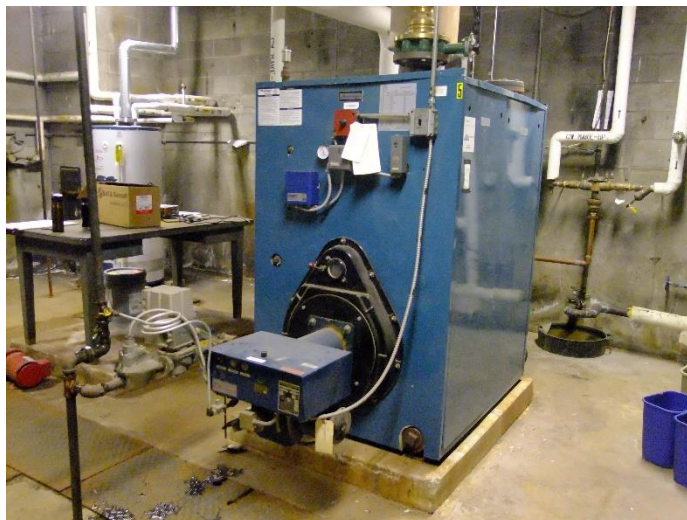
Figure 8: Central Gas-Fired Boiler Unit

The below-grade mechanical room is located on the western side of the office corridor. The room houses a large boiler (Figure 8) and five smaller capacity direct-venting boilers (Figure 9). Three floor drains located in the boiler room are connected to a floor sump. A formerly used chimney is located in the southeast corner of the room. A chase-way was observed in the boiler room designed to drain groundwater welling up through the basement into the sanitary sewer.

In addition to no existing ventilation system, the boiler room did not have dedicated air intake for combustion air for the larger boiler. The four smaller boilers have individual direct piped combustion air intakes. Combustion makeup air is supplied through the fixed louvers in the exterior boiler room entry doors, however, they have been covered. Therefore, the main boiler obtains combustion air from indoor air and leakage through the doors and walls of the boiler room. This may result in a negative air situation when the boiler is in operation.

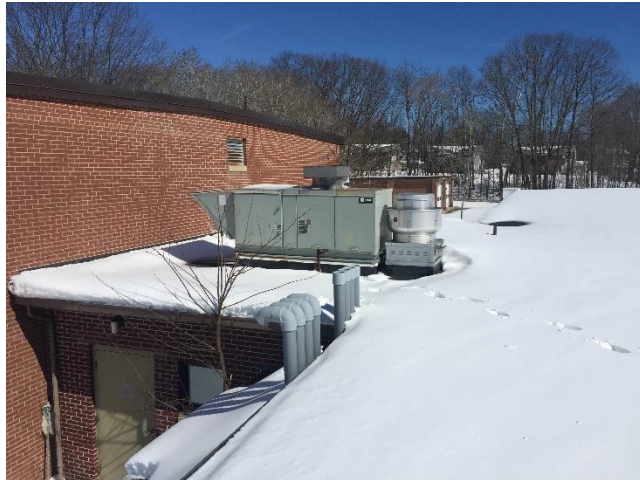
Figure 10: Rooftop Air Handler and Exhaust Fan (Typ.)

additional rooftop ventilators were identified in the kitchen preparation area. A rooftop air handler is dedicated to the kitchen exhaust hood (Figure 10).

handler supplied fresh air to the space. To bring the building into compliance with *ASHRAE 62 The Standards for Ventilation and Indoor Air Quality*, fresh air ventilation will need to be added.

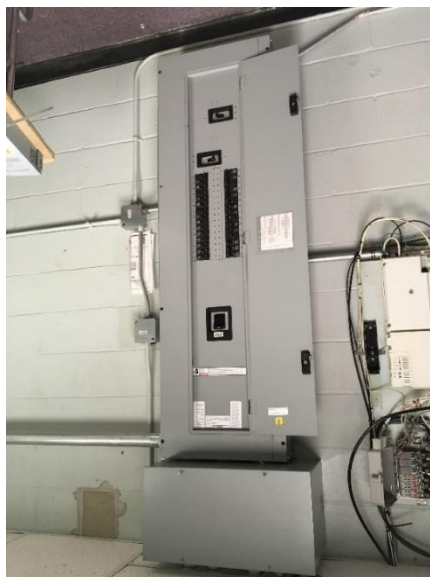
Figure 11: Main Circuit Panel

A buried electrical service (400 amp, 230 volt, 3-phase) is fed from Cottage Street to the service entrance at the southwest corner of the main building (Figure 12). The main distribution panel (MDP) is located in the utility room adjacent to the boiler room (Figure 11). Six subpanels are located throughout the facility. Each subpanel has spare breakers available. Subpanels exist in the following spaces:

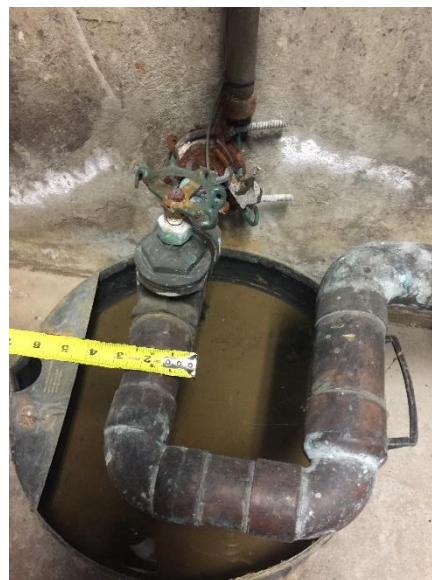
Figure 13: Main Water Service

Municipal water is supplied to the building on the southwest corner of the building into the boiler room. The main service provides cold water and domestic hot water (DHW) to fixtures throughout the facility (Figure 13). Condition of the existing service should be verified as part of any major site construction project planning. If the water service is original to the building (60-70 years old), replacement / upgrade is recommended. This should be completed in parallel with the new fire sprinkler service required for the building.
