June 22, 2018

Benjamin Fletcher
Director of Parking
City of Portsmouth, NH
680 Peverly Hill Road
Portsmouth, NH 03301
bmfletcher@cityofportsmouth.com

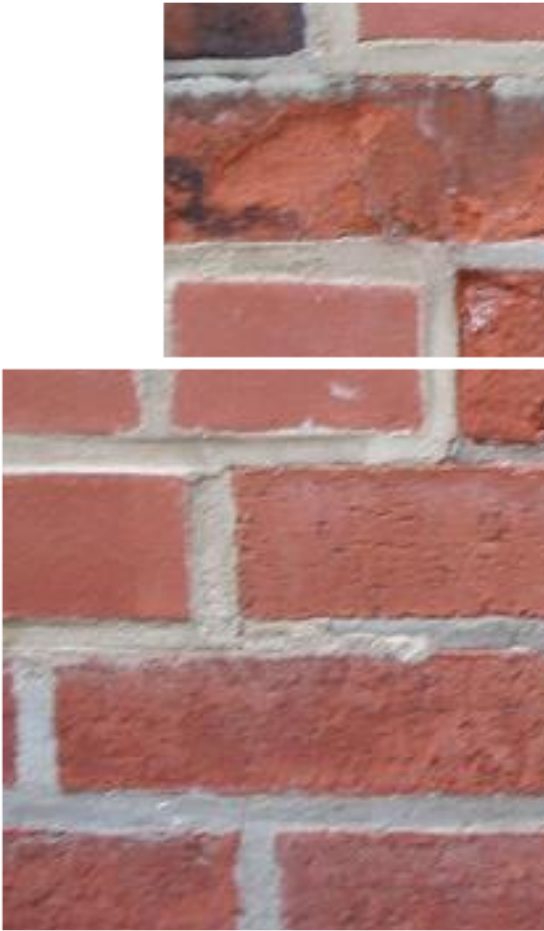
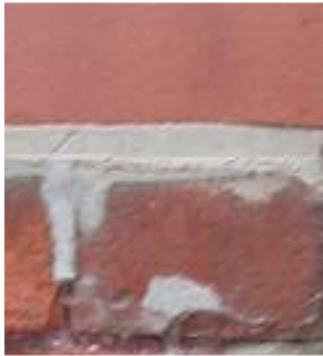
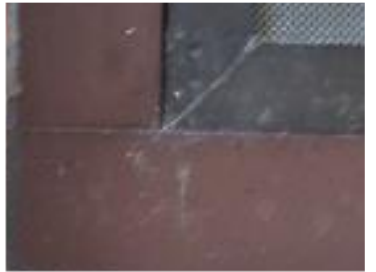
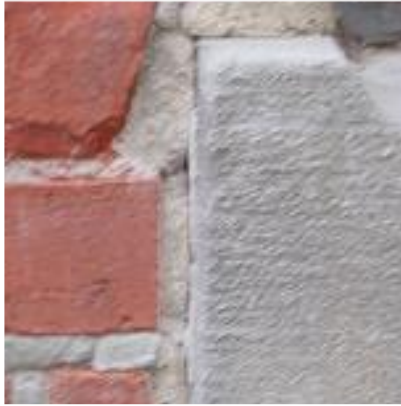
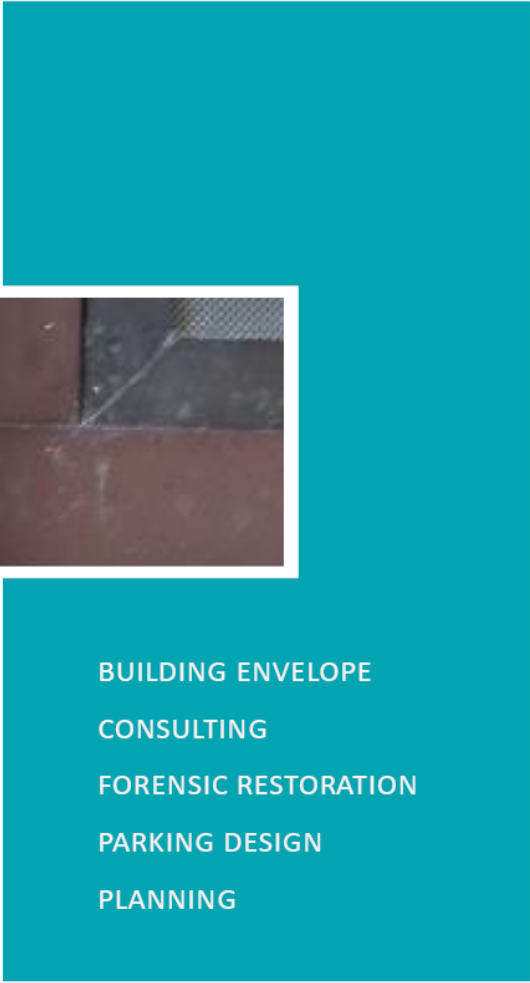
BUILDING ENVELOPE
CONSULTING
FORENSIC RESTORATION
PARKING DESIGN
PLANNING

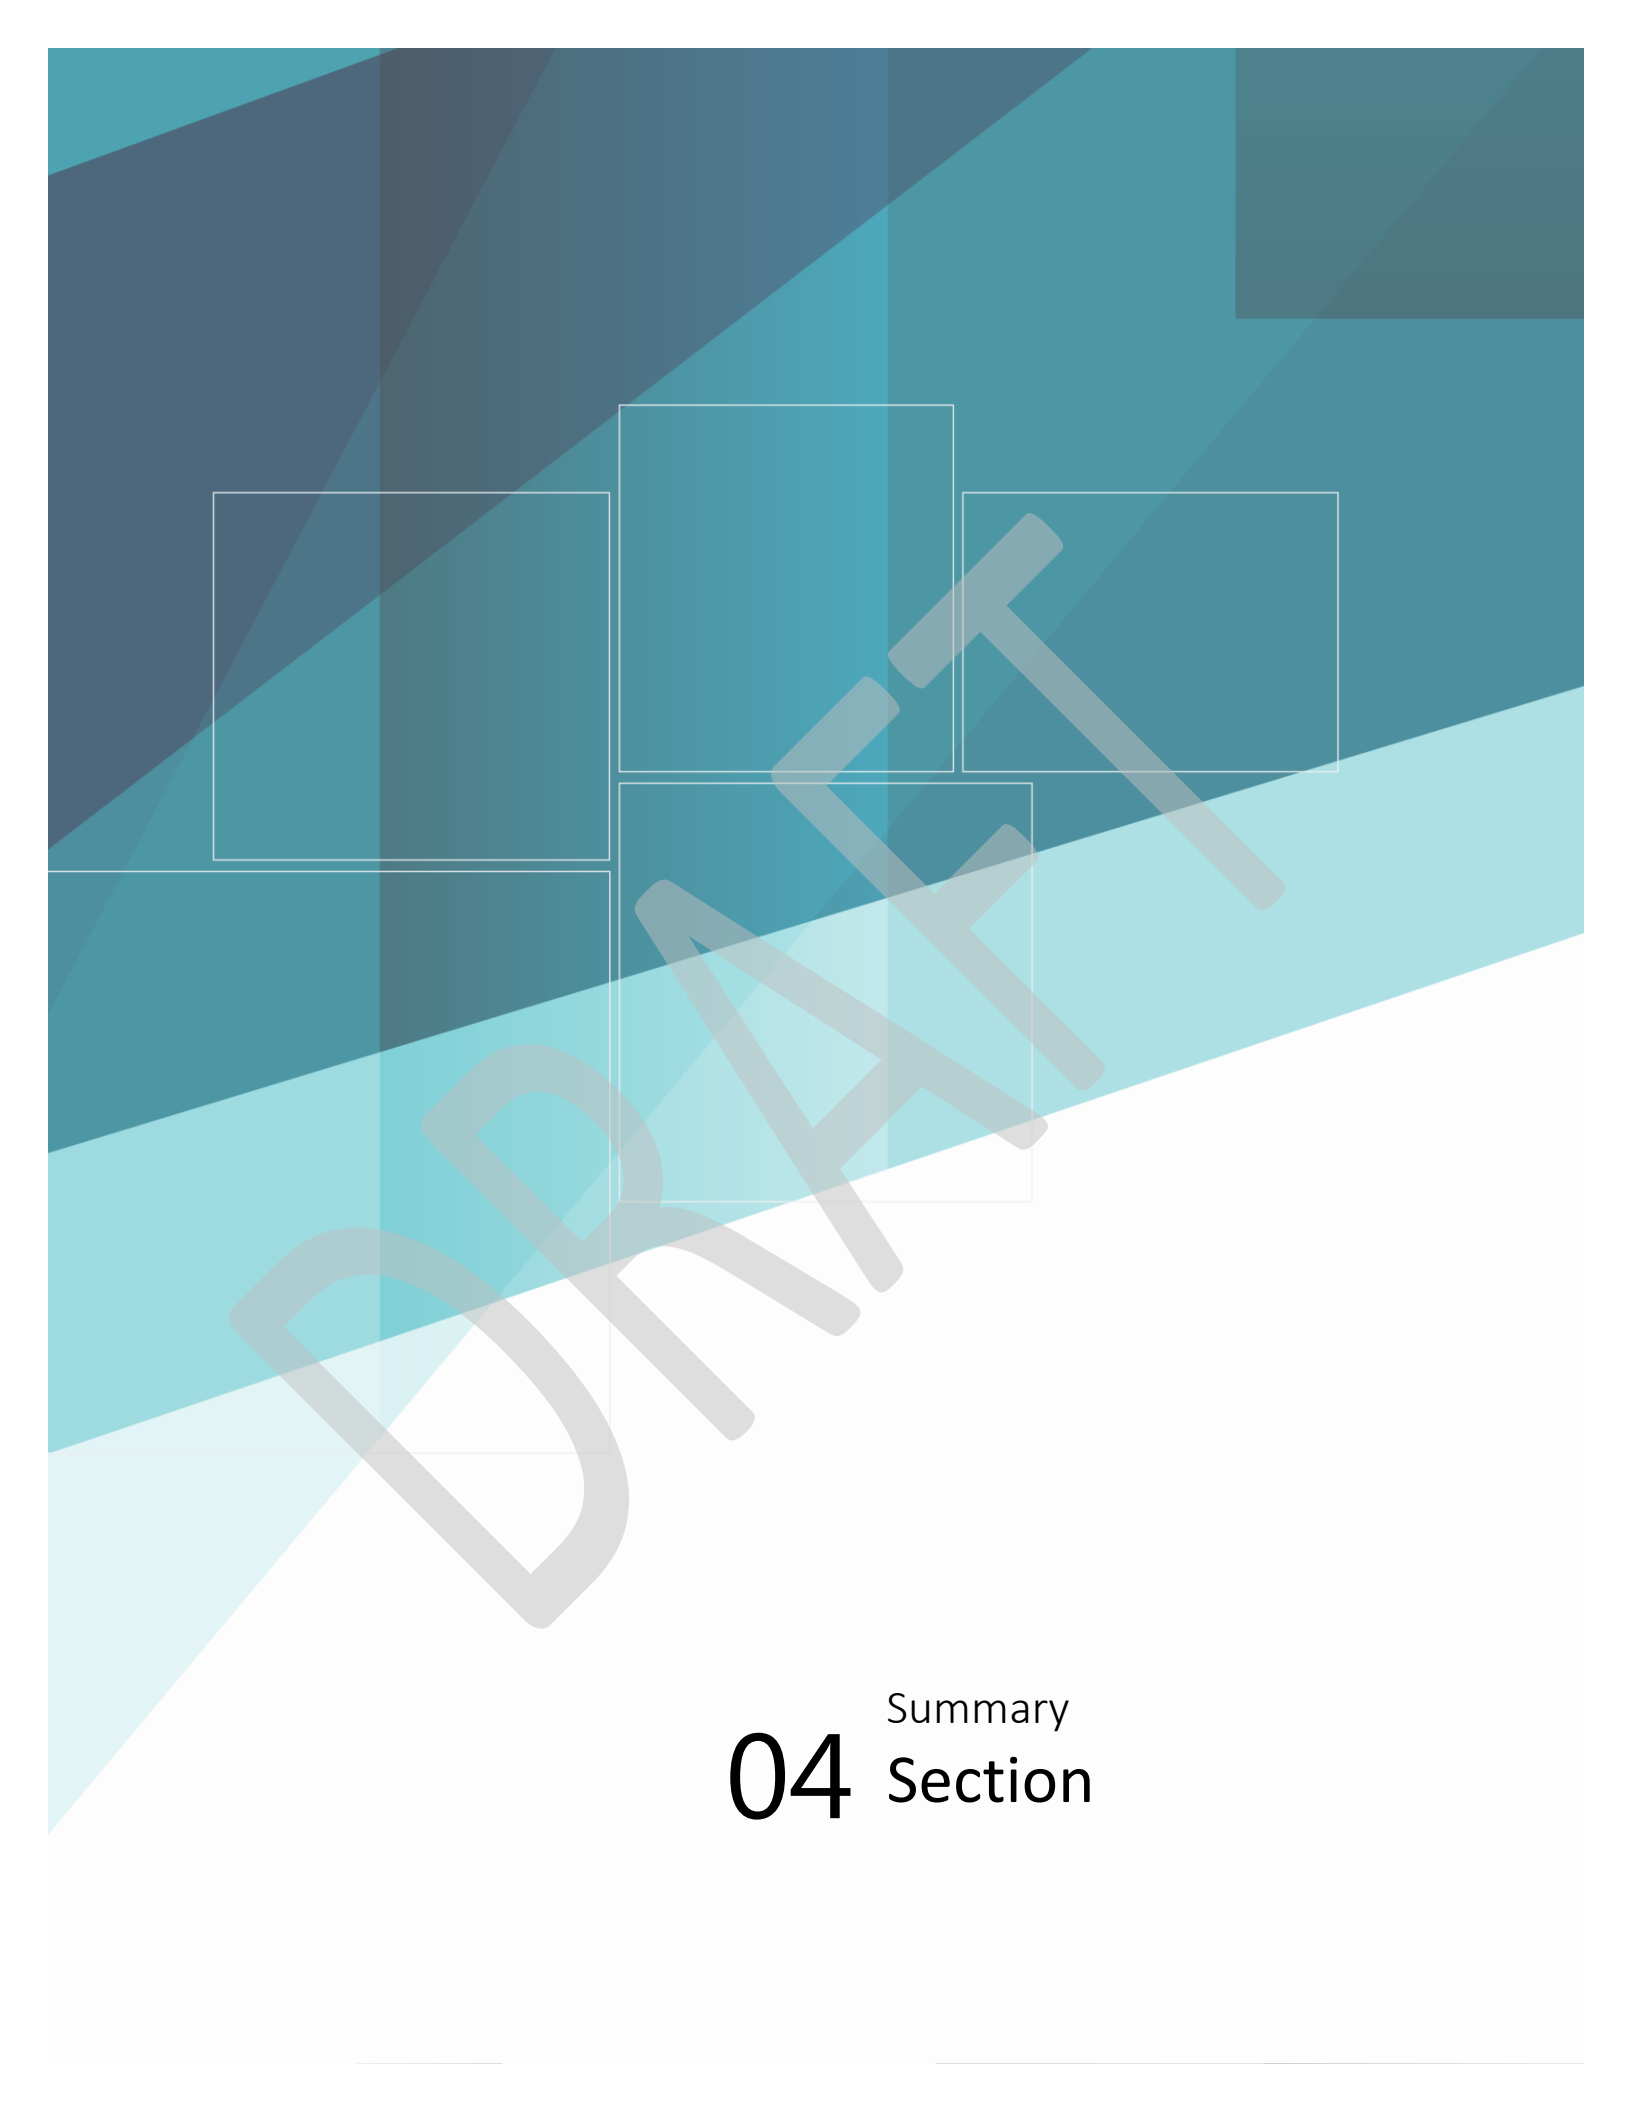
Concrete overlays provide a greater level of protection than topical protection systems by having a dense chloride free concrete matrix provided with corrosion inhibiting admixtures to stop the corrosion process. In addition, the new overlay combined with new epoxy coated reinforcing steel will provide sufficient redundancy in arresting future corrosion from occurring for 20 years.

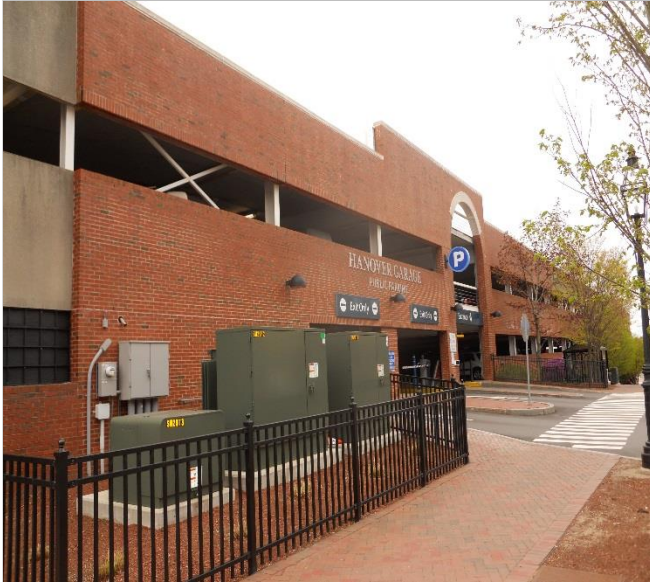
Photo 1 – View of façade northwest corner. Note staining on masonry veneer.

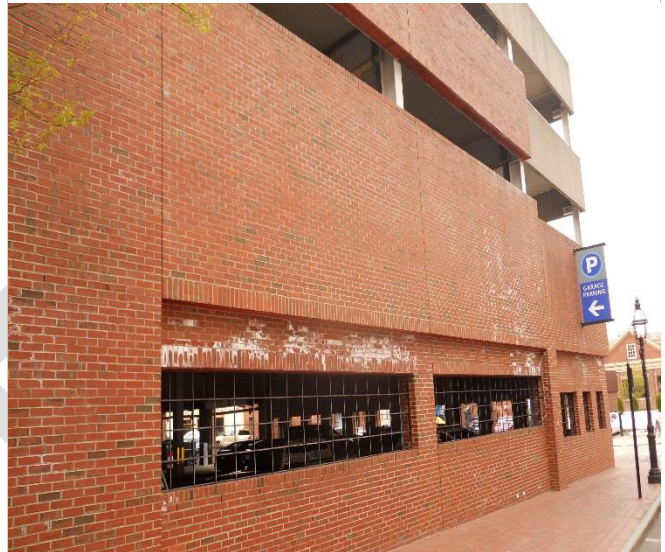
Photo 3 – View of façade northwest bar grille at street level.

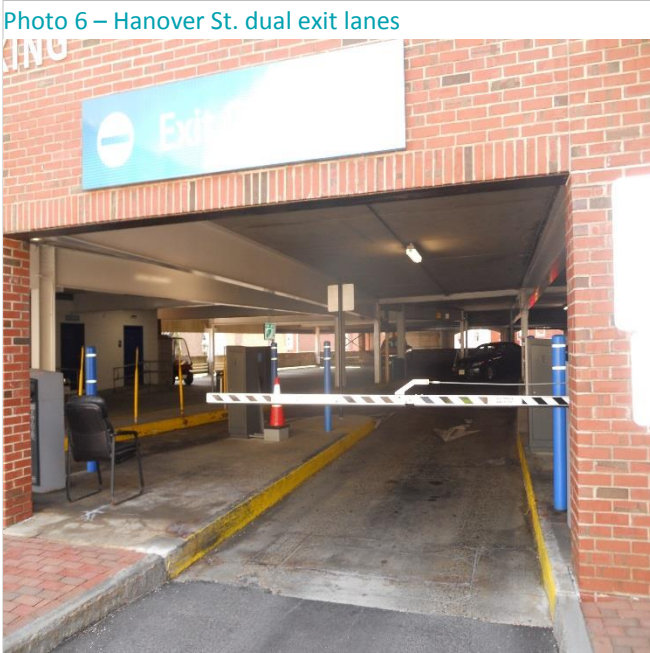
Photo 5 – South façade view of typical lineal cracking on sill stones.

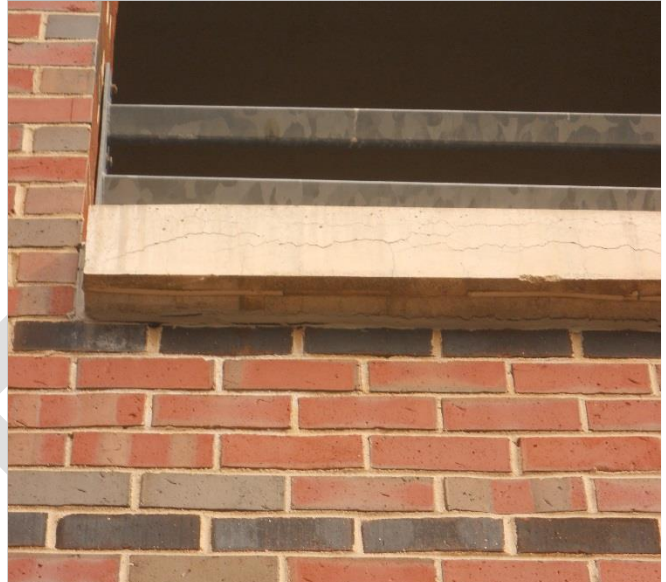
Photo 8 – North elevation interior view of façade masonry. Note protective netting applied to deteriorating masonry.

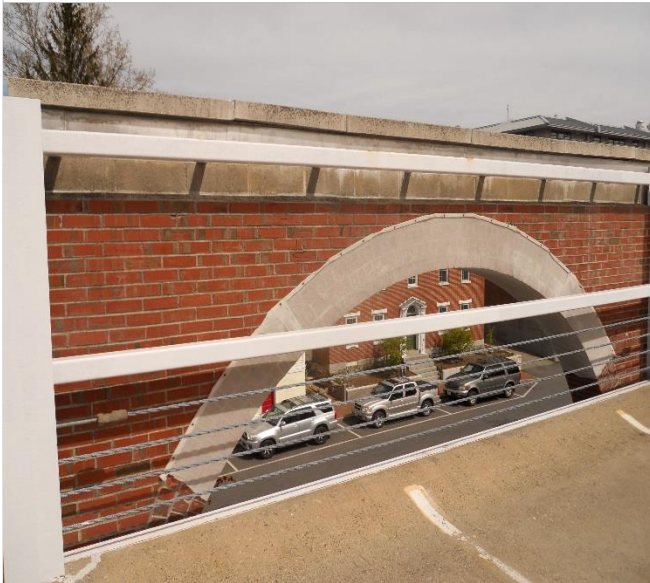
Photo 7 – North elevation interior view of façade CMU wall. Note progressive cracking on masonry block.

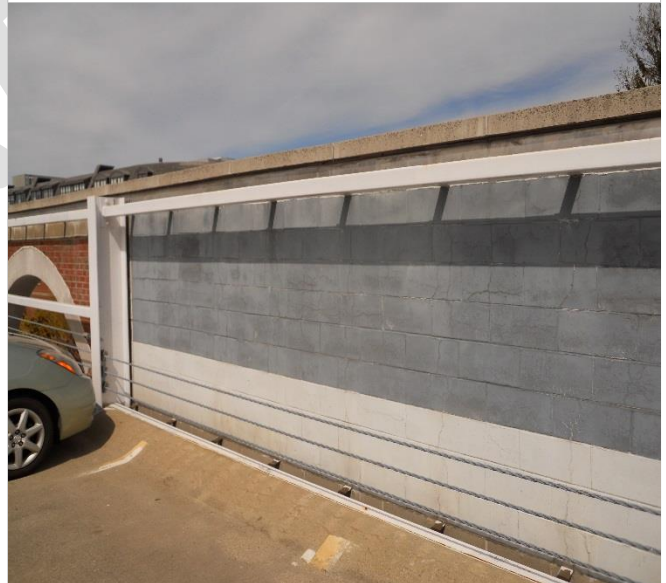
Photo 10 – Waterproofing membrane applied to masonry barrier wall and capstone on level 5.

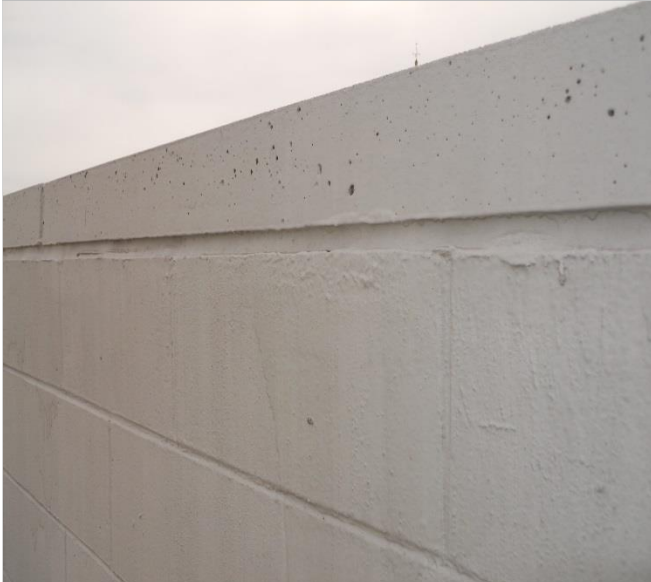
Photo 9 – deteriorated capstones on level 5 barrier wall. Note debris netting applied to top of wall as a precautionary measure.

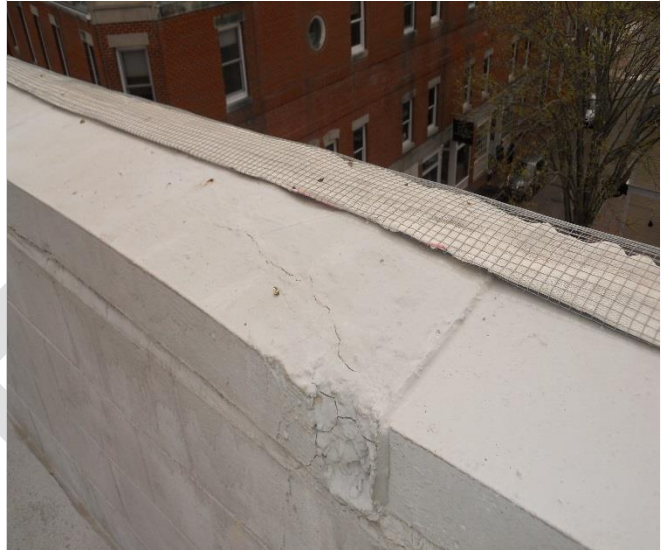
Photo 12 – Barrier wall capstone showing progressive pattern cracking.

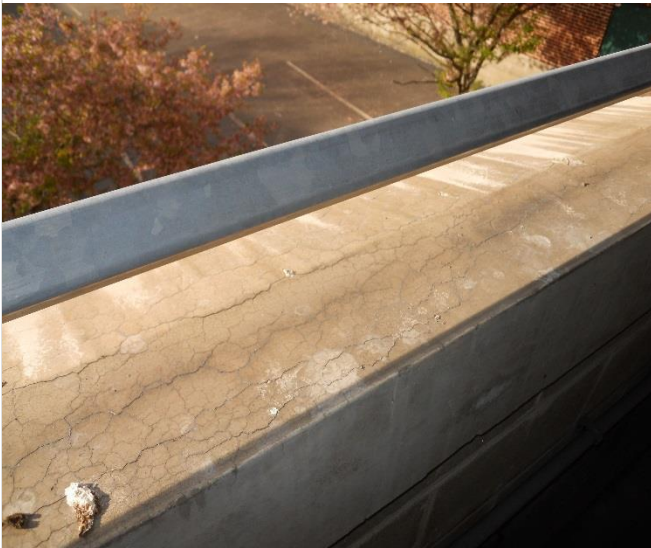
Photo 11 – Structural framing column and beam corrosion at east end of grade level 1. Note deterioration and staining on floor slab above.

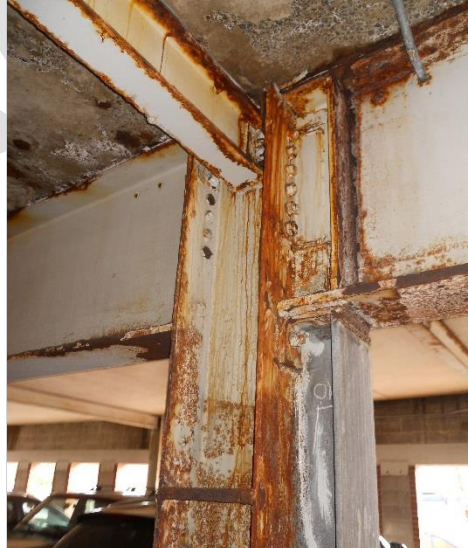
Photo 14 – Level 2 floor underside deterioration and staining on the precast filigree planks. Note corrosion damage to supporting beam.

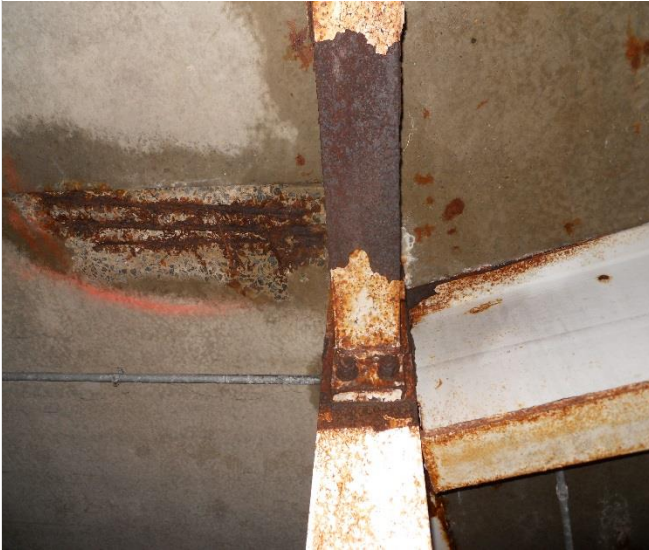
Photo 13 – Level 1 – Tube column support provided below beam due to sectional loss on steel girder.

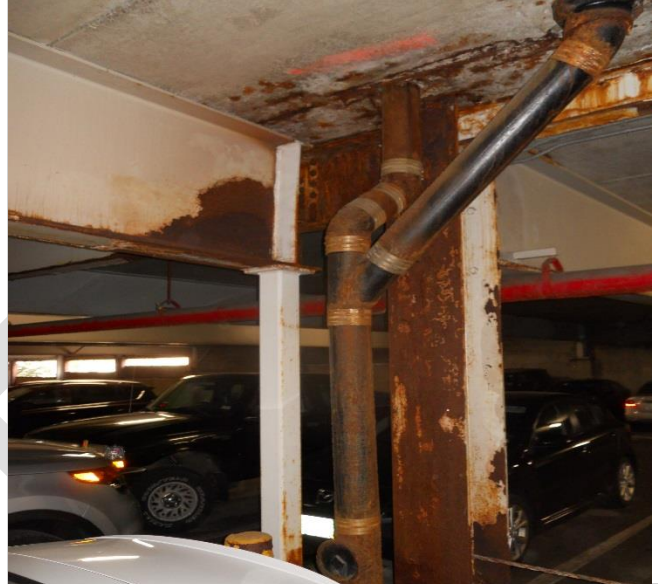
Photo 15 – level 1 – Corrosion on column base plate and deterioration of concrete pier.

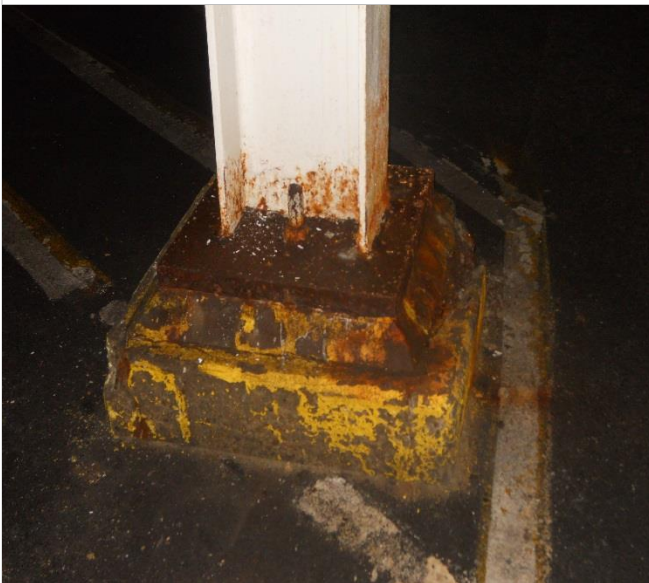
Photo 16 – Level 1 – Severe corrosion damage to structural steel column at floor perimeter (north elev.).

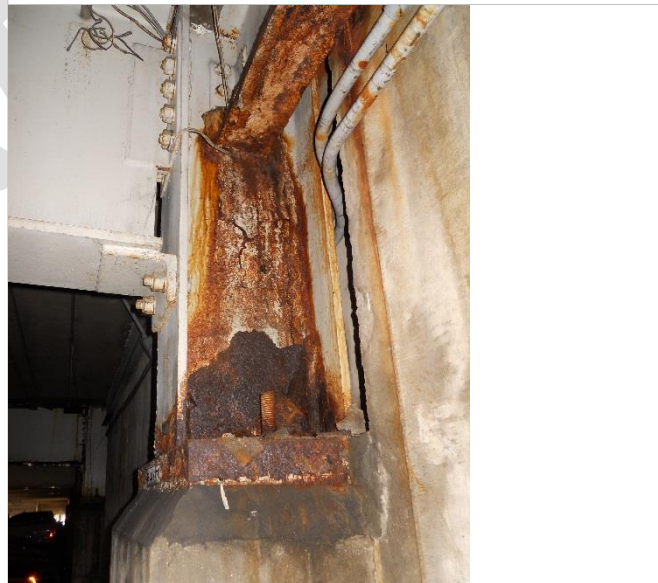
Photo 15 – Level 2 framing connection. Note corroded condition of high strength bolts and nuts.

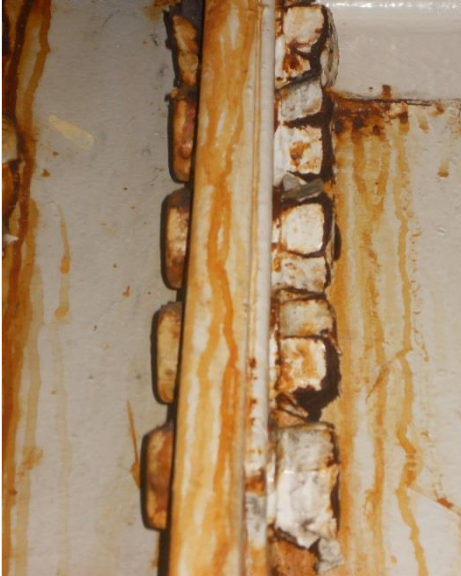
Photo 16 – Level 1 – corrosion damage to steel column. Note delaminated concrete on column.

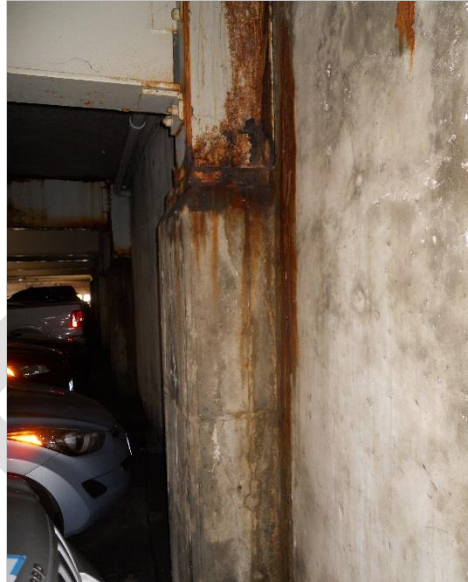
Photo 19 – Level 2 - underside framing corrosion along expansion joint line. Note corrosion on FP line.

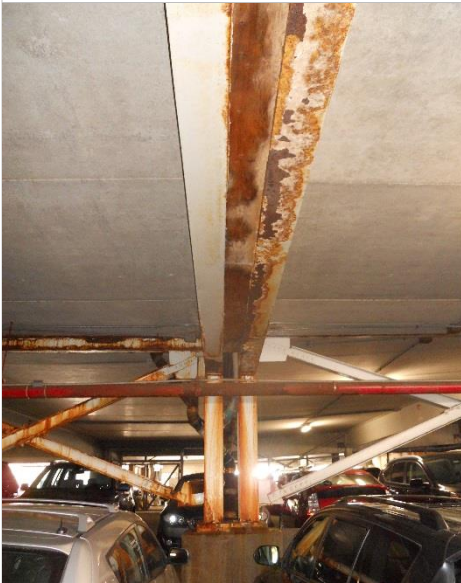
Photo 20 – Level 1 - framing corrosion at column base and wind bracing.

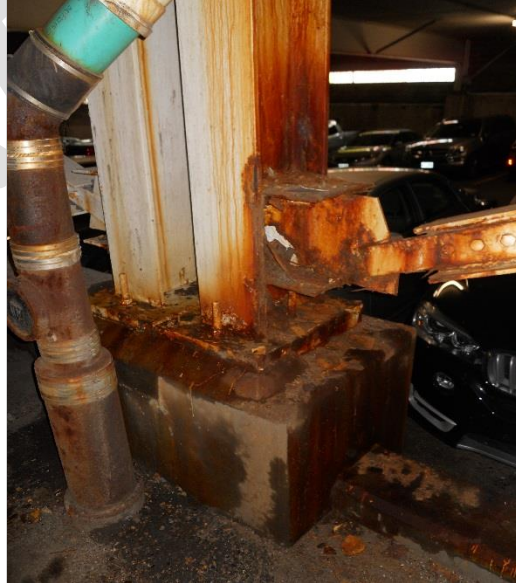
Photo 17 – Level 2 Floor slab deterioration and severe corrosion on structural framing.

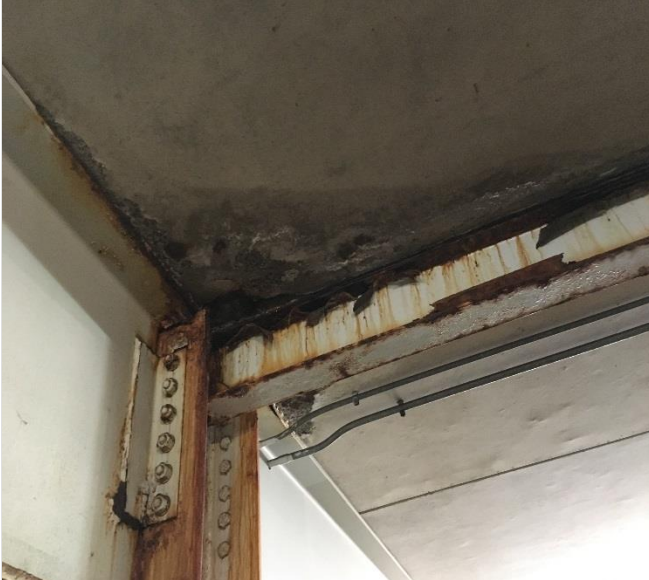
Photo 22 – Level 2 floor painted outline of deterioration formation beyond patch repair sites.

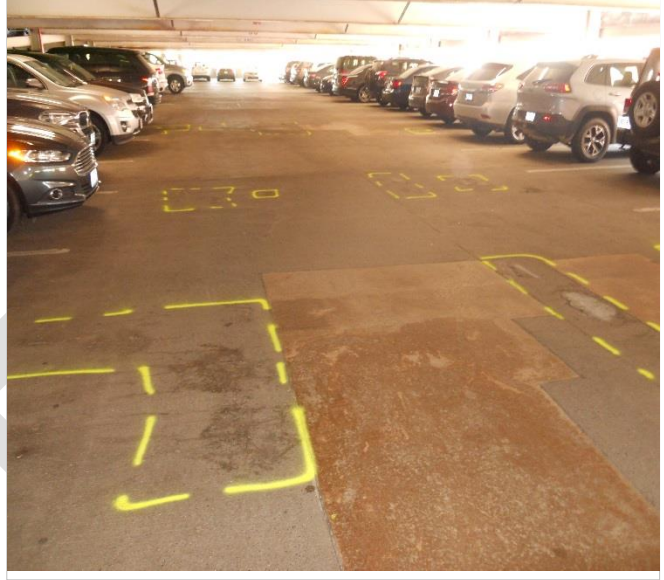
Photo 23 – Level 3 painted outline of deterioration formations above structural framing.

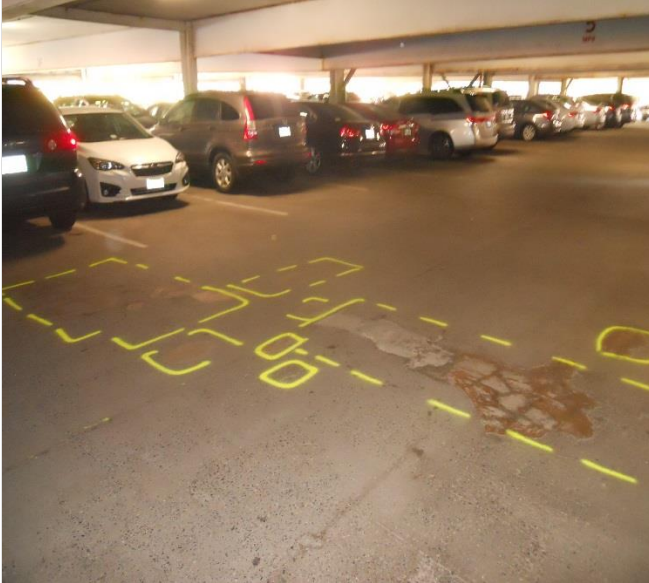
Photo 24 – View of corrosion on structural framing below deteriorated floor slab area.

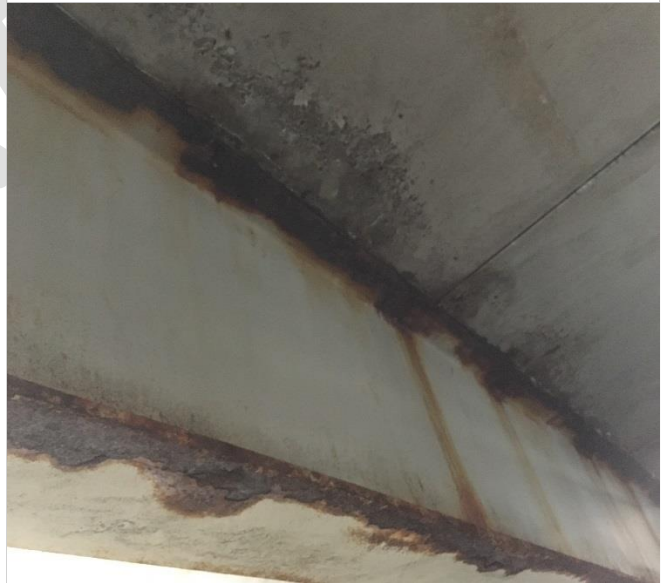
Photo 25 – Level 3 floor drain plugged with debris. Note water staining and corrosion around column and drain line.

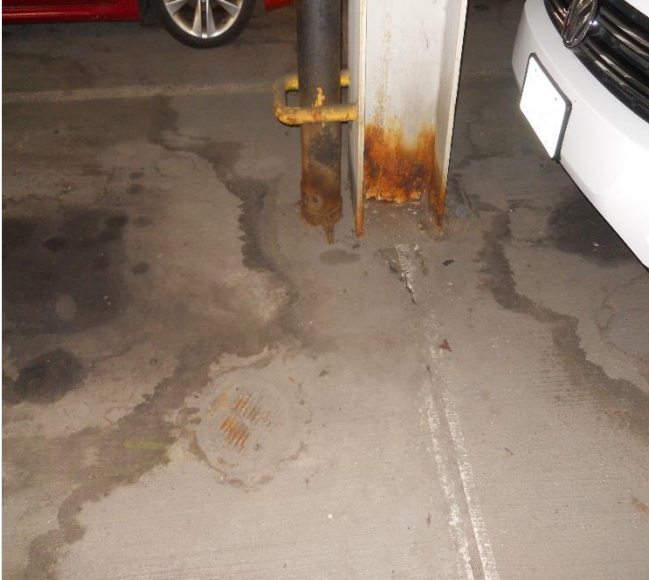
Photo 26 – Floor deterioration at drain line penetration. Note corroded condition of drain and line.

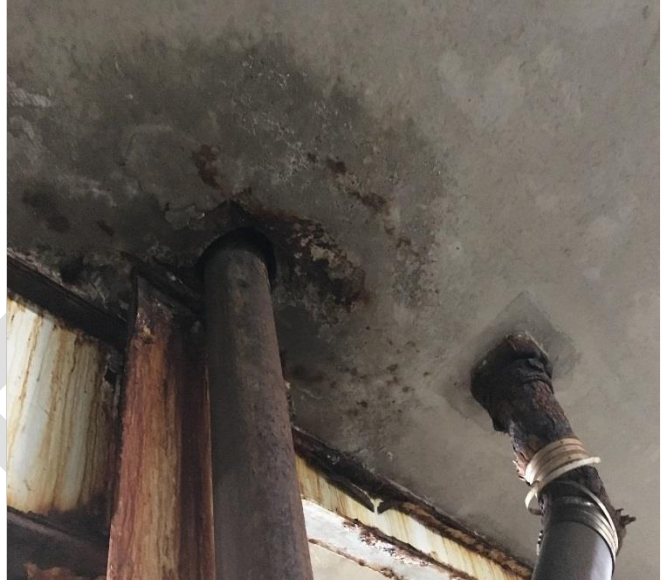
Photo 27 – Structural framing in garage expansion area (1999). Note straining and spotted rust on framing.

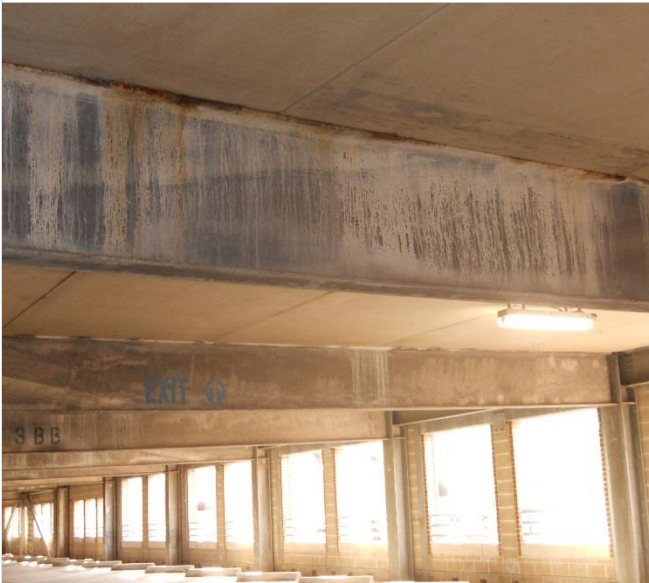
Photo 28 – Garage expansion area. Note sealant adhesion failure along filigree plank joint line.

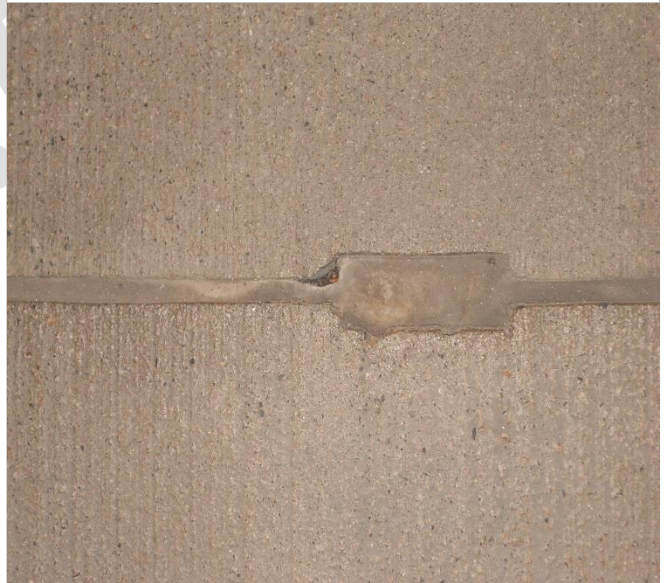
Photo 29 – Garage expansion area. View of typical joint sealant adhesion failures.

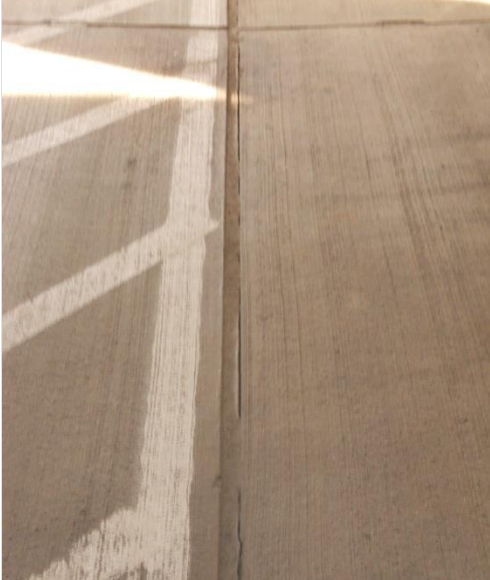
Photo 30 – Garage expansion area. Corrosion on weldments. Sealant failures noted above framing line.

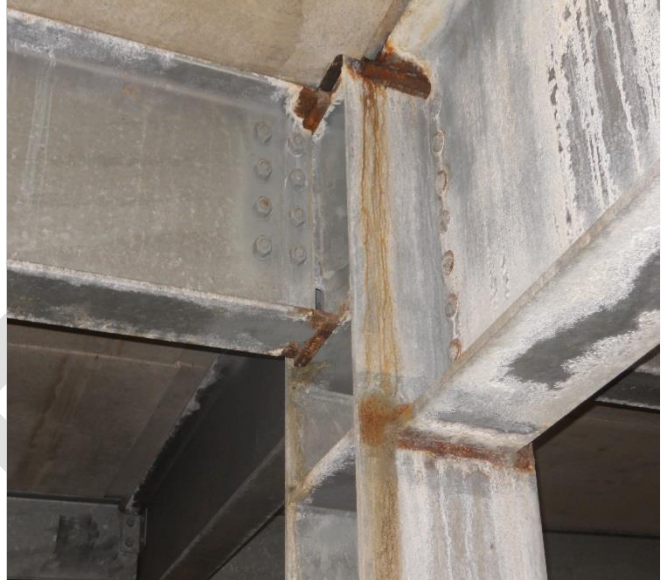
Photo 31 – Level 4 barrier guard railing. Note size of openness between cable strands.

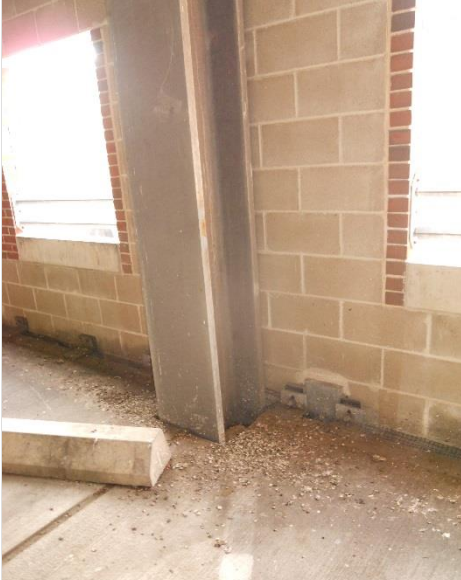
Photo 34 – Stair #3 raised walk at doorway. Note deterioration and separation of walk from floor slab.

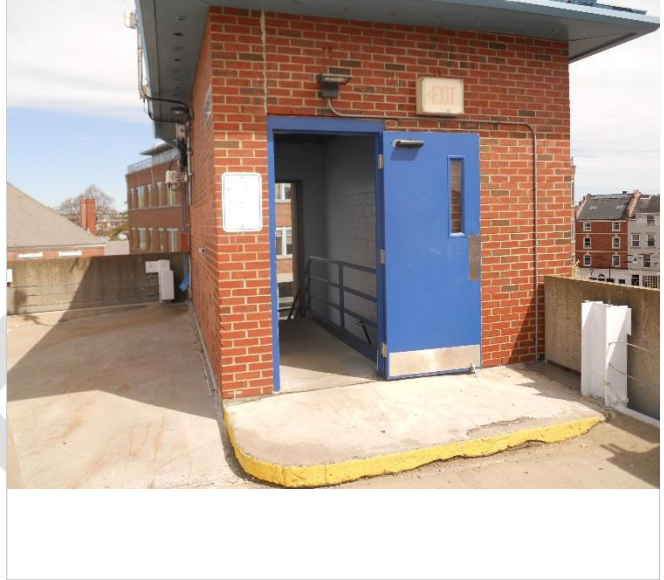
Photo 35 – Stair #1 interior view of wall. Note blistering and peeling paint on walls.

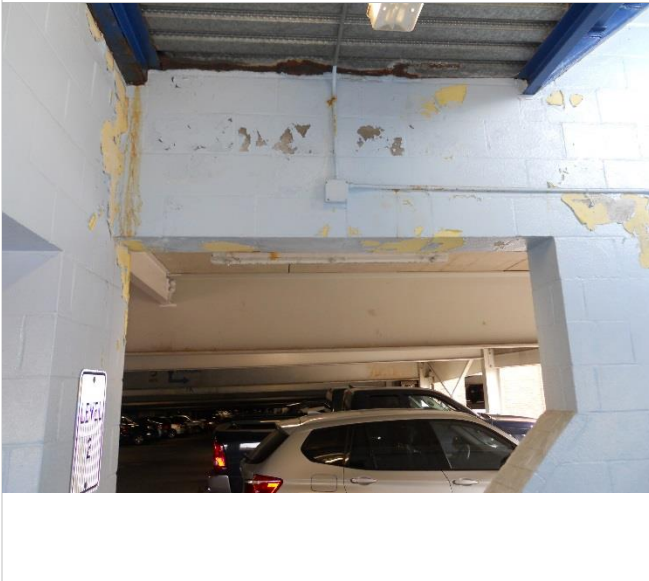
Photo 36 – Stair #1 corrosion damage to stair step pans.

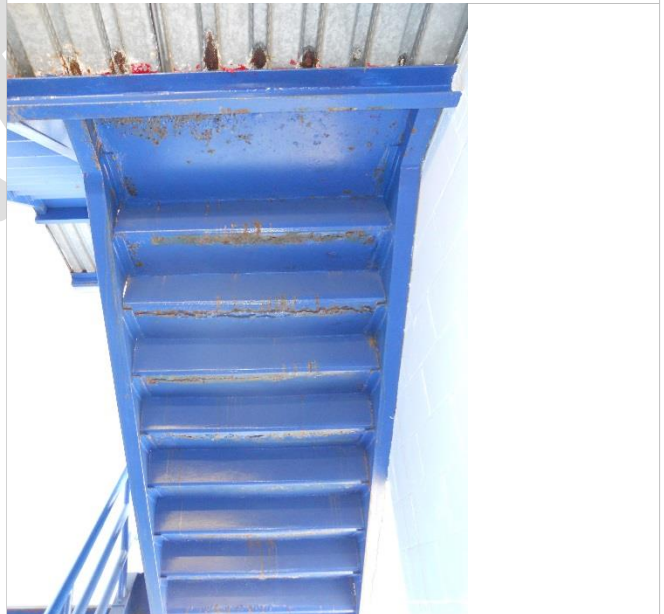
Photo 37 – Sealant deterioration at glazed curtain wall in stair tower #1

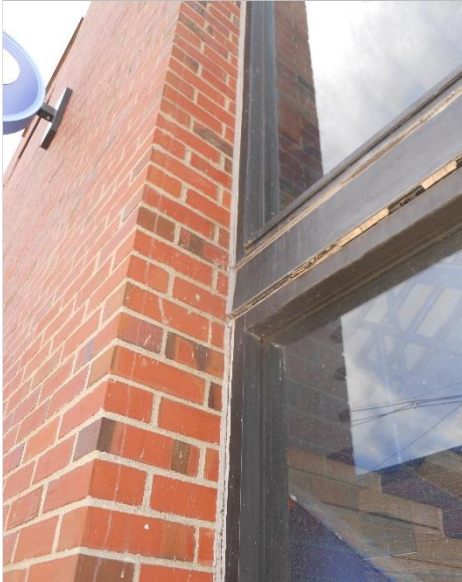
Photo 38 – South façade. Note through bolted connection to secure loose cornice.

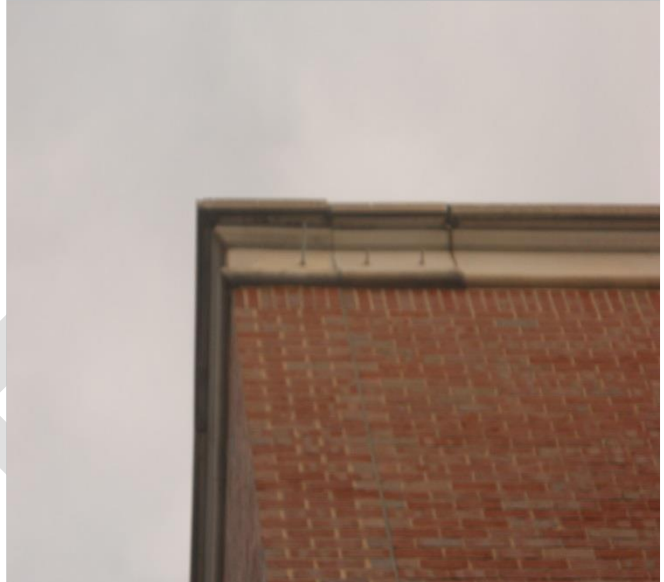
Photo 39 – Floor directional graphics stenciled on steel framing.

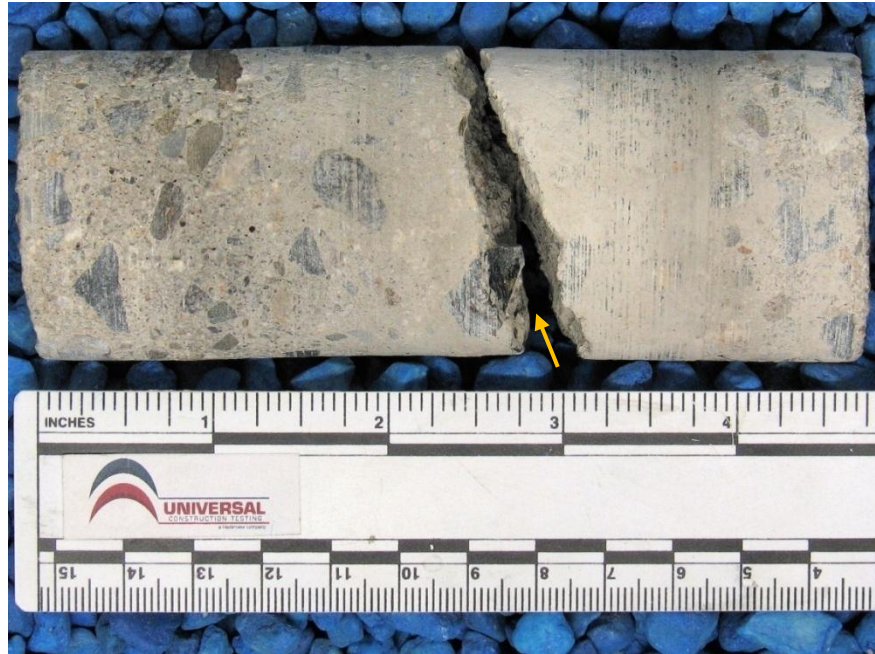
Figure 1 – Side view of core sample as-received for examination. The quality and integrity of the concrete appears relatively good; arrow clearly indicates the general characteristics of the open fracture.

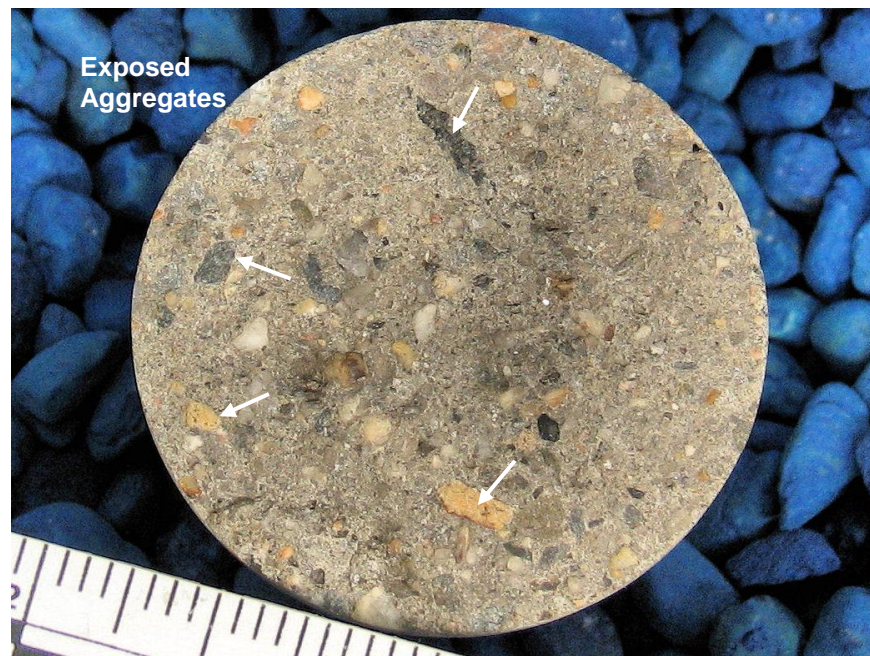
Figure 2 – One core end of the sample as-received for examination; the opposing end exhibits similar features (worn surface with little to no texture; smooth and polished sand grains). Scale is marked in 1/16-in. increments.

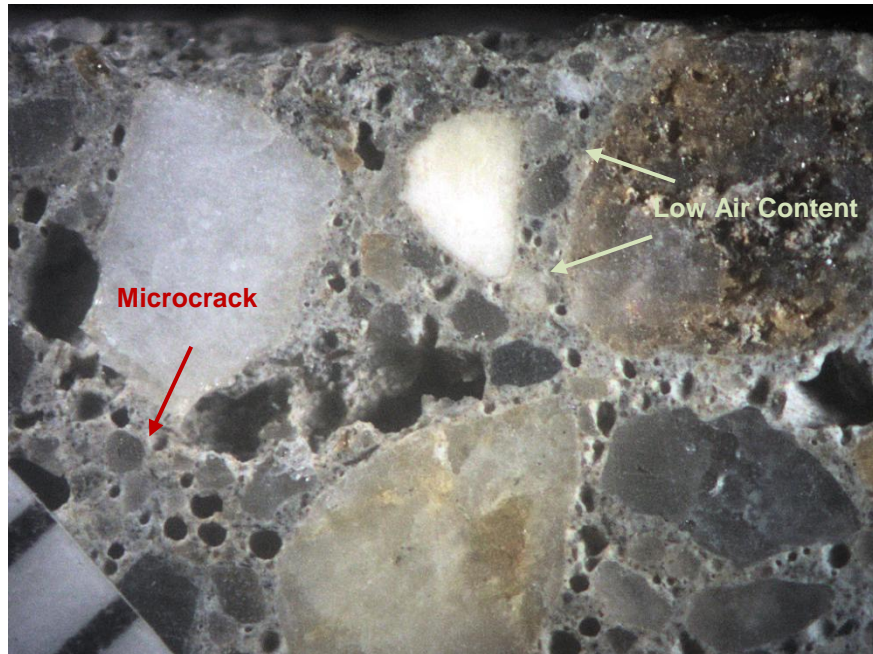
Figure 3 – Photomicrograph showing the air-void system in the near-surface region (millimeter scale). Note coalesced and deformed air voids just below the zone of low air content concrete at the surface; the paste of the low air-content concrete is darker gray (densified). A sub-surface microcrack appears to interconnect a few voids.

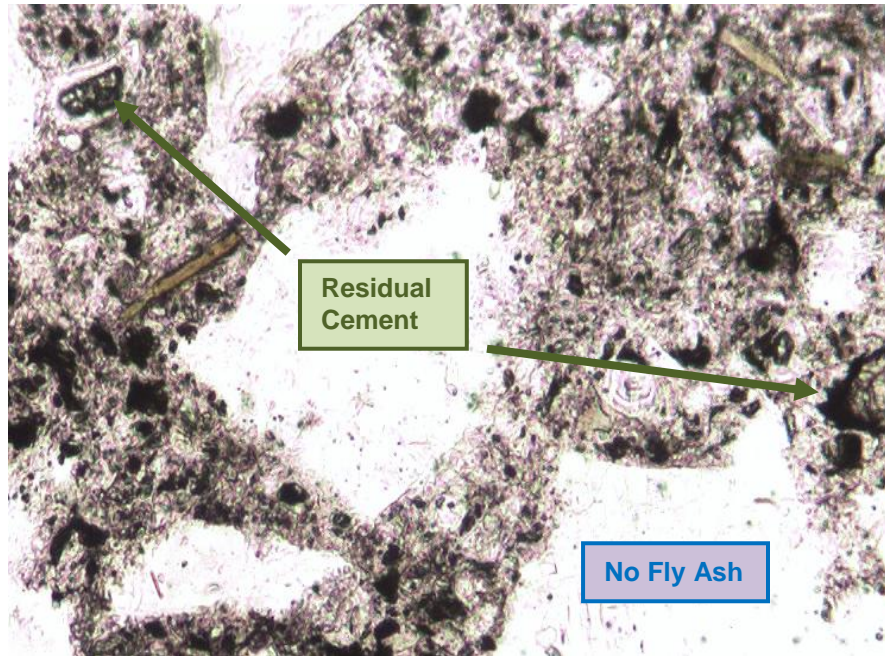
Figure 7 – Thin-section photomicrograph showing the cement-paste microstructure. 100X, plane light. The concrete was produced using portland cement; no supplementary cementitious material, such as fly ash, is present.
