Dear historical commission.

We are requesting your approval to remove the chimney in the southeast section of our property at 232 court / 93 pleasant St. We have 2 other chimneys that we are keeping and utilizing. We have included pictures of the subject chimney, as well as a highlighted section of our engineers' report after physical inspection of our property. Thank you for your time and consideration in this matter.

**BMC Engineering's comments/recommendations:**

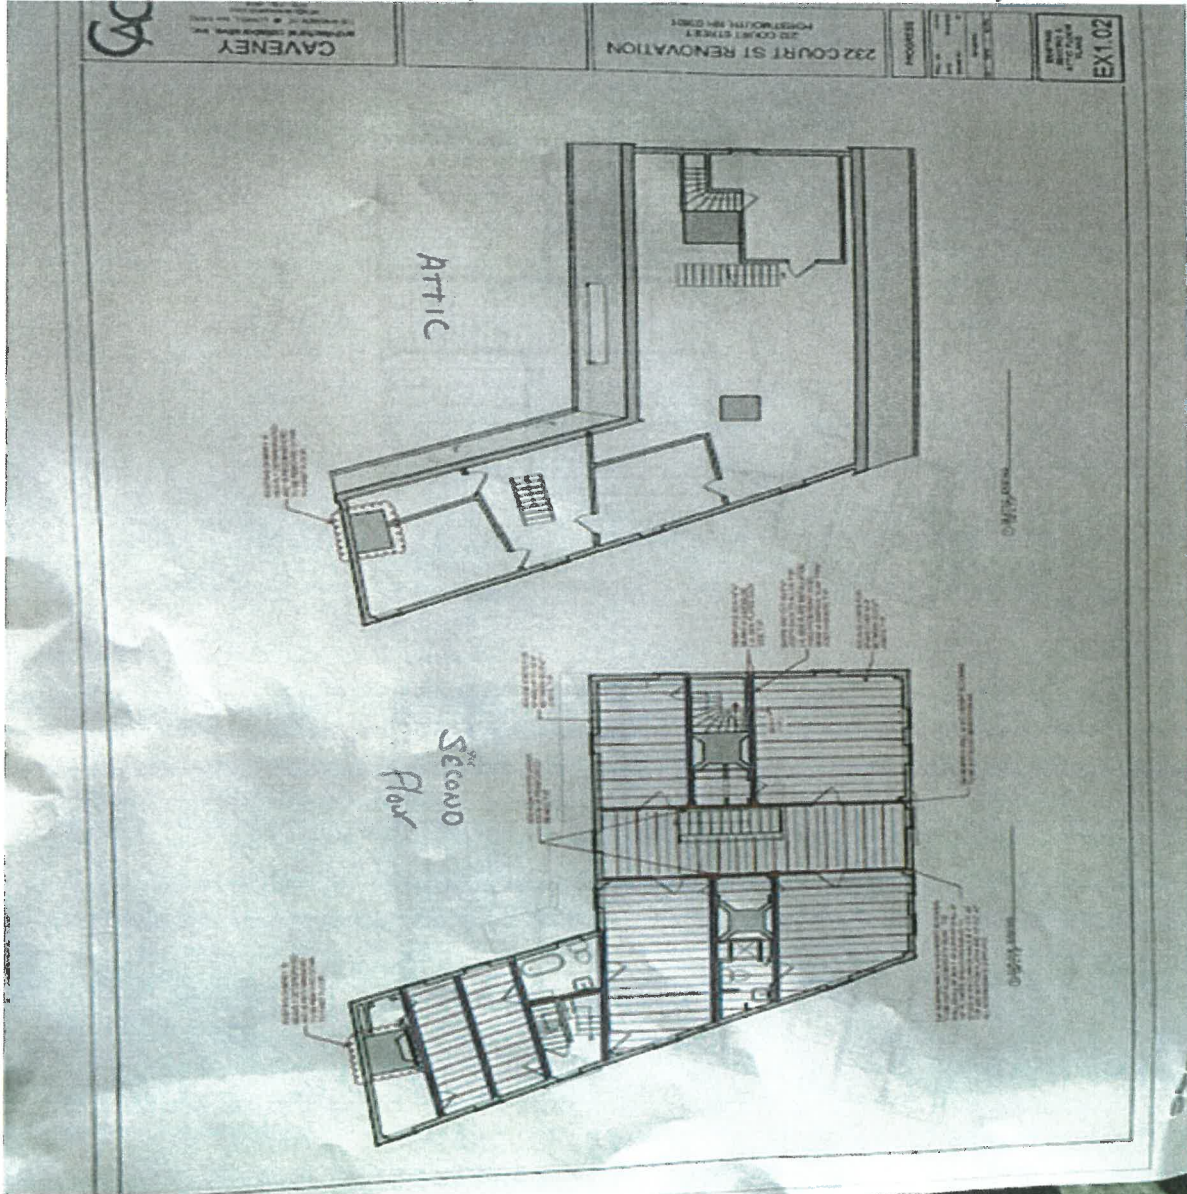
Here is a broad view of the chimney in attic and second floor from the blueprints.

EXISTING CHIMNEY IS  
HEAVILY DETERIORATED  
AND IS RECOMMENDED  
TO BE REMOVED DOWN  
TO FIRST FLOOR

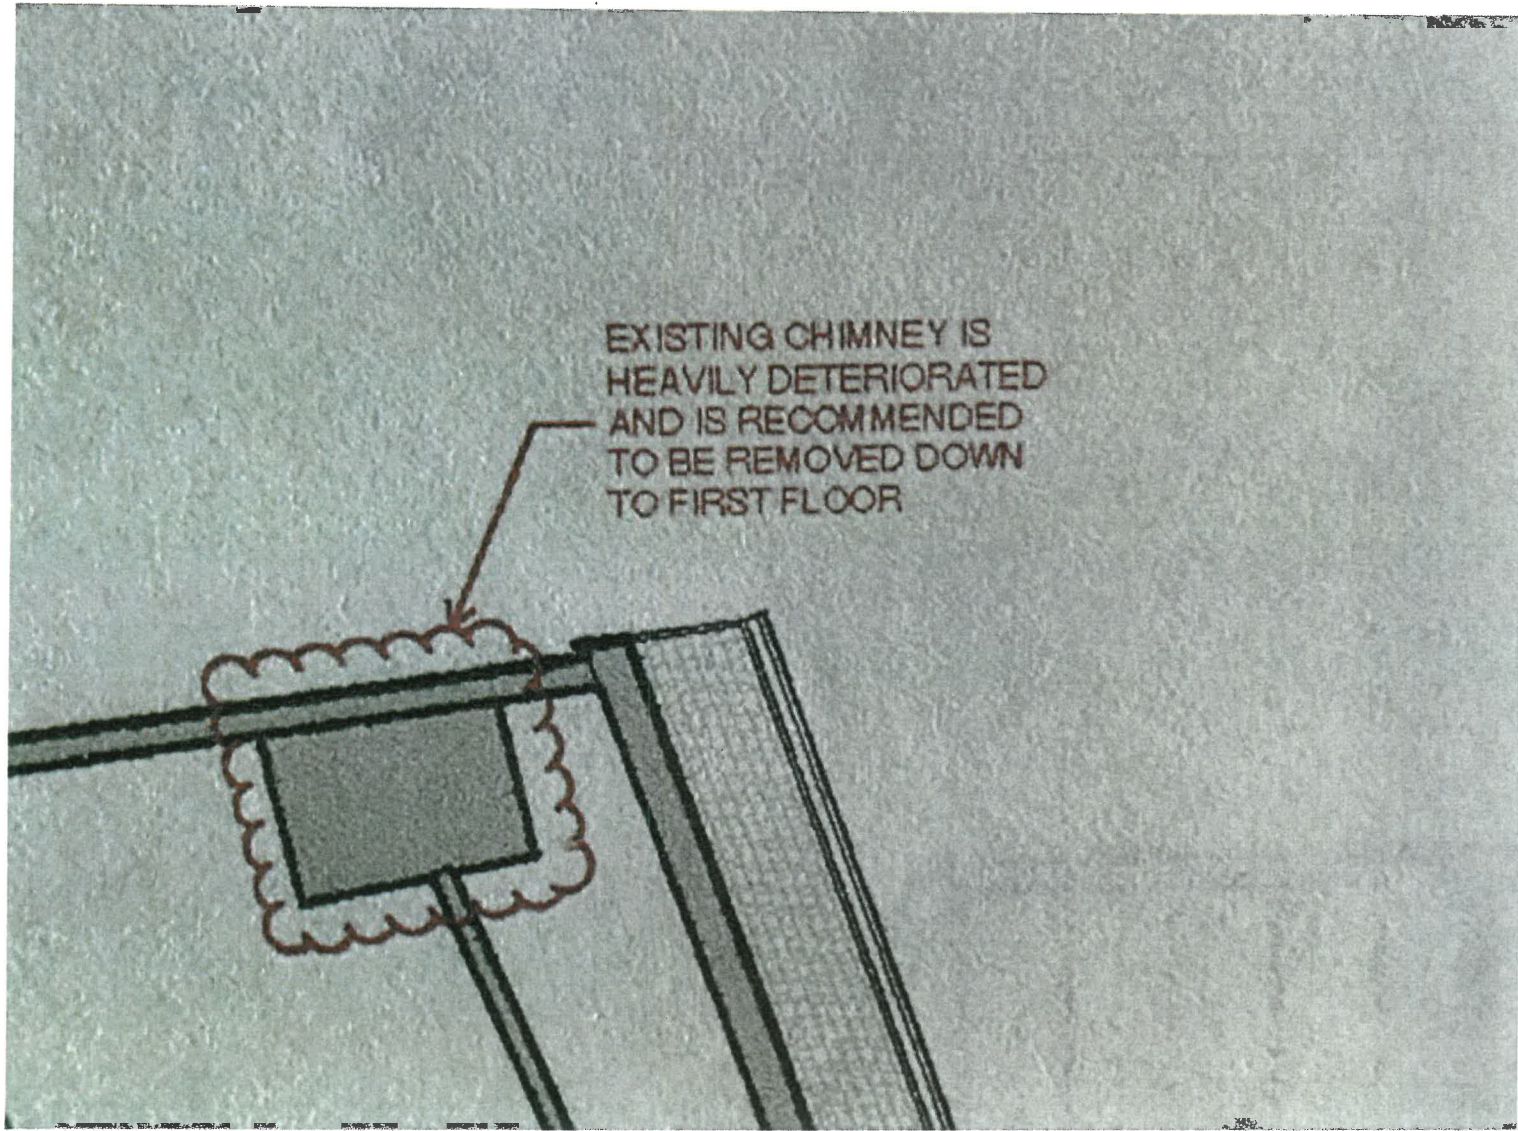
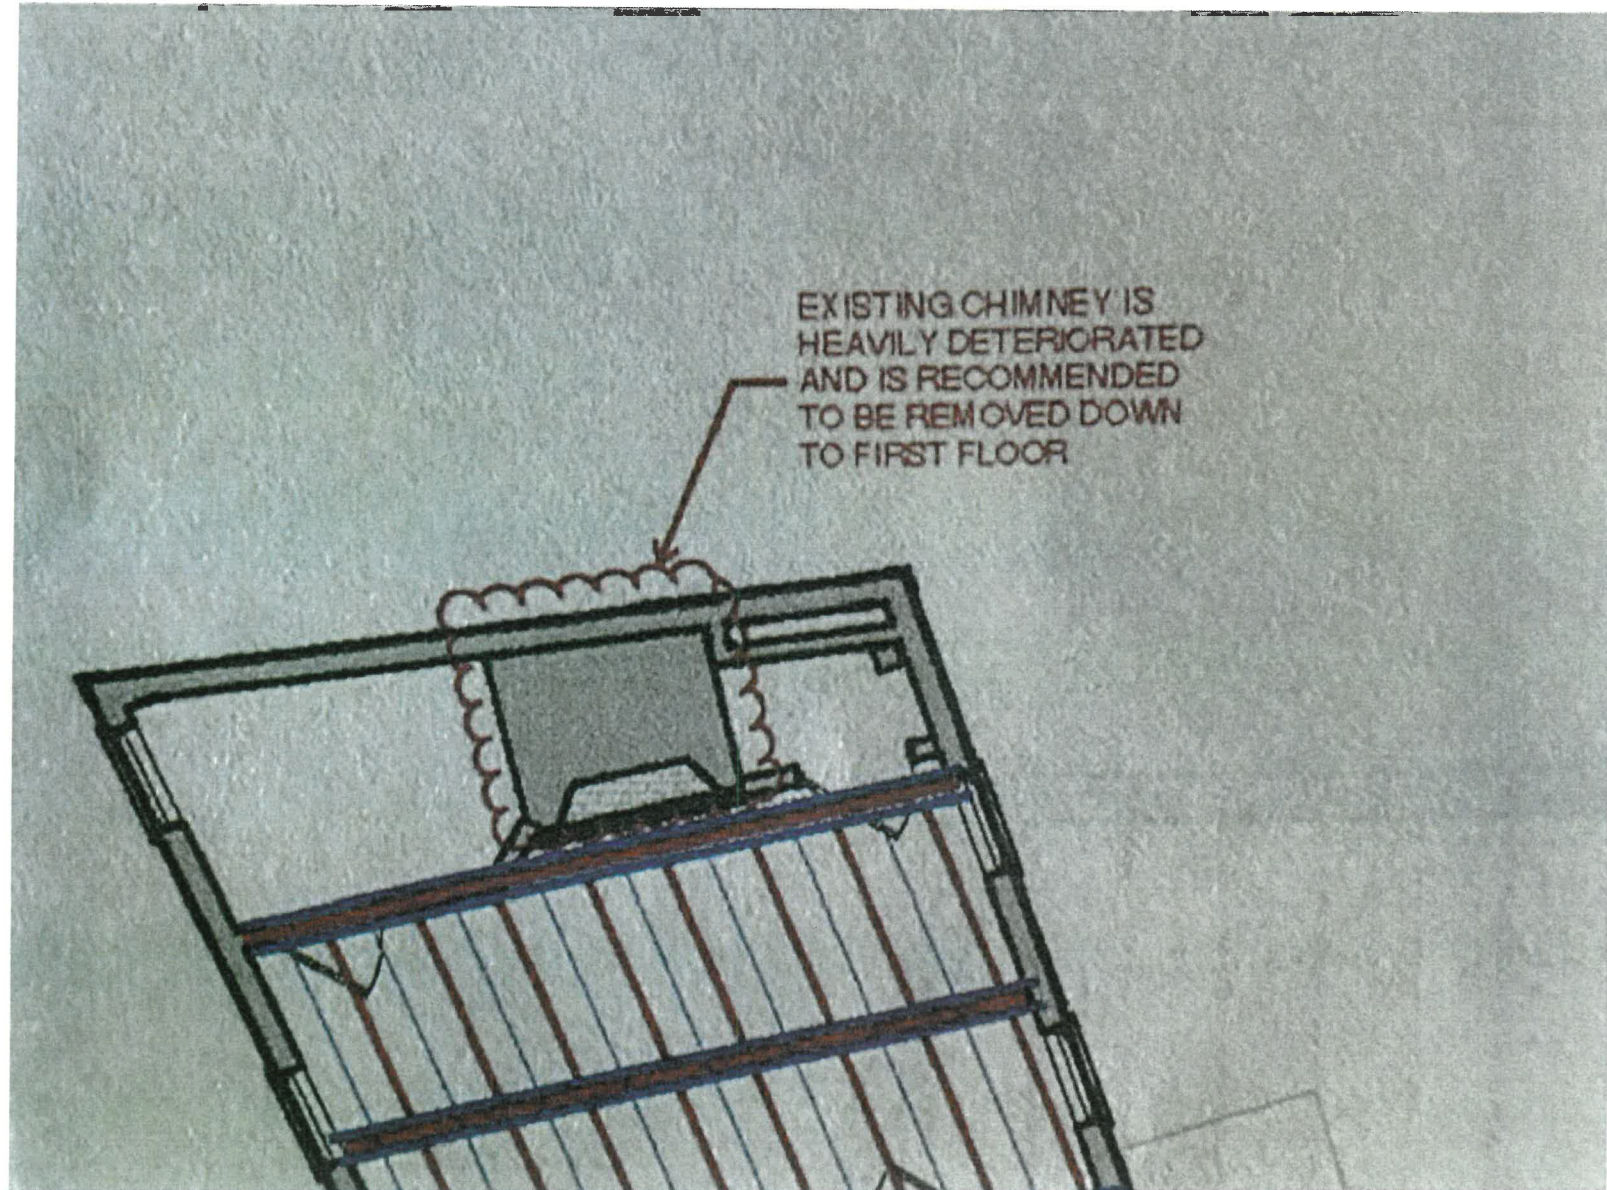
EXISTING CHIMNEY IS  
HEAVILY DETERIORATED  
AND IS RECOMMENDED  
TO BE REMOVED DOWN  
TO FIRST FLOOR

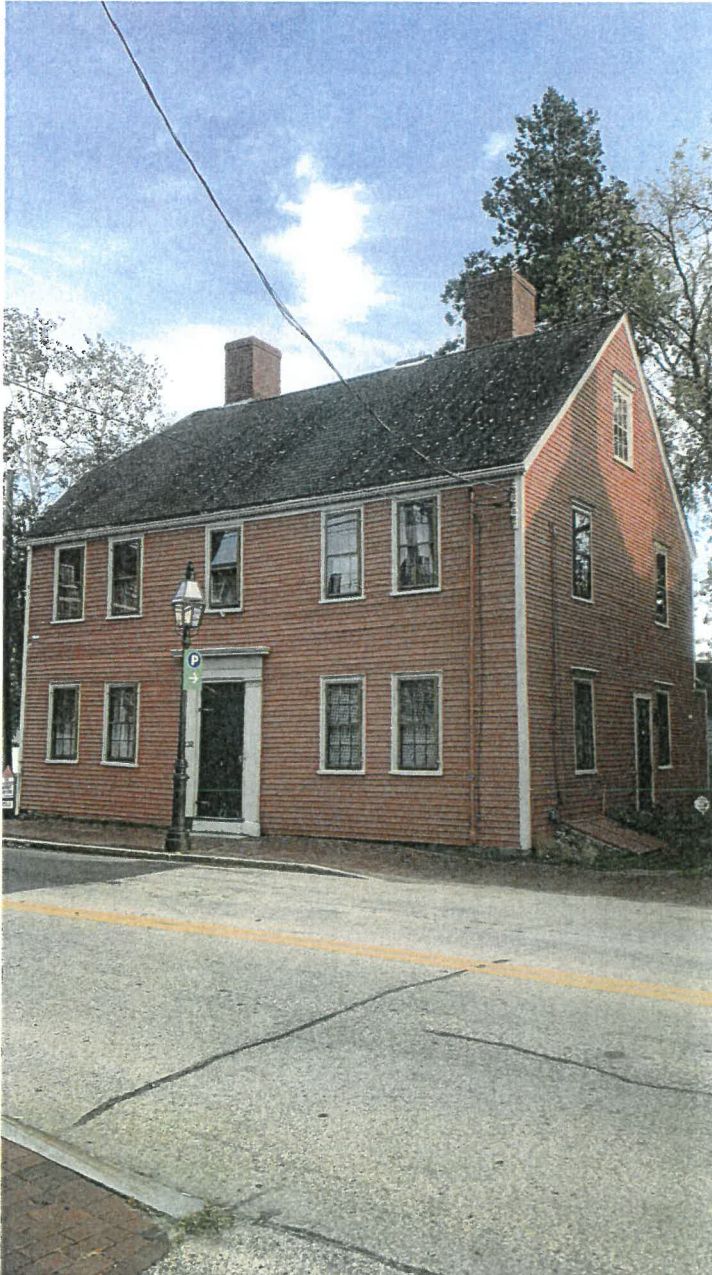
Here is an exterior view of the 2 chimneys that will remain

intact and visible from the front of Court St.

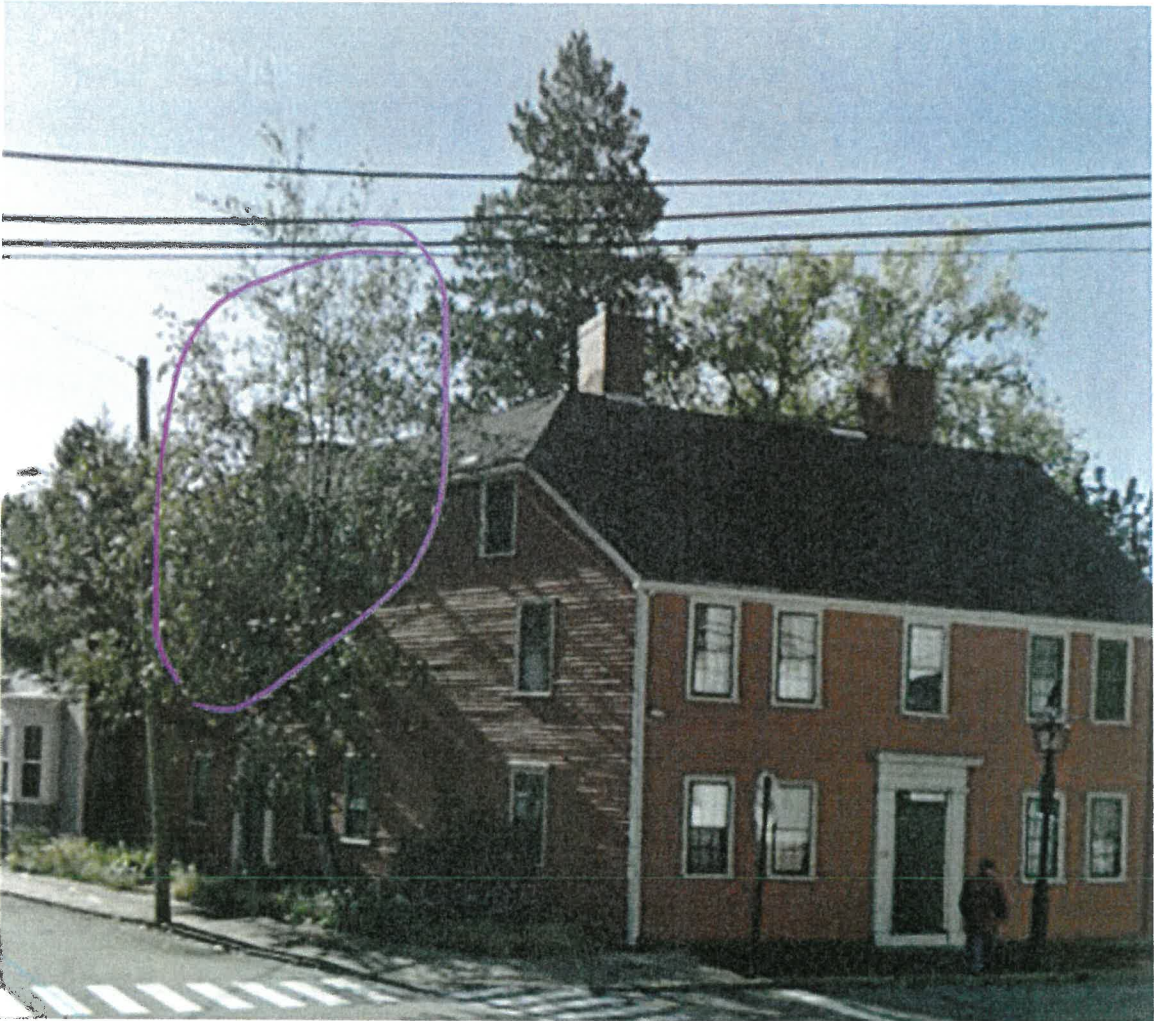
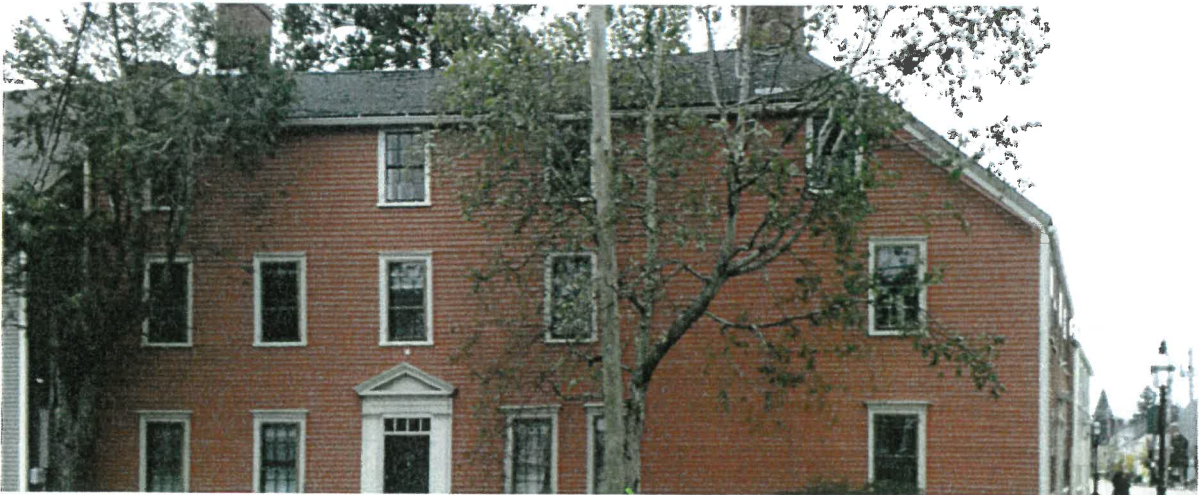
The existing brick chimney in the southeast end of the building is considered unsafe in its existing condition. Due to the apparent tilt in the top section within the attic, any repairs to the chimney would need to include straightening the leaning portion, replacing all compromised bricks, and repointing all mortar joints. Thus, it is recommended that the chimney be removed from the attic floor level and above, with all resulting holes in the framing infilled with 2x8s.

**Here is the failing chimney that will be removed.**

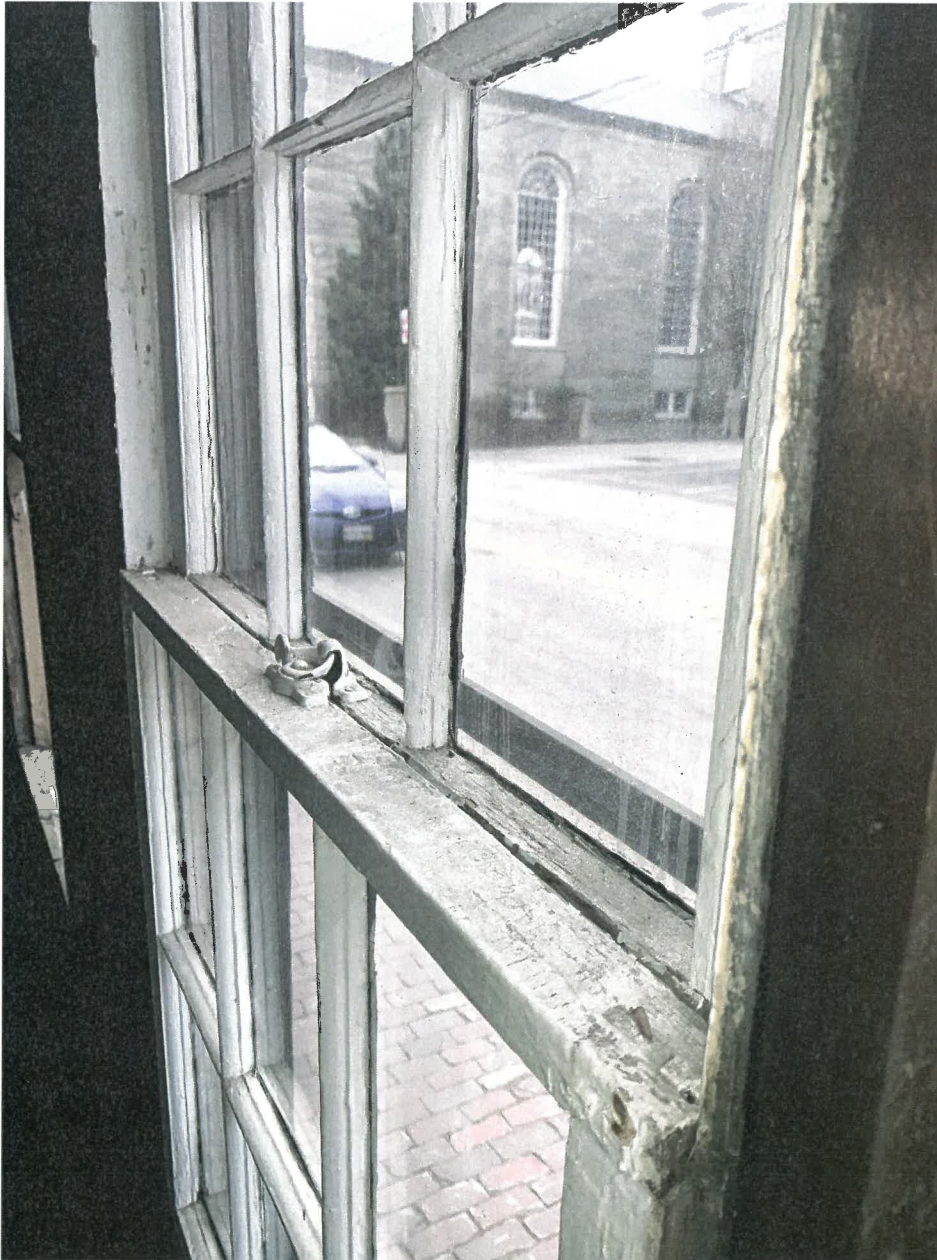
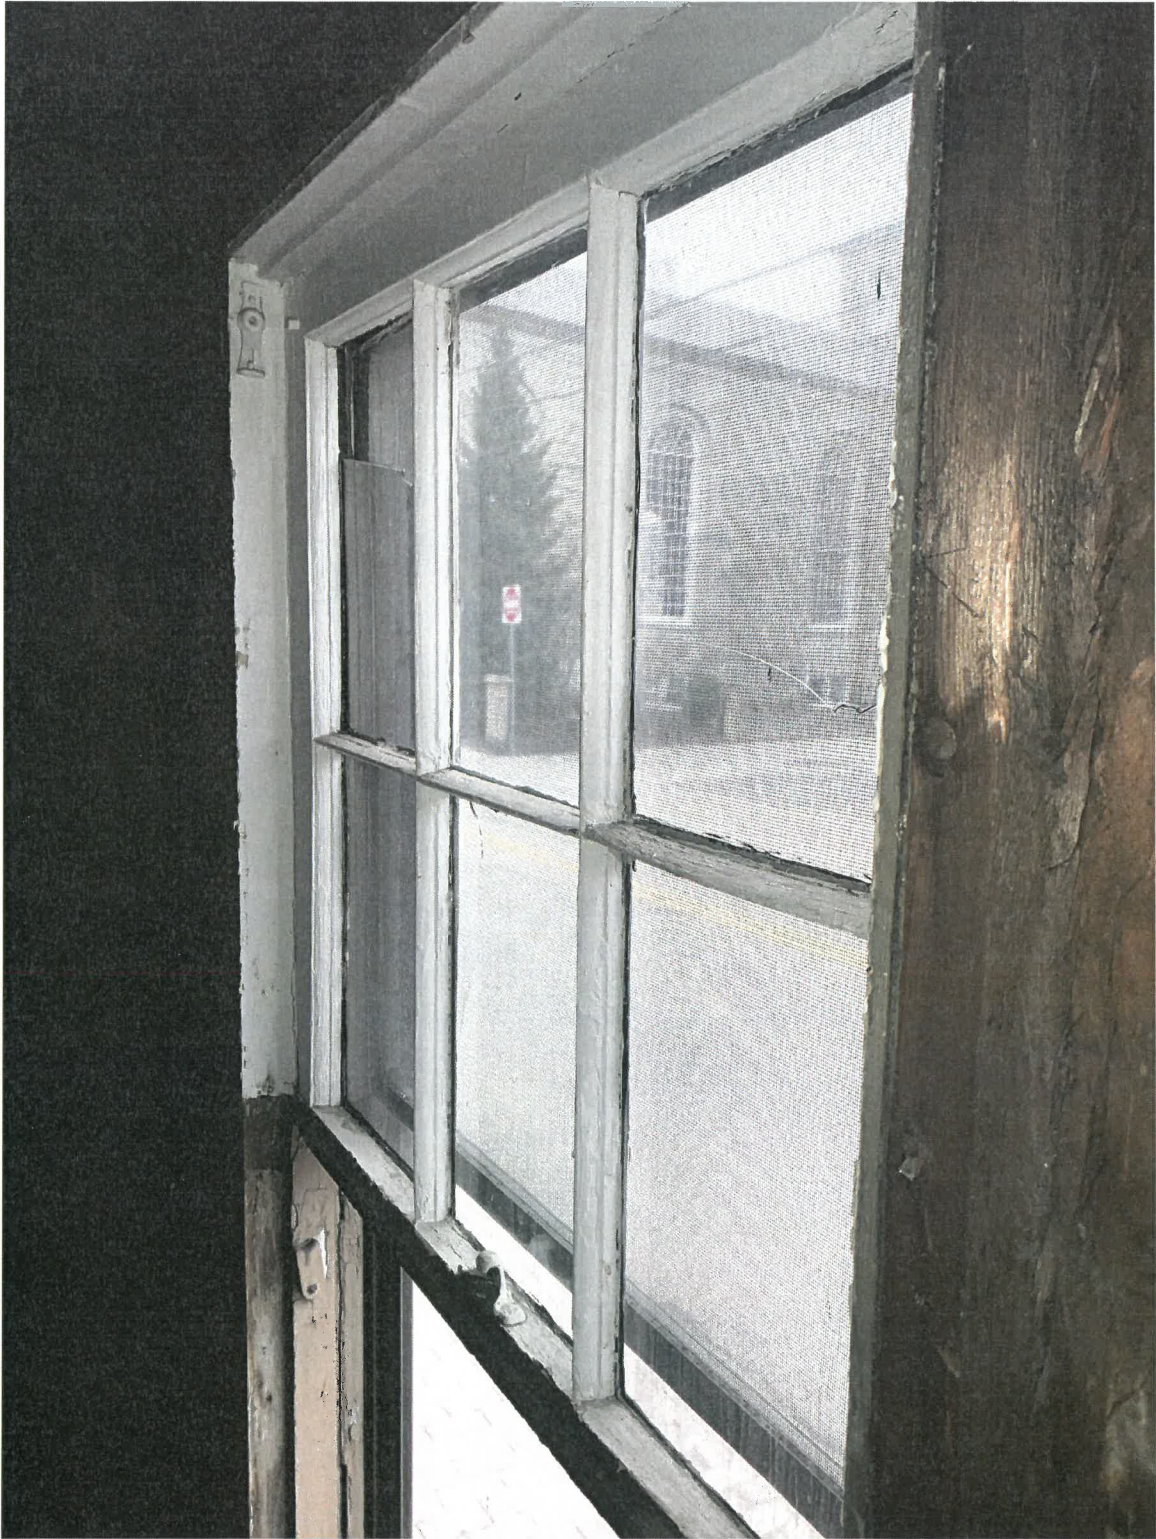
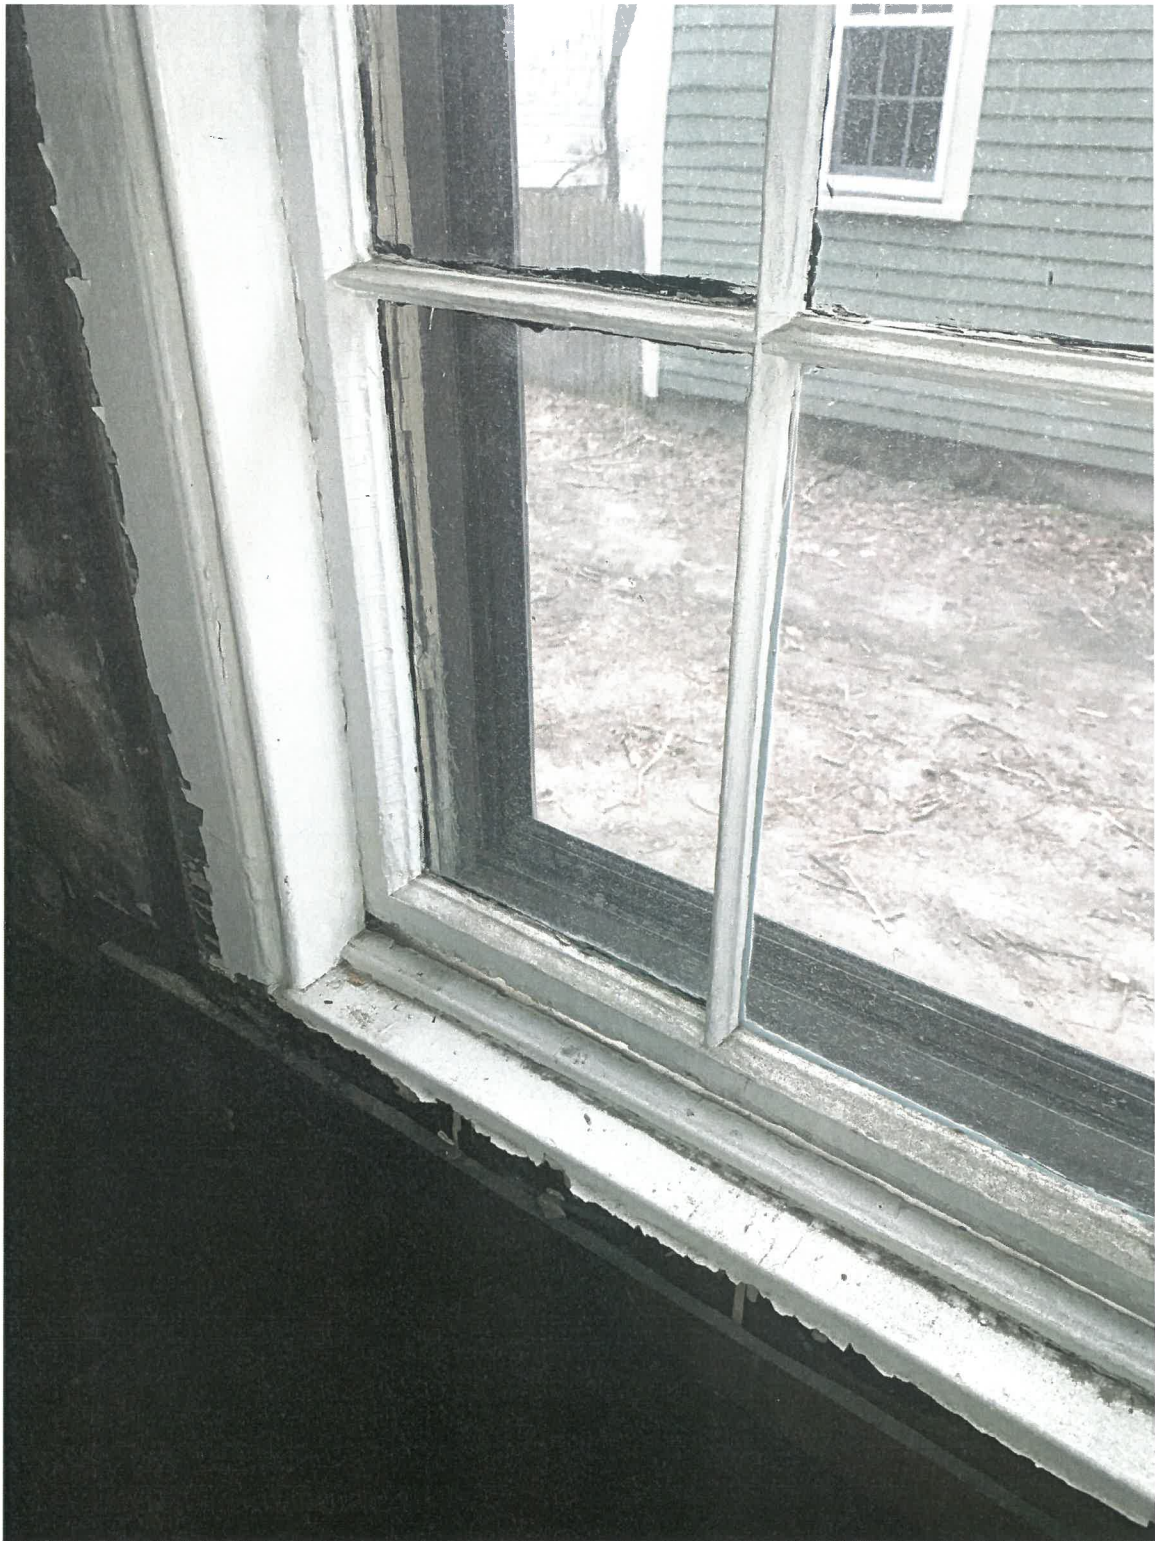
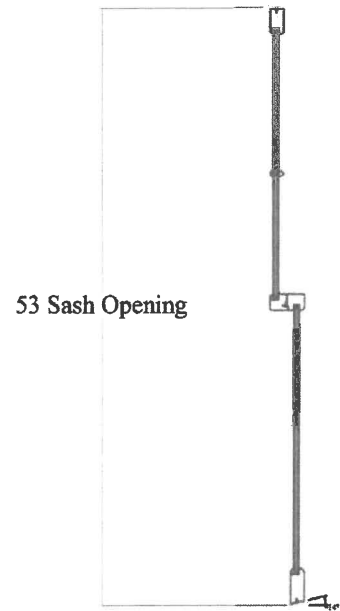
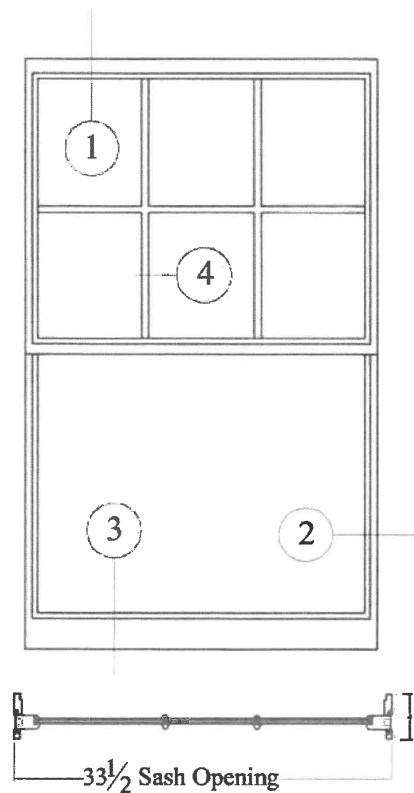
**Pictures of current failing windows in request to be replaced:**
