Tree Removal Proposal 10 FW Hartford Drive

Project representatives

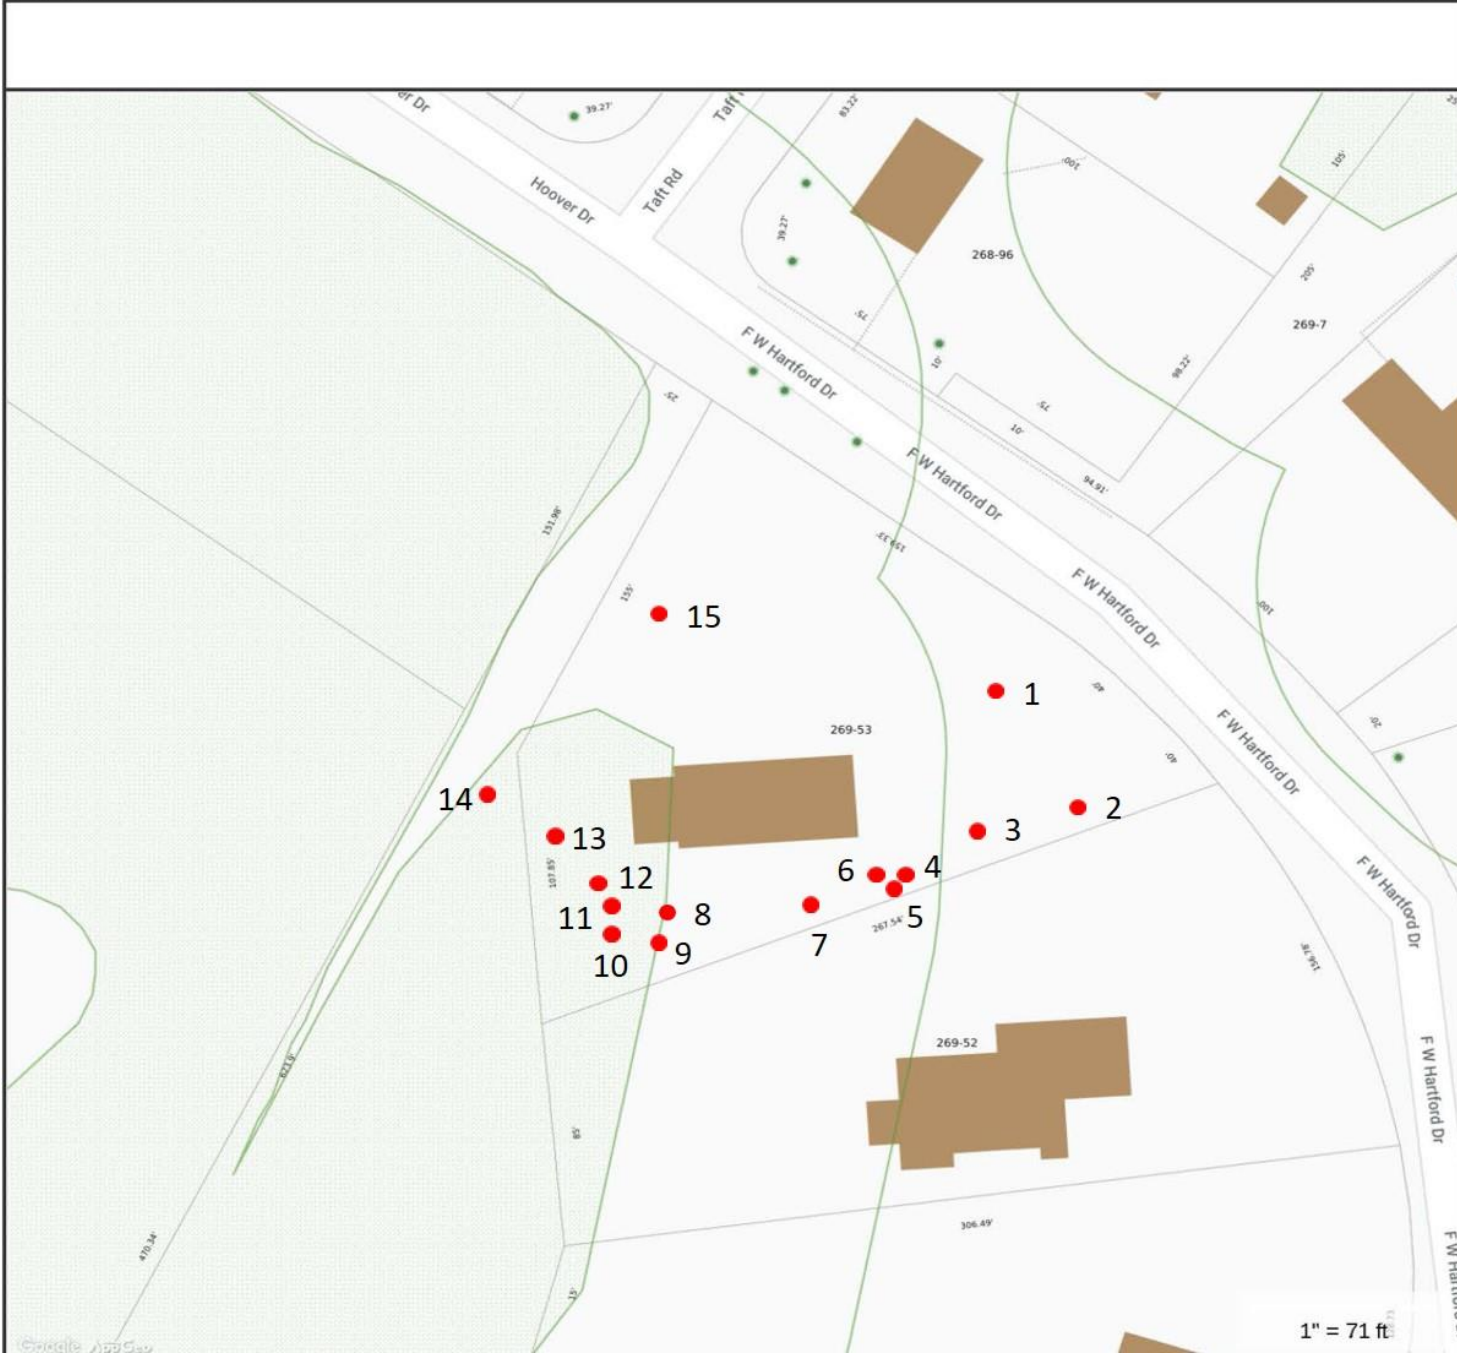
Plan showing the approximate location of the trees to be removed from 10 FW Hartford Drive. See individual description of the trees numbered in the plan.

Shaded green area indicates wetland. Green line outlines the 100 foot buffer zone

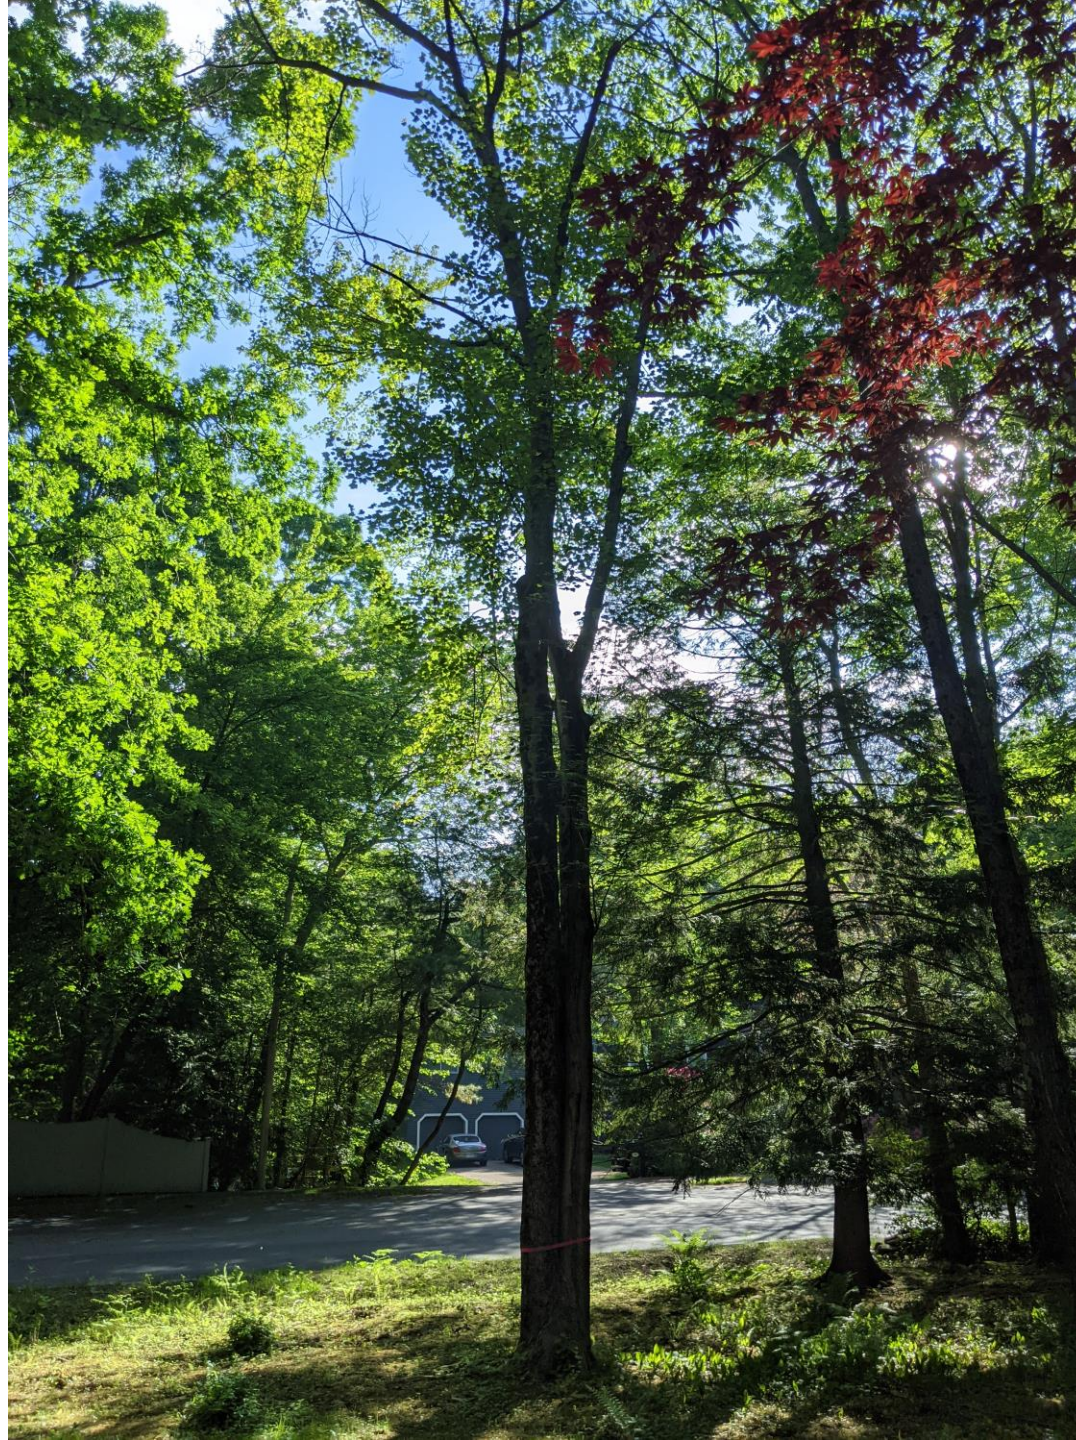
Tree 1

This tree is outside of the wetland and buffer zone. It is struggling and many of its branches are dead or dying

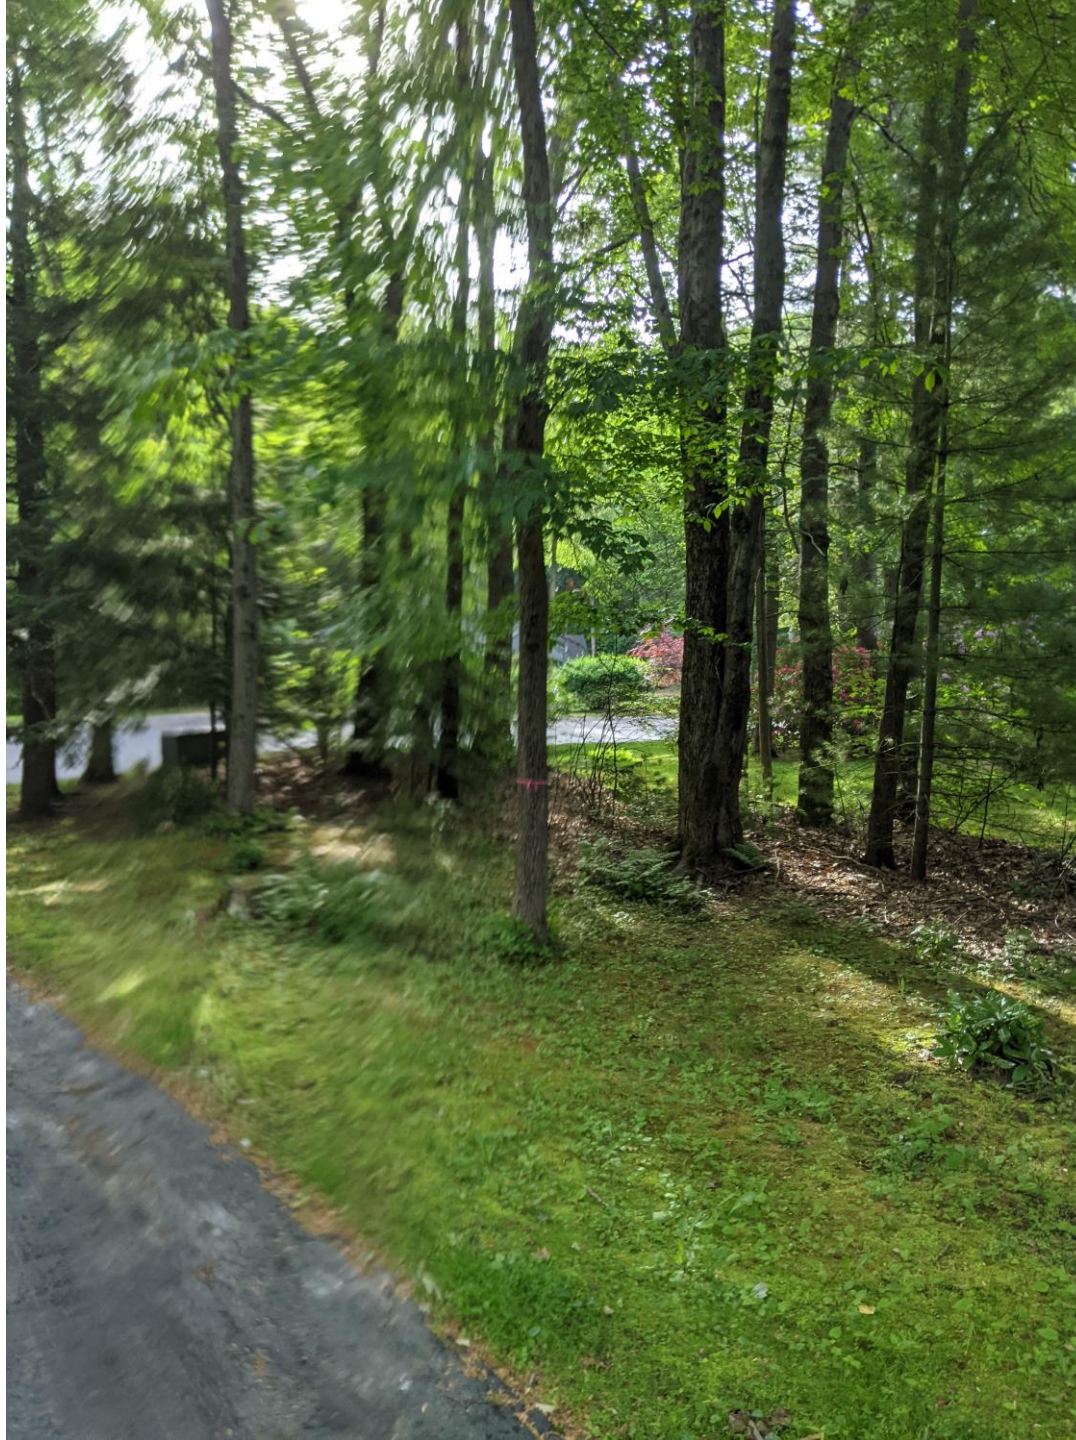
Tree 2

This tree is outside of the wetland and buffer zone. Felling it would help with the light and air circulation to our yard.

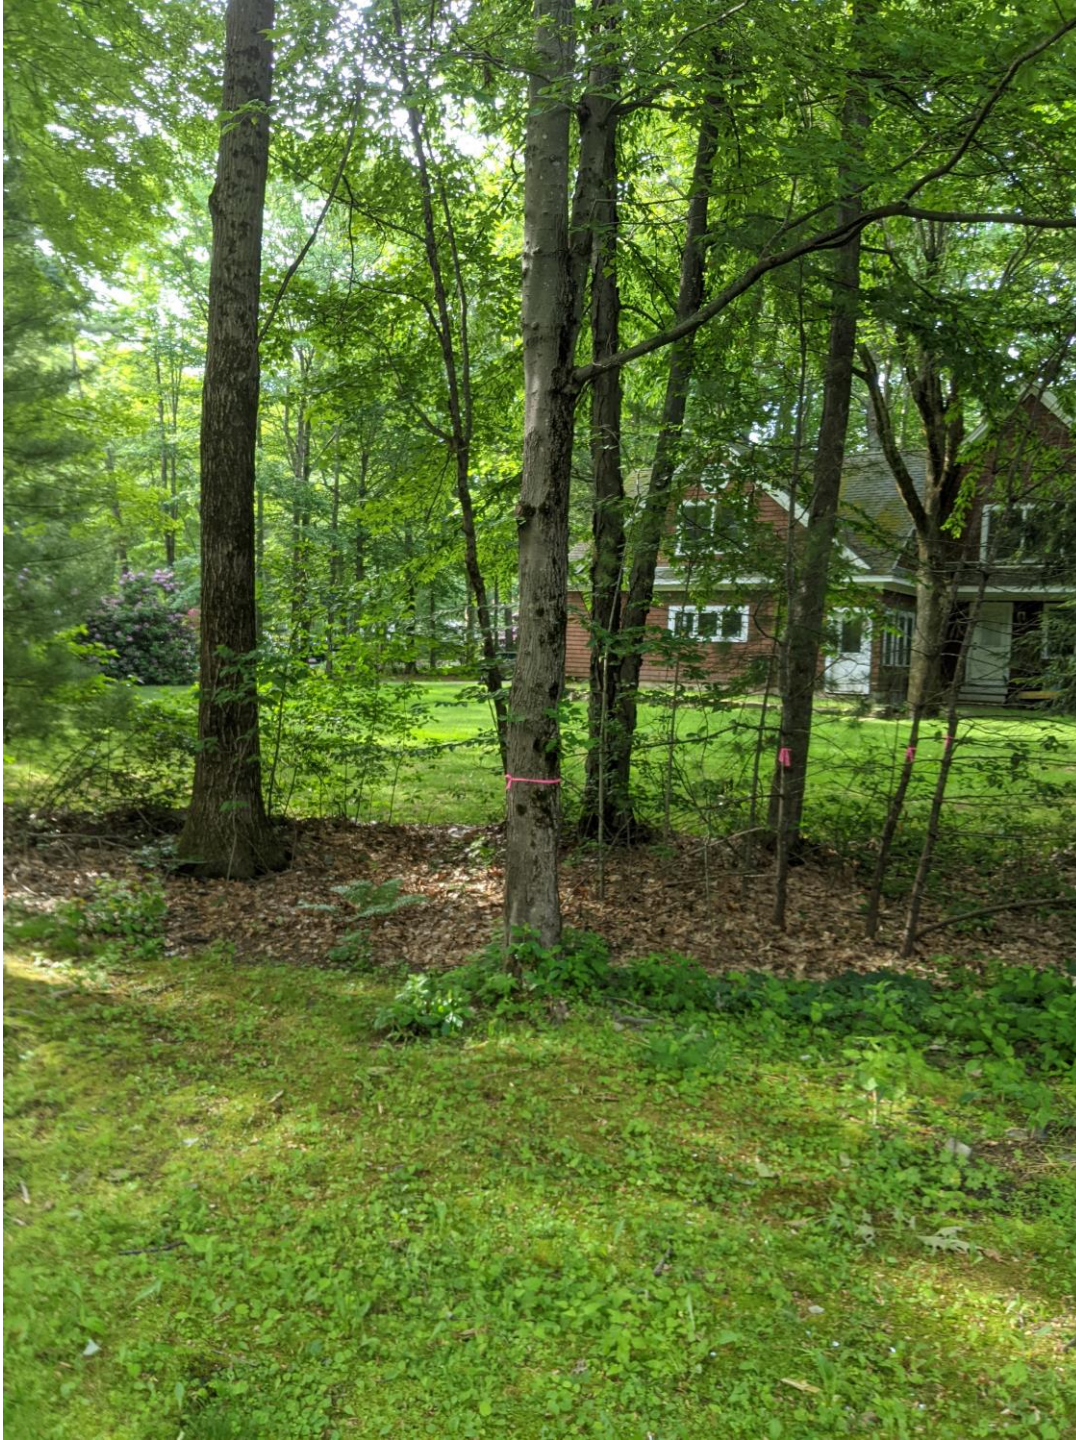
Tree 3

This tree is outside of the wetland and buffer zone. Felling it would help with the light and air circulation to our yard.

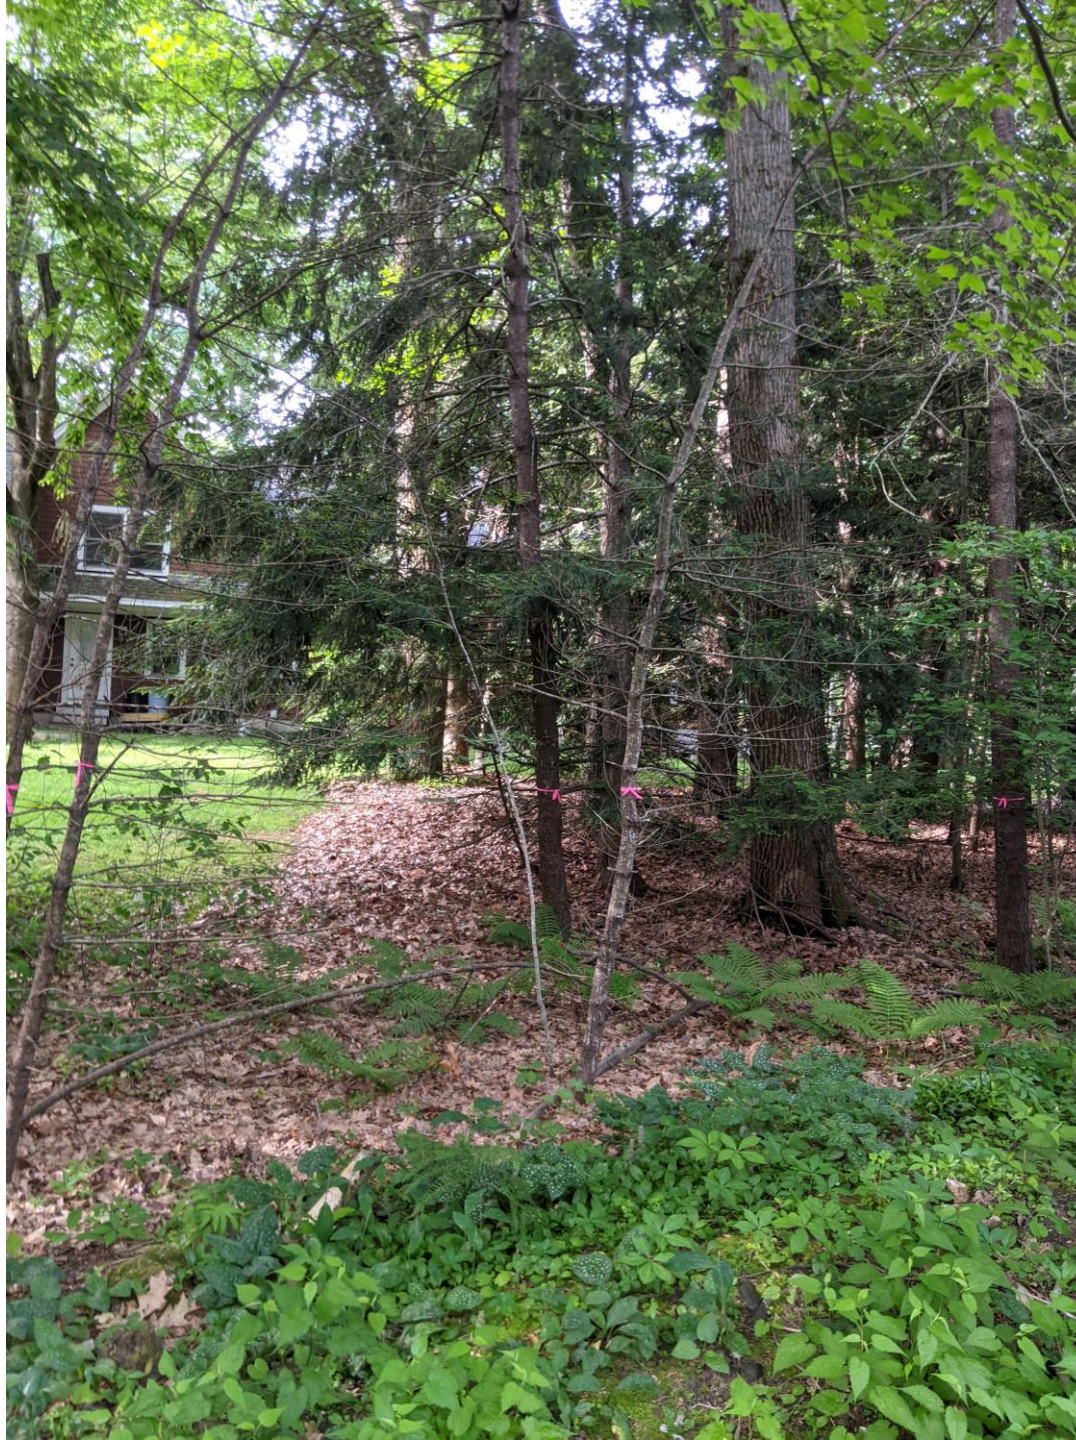
Tree 4 (background left)and tree 5 (background right)

The branches are dying, and the trees seems sick. Trees can fall on to the property if not removed.

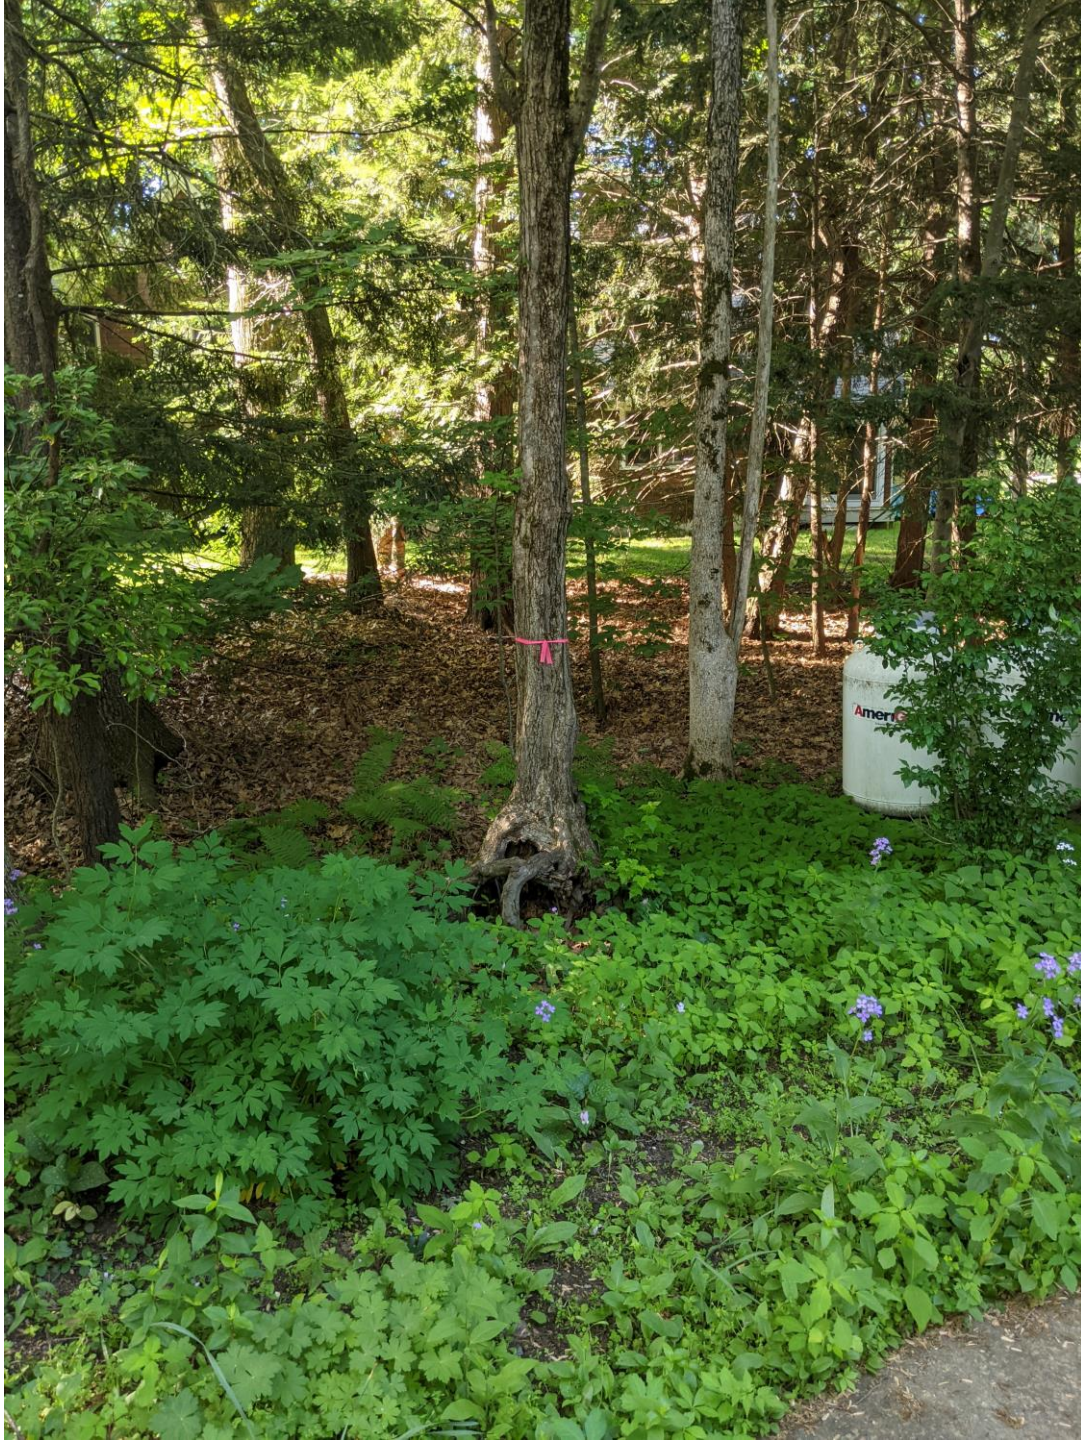
Tree 6

This tree exhibits dangerously exposed roots. It is unstable and threatens to fall on the propane tanks and the house located behind the photograph.

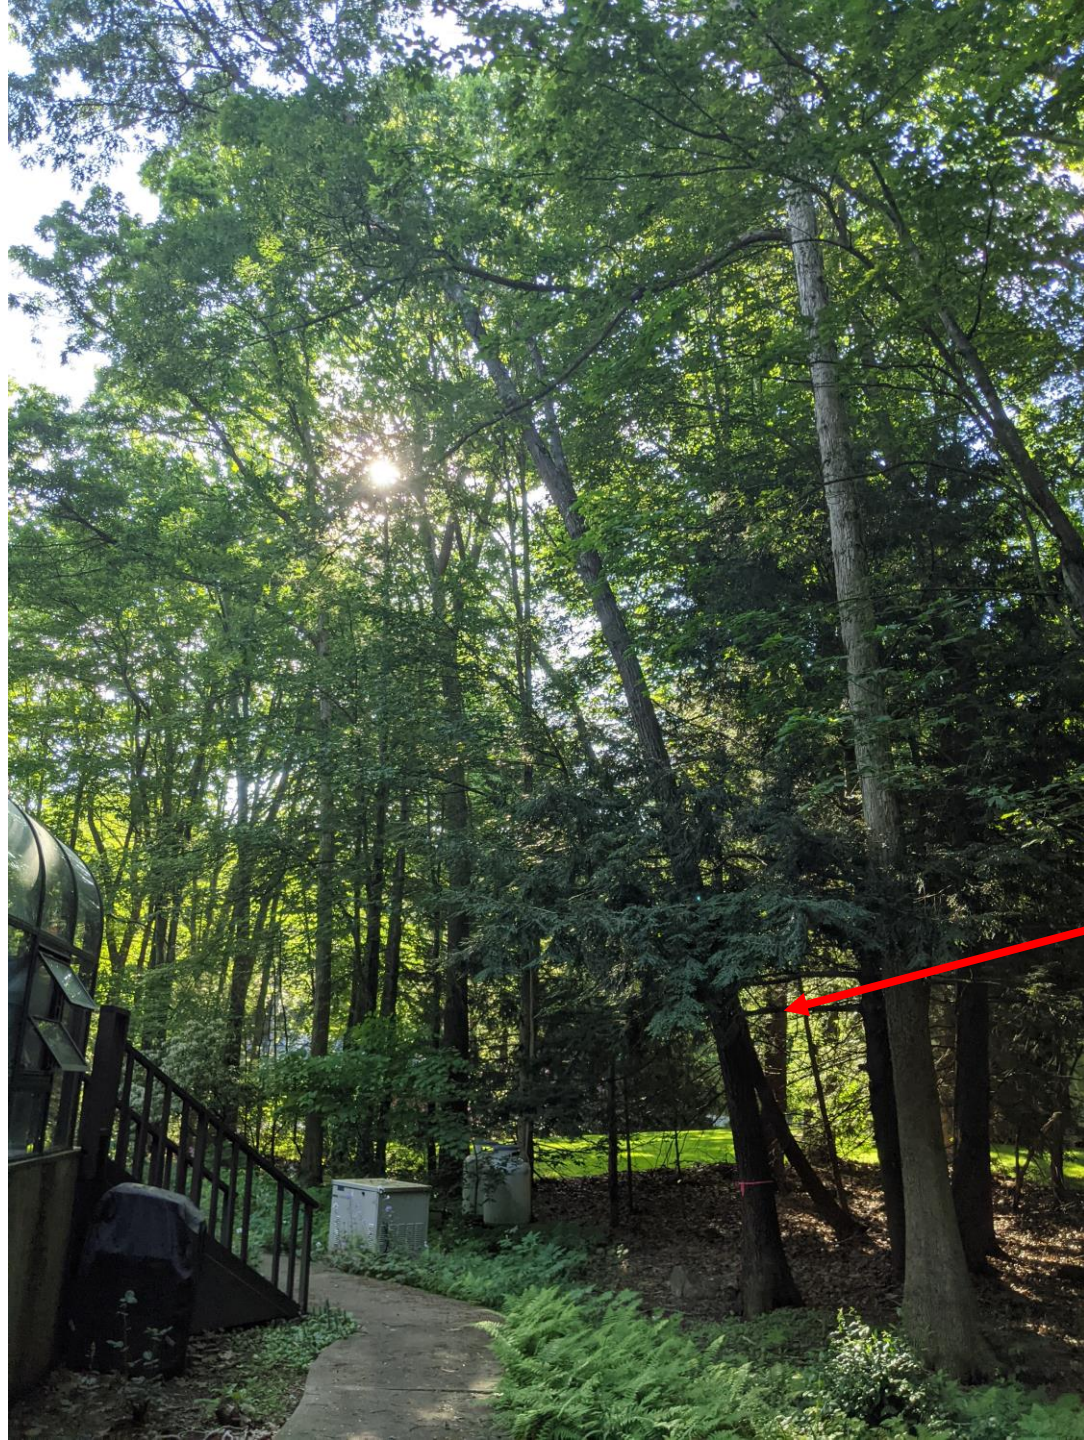
Tree 7

This tree leans dangerously over the house. It is in danger of snapping or falling onto the house.

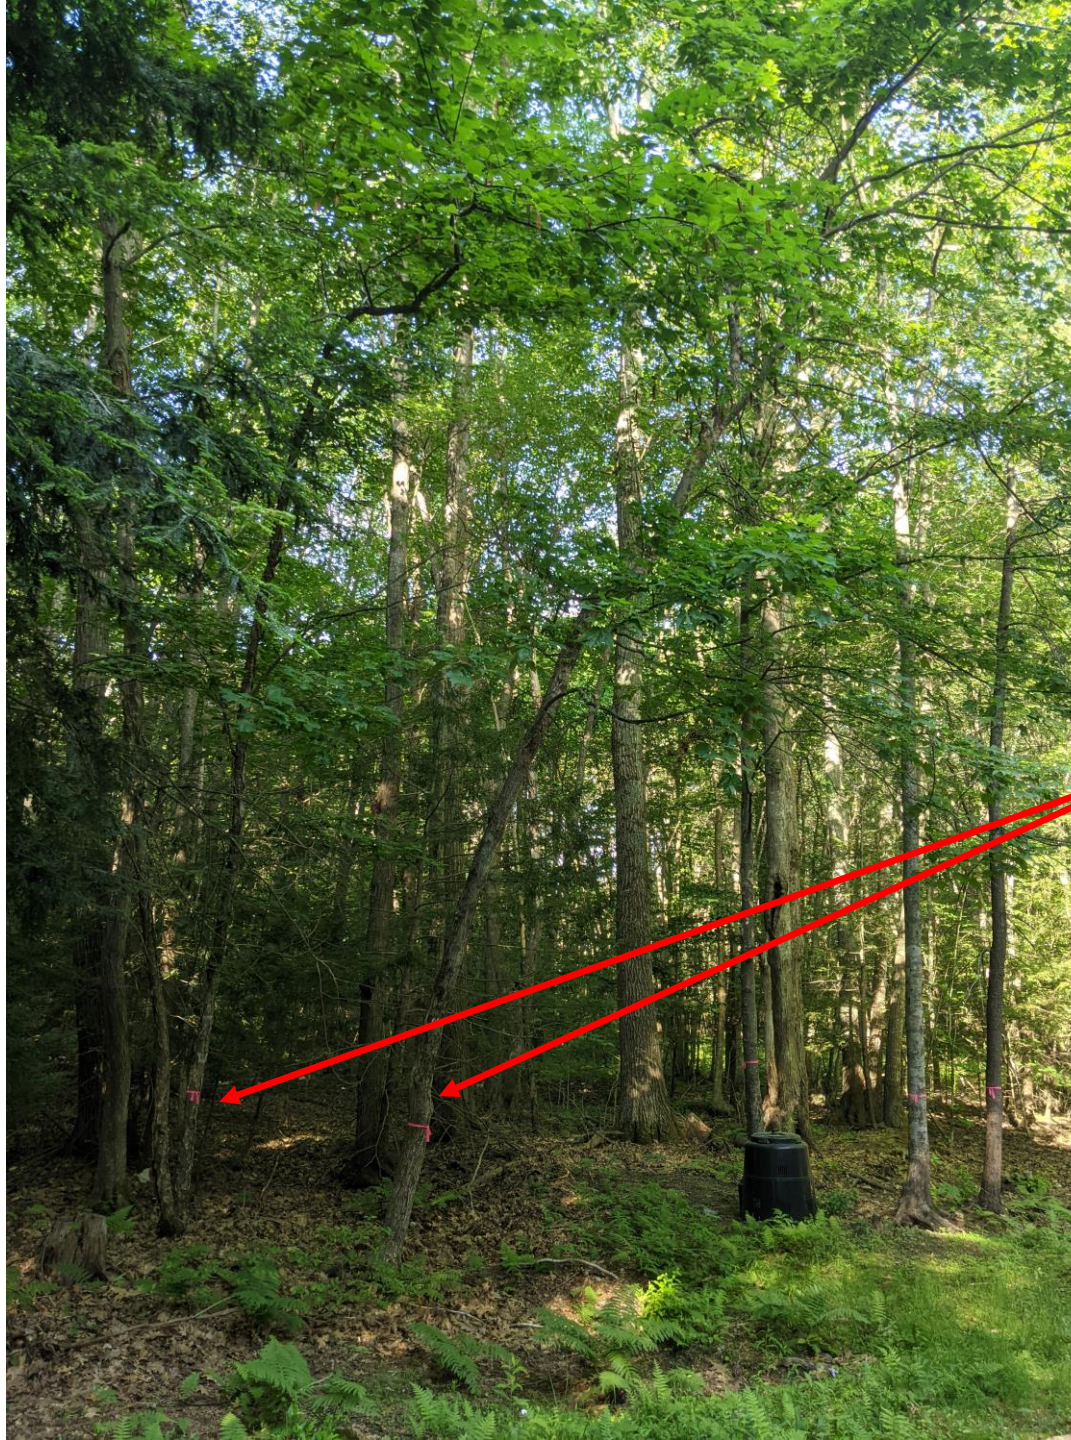
Trees 8 and 9

These two trees lean toward the house with their limbs almost touching the roof. Their removal would improve safety as well as air circulation to prevent moss growth on the concrete foundation, roof, and siding

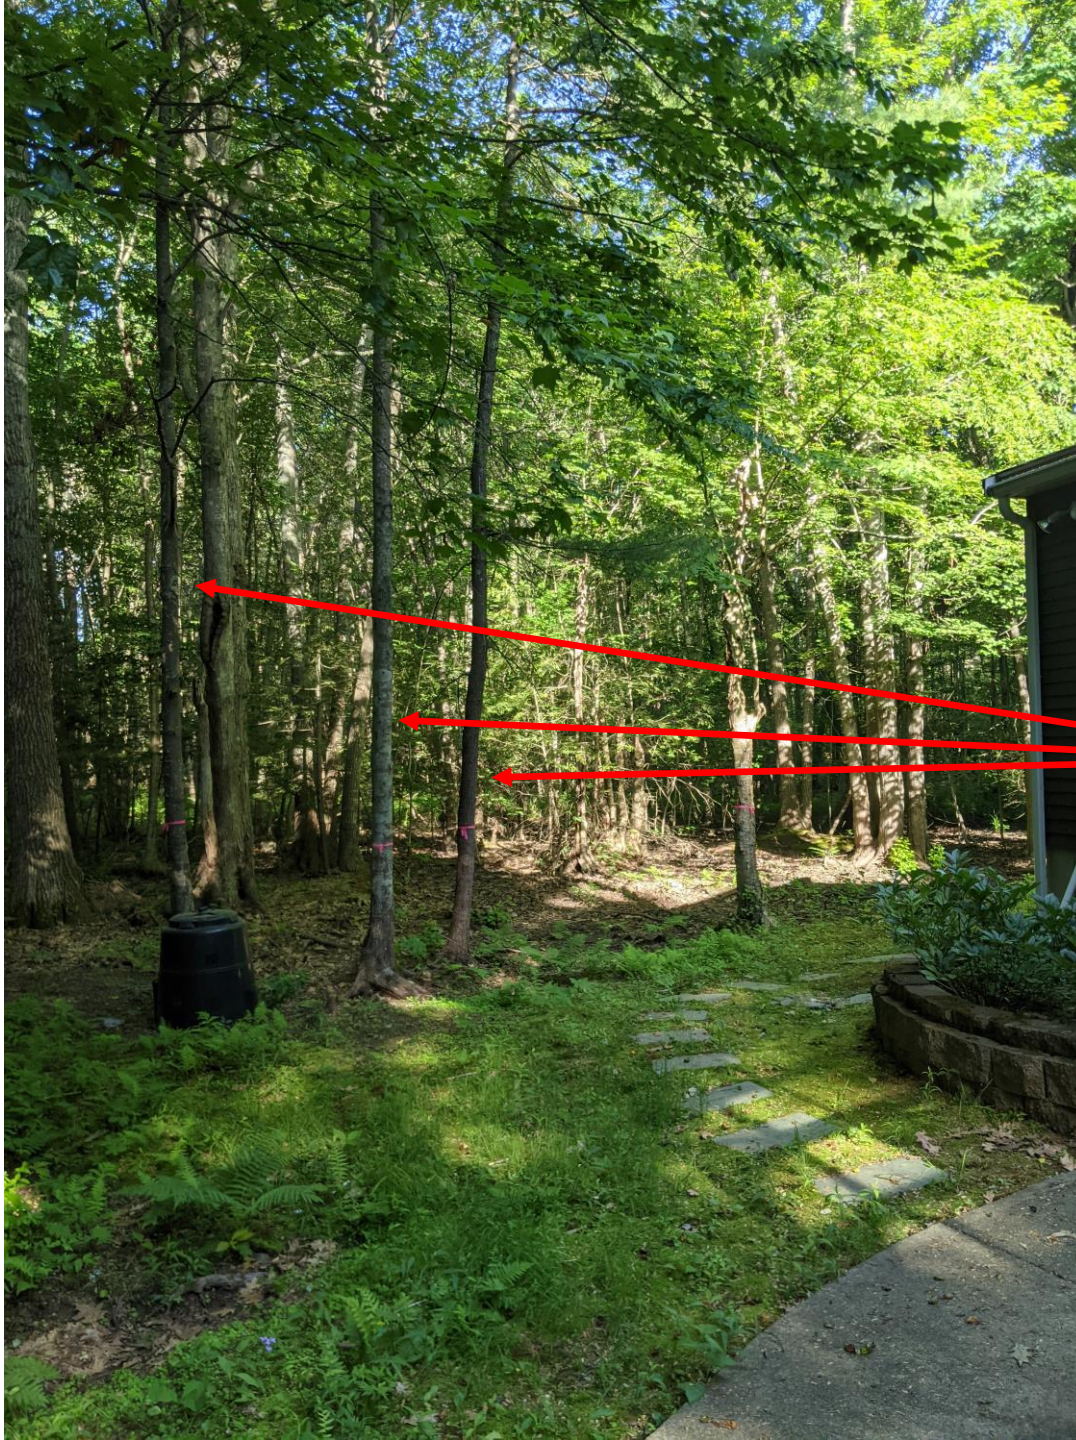
Trees 10, 11, and 12

These three trees lean toward the house with their limbs almost touching the roof. Their removal would improve safety as well as air circulation to prevent moss growth on the concrete foundation, roof, and siding.

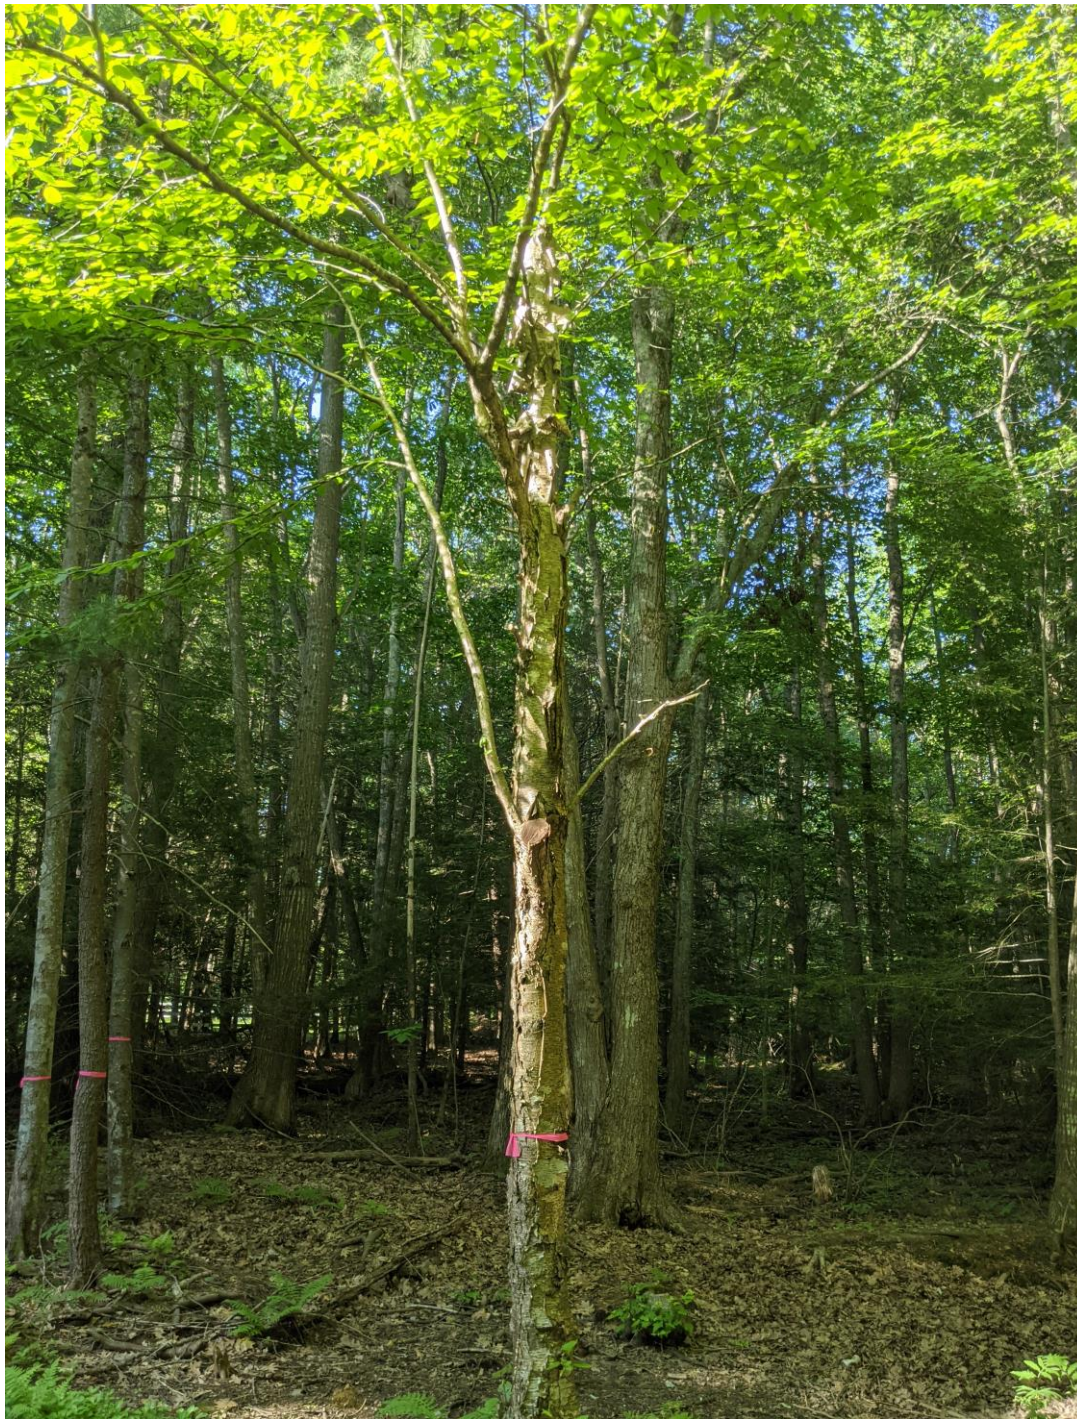
Tree 13

The top of this tree snapped off many years ago prior to us moving here. Its limbs almost touch the house. Any further pruning will almost certainly kill it. Better to remove it before it dies and threatens the house.

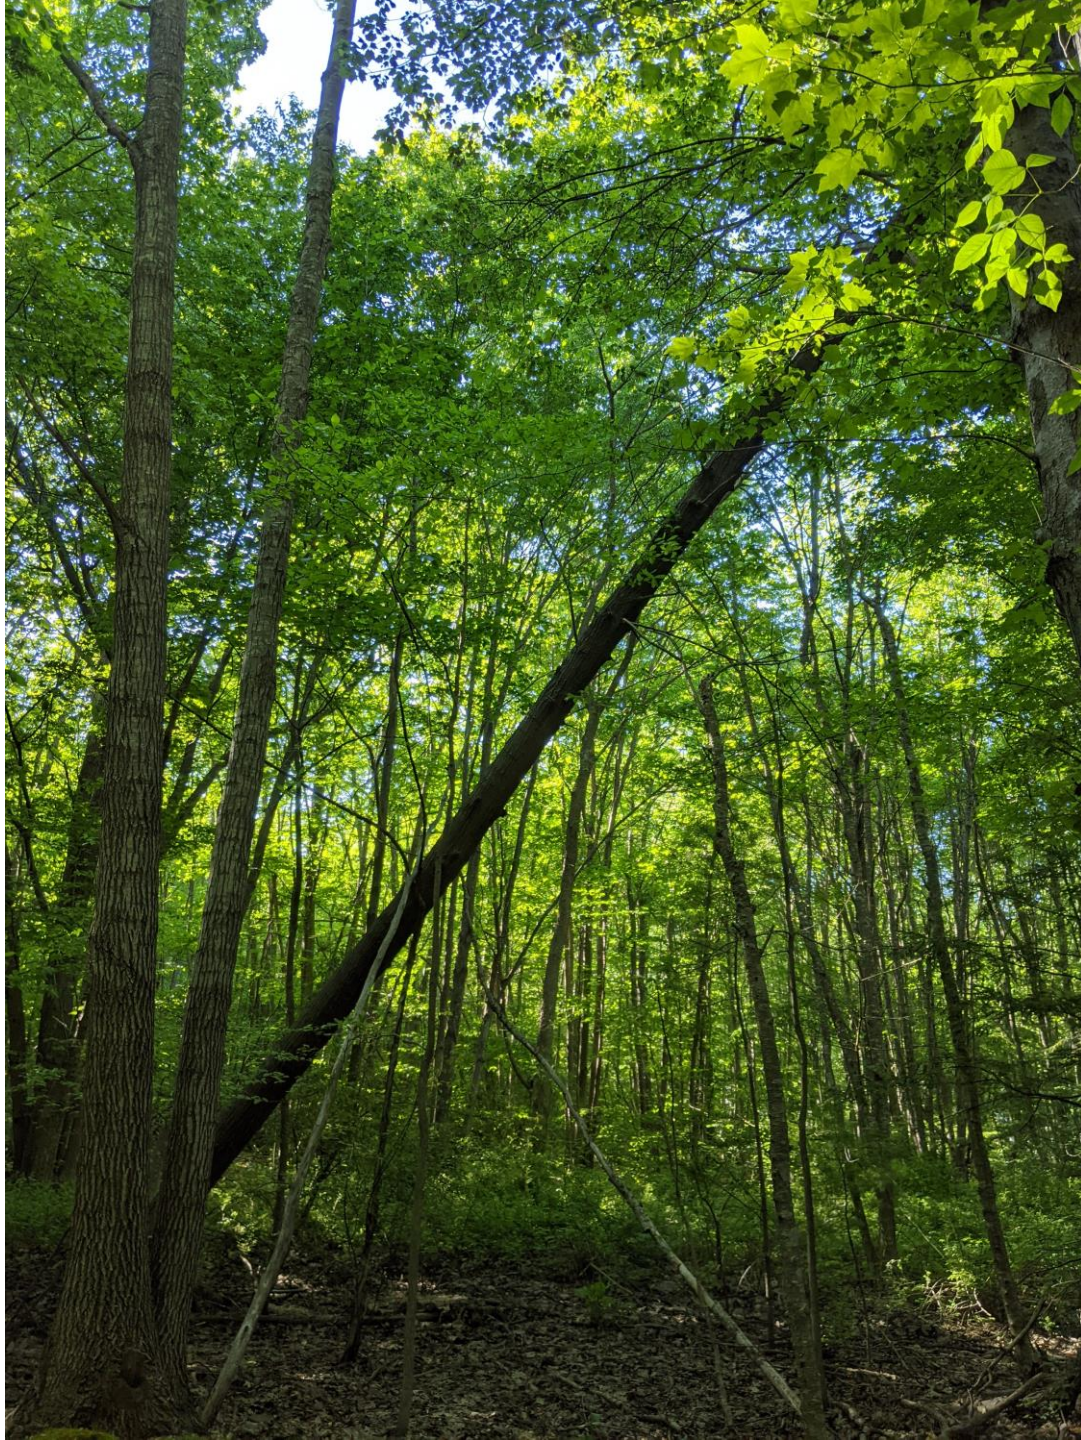
Tree 14

This tree leans heavily toward the back of the house and uses several other trees to hold it up. Its roots are heavily exposed. Given its size and instability it threatens to take several other trees with it when it falls.

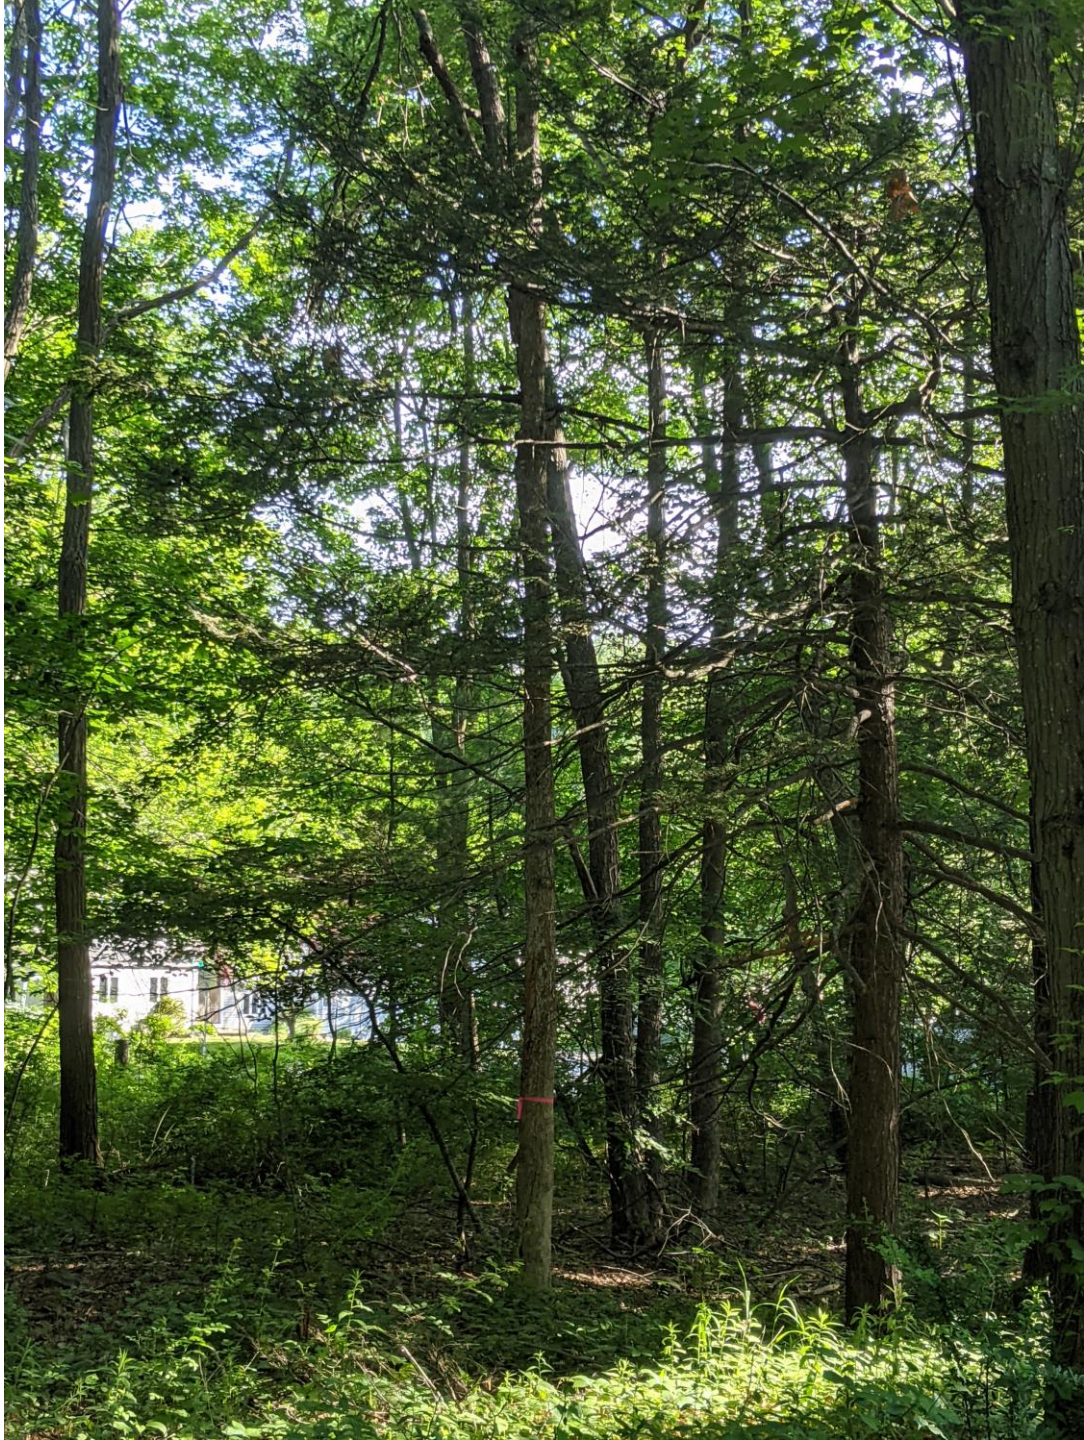
Tree 15

This is a dead tree in the buffer zone that has lost all its branches. It needs to be removed to prevent it from falling over on the property.
