June 11, 2020

Re: Portsmouth City Hall, Electrical Renovation Project  
Limited Building Survey Findings  
RPF File No. 209860

**OAK POINT ASSOCIATES**  
**Portsmouth Police Department**  
**1 Junkins Avenue, Portsmouth, NH**  
**Limited Survey of Various Rooms in the Basement and 1<sup>st</sup> Floor**

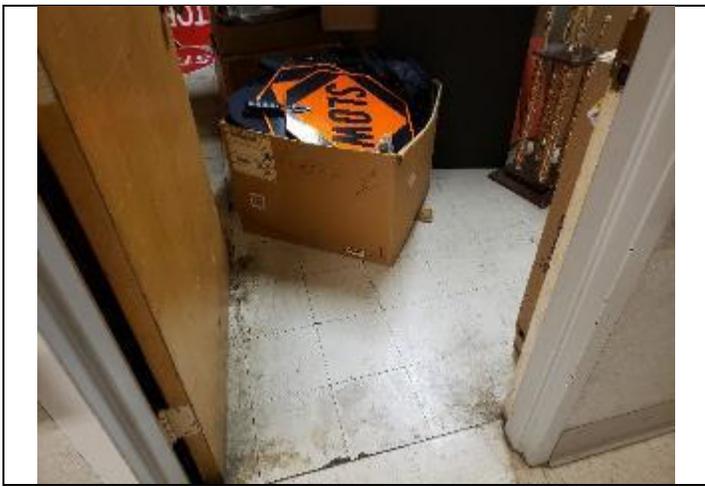
<b>Building Material</b>	<b>Location</b>	<b>Approximate Quantity</b>	<b>EPA Category</b>	<b>Asbestos Results</b>
White 9” Floor Tile & Mastic	1 <sup>st</sup> floor, Rooms 135 and 137	350 square feet	Category II Nonfriable	5% Chrysotile

The ACM identified during this survey consists of nonfriable material which was observed to be in good to fair condition and, left undisturbed and properly managed, is unlikely to cause any major fiber release episodes.

1. Room 137, ACMB white 9" floor tile and mastic present.

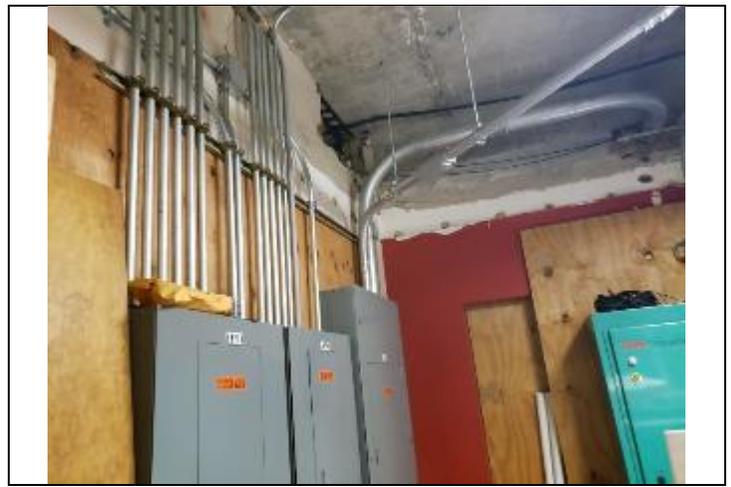
2. Room 137, electrical components present.

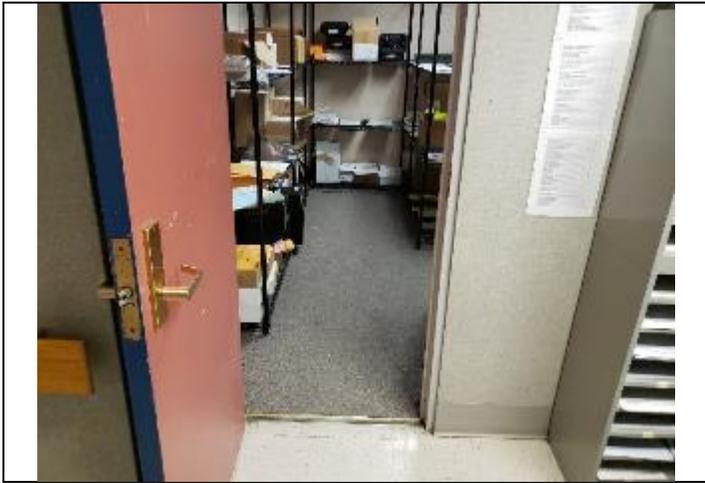
3. View of Room 135.

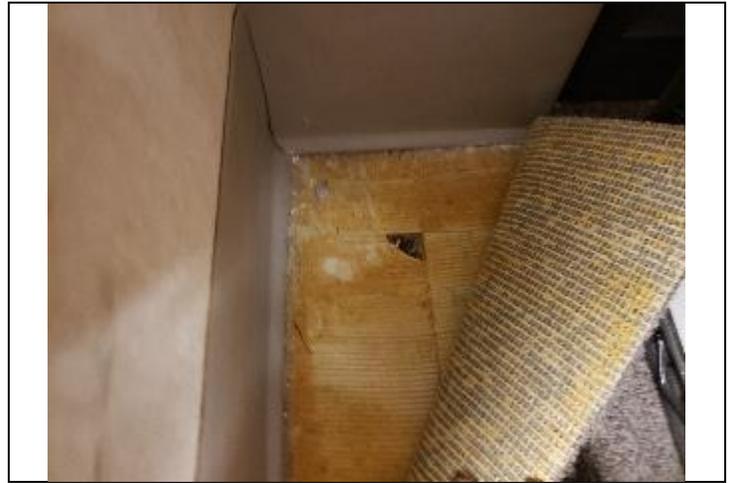
4. ACMB white 9" floor tile and mastic present under the carpet in Room 135.

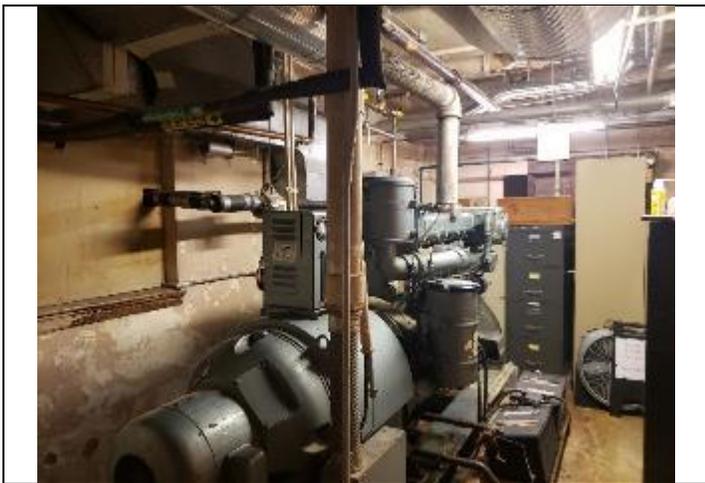
5. Room 125, lead paint present.

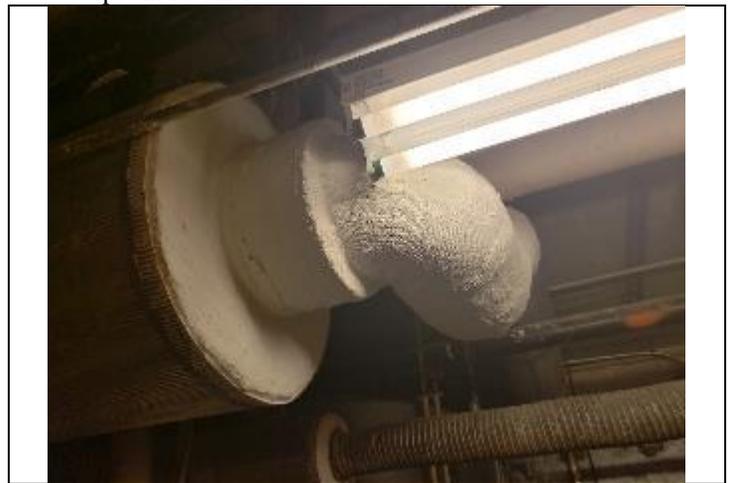
6. White canvas insulation on exhaust pipe in Room 125, no asbestos detected.

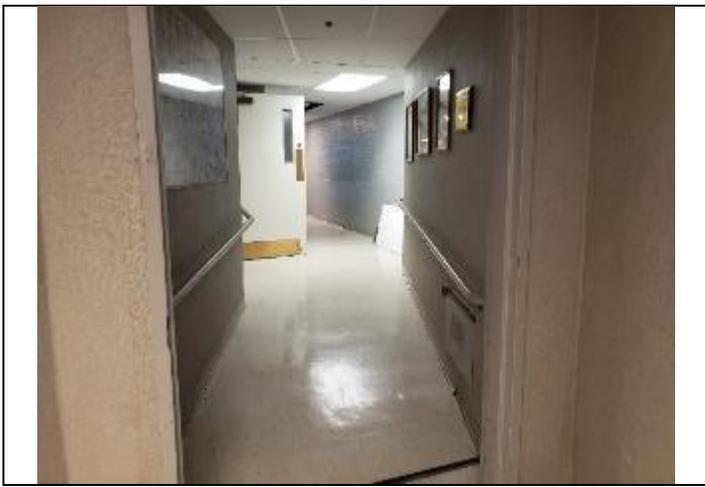
7. Hallway outside Rooms 125 and 126.

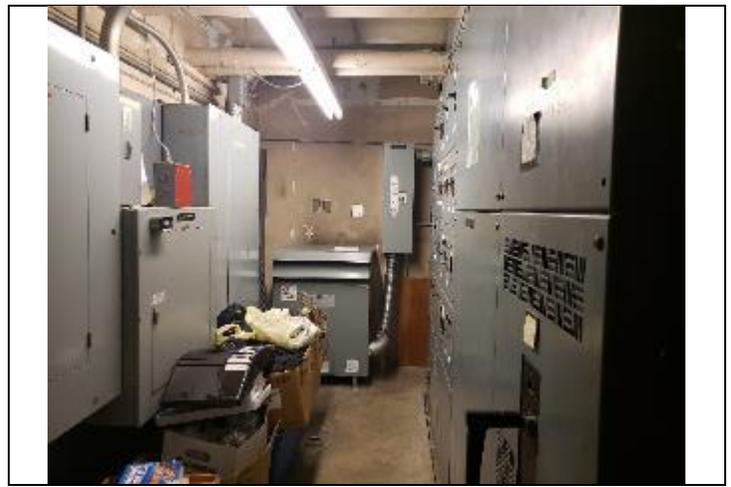
8. View of Room 126.

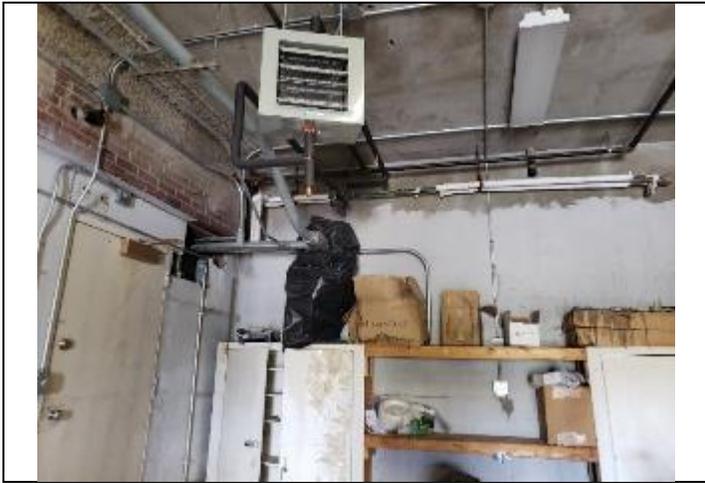
9. Basement Room B16C.

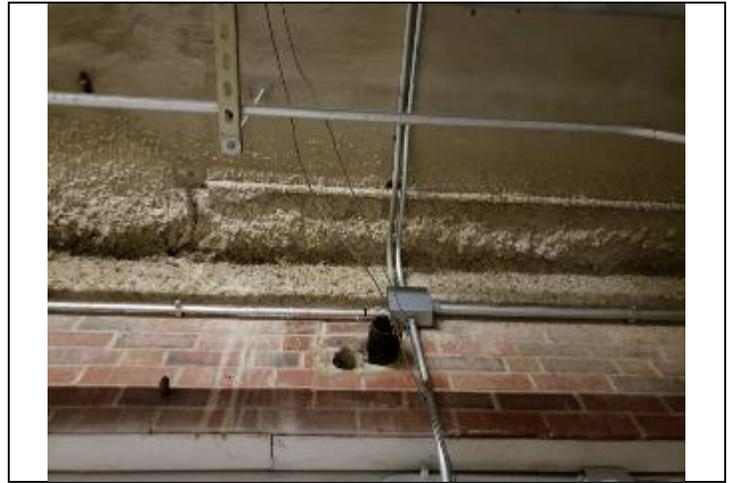
10. Spray-on fireproofing present, previously tested and had no asbestos detected.

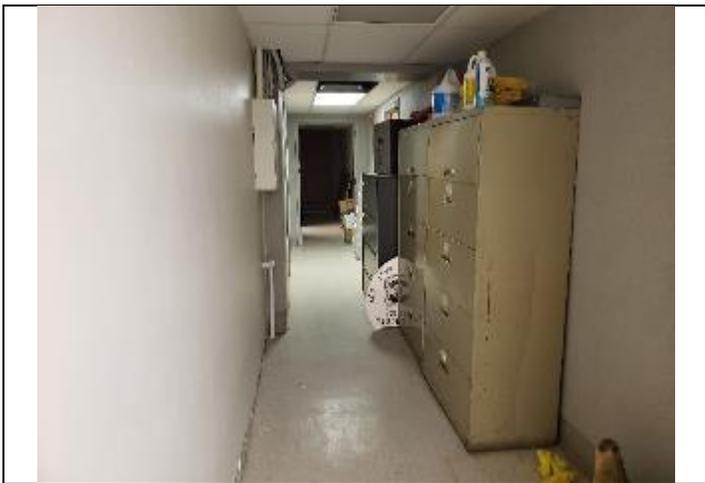
11. Hallway outside Rooms 121 and 123.

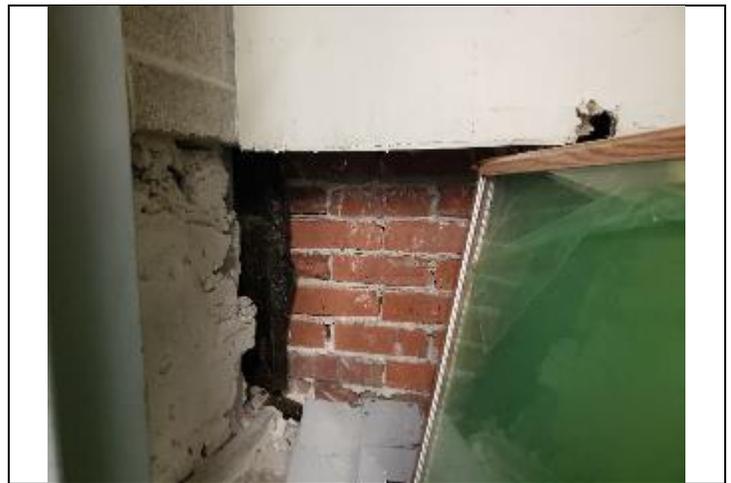
12. Non-asbestos tar paper present in Room 123.
