DANIEL STREET BETWEEN HARBOUR PLACE & MEMORIAL BRIDGE

MAPLEWOOD AVENUE AT NORTH MILL POND

SOUTH MILL POND ADJACENT TO LIVERMORE STREET

SOUTH MILL POND ADJACENT TO POLICE STATION

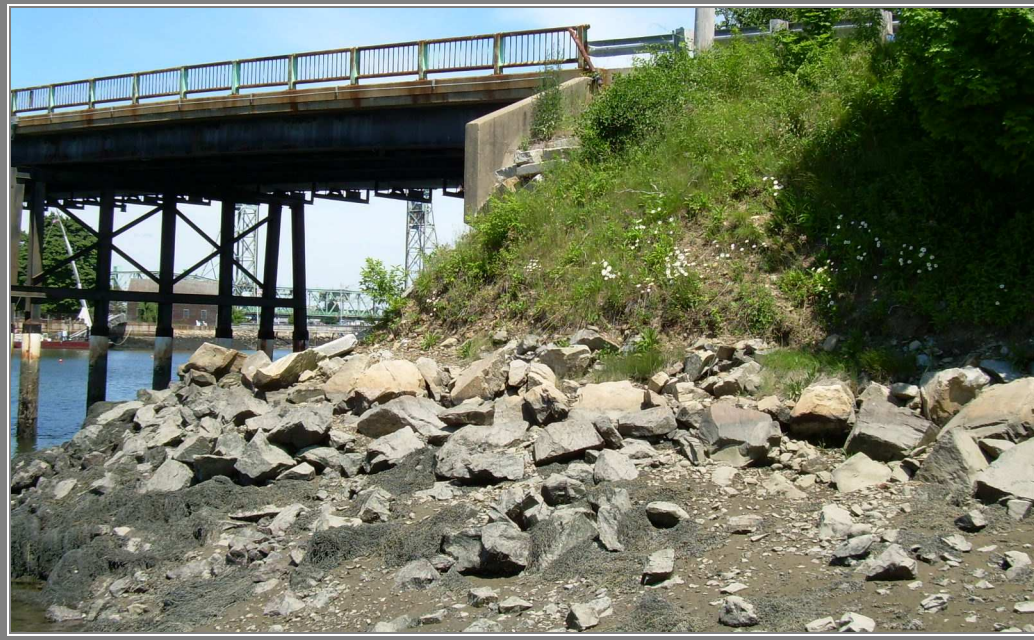
PHOTO 13 Pierce Island Bridge south approach wall (the granite blocks, not the concrete abutment) – note slope erosion above riprap.

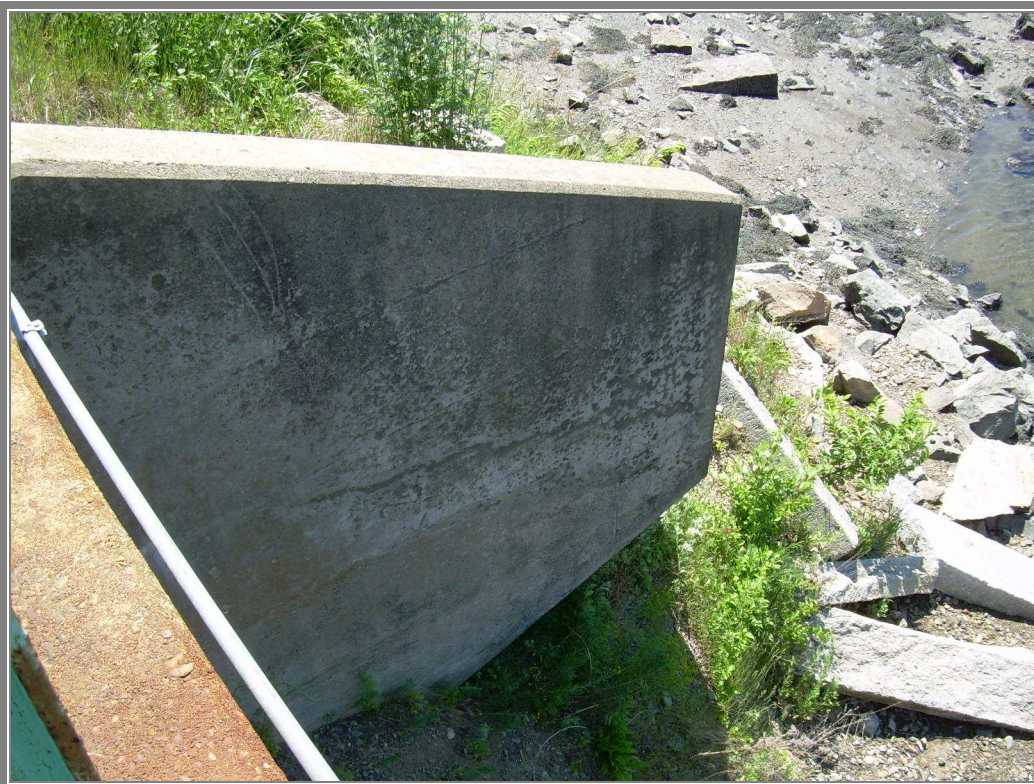
PHOTO 14 Pierce Island Bridge south wingwall undermined by erosion.

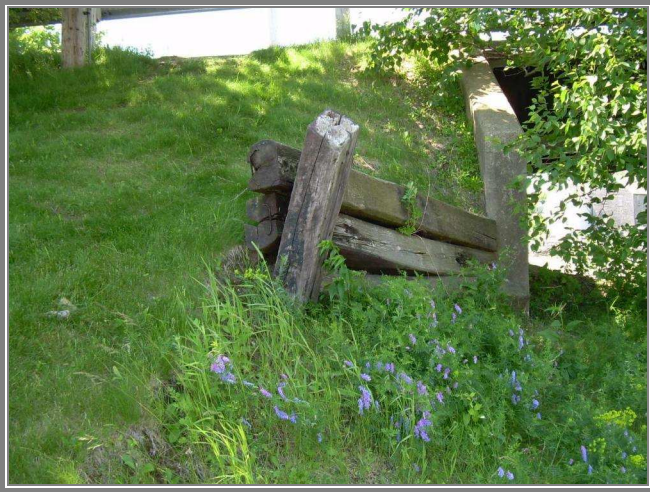
The northern approach wall is comprised of a low stack of treated timbers/railroad ties with a single support post at the northeast end. The post is leaning down slope and the stack of timbers is leaning offshore. While there presently is minimal erosion at this

PHOTO 15 Pierce Island Bridge north approach wall leaning down slope.

wall, it is recommended that this wall be replaced with a riprap slope, similar to the south approach wall.

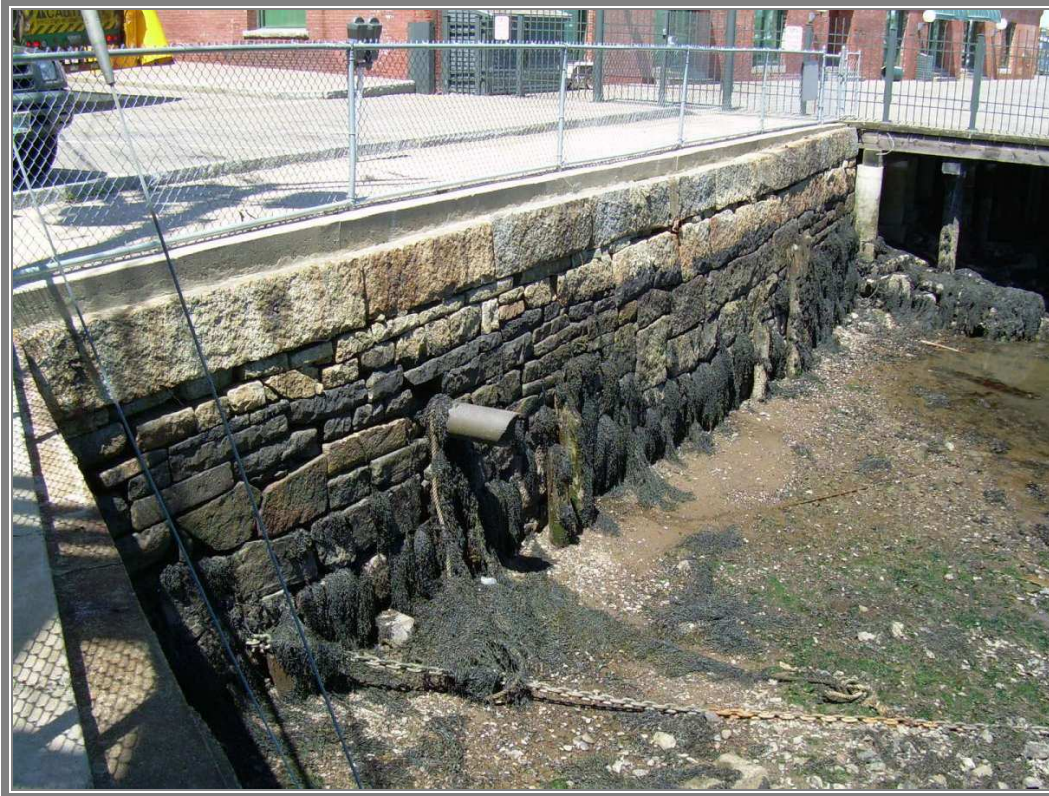
PHOTO 16 Daniel St primary seawall section – note tensioned floating dock mooring chains attached to wall base stones.

The wall here is comprised of two sections. The primary section of wall (56 linear feet) is parallel to the channel and does appear to be stable and in relatively good condition, with a positive inshore batter to the wall face and good quality stonework. There are a few isolated locations with missing chinking stones (small wedge-like stones used to fill gaps), often at pipe penetration locations. It was noted that two large mooring chains are attached to wall stones at the base of the wall, presumably securing the Harbour Place floating docks. The Harbour Place floating docks are located in strong tidal currents and have a history of being torn away by the currents, thus there is a likelihood of high loads being applied to these chains and possibility of the mooring chains pulling out wall base stones, which in a worst case, may collapse the wall.

The main section of wall needs only minor repairs, including replacement of a few missing chinking stones and repointing around the outfall pipe penetrations (if these pipes are still active). The dock mooring chains attached to the wall should be removed as these mooring loads could pull stones out of the wall. The secondary section of wall which connects to the Memorial Bridge pier is apparently stable, but contains open gaps in the stone joints. Near term repairs at this section could include some chinking/repointing of joints and filling of the sinkhole with coarse crushed stone. Longer term, lower priority reconstruction of this section of wall should be considered in the future, and may need to be coordinated with planned bridge repairs.

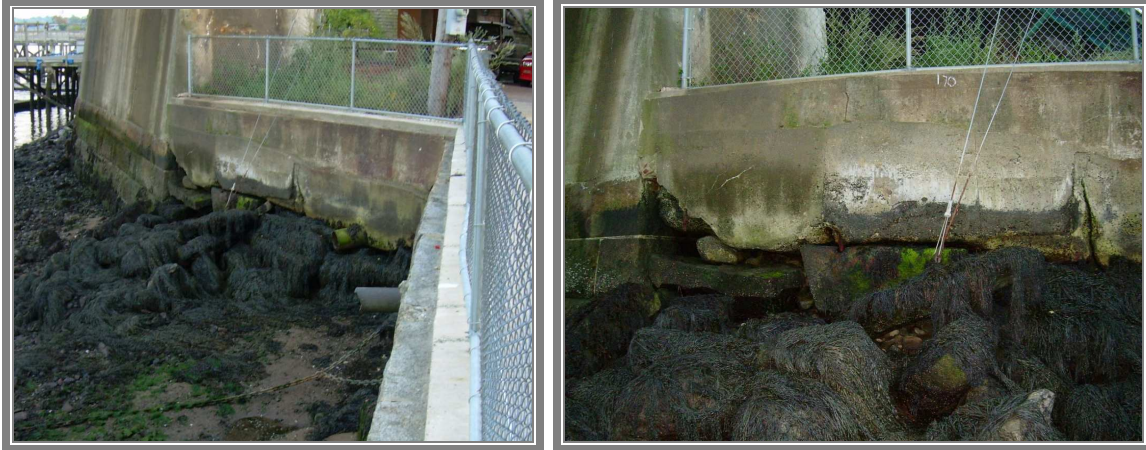
The secondary section of wall connects the primary wall to the Memorial Bridge pier. This section of wall is of rough rubble stone construction, overlaid with a partial concrete veneer, perhaps as a repair. There is a pile of rubble stone in front of this section of wall, which includes a tie-down anchor for the utility pole brace.

PHOTO 17 & 18 Daniel St end seawall section – note gaps under concrete.

There are outfall pipes passing through the wall at stations 0+29, 0+44, 0+61 (sta 0+00 at end by HP wharf). There is a sinkhole behind the corner of the wall, adjacent to the utility pole and also over an outfall pipe. This may have been caused by the utility pole installation, or by soil loss around the outfall pipe.

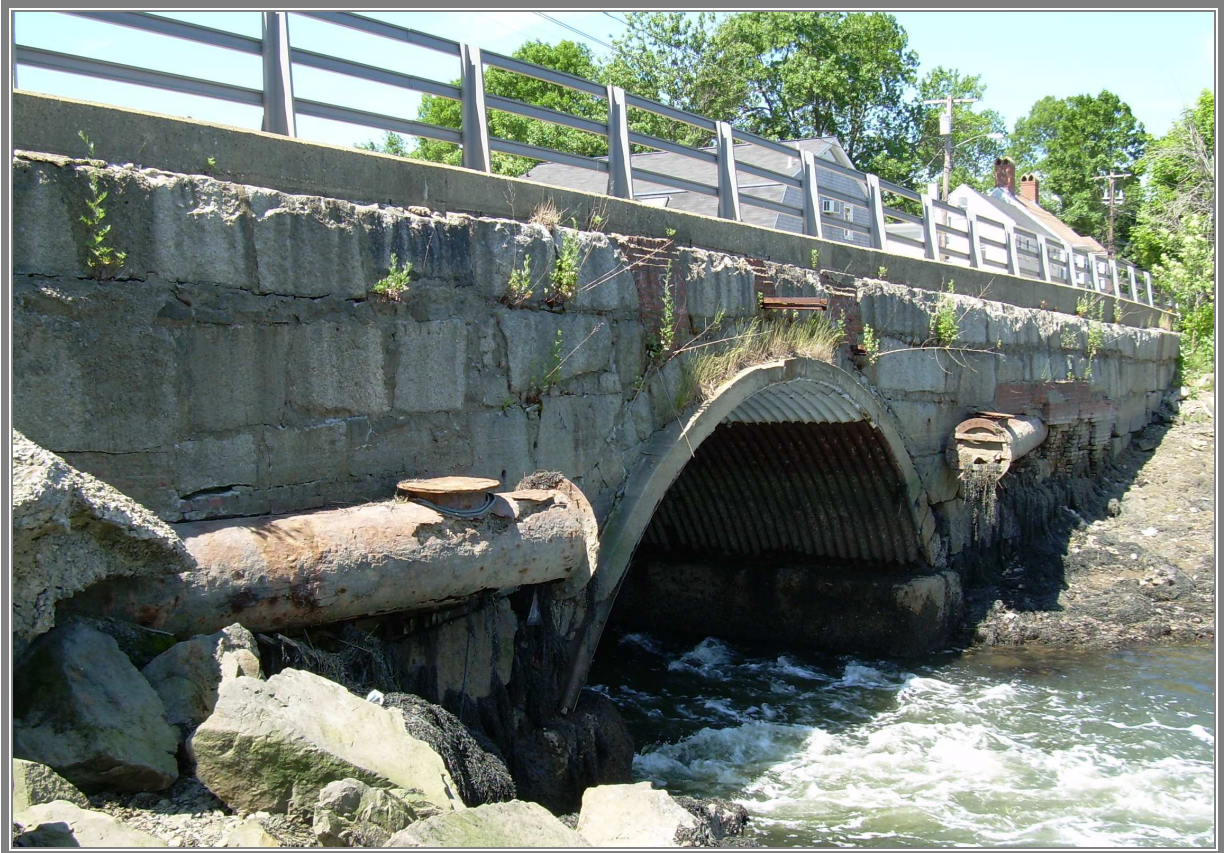
The walls here are comprised of three sections, all parallel to Maplewood Avenue where the street crosses North Mill Pond. The north section of wall supports the west bound traffic lane and sidewalk, and its visual appearance is dominated by the abandoned sewer line penetrations, which are nearly parallel to the wall on both sides of the arch culvert penetration. The North side wall is primarily a granite block retaining wall 155

PHOTO 19 Maplewood Ave north wall – note abandoned sewer line penetrations.

The North wall should be rebuilt, including removal of the abandoned sewer line and associated brick patching. The South western (main) wall could perhaps be stabilized by excavating unsuitable backfill and adding a concrete or flowable fill mass behind the existing stones and repointing the joints, however the budget estimate assumes full replacement of 155 linear feet of wall on both the north and south sides of the street (requiring road closure during construction). The 24 inch diameter sewer main is visible where it penetrates the culvert walls with an invert near mean high tide level roughly along the road centerline, so it is unlikely to be damaged by a possible wall collapse, but it will be an issue during culvert replacement.

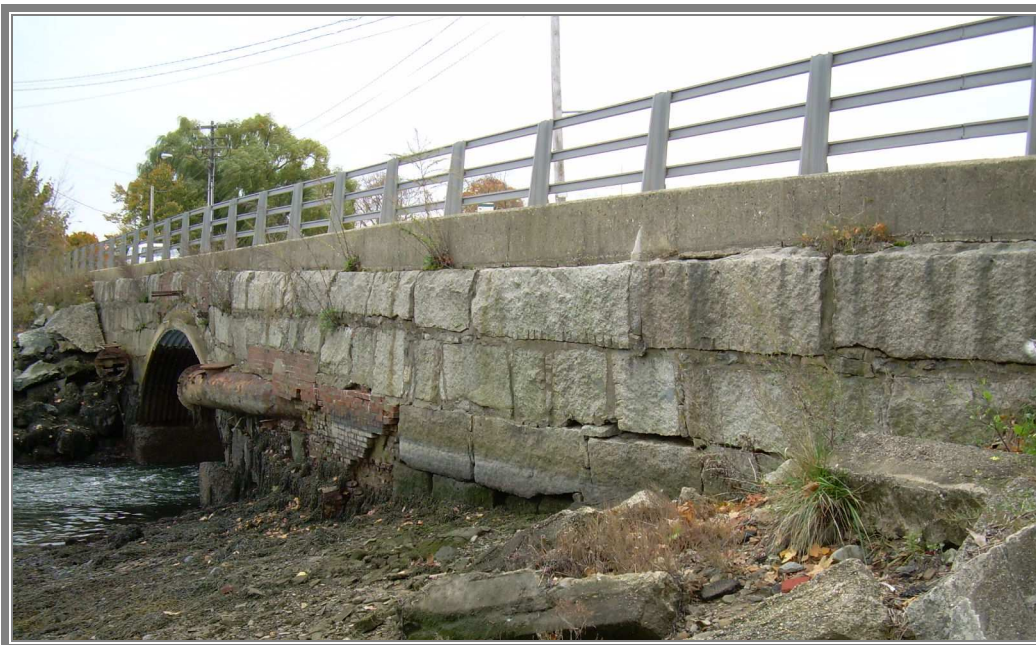
PHOTO 20 Maplewood Ave north wall – note deterioration at penetrations.

The North wall does have several signs of leaning offshore and of settlement. As observed from the 1948 archive drawing, the wall was apparently being monitored for movement. The wall stone over the arch culvert (on timber pile supported footings per

archive drawings) is higher than the rest of the North wall and the North wall to the west of the culvert also has the most severe lean offshore (up to -1H:12V), with opened joints, some block to block sliding. The earth fill slope to the east of the culvert may also be repair material, placed to stabilize a moving wall. The sidewalk and roadway above the North wall shows signs of differential settlement in the vicinity of the culvert, with perhaps 3 inches of differential settlement on each side of the culvert, road pavement cracking, sidewalk cracking and drainage problems.

The 1896 drawings that built the North wall indicates the outer face of the wall was to lean inshore at a 1H:12V batter, however the 9 foot base width of the wall footing was probably insufficient for a 19 foot high gravity wall founded in the tide zone and with modern highway vehicle loads. The North wall was probably also compromised by the sewer line penetrations (pipe now corroded through), which are almost parallel with the wall and have been patched in with brickwork, which is not a durable material in a salt water freeze/thaw environment.

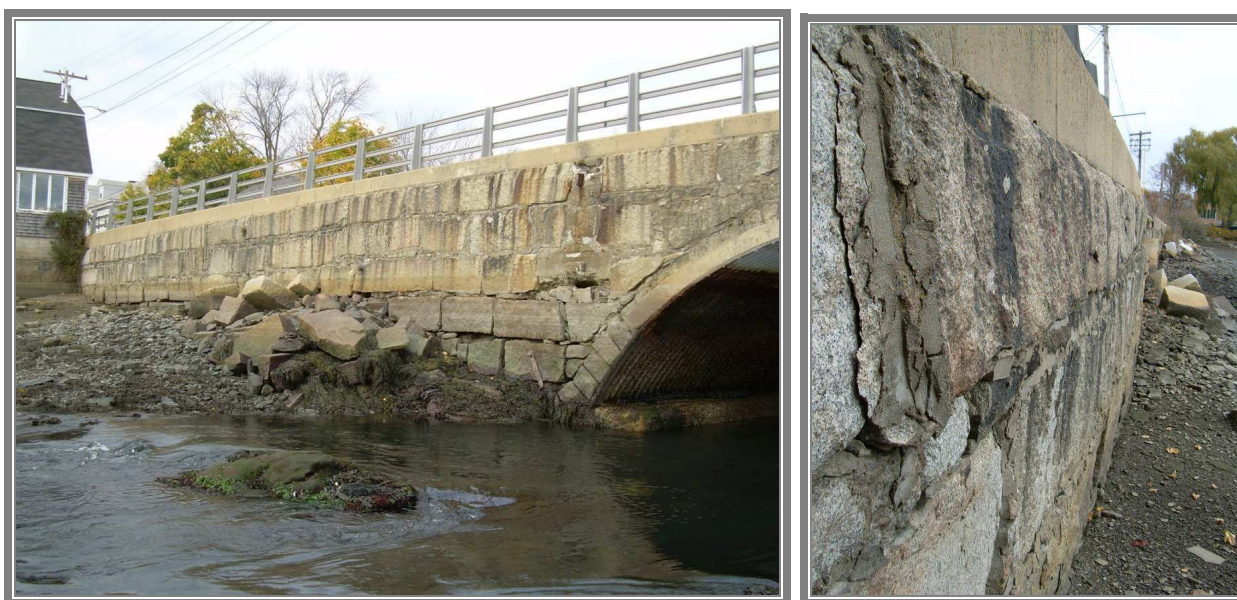
The South western wall also has signs of leaning offshore (up to -0.4H:12V), and of settlement similar to the North wall and there is a noticeable offshore bulge at mid height of the wall (Photo 22). Many of the mortar pointed stone joints have opened, cracking the mortar, in the vicinity of this bulge. A clay drain pipe outfall at the western end of this wall is cracked and appears to be collapsed within the wall and this may be contributing to the loss of backfill soil.

PHOTO 21 & 22 Maplewood Ave south wall west with bulge and opened joints.

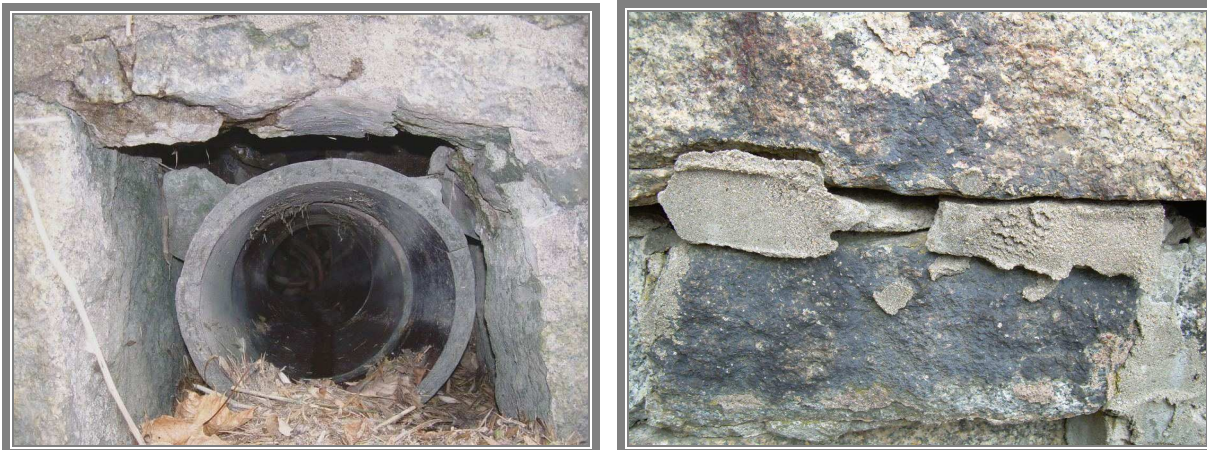
PHOTO 23 & 24 Maplewood Ave south wall west drain outfall & opened joints.

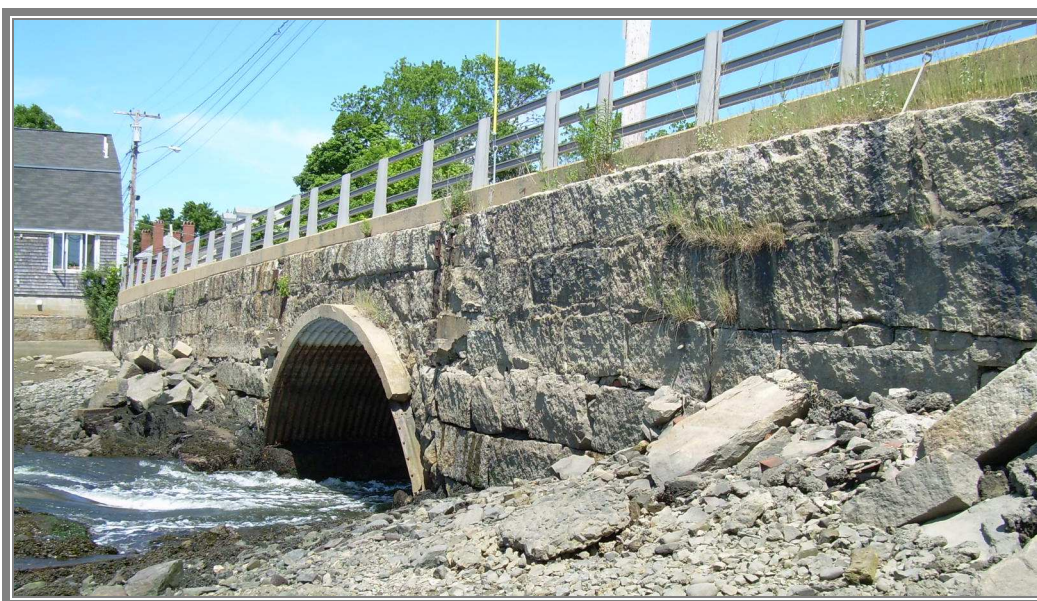
PHOTO 25 Maplewood Ave south wall at culvert.

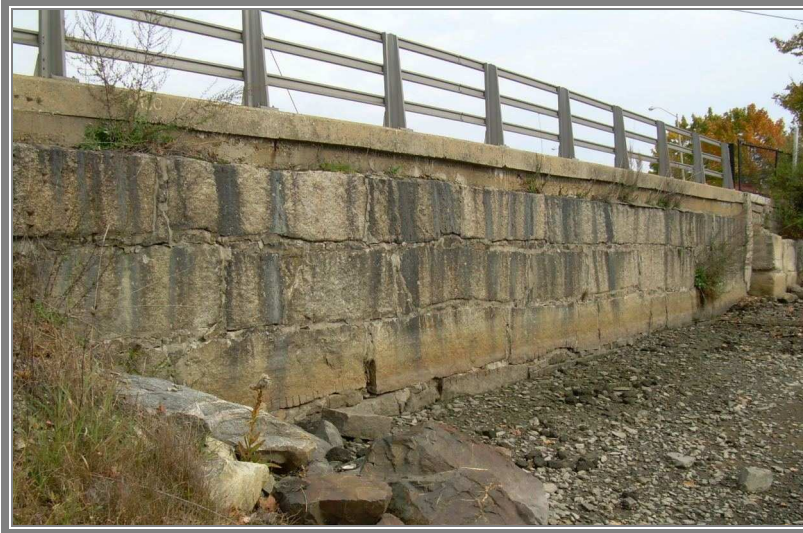
To the east of this slope is another 60 linear feet of stone seawall that appears to be in generally satisfactory condition (Photo 26) with only some upper stone blocks pushed offshore about an inch relative to the blocks below. The easterly most few feet of this wall are comprised of mortared mass waste concrete blocks and some stone blocks (below black chain link fence in Photo 26).

PHOTO 26 Maplewood Ave south wall east.

Based on these observations, it is recommended that this wall be monitored to see if the observed wall movement is active. The adjacent south fill slope has some active erosion and stone riprap should be added to halt this erosion.

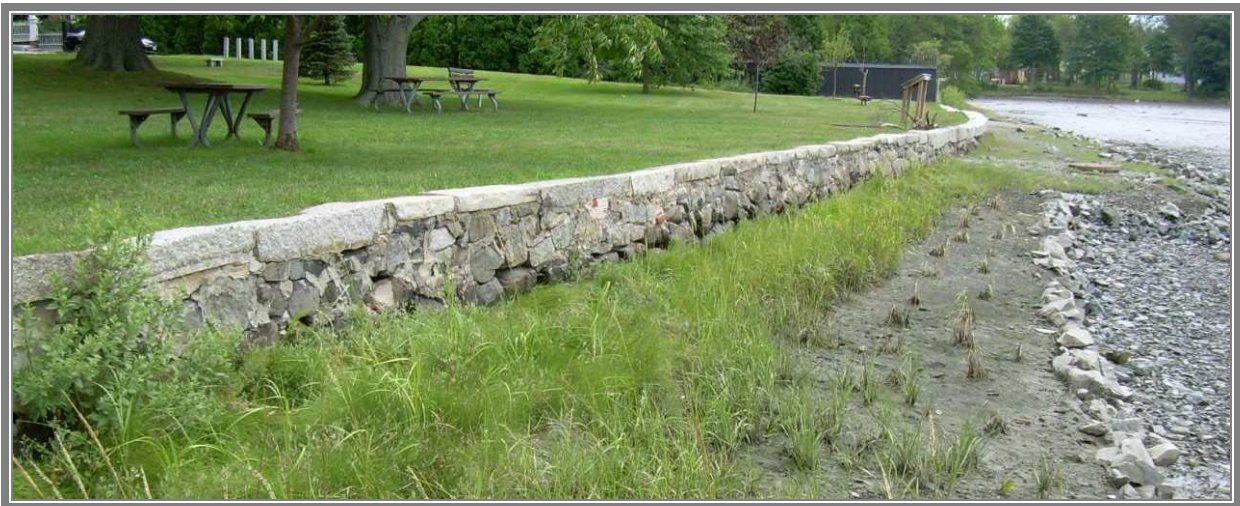
PHOTO 27 South Mill Pond near Livermore St.

The wall does appear to be generally in fair condition, with rough stonework. About half of the length of the wall has a negative batter angle to the face of the wall (leaning offshore) up to -3H:12V. There are a few isolated locations with missing chinking stones and lost pointing mortar, resulting in 4 small sinkholes where backfill soil has washed out. There is a missing cap stone at the west end of the wall and a cap stone dislodged at the eastern end of the wall.

Based on these observations, it is recommended that this wall be monitored to see if the observed wall movement is active. Given the low risk for potential damage to infrastructure if the wall was to collapse (sewer inverts below toe of wall elevation), this wall replacement may have a low priority, but should be considered for future planning.

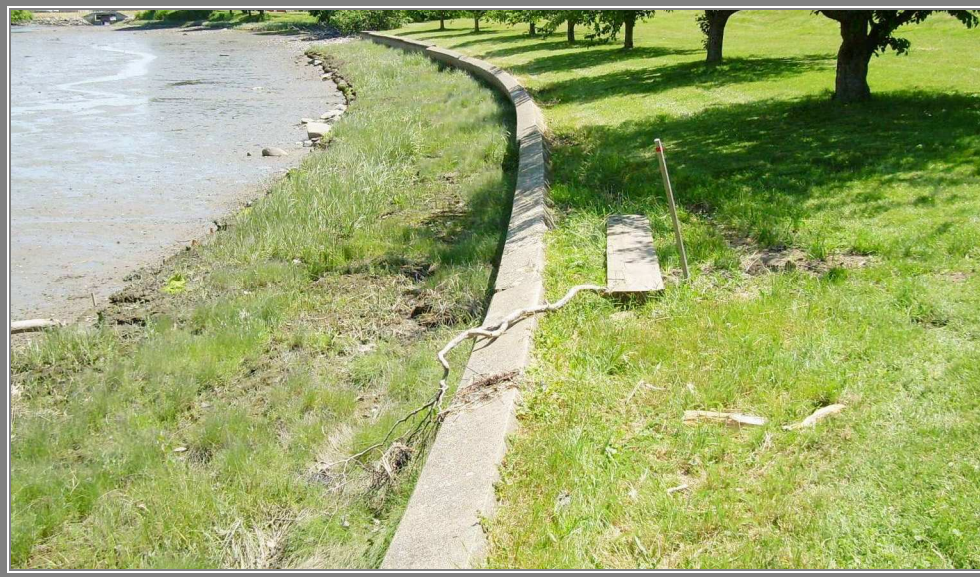
PHOTO 28 South Mill Pond near Police Sta. – note wall rotated offshore.

This wall is quite consistent on height and condition. The wall concrete is in relatively good condition, however it has rotated and the wall leans offshore significantly with the offshore face at a negative batter angle between $-2H:12V$ and $-3.5H:12V$. The level of deterioration to this wall is minimal, consisting primarily of concrete spalls at some of the construction joints, some of which may have been load induced by the wall movement

shearing force at the joints. The low height of the wall and lack of backfill live loads (no roadway or even pathway), suggest that the wall rotation may have been caused by poor foundation soil conditions.

Based on these observations, it is recommended that this wall be monitored to see if the observed wall movement is active. Given the low risk for potential damage to infrastructure if the wall was to collapse, this wall replacement may have a low priority and the replacement method might be stone riprap as this is not a historical stone wall, the shoreline slope is quite flat and the foundation soils are likely to be weak.

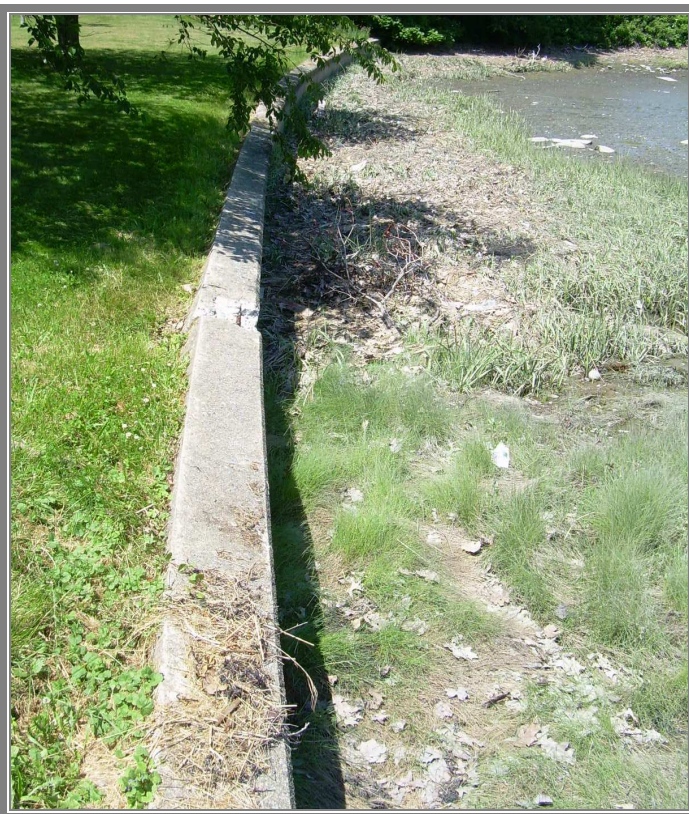
PHOTO 29 South Mill Pond near Police Sta. – west end with wall rotated offshore.
