# appendix a

EXISTING INFRASTRUCTURE REPORTS AND MAPPING

Re: Prescott Park Master Plan

Subject: Summary of Subsurface Utility Conditions  
Prescott Park  
Portsmouth, New Hampshire

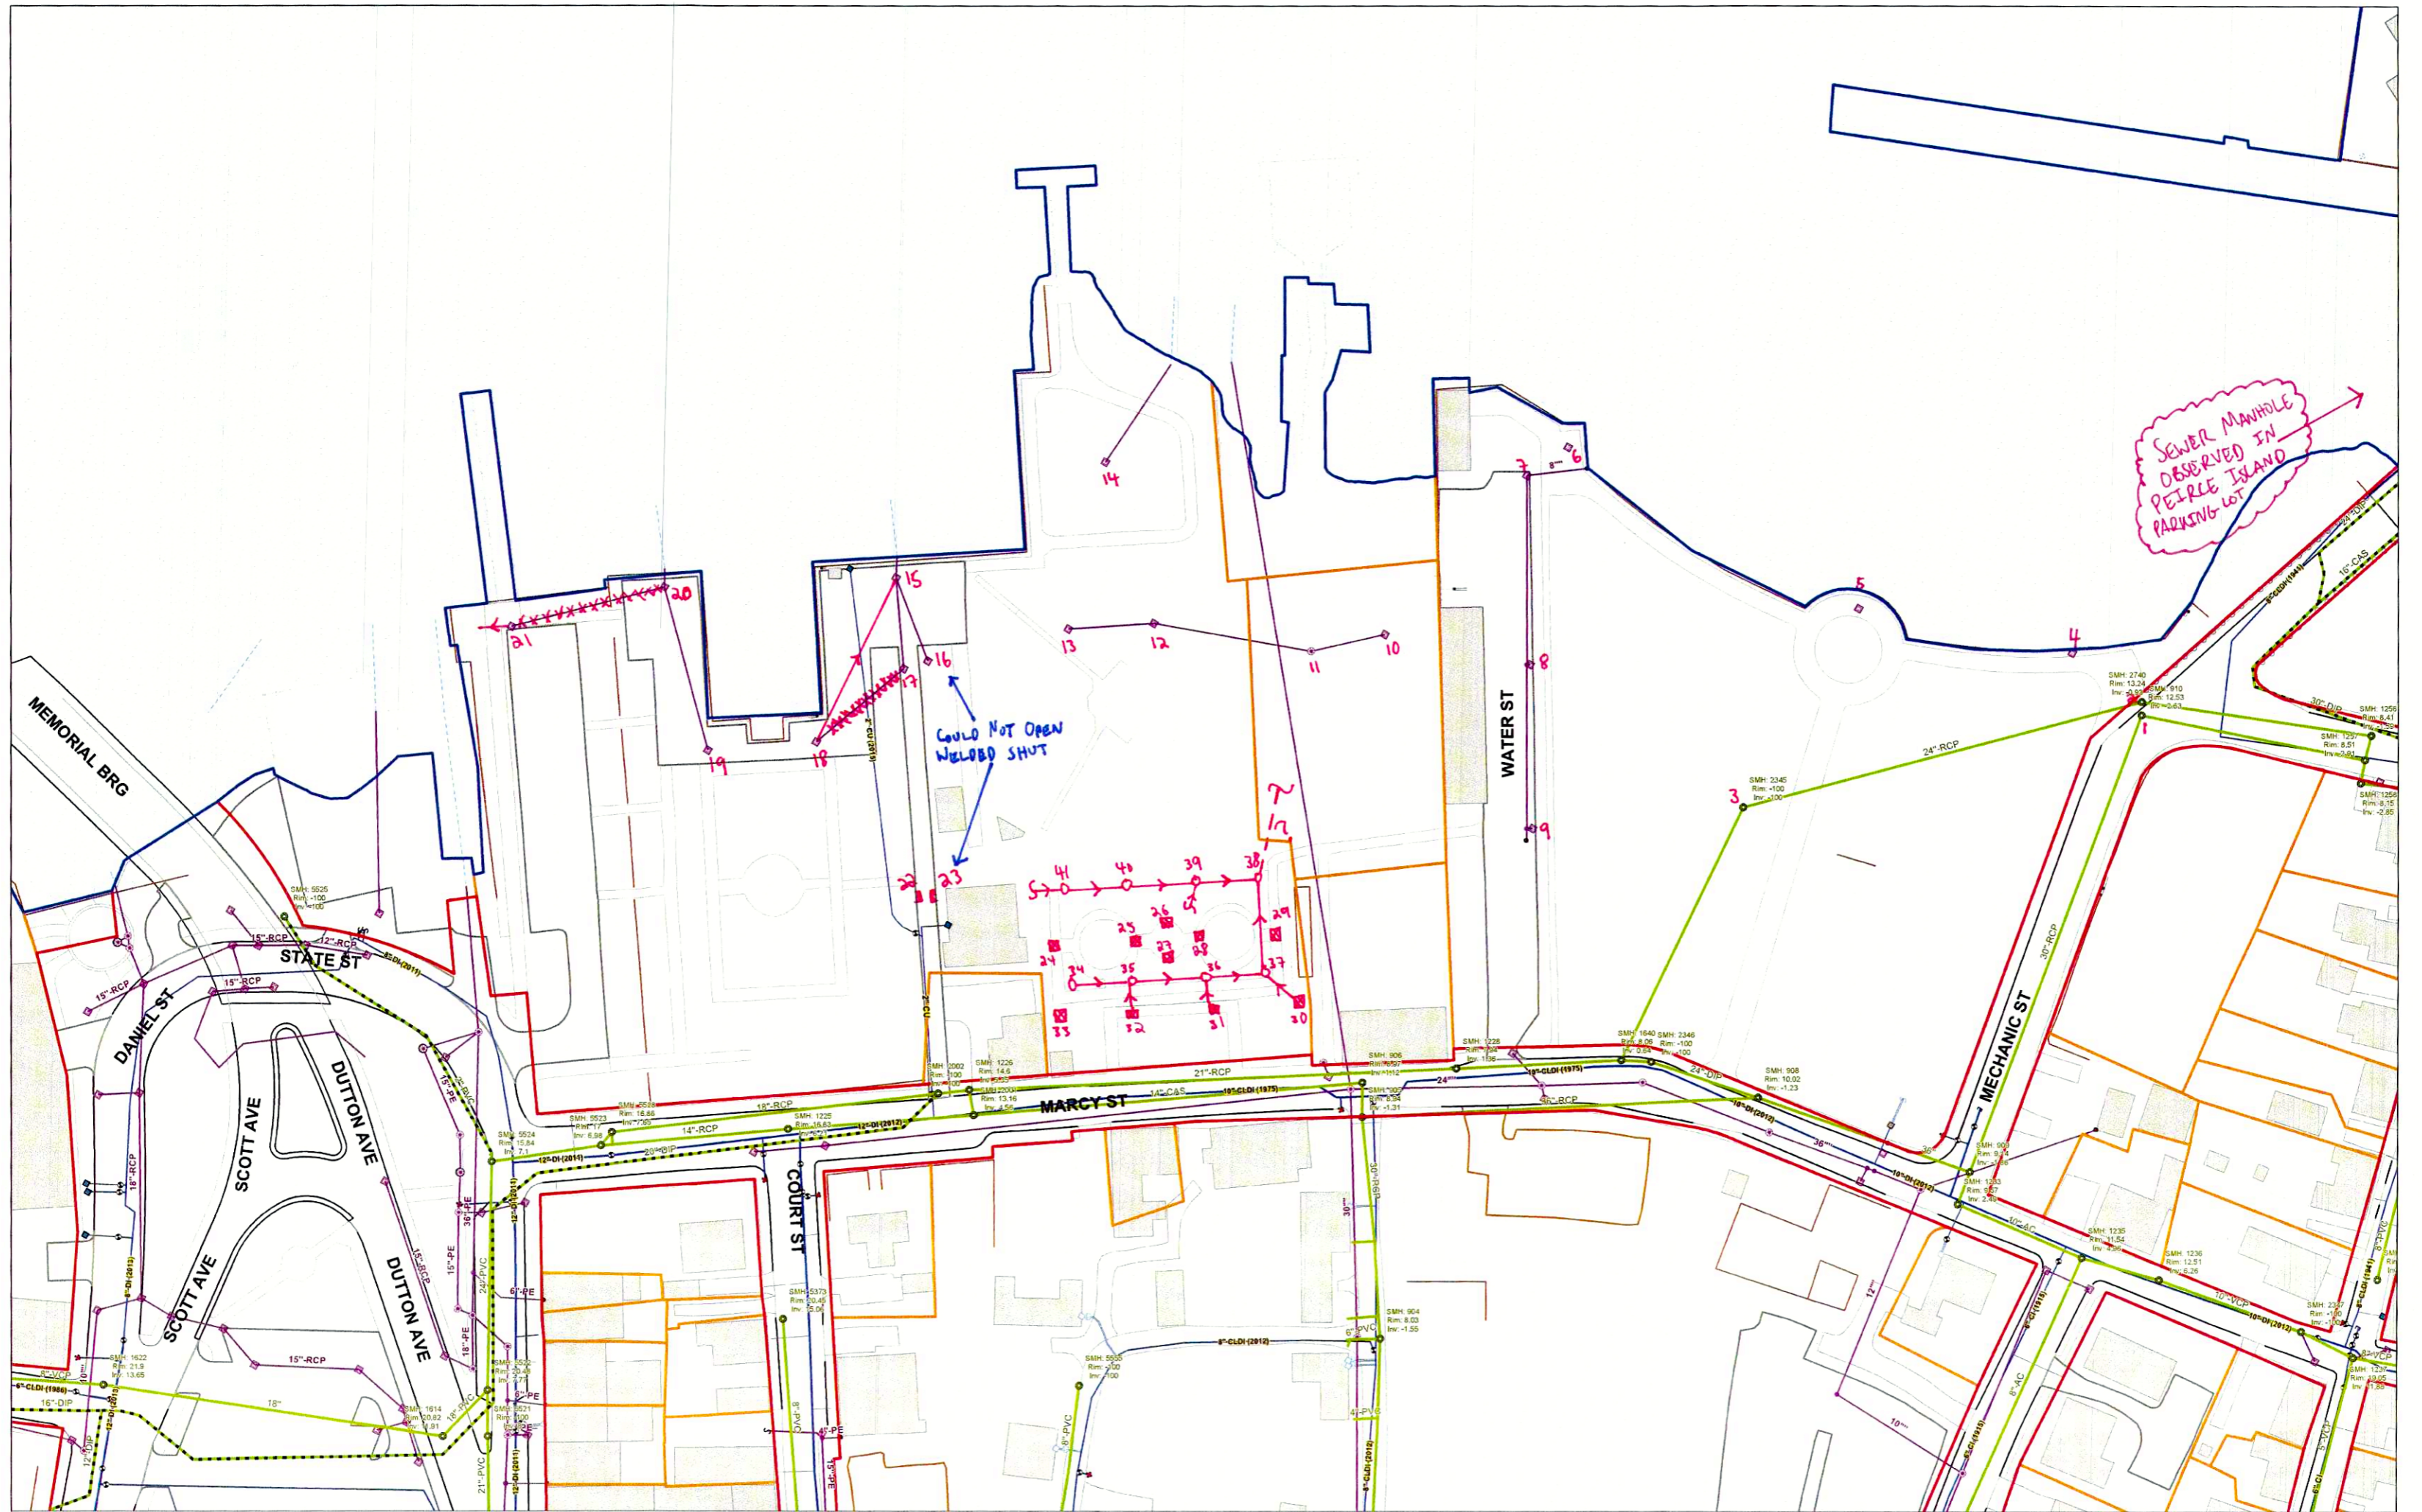
**FIGURE 1**

All drainage for Prescott Park is directed to outfalls along the Piscataqua River which runs adjacent to the park on the eastern border. The Park contains 27 storm water catch basins throughout the park site which collect rain water during storm events. Three (3) of these catch basins were observed to be drywells which retain storm water for exfiltration into the surrounding groundwater. Additionally, eight (8) yard drains were observed in the central garden area and were discovered to be an integral part of the drainage system. One (1) drainage manhole was located and inspected near the center of the park. Please see the attached **Figure 1** for locations and numbering of all drainage structures observed.

Four (4) sanitary sewer manholes were inspected in the southern section of the Park. Two sewer manholes were located along Mechanic Street with a third on Mechanic Street located in the parking lot area for Peirce Island. The fourth sewer manhole was located in the center of the grass area between Water Street and Mechanic Street. Please see the attached **Figure 1** for locations and numbering of all sewer structures observed.

Catch basins 16 and 23 were unable to be inspected as the grate was welded shut to the frame for each structure. Upon inspection of catch basins 17 and 22, no pipes were clearly visible, however the bench for each catch basin was observed to slope down towards the center of the walk way. Therefore it is under the assumption that catch basins 16, 17, 22 and 23 may discharge down into a drainage interceptor pipe located down the center of the walkway, which ultimately discharges to catch basin 15.

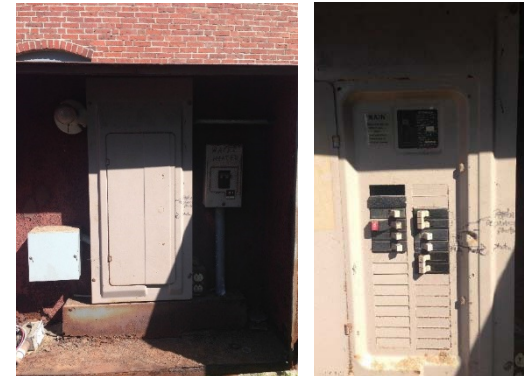
**The first service** is located on Water Street and is a 200A, 120/240V 1-phase service Unistrut mounted in an electrical enclosure. The service runs underground from Marcy Street to this enclosure. This service feeds the Sheafe Warehouse, Shaw Warehouse and the Players Ring Building. All three of the services run from this enclosure underground to each of the buildings. The enclosure is rusted and the panel is the original panel. Both the enclosure and the panel appear to be in fair to poor condition.

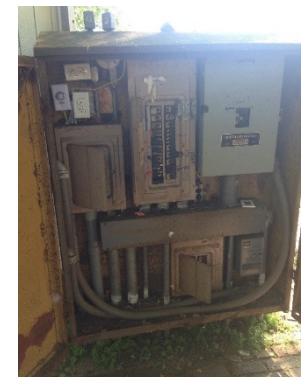
**The second service** is located in front of the Concession Building next to the arts area. The service runs underground from Marcy Street to this enclosure. The service is installed within a pad mounted electrical enclosure and is a 400A, 120/240V, 1-phase service. This service provides power to 2 utility poles located within the arts entertainment area, a storage building, the water fountains and much of the site lighting poles located throughout the park. The service, enclosure and the electrical equipment all appear to be in fair to poor condition.

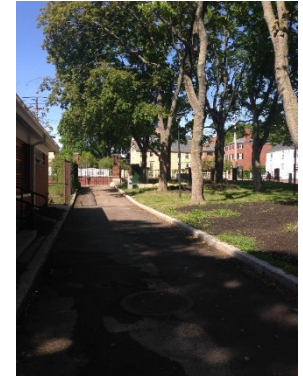
**The third service** is located in the park near Marcy Street and Court Street. This service is a utility pad mounted transformer and feeds underground to (2)800A 3-phase panels located in the Arts Entertainment area, (1) 400A 3-phase panel located in the Concession Building and (1) 100A single phase panel located in the Merchandise Building.

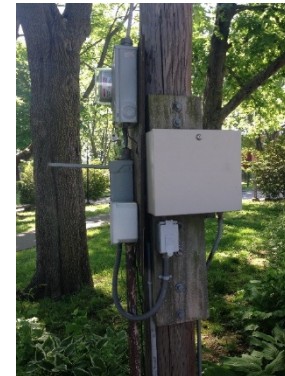
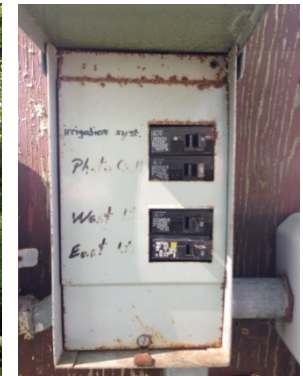
**The fifth service** is located on Marcy Street near State Street. This service is pole mounted and feeds (2)20A, 120/240V, 1-phase circuit breakers. These circuit breakers feed the existing Irrigation system. The service appears to be in fair to poor condition.

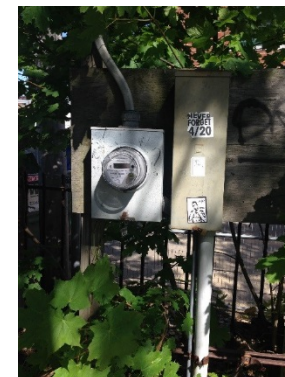
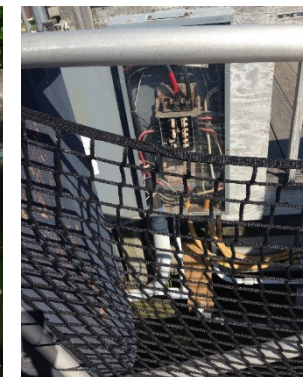
**The sixth service** is located outside of the parking lot near State Street. This service is a 100A, 120/240V, 1-phase service Unistrut mounted. The service feeds underground to a panel located on the side of the ramp to the old docks. The panel feeds the power and lighting for the docks and the pier located next to the docks. The panel is missing the interior cover which has been replaced by a piece of Plexiglas. The panel is located on the side railing of the pier directly over the water. The location is in violation of the National Electrical Code for working clearances and access. The panel and service appear to be in fair to poor condition.

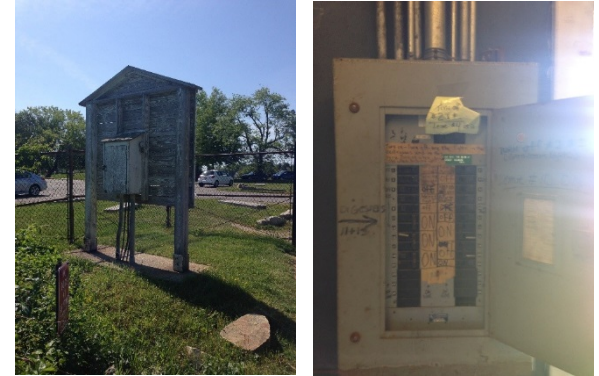
**The seventh service** located on Four Tree Island is a 100A, 120/240V, 1-phase service mounted in a wooden enclosure mounted on the back of the Island sign. This service feeds underground to an existing 100A panel located in the storage room of the existing building. This panel feeds the ejector pumps, the Island lighting and the misc. outlets located around the Island. The service and the panel appear to be the original equipment and appear to be in fair to poor condition.

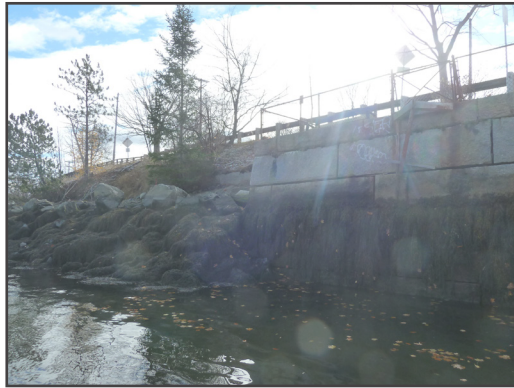
1. Quaywall  
-Graffiti gate, blocks are level.  
-Missing grout top course, mortar missing, repoint & rechalk  
-Fence is rusting

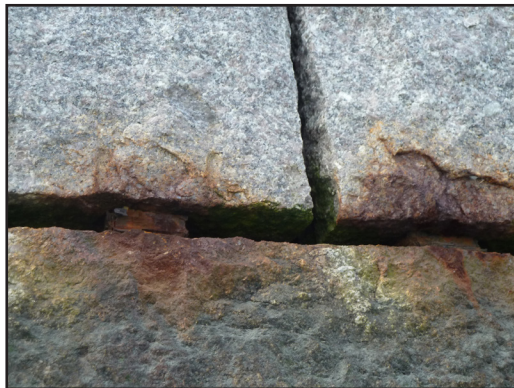
3. Quaywall  
Missing mortar steel shim plates

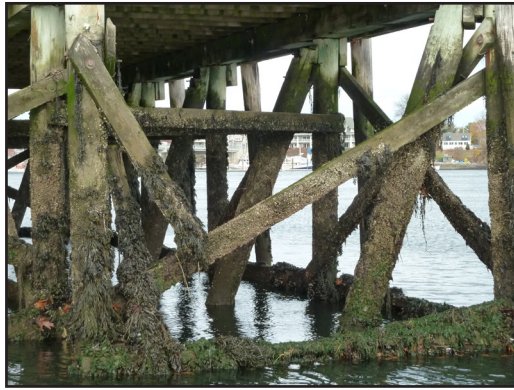
7. South pier  
Broken cross members under deck, it is recommended to replace the failed bracing member as soon as possible. The structure has 15 years of service life remaining, assuming it is repaired and maintained.

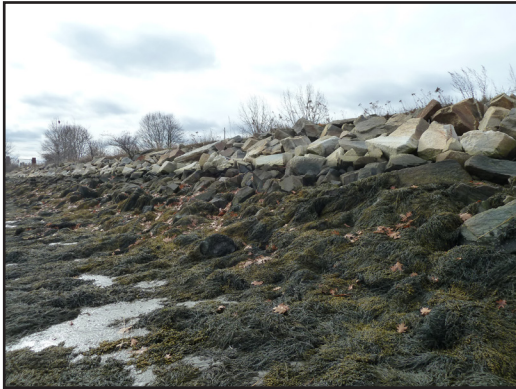
25. Four Tree Island  
Dumped rip rap along east  
shore.

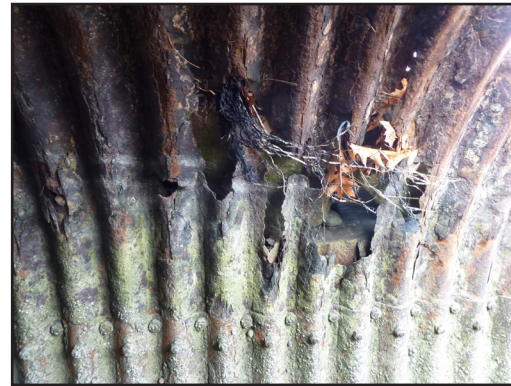
26. Four Tree Island  
Culvert under causeway  
requires lining or  
reinforcement. Excessive  
section loss in areas.

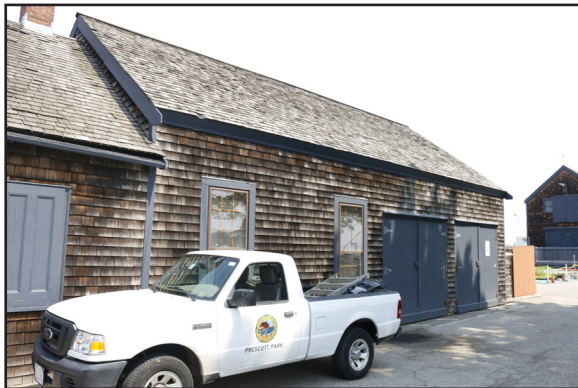
Section (2): One-story space with a concrete slab on grade floor with extensive settlement and wide cracks formed. There is a floor drain in this space. The roof framing is heavy timber that is partially exposed below the level of the collar ties. No ceiling in the space and the walls are finished with wood plank wall boards.
