21 January 2022

Structural Condition Assessment - Annex  
Captain Thomas Thompson House  
179 Pleasant Street  
Portsmouth, New Hampshire

**ASSESSMENT OF HISTORIC INTEGRITY**

PROPOSED ANNEX SCOPE OF WORK  
SOUTH ELEVATION  
HDC WORK SESSION #2 APPLICATION TO AMEND PREVIOUS APPROVAL: FEBRUARY 2, 2022

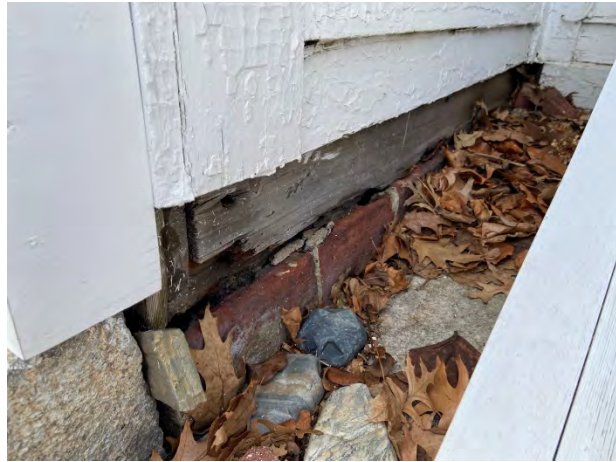
Side entry foundation detail view

The full-height stone foundation wall along the side entrance appears to be bowing inward with numerous cracks in the mortar joints. This is most likely due to the surcharge force

from the side entrance foundation, which is in visibly poor condition and in need of repair or replacement. Further investigation of this area is recommended.

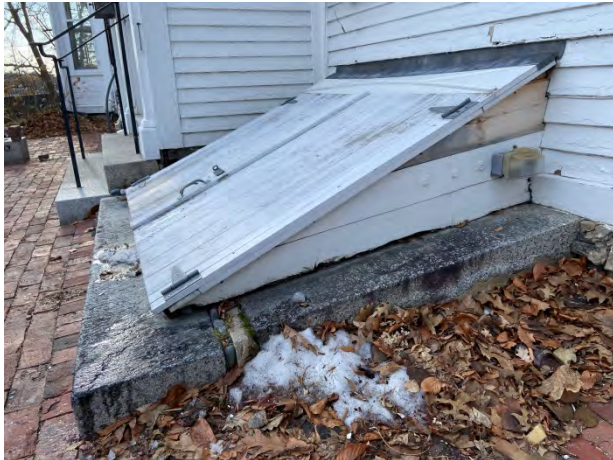
Bulkhead detail view

- See page 2 and 9 on the structural report for orientation
- Remove bulkhead address portico foundation, and patch rubble wall where needed
- Historic architectural elements to be saved and reused are as follows:

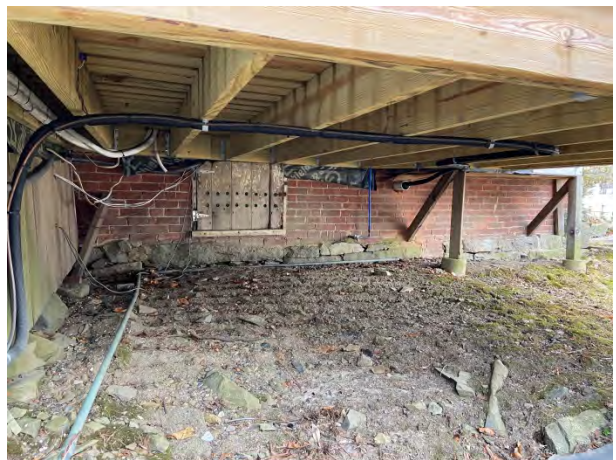
East wall foundation with access panel

The brick and stone foundation is in poor condition with eroded mortar joints and some wall areas visibly leaning out of plumb. My opinion is that the crawl space foundations will require significant repair.

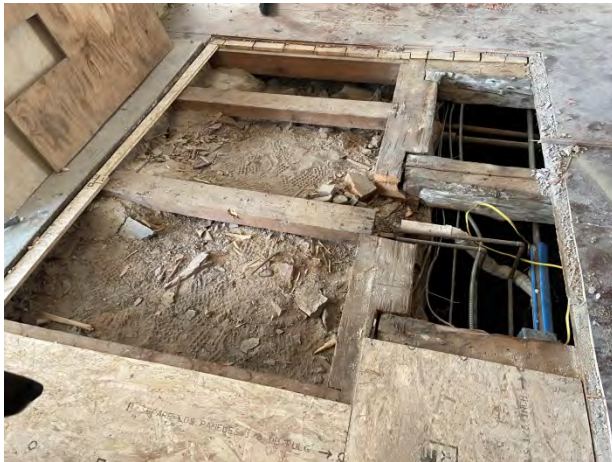
First floor transition at full foundation

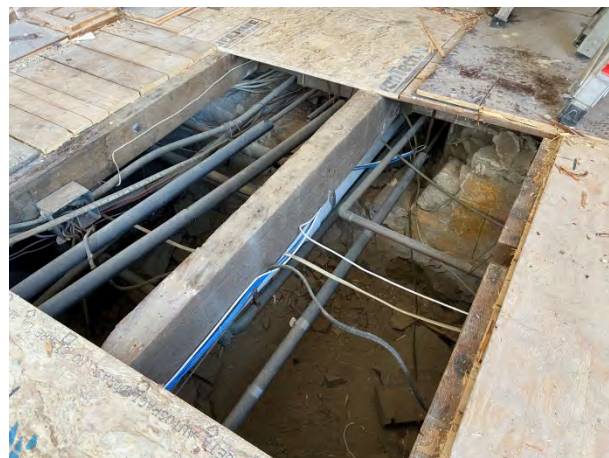
First floor near chimney/hearth

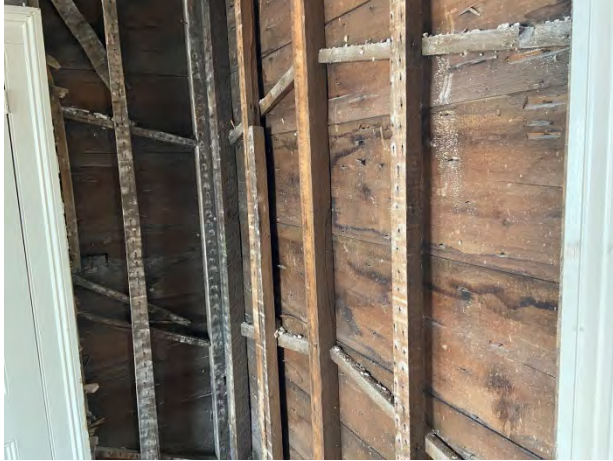
The first floor exterior wall framing appears to have been modified numerous times over the life of the building. Some areas which look original are framed with 3x3 studs spaced at 30" on center with 2x2 infill studs and sloped furring. In other areas, it appears that new windows were installed and significant, but structurally dubious, framing modifications have been made. Significant repairs have been made at the curved wall.

3x3 and 2x2 first floor wall framing

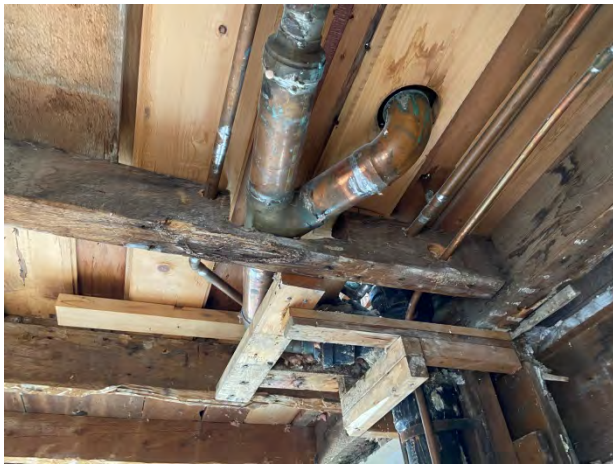
The second floor is framed using 3"x5½" joists spaced at 24" on center. See SK3 attached. The joists are supported at a (4)2x10 beam spanning 18-feet and a 3½"x7" beam which is supported at the chimney. Both beams are significantly overstressed. A number of the joists have been notched, drilled, or otherwise damaged to an extent that they have no tangible structural value. It was observed that one ply of the (4)2x10 beam is fractured. Assuming Hem-Fir material, the allowable total load for this floor system would be less than 5 psf. This floor must be considered unsafe in current condition and will require significant reinforcing or replacement.

Second floor joist

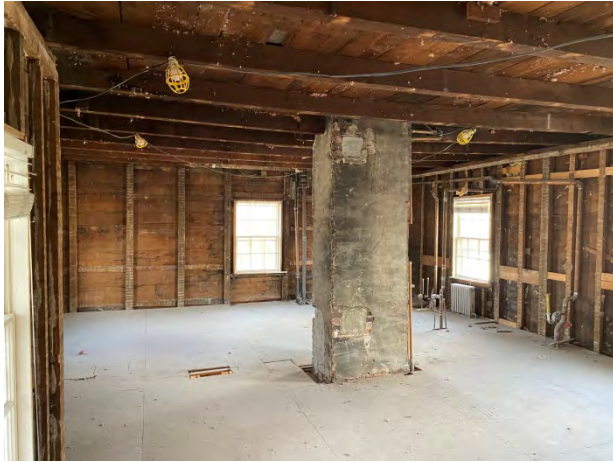
The second floor exterior walls are constructed using 3"x4" studs spaced at 32" on center and are in good condition.

View of second floor wall framing

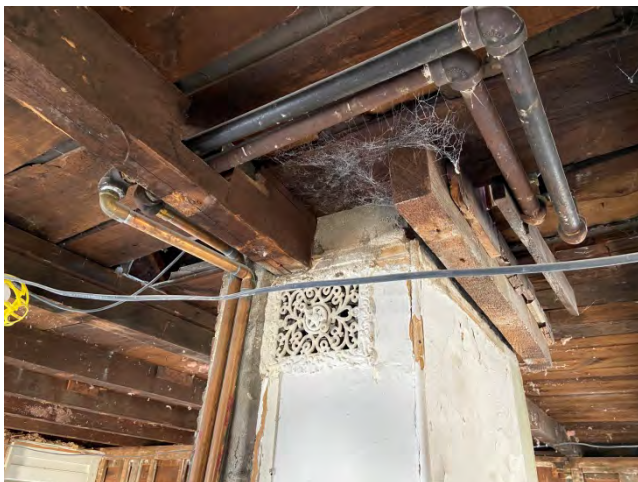
The third floor is framed using 4"x5 $\frac{3}{4}$ " wood joists spaced at 32" on center. See SK4 attached. Assuming Hem-Fir material, the allowable total load for this floor system would be approximately 10 psf. Joists are supported at the chimney and some joists are lacking adequate support, which are conditions that will need to be corrected.

Third floor framing supported at chimney

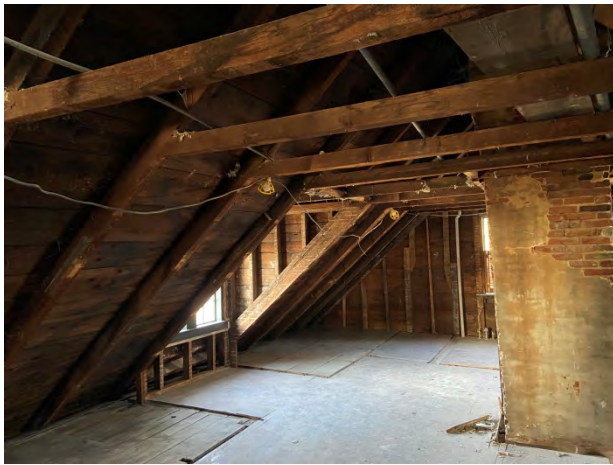
The annex roof is framed using 2 $\frac{3}{4}$ "x4 $\frac{3}{4}$ " rafters spaced at 32" on center with 3"x4" collar beams located about 7-feet above the floor. The large roof overhang along the north side is partially supported by vertical struts, aligned with the exterior wall below, and extending to the underside of the rafters. Some of the gable wall framing is spliced. Assuming Hem-Fir material, the allowable total load for this roof system would be approximately 20 psf. The roof will require significant reinforcing or replacement to increase load capacity.

Roof framing at dormer

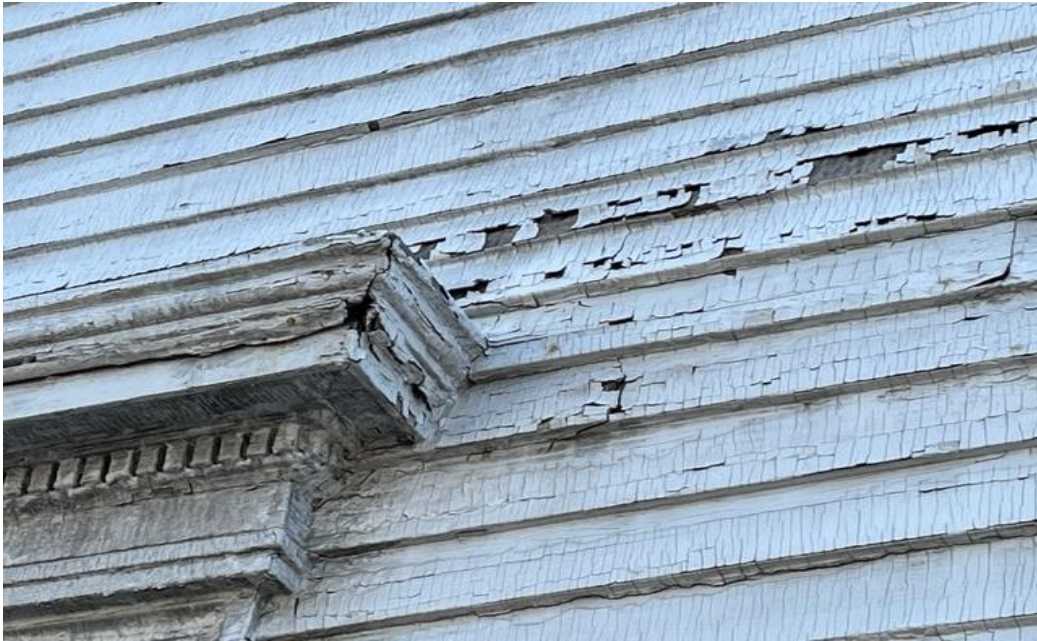
Siding & Trim repair/replacement

- Siding & Trim
  - All siding and trim paint to be removed down to original wood
    - Sponge jet, scrap, heat, strip, will need to define method
  - Repairs or replacements will be made with wood and in kind as needed

- There are several repairs/replacements needed throughout the mansion
    - Trim will be made with the exact profile where needed
    - Siding lap joints will be recreated where needed

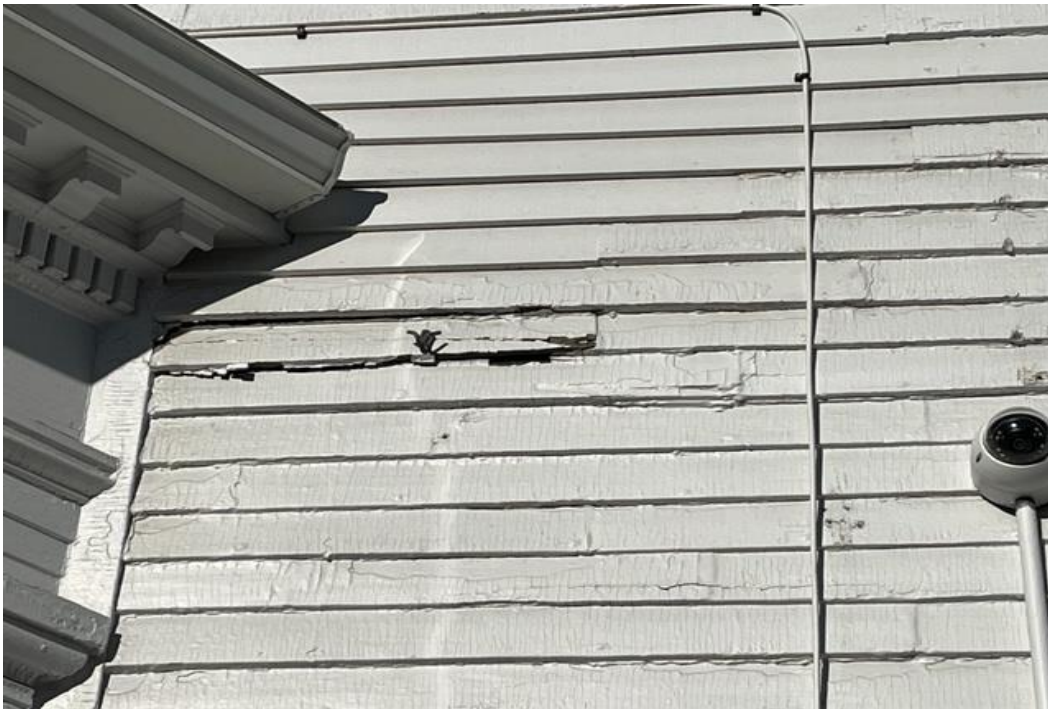
Siding & Trim repair/replacement

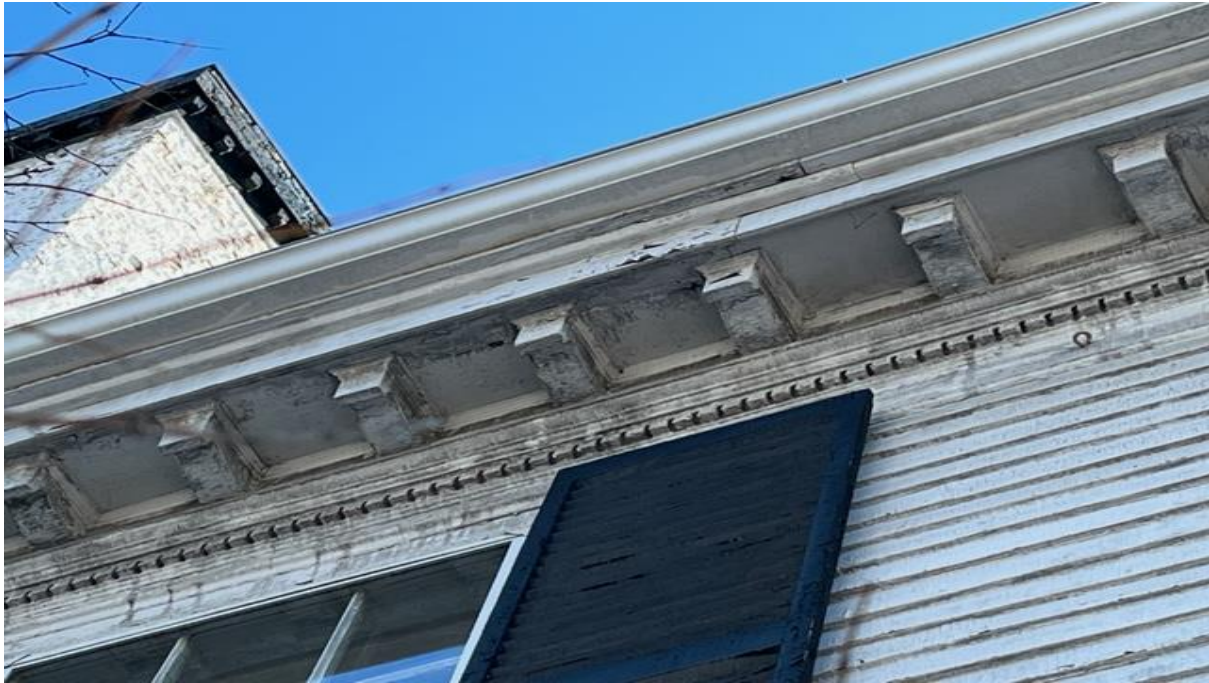
North wall with water issues, cornice repair

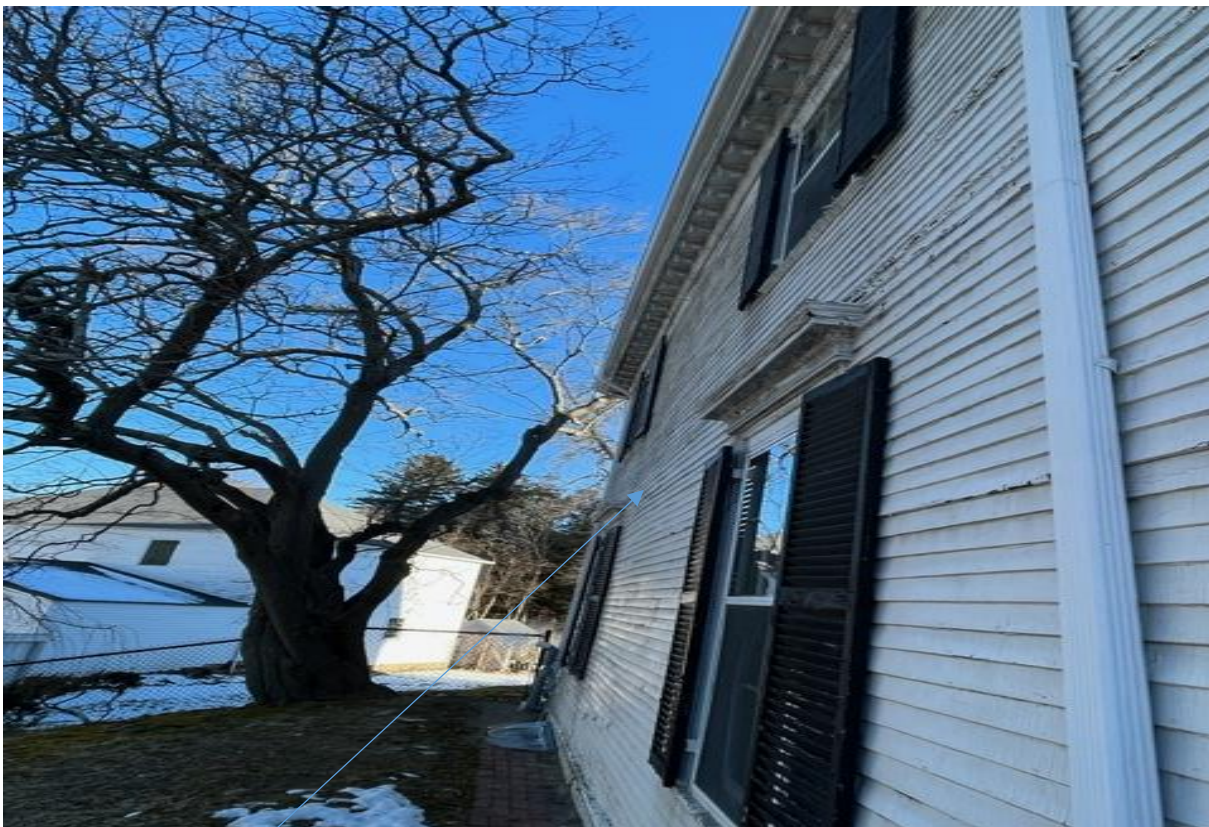
- Siding & Trim
  - Remove all siding on this side of the house to expose sheathing
    - There is a large bow in the center of the wall
    - Significant water infiltration visible on both exterior and interior surfaces

- Concerns for health of the wall system and chimney, which correlates with the bow in the wall mid-span
  - All siding removed will try to be salvaged and reused for repairs on other walls

North wall with water issues, significant bow in wall

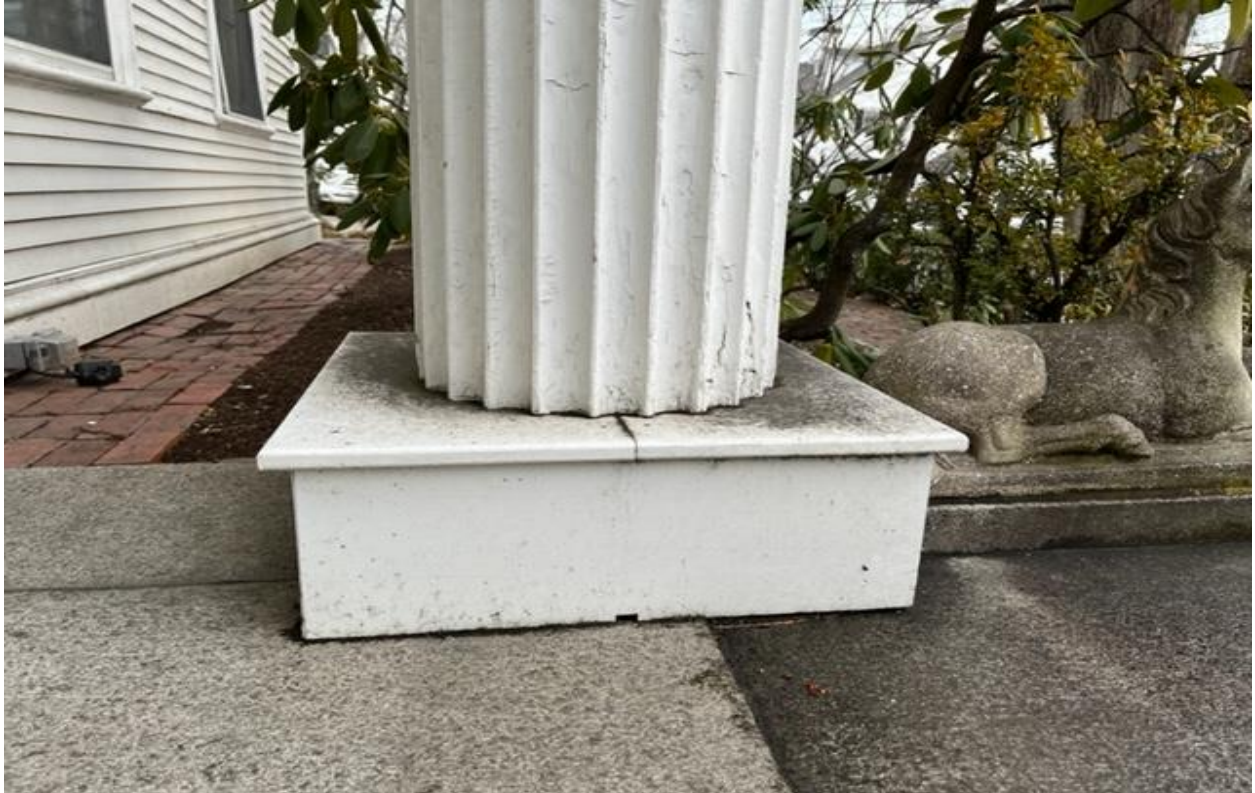
Main entry portico column base

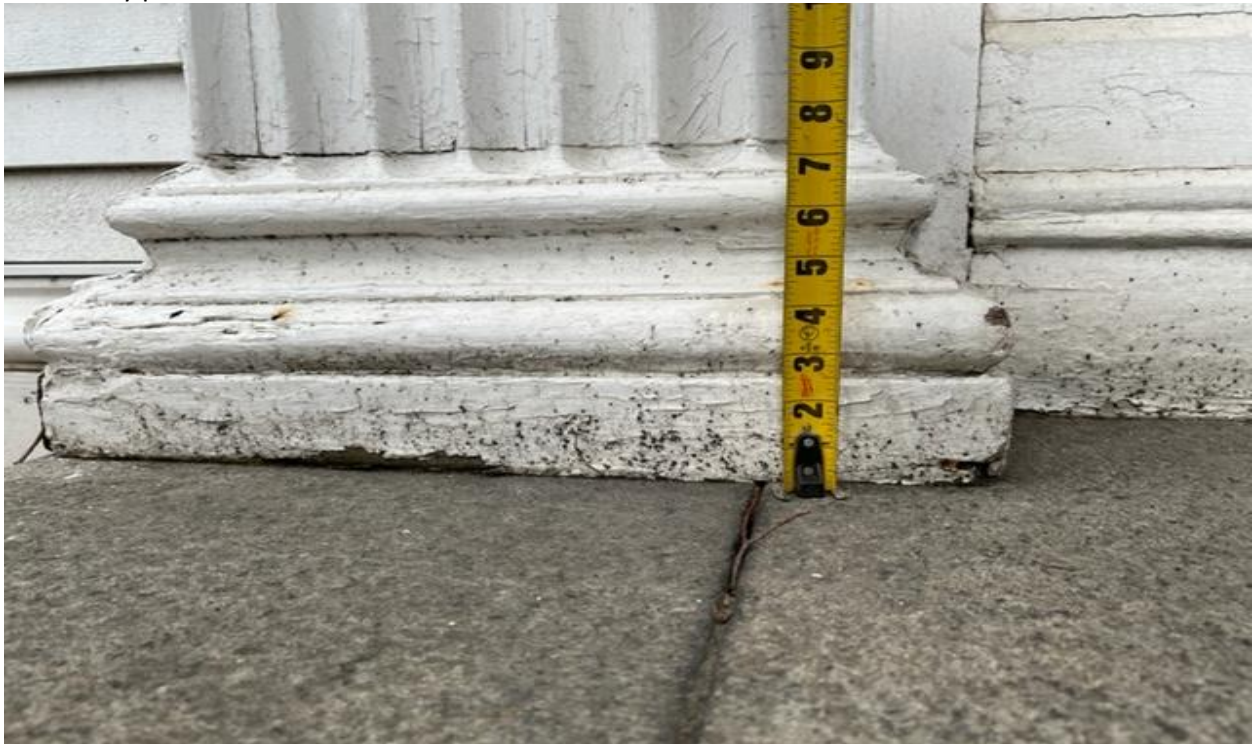
Main entry pilaster base

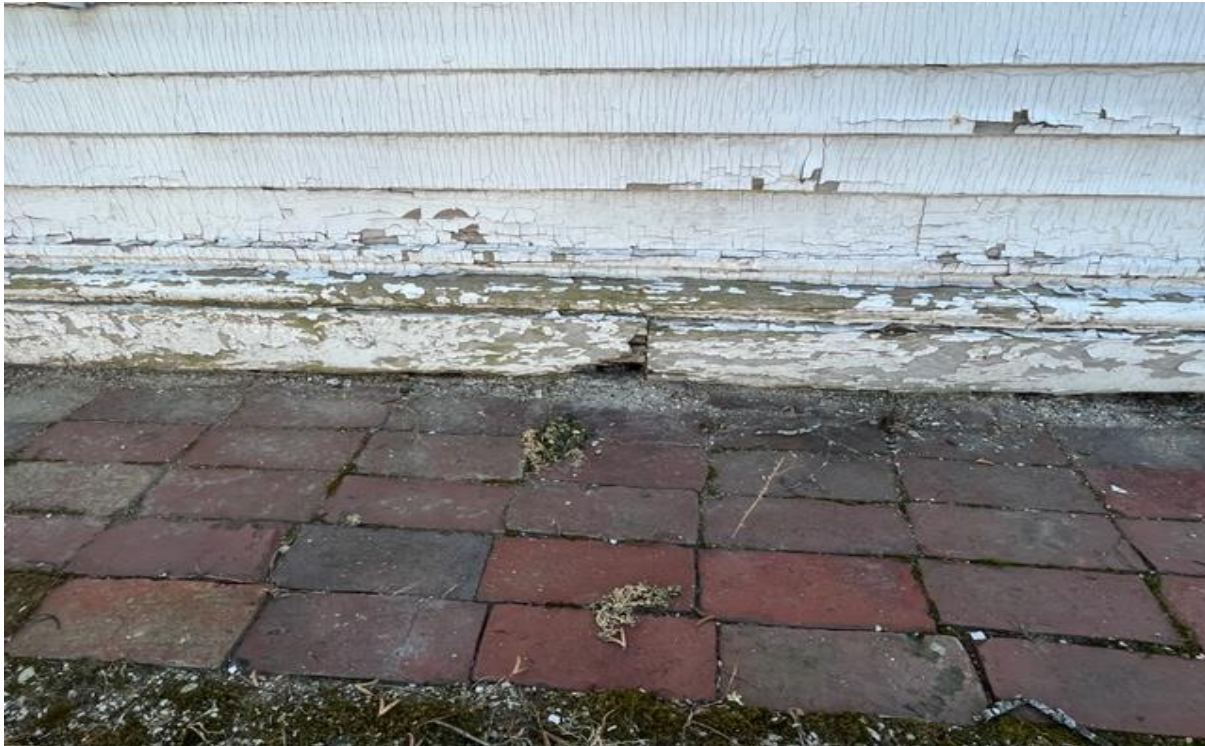
Bricks and grade at or above sill beam, promoting rot

- Please see supporting pics on page 9
  - Remove bottom 18" of siding and trim on all sides of the mansion
    - Remove all siding, trim, and sheathing so sill beam rot can be addressed

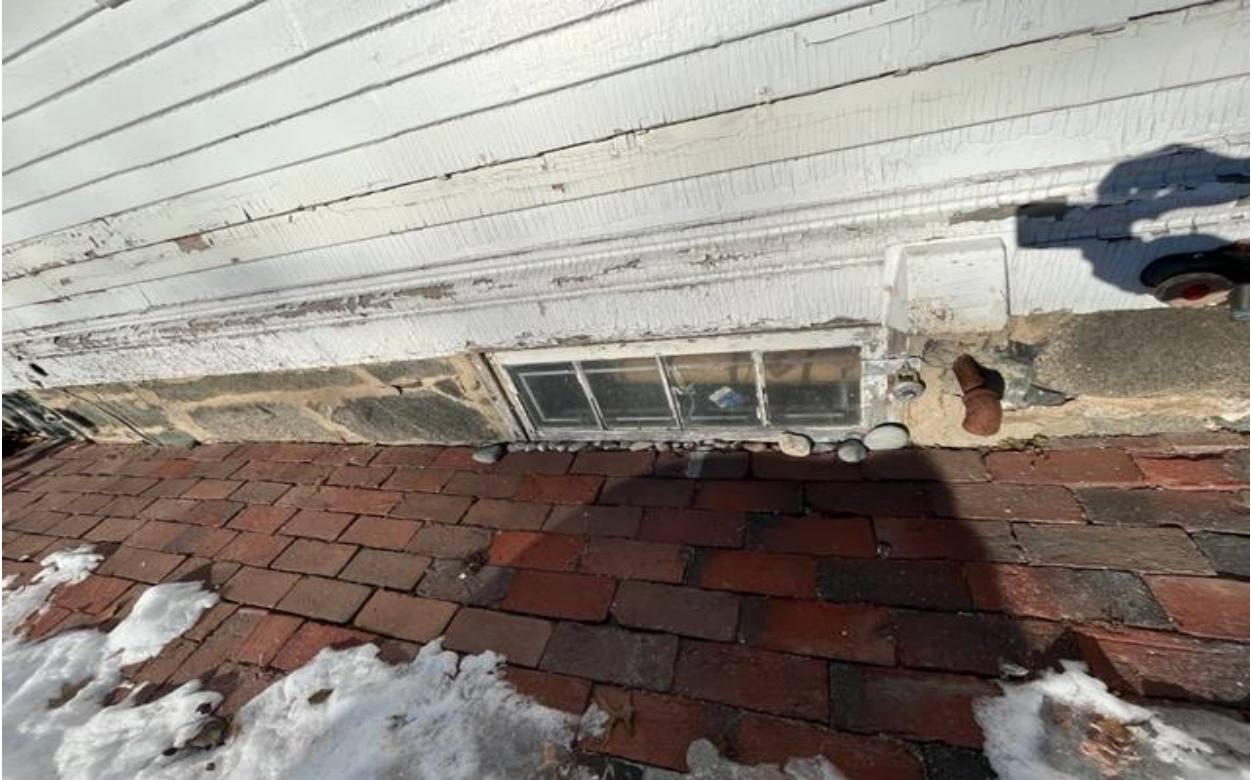
Basement window

- Hide or disguise as much as possible
  - This will be expanded upon in "phase 2" with exterior lighting and hardware
- Basement Windows
  - Replace all basement windows with new wooden sash windows (4) in total

- Basement windows to be 4 light as existing windows, non-operational
  - See pictures showing basement window light cut
- Grading & Landscaping
  - During construction we would like to dig down around foundation of main house

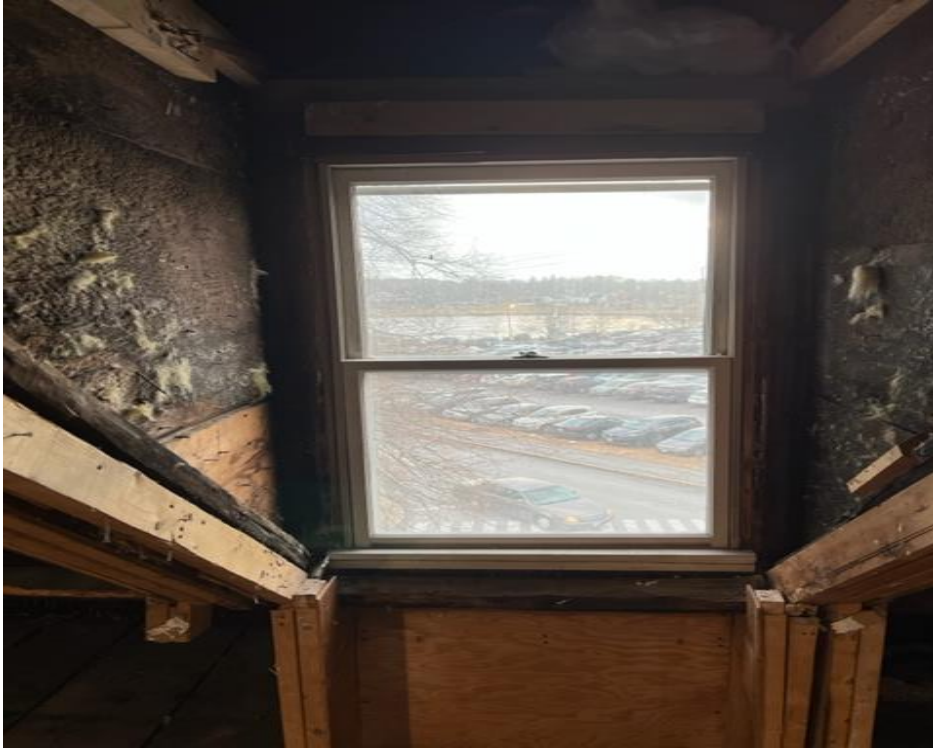
Dormer window

- Dormers
  - All (3) dormers will remain
  - Dormers to receive same proposed treatment as described in siding & trim section
  - Dormer windows will however be replaced with Marvin wood sash windows
    - Current windows are vinyl jamb wood sash, not original
- Window Head Casings
  - The head casings on the 1<sup>st</sup> floor windows show signs of water infiltration and rot
  - Remove 2 courses of siding above the head units to properly flash
    - All flashings will be copper
  - We will restore the trim wherever possible
  - If the trim is beyond restoring, an exact replicated head casing will be made in wood
  - New wood siding or salvaged siding to be installed after flashing has been corrected
  - See pictures for head flashing issues

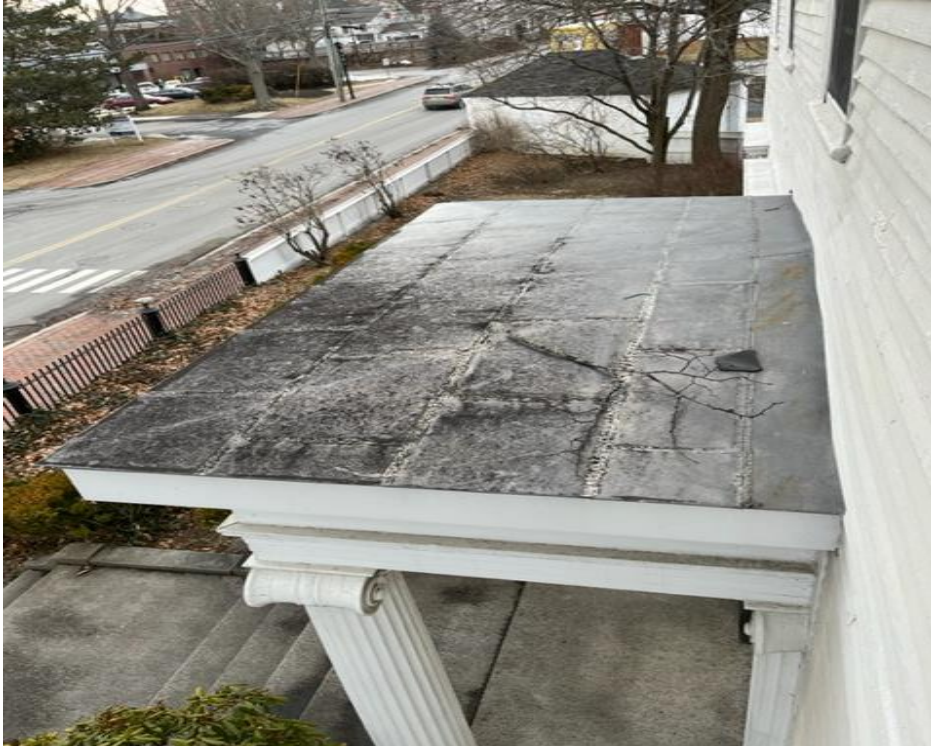
Main entry portico roof

- Main Entry Portico
  - Portico to receive same treatment as described above in siding & trim section
  - Review existing flat seamed copper roof
  - If the roof is inadequate then we will replace in kind with flat seam copper, soldered
  - Remove column bases, currently boxed in
    - See attached pictures for detail
  - Install new ionic style bases to match the profile of the pilaster bases on the portico
    - See attached pictures for profile
  - I would like to replace the column and pilaster bases with exact replicated bases
    - Would a synthetic be acceptable here since it is in contact with granite steps

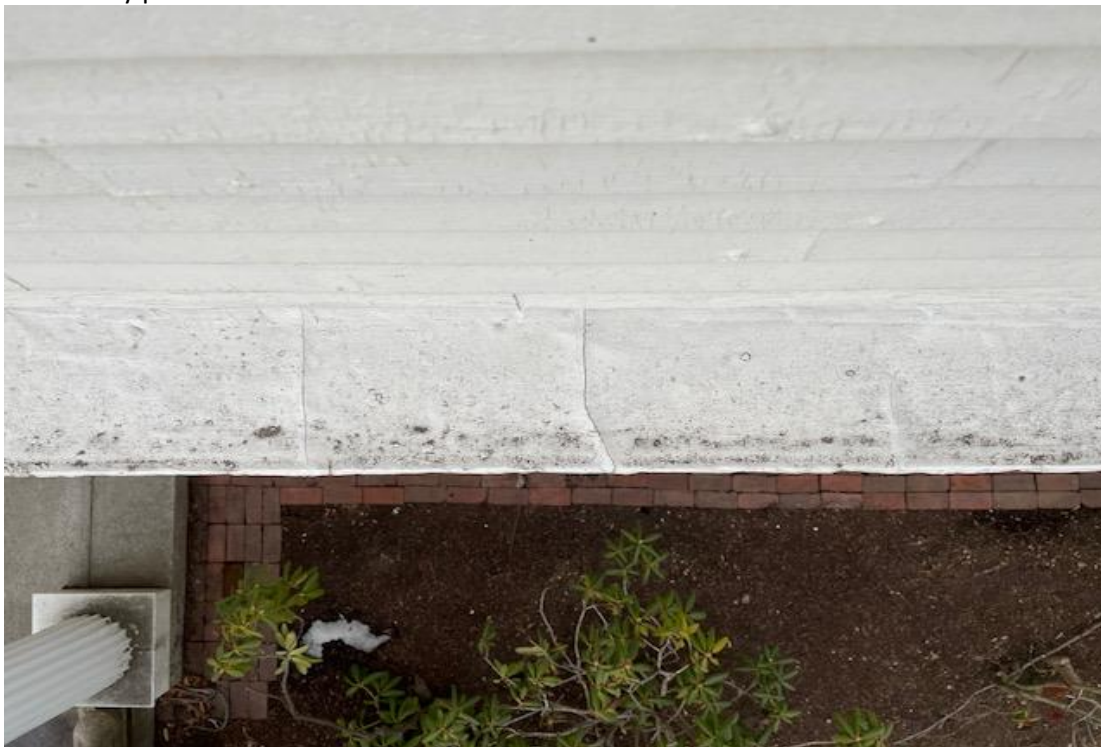
- The head casings on the 1<sup>st</sup> floor windows show signs of water infiltration and rot
  - Remove 2 courses of siding above the head units to properly flash

Window head unit flashing

- New wood siding or salvaged siding to be installed after flashing has been corrected
  - See pictures for head flashing issues
