179 PLEASANT STREET
PORTSMOUTH, NEW HAMPSHIRE

HDC WORK SESSION #2 APPLICATION TO AMEND PREVIOUS APPROVAL: JUNE 1, 2022

Structural Condition Assessment
Connector, Barn and Carriage House
Captain Thomas Thompson House
179 Pleasant Street
Portsmouth, New Hampshire

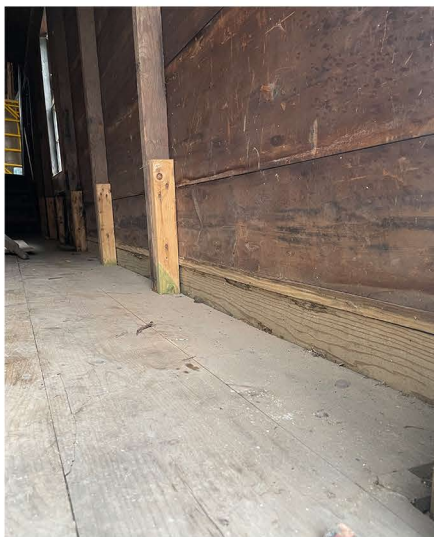
PRESSURE TREATED SILL
REPAIR

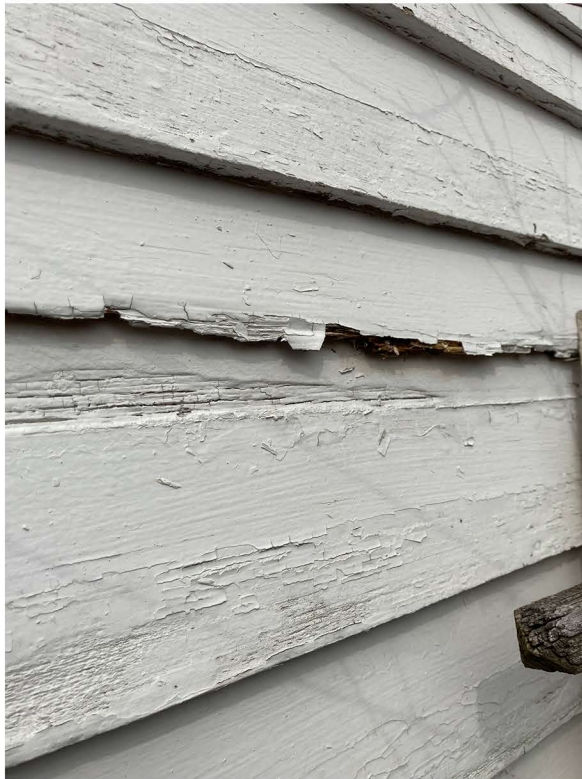
TYPICAL SIDING ROT

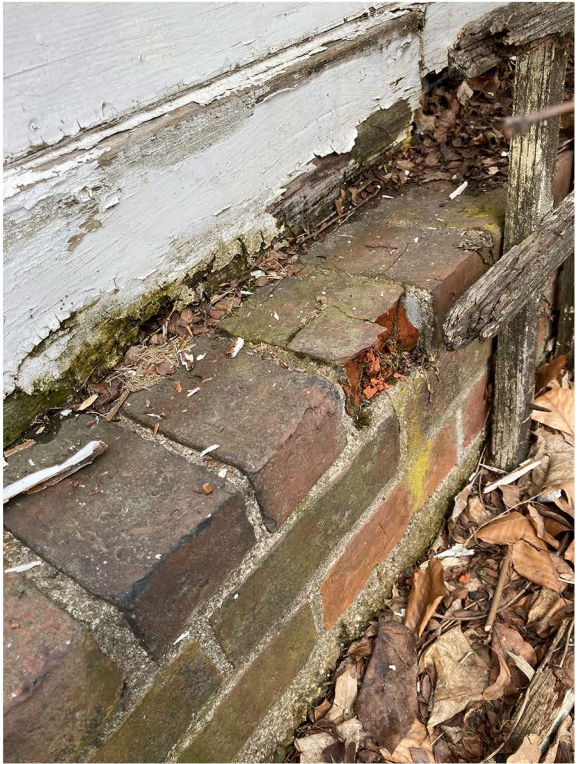
FOUNDATION SHELF AND ROT FROM STANDING WATER

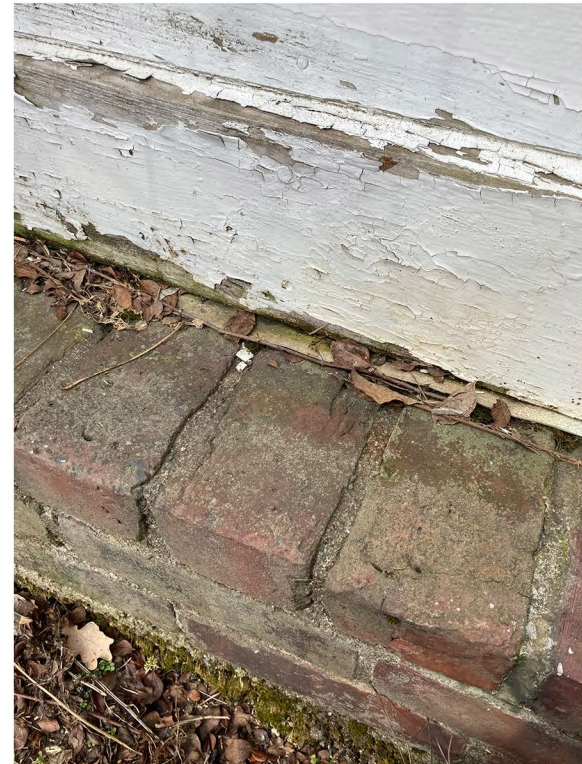
INSUFFICIENT FLASHING

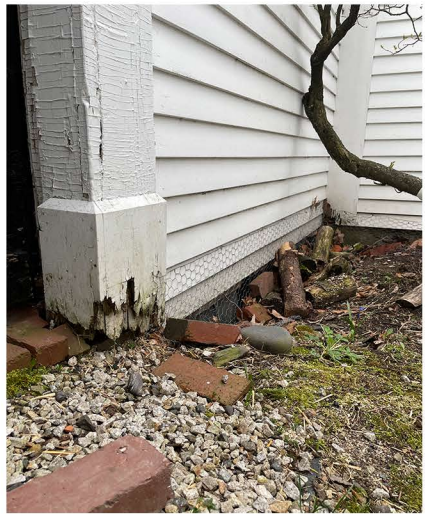
POST BASE ROT

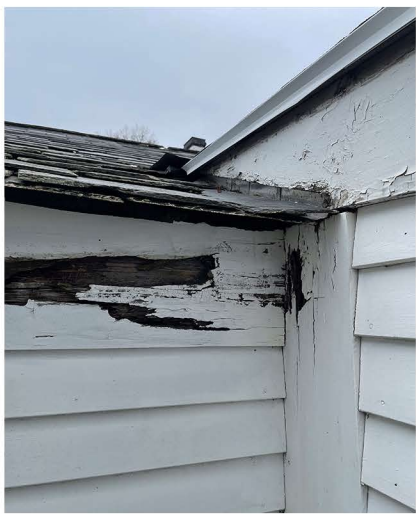
SIDING ROT

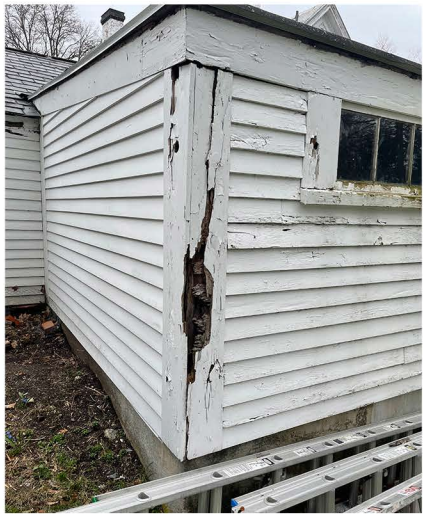
CORNER BOARD ROT

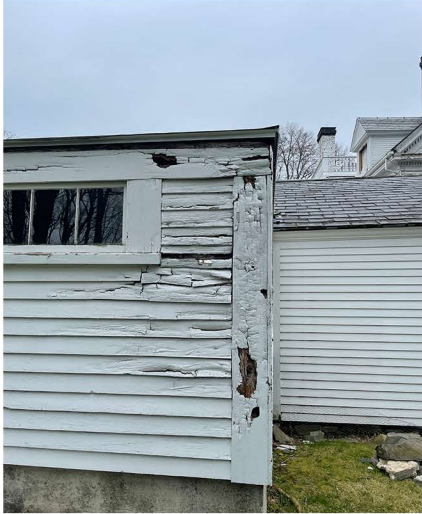
SIDING / CORNER BOARD ROT

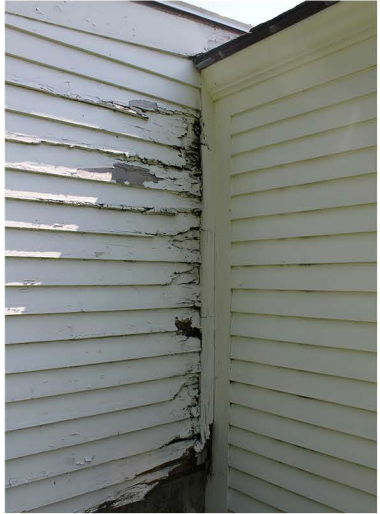
SIDING ROT

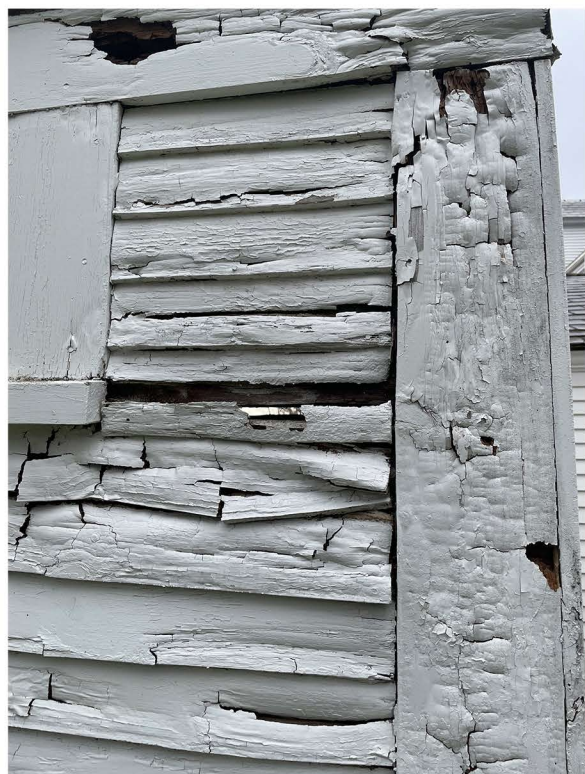
SIDING ROT AND INSUFFICIENT FLASHING

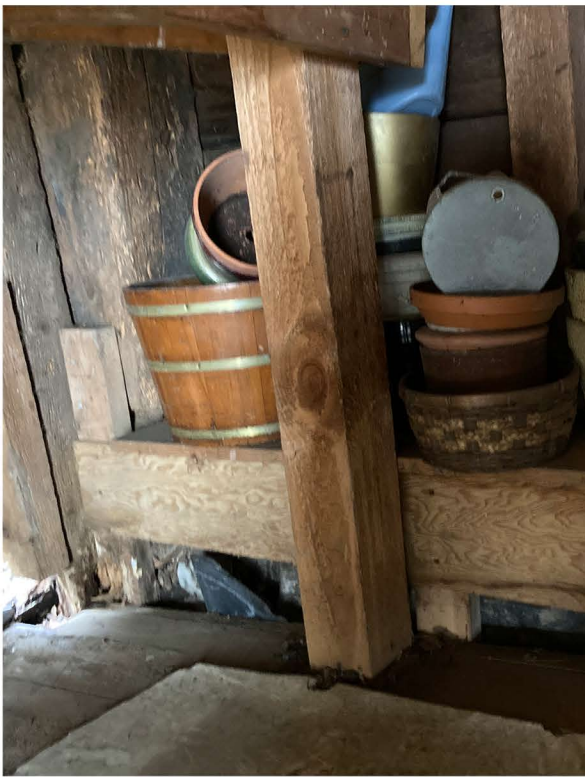
REPAIRS AT COMPROMISED STRUCTURE AT BASE

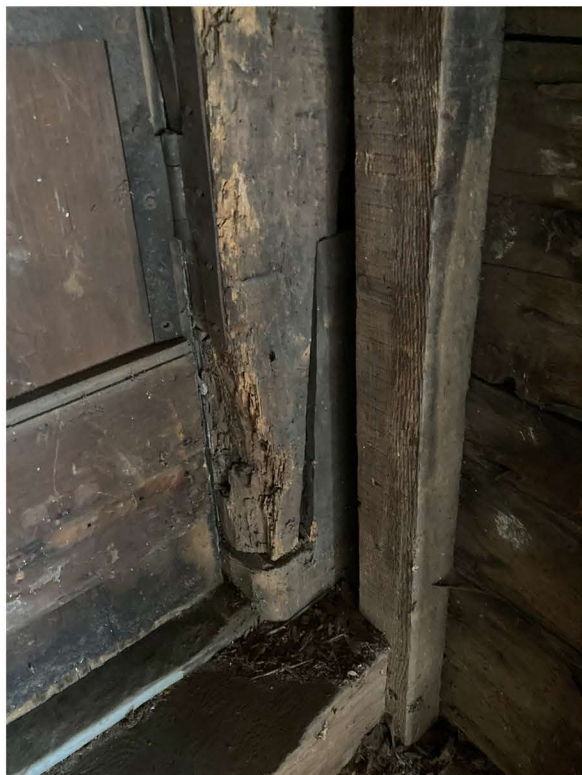
TYPICAL HALF LAP POST ROT REPAIR SEEN THROUGHOUT CONNECTOR

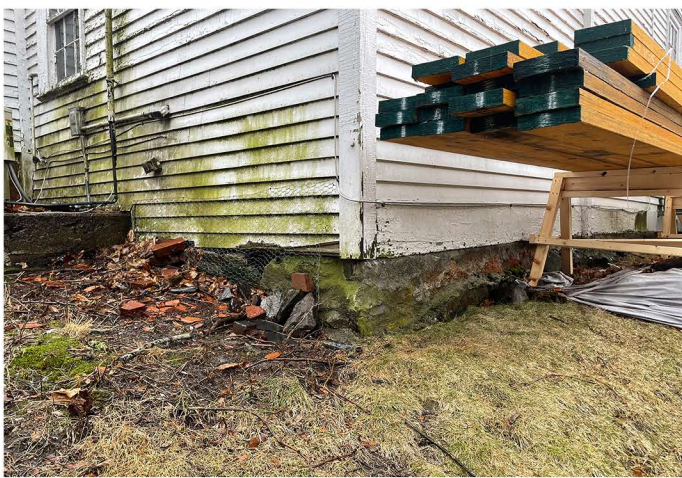
SILL ROT

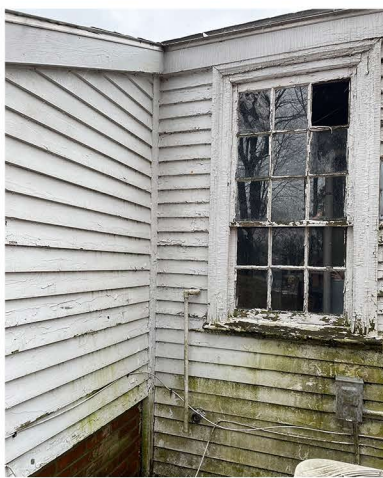
WINDOW ROT

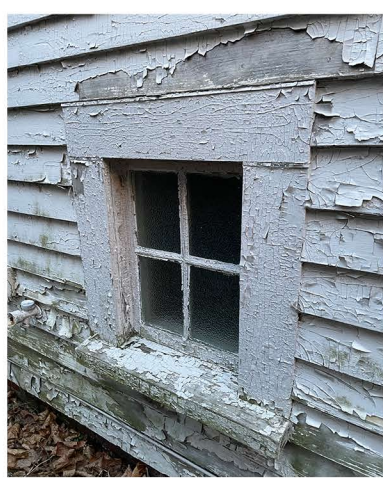
WINDOW SILL NEAR/ON GRADE

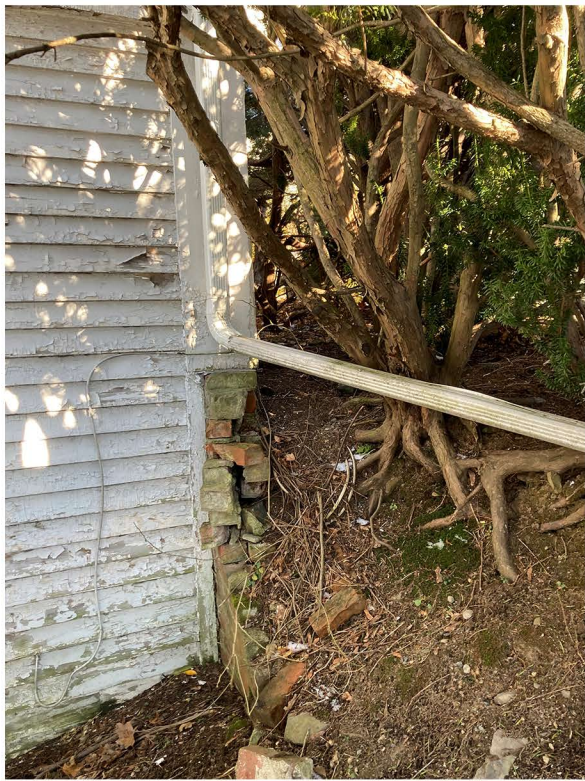
CRUMBLING FOUNDATION LACKING POSITIVE DRAINAGE

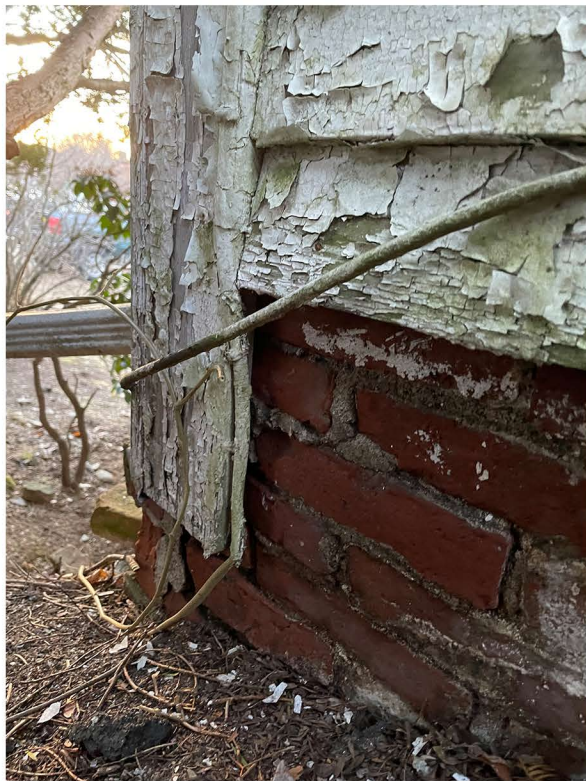
ROT FROM STANDING WATER

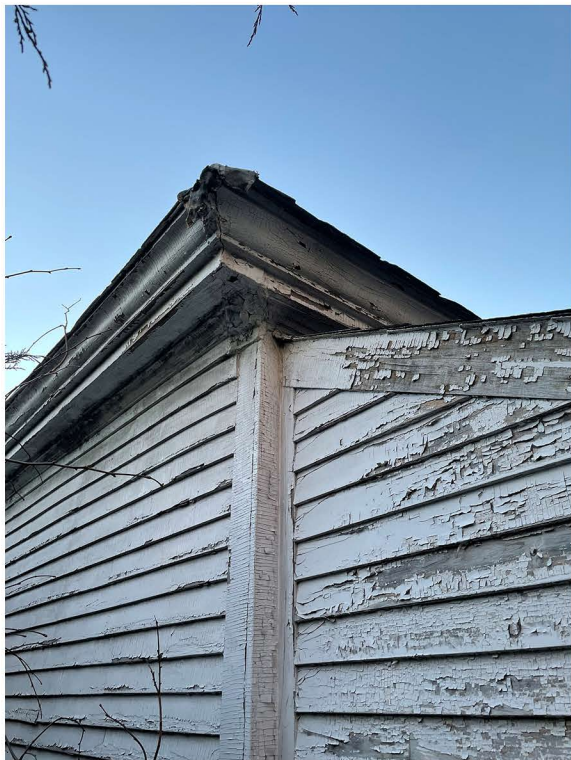
TYPICAL SIDING ROT

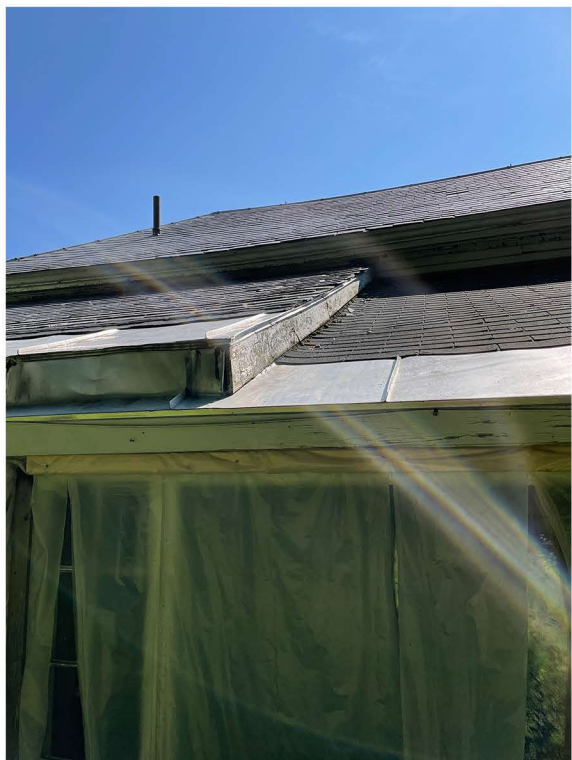
INSUFFICIENT ROOF FLASHING

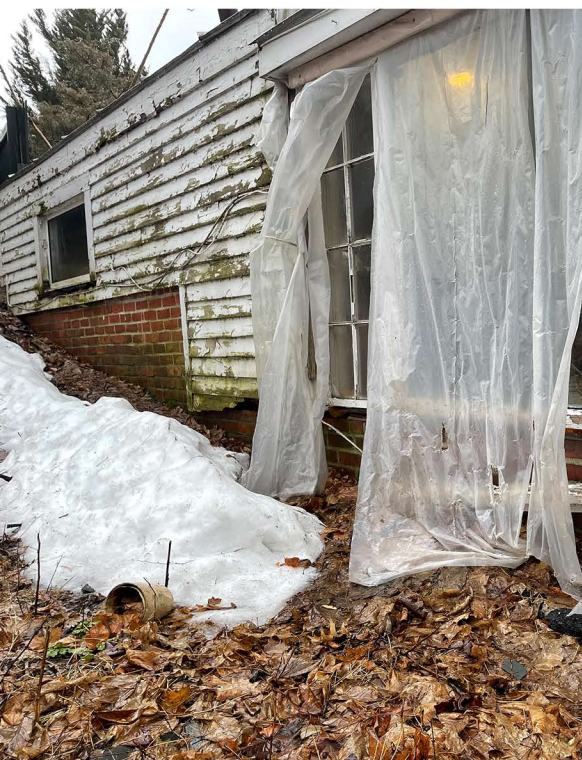
TYPICAL SIDING ROT AND FOUNDATION DAMAGE

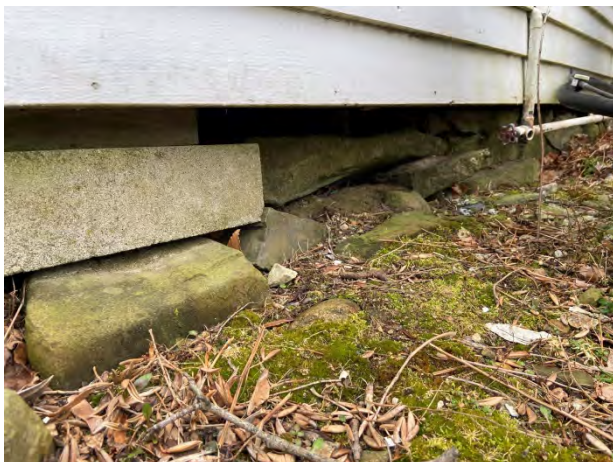
The connector foundation is made of loosely spaced stone supporting a timber plate. The exterior grade along the north side is about 1-foot below the top of the foundation wall. The exterior grade along the south side is approximately at the same elevation as the interior wood floor. Brick masonry cladding has been added along the outside face of the south wall in an attempt to provide some decay protection to the wall and timber sill. The top of this brick cladding is about 1-foot above the exterior grade and interior floor and covers decaying wall sheathing. (Images 1 – 5)

5-Connector foundation on north side

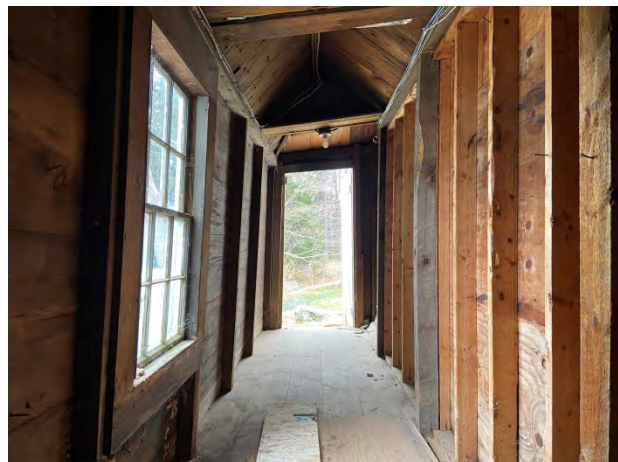
The first floor is framed with 2x4 joists spaced at 16" on center. The joists are supported on a 2x2 ledger fastened to 6x6 timber plates. The north exterior wall is constructed using board sheathing over 2x3 studs spaced at 39" on center. The south wall is constructed using plywood sheathing over 2x3 studs spaced at 16" on center with 4x4 post spaced at 4-feet on center. The majority of the roof is framed with boards spanning from the exterior walls to a 2x2 ridge. (Image 6)

6-Connector interior looking east

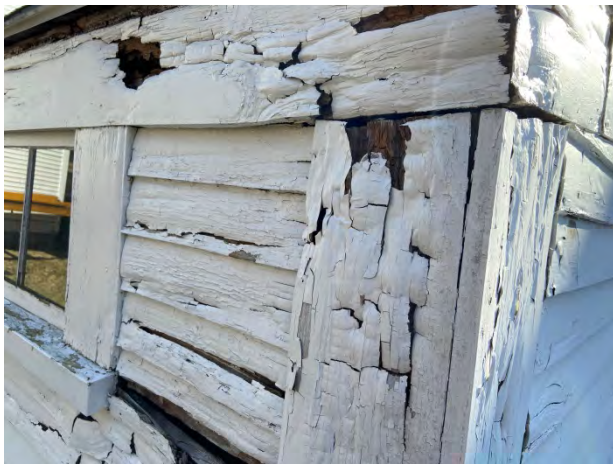
15-Barn decay damage

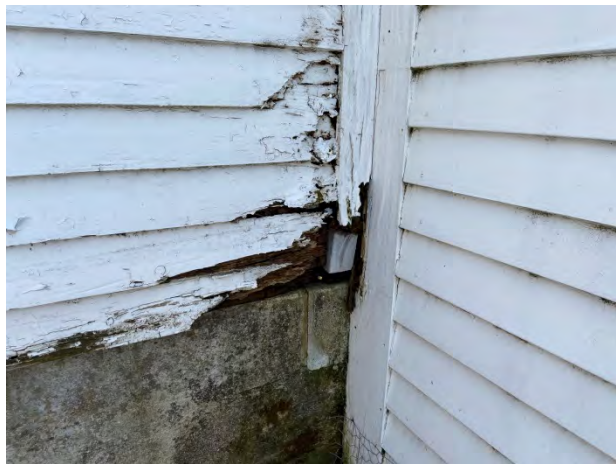
16-Barn decay damage

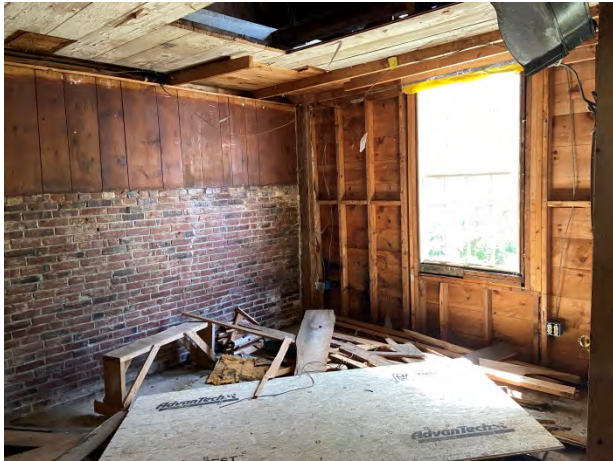
The first floor exterior walls along the front and right sides are framed with conventional 2x stud framing, similar to what we might see today, with pine board sheathing. My opinion is that these walls may have been constructed in the 1960s to 70s timeframe. The original posts along the front wall have been cut down to fit within the newer stud walls, and it was observed that the bases of some of the posts have been repaired. (Images 19 and 20)

19-Brick foundation and front wall framing

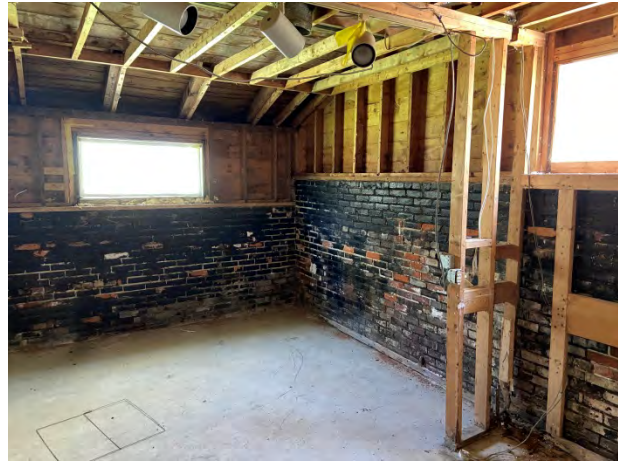
20-Brick foundation and side wall framing

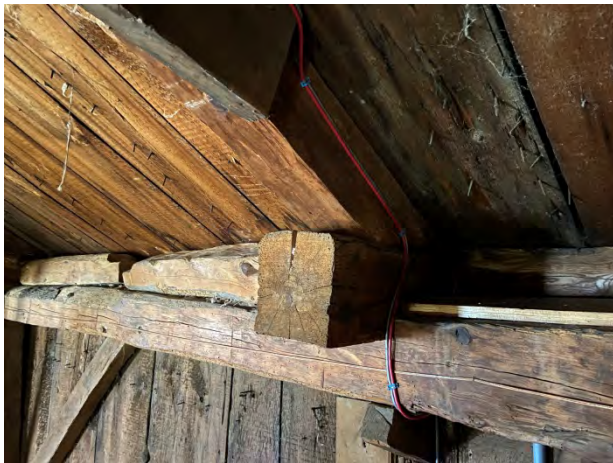
The structure has two major frames along lines 7 and 8 with steel hanger rods that extend from the second floor 8x8 carrying timber to the rafter peak. (See SK-B and SK-C) This system provides support to the second floor and relies on diagonal bracing at the second floor level and balloon posts that are continuous from the foundation to the roof truss. (See 1/SK-E) At the frame on line 7.5, the timber bottom chord was cut and removed. In an effort to compensate, 2x8 diagonal chords were installed in an attempt to create a scissor truss. (See images 21 & 22, and 2/SK-E)

21-Cut bottom chord on line 7.5
