179 PLEASANT STREET
PORTSMOUTH, NEW HAMPSHIRE

HDC WORK SESSION #1 APPLICATION TO AMEND PREVIOUS APPROVAL: MAY 4, 2022

DOG LEG CONNECTOR - EXISTING CONDITIONS

Structural Condition Assessment
Connector, Barn and Carriage House
Captain Thomas Thompson House
179 Pleasant Street
Portsmouth, New Hampshire

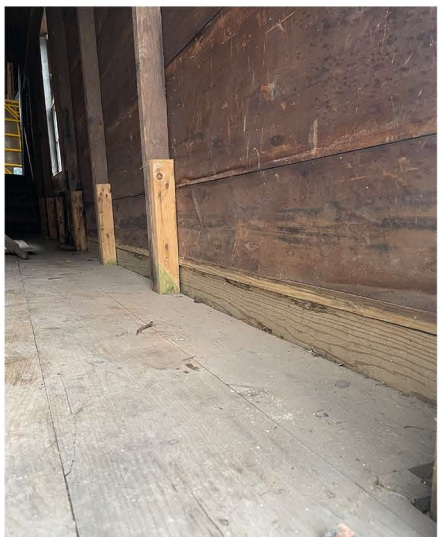
PRESSURE TREATED SILL
REPAIR

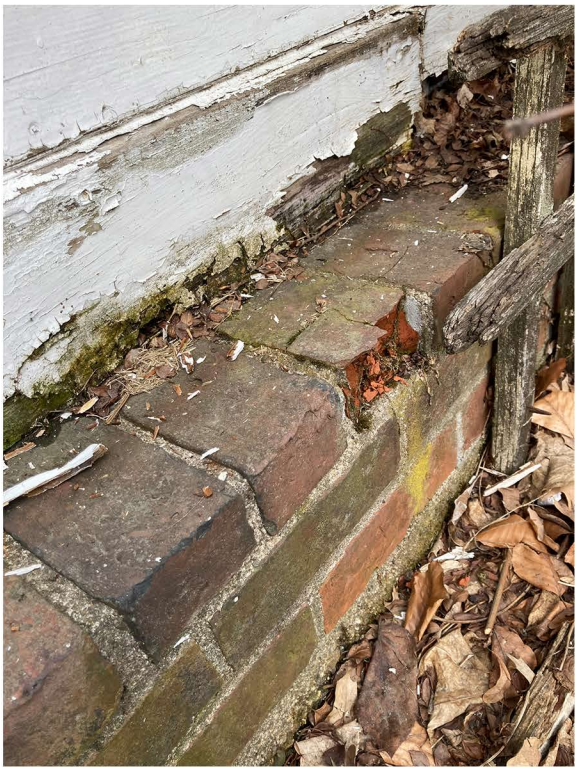
FOUNDATION SHELF AND ROT FROM STANDING WATER

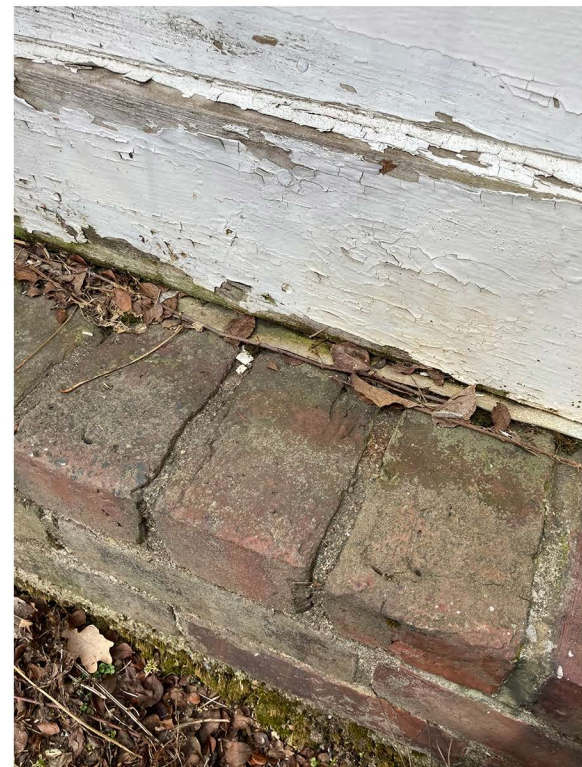
INSUFFICIENT FLASHING

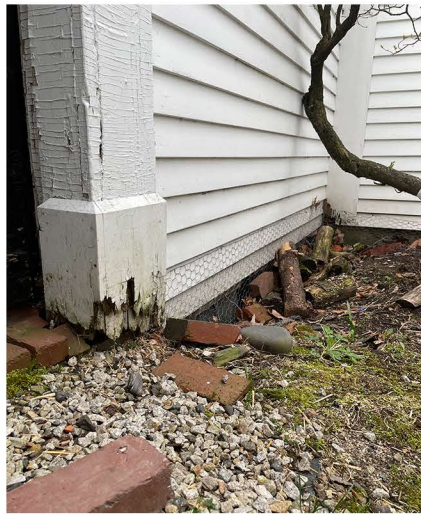
POST BASE ROT

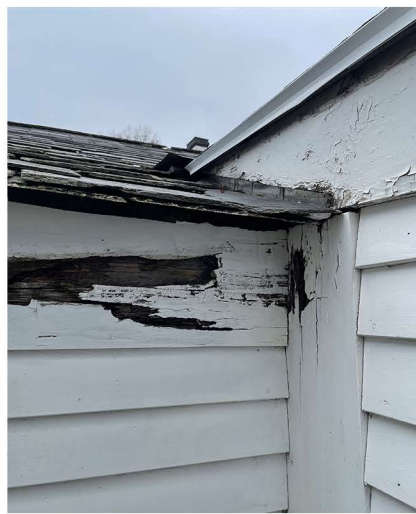
SIDING ROT

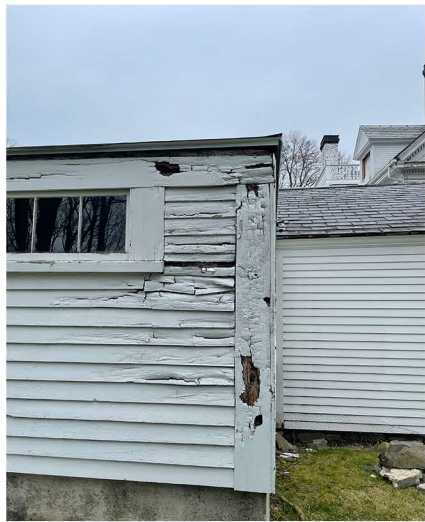
SIDING / CORNER BOARD ROT

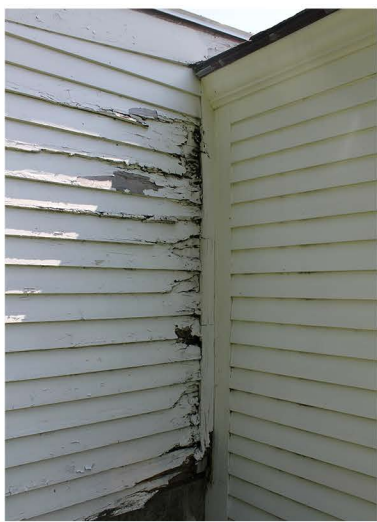
SIDING ROT

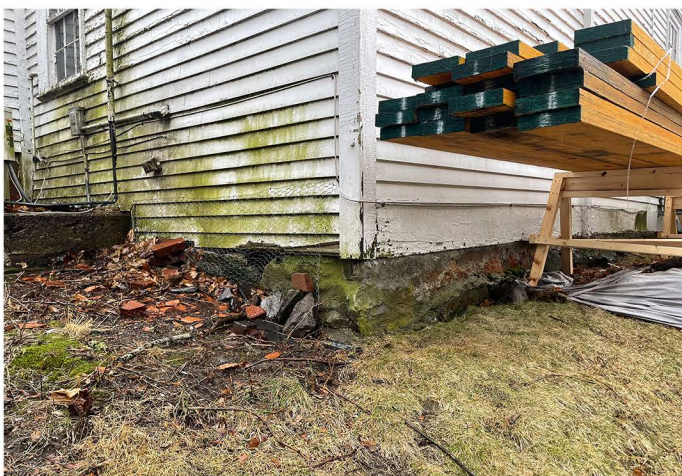
SILL ROT

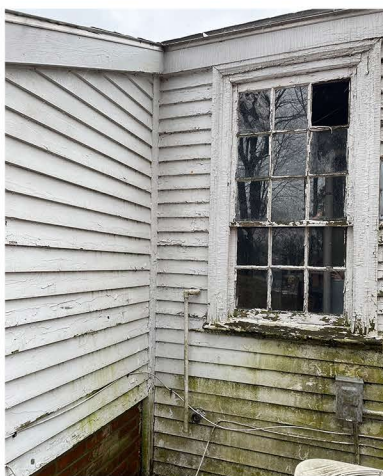
WINDOW ROT

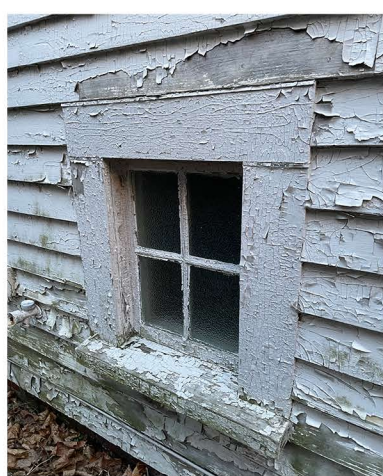
WINDOW SILL NEAR/ON GRADE

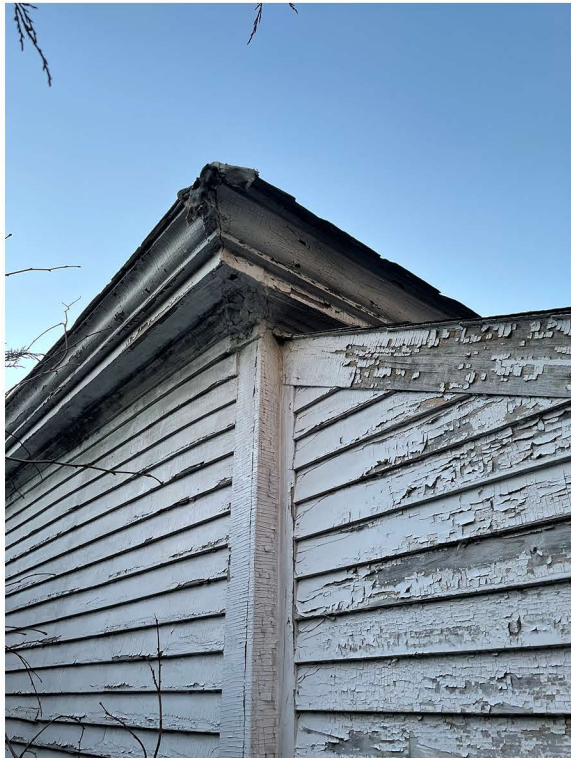
TYPICAL SIDING ROT

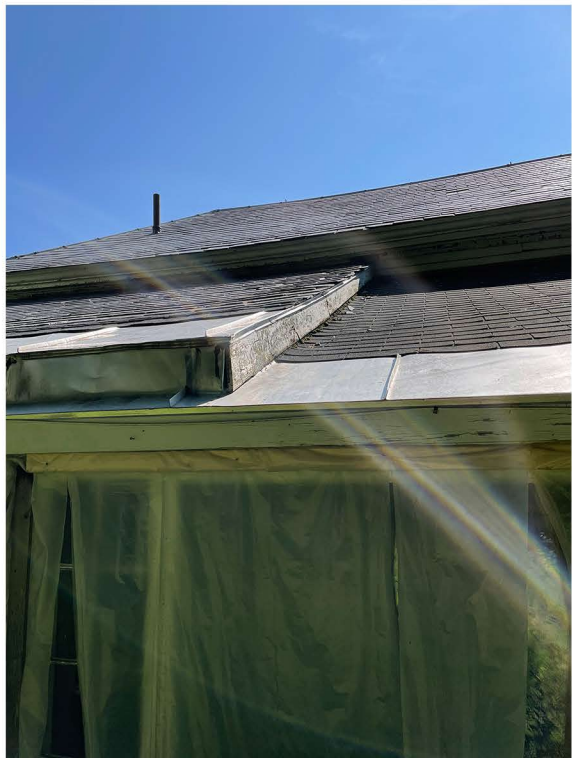
INSUFFICIENT ROOF FLASHING

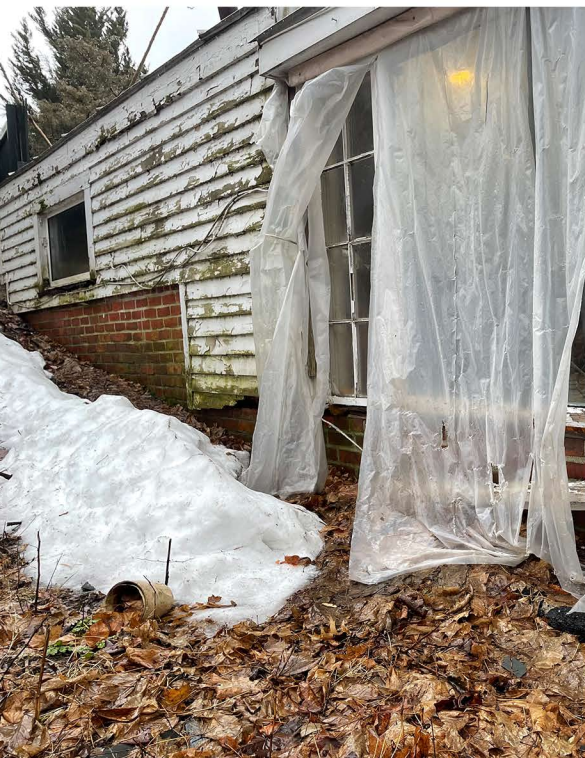
TYPICAL SIDING ROT AND FOUNDATION DAMAGE

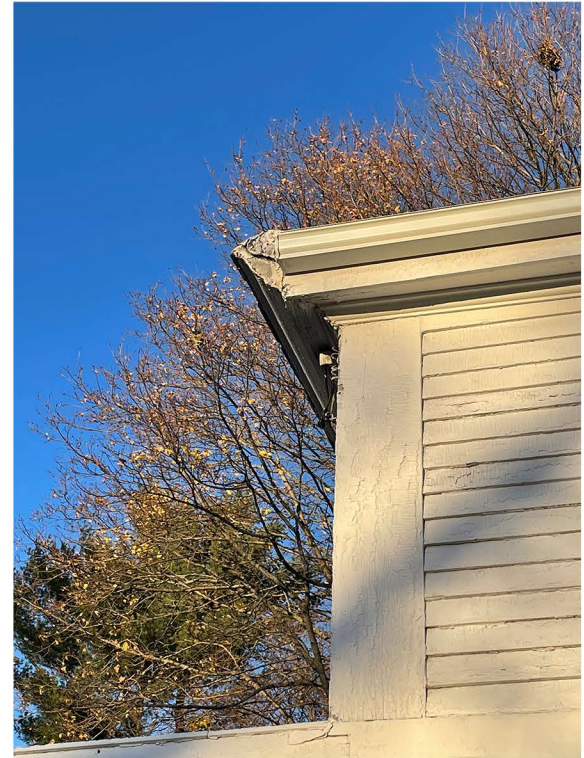
MODIFICATION OF ORIGINAL CORNICE TO INCLUDE GUTTER
