93 Pleasant Street, Treadwell House

## Stone Wall Masonry – Temporary removal and reconstruction

December 16, 2022

## Old Stone Wall, History & Work Plan

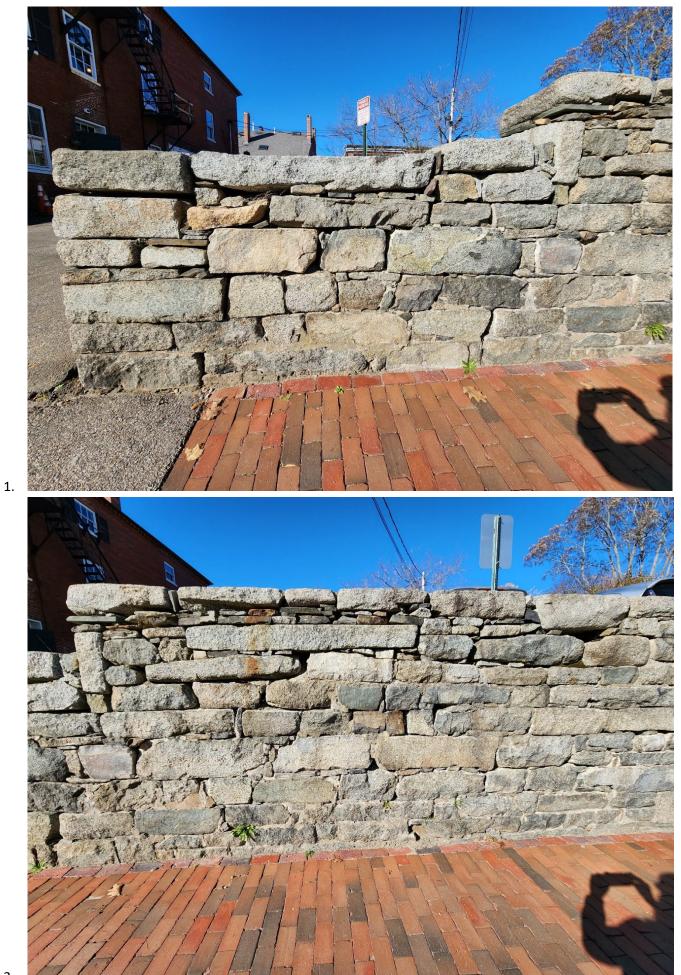
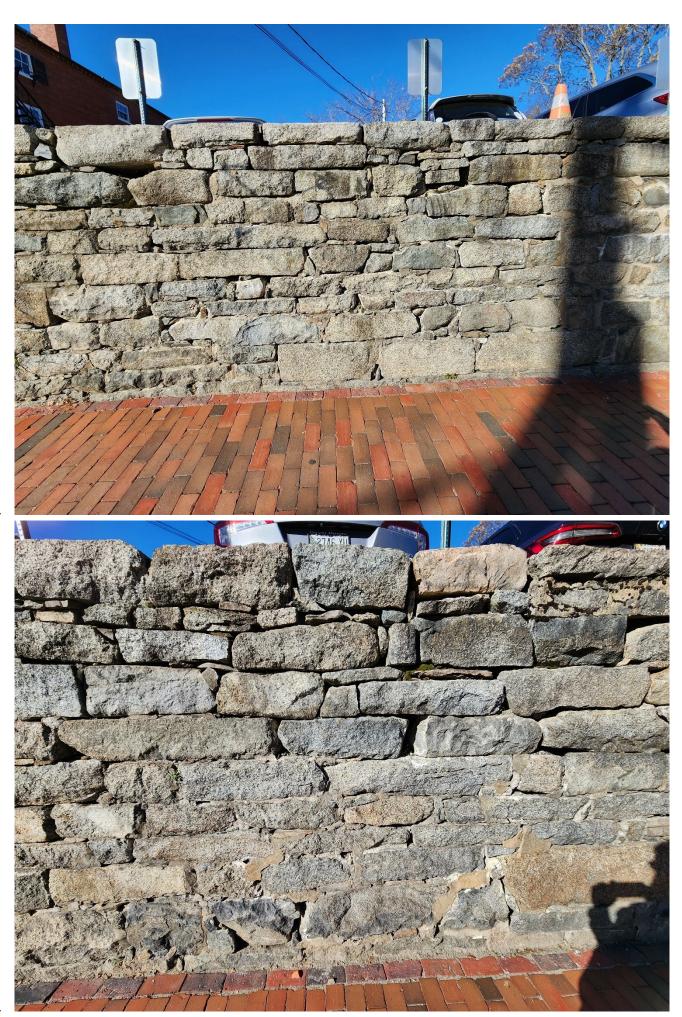
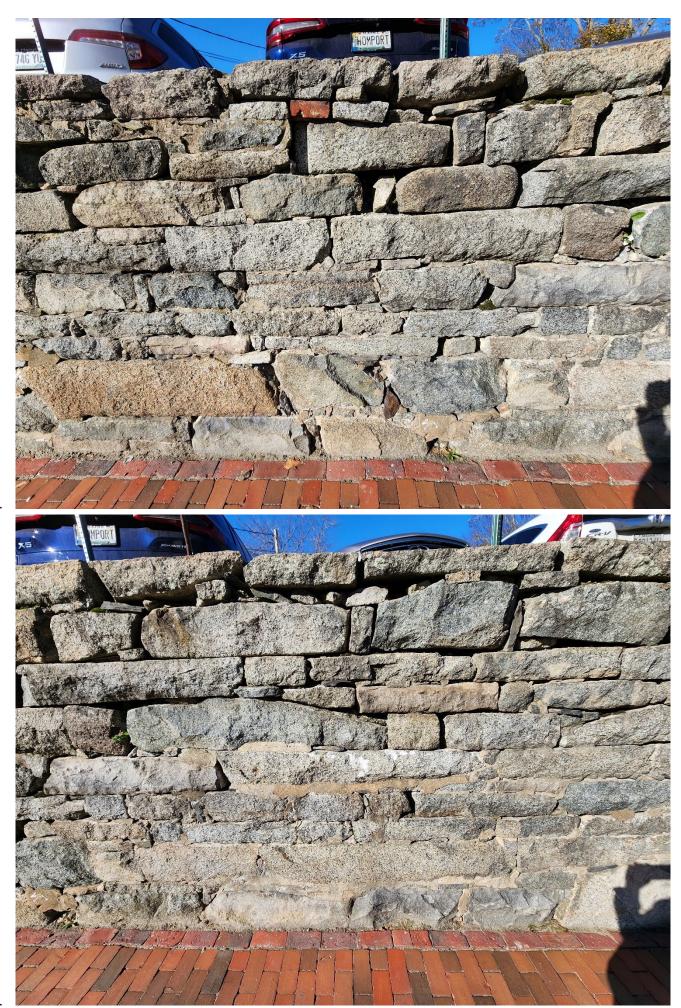
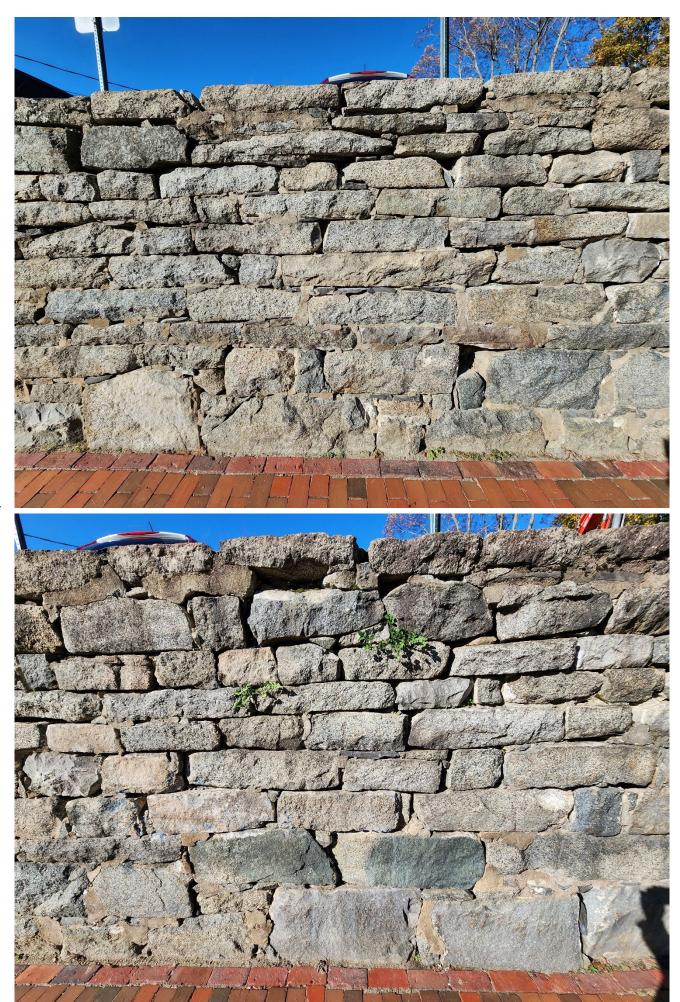
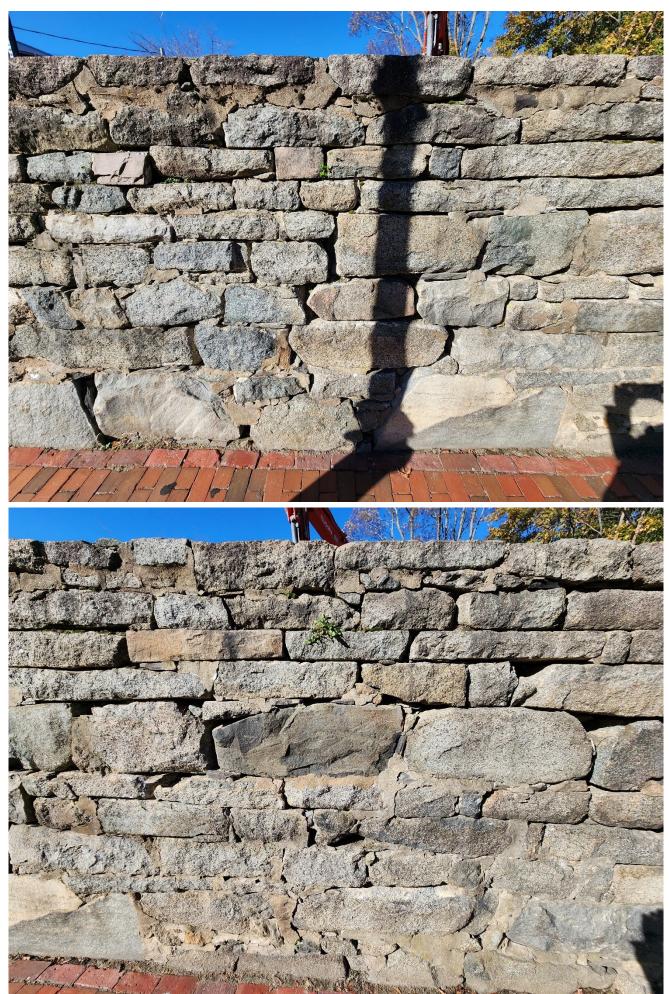
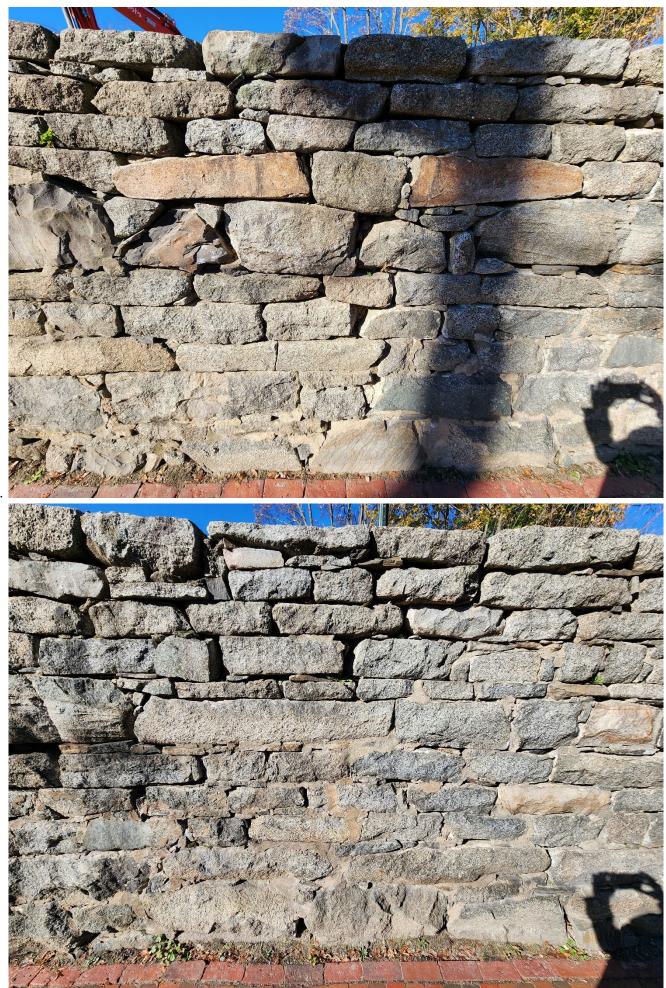
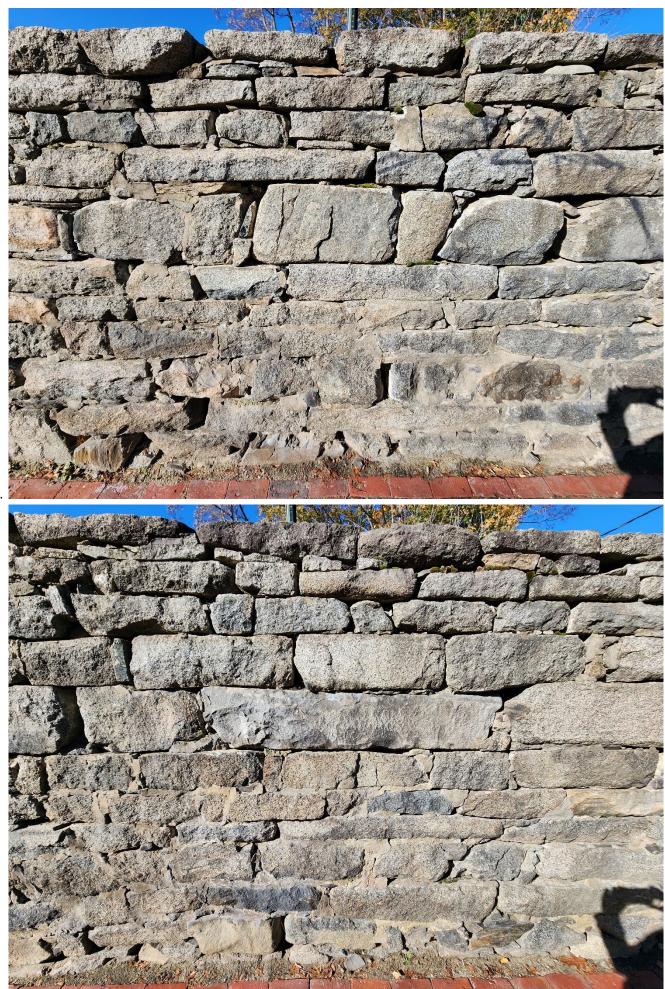
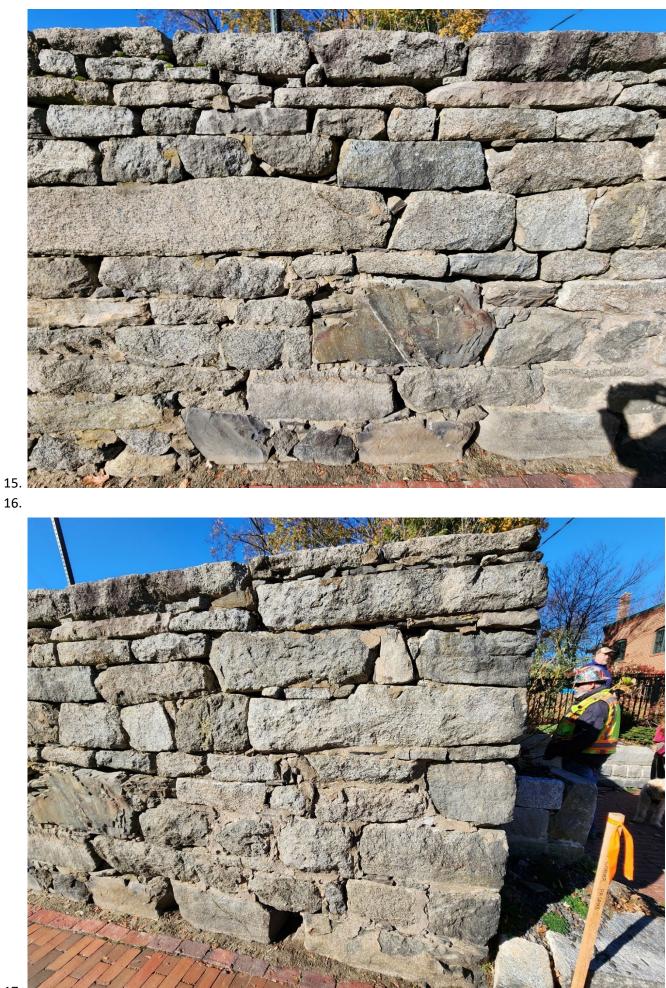
Existing Conditions - Front wall, Court Street

Repairs and back excavation to the wall ten years ago were for purposes of straightening its "leaning out over the sidewalk" condition. This work revealed a dressed face at the back of the wall, indicating that when originally constructed it was free standing. Subsequent backfill over centuries has placed lateral forces on this wall for which it was not designed to withstand. Periodically and gradually it leans out over the sidewalk, creating unsafe pedestrian conditions requiring continual repairs to replumb the wall. Many such repairs over the years are clearly evident. These repairs include mortar, stone shims, and mismatched larger stones which are not original to the historic wall. The current condition of the wall includes the original stones in good condition, plus many failing recent mortar joint repairs, added stone shims, and mismatched newer replacement stones.

Our request is to protect the stone wall from potential construction damage and to mitigate the need for future invasive repairs, by temporarily removing and safely storing it during construction, and then rebuilding it with the original stored materials after site excavation, utility and foundation work is complete. This workplan will protect the wall from damage which could occur from collapse during construction due to excavation of bedrock found behind and under the wall. This bedrock is contiguous to the bedrock upon which this wall partially sits. Temporarily and safely removing the stones will protect them from damage that would occur if the wall was left in place. Protecting in-place with shoring was pursued but found unfeasible. Because the wall is a dry-laid, multi-wythe three-foot-thick wall it would require through-rods 24" on center, which would damage some of the stones and would be ineffective for utility excavation below the wall. By protecting the wall in this way, we have the opportunity to not only repair previous repairs, but to properly restore this historic wall more closely to its original state and prevent damage from future repairs.

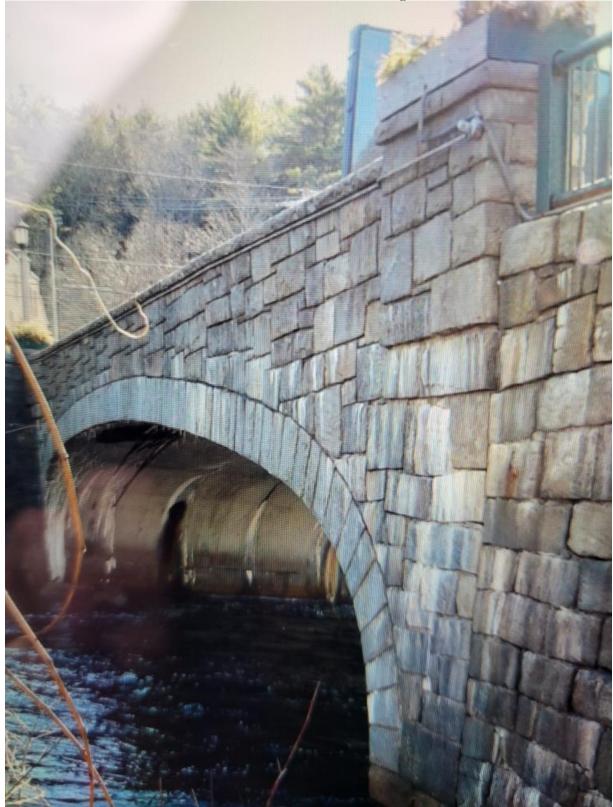
Please see attached picture of bridge in Peterborough, NH reconstructed with similar method this past year.
