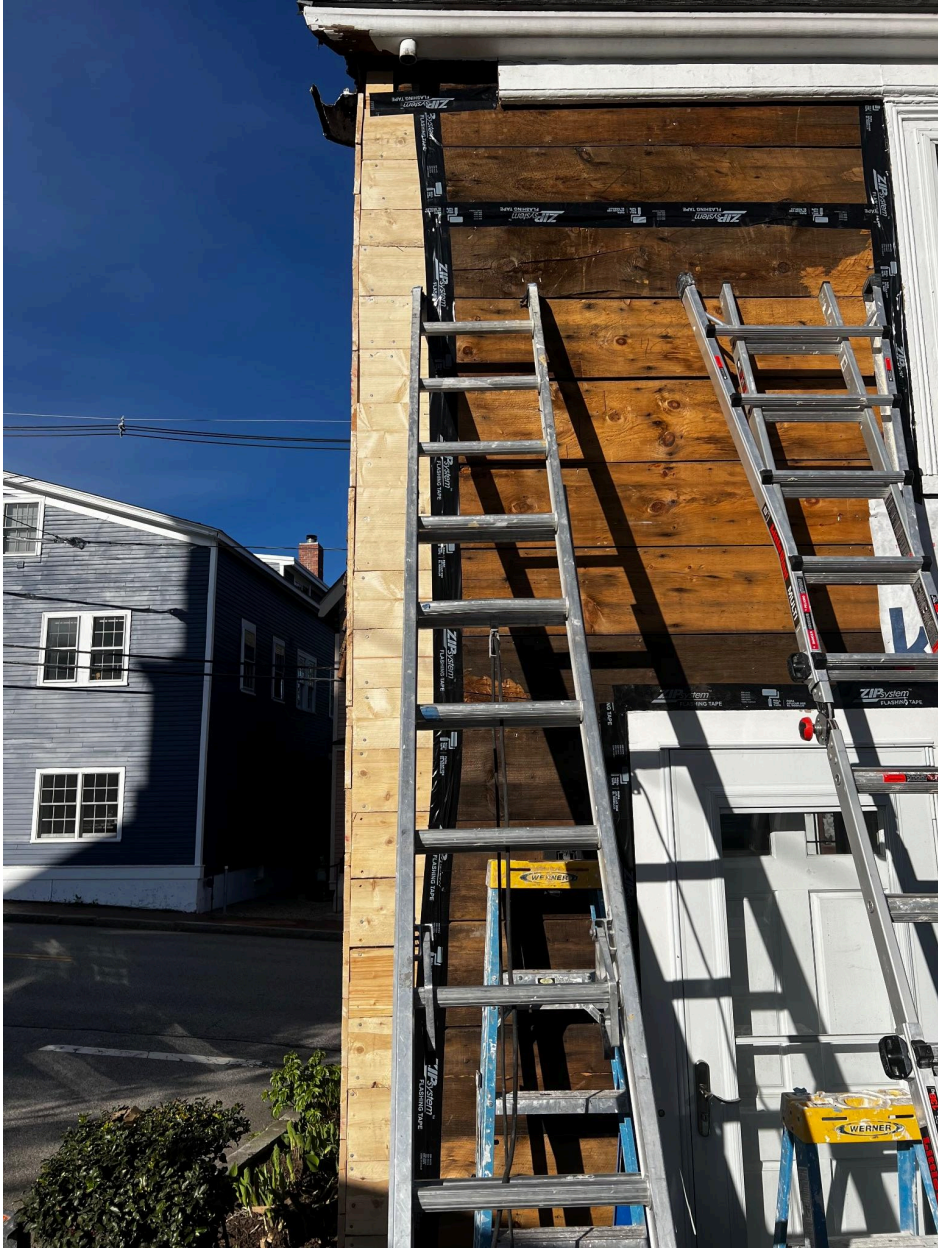
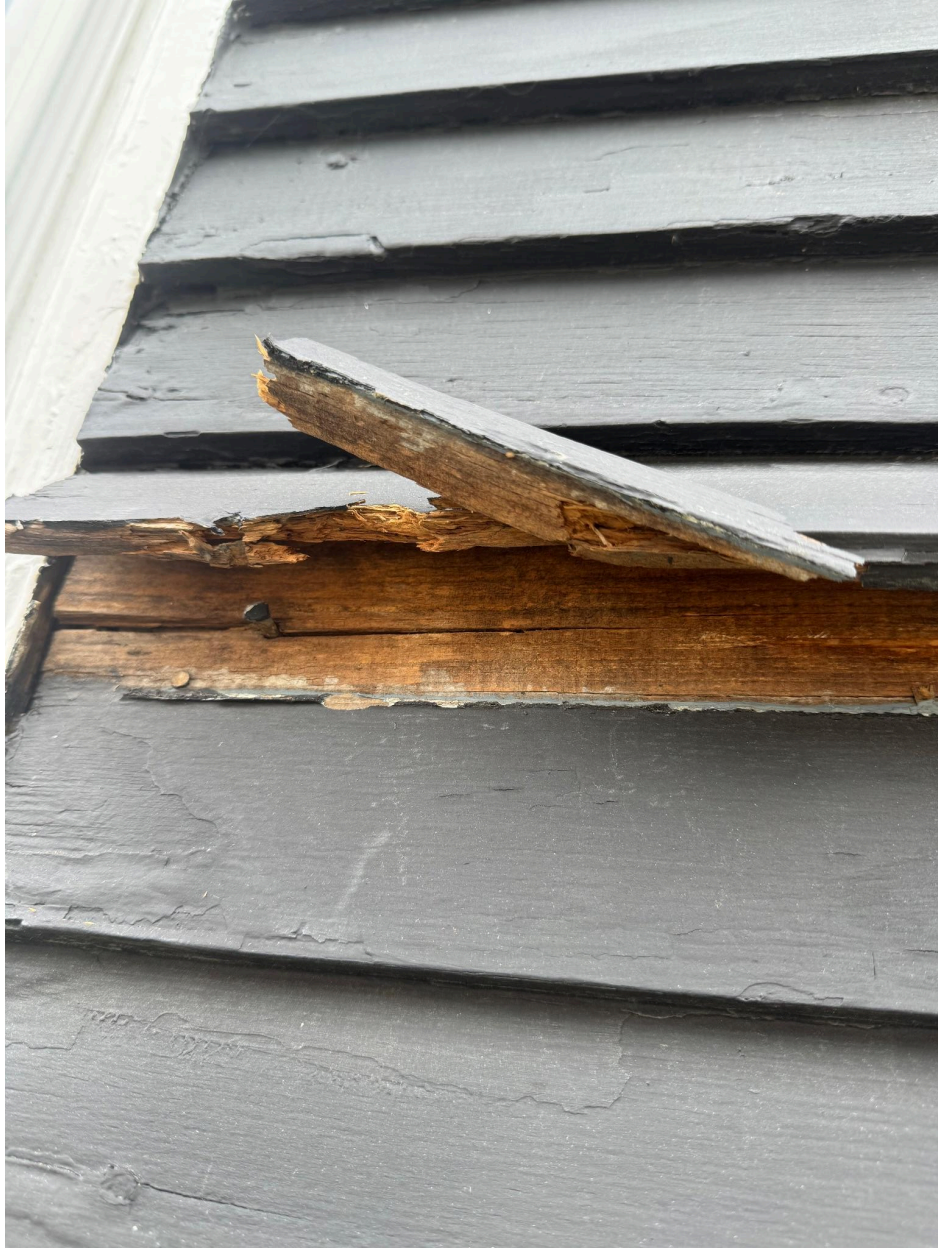
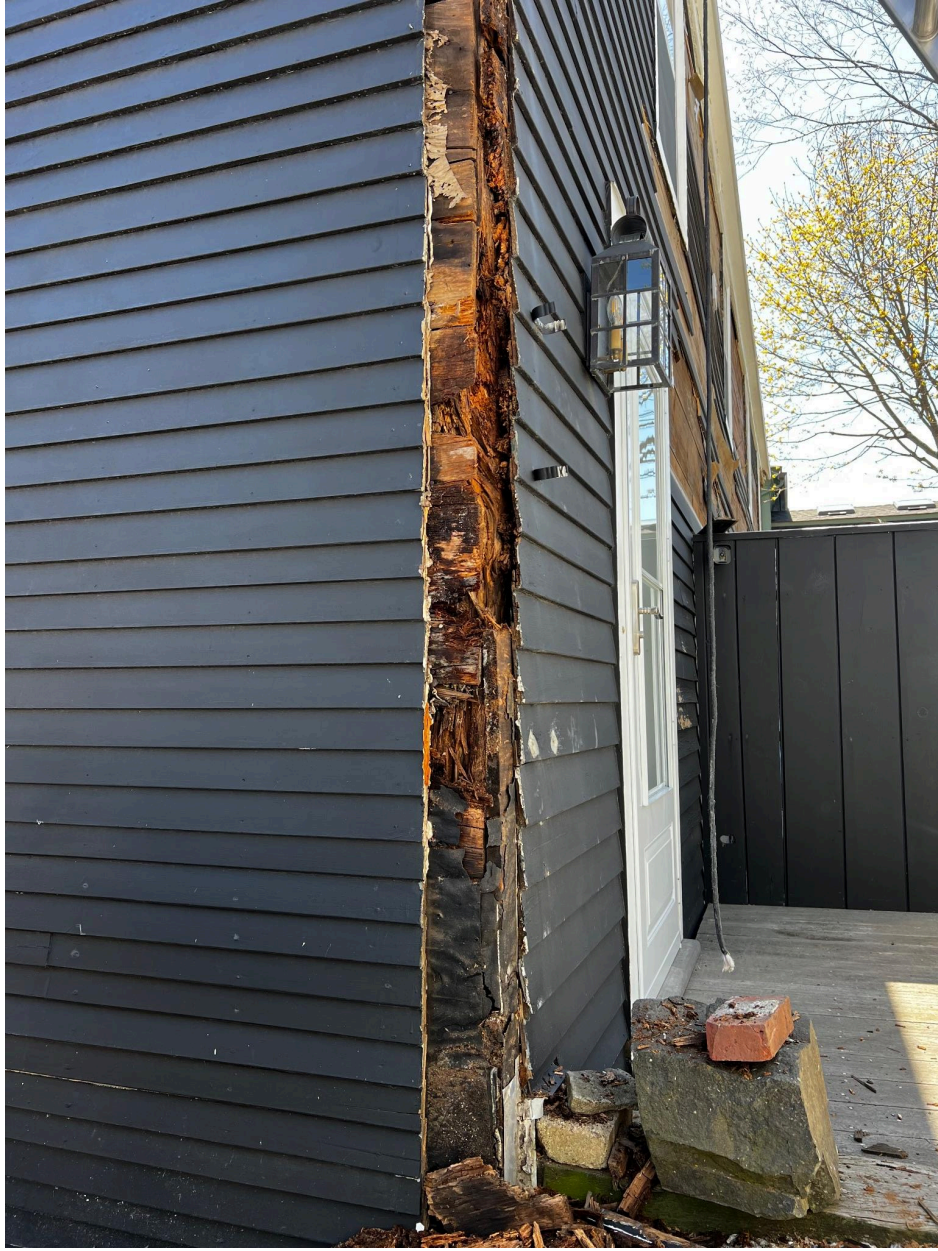
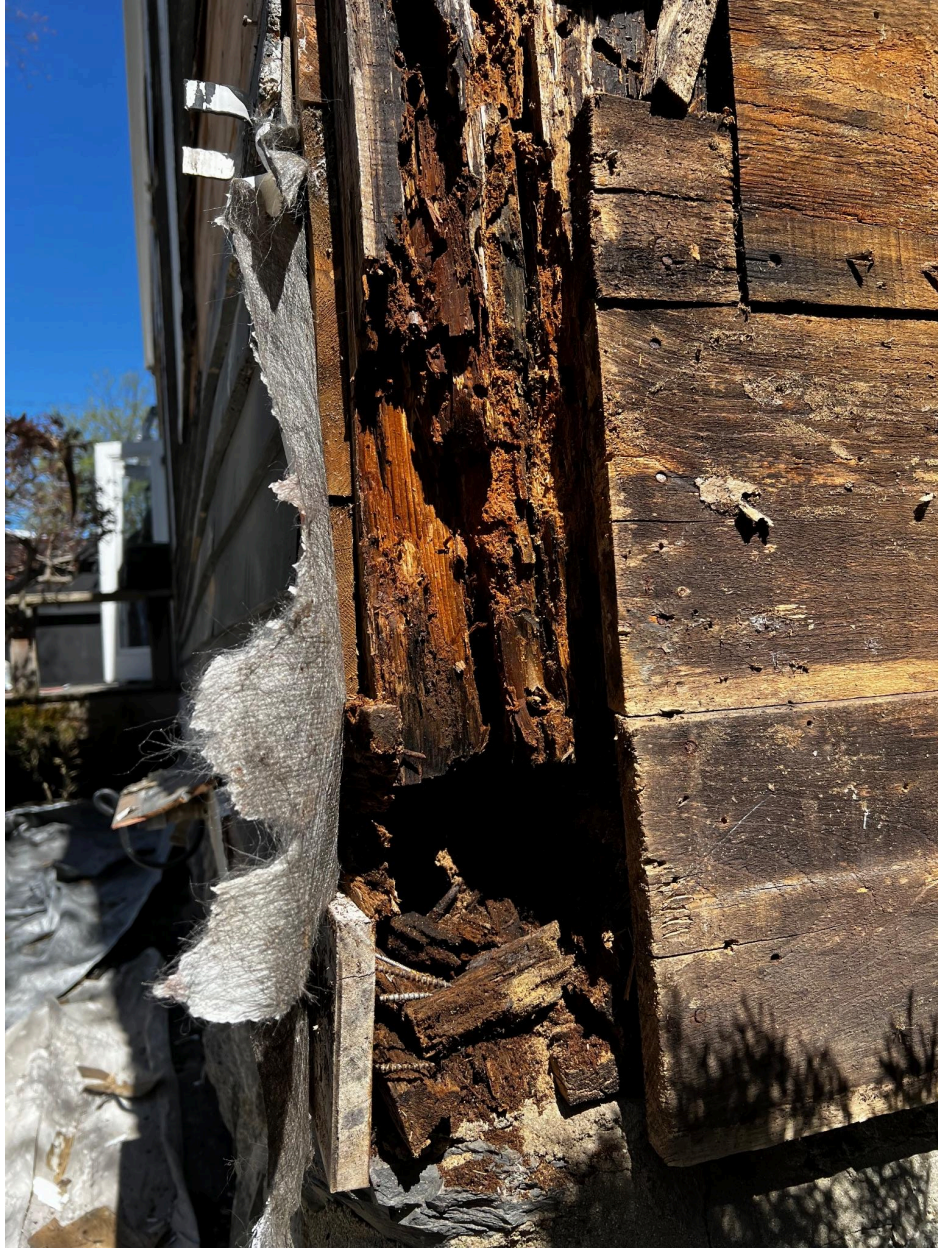
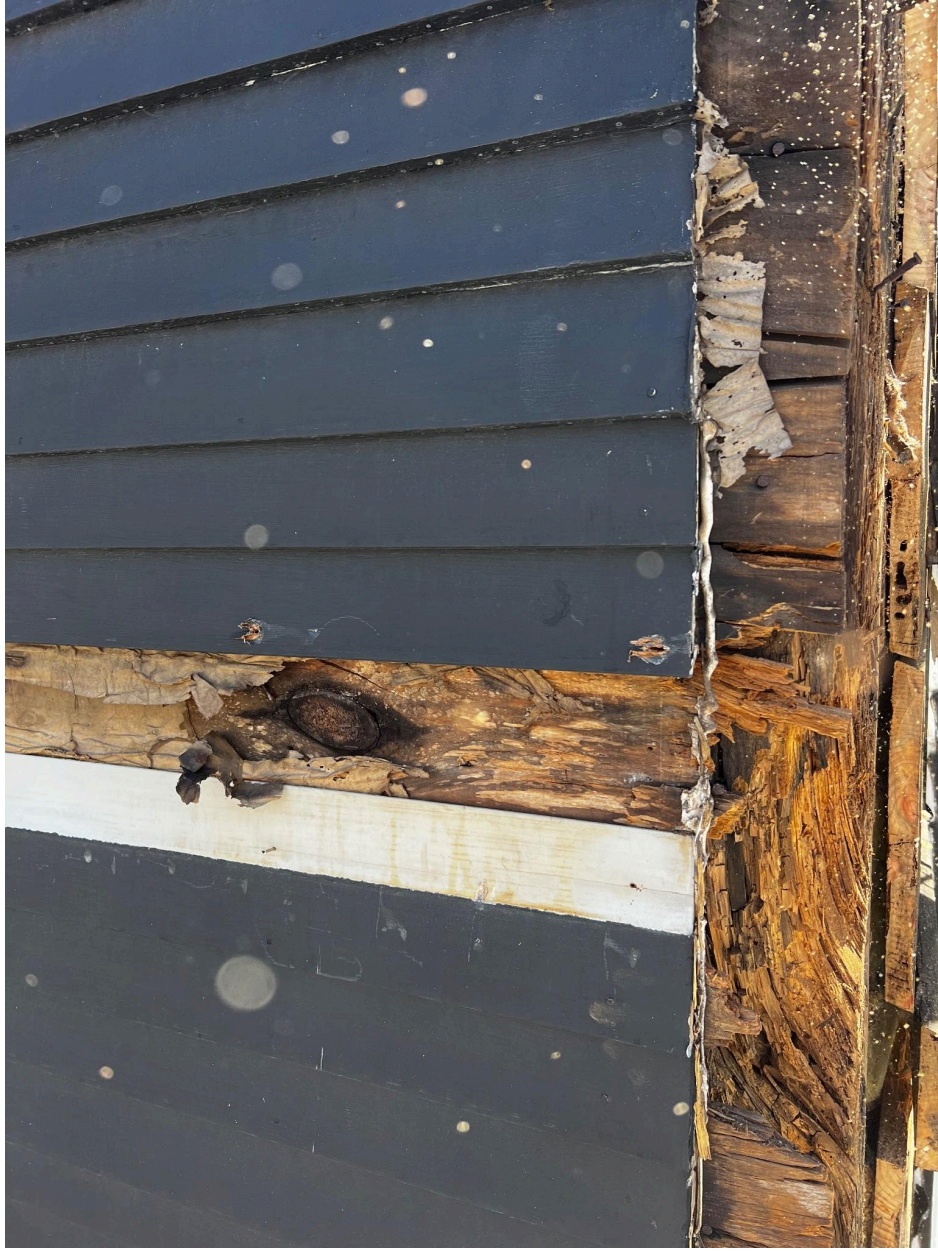
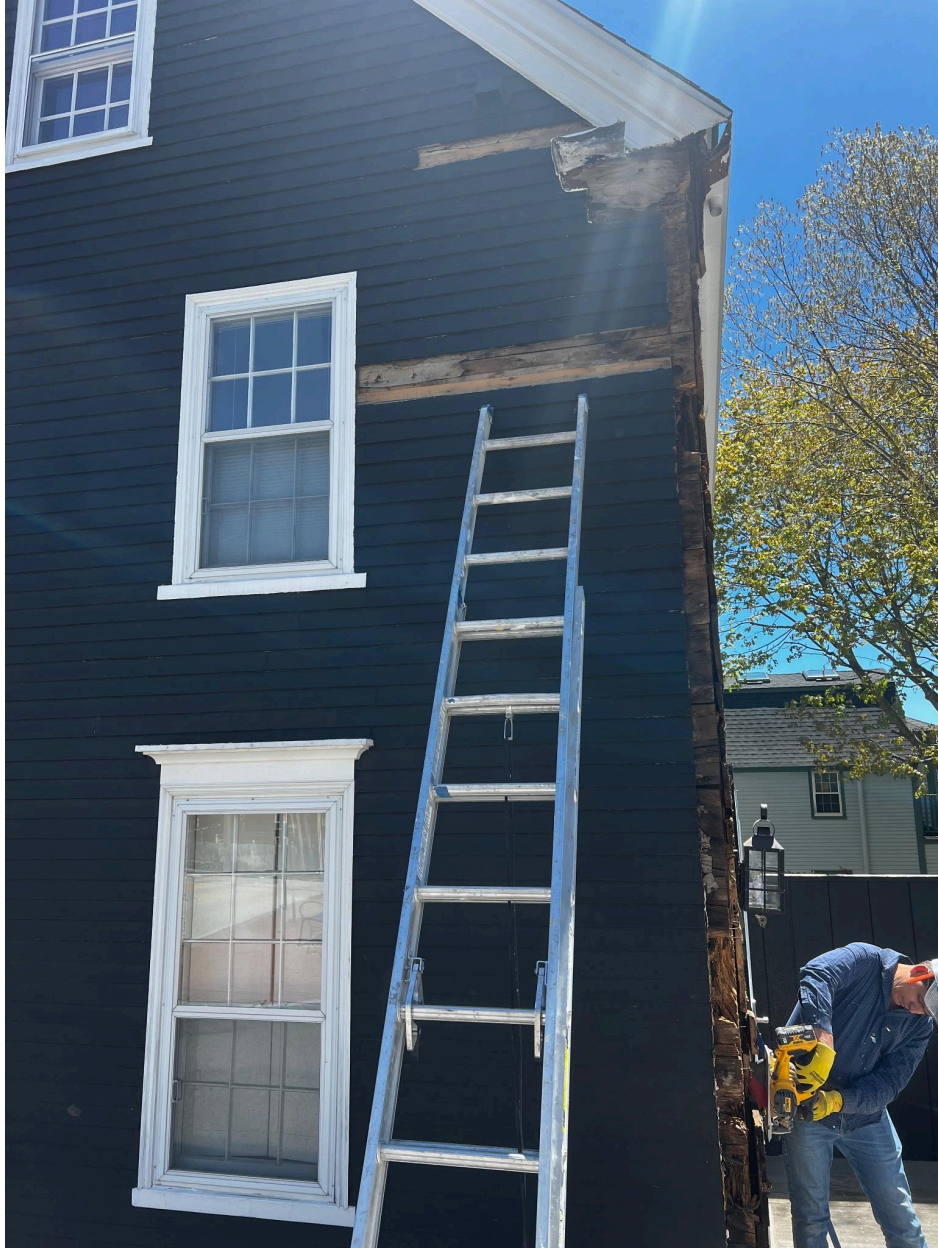
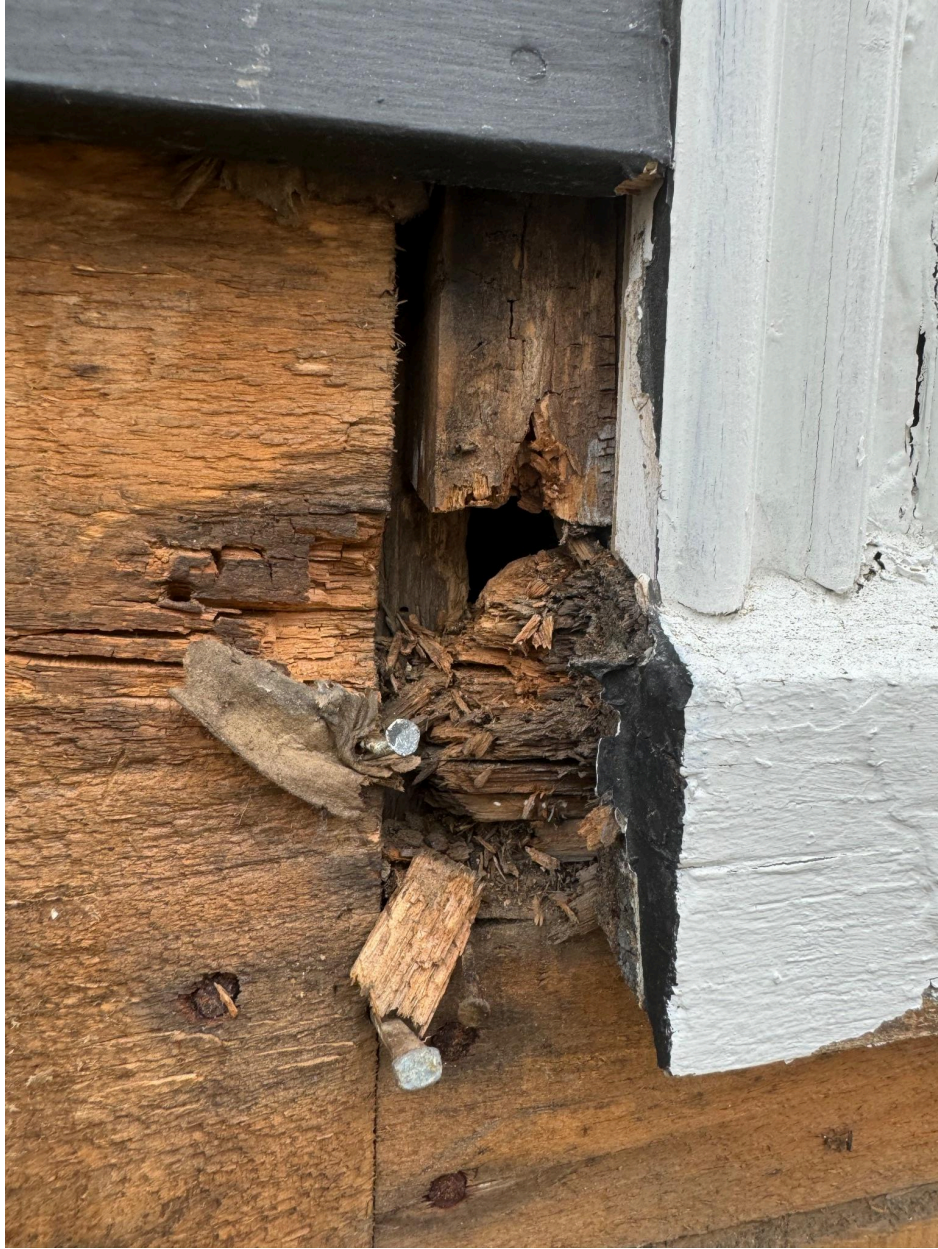
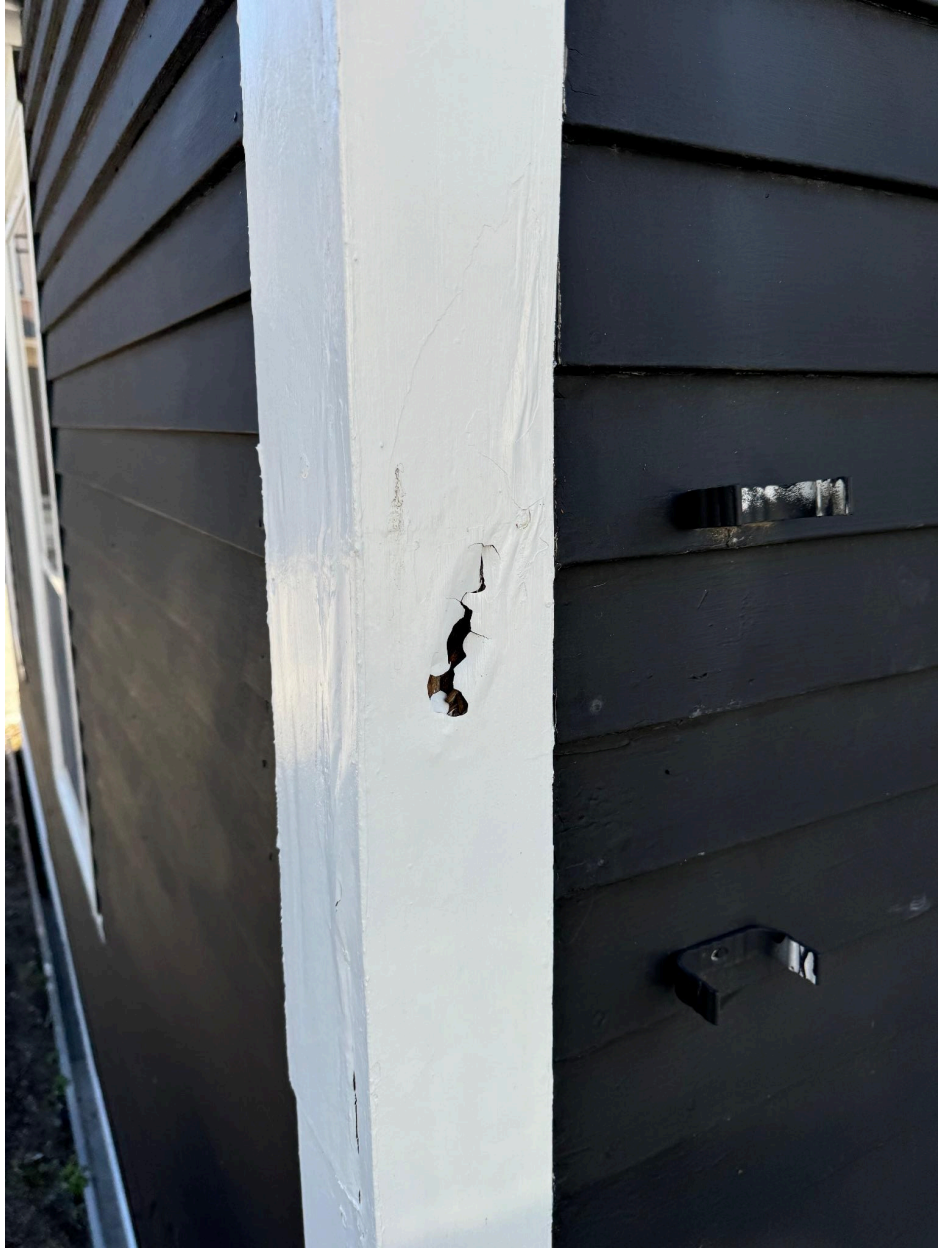
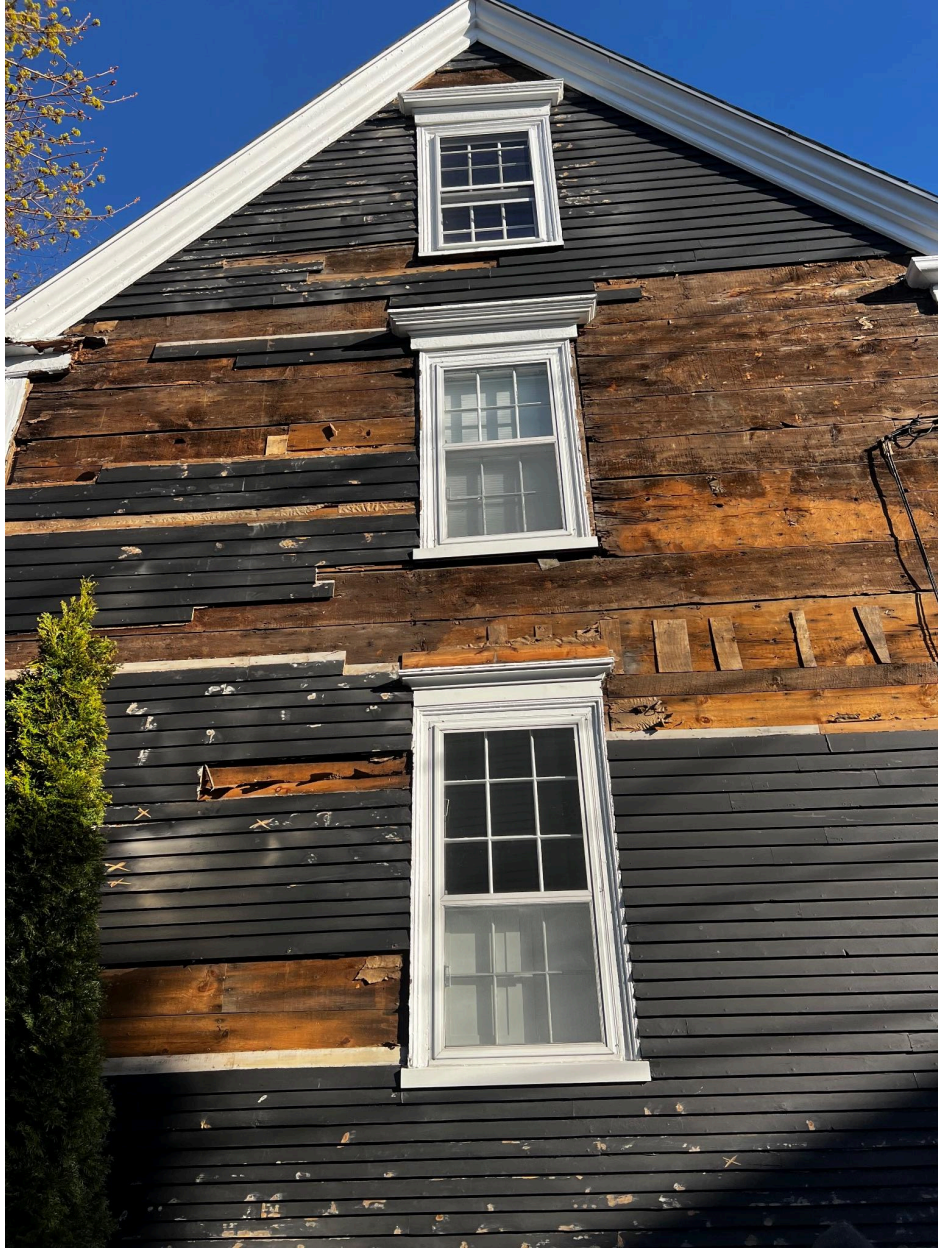
There is excessive damage to the corners of the house caused by failed gutters. The water also caused damage to underlayment preventing a nailing surface for the new clapboards. Removing the clapboards, fixing the corners and then zip taping/tyvek to prevent future issues was deemed the best solution. So many of the clapboards were cracked and split allowing more weather damage beneath. When preparing the surface for paint, it was evident that paint and caulking was holding a lot of the exterior together. Many boards disintegrated upon contact.
