John Wastrom – Masonry Consultant

Existing Conditions Assessment Report and Restoration Plan

Historic Burial Grounds and Cemeteries –
Portsmouth, NH

David Moore
Community Development Director
City of Portsmouth
10/25/13

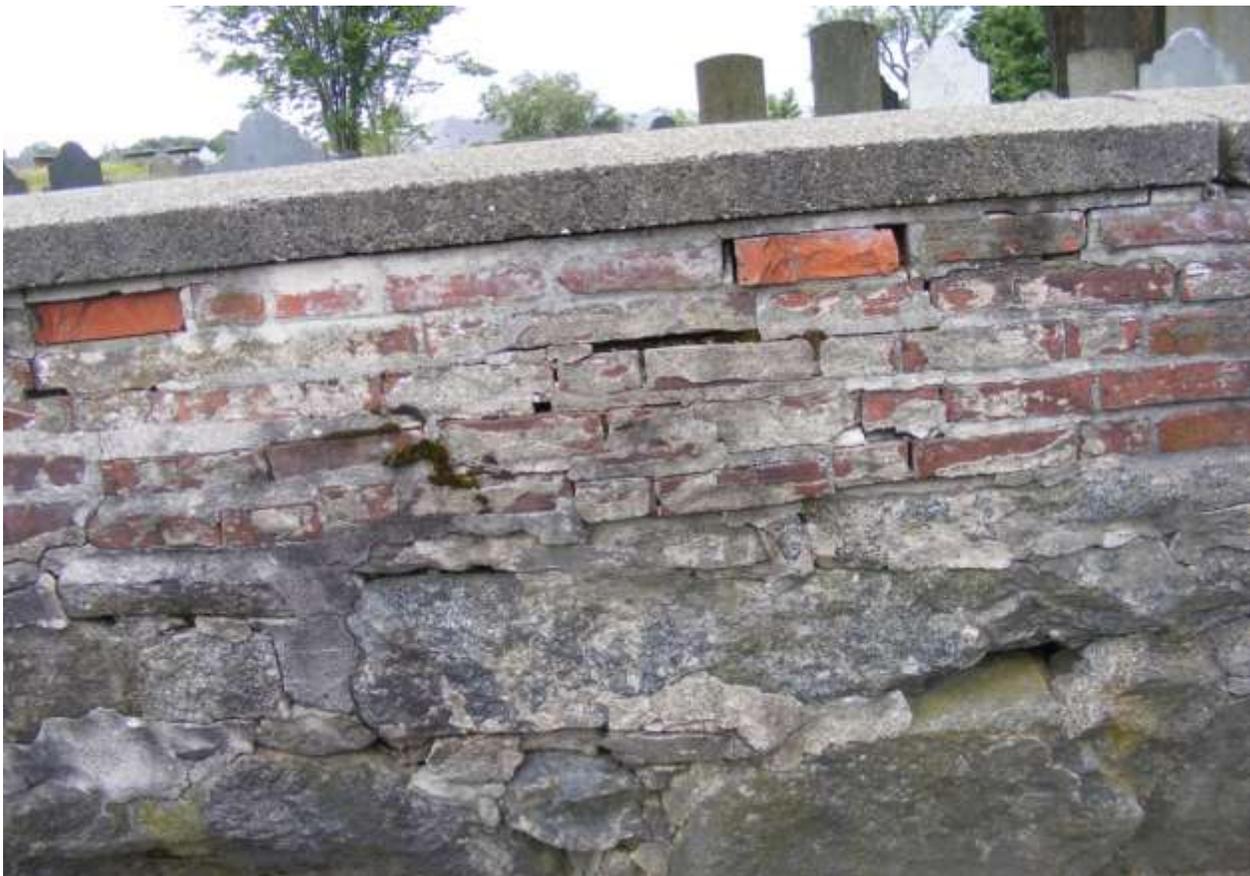
The front enclosure wall has been re pointed so many times it is impossible to comment on all the different types of repair mortar present except to say that none of them contained the original building material, lime. These Portland cement based repair mortars were too dense to allow moisture out of the wall's interior and only accelerated the deterioration of the soft old bed mortar. Virtually all the bricks and stones have lost their bonding and are now held together only by gravity and the weight of the concrete caps which are no longer bonded to the top of the wall either. The wall has settled over the years along with the surrounding landscape. That combined with the migration of deteriorated bed mortar from the interior of the wall, (due to water infiltration) has caused a large section of the wall to lean out over the sidewalk. It is very visible at its western end where a twenty foot long section of the wall appears to be close to collapse. The continued growth of the large trees behind the wall has also contributed to the outward movement of the wall.

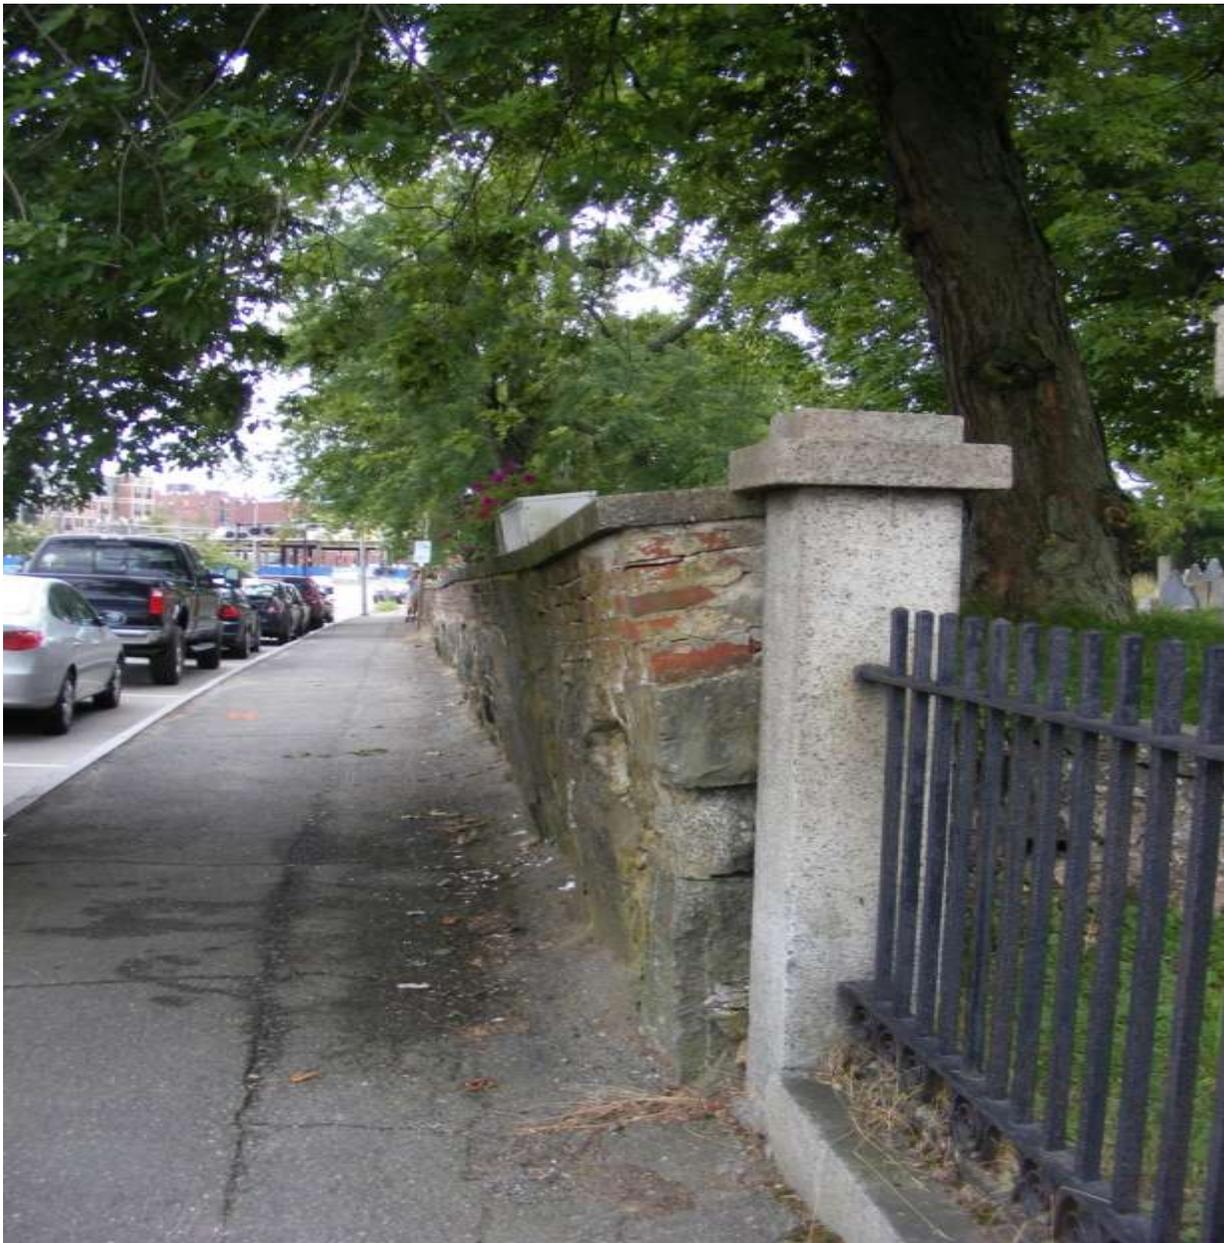
The front enclosure wall has settled over the years along with the surrounding landscape. That combined with the migration of deteriorated bed mortar from the interior of the wall, (due to water infiltration) has caused a large section of the wall to lean out over the sidewalk. It is very visible at its western end where a twenty foot long section of the wall appears to be close to collapse. The continued growth of the large trees behind the wall has also contributed to the outward movement of the wall.

The reconstruction of the North Cemetery's front enclosure wall is the highest priority repair project in the city's historic cemeteries. The existing wall is in poor condition and has become unstable. It has deteriorated beyond the point of restoration or repair. It is recommended that the entire wall be carefully dismantled and rebuilt on a concrete footing using the original stones and concrete caps. The bricks should be sorted through and re used if possible. In kind replacement bricks should be acquired to replace the deteriorated ones. A lineal photo map can be created of both sides of the wall which can be used during the reconstruction process. Also the wall stones should be arranged in a lineal grid that has been set up near the site. The biggest challenges on this site will be logistics and the narrow work area. Based on my previous cemetery projects there can be no excavation beyond the footprint of the wall and no machinery or materials can be place on or near a gravesite.

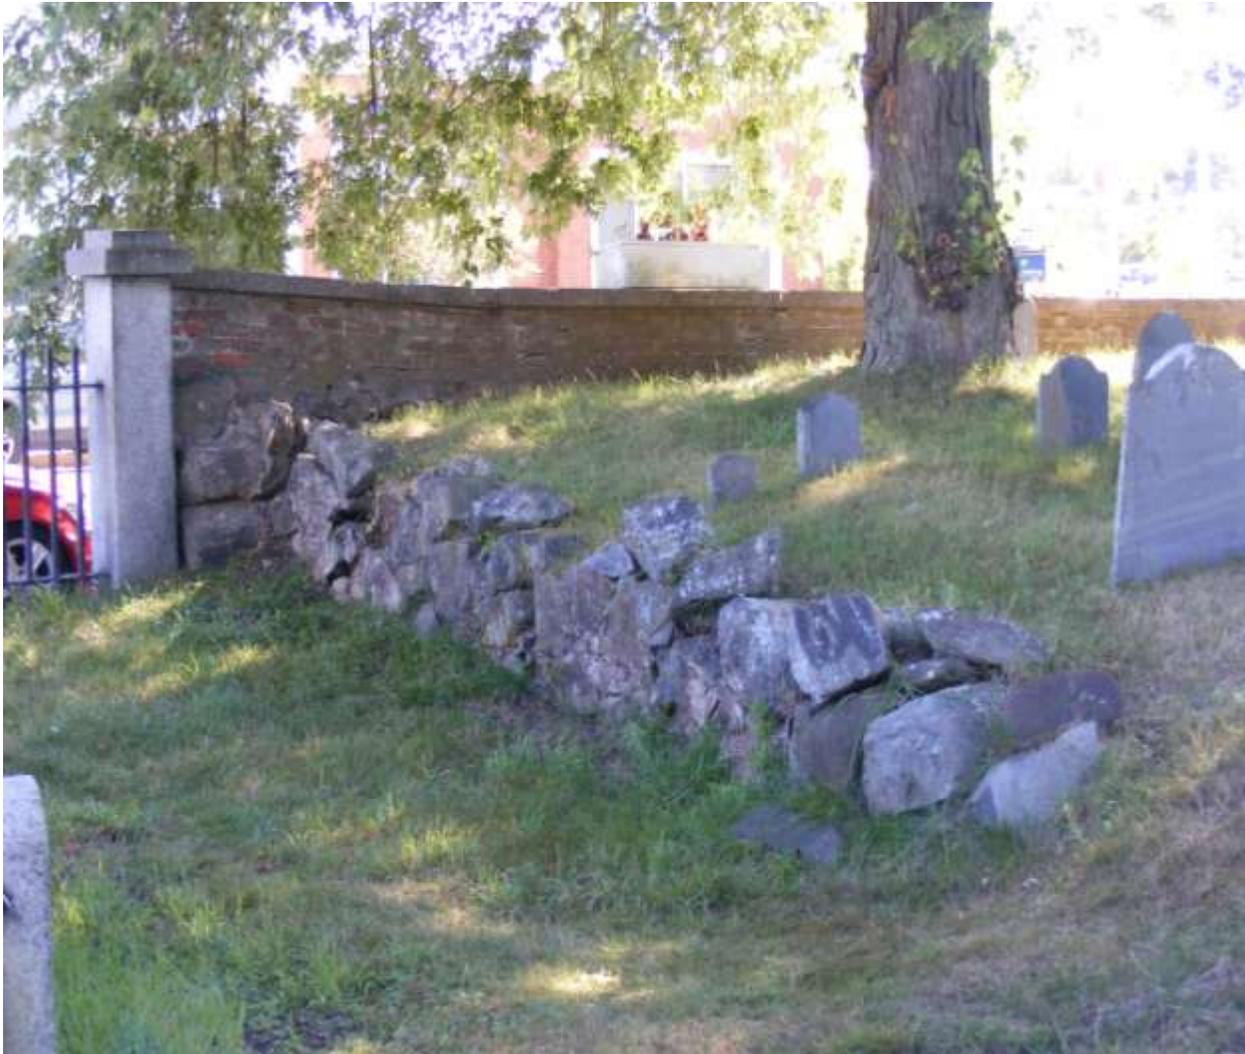
Wall #2 – Between North and Union Cemeteries: There is a remnant of a small retaining wall between the two cemeteries. This wall began behind the western end of the North Cemetery’s front wall and extended about twenty feet between the properties. It averaged about two feet in height and defined a change in elevation between the two graveyards. It was originally built as a dry laid stacked wall using a mix of weathered fieldstones but it was dismantled and rebuilt at least once. The stonework appeared to have been rebuilt with a Portland cement based mortar during the early 20th century. The existing wall is in poor condition and appeared to have been partially dismantled.

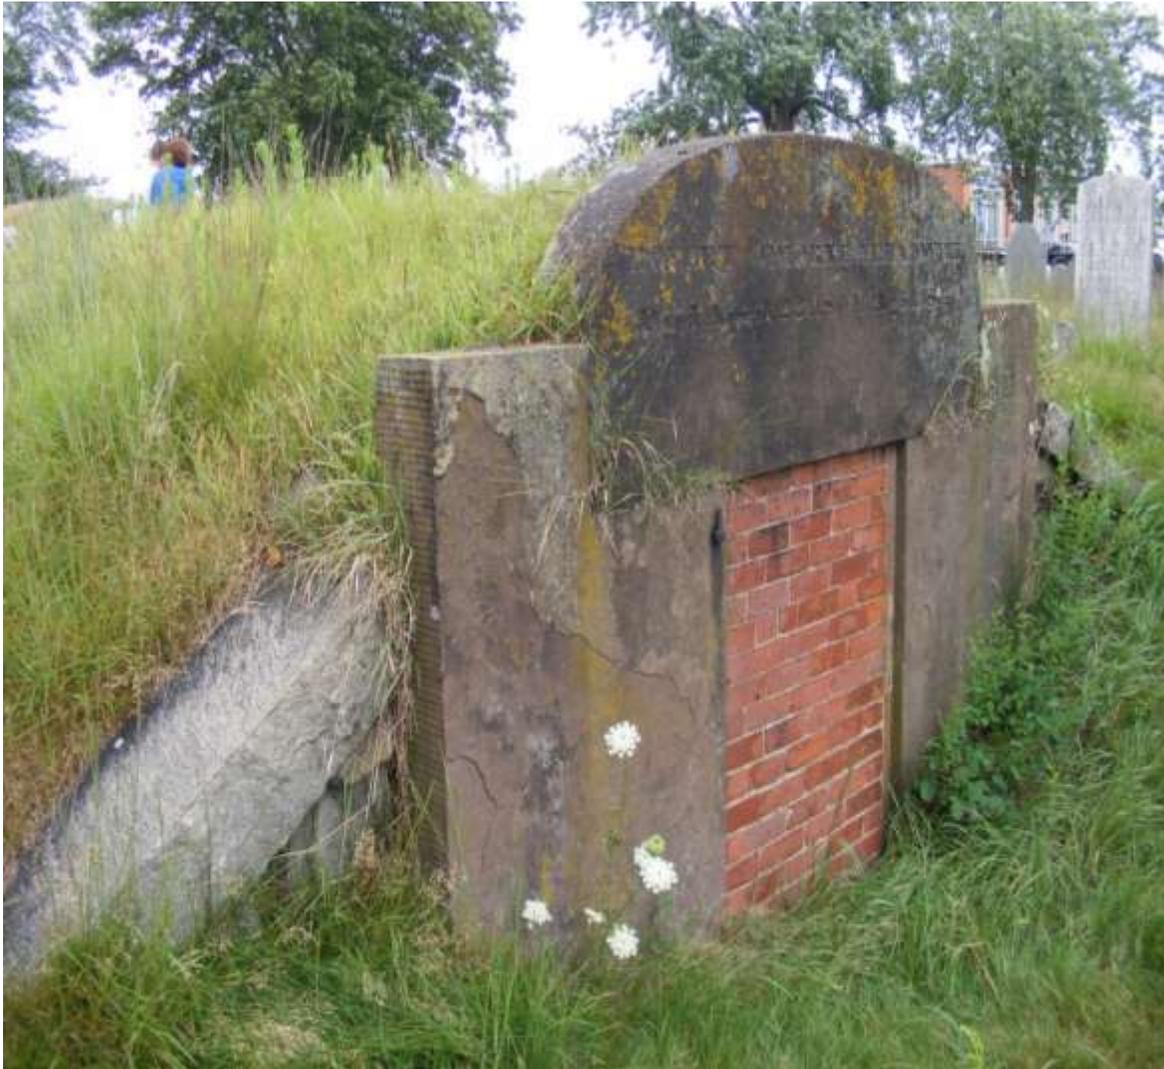
The Robert Odiorne Treadwell Tomb is the first hill tomb encountered beyond the front entrance to the cemetery. The tomb appeared to be in fair condition. The facade was constructed out of three carved and finished brownstone blocks which were fourteen inches thick. Notches were cut out of the top inside corners of the two rectangular wall stones to support the arched pediment stone that crowned the facade. Located on either side of this facade are granite block wing walls capped by thick granite tread stones. The entire tomb measured 15 feet in width, 16 feet in length and 6 feet on height. The entrance to this tomb had been in filled with brickwork. The facade's lower wall stones have lost about half of their outer surfaces due to weathering. The surviving areas of the original polished surfaces are very fragile and have started to delaminate.

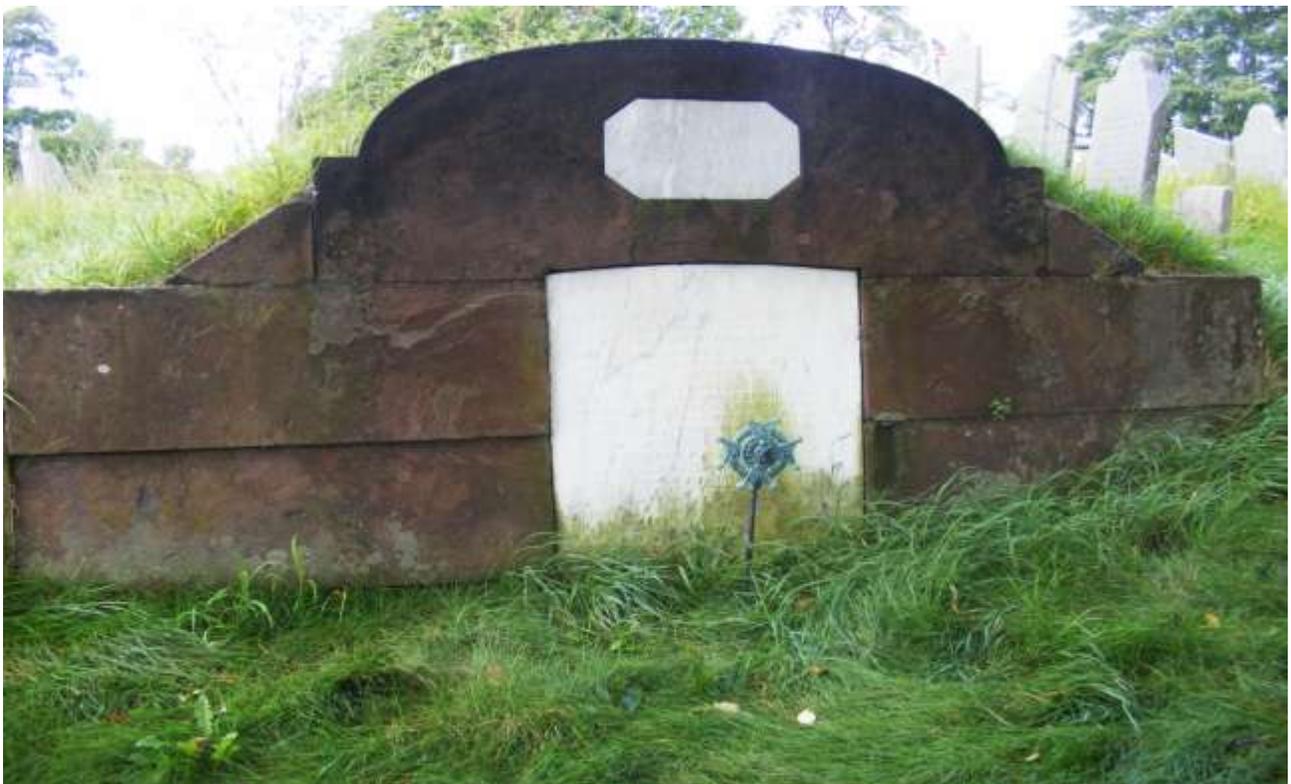
North Cemetery-Governor John Langdon Hill Tomb

The **Governor John Langdon Tomb's** facade was constructed with several large cut and finished brownstones. The lower walls were made of four rectangular blocks that supported an elliptical arched, (elliptical) pediment stone. The pediment stone was framed on either side by two small triangular blocks. All of these stones were fourteen inches thick. There are also two larger triangular blocks/wing walls that flank the base of the facade. The tomb's dimensions are 13 feet in width, 14 feet in length and 6 feet in height. There has been some shifting of the facade wall stones and there has been surface loss on the facade stones. There are no visible recent repairs but a partially exposed band of the vault brickwork behind the facade stones appeared to have been reconstructed with a modern bricks and mortar. An existing iron latch pinned in place on the right face of the tomb indicate an earlier exterior mounted metal or iron door similar to the Wendell Tomb. The condition these permanently sealed subterranean vaults cannot be completely assessed. There are no indications of soil displacement or settling on top of the tombs which would indicate a partial collapse or failure of the buried masonry.

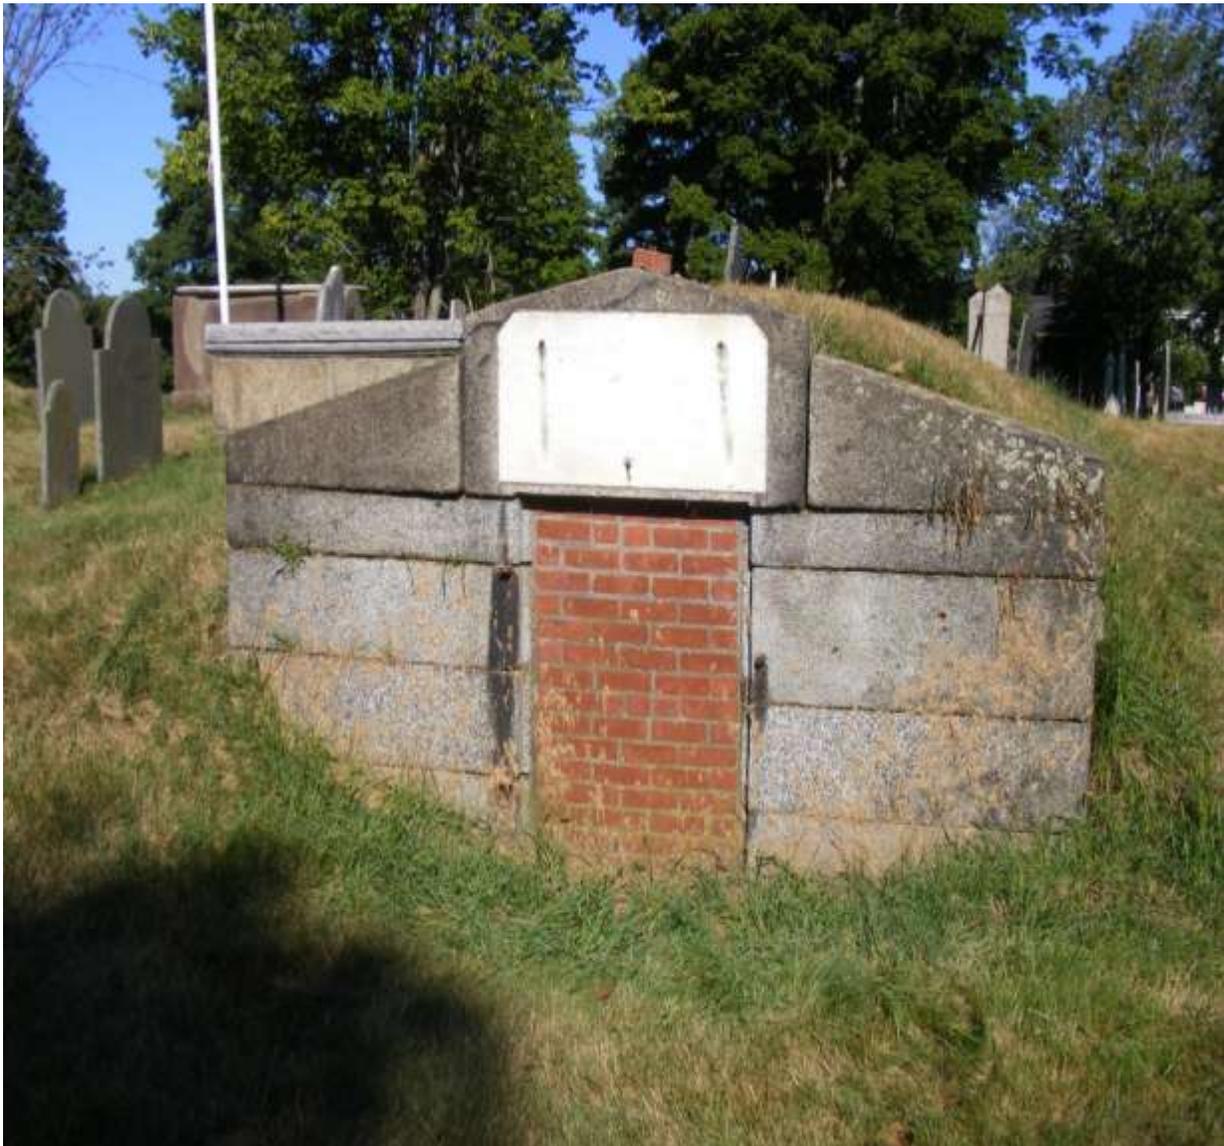
The other granite facade hill tomb in the North Cemetery was sited near the W. Langdon Tomb. The **Shelburne Hill Tomb** facade was composed of eleven hammered finish granite blocks. The side walls were constructed of eight rectangular stones and the pediment contained three cut pieces. The overall dimensions of this tomb are 13 feet in width, 20 feet in length and 6 feet in height. The wing walls are partially buried but appear to have been built with small worked granite blocks.

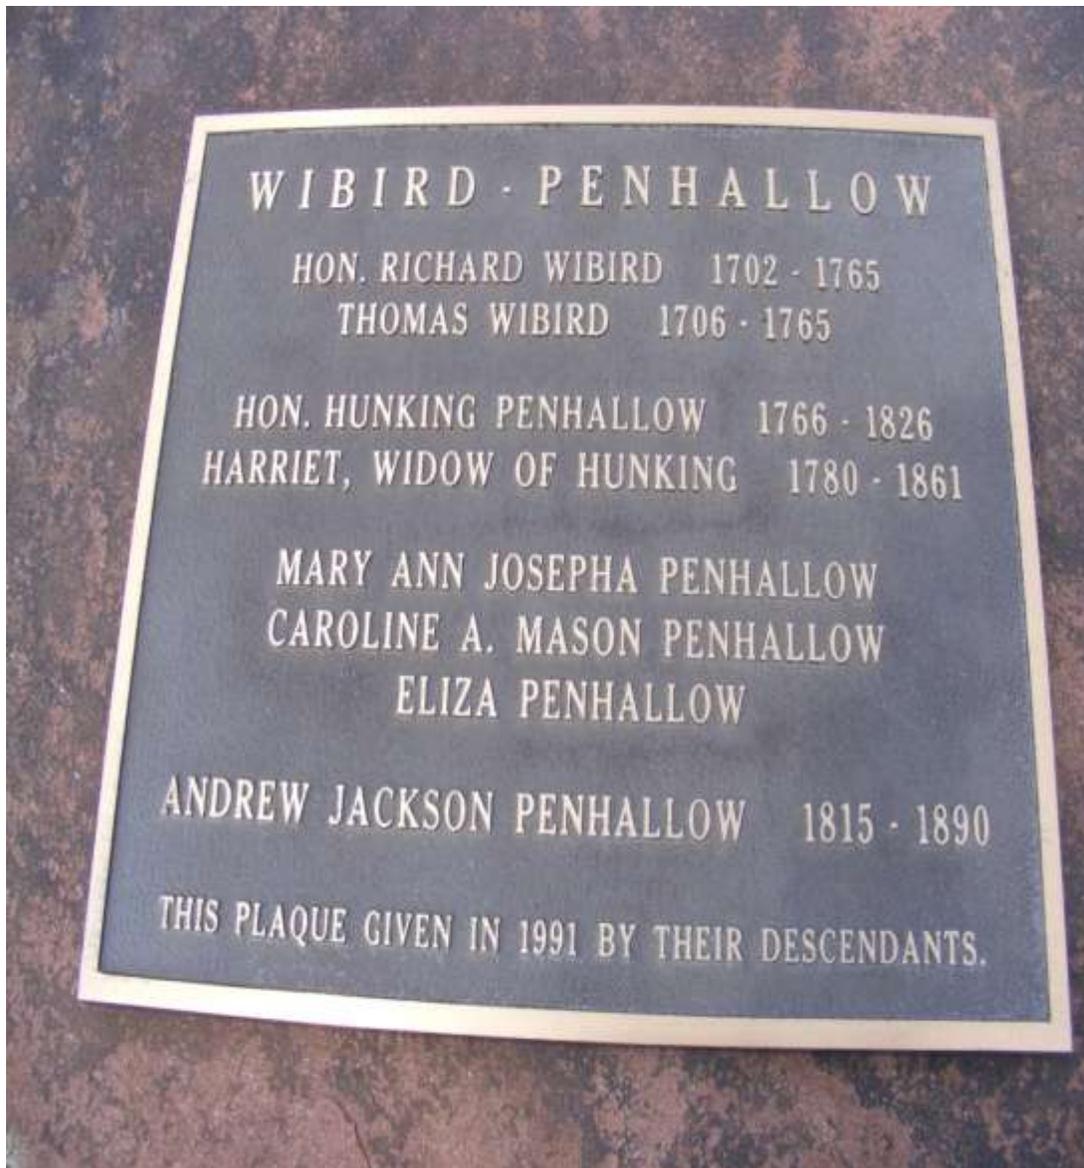
The tomb's brownstone inscription slab has a similar molding profile to the other brownstone tomb covers in the cemetery. The upper part of the tomb's inscription has deteriorated because of surface loss and weathering but most of it was still intact. The existing slab was covered with lichen but there has been no cracking or shifting of the slab. The chest masonry is in poor condition. This modern brickwork may have replaced an earlier brownstone configuration. The descendants of this family attached a bronze plaque to the top of the inscription slab in 1991.

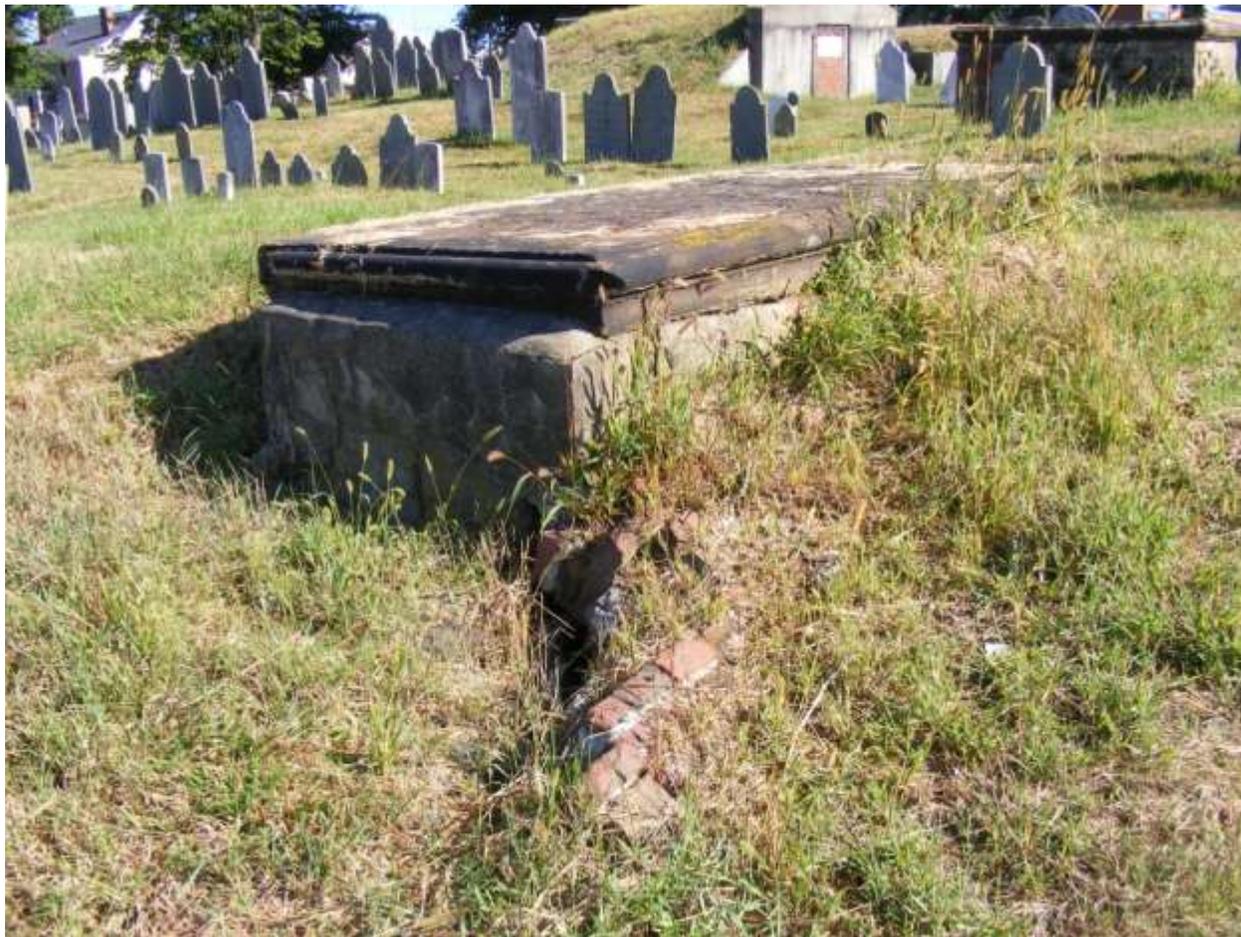
Just down the hill towards the rear of the cemetery there was another brownstone chest tomb. The partially buried **Anna Treadwell Walden Tomb** also appeared to have been rebuilt at some point in the early 20th century. The lichen covered brownstone slab is basically intact although there has been enough surface loss to obscure the inscription. The low chest walls were rebuilt with concrete blocks and then plastered over with a thick layer of Portland cement based mortar. It was not clear what the original chest walls were made of but the tomb's original dimensions were probably similar to the other chest tombs in the cemetery. The brick burial vault underneath the chest masonry has been exposed to the weather for many years. The brickwork has partially collapsed leaving a ragged opening on top of the vault. There was visual evidence of an active rodent colony in the burial chamber. The exposed section of the vault brickwork illustrated just how large these chest tomb burial chambers were.

The **Anna Treadwell Walden Tomb** is in very poor condition in part because of the overgrown vegetation around it which encouraged water infiltration in to the brickwork. The succession of bad repairs that took place several decades ago and the removal of the original chest walls have seriously degraded this tomb. The existing, exposed breach in the burial vault could be a potential danger to the cemetery's visitors if there is an ongoing collapse of the subterranean brickwork.

The most important of these repairs would be to cover and stabilize the area around the partially collapsed subterranean vault associated with the Anna Treadwell Walden Tomb.

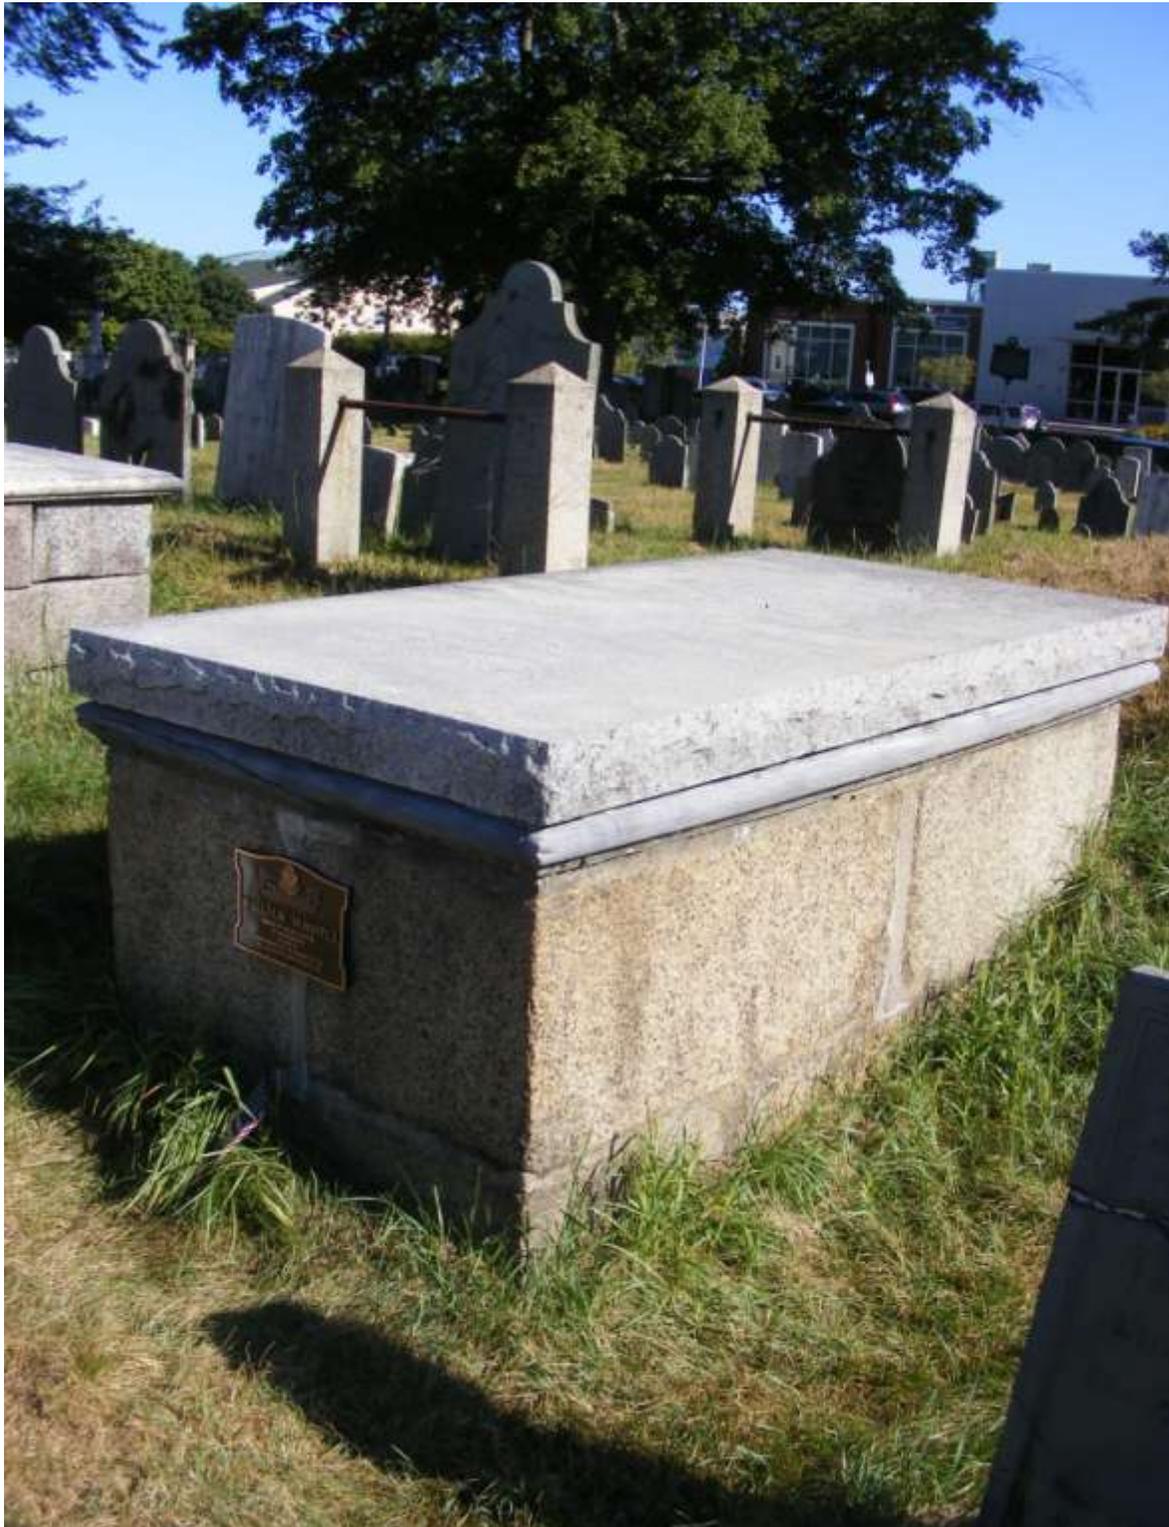
The William Whipple Tomb was composed of brown granite blocks and a four inch thick slate inscription slab. The granite walls were re pointed many years ago with a Portland cement based mortar. This tomb measured 6 feet in length, 3 feet in width and 2 feet in height. The slate slab must have become badly eroded because it was covered in 1976 with a 4 inch thick slab of light colored granite. The old slate slab appears have been partially crushed under the weight of the new stone. There are numerous horizontal cracks along its finely carved molded edge where the freeze and thaw of New England weather has caused this sedimentary stone to delaminate.

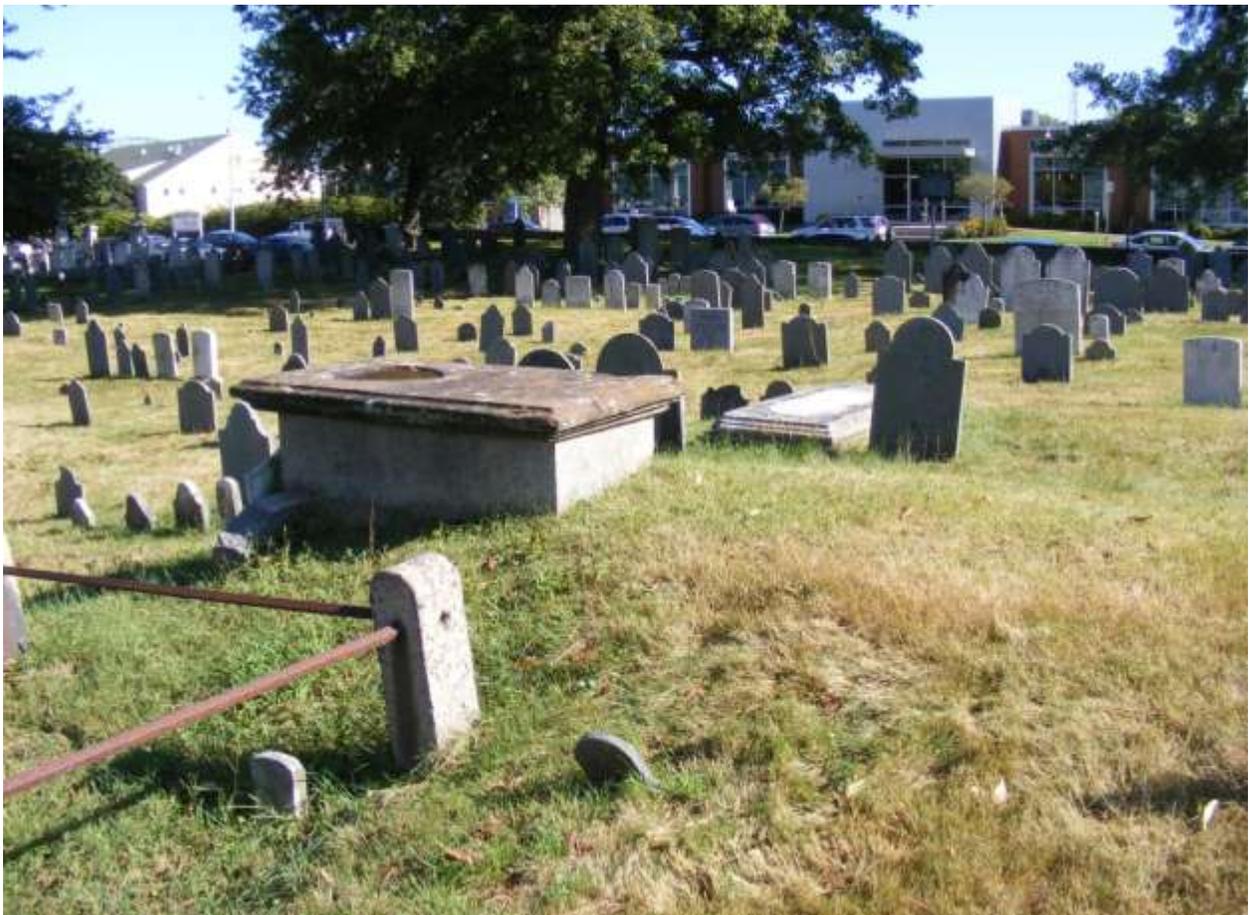
There are two other variations of the chest tomb design located between the small group of tombs on the hill and the front border wall. The **Jotham Odiorne Tomb** was constructed with three large pieces of light gray granite. The tomb's chest was made from one rectangular light gray hammer finished granite block which is supported at its exposed end by rough finished footing stone. A similar footing stone was probably installed at the opposite end of the chest stone. It is now buried under the soil line. It appeared that the footing areas between these end stones were filled with small pieces of granite. . The overall dimensions of this tomb are six feet in length, three feet in width and approximately three feet in height. The size of the subterranean vaults underneath these chest tombs is clearly illustrated by this tomb which is in good condition except for the missing inscription stone.

The **Jotham Odiorne Tomb**: The design and finish of the existing lichen covered brownstone inscription slab matched the other brownstone inscription stones in the cemetery. The heart shaped inscription stone has completely deteriorated or been removed. The remaining open void appeared to be constantly filled with standing water. There has been some surface loss on the top and along the molded edges of the brownstone due to weathering

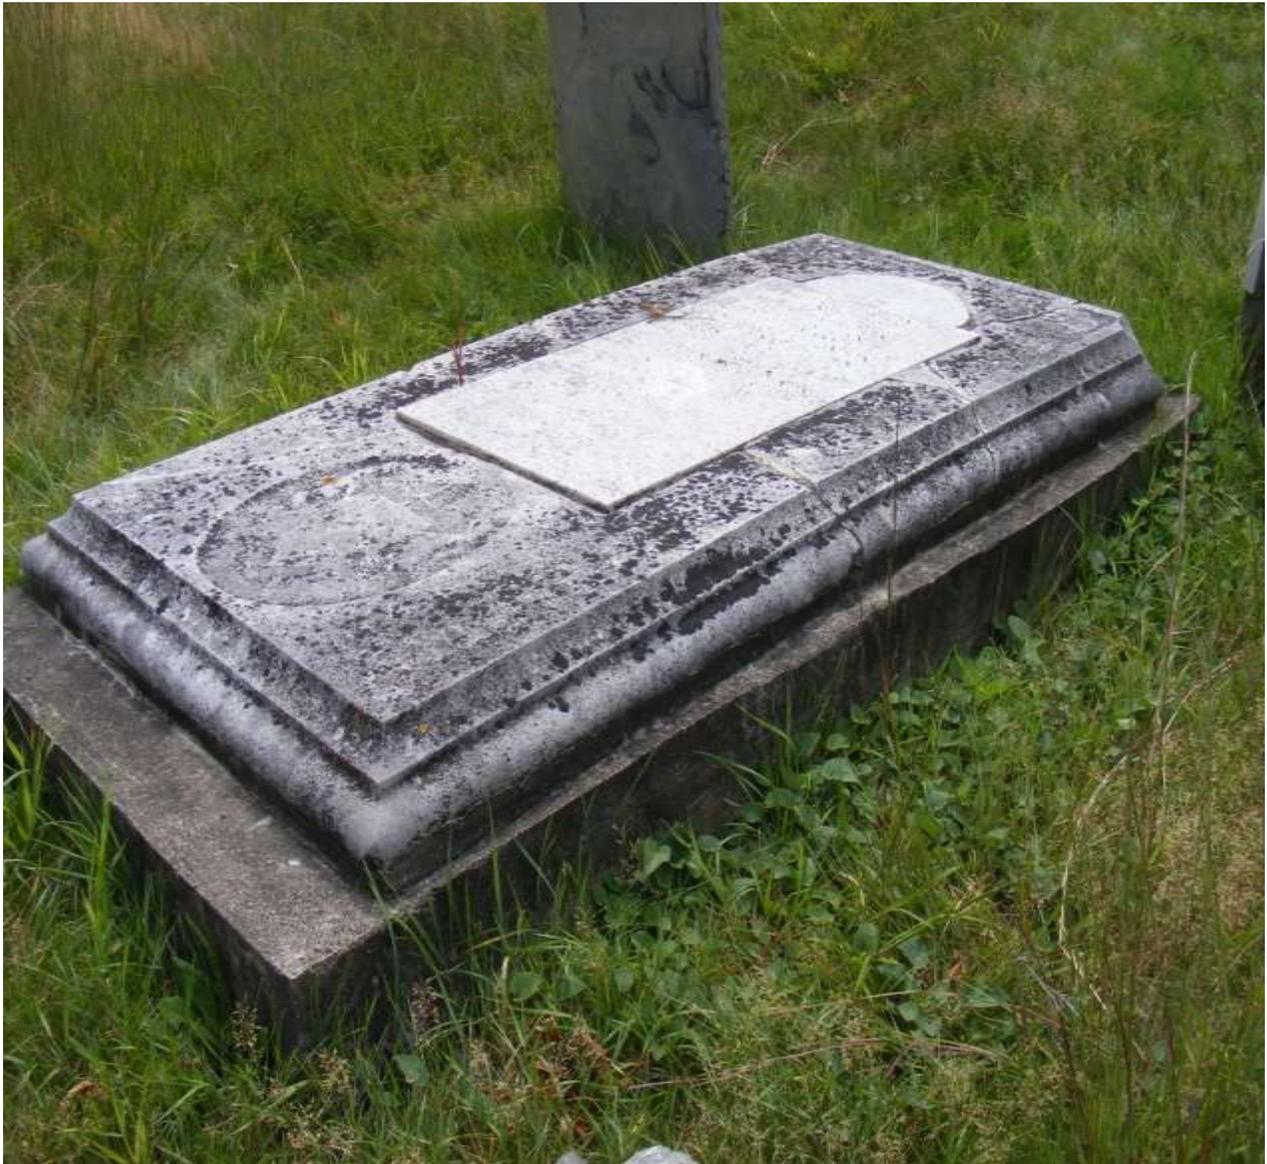
The **George Boyd Tomb**, d. 1787, was originally erected as a pedestal tomb which was essentially a deconstructed chest tomb. The marble inscription slab was supported about two feet off the ground with six carved marble balusters. .Mr. Boyd was successful businessman in colonial Portsmouth. He commissioned the carving of his tomb while sitting out the American Revolution in London. After the war he died while returning to New Hampshire with his tomb

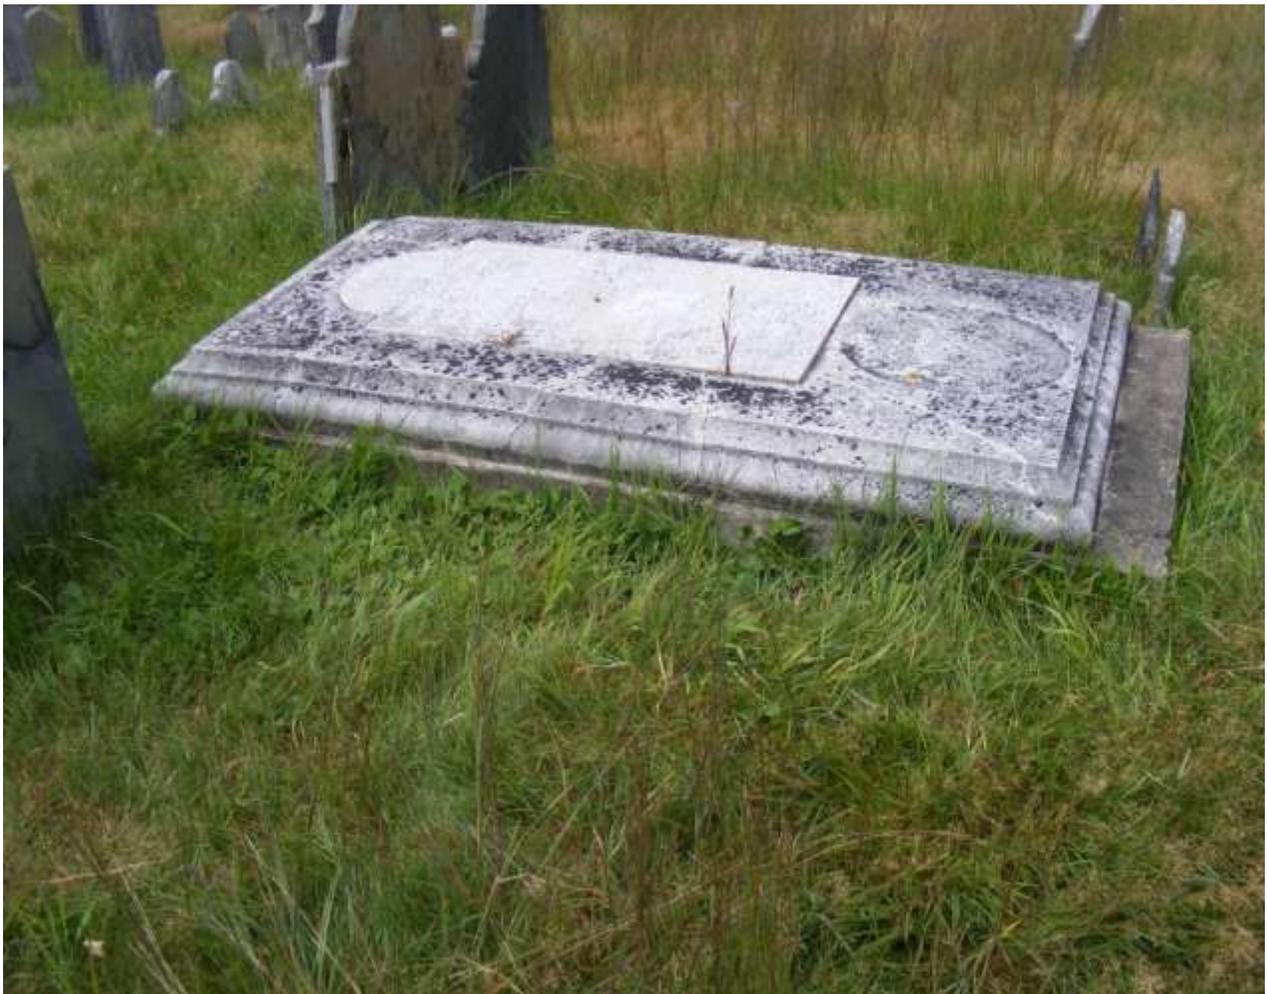
The George Boyd Tomb, d. 1787: The marble elements of the tomb were probably set on a stone footing which is now buried. The existing tomb is in very poor condition. The surviving marble slab is badly cracked and weathered. The pedestals which survived into the 20th century were removed and lost at some point possibly after the tomb was vandalized. The inset stone on the marble inscription slab appeared to have been removed at the same time. The marble inscription stone was eventually placed on a concrete slab about four inches off the ground. The missing gravestone shaped inset stone was eventually replaced with an inscribed granite panel.

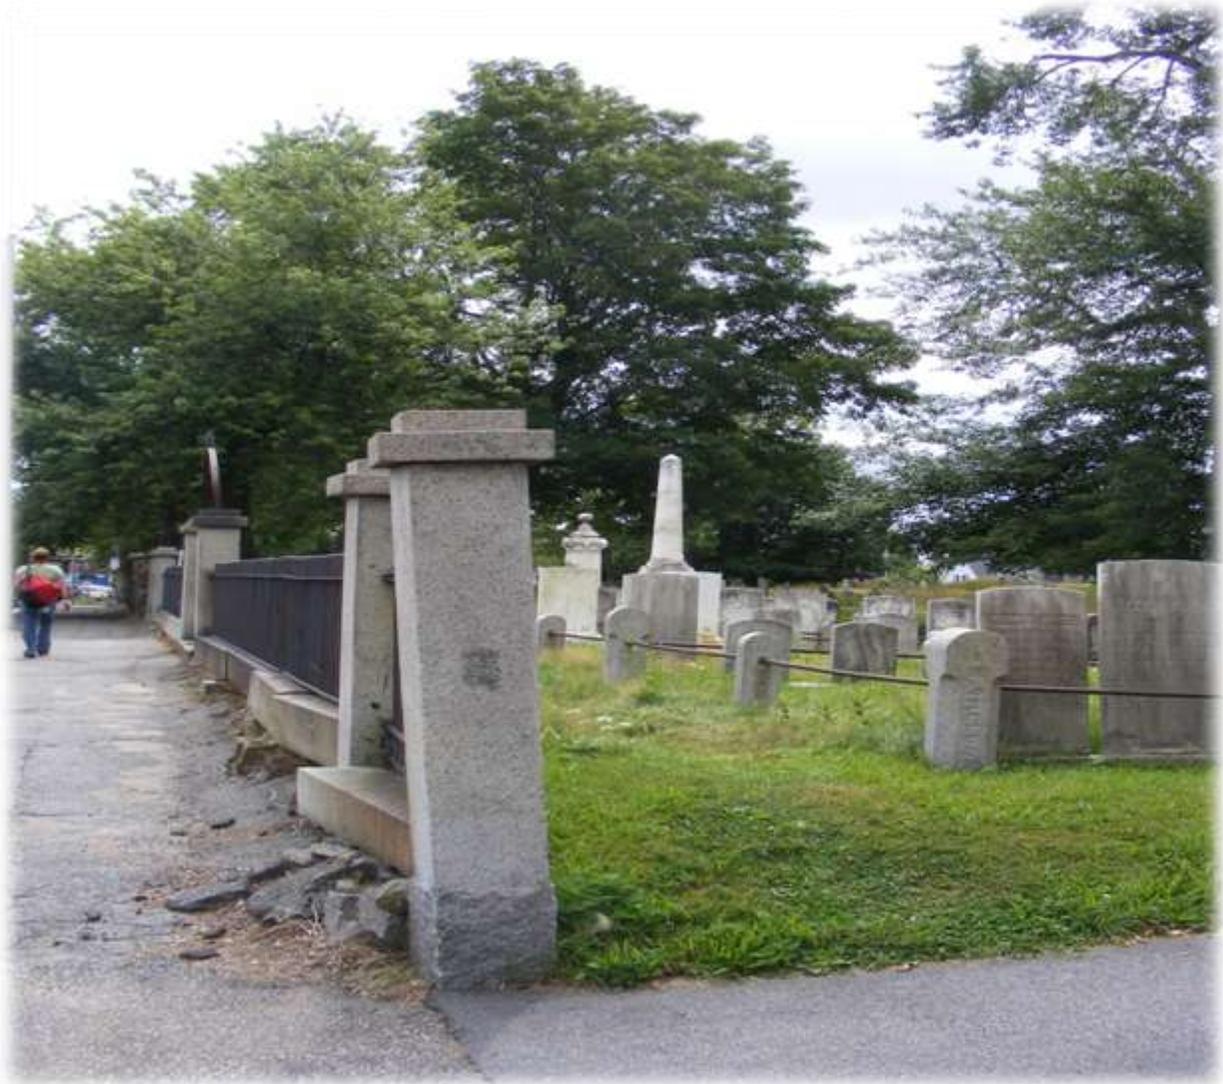
There has been a noticeable subsidence of the sidewalk in front of the two cemeteries over the years. This change in elevation in the landscape around the Union Cemetery's front fence has caused some of the stonework to shift out of alignment especially at its western end. All of the pillars are no longer plumb and the westernmost pillar is now leaning noticeably.

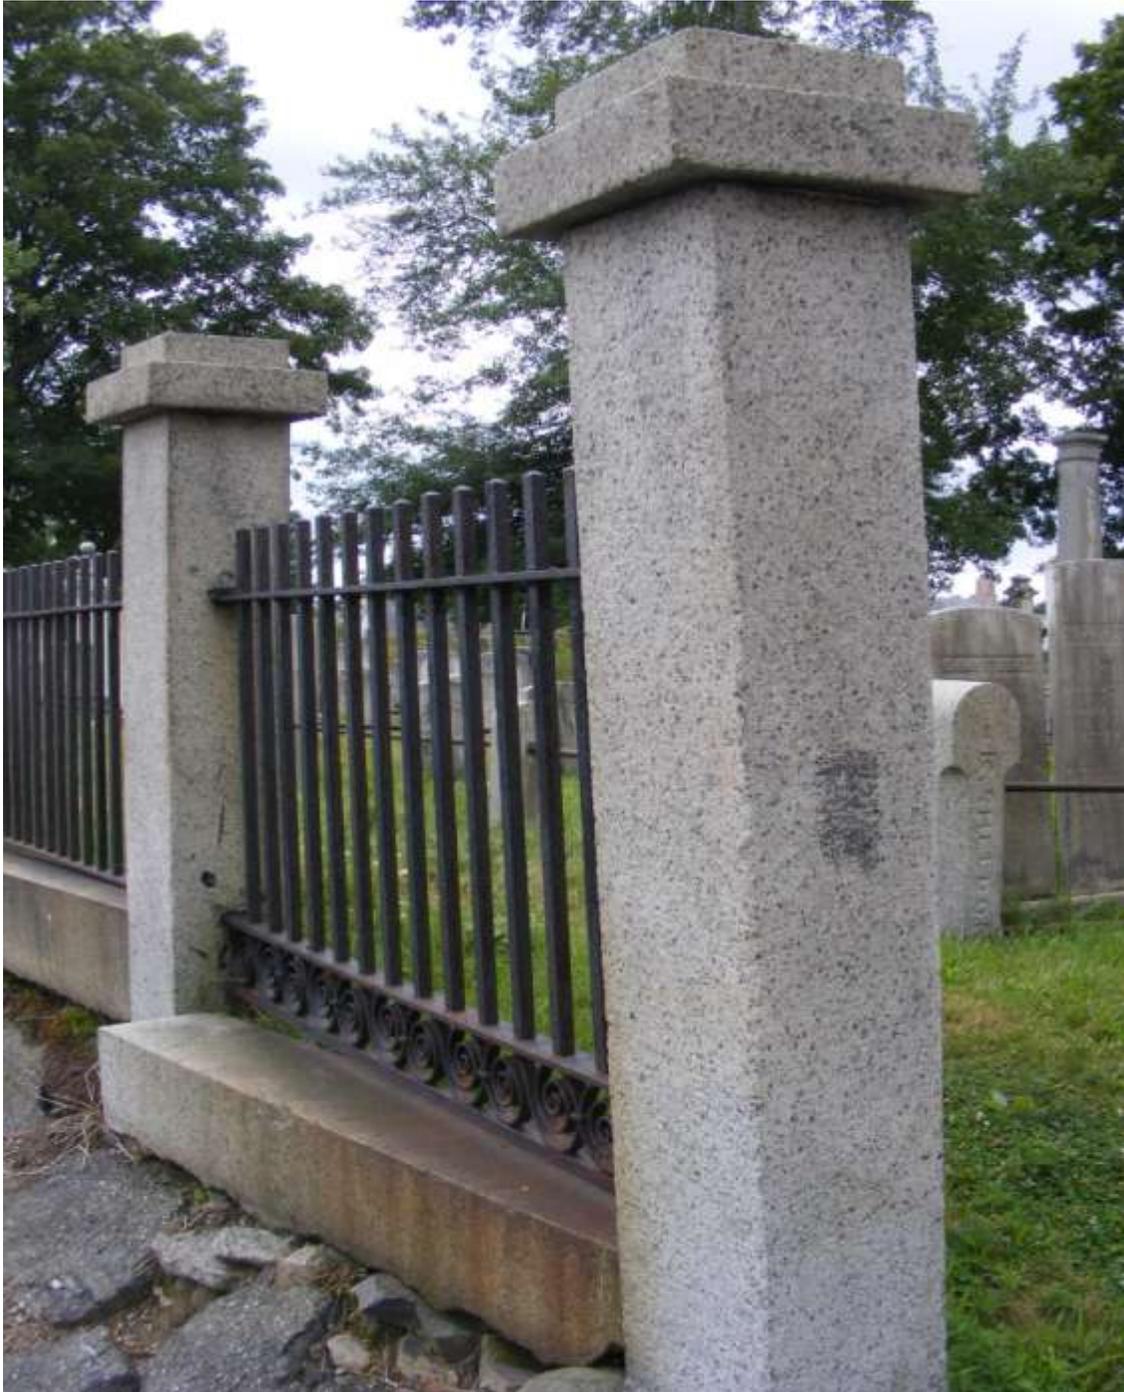
Cemetery Enclosure Fence and Stonework: Decorative corbel stones crowned each pillar. These smaller tablet stones were traditionally anchored with bronze pins. There is existing visual evidence that the horizontal joints between the tops of the pillars and the lower corbel stones were caulked with sheet lead.
