John Wastrom – Masonry Consultant

Existing Conditions Assessment Report and Restoration Plan

Historic Burial Grounds and Cemeteries –
Portsmouth, NH

David Moore
Community Development Director
City of Portsmouth
10/25/13

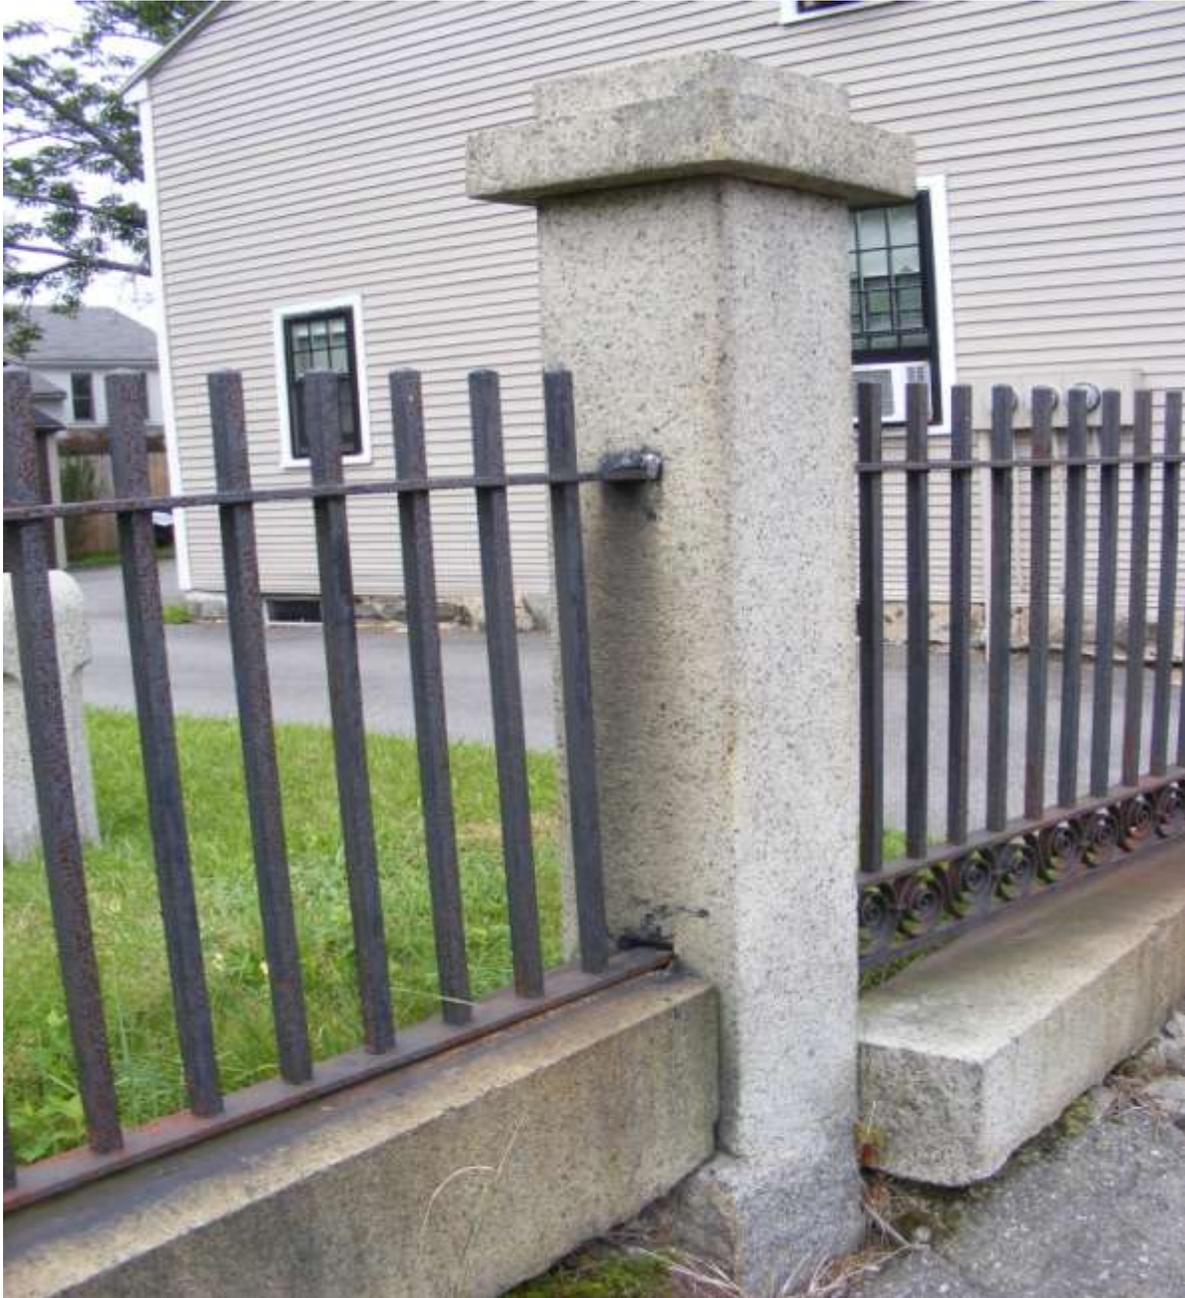
Because of its size and its location on a city sidewalk, the poor condition of the stone components of this fence would make their realignment a high priority repair. The decorative wrought iron fence sections, gates and entrance arch appeared to have not been maintained for many years. The fence has rusted enough to stain the curb stones in places but overall this ironwork is intact enough to restore.

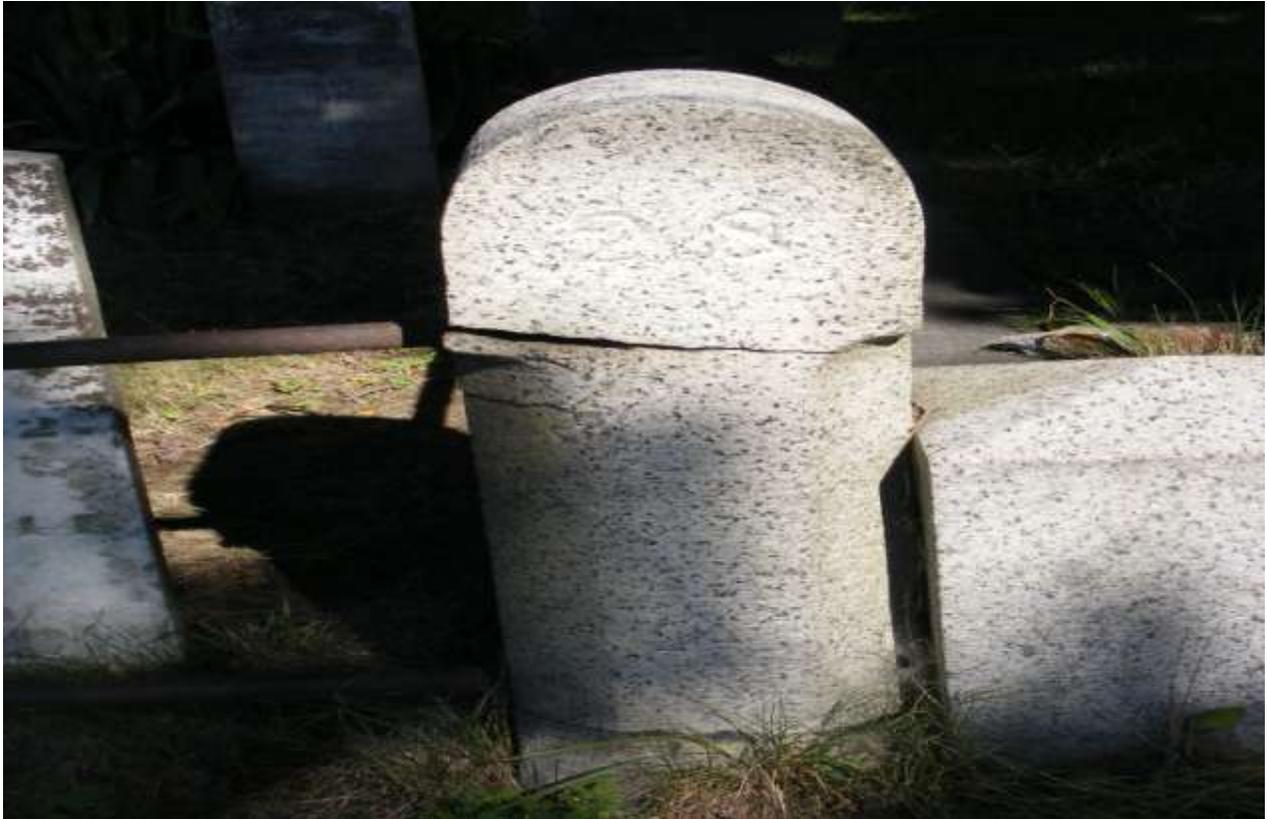
Granite Posts: Damage caused by expansion of rusted iron fence rail

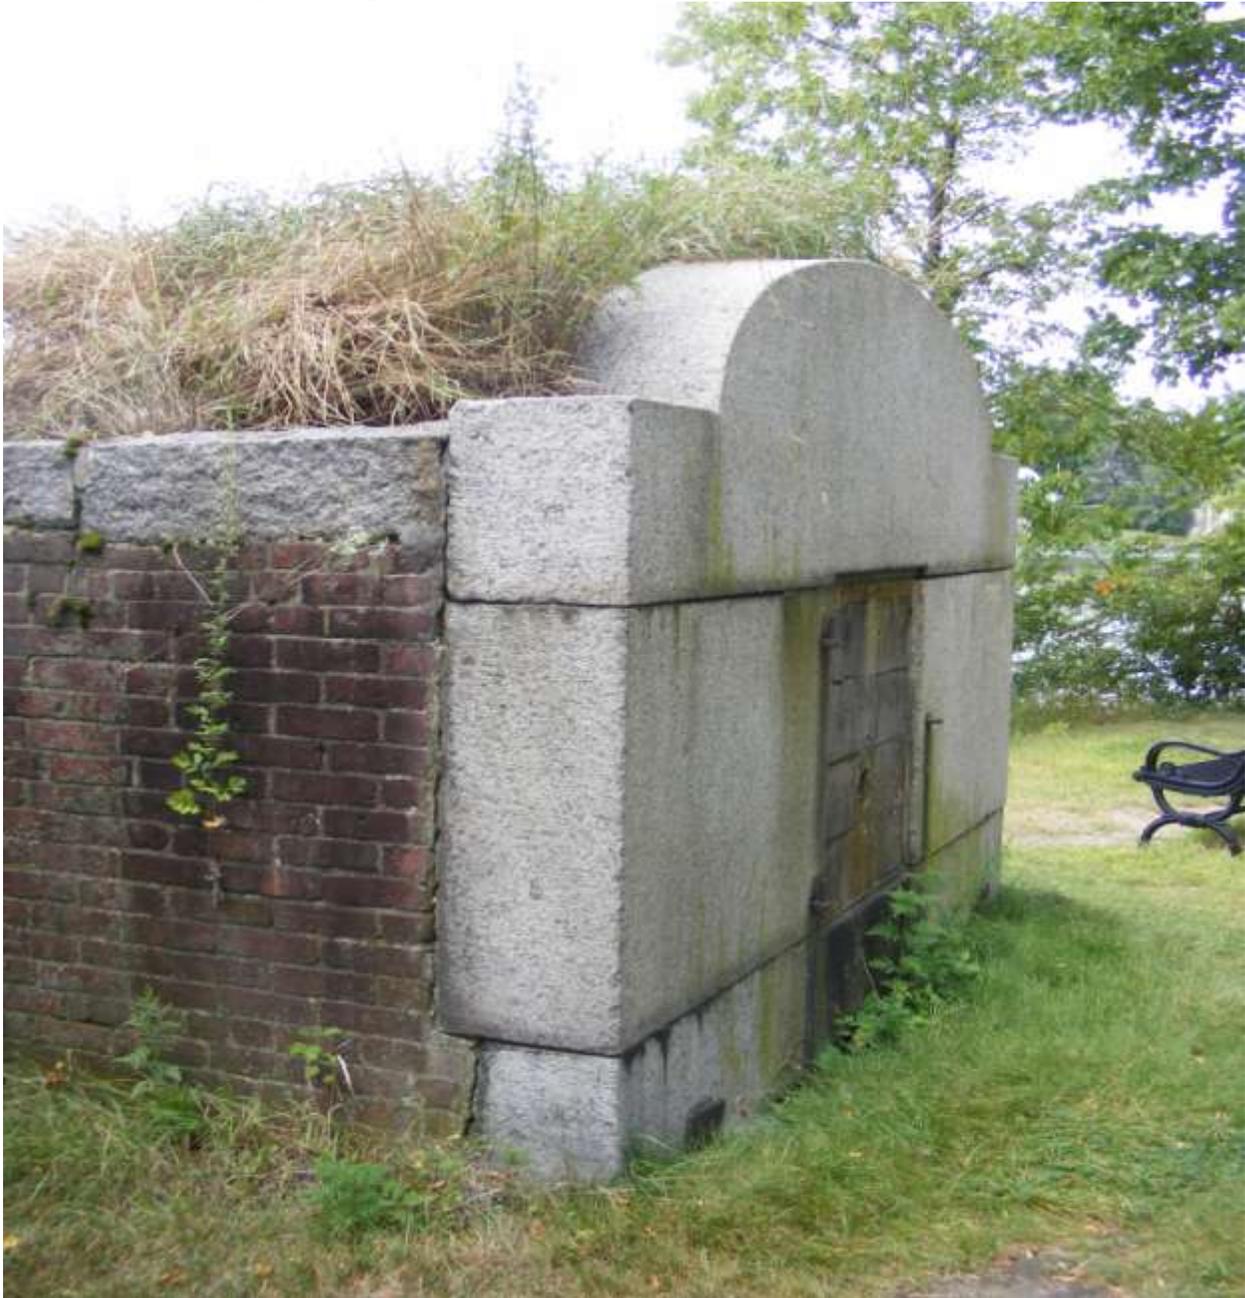
The actual date of this tomb's construction has also been a topic of debate but its location appeared to be an integral part of the cemetery's original design. The tomb's granite facade was immediately visible upon entering the cemetery. The original tomb was probably constructed when the cemetery was enclosed in 1844. The existing tomb measured 12 feet in length, 6 feet in height and was 10 feet wide. It is in very poor condition.

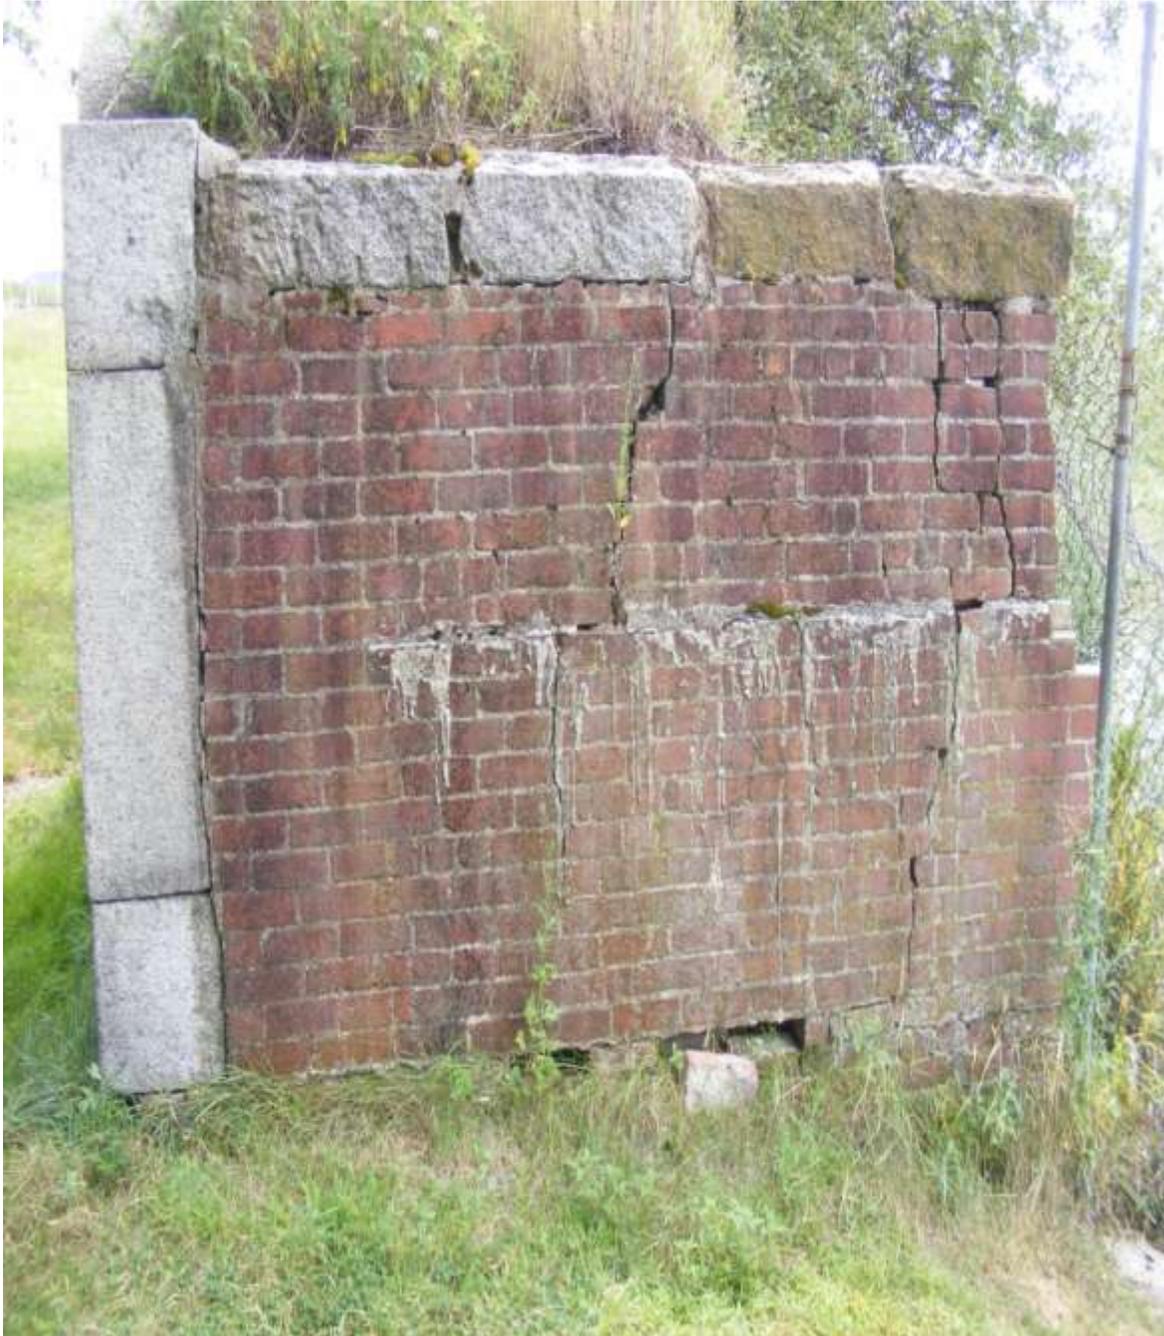
The two surviving brick side walls are badly cracked and unstable. The rear wall of the tomb has collapsed into the pond along with its supporting stonework and several of its granite roof stones. The light gray hammered finish granite facade was composed of four large wall stones spanned by an arched pediment stone. The tomb's iron door has been gone for a long time and the doorway has been filled in with concrete block.

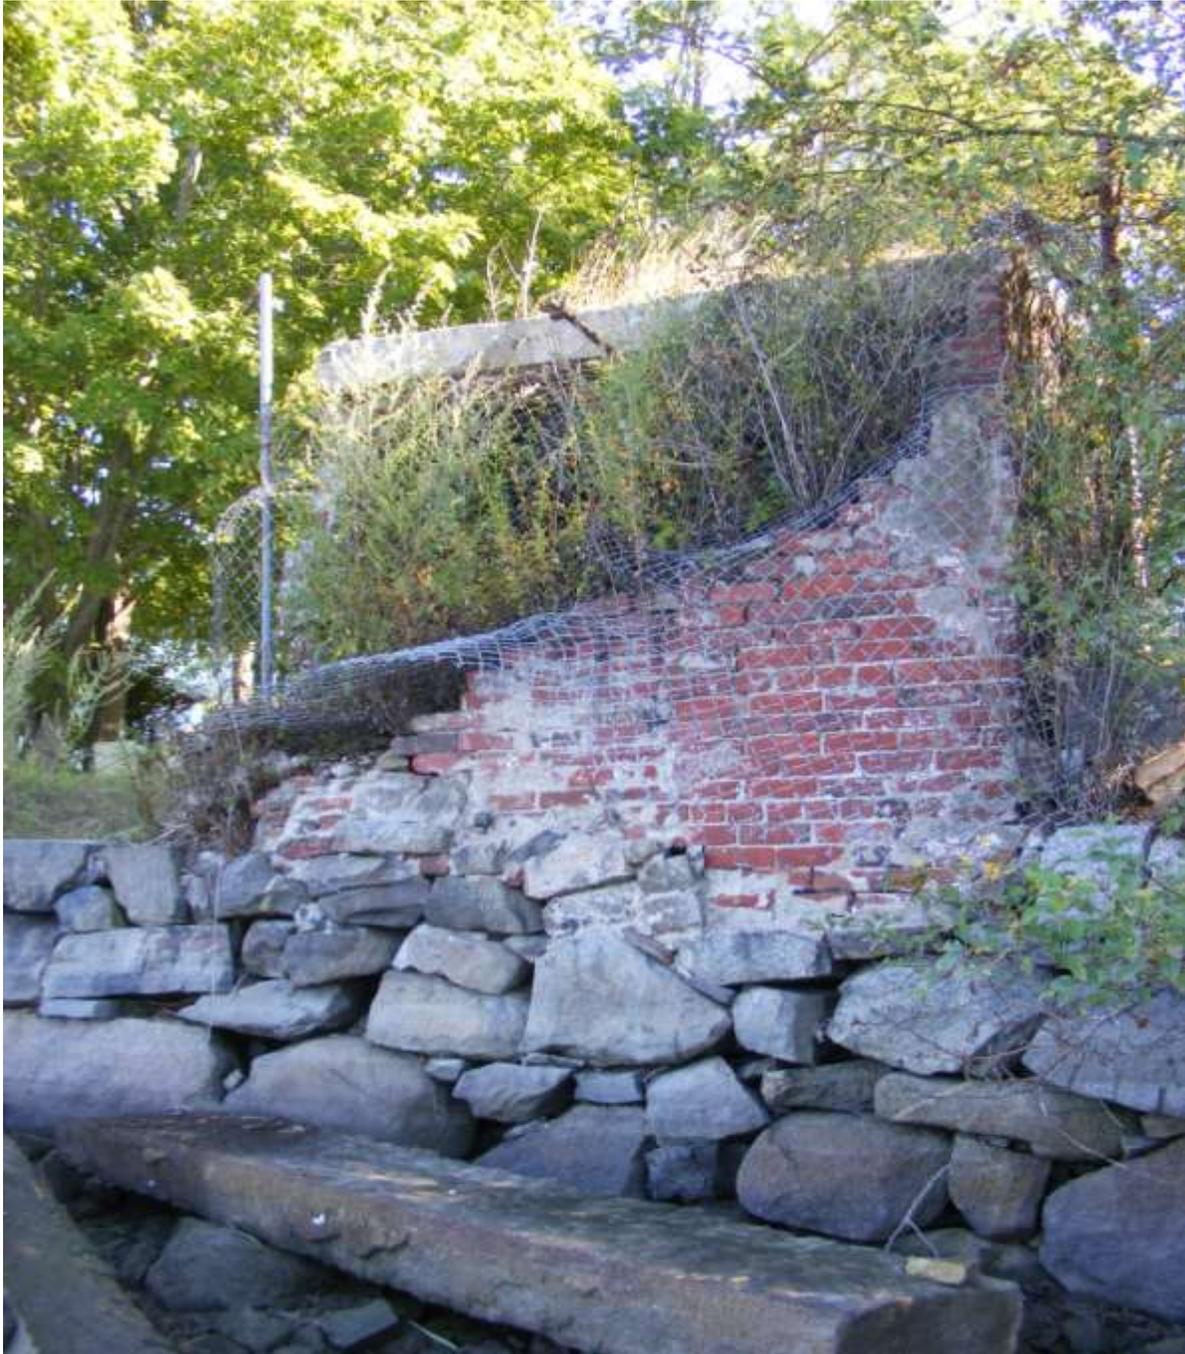
This tomb probably collapsed and was rebuilt at the beginning 20th century. The existing exterior side wall bricks and mortar are modern materials. The surviving section of the rear wall contained a mix of recycled older bricks and Portland cement based mortar. Two of the existing granite roof slabs were discolored and appeared to have been retrieved from the mill pond.

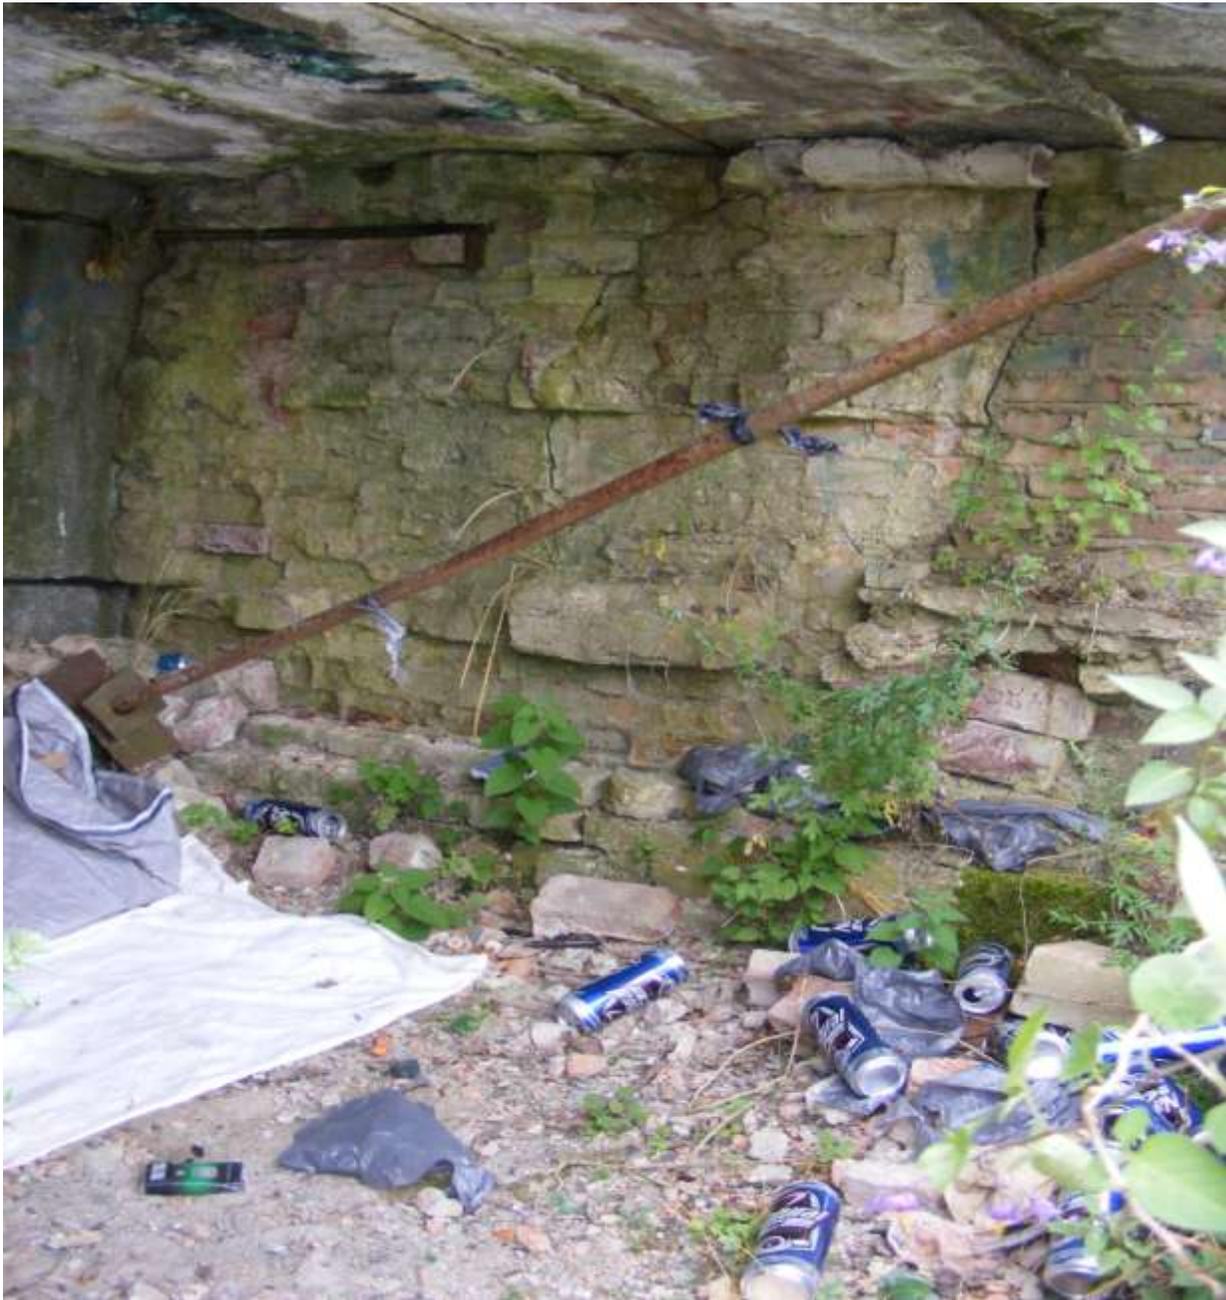
At some point in the mid 20th century, the entrance door opening was filled with concrete block. This block work served as an anchoring point for one end of a 13 foot long iron rod which spanned the interior. The other end of the iron rod was inserted through the rear wall and secured. This was an attempt to anchor the masonry to the rest of the tomb. The rear wall showed evidence that it had been repaired and partially rebuilt several times after that.

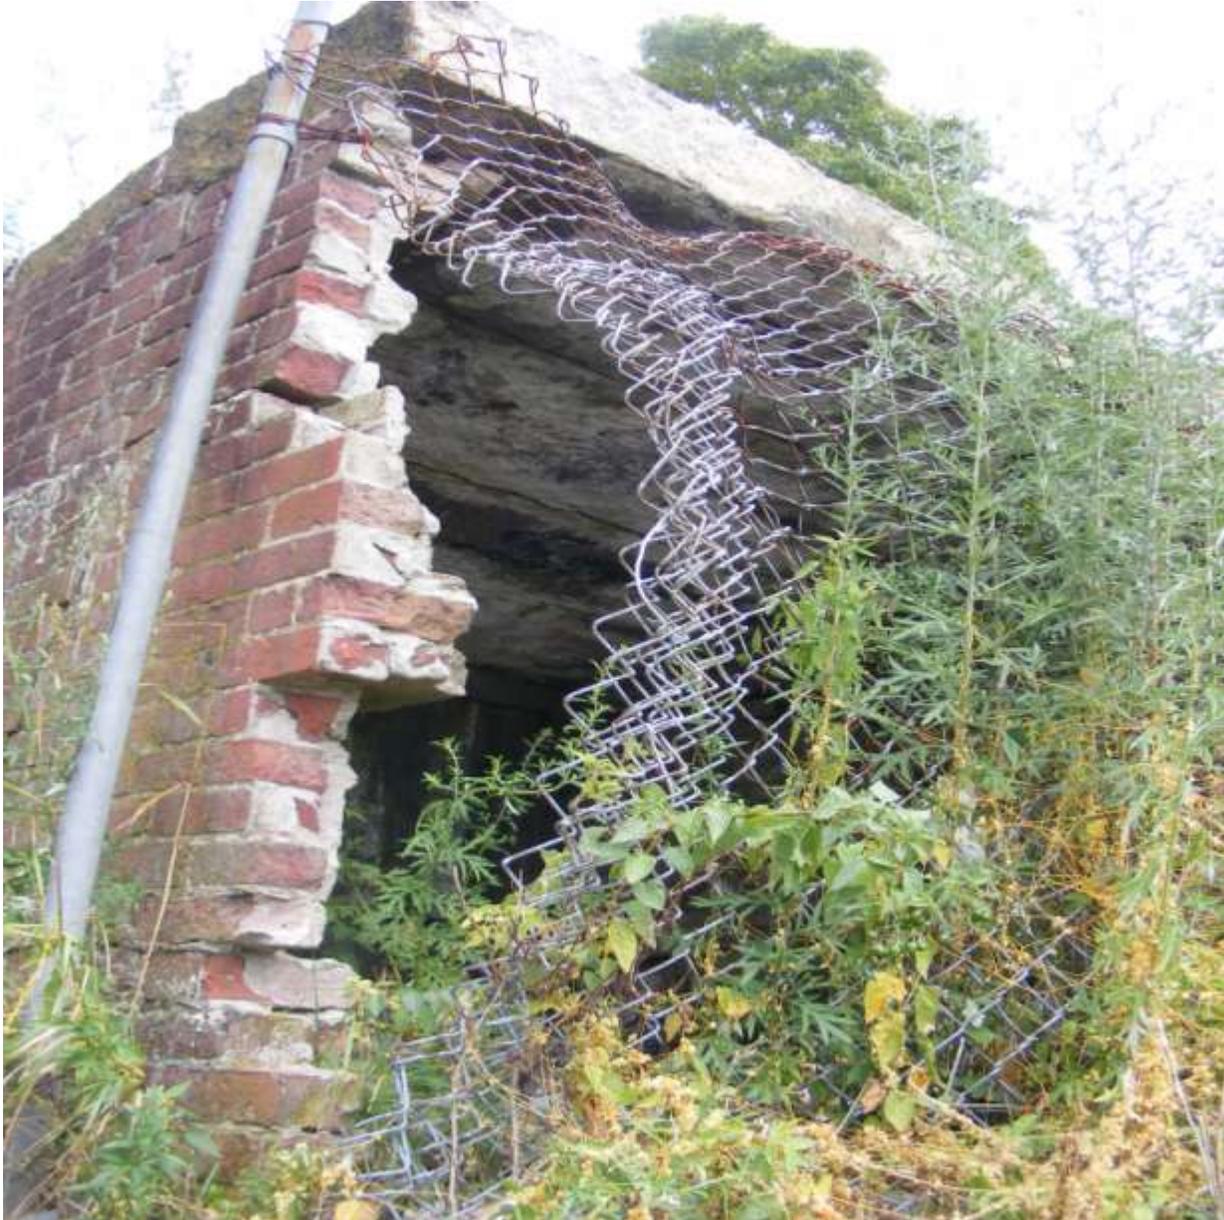
In response to the last more recent collapse of the tomb's rear wall, the Portsmouth DPW installed a section of chain link fence over the opening. This barrier has been pulled off and the tomb is being used as a shelter for homeless people. The campaign to deconstruct this tomb and create a sitting area by the river was not successful and the long term problem of vandalism and unauthorized use of the old tomb have continued to this day.

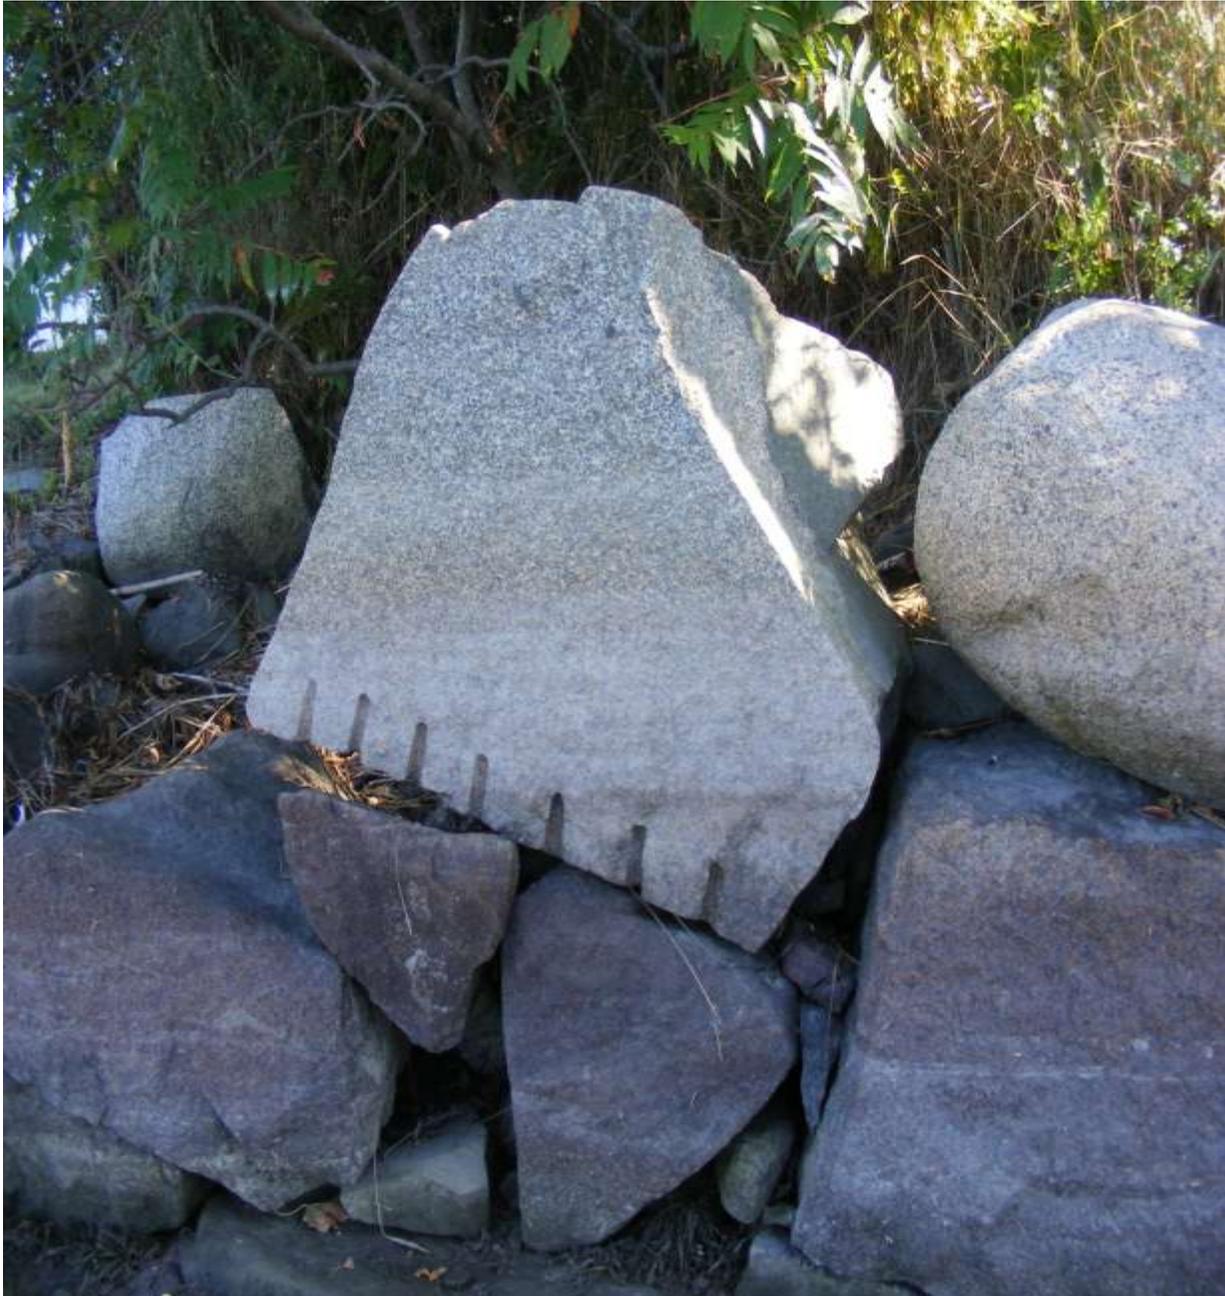
Most of the granite boulders were drilled and split with feathers and wedges before their installation. The size and shape of the remaining drill marks indicate a mid 19th century building technology. The dry laid retaining wall at the back of the Union Cemeteries is in very poor condition and there is ongoing soil loss through this failing stonework. There is a large area behind the north western corner of the wall where the soil banking has been completely washed out.

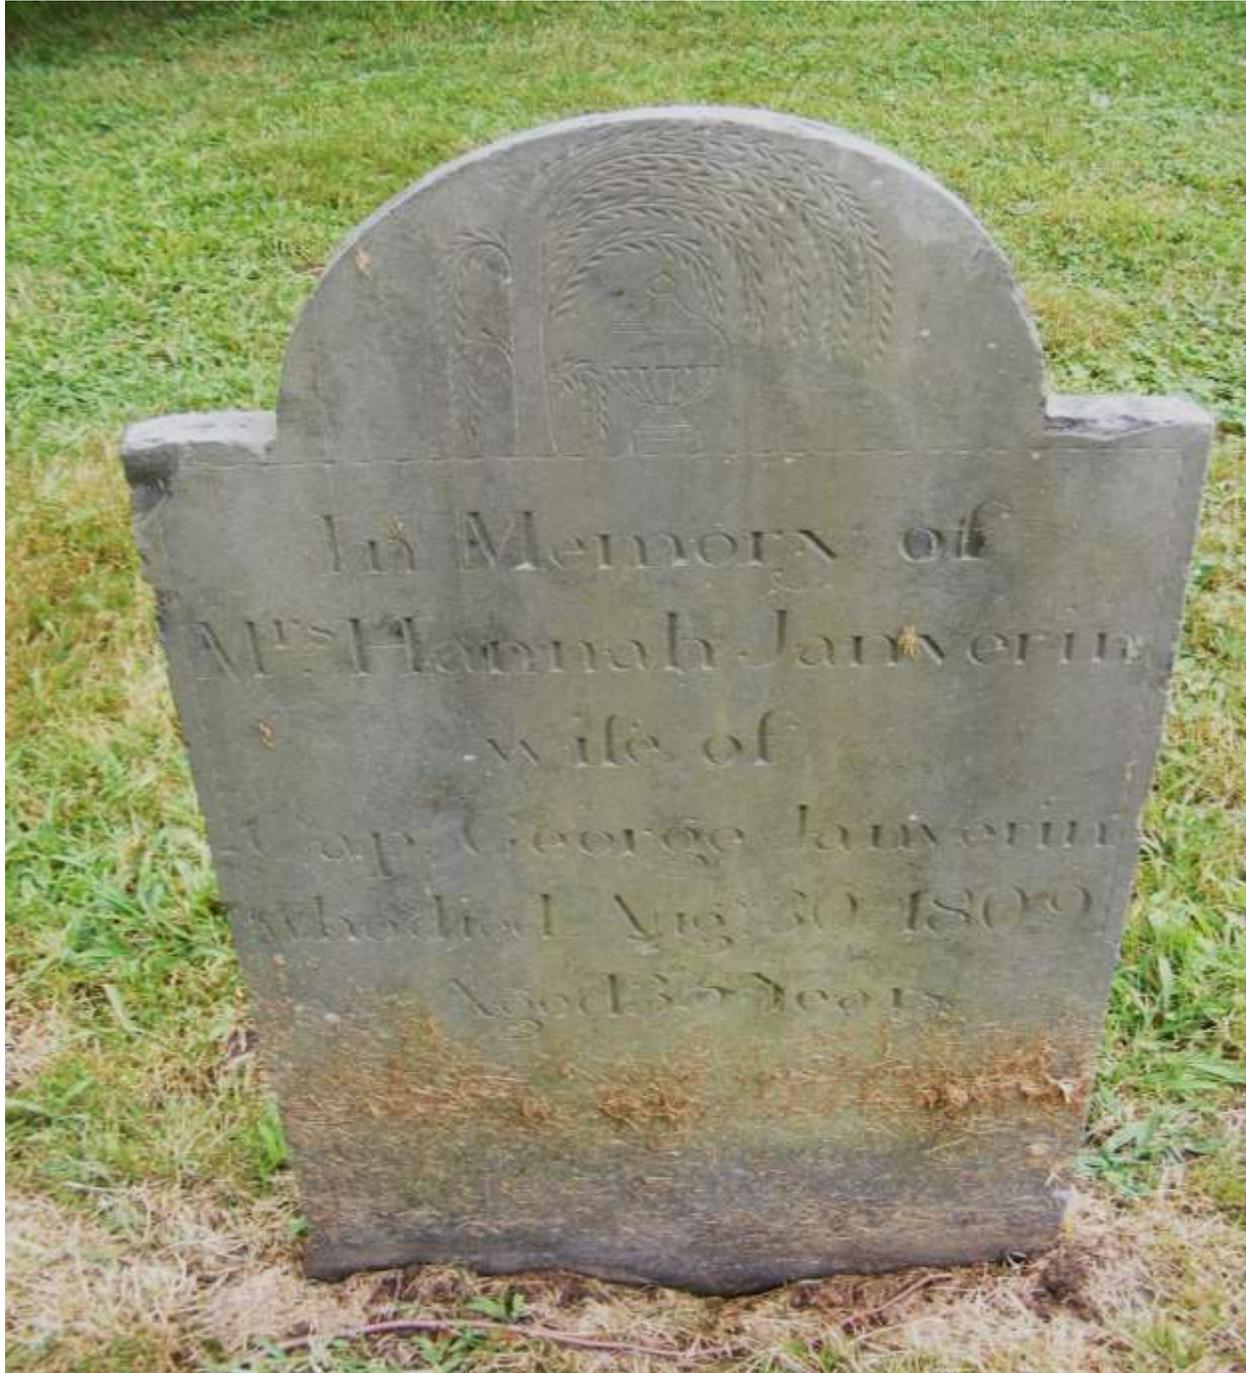
Pleasant Street Burial Ground - Tombs and Gravestones: The surviving slate stones in this burial ground are in fair condition. Most of them exhibit small areas of stone loss and partial delimitation along their top edges due to weathering. Most of these stones also have small nicks and scratches along the soil line caused by the lawnmowers.

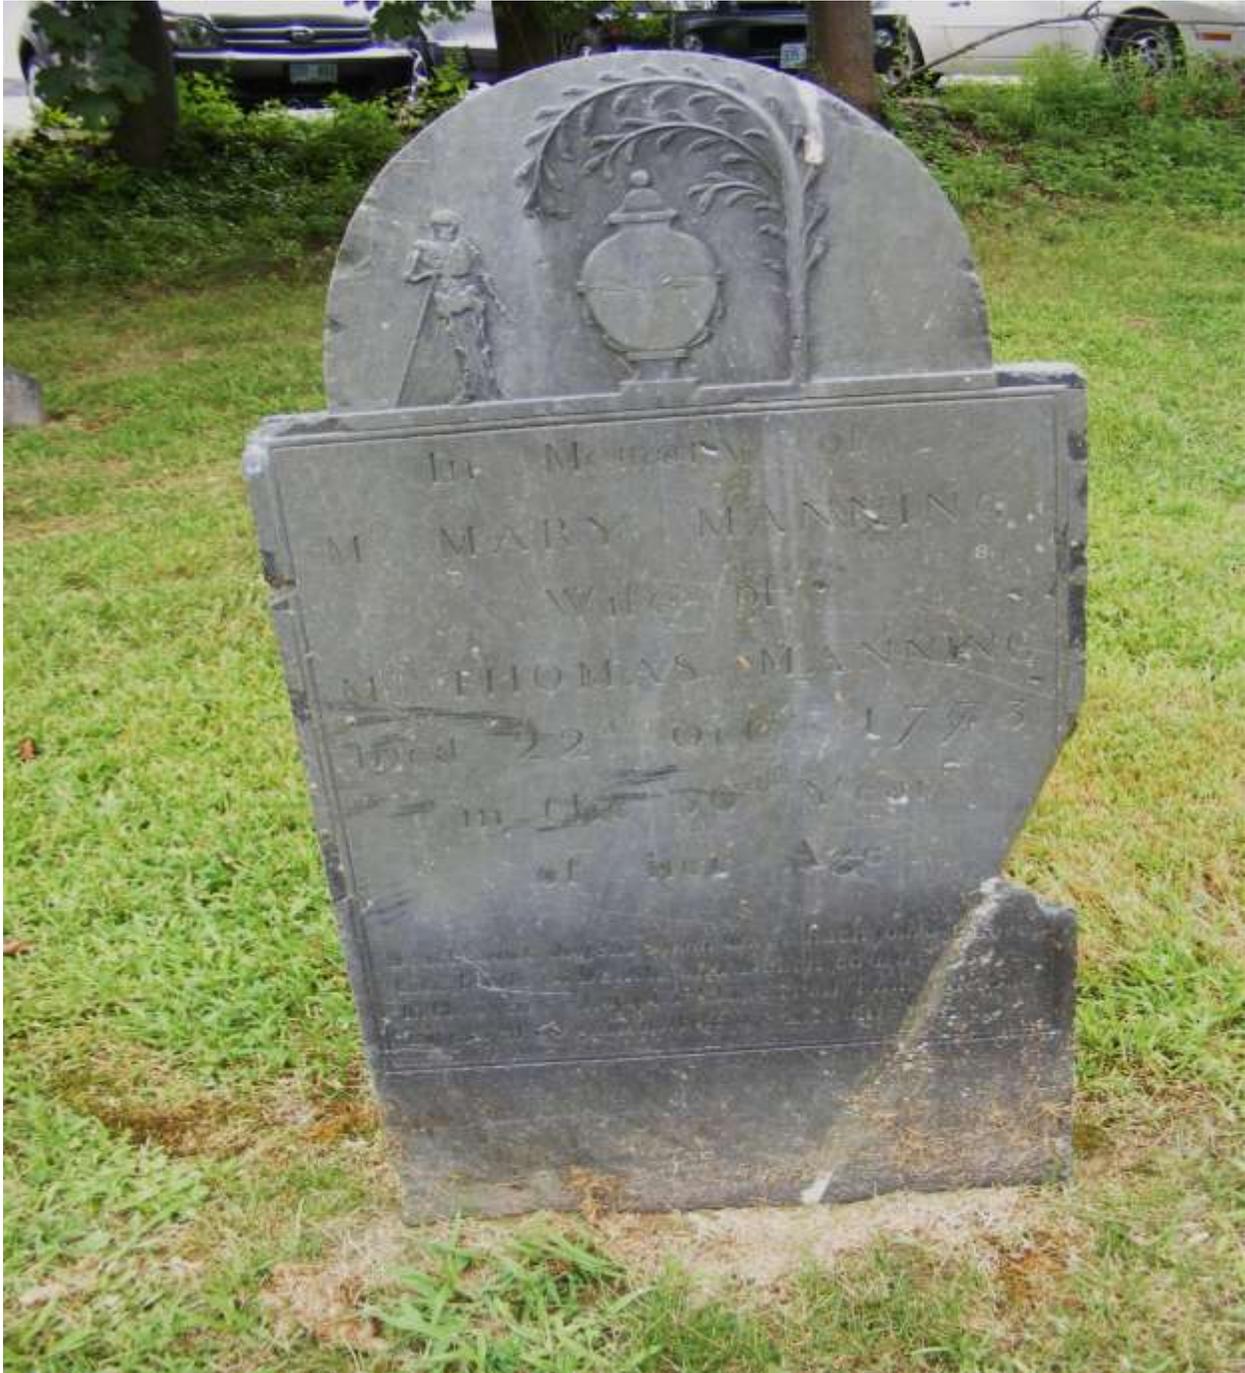
Pleasant Street Burial Ground - Tombs and Gravestones: The most significant existing slate stone marked the grave of Mary Manning, d.1773. This unusual stone which was crowned in part by a bas relief of the grim reaper portrayed as a complete skeleton. This stone had been badly damaged at some point in the past and only partially repaired with cement mortar.

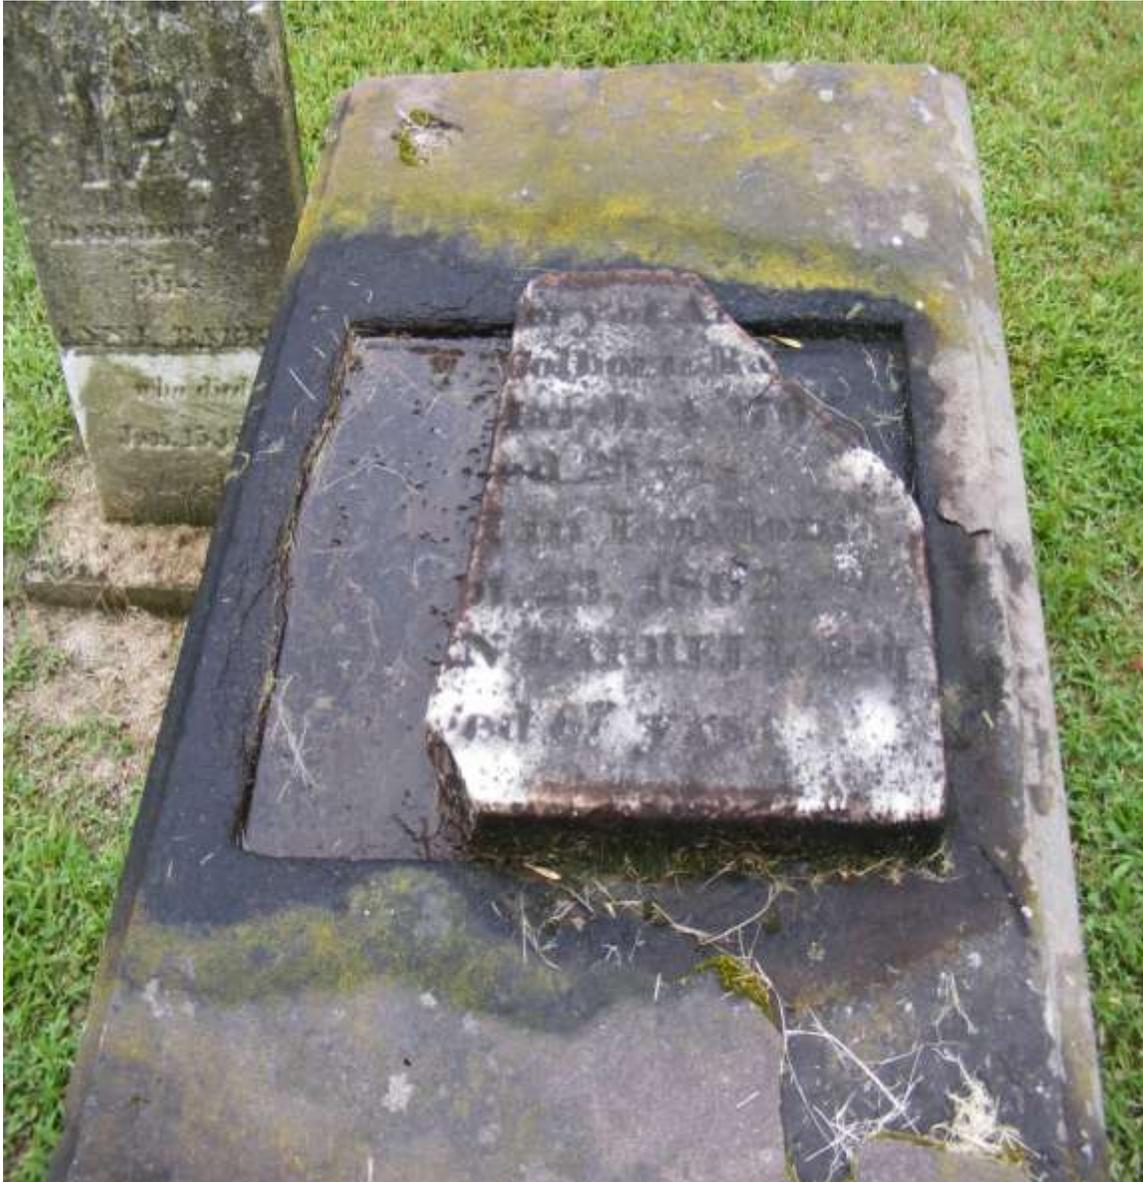
Pleasant Street Burial Ground - Tombs and Gravestones: The moss covered brownstone slab is still in place but has been badly weathered. The original outer surface appeared to have partially delaminated and lifted off the rest of the stone. The existing marble fragment on this stone may have been the original inscription panel for this tomb. It must have been removed and broken at some point. The damaged stone was placed back in its inset pocket which is full of standing water.

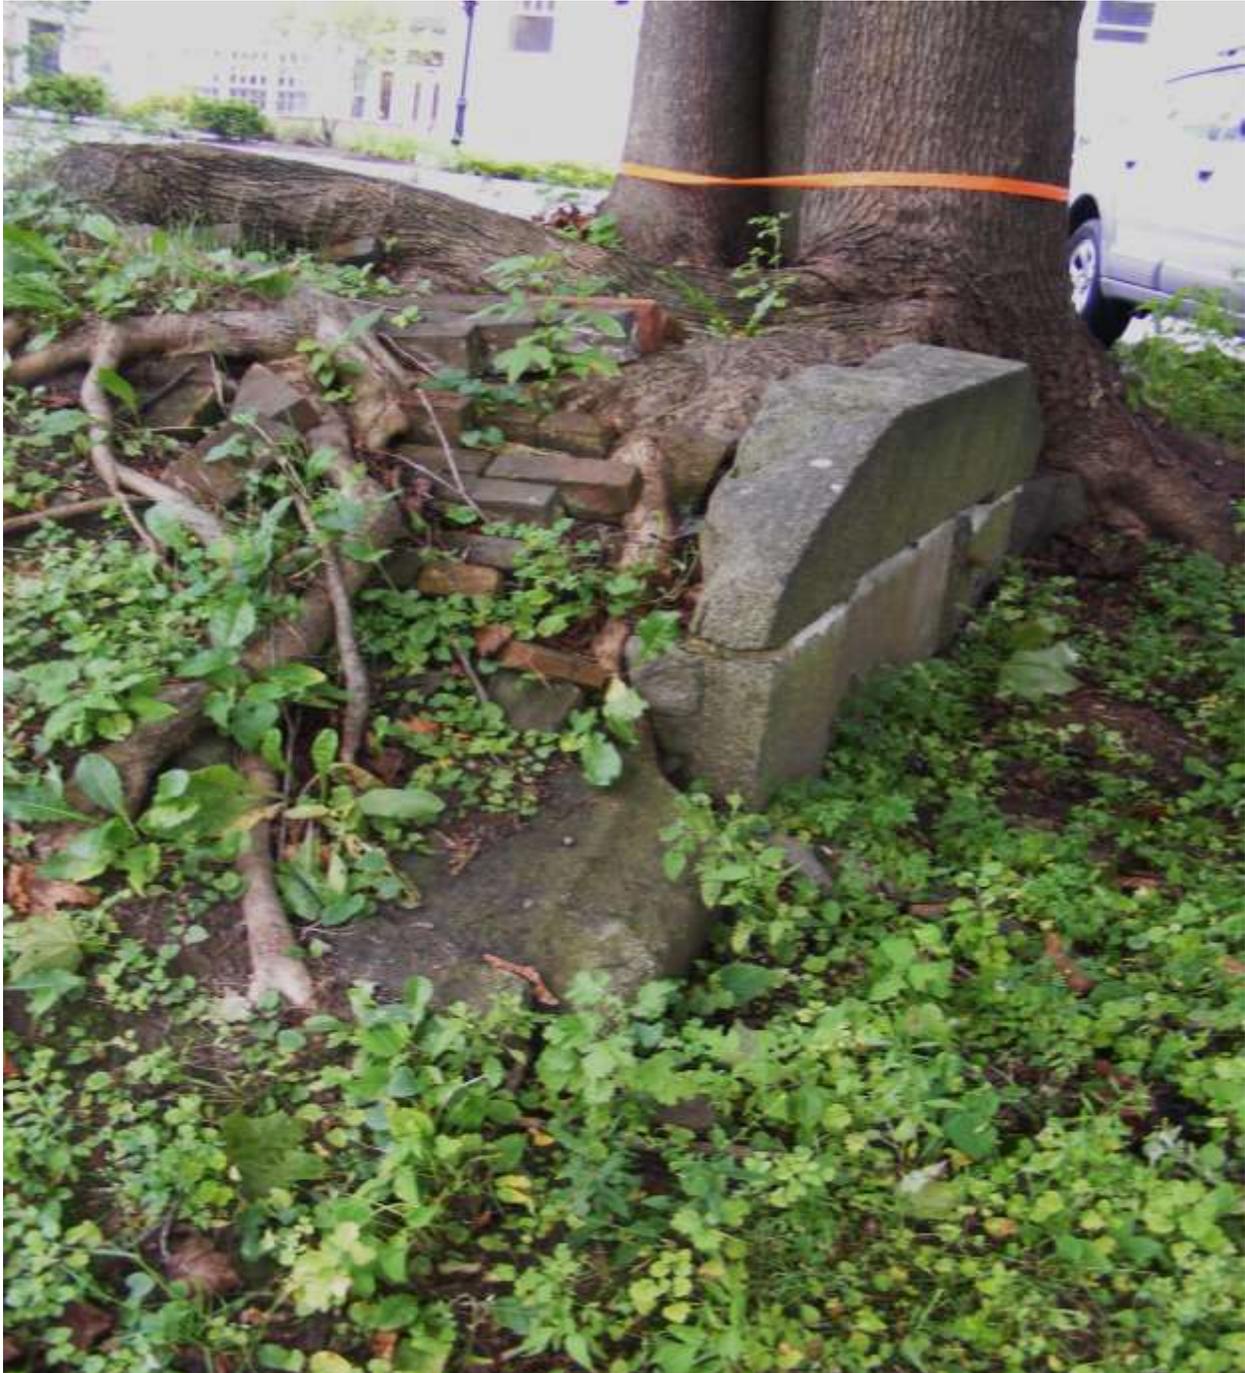
Pleasant Street Burial Ground - Tombs and Gravestones: The three hammer finished granite blocks that compose the tomb's facade have been partially buried. The original entrance door has been removed at some point in the 20th century and the doorway was filled with concrete block. The tomb is essentially a ruin

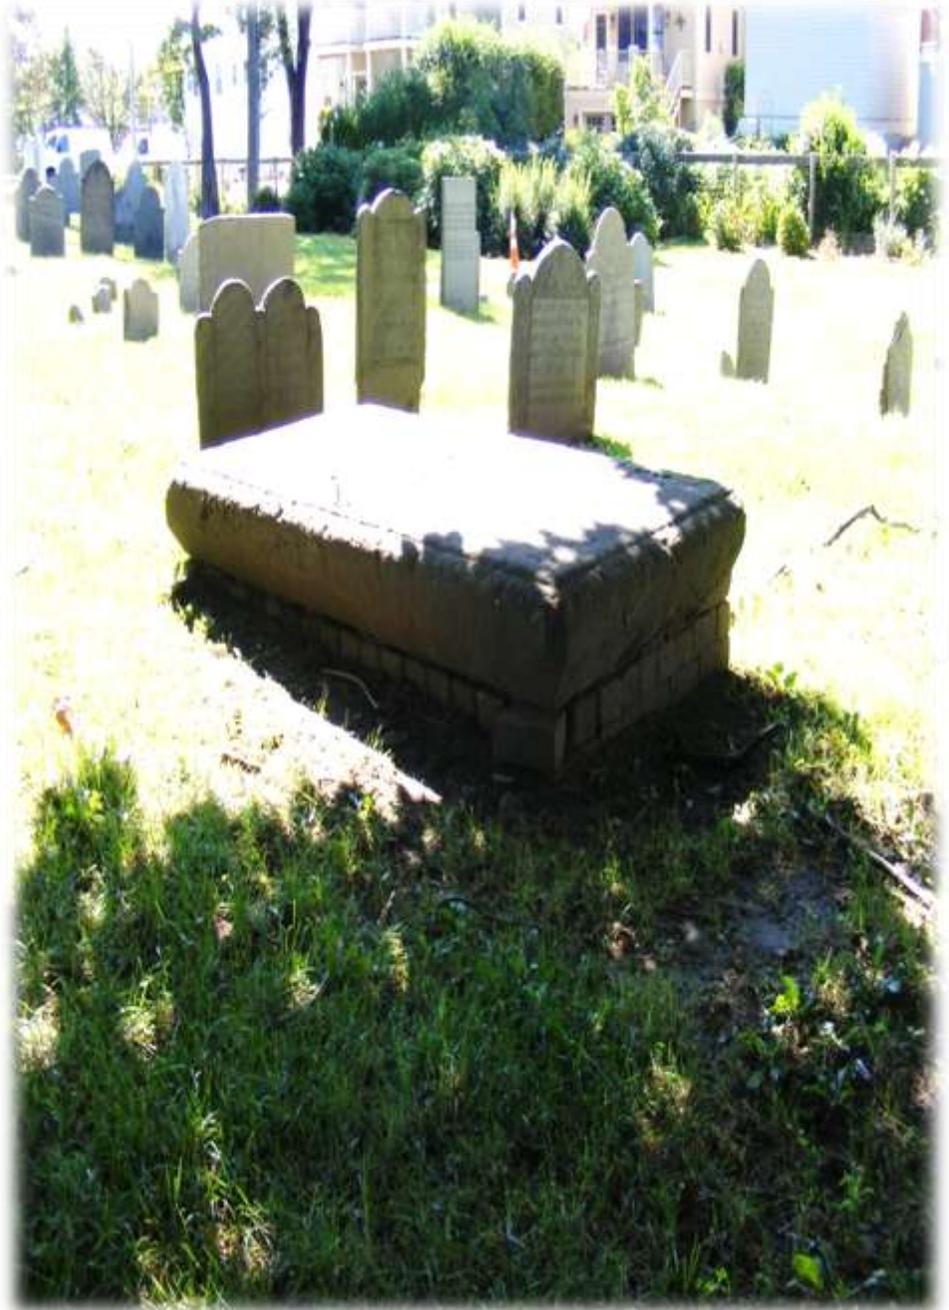
tomb are in better condition than the other similar tombs in the burial ground but most of its inscription has weathered away. There has been very little apparent movement of the large slab but some of its support stones have shifted out of alignment and are no longer holding up the tomb. This has also provided access for rodents to enter underneath the slab
