City-Wide Bridge Evaluation Portsmouth, New Hampshire

Prepared for:
City of Portsmouth, New Hampshire

Hoyle, Tanner
& Associates, Inc.
www.hoyletanner.com

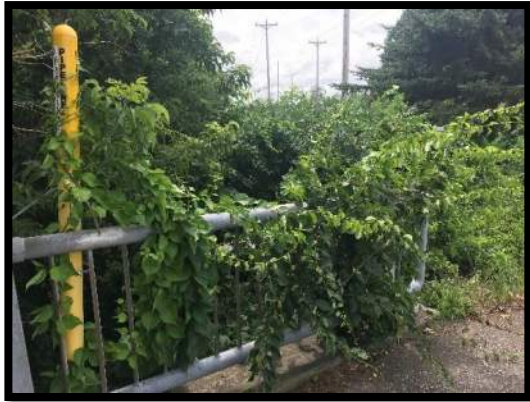
The pavement has settled in both approaches, causing a tripping hazard at both ends of the deck, with maximum settlements observed at the time of inspection of 2-3/8" and 1-1/2", in the west and east approaches, respectively. Vegetation overgrowth is present on the west approach and continues onto the bridge. The embankment at the northeast quadrant of the bridge has eroded with stormwater runoff appearing to be the cause. There are several isolated locations of abrasion on the concrete deck with exposed aggregate. The galvanized metal rail posts exhibit surface damage, most likely from plow impact, and two pickets on the northwest quadrant are broken.

West End Vegetation

- Repave both approaches to correct tripping hazard.
- Touch-up the rail system with cold galvanizing compound and replace broken pickets.
- Remove spalling and loose concrete from the deck and seal to prevent further abrasion.
- Regrade the approach shoulders and embankments and add erosion stone (as necessary) to promote proper drainage and minimize erosion.
- Add filler material between abutment and brush curb.
- Clear vegetation overgrowth along west approach.

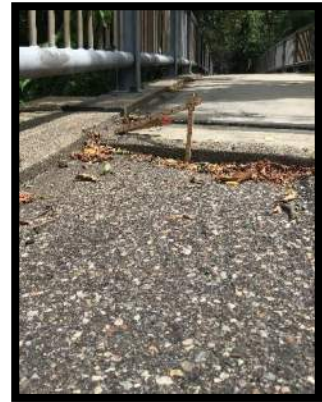
Tripping Hazard at
West End

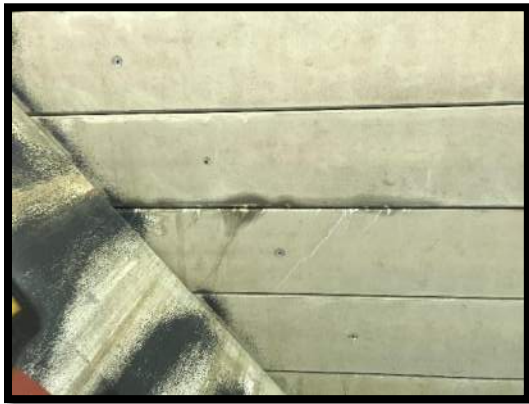
The underside of the deck exhibits signs of efflorescence, leaking and rust staining. The as-built drawings indicate that the bridge was constructed in two phases; the leaking appears to be concurrent with the phase construction joint, which is also located near the median curb line. It is likely that water is penetrating the pavement and waterproofing membrane at the median curb line and migrating to the phase construction joint, where it is leaching through the superstructure.

Underside of Deck Near Centerline

- Seal along curb lines, with hot-poured crack sealant, to minimize water intrusion through the pavement. This maintenance fix would be completed as an interim-repair with a more substantial repair completed in the long-term, and would only be effective as long as the pavement remains in good condition.
- Seal transverse cracks in the pavement in the approaches; monitor cracking for additional settlement in the approaches.
- Seal the underside of the deck to prevent future rusting and staining.
- Continue to paint-over or remove graffiti from the abutments.

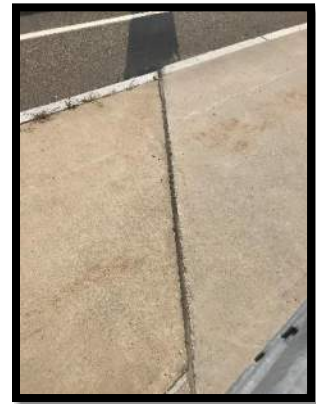
North Sidewalk
Expansion Joint

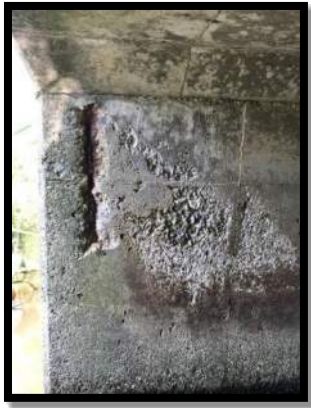
During periods of normal flow, Hodgson Brook is slow-moving with a normal water depth of approximately 2' in each of the three barrels of the concrete culvert. The streambed consists of loose sediment and muck near the banks and firm gravel near the center of the channel. The upstream face of the concrete walls of the culverts exhibit loss of fine aggregate and abrasion. Spalling and concrete loss continues into the culverts along the waterline. The underside of the deck exhibits scattered abrasion and light leaking. Rebar is exposed in several isolated locations below and above the waterline. The southwest wingwall exhibits severe spalling around the drainage outlet.

Barrell 2 Abrasion and Exposed Rebar

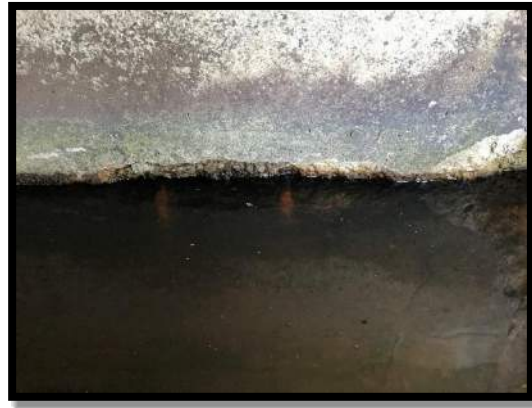
Loss of Concrete Below Waterline

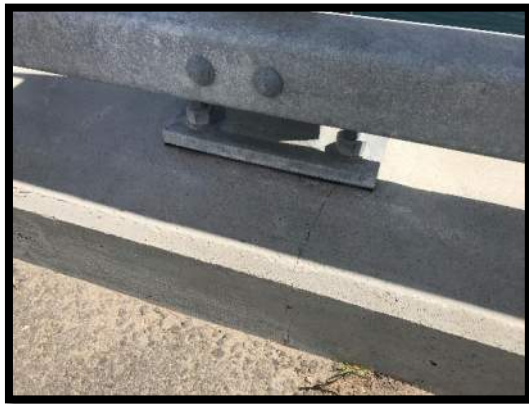
The bridge is generally in excellent condition. There are transverse hairline cracks in the sidewalk and brush curb. The expansion joints have accumulated debris and sand that inhibits proper operation of the joints; the debris reduces the allowable thermal movement of the bridge, inducing thermal stresses into the bridge structure.

Hairline Crack in Brush Curb

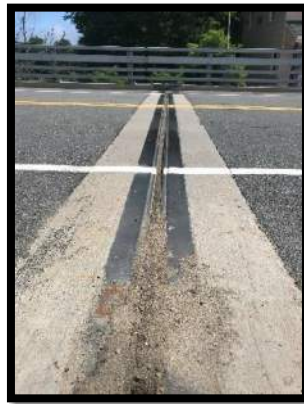
Debris in South Expansion Joint

There are no recommendations at this time beyond general routine maintenance activities, which includes flushing the expansion joints and washing the bridge annually.

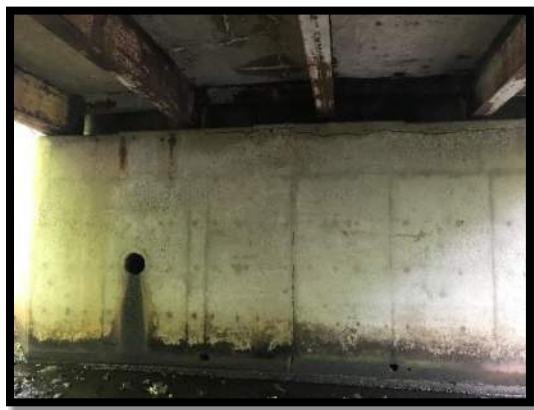
visible on the underside of the deck. All five steel beams exhibit heavy corrosion and section loss with various levels of paint system failure ranging from minimal peeling to 100% failure. Both abutments exhibit spalling and cracking with localized areas of exposed rebar. A horizontal crack extends approximately 75% of the total width of both abutments at a location approximately 1' below the top of the bearing seat. A full-height vertical crack is located at the eastern-most portion of the north abutment.

North Abutment

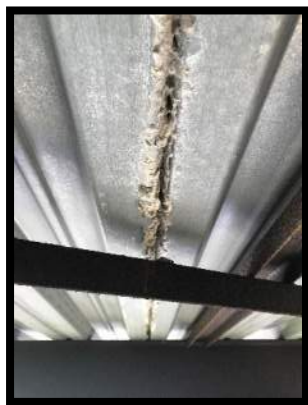
The weathering steel superstructure is in good condition. Although the beam seats are fairly clean, rust staining has developed on both abutments. Efflorescence is visible on the underside of the deck between the stay-in-place form joints. The slotted holes in the sole plates are

Efflorescence on
Underside of Deck

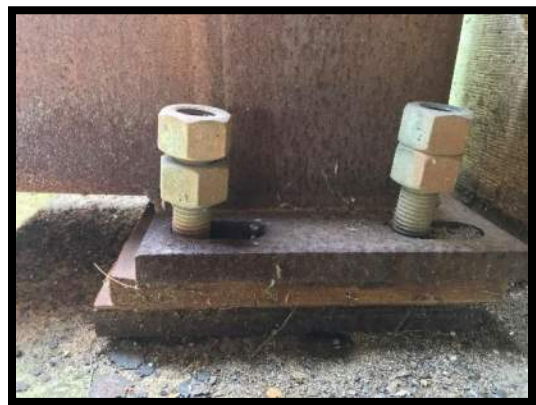
Typical Bent Anchor Bolt

either undersized or the anchor bolts are in the incorrect location as evidenced by the bent anchor bolts at the west abutment bearings; the anchor bolts bear against the side of the slotted holes and do not leave any room for additional expansion of the superstructure.

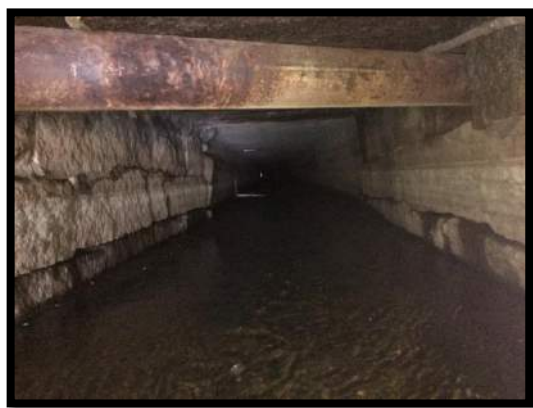
The bridge carries several underground utilities, some within the hydraulic opening of the bridge and the remainder installed in the roadbed material above the top slab. Field observation of DigSafe markings, manholes, and valve boxes indicates the bridge carries telephone/data conduits in the area of the downstream sidewalk, water mains near both the downstream and upstream curblines, a 4" dia. plastic gas main near the upstream sidewalk, and a gravity sewer main near the centerline of roadway. The upstream water and gravity sewer mains are located within the hydraulic opening. There is also a closed storm drainage system at the bridge, with an outfall penetrating through the northern stone masonry wall into the bridge.

Utility in Hydraulic Opening Near Outlet

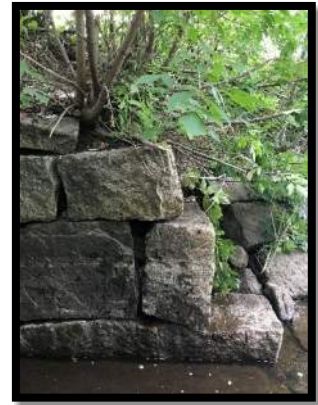
Wingwall Stone
Rotation

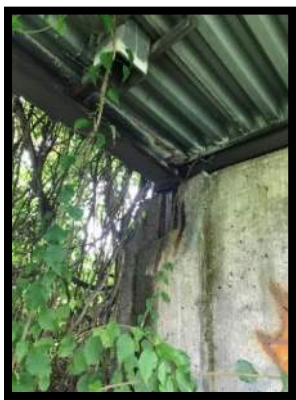
Exposed Anchor Bolts
at Concrete Spall

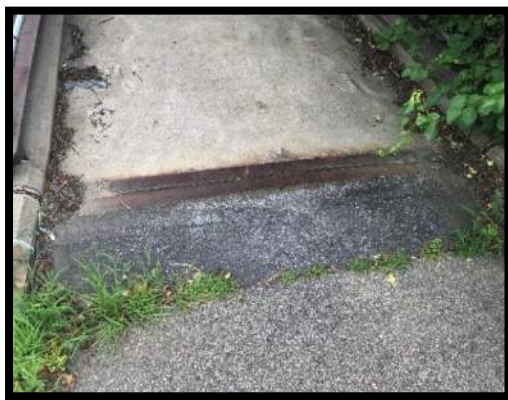
South Abutment Expansion Joint

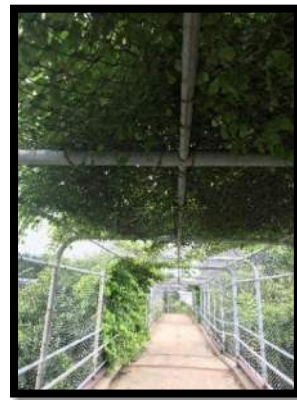
Sagging Fence due to
Overgrown Vegetation

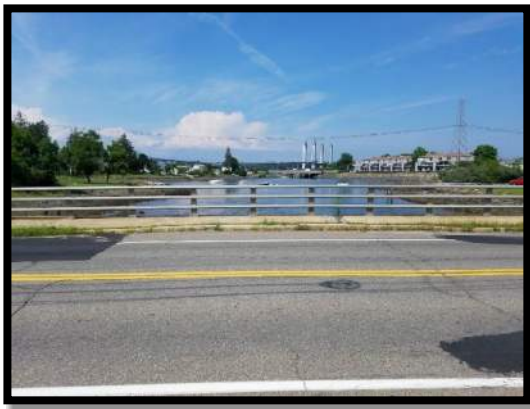
The pavement is in poor condition with cracking, settlement, and potholes throughout the approaches and on the bridge; pavement repairs have been completed in several locations. There is poor stormwater drainage at the bridge as evidenced by ponding on the west side and vegetation growth on and around the curbs. The sidewalks are rotating towards the road with significant settlement along both the west and east curb lines at the north and south ends. This settlement/rotation creates uneven walking surfaces on the sidewalk (i.e. tripping hazards). A section of the vertical granite curb is missing on the east side. The rail system, though substandard, is in good condition with minor plow damage.

Typical Pavement Condition

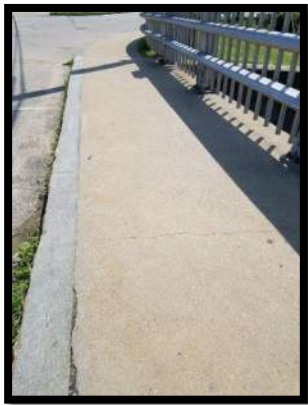
Typical Transverse
Sidewalk Cracking

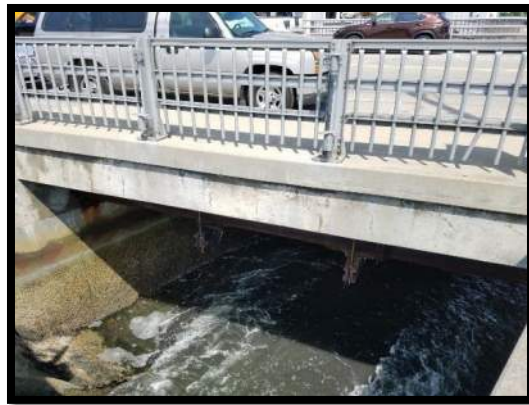
Minor Cracking on West Fascia

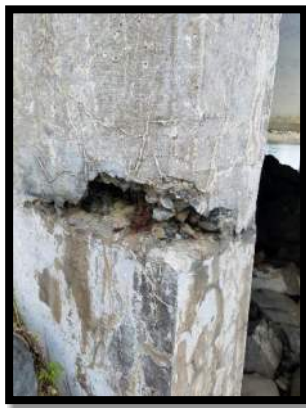
Spall on Southwest
Wingwall

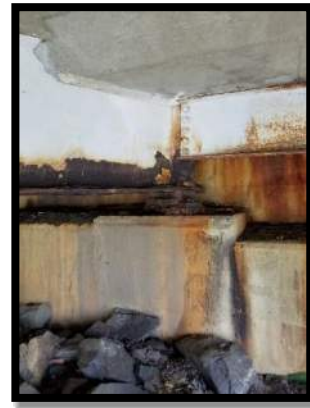
Beam End Deterioration

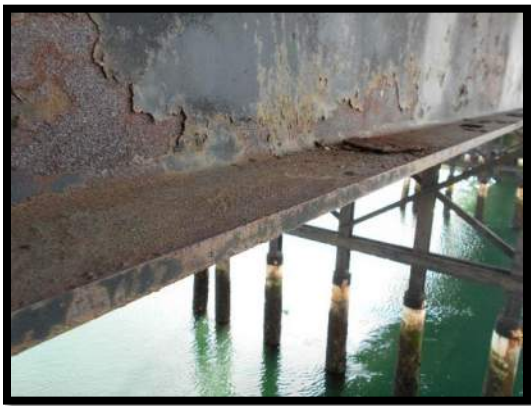
The steel beams are in fair to satisfactory condition with moderate paint system failure throughout, minor surface rusting and some laminar corrosion.

Typical Beam Corrosion

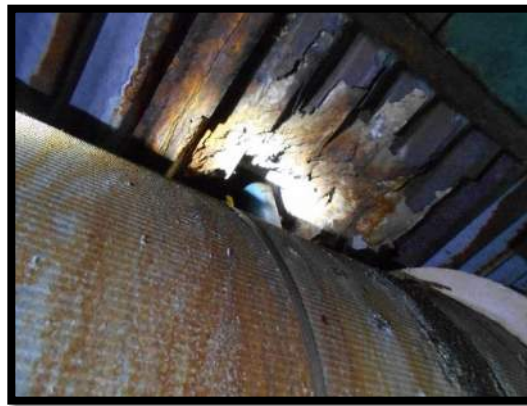
Deck Spall at Northern Air Release Valve

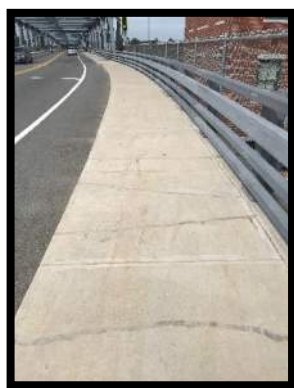
Longitudinal and transverse hairline cracks are present in the sidewalk, some of which have been previously sealed. There is minor longitudinal cracking in the pavement along the pavement joint at the crown of the bridge. The bridge and approach rail are in good condition.

Sidewalk Cracking

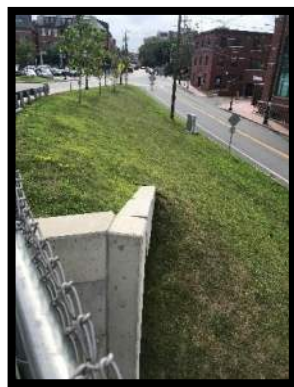
Rotated Southwest Wingwall Coping

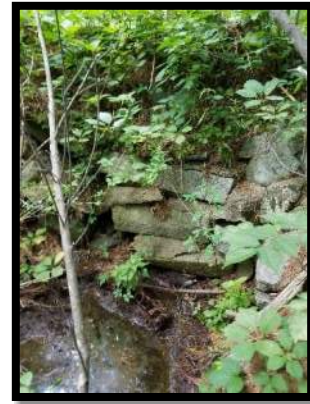
- Little Harbor Road over Brook
 - Masonry stone blocks obstruct the inlet and outlet of the brook that would travel under Little Harbor Road; stagnate water was observed at this location with little to now flow passing through the masonry stone blocks.
 - It is likely that these masonry stone blocks were part of headwalls that have collapsed over time.
 - The bankfull width of the brook appears to be 5'-6", therefore, a culvert to convey the brook would not be considered a bridge. However, the City should be aware of this structure and determine if a culvert needs to be installed to prevent erosion of Little Harbor Road.

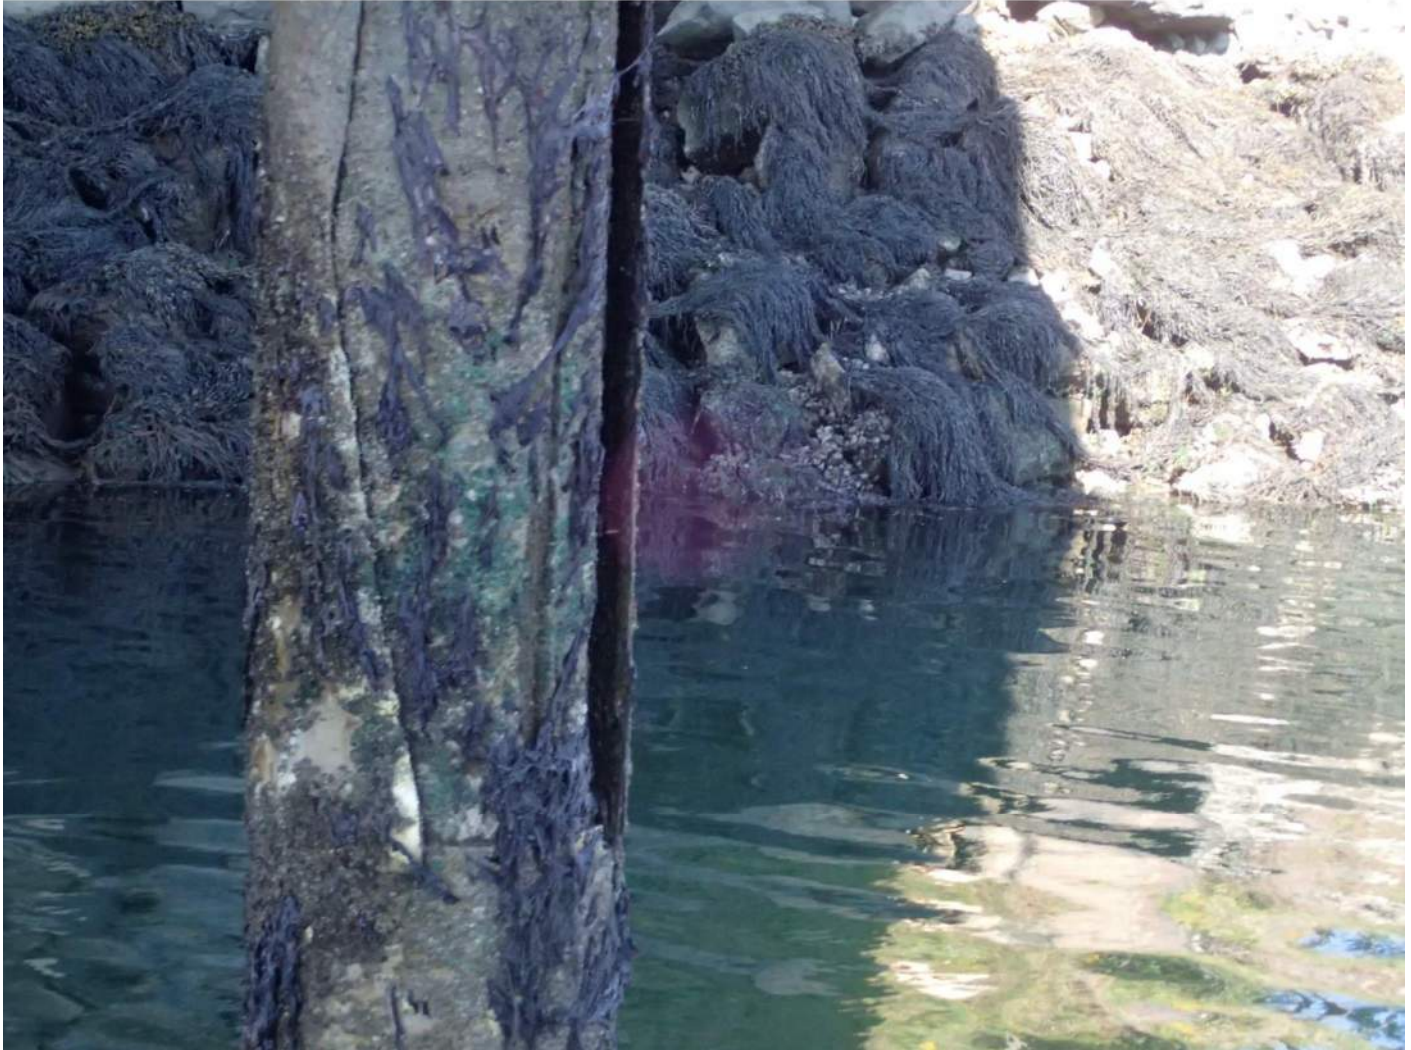
Structure ID #: 241-069, Pierces Island Road over Little Harbor Date: 08/05/2016
County: Rockingham State: New Hampshire
Description : Missing pile jacket, concrete fill being eroded. Bent 1 3rd pile from the north

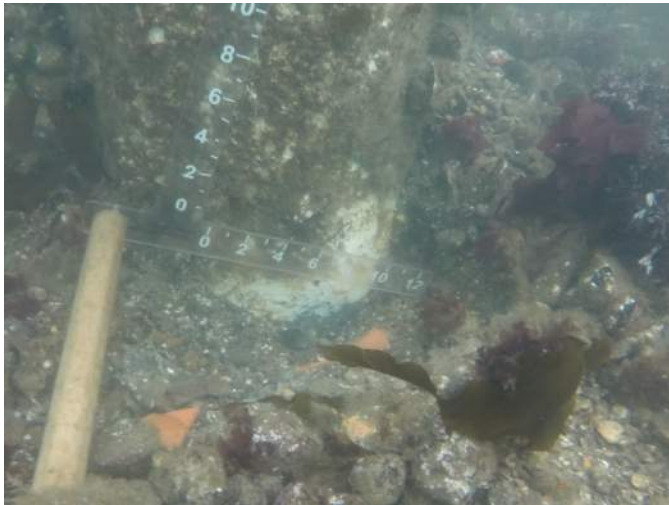
Photo 2

Fiberglass jacket extending at least one foot
below riverbed

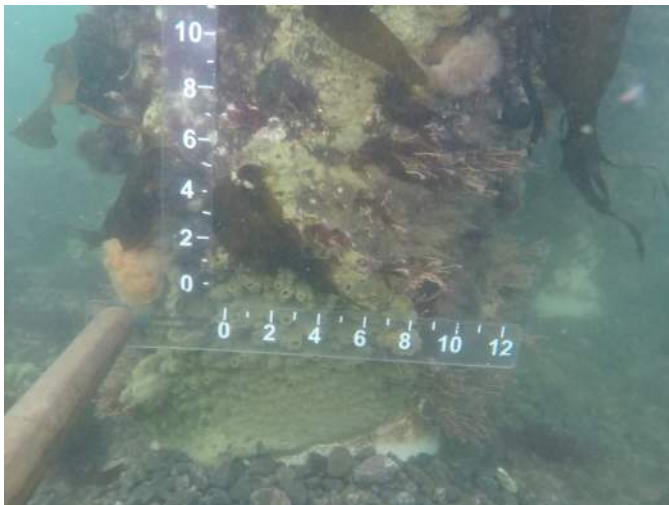
Photo 3

Typical marine growth on pile jackets
