Re: Stephen H. Roberts, Trustee, The ADL 325 Little Harbor Road Trust,
Owner/Applicant
325 Little Harbor Road
Tax Map 205, Lot 2
Rural (R) District
LU 21-220

Belle Island Barn

Existing Conditions Assessment (Part 1 of 2):

Conditions Assessment April 2018

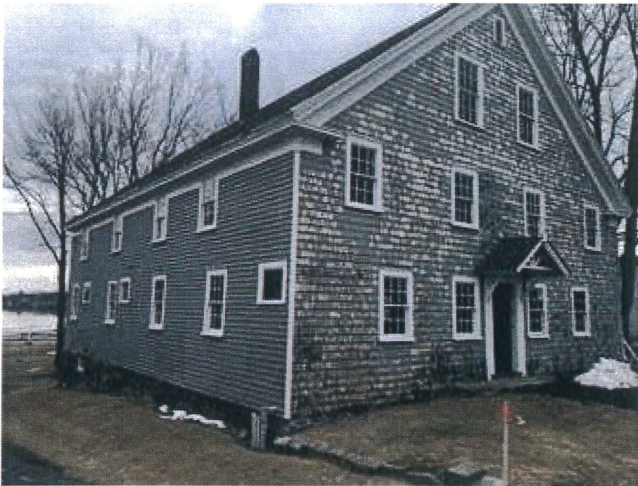
A many windowed facade hides a much earlier timber framed barn within. The approach to the barn is paved and higher than the sills. A concrete poured mini ramp replaces the wood structural sill.

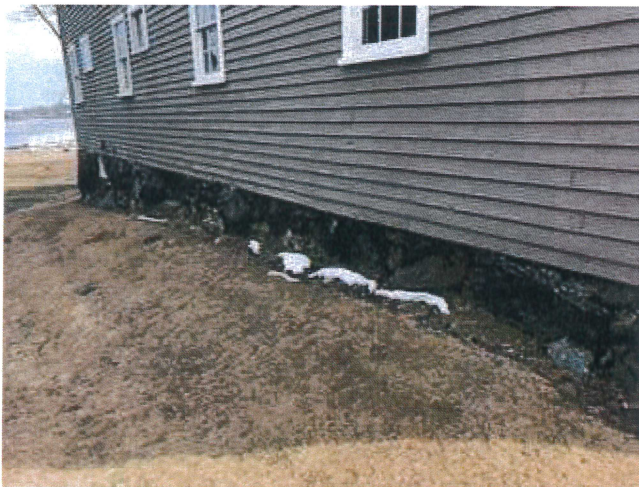
Grade has changed around the barn over time. The grade at the front gable of the barn covers the sills and the sills have subsequently rotted away. New grading can pitch water away from the barn.

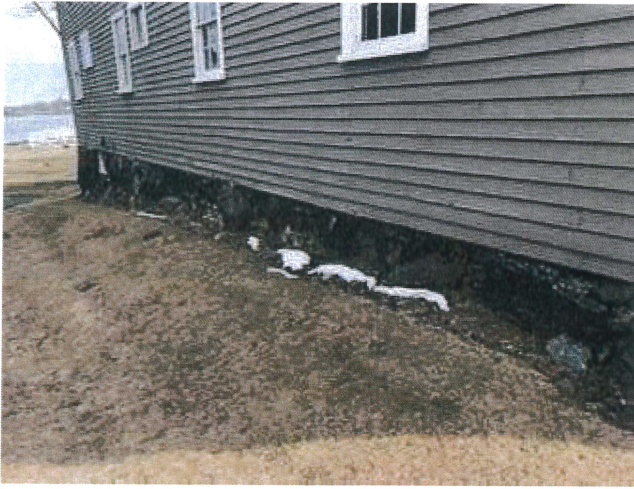
North Foundation:

The north foundation wall is in good shape with only minor repointing of the rubble stone needed. This grade is likely a little lower than optimal for this wall.

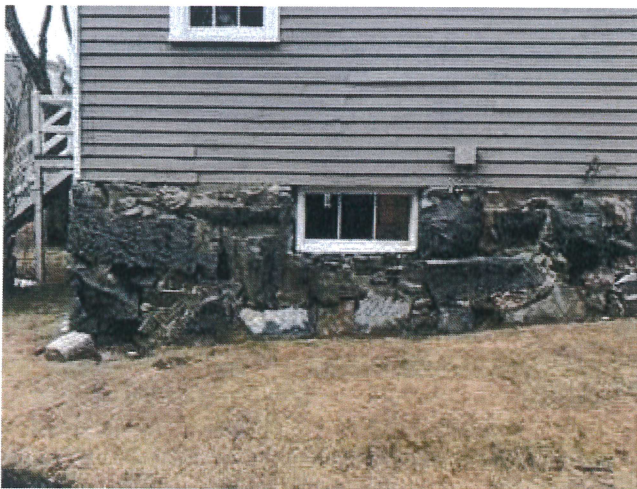
A mix of cut stone and rubble stone make up a substantial foundation for the barn.

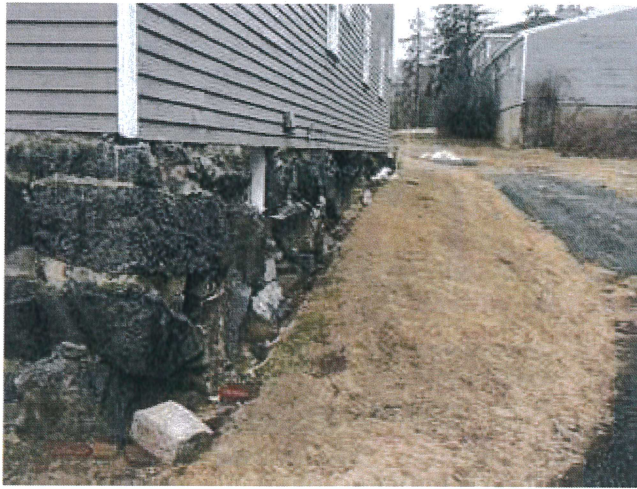
Some stone work has loosened from the foundation. Some mortar repair has also been done. This corner will need a bit of work, but overall the foundation is amazing.

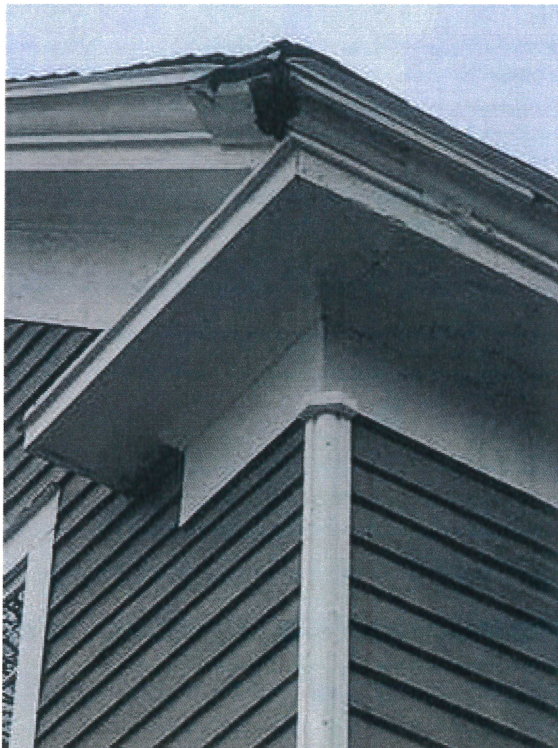
Missing clapboards reveal two inch holes that were drilled often on all sides of barn for blown in insulation. Latex paint covers lead paint. Clapboards are nailed over and over.

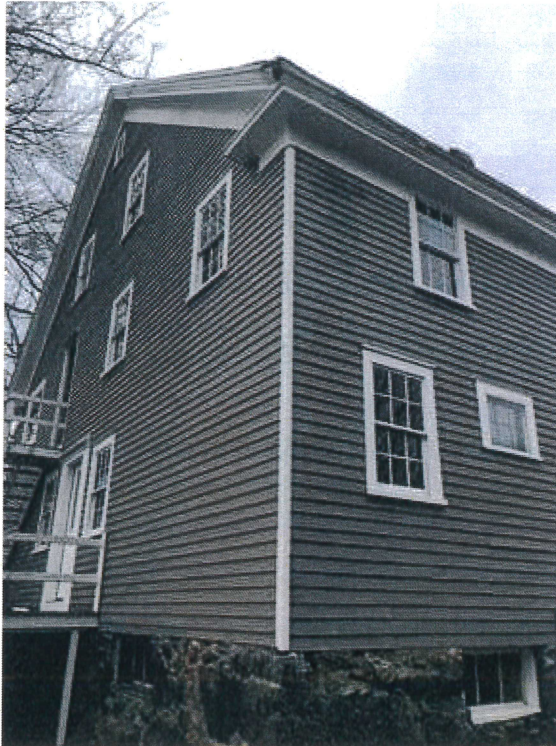
Looking South along the East gable. A large deck shades the stone foundation. This foundation is exposed to severe weather on this end of the barn.

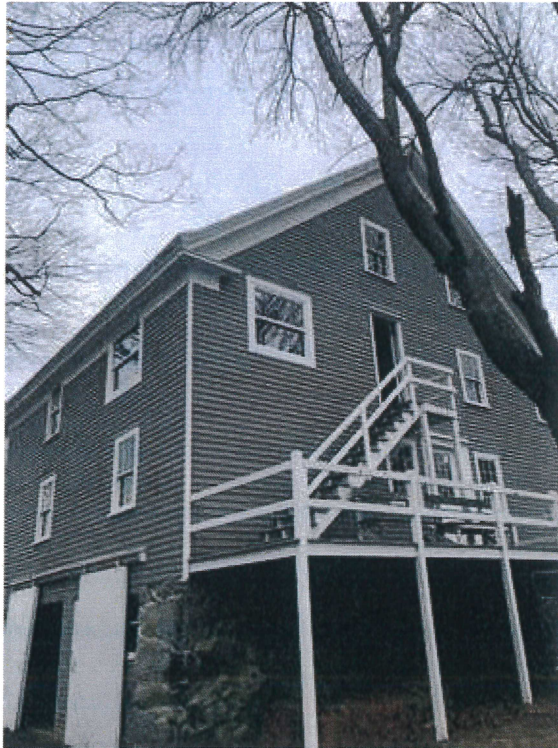
The east gable end is confused by two levels of deck and multiple windows scattered throughout the facade.

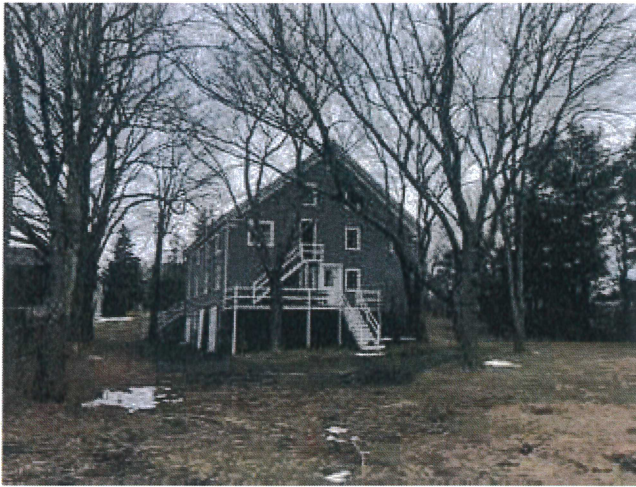
A significant grade change occurs on the South eave wall and this grade is carried partially around the gable end. The foundation is exposed and very well done. Deck posts are inadequate.

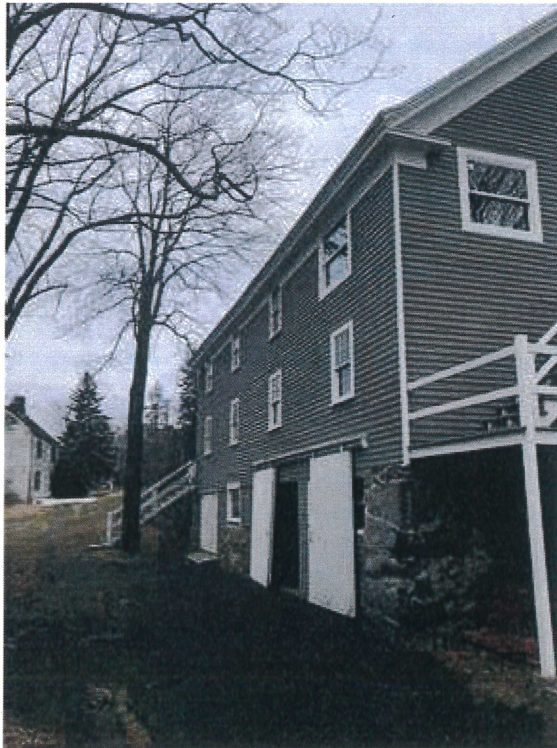
Seaweed is strewn from the islands edge up to the east gable of the barn. The elements pound this end of the barn and the frame shows signs of decay despite newer siding and decks.

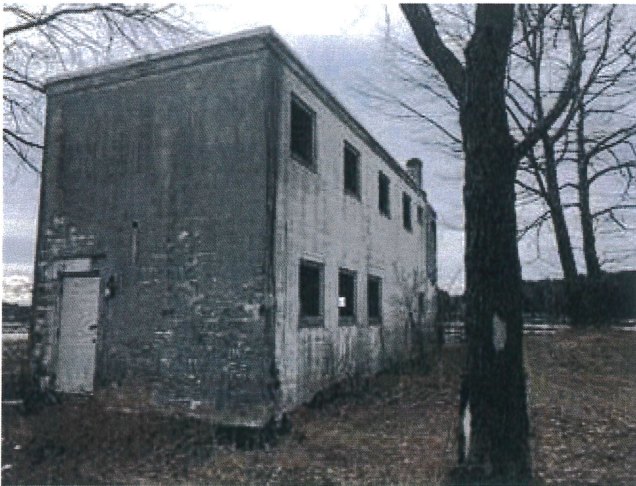
A series of outbuildings decay along the south side of the barn. They are soon to be removed.

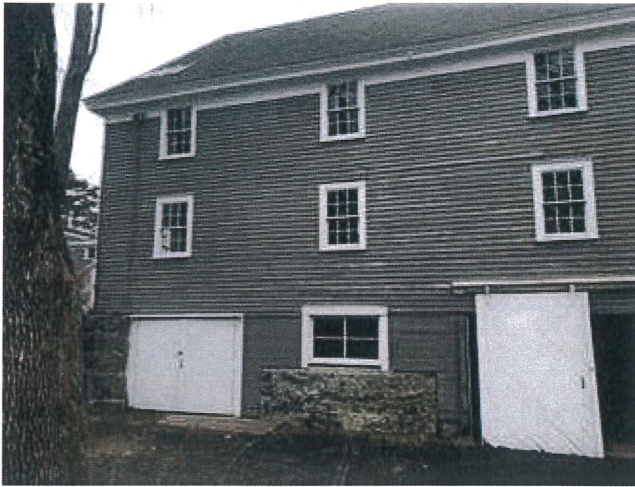
Some foundation repairs are seen here. They are not of the quality of the rest of the stonework. Rolling doors cover original foundation openings.

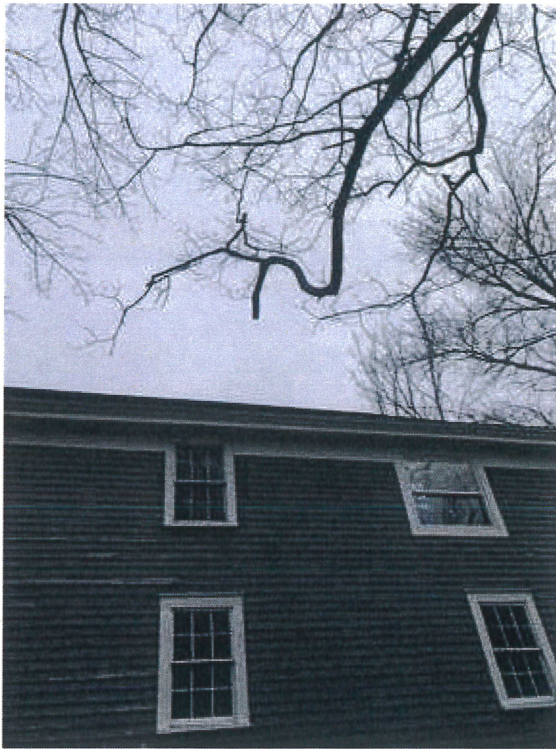
Most of the trees are savable near the barn but this one is too close to the foundation and will be problematic over the long term.

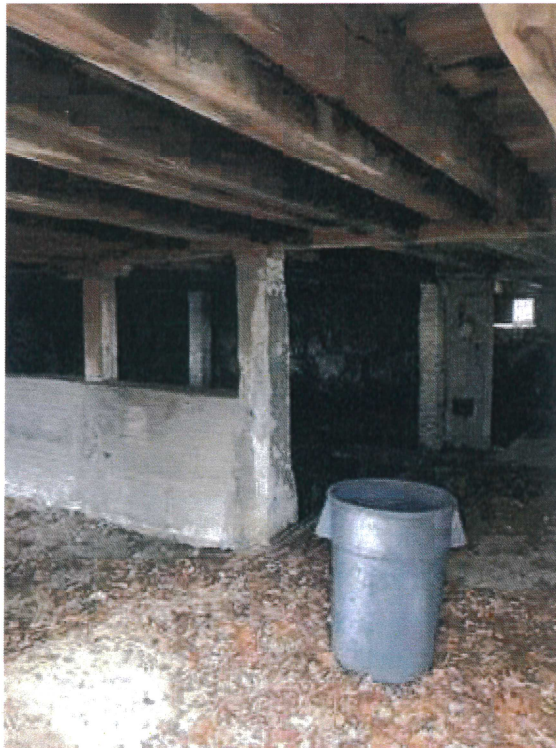
Cut granite piers support the drive posts in the cellar of the barn. They are substantial and extremely well done.

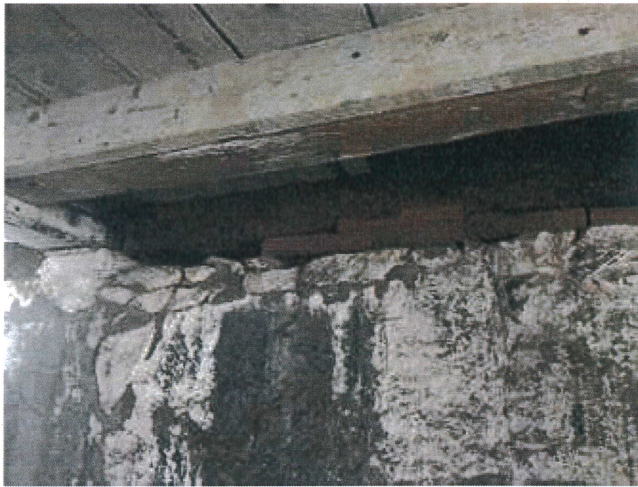
Both gable sills on the barn are rotten and need to be replaced in kind.

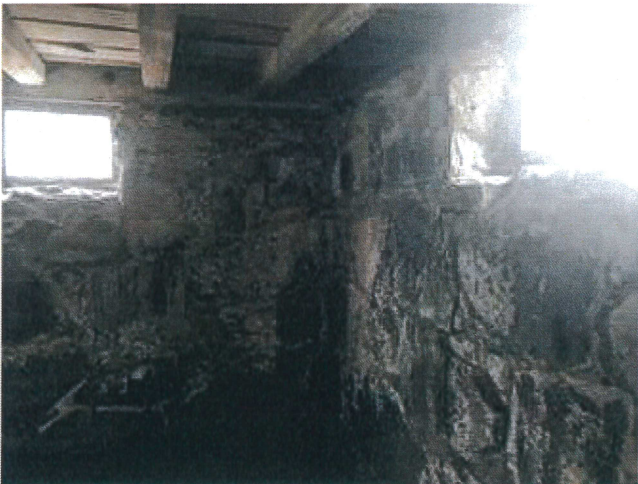
The foundation stones rise up to support a carrying beam that runs along under the drive posts. The ends of these beams are rotten as they engage the rotten gable end sills. They can be repaired in kind and utilize the foundation once again for support.

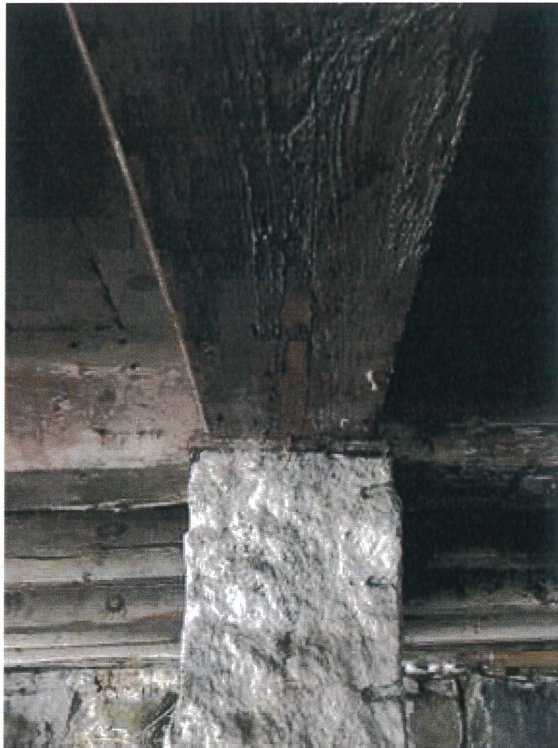
The cellar foundation is wonderful needing only minor repair.

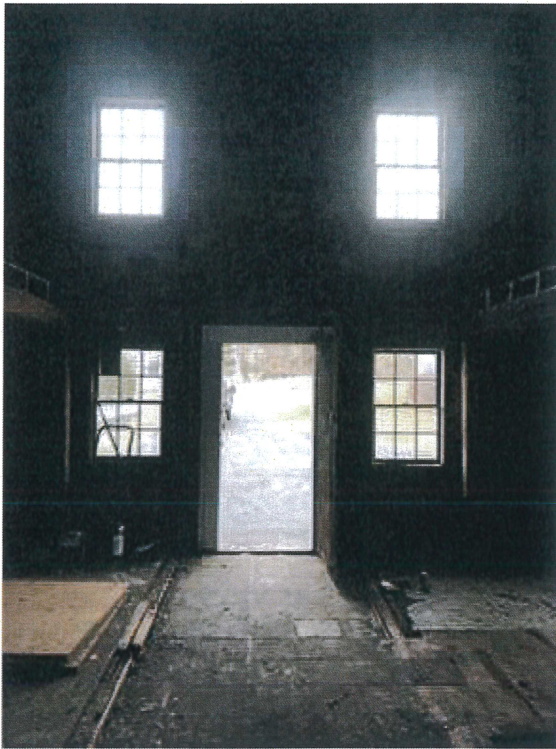
Pavement comes close to the barn and transitions into a concrete ramp that covers the original sill. This ramp will need to be removed to repair the sills below and a wood ramp can traverse the space remaining between asphalt and barn.

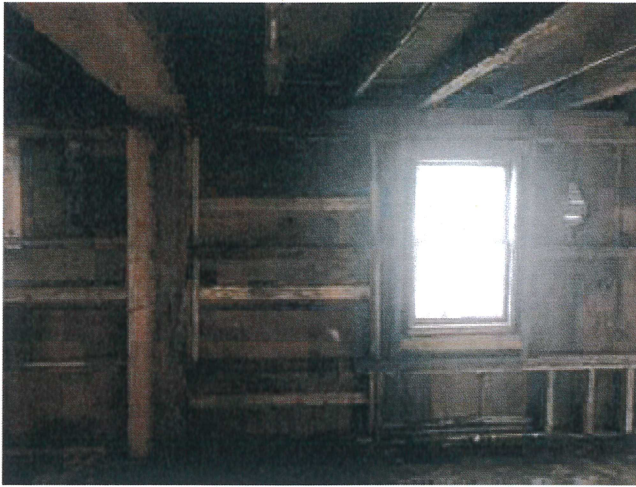
The South eave wall has suffered considerable damage from rain water penetrating the roof and sheathing. New siding covers the patched sheathing and ignores the structural damage that was clearly present when the siding was installed.

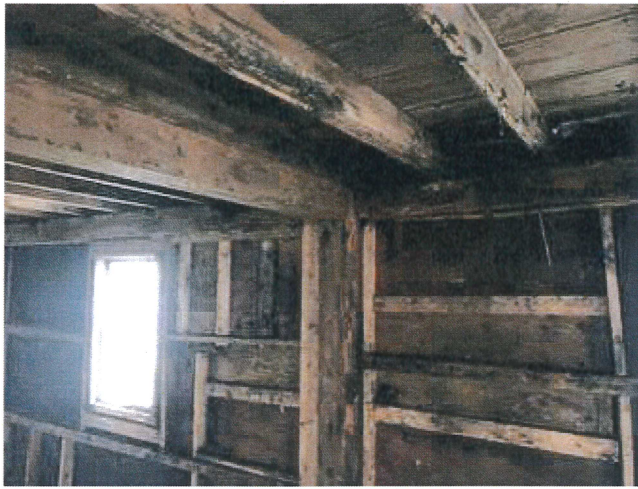
Significant damage is present in the top plate of the south eave wall. Pressure treated 4 x 4 lumber replaces rotten roof rafters and new sheathing is in place. This area will be taken apart and the top plate repaired with in kind timber. Roof rafters will match original fabric and the sheathing can also match original fabric.

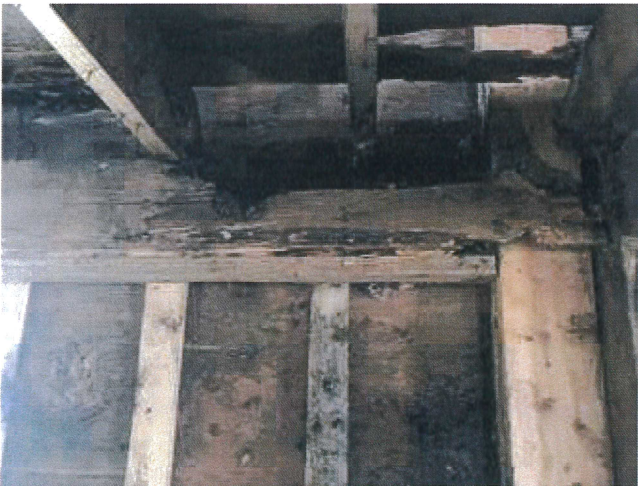
The center bays along the south wall are deteriorated and since repaired with inappropriate materials. This will all be opened up and the timber frame repaired correctly with matching materials.

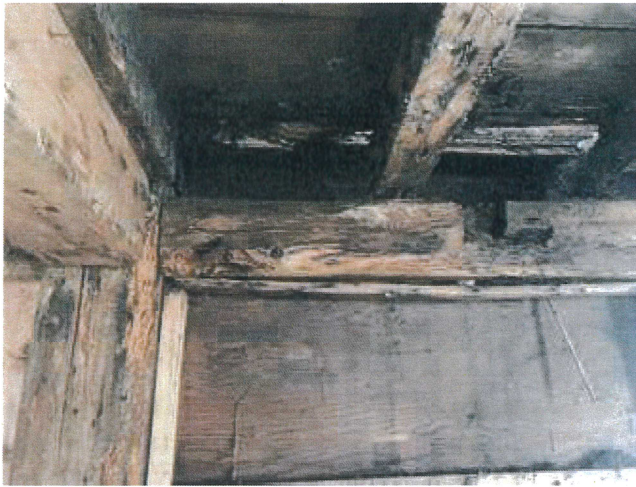
Extensive water penetration has caused significant rot in the South wall. Much of the center of this wall will be rebuilt with new in kind timbers to match the original form of the barn. Dimensional lumber currently in place will be removed.
