Appledore Marine Engineering Inc.

Re: Prescott Park Waterfront Inspection – Letter Report
Location: Portsmouth, New Hampshire
Appledore Project No. 5122

PRESCOTT PARK PORTSMOUTH, NH FIG. NO.
WATERFRONT CONDITION PLAN 1

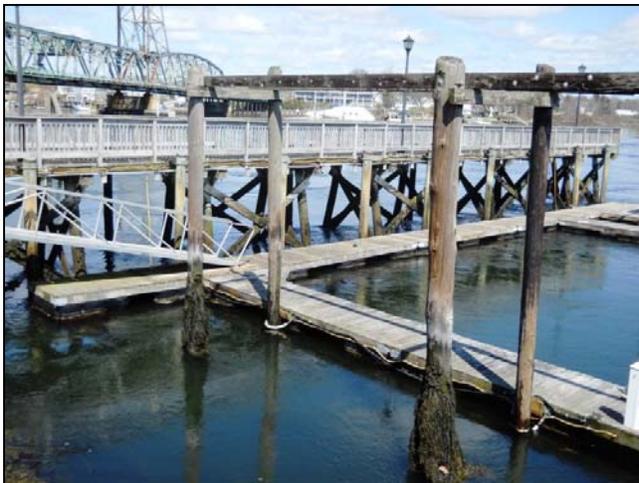
The 1999 vintage North Pier is in Satisfactory condition with deterioration primarily limited to marine borer damage to the lower pile bracing connections located below Mean Low Water (MLW). It is estimated that the North Pier has 30 years of service life remaining, assuming it is repaired and maintained. The majority of the bracing members exhibited marine borer damage with deterioration ranging from 10% up to 90% at the lower connection. The piles, pile caps, stringers, decking, and railing were all found to be in satisfactory condition with only minor signs of deterioration. It is recommended to replace the timber bracing within 5 years.

Photo 1: North Pier and North Dock

| Structure | Engineering Assessment Rating ¹ | Estimated Remaining Service Life (years) ² | Repair Priority ⁵ | Repair Recommendations ³ | Estimated Budget Amount ⁴ |
|--|--|---|---|--|---|
| North Pier | Satisfactory | 30 | Near Term | • Replace deteriorated timber bracing | \$1,700 |

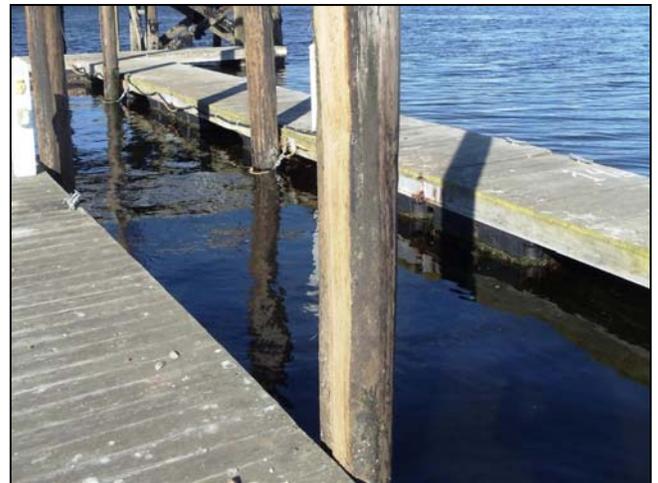
The North Dock is of unknown vintage and is found to be in Fair condition. It is estimated that the timber docks have 5-10 years of service life remaining. Of the 27 timber guide piles, 4 were found to have abrasion loss within the tidal zone ranging from 15% to 30% and one pile was found to have 75% section loss at the mudline due to marine borer activity. The chain pile guides have failed in two locations and the gangway, floats, and mooring hardware were found to be in Satisfactory condition. It is recommended to replace one pile and monitor the deterioration in the remaining guide piles and plan to replace them within 3 years. The two failed chain pile guides and the severely deteriorated guide pile should be replaced prior to the next boating season.

Photo 2: Typical Abrasion Damage to Guide Pile at North Dock

| Structure | Engineering Assessment Rating ¹ | Estimated Remaining Service Life (years) ² | Repair Priority ⁵ | Repair Recommendations ³ | Estimated Budget Amount ⁴ |
|--|--|---|---|--|---|
| North Dock | Fair | 5-10 | Near Term | • Replace deteriorated timber guide piles (4 total) | \$9,600 |
| | | | Immediate | • Replace two broken chain pile guides | \$350 |
| | | | Immediate | • Replace 1 deteriorated guide pile | \$2,400 |

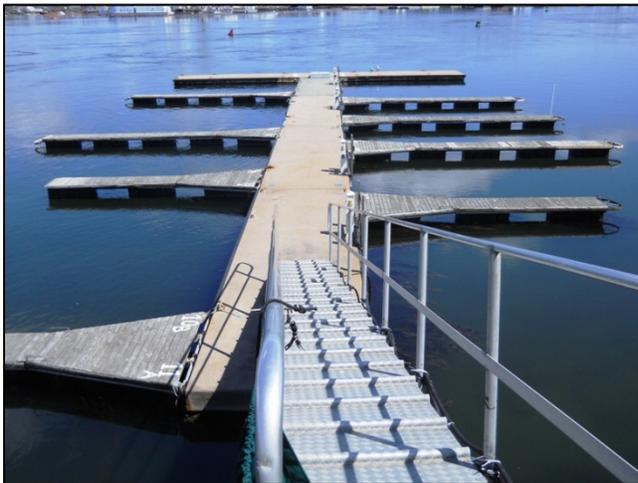
The South Dock has a long history of repeated failure, primarily relating to the connections between the concrete float modules. Overall the dock is in Serious condition with several of the float modules maintained in operation through the use of temporary repairs. The dock is at the end of its service life and should be replaced as soon as possible. The gangway is in Satisfactory condition but should be considered for replacement when the new floats are installed. The mooring blocks used to anchor the dock were found to be in Satisfactory condition and should be considered for re-use (mooring chain to be replaced).

Photo 3: South Dock

| Structure | Engineering Assessment Rating ¹ | Estimated Remaining Service Life (years) ² | Repair Priority ⁵ | Repair Recommendations ³ | Estimated Budget Amount ⁴ |
|--|--|---|---|--|---|
| South Dock | Serious | 0-1 | Immediate | • Replace dock and gangway | \$385,000 |

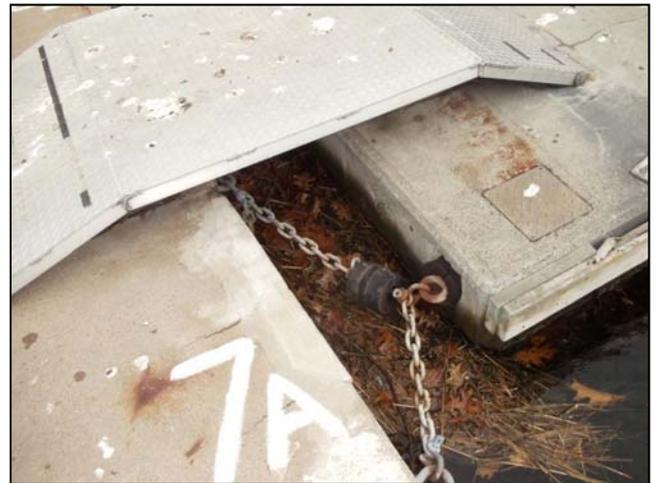
Photo 4: Temporary repair to float module connection at T-head

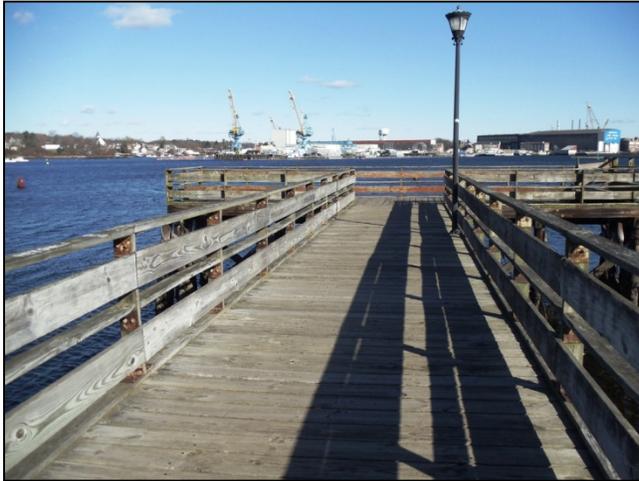
The T-Head was overall found to be in Fair condition. The piles, bracing, pile caps and stringers were found to be in Satisfactory condition with only minor signs of deterioration. The timber decking and railing exhibited moderate fungal decay and should be replaced within 5 years. It is estimated that the T-Head Pier has 20 years of service life remaining, assuming it is repaired and maintained.

Photo 5: T-Head Pier

| Structure | Engineering Assessment Rating ¹ | Estimated Remaining Service Life (years) ² | Repair Priority ⁵ | Repair Recommendations ³ | Estimated Budget Amount ⁴ |
|--|--|---|---|--|---|
| T-Head Pier | Fair | 20 | Deferrable | • Replace decking and railing | \$54,000 |

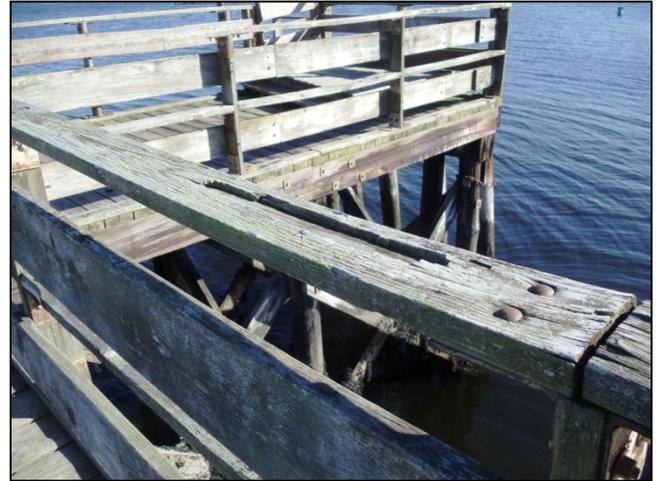
Photo 6: Typical Fungal Decay on Railing

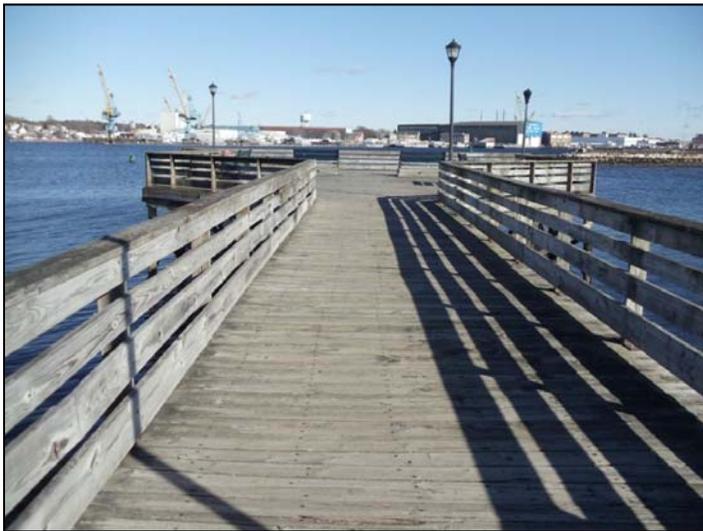
The South Pier was found to be in Fair condition. The piles, bracing, pile caps and stringers were found to be in Satisfactory condition with only minor signs of deterioration. One failed bracing member was found on the eastern face of the South Pier and the fender piles along the north face were all found to have severe fungal decay and to be in Poor condition. The fender piles provide a berthing face for vessels and should be replaced only if the intent is to restore future berthing capabilities to the pier. It is recommended to replace the failed bracing member within the next 5 years and it is estimated that the structure has 20 years of service life remaining, assuming it is repaired and maintained.

Photo 7: South Pier

| Structure | Engineering Assessment Rating ¹ | Estimated Remaining Service Life (years) ² | Repair Priority ⁵ | Repair Recommendations ³ | Estimated Budget Amount ⁴ |
|--|--|---|---|--|---|
| South Pier | Fair | 20 | Near Term | • Replace failed bracing | \$24,000 |
| | | | Near Term | • Replace fender piles if berthing capability is to be restored | \$12,000 |

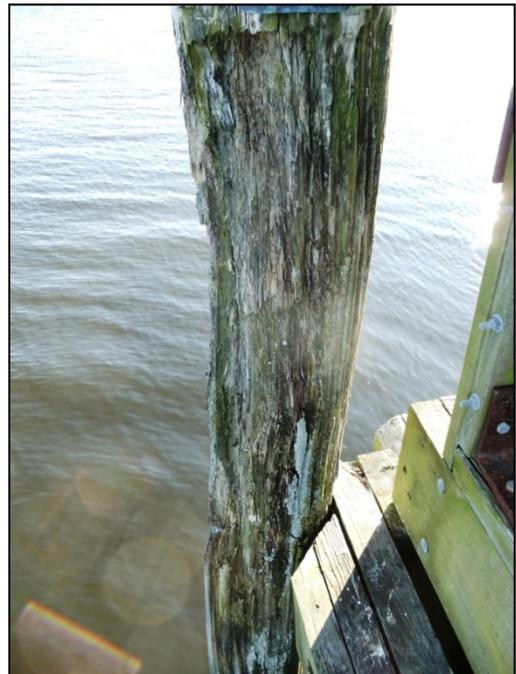
Photo 8: Typical deteriorated fender pile on South Pier

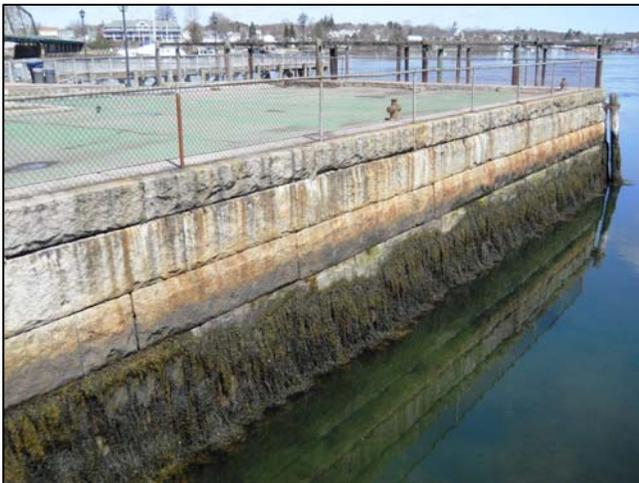
The quaywalls are generally found to be in Satisfactory condition. The 2005 repairs in the vicinity of the floating docks are intact and in satisfactory condition. It is estimated that the quaywalls have 50 years of service life remaining, assuming they are repaired and maintained. Evidence was found of past sinkhole repairs behind the quaywall, however no significant additional subsidence was found during inspection. One 6 ft. by 4 in. area of missing chinking and mortar was found in the quaywall near the T-Head Pier (see attached plan for location) and should be re-pointed within the next 5 years. No missing or displaced stones or significant subsidence behind the walls were observed. The fencing along the top of the quaywalls was not included in this inspection.

Photo 9: Quaywall at Basin Looking North

| Structure | Engineering Assessment Rating ¹ | Estimated Remaining Service Life (years) ² | Repair Priority ⁵ | Repair Recommendations ³ | Estimated Budget Amount ⁴ |
|--|--|---|---|--|---|
| Quaywall | Satisfactory | 50 | Near Term | • Chink and re-point 6 ft portion of joint as indicated on drawing | \$6,000 |

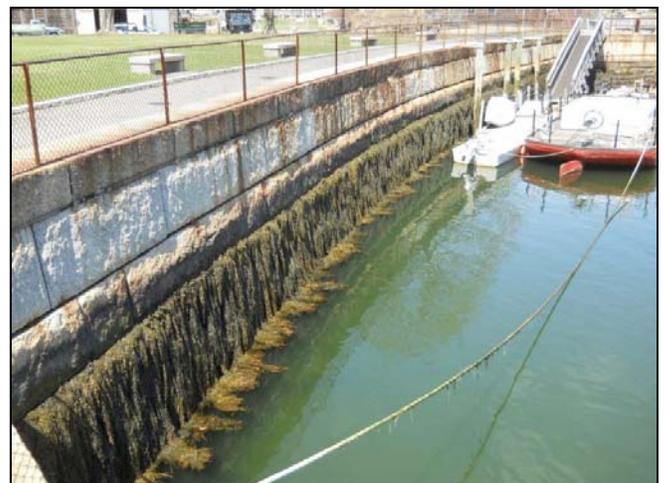
Photo 10: Quaywall at Southern End of Park

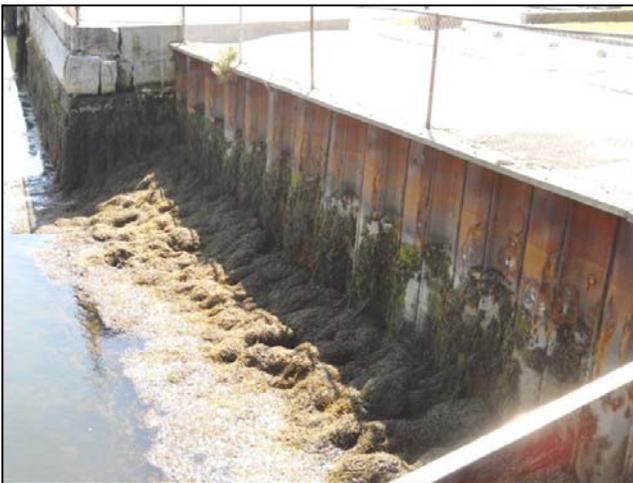
At the north end of the park, an approximately 90 ft long section of sheet pile bulkhead is found in the vicinity of the North Pier. Approximately 6 ft of the sheeting is exposed at low water with riprap toe protection extending to the mudline below.

The exposed portions of steel sheeting on both bulkheads exhibit moderate surface corrosion and no coating was found. No holes or significant corrosion scale were observed and ultrasonic measurements of the steel thickness indicates that the sheet piles have a nearly full section. The riprap toe protection in front of the sheet pile is intact with no observed missing or displaced stones. It is estimated that the steel sheet pile bulkhead has 20 years of service life remaining and it is recommended to recoat the exposed portions of both sections of sheet pile within the next 5 years.

Photo 11: Steel sheet pile bulkhead at North Pier

| Structure | Engineering Assessment Rating ¹ | Estimated Remaining Service Life (years) ² | Repair Priority ⁵ | Repair Recommendations ³ | Estimated Budget Amount ⁴ |
|--|--|---|---|--|---|
| Sheet Pile Bulkhead | Satisfactory | 20 | Deferrable | • Re-coat exposed steel | \$30,000 |

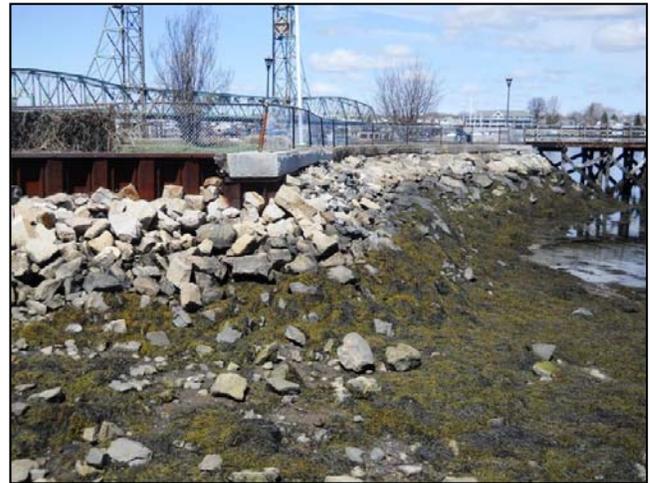
Between the T-Head Pier and the South Pier, there is an approximately 80 ft long section of sheet pile bulkhead with a riprap slope outboard of the wall. Approximately 2ft of the sheeting is exposed above the riprap, which extends above Mean High Water.

Photo 12: Steel sheet pile bulkhead south of T-Head Pier

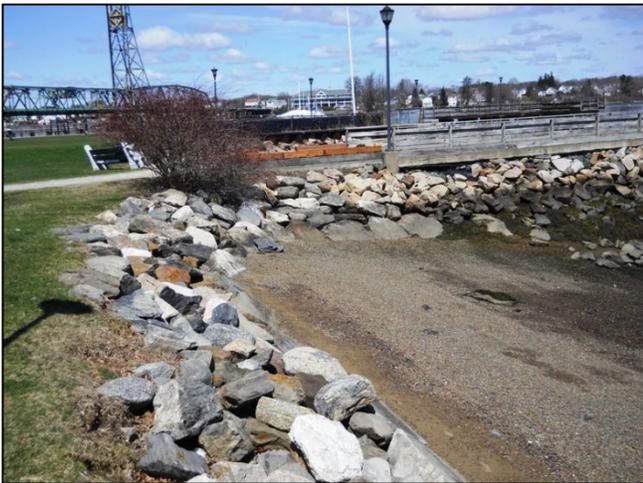
Approximately 535 ft of riprap protected shoreline is located the vicinity of the T-Head and South Piers where it serves to support and protect the pier approaches, abutments and adjacent beach areas. On Four Tree Island, approximately 1,500 ft of riprap shoreline protects the walkway to the island and the exposed northern shoreline.

Photo 13: Riprap slope at South Pier

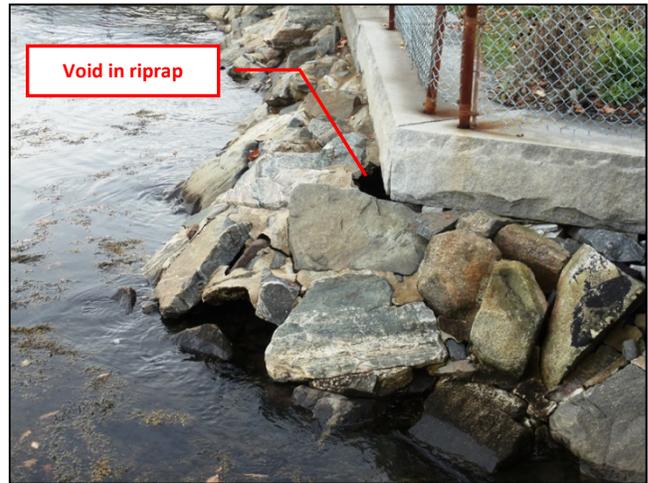
In 2005, repairs were made to replace missing or displaced stones and repair undermining of the South Pier approach. The repairs were generally found to be intact, however one area of undermining was found at the eastern end of the T-Head Pier where an approximately 3 ft x 3 ft x 1 ft void exists beneath the corner capstones. It is recommended to use a cementitious grout to fill and seal the void in order to prevent further erosion and possible displacement of the capstones.

Photo 14: Void in riprap at South Pier abutment

| Structure | Engineering Assessment Rating ¹ | Estimated Remaining Service Life (years) ² | Repair Priority ⁵ | Repair Recommendations ³ | Estimated Budget Amount ⁴ |
|--|--|---|---|--|---|
| Riprap Shoreline | Satisfactory | 30 | Near Term | • Repair void in riprap near T-Head Pier abutment | \$4,500 |
