PORTSMOUTH IDDE | REPORT

TO: Terry Desmarais & Ray Pezzullo, City of Portsmouth
FROM: Laura Diemer, FB Environmental Associates
SUBJECT: **Portsmouth IDDE Summary Report for Marcy St/Prescott Park**
DATE: May 10, 2017
CC: Forrest Bell, FB Environmental Associates

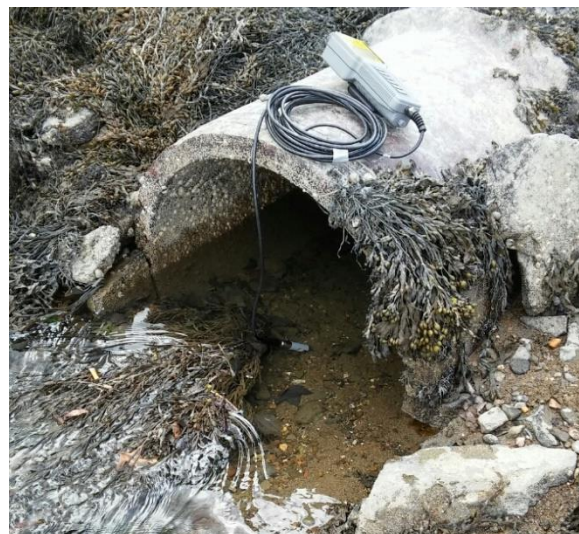
OF 12564 sampled on 5/3/2017. Photo: FBE.

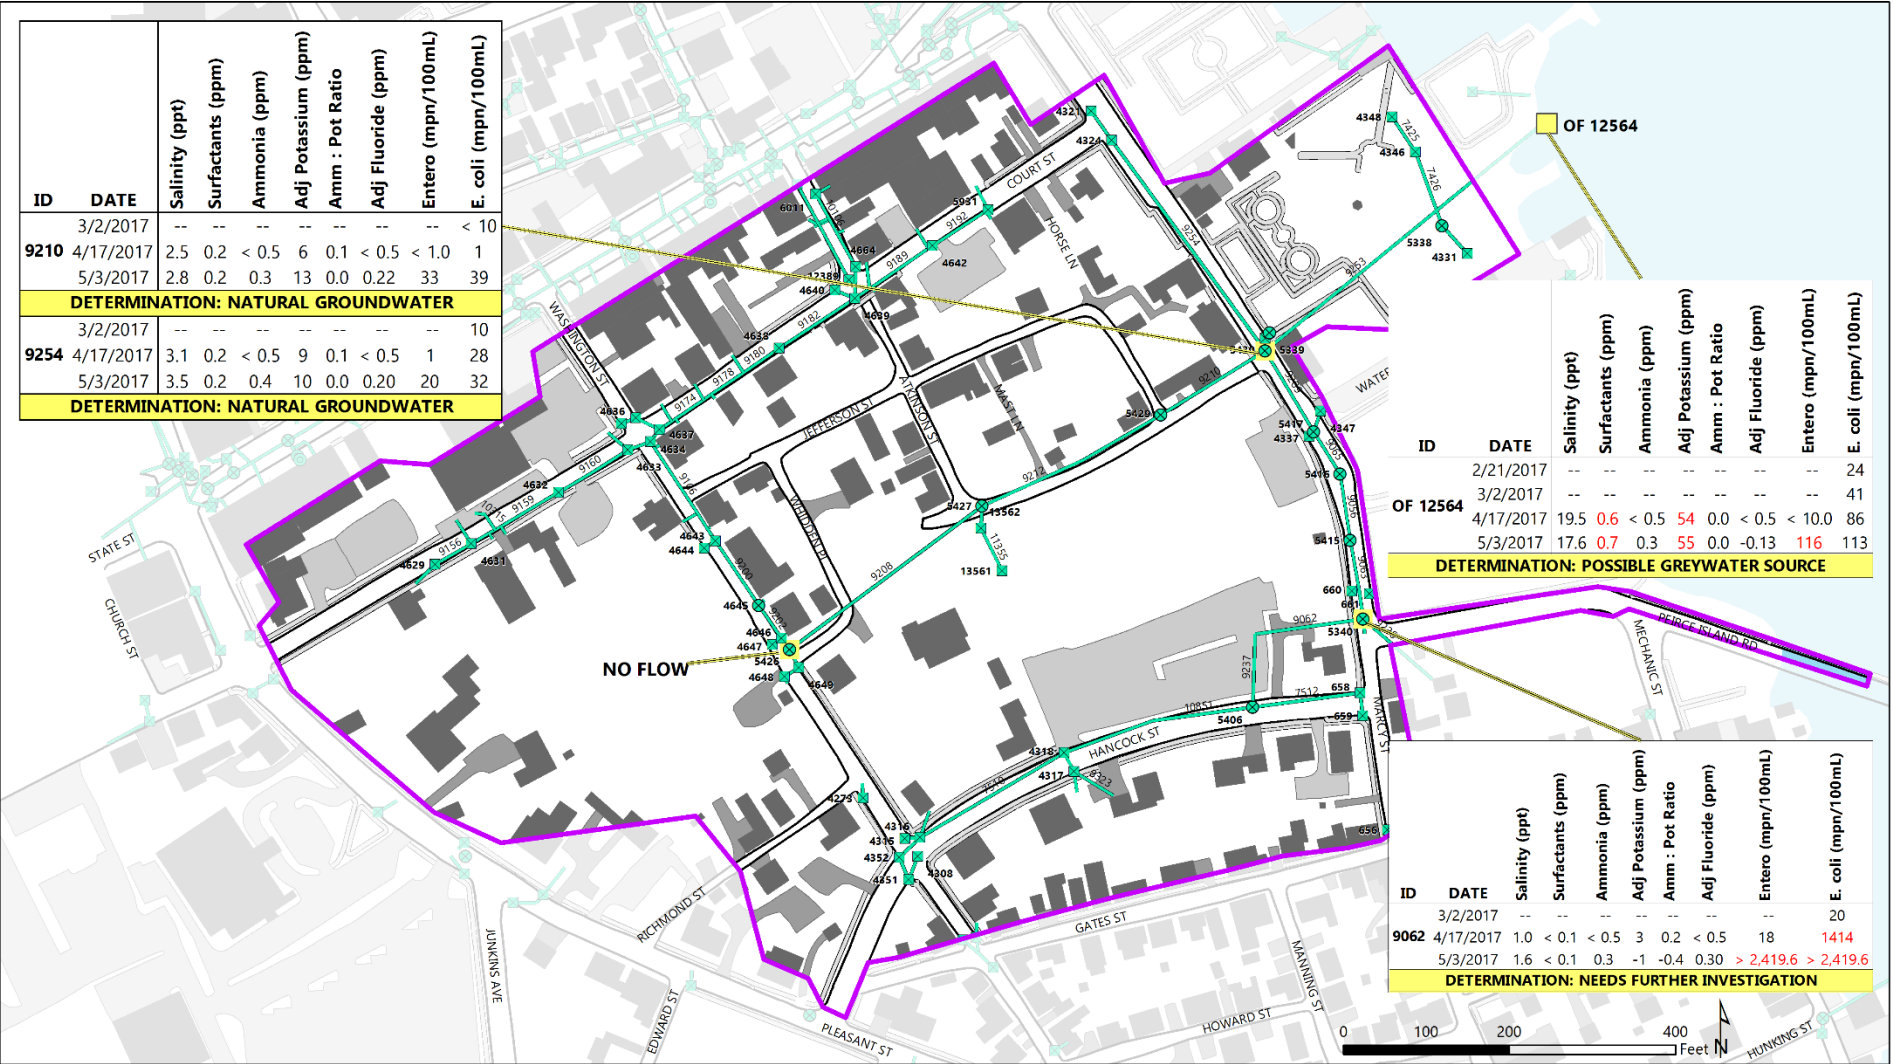
Figure 1. Map of sampling locations and results.

Overall, results showed no indication of sewage contamination within the drainage area to OF 12564 (Figure 1; Table 3). CCTV line inspections by City staff on 3/7/17, 3/17/17, 3/20/17, and 3/21/17 also showed no indication of line breaks or points of possible contamination (Figure 2; Appendix C). The outfall itself showed elevated levels of surfactants, potassium, and chlorine, which suggests a possible greywater source; however, the relatively low readings for surfactants, potassium, and chlorine indicate that the possible greywater source was minor and was likely from one or two small, non-commercial buildings or from surface runoff. Elevated fecal indicator bacteria were also measured at inlet pipe 9062 on Marcy Street, which drains Hancock Street. Since the other indicator parameters were low and did not signify sewage or greywater contamination, elevated fecal indicator bacteria alone likely does not constitute a sewage contamination. Bacteria can proliferate on sediment, which was observed during CCTV line inspections; thus, the high bacteria counts were likely from regrowth within the stormwater pipe.

- Sediment within the pipes feeding to inlet pipe 9062 should be cleaned out and the manholes at and upstream of inlet pipe 9062 should be resampled for all indicators. If fecal indicator bacteria (along with the other indicators) come back low and within acceptable limits, then we can determine that the source of flow to inlet pipe 9062 is natural groundwater.
- OF 12564 showed a possible greywater source, which should be followed up with upstream source identification.
