# CITY OF PORTSMOUTH SEAWALL INSPECTIONS

RFP# 49-07

PERFORMED BY  
**WATERFRONT ENGINEERS LLC**  
Stratham, New Hampshire

FOR  
**CITY OF PORTSMOUTH**  
Portsmouth, New Hampshire

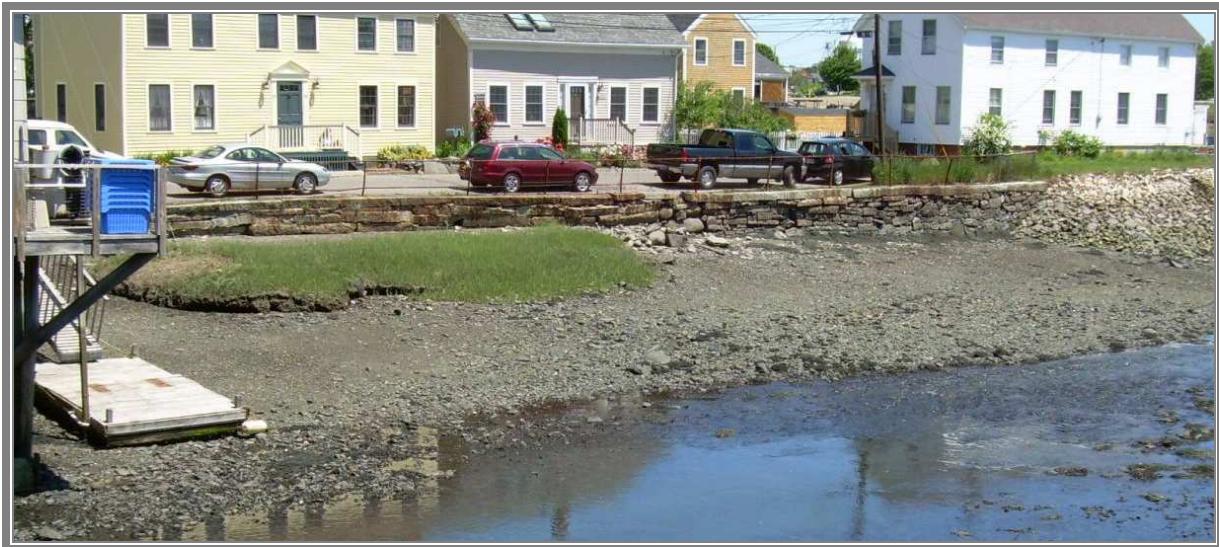
**PHOTO 1** Overall view of South Mill St Seawall.

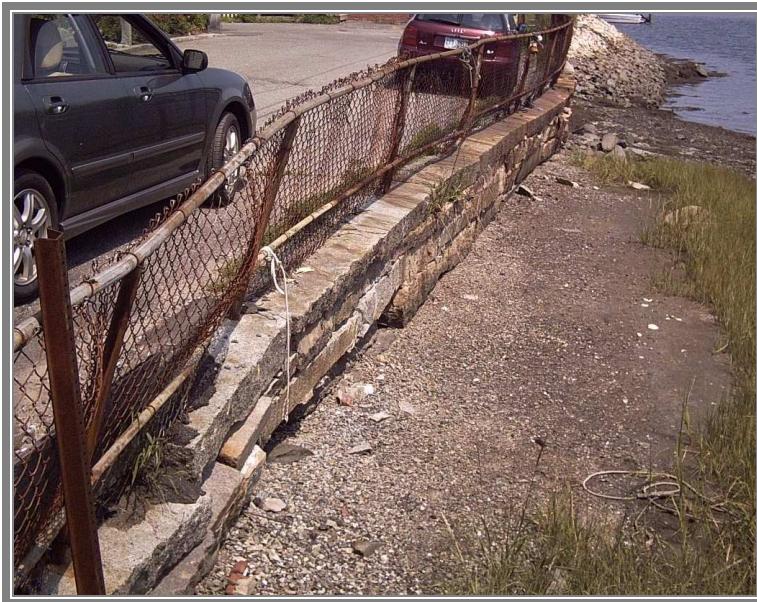
Basic plumb bob checks along the wall did show that the face of the wall is leaning offshore to varying amounts, up to -2 Horizontal to 12 Vertical. The scope of this investigation did not include subsurface excavation to measure wall thickness; however the observation of the wall leaning offshore does suggest the wall may not have adequate thickness to act as a gravity wall under the present street loading with an adequate factor of safety. This is a fairly typical occurrence in New England when stone retaining walls originally built at a time when street traffic was horses and wagons, may now be subjected to 80,000 lbs truck loading.

**PHOTO 2** South Mill St Seawall looking east – note wall bulge and lean offshore.

Based on these observations, it is recommended that this wall be rebuilt on a priority basis. Since this seawall is located in the city historic district, it is expected that the replacement seawall will need to be rebuilt using stone, in a manner consistent with historical seawalls in this area. An engineers opinion of probable construction cost has been prepared for a replacement stone seawall, assuming adequate bearing capacity soils are found below the existing wall to utilize a concrete spread footing and that a pile foundation will not be required. Due to the proximity of the intertidal and salt marsh resource areas, it is also expected that the replacement wall will need to be built along the existing alignment with no additional encroachment seaward, thus requiring removal of the existing wall. Since South Mill Street is narrow and in a low traffic neighborhood, we have assumed that the street will be closed to traffic during the excavation and wall reconstruction. We did note that much of the existing wall stone is small or of poor quality and therefore have assumed the existing stone can only be reused for 50% of the new wall construction(to proper thickness) and imported stone will be needed. Other cost items include vehicular guard rail to meet modern design standards and a

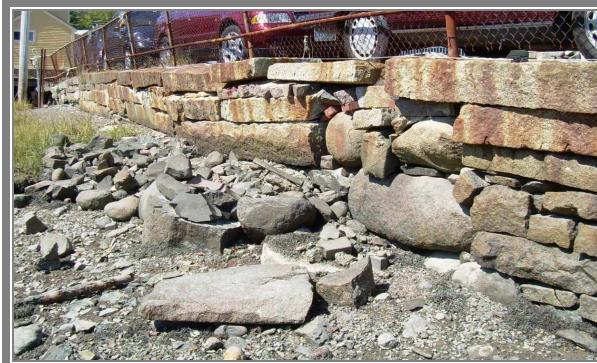
**PHOTO 3 (left)** South Mill St Seawall looking west – note wall leaning offshore.

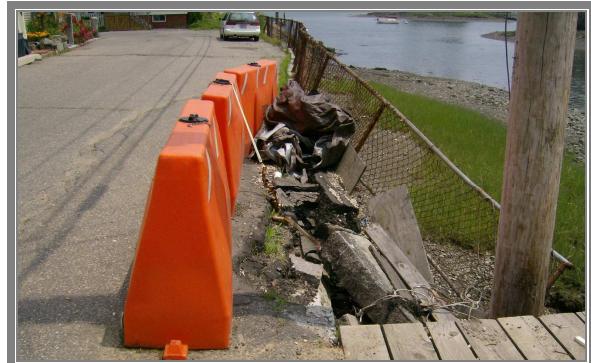
**PHOTO 4 (right)** South Mill St Seawall collapse area at western end.

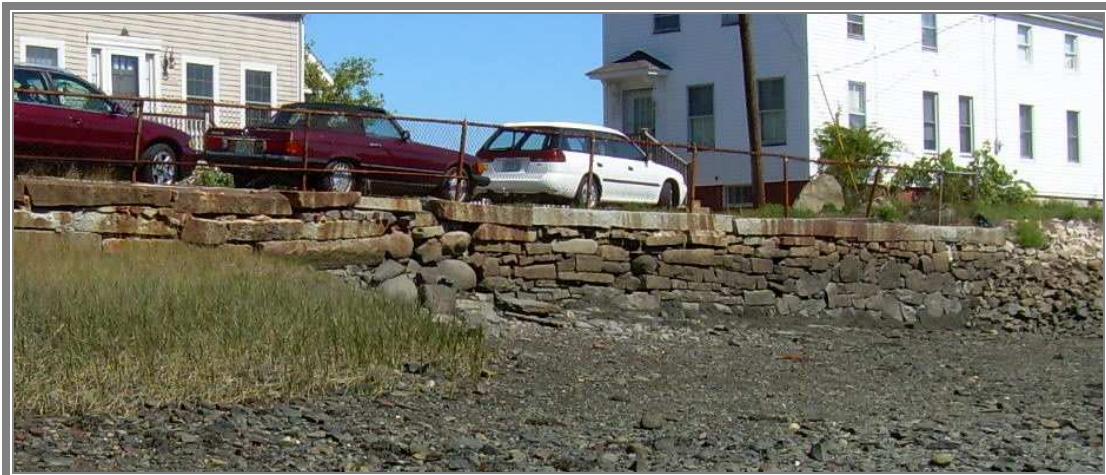
PHOTO 5 South Mill St Seawall eastern end.

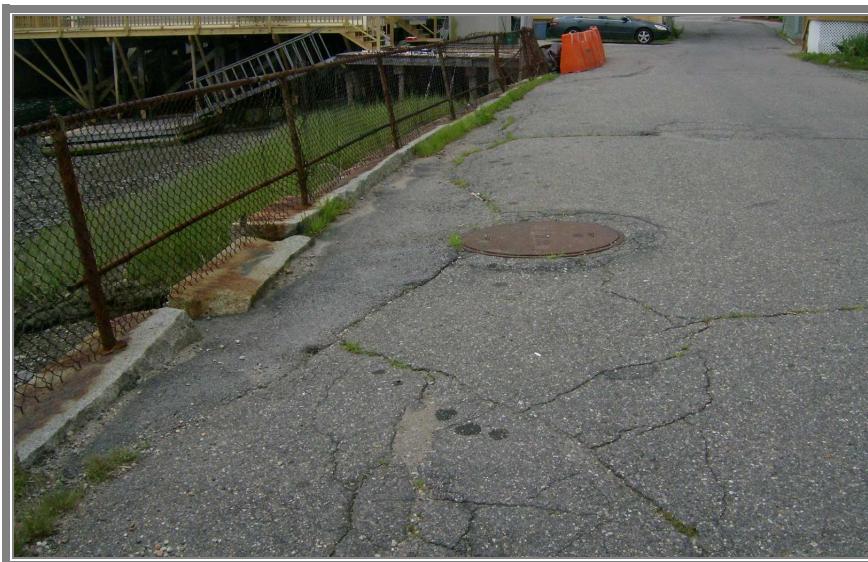
PHOTO 6 South Mill St Seawall – note sewer manhole close to wall.

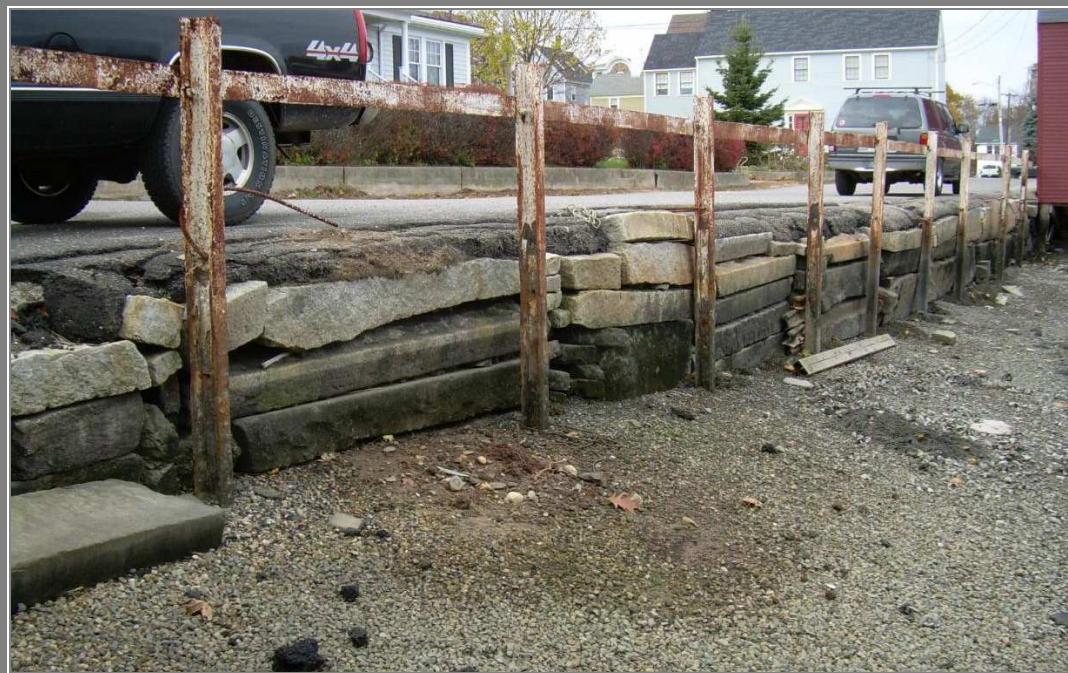
PHOTO 7 Mechanic St Seawall.

Based on these observations, it is recommended that this wall be rebuilt. Since this seawall is located in the city historic district, it is expected that the replacement seawall will need to be rebuilt using stone, in a manner consistent with historical seawalls in this area. An engineers opinion of probable construction cost has been prepared for a replacement stone seawall, assuming adequate bearing capacity soils are found below the existing wall to utilize a concrete spread footing and that a pile foundation will not be required. Due to the proximity of the intertidal resource area, it is also expected that the replacement wall will need to be built along the existing alignment with no additional encroachment seaward, thus requiring removal of the existing wall. Since Mechanic Street is narrow and in a low traffic neighborhood, we have assumed that the street will be closed to traffic during the excavation and wall reconstruction. We have assumed the existing stone can only be reused for 50% of the new wall construction (to proper thickness) and imported stone will be needed. Other cost items include vehicular guard rail to meet modern design standards and a steel picket fence designed to meet current building code guard requirements and historical district aesthetic standards. An engineers opinion of probable construction cost has been prepared for these recommended repairs and the estimate including allowances for subsurface soil investigation, design engineering, bid document preparation and construction phase services, for the wall replacement is expected to cost on the order of \$137,000 and take approximately 5 weeks to complete after permits and the construction contract are awarded (street closure time will be less). The costs for environmental permitting and permit fees have been excluded as these services may be provided by City staff and the permit fees due the state are not known at this time.

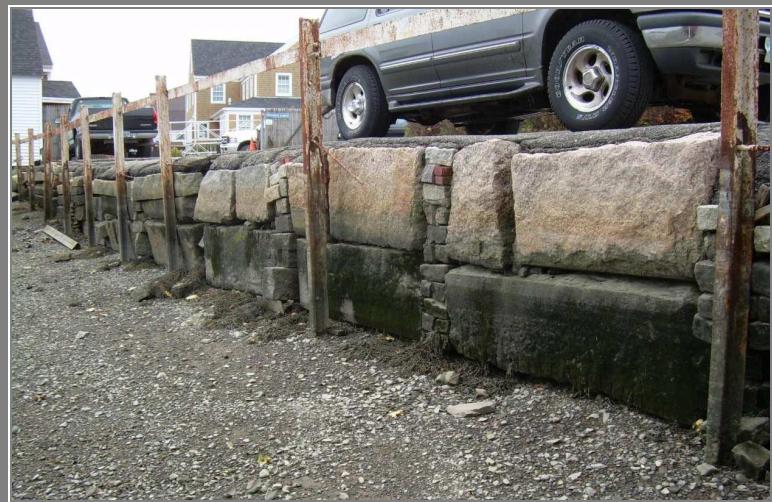
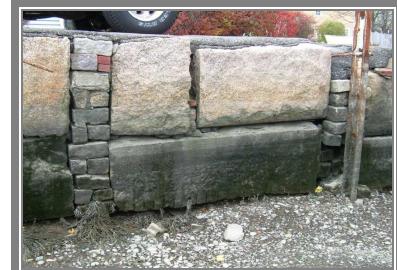
The wall is of unusual construction, using former granite curbing and granite blocks, stacked vertically without overlap interlocking and with discrete vertical joints filled with cobblestones.

PHOTO 8 A&B Mechanic St Seawall – note unusual vertical joint construction

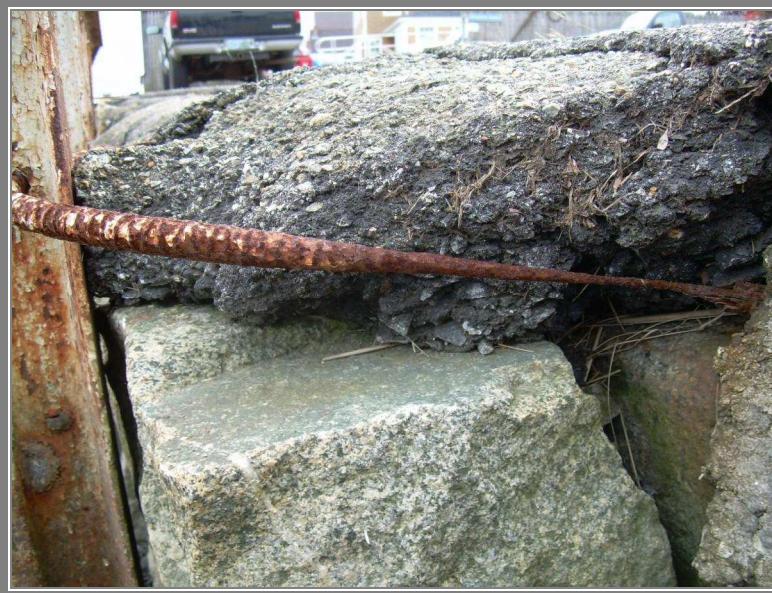
This wall does include vertical railroad rail posts that are tied-back with bent rebar tie-rods, however the tie-rods are severely corroded where they enter the backfill and some are completely failed.

PHOTO 9 Mechanic St Seawall – severely corroded tie-rods

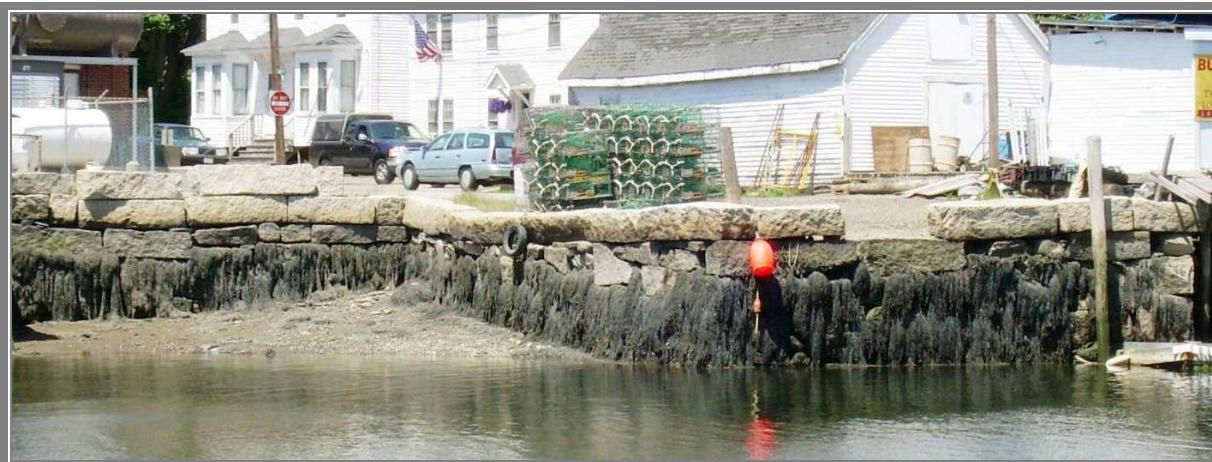
PHOTO 10 Mechanic St Pump Sta. Seawall – note missing cap stone to the right of the orange buoy – outfall is to the left of the orange buoy.

The outer section of wall parallel to the channel is missing a cap stone at the southeastern corner of the wharf area, and can be seen underwater. Since the loss of these cap stones does not appear to have been caused by wall instability, it is possible that this was caused by vehicle impact, by vandalism, or from boat mooring lines.

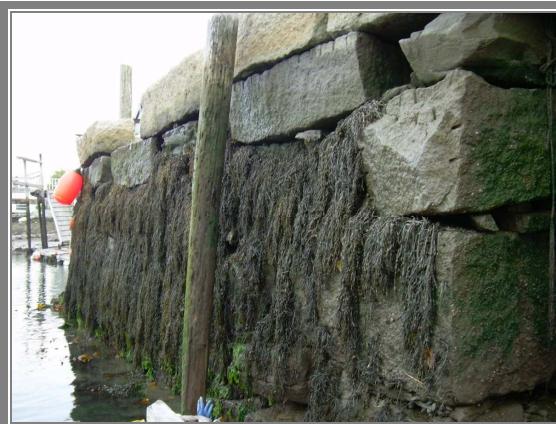
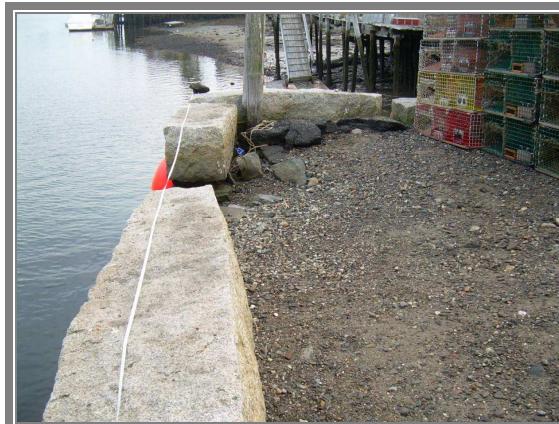
There is a relatively large shallow soil depression in this same corner, which appears to be caused by backfill washing out through the wall, which has large irregular joints in this area. A few of the rubble stone joints are open 2 to 6 inches (possibly due to lost chinking stones) and there are a few holes in the face of the wall below the lost cap stone including a hole 12"Wx18"Hx18"D and 14"Wx32"x50"D. There are also several bottom stones along this section of wall that appear to have rotated offshore.

PHOTO 11 A&B Mechanic St Pump Sta. Seawall – outer wall.

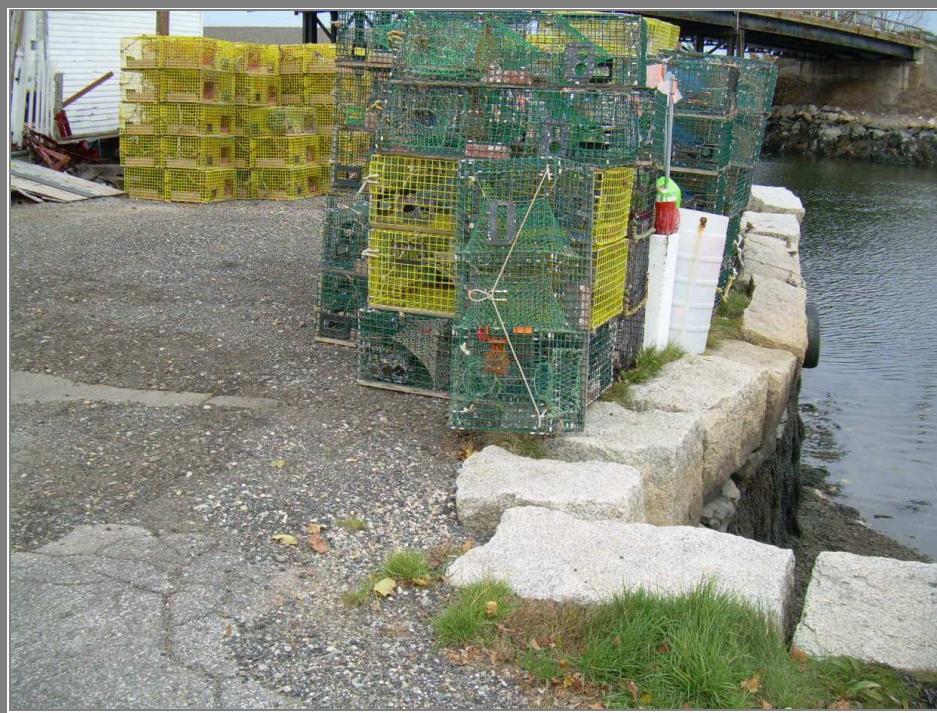
The section of wall perpendicular to the channel does have an obvious bulge mid length and is leaning offshore varying amounts, suggesting this section of wall is not stable. As this is close to the large outfall pipe, this could be related to soil movement during and following outfall construction, or soil loss associated with outfall water flow (if there are unsealed pipe joints or pipe breaks), or it could have been caused by wall overload by vehicles or the stacked lobster traps observed in this location. This section of wall also contains holes, with the largest hole about 6 feet from the outer corner, at the toe of

the wall measuring 24"Wx12"Hx22"D. Another hole near the inshore corner measures 18"Wx14"Hx30"D.

PHOTO 12 Mechanic St Pump Sta. Seawall – perpendicular wall with pronounced bulge.

Based on these observations, it is recommended that this wall be monitored to see if the observed wall movement is active, and at least the perpendicular section of wall should be rebuilt in the near term. The two sections of wall parallel with the channel also have signs of past movement and voids and should be repaired or these sections also be rebuilt. The soil behind the wall at the outer corner erosion area and in the area behind the bulging portion of wall were both observed to be wet from flooding at a time of spring high tides, so some additional backfill soil will be needed in these areas to restore backfill elevations. The relatively low level of this wall does indicate that the rebuilt seawall and backfill may need to be higher if periodic tidal flooding will be an issue with planned uses.
