# 179 PLEASANT STREET

HDC WORK SESSION #4 APPLICATION TO AMEND PREVIOUS APPROVAL: AUGUST 3, 2022

Structural Condition Assessment Connector, Barn and Carriage House Captain Thomas Thompson House 179 Pleasant Street Portsmouth, New Hampshire

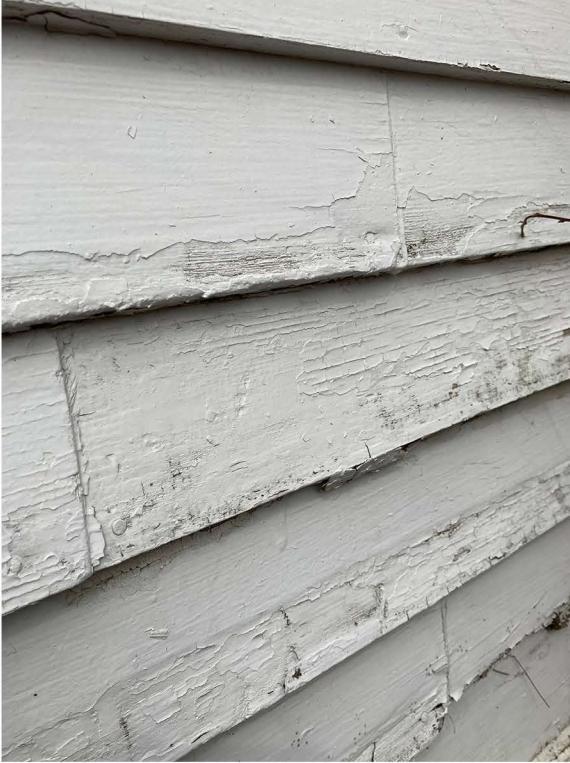
TYPICAL SIDING ROT

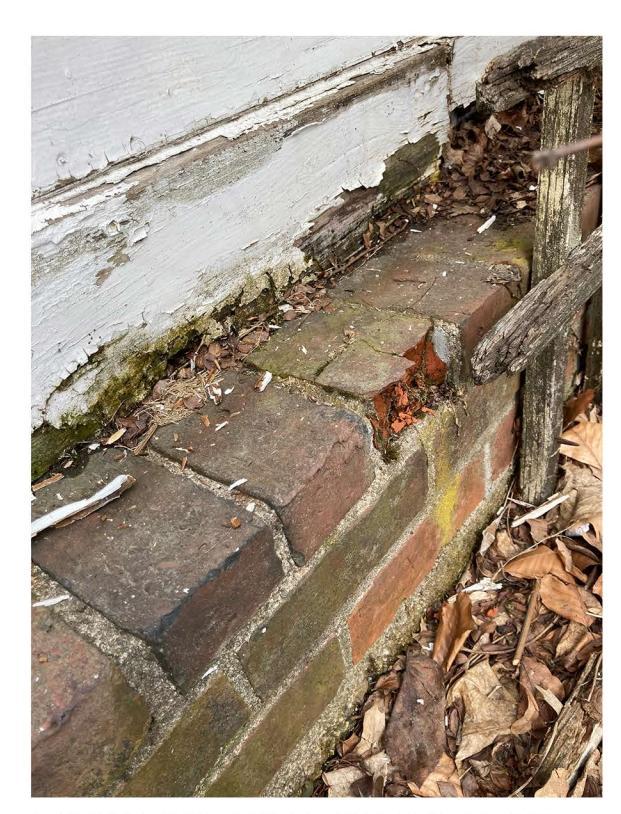
FOUNDATION SHELF AND ROT FROM STANDING WATER

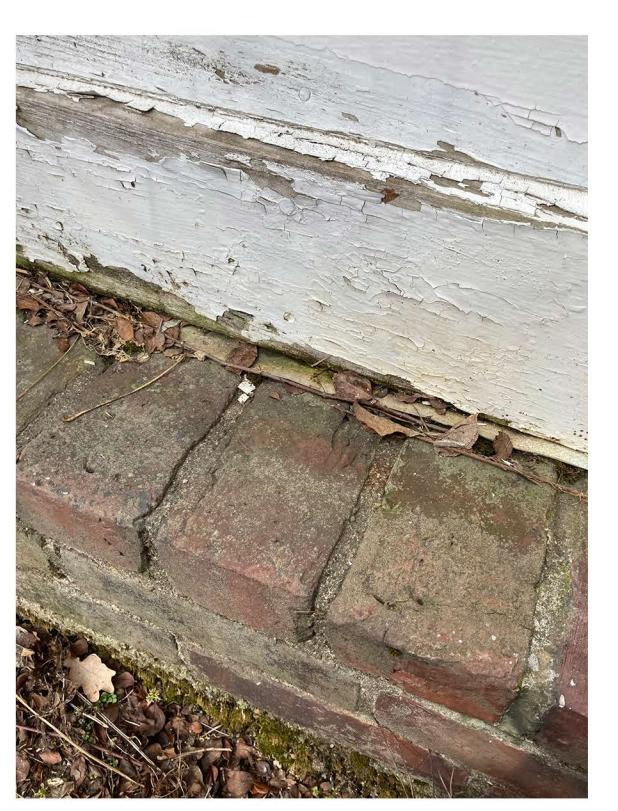
INSUFFICENT FLASHING

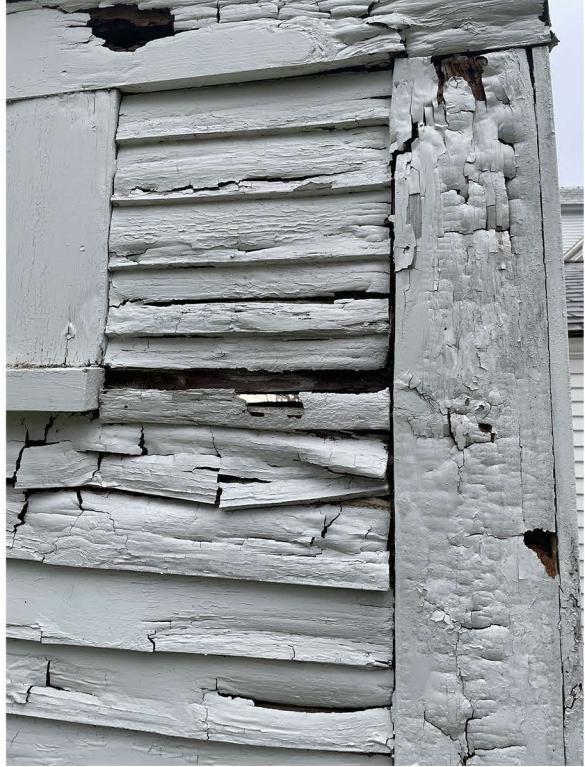
SIDING ROT AND INSUFFICENT FLASHING

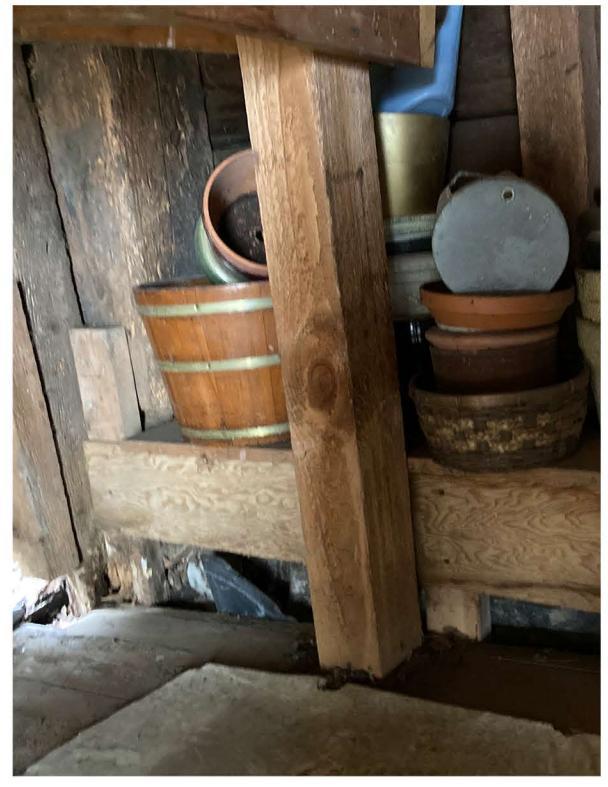
COMPROMISED STRUCTURE AT BASE

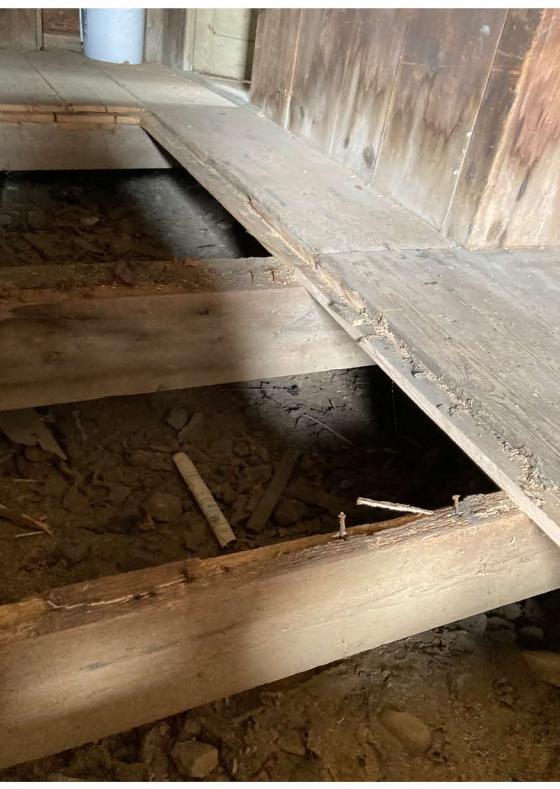
REPAIRS AT COMPROMISED STRUCTURE AT BASE

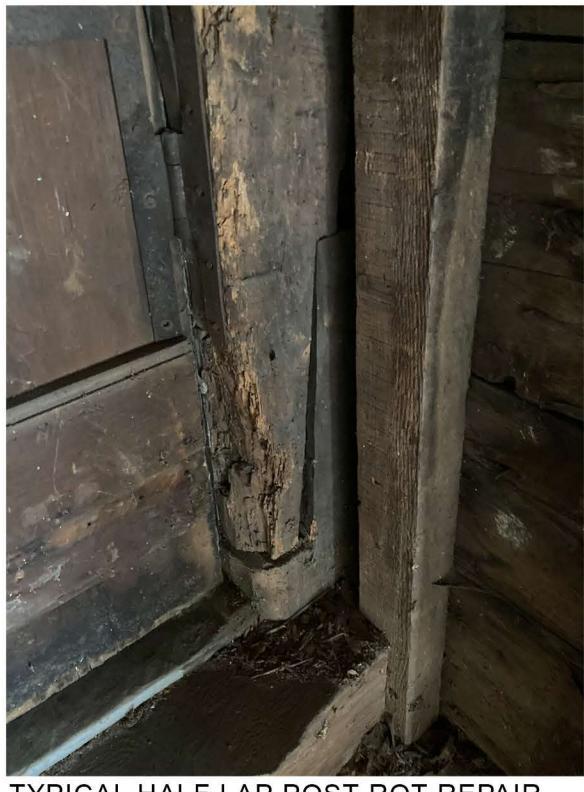
TYPICAL HALF LAP POST ROT REPAIR SEEN THROUGHOUT CONNECTOR

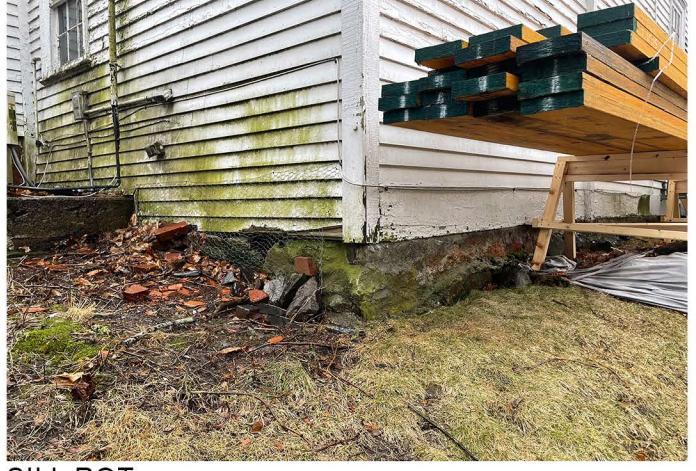
SILL ROT

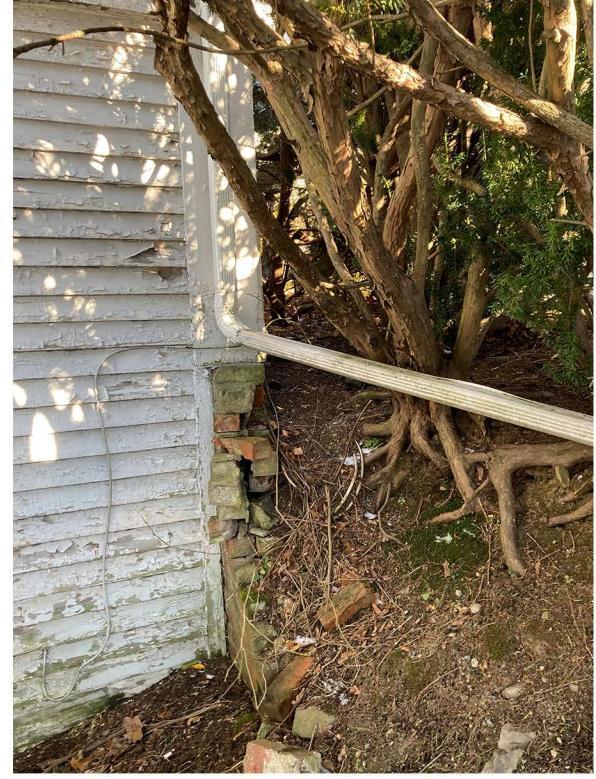
CRUMBLING FOUNDATION LACKING POSITIVE DRAINAGE

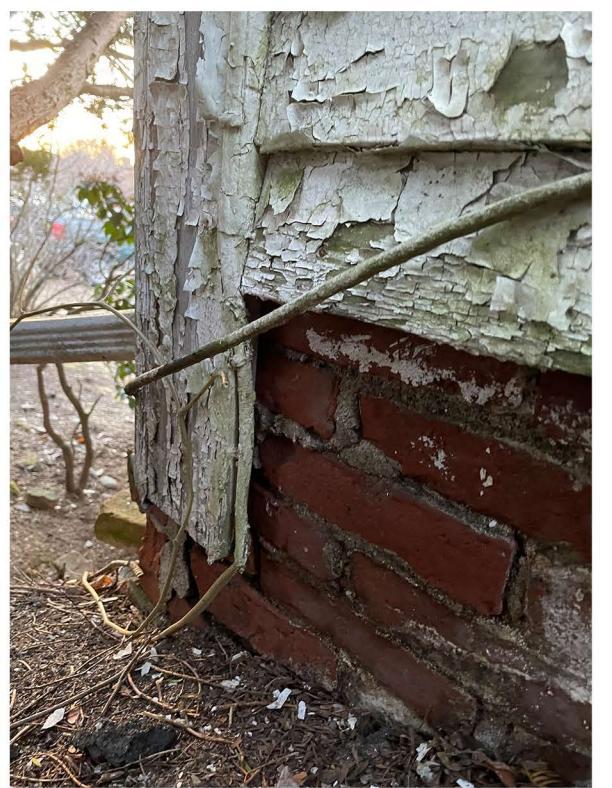
ROT FROM STANDING WATER

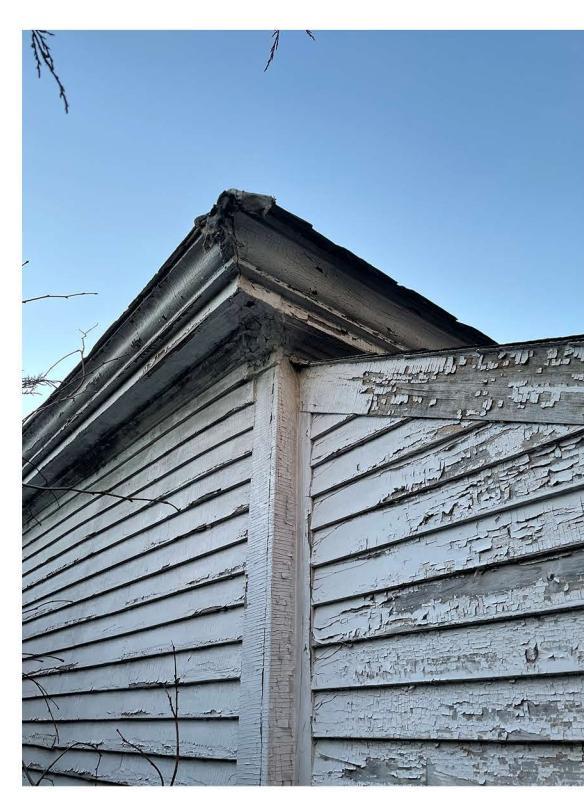
TYPICAL SIDING ROT

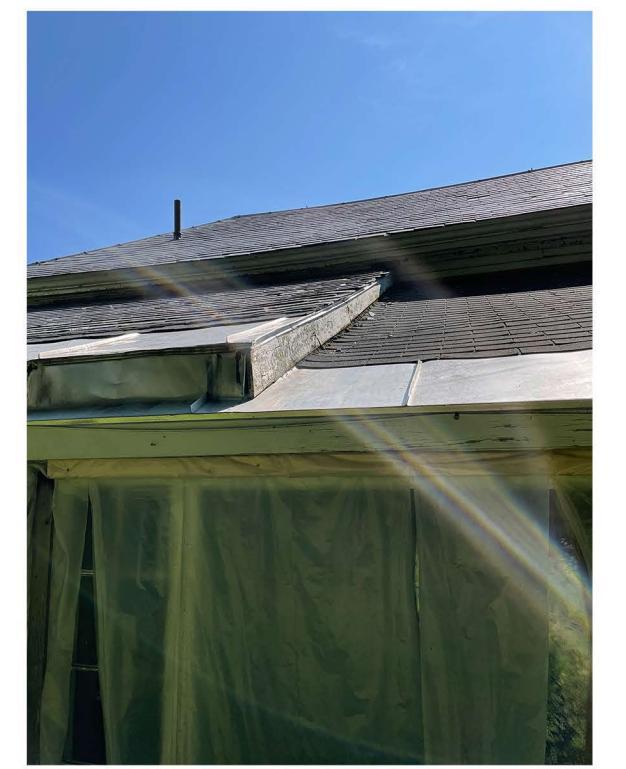
INSUFFICIENT ROOF FLASHING

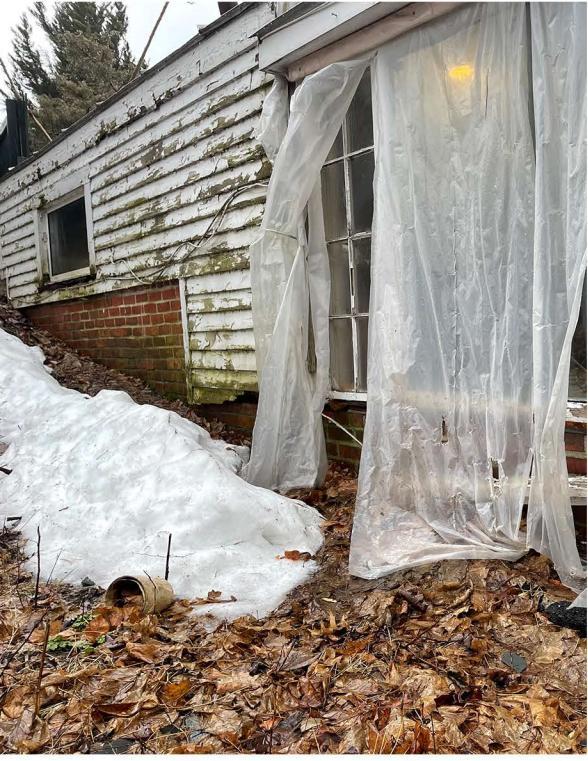
TYPICAL SIDING ROT AND FOUNDATION DAMAGE

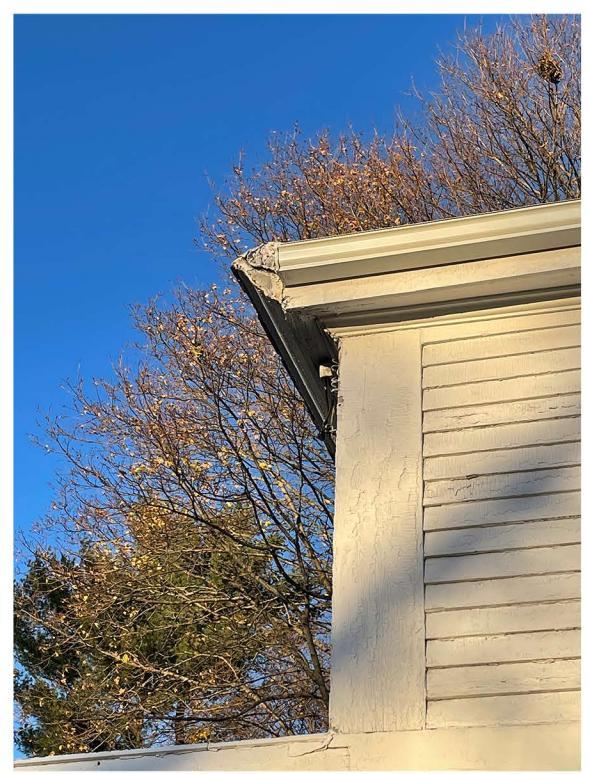
MODIFICATION OF ORIGINAL CORNICE TO INCLUDE GUTTER

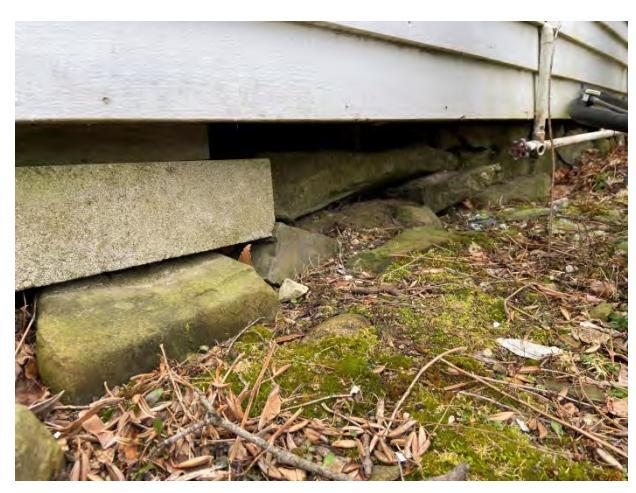
The connector foundation is made of loosely spaced stone supporting a timber plate. The exterior grade along the north side is about 1-foot below the top of the foundation wall. The exterior grade along the south side is approximately at the same elevation as the interior wood floor. Brick masonry cladding has been added along the outside face of the south wall in an attempt to provide some decay protection to the wall and timber sill. The top of this brick cladding is about 1-foot above the exterior grade and interior floor and covers decaying wall sheathing. (Images 1 - 5)

5-Connector foundation on north side

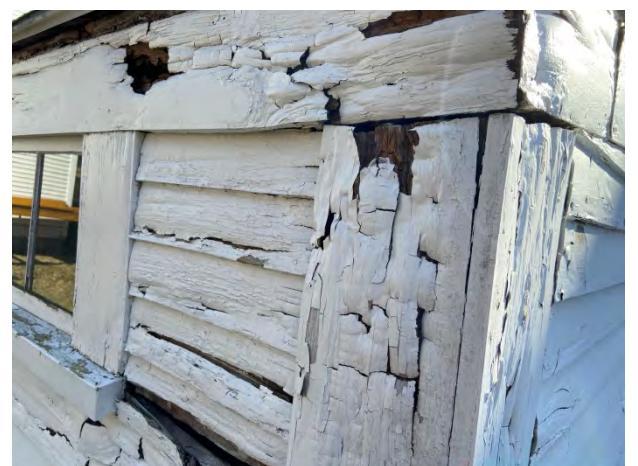
15-Barn decay damage

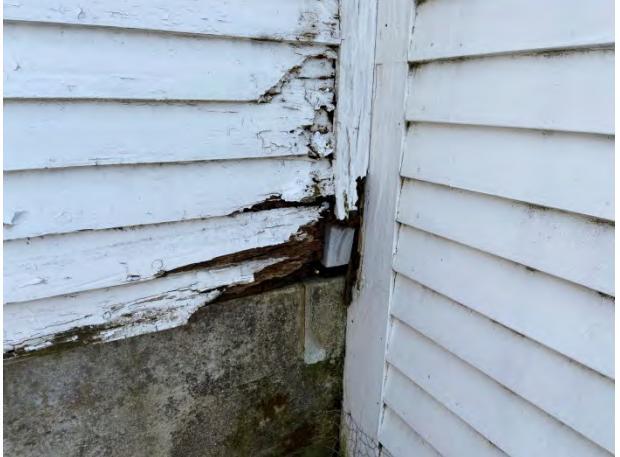
16-Barn decay damage

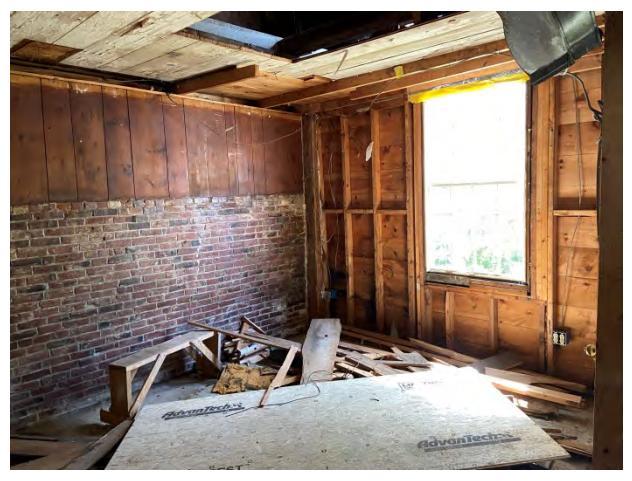
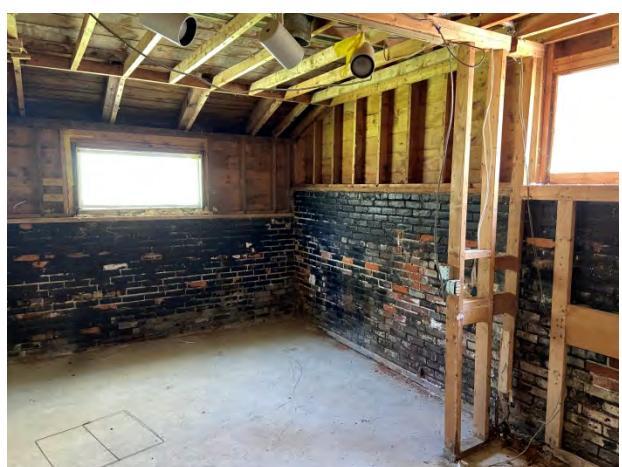
The first floor exterior walls along the front and right sides are framed with conventional 2x stud framing, similar to what we might see today, with pine board sheathing. My opinion is that these walls may have been constructed in the 1960s to 70s timeframe. The original posts along the front wall have been cut down to fit within the newer stud walls, and it was observed that the bases of some of the posts have been repaired. (Images 19 and 20)

19-Brick foundation and front wall framing

20-Brick foundation and side wall framing

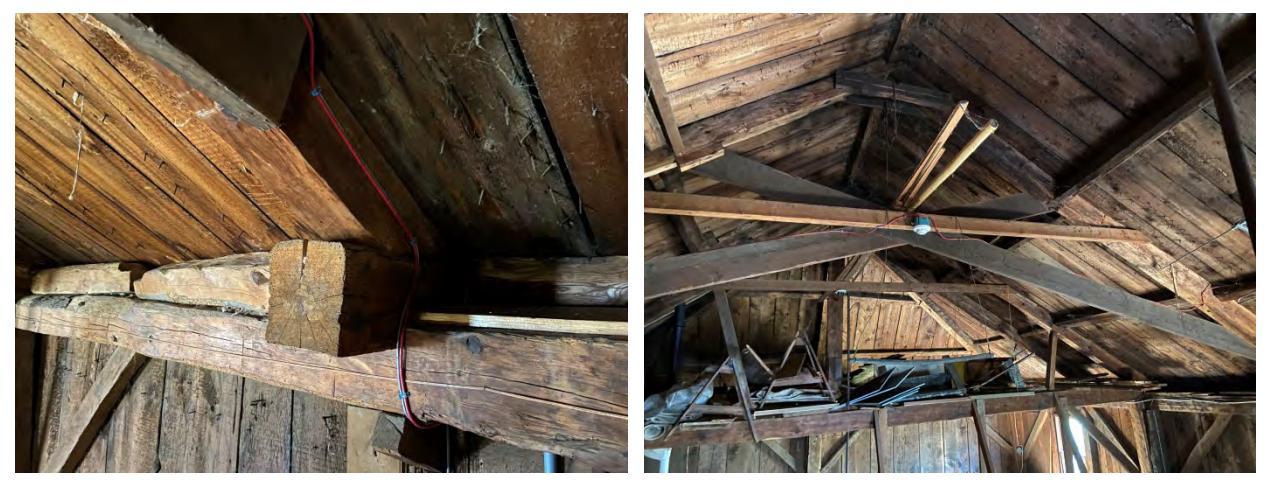
The structure has two major frames along lines 7 and 8 with steel hanger rods that extend from the second floor 8x8 carrying timber to the rafter peak. (See SK-B and SK-C) This system provides support to the second floor and relies on diagonal bracing at the second floor level and balloon posts that are continuous from the foundation to the roof truss. (See 1/SK-E) At the frame on line 7.5, the timber bottom chord was cut and removed. In an effort to compensate, 2x8 diagonal chords were installed in an attempt to create a scissor truss. (See images 21 & 22, and 2/SK-E)

21-Cut bottom chord on line 7.5

22-Modified roof framing at line 7.5
