179 PLEASANT STREET
PORTSMOUTH, NEW HAMPSHIRE

HDC WORK SESSION #3 APPLICATION TO AMEND PREVIOUS APPROVAL: JULY 6, 2022

Structural Condition Assessment
Connector, Barn and Carriage House
Captain Thomas Thompson House
179 Pleasant Street
Portsmouth, New Hampshire

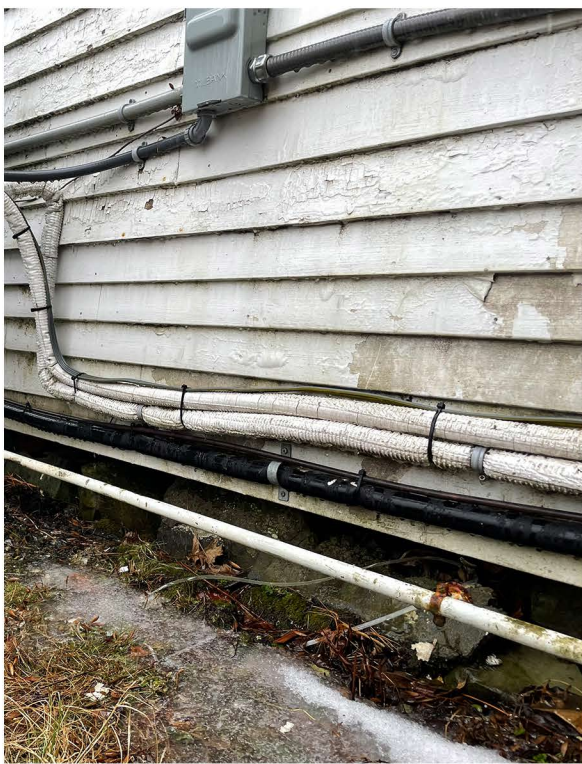
STONE RUBBLE FOUNDATION

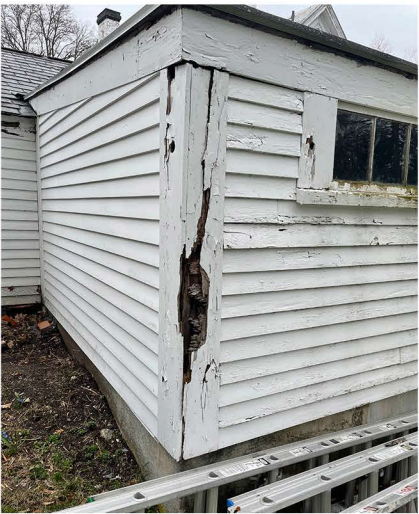
CORNER BOARD ROT

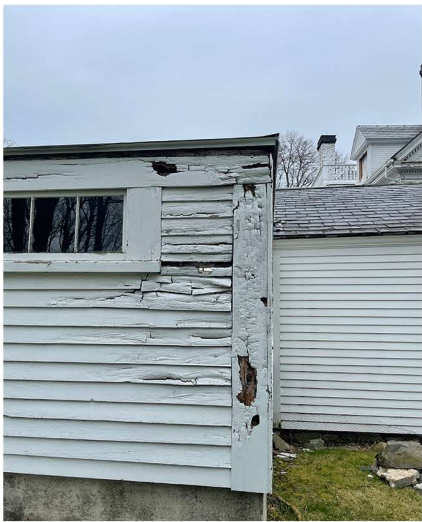
SIDING / CORNER BOARD ROT

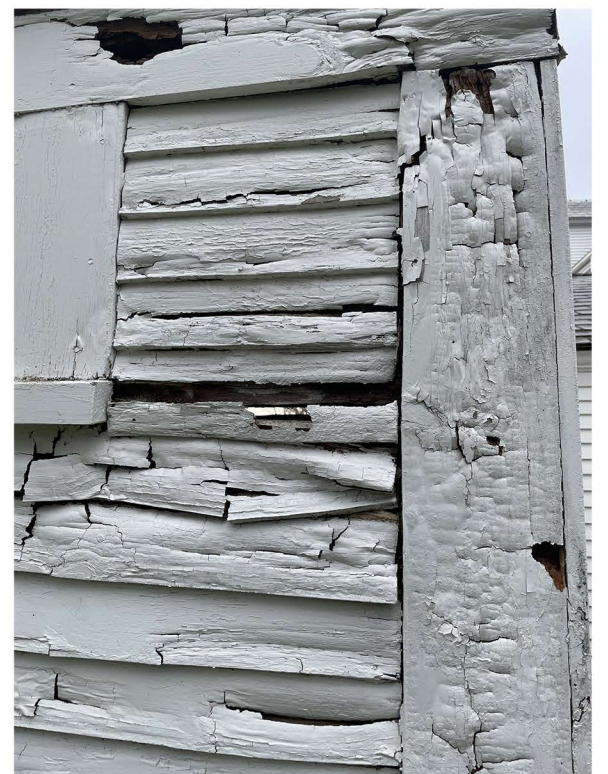
SIDING ROT AND INSUFFICIENT FLASHING

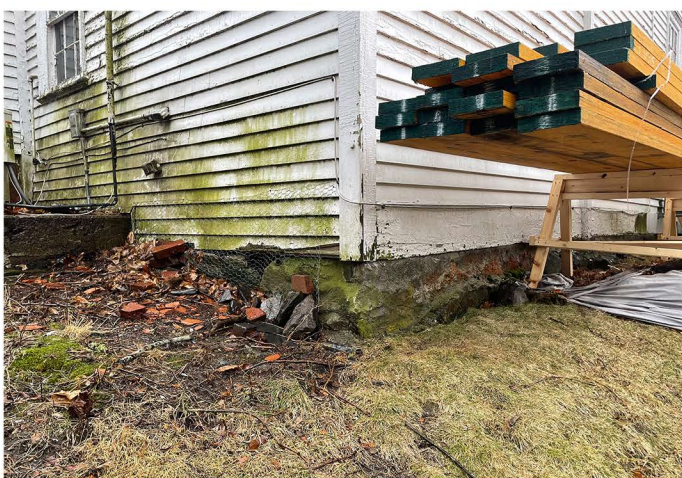
SILL ROT

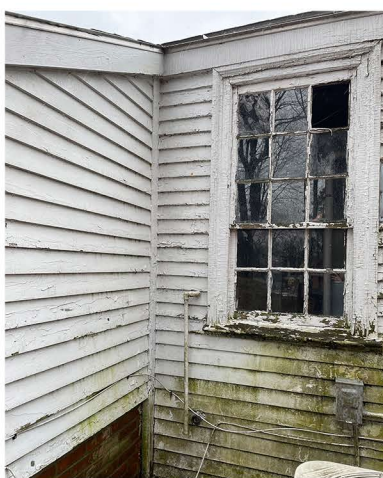
WINDOW ROT

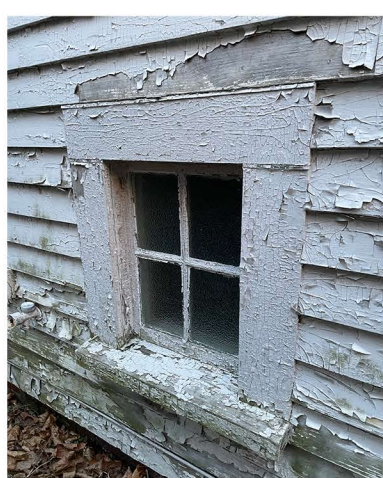
WINDOW SILL NEAR/ON GRADE

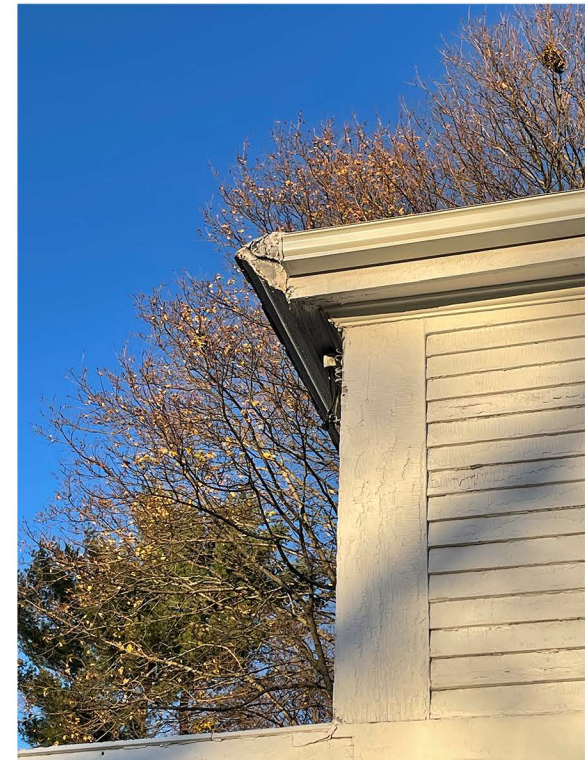
MODIFICATION OF ORIGINAL CORNICE TO INCLUDE GUTTER

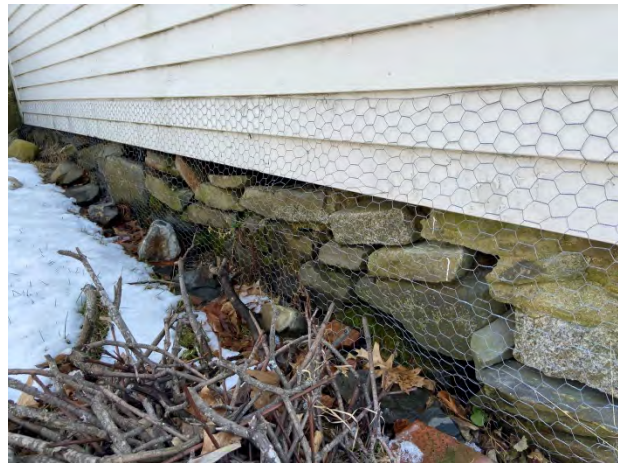
10-Stone foundation along back of barn
