179 PLEASANT STREET
PORTSMOUTH, NEW HAMPSHIRE

HDC APPLICATION TO AMEND PREVIOUS APPROVAL: SEPTEMBER 7, 2022

Structural Condition Assessment
Connector, Barn and Carriage House
Captain Thomas Thompson House
179 Pleasant Street
Portsmouth, New Hampshire

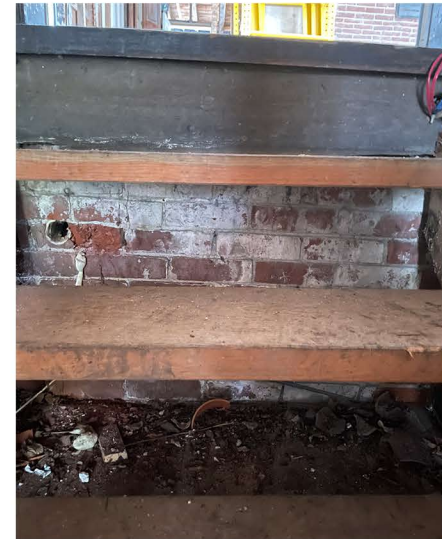
PRESSURE TREATED SILL REPAIR

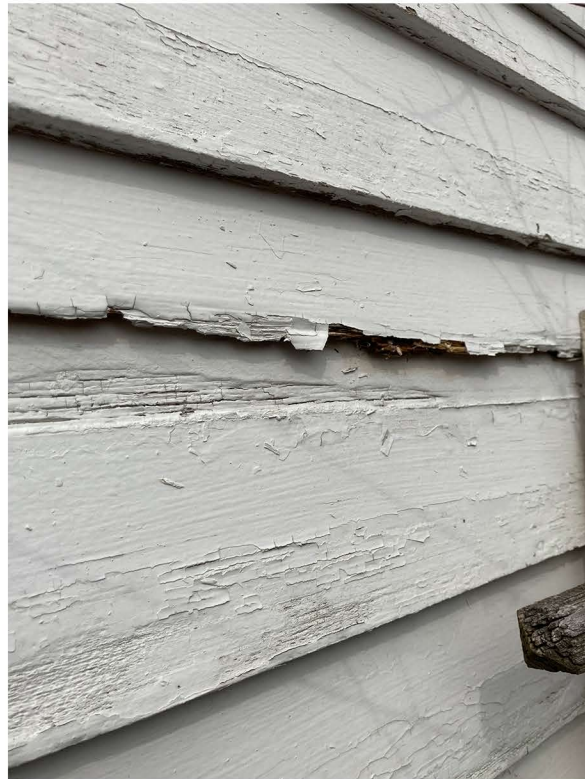
TYPICAL SIDING ROT

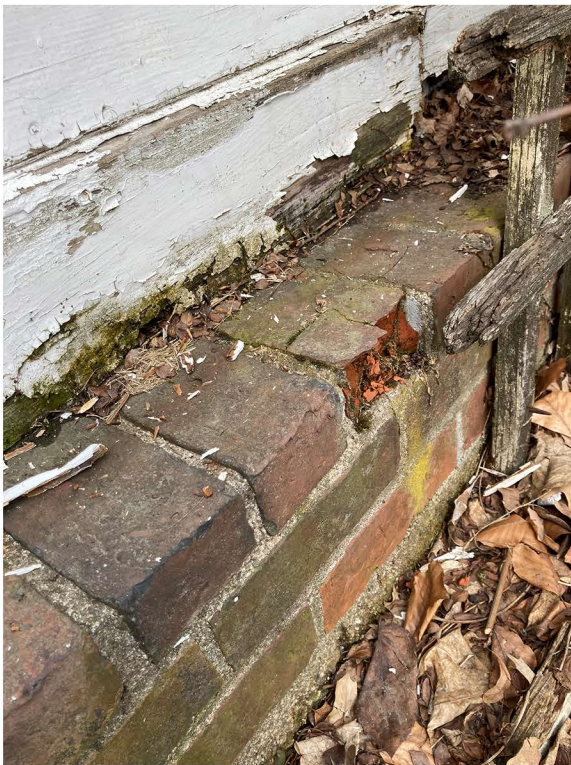
FOUNDATION SHELF AND ROT FROM STANDING WATER

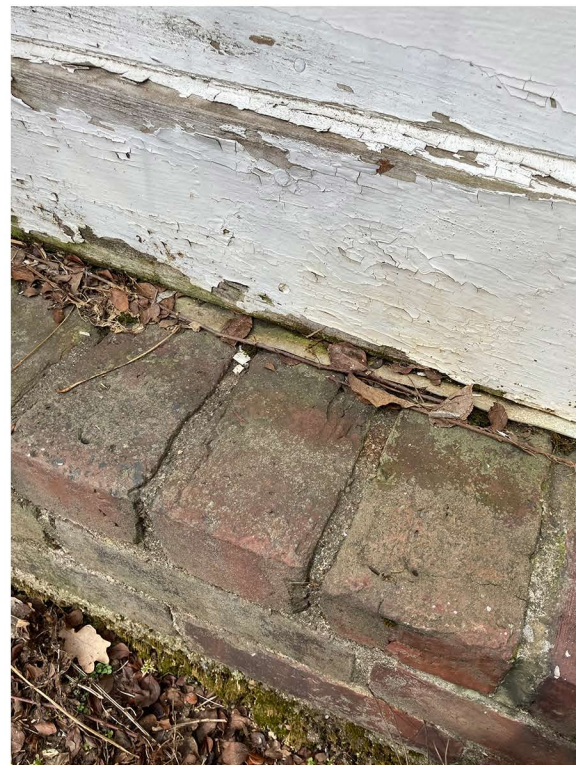
INSUFFICIENT FLASHING

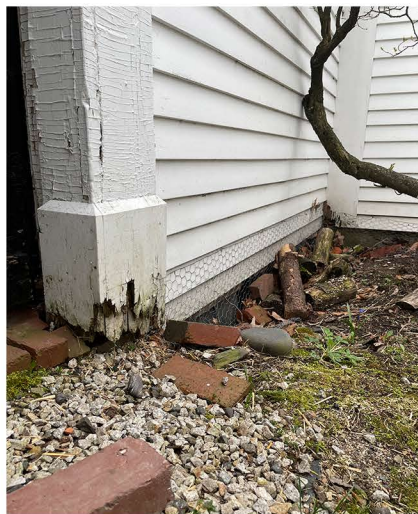
POST BASE ROT

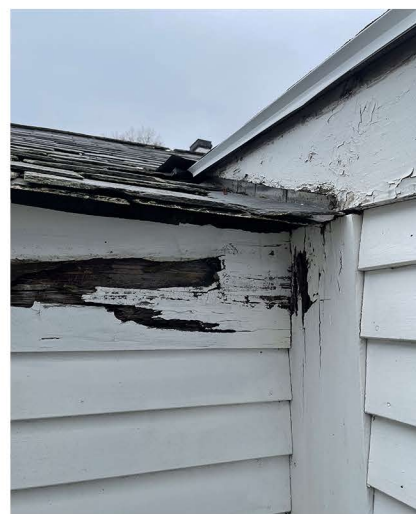
SIDING ROT

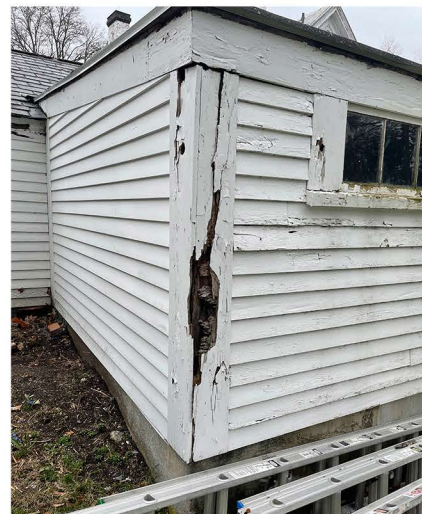
CORNER BOARD ROT

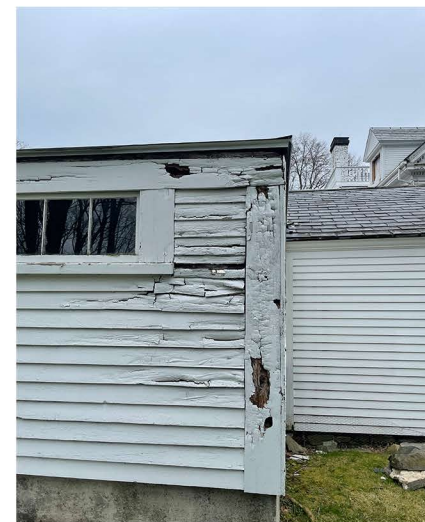
SIDING / CORNER BOARD ROT

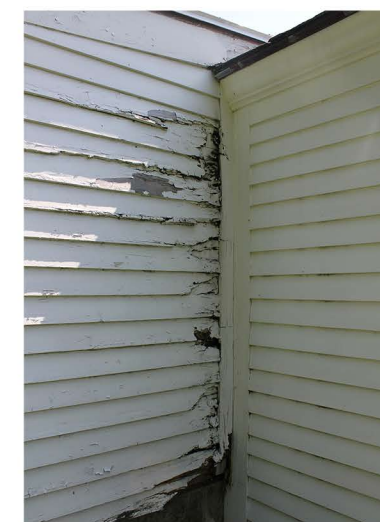
SIDING ROT

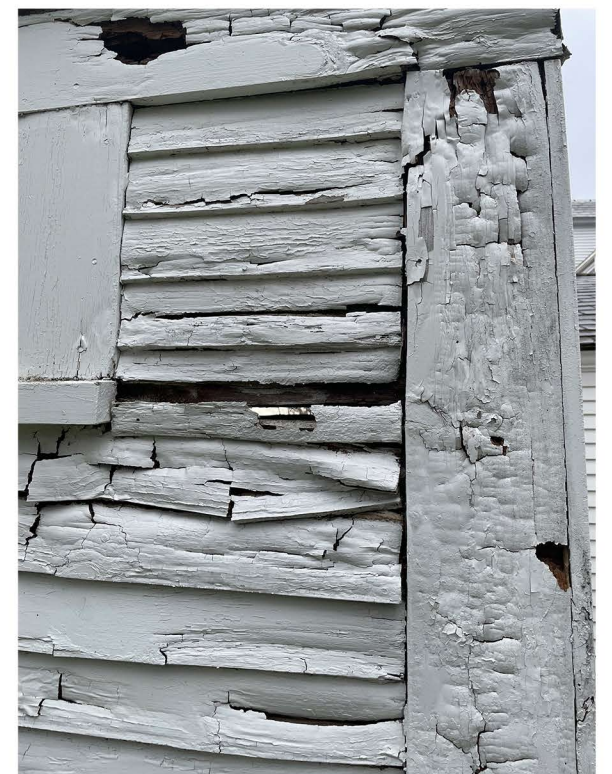
SIDING ROT AND INSUFFICIENT FLASHING

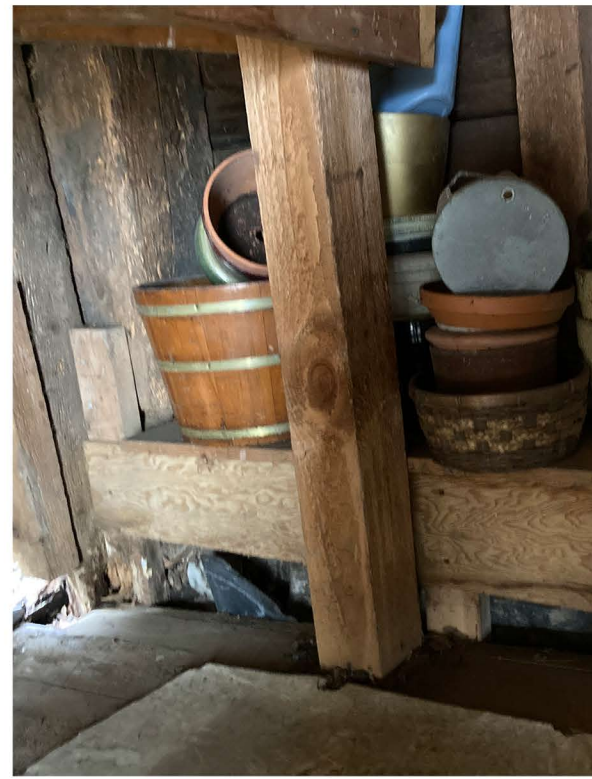
REPAIRS AT COMPROMISED STRUCTURE AT BASE

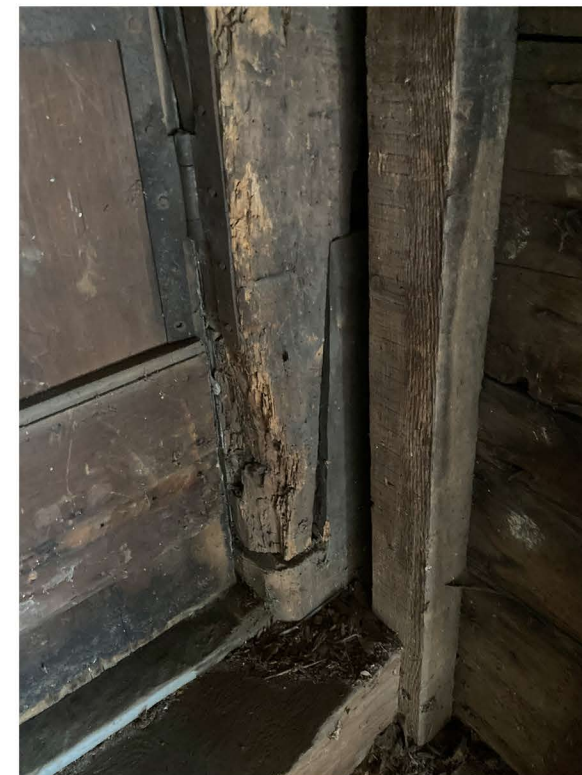
TYPICAL HALF LAP POST ROT REPAIR SEEN THROUGHOUT CONNECTOR

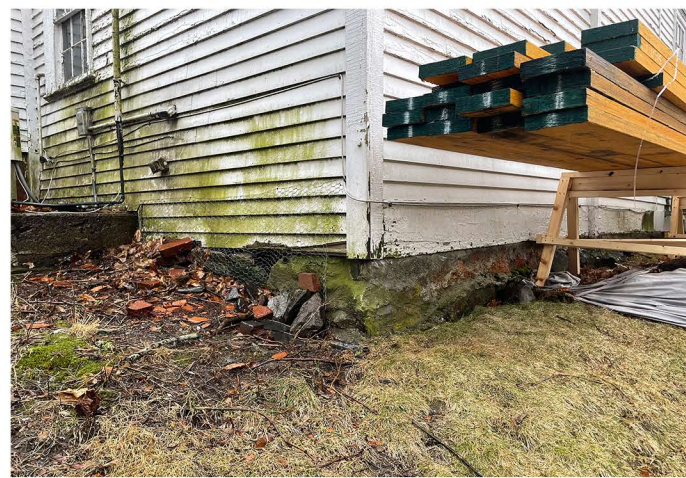
SILL ROT

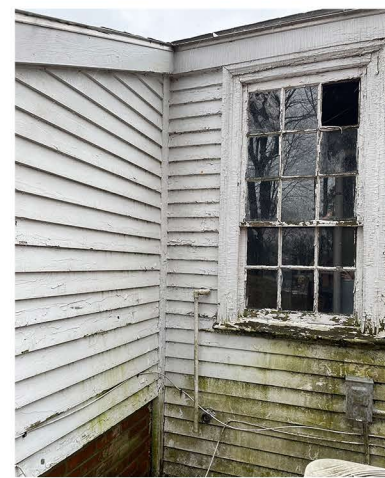
WINDOW ROT

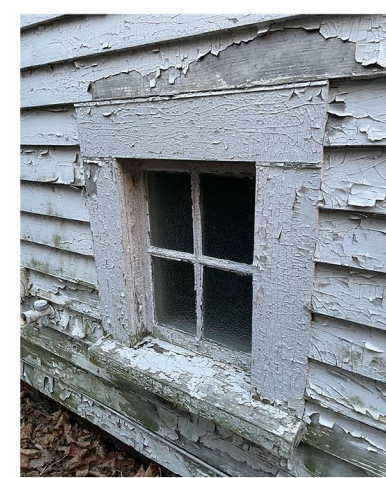
WINDOW SILL NEAR/ON GRADE

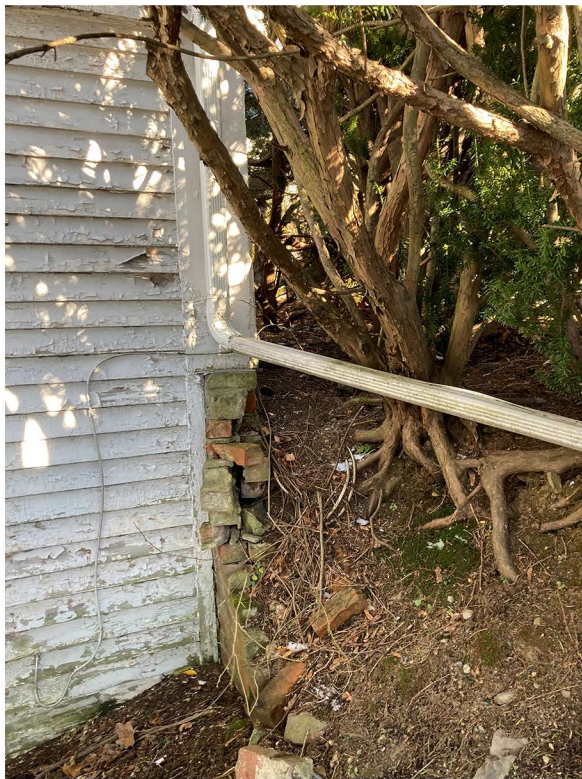
CRUMBLING FOUNDATION LACKING POSITIVE DRAINAGE

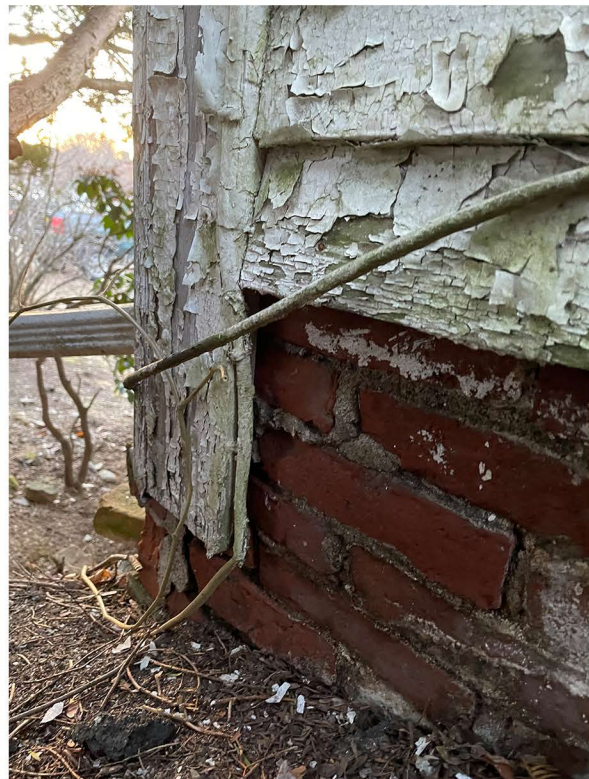
ROT FROM STANDING WATER

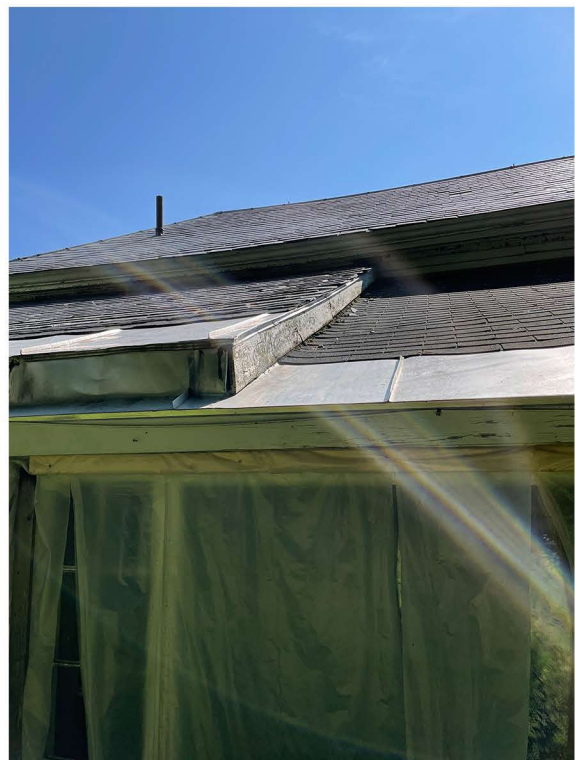
INSUFFICIENT ROOF FLASHING

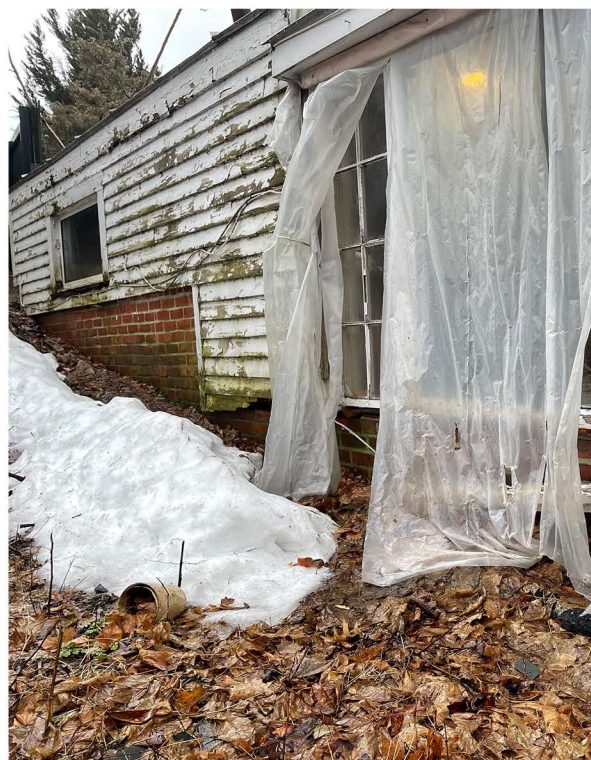
TYPICAL SIDING ROT AND FOUNDATION DAMAGE

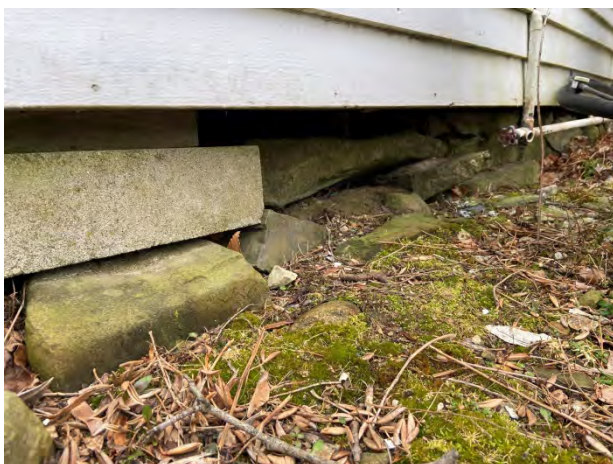
The connector foundation is made of loosely spaced stone supporting a timber plate. The exterior grade along the north side is about 1-foot below the top of the foundation wall. The exterior grade along the south side is approximately at the same elevation as the interior wood floor. Brick masonry cladding has been added along the outside face of the south wall in an attempt to provide some decay protection to the wall and timber sill. The top of this brick cladding is about 1-foot above the exterior grade and interior floor and covers decaying wall sheathing. (Images 1 – 5)

5-Connector foundation on north side

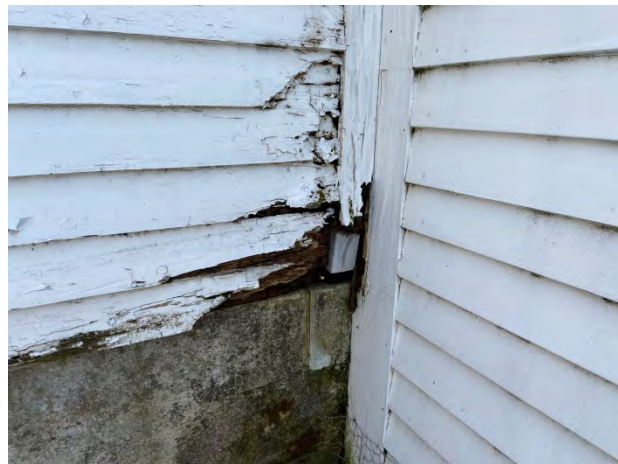
16-Barn decay damage

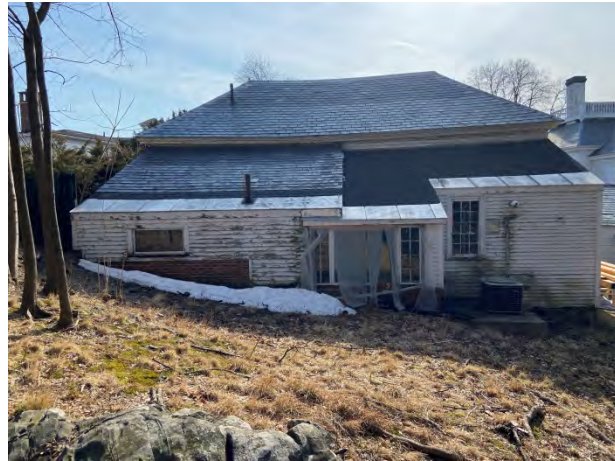
18-Carriage house northeast elevation

From outside the building, looking at the carriage house, one can observe significant distortion, which could be describe as a swayback condition, along the ridge, the hips, and roof planes. These distortions indicate that the building structure is significantly overstressed to levels that should be considered unacceptable. The results of basic engineering calculations, that should not be considered conservative, confirm that the buildings' member stresses and deflections are excessive.

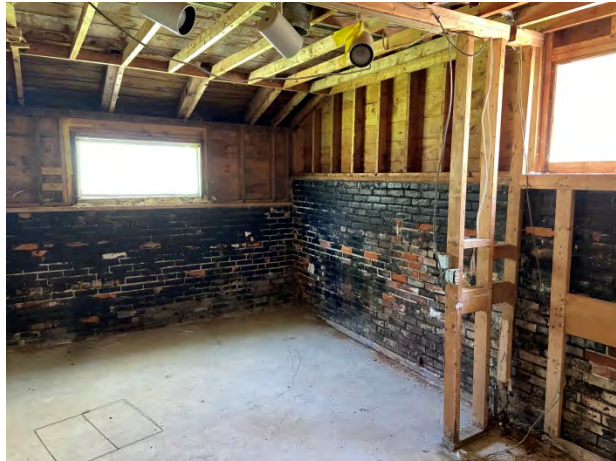
The first floor exterior walls along the front and right sides are framed with conventional 2x stud framing, similar to what we might see today, with pine board sheathing. My opinion is that these walls may have been constructed in the 1960s to 70s timeframe. The original posts along the front wall have been cut down to fit within the newer stud walls, and it was observed that the bases of some of the posts have been repaired. (Images 19 and 20)

20-Brick foundation and side wall framing
