IRock Condominium
Located 4 & 6 Rock Street and 125 Islington St.

Summary: As President and Treasurer of the IRock Condo Association, and owning 86% interest in the building, on behalf of the association we would like to replace the windows in the building. The windows are mismatched with three different ages and materials. The majority of the windows were replaced in the 1940's and are historically inaccurate. There are also a few vinyl replacement windows. We have identified 5 original windows, located in the back of the building. Those windows have some replacement glass. The reason for this request is due to terrible condition of the windows and also to restore the building to make it more architecturally historically accurate by replacing the current 2 over 2 windows and old rusty storm windows with historically accurate wood 6 over 6 windows, consistent with Greek Revival buildings constructed in the 1840's. There will be no light loss with the replacement of the windows because only the sashes will be replaced.

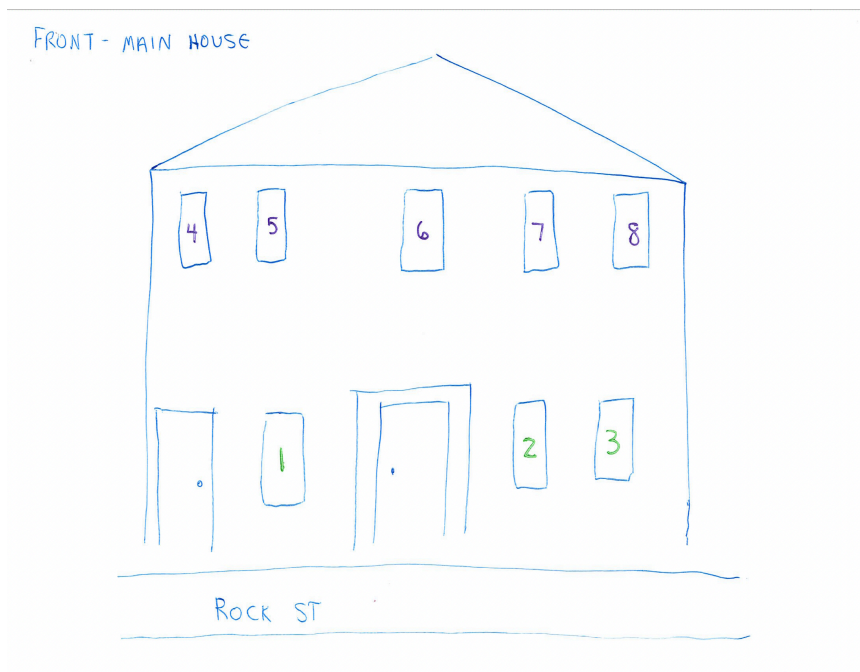
Windows 1-8: These windows were all replaced in the 1940's. They are 2 over 2. Our proposal is to replace the sashes only with double hung style 6 over 6. There will be NO light loss with this replacement. The approximate size of these windows are 32"x 58" for the first floor (windows #1-3) and 32" x 54" for the second floor (windows #4-7).

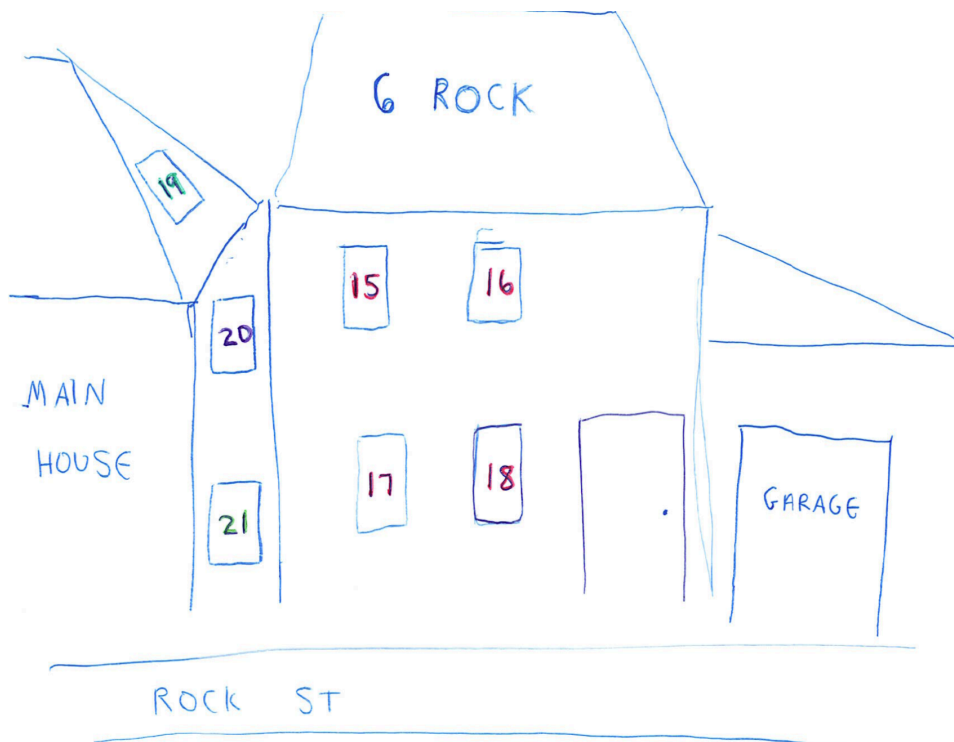
Windows 15-18, 20 and 21 were replaced in the 1940's. They are 2 over 2. They are not original sashes and there is no wavy glass. Our proposal is to replace the sashes only with double hung style 6 over 6. There will be NO light loss with this replacement. The approximate size for windows #15-16 is 25" x 46" and 32" x 58" for windows 17-18, 21. The approximate size for window #20 is 32" x 54".

Window #19 is original. We would propose restoring this window. The sash is 6 over 6 with at least one pane of wavy glass.

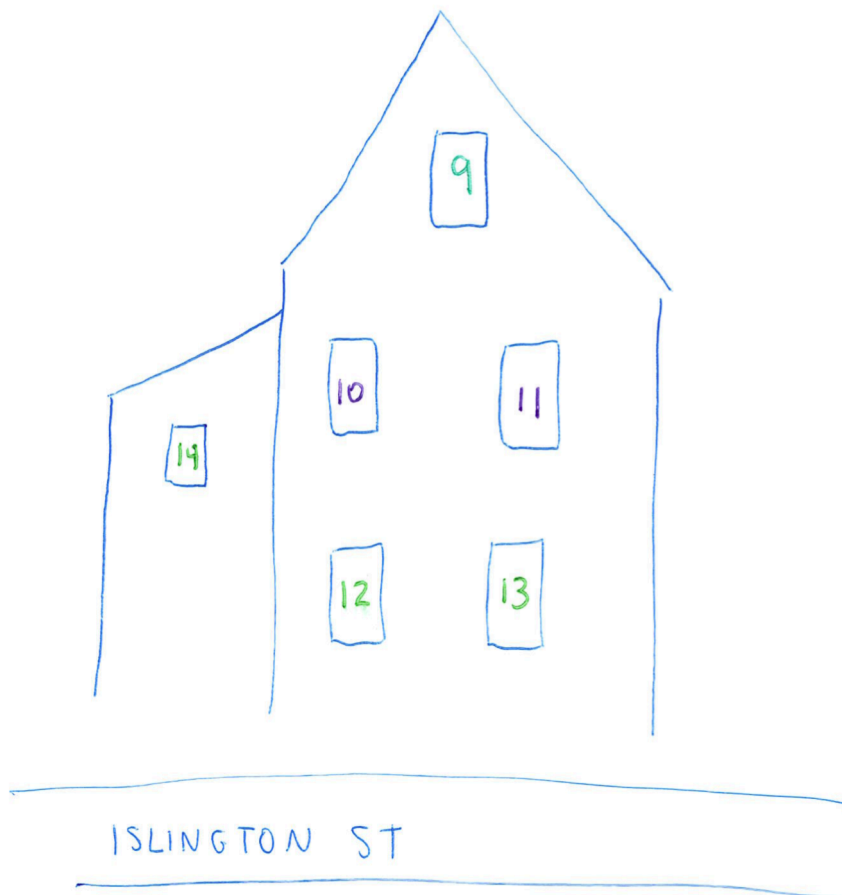
Window #9 is a vinyl replacement window installed in the 1980s. It is 1 over 1. We would propose replacing the frame in order to install a casement window with a double hung 6 over 6 appearance. This window size is 32" x 54"

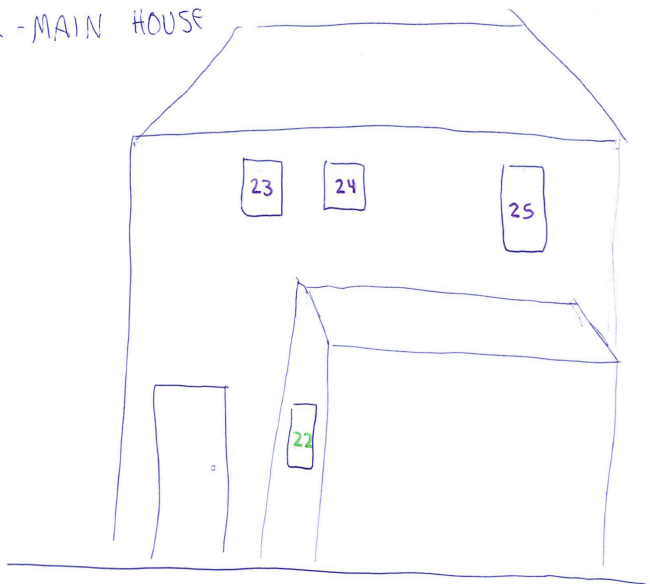
BACK-MAIN HOUSE

Windows #23-24 are 1960's vinyl windows. Our proposal is to replace the sashes only with double hung style 6 over 6. There will be NO light loss with this replacement. The approximate size of these windows are 25" x 46".

Window #25: This window was replaced in the 1940's. It 2 over 2. Our proposal is to replace the sashes only with double hung style 6 over 6. There will be NO light loss with this replacement. The approximate size of this window 32" x 54".

Window #22: There is no existing window. It appears someone merely cut a whole in the siding and installed a storm window. We would propose to replace the storm with a double hung window style 6 over 6. There will be NO light loss with this replacement. The approximate size of this window 25" x 46".

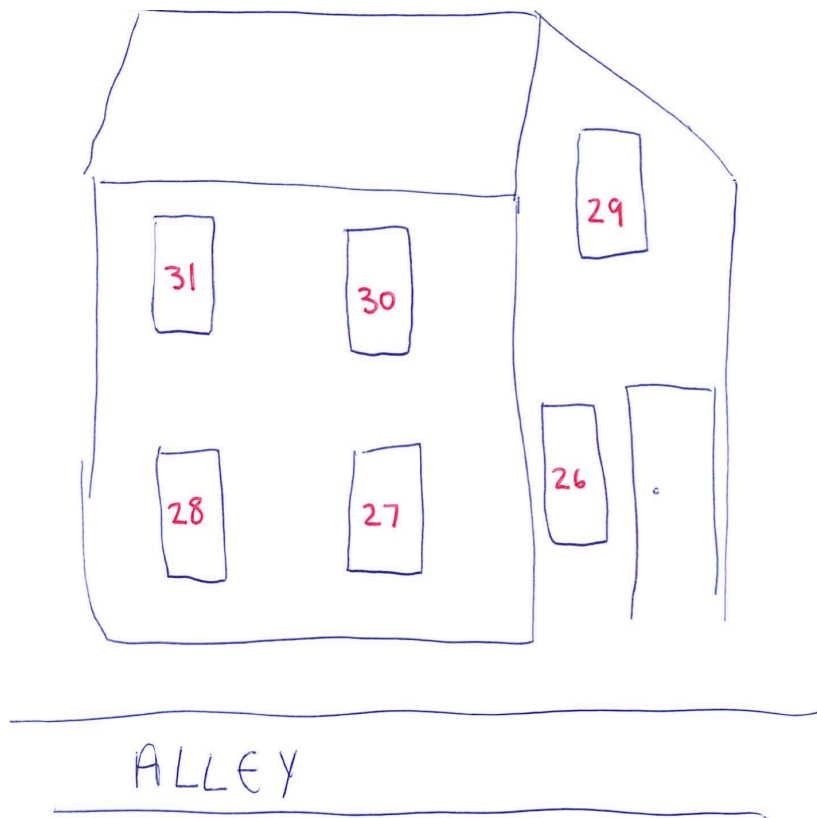
Windows #27, 28 and 31 are original. We would propose restoring these windows.

Windows #26, 29, and 30 were replaced in the 1940's. They are 2 over 2. They are not original sashes and there is no wavy glass. Our proposal is to replace the sashes only with double hung style 6 over 6. There will be NO light loss with this replacement. The approximate size of window #26 is 32"x 58". The approximate size of windows #29 and 30 is 32"x 54".

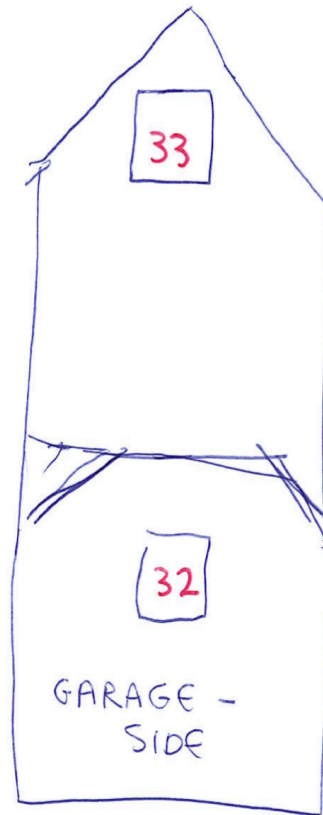
RIGHT SIDE - 6 ROCK

Window #33 is original and we would propose restoring that window.

Window #32 is a replacement window on the side of the garage and we do not intend on replacing that window.
