## Figure 2a. Invasive Species Inventory

North Mill Pond | Multi-use Trail | Portsmouth, NH

Figure 2d. Living Shoreline Images

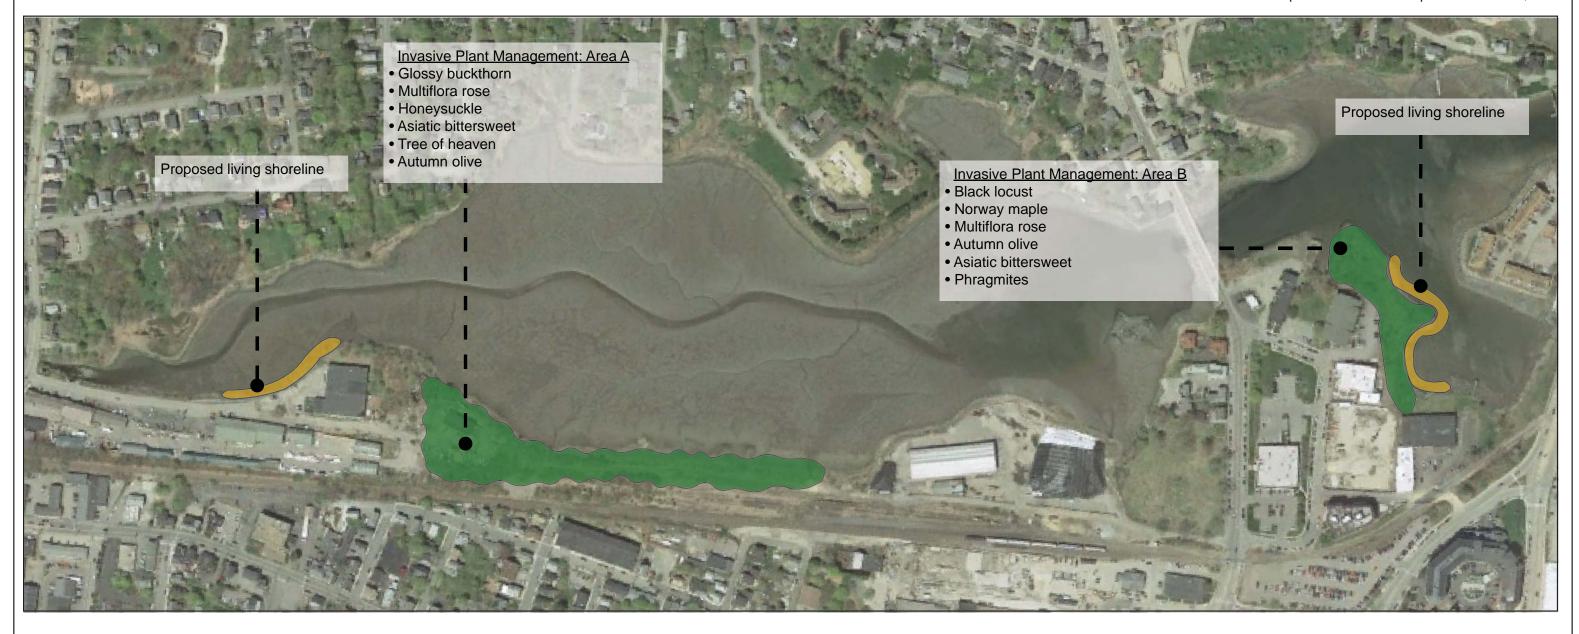
- 1. Base image from Google Earth, May 2018.
- 2. An inventory of invasive and native plant communities was implemented in October 2018. Notes added by DeRosa Environmental Consulting, Inc. on November 1, 2018.
- 2. The principal strategy will be the selective removal of woody invasive plants within understory using whole plant removal techniques and multiyear maintenance.
- 3. Care is to be taken in removing invasive plant material to minimize disturbance to existing native plant species.
- 4. Disturbed soils to be seeded and hay mulched following removal. Native plants will be installed in these areas and are detailed in the Native Species Planting Plan (Figure 2c).

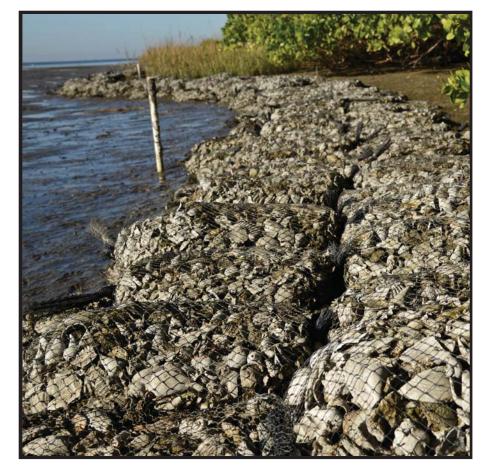
GABIONS WITH OYSTER SHELL (CULTCH)

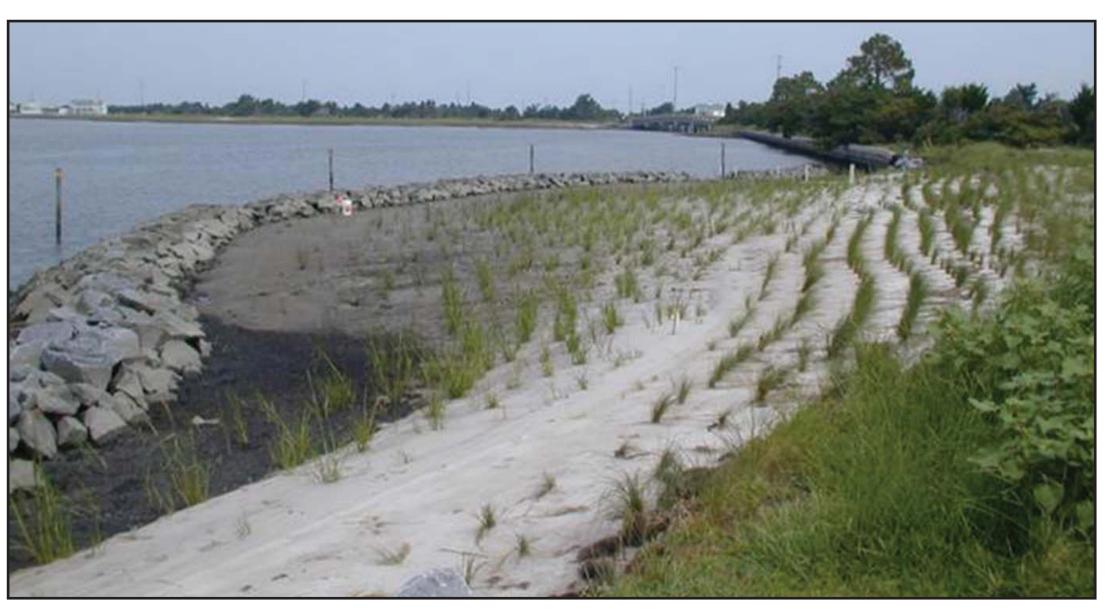
BOULDERS AS SILL STRUCTURE | PROPOSAL WILL BE TO USE WIRE GABIONS FILLED WITH OYSTER SHELL

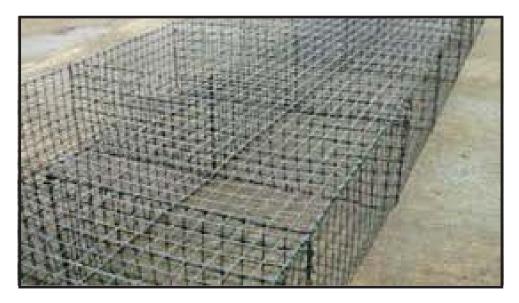
**JOINED GABIONS**
