Re: Zoning Relief
Stephen M. Foster, Applicant
Wentworth-Gardner & Tobias Lear Historic Houses Association, Owner
Property: 49 Hunking Street
Tax Map 103, Lot 39
General Residence B (GRB District/Historic District)

The scope of work for the Historic Building Assessment shall include exterior existing conditions, interior existing conditions and estimates for the appropriate repairs/restoration based upon the Secretary of the Interior's Guidelines for the Treatment of Historic Properties.

Existing Exterior Conditions

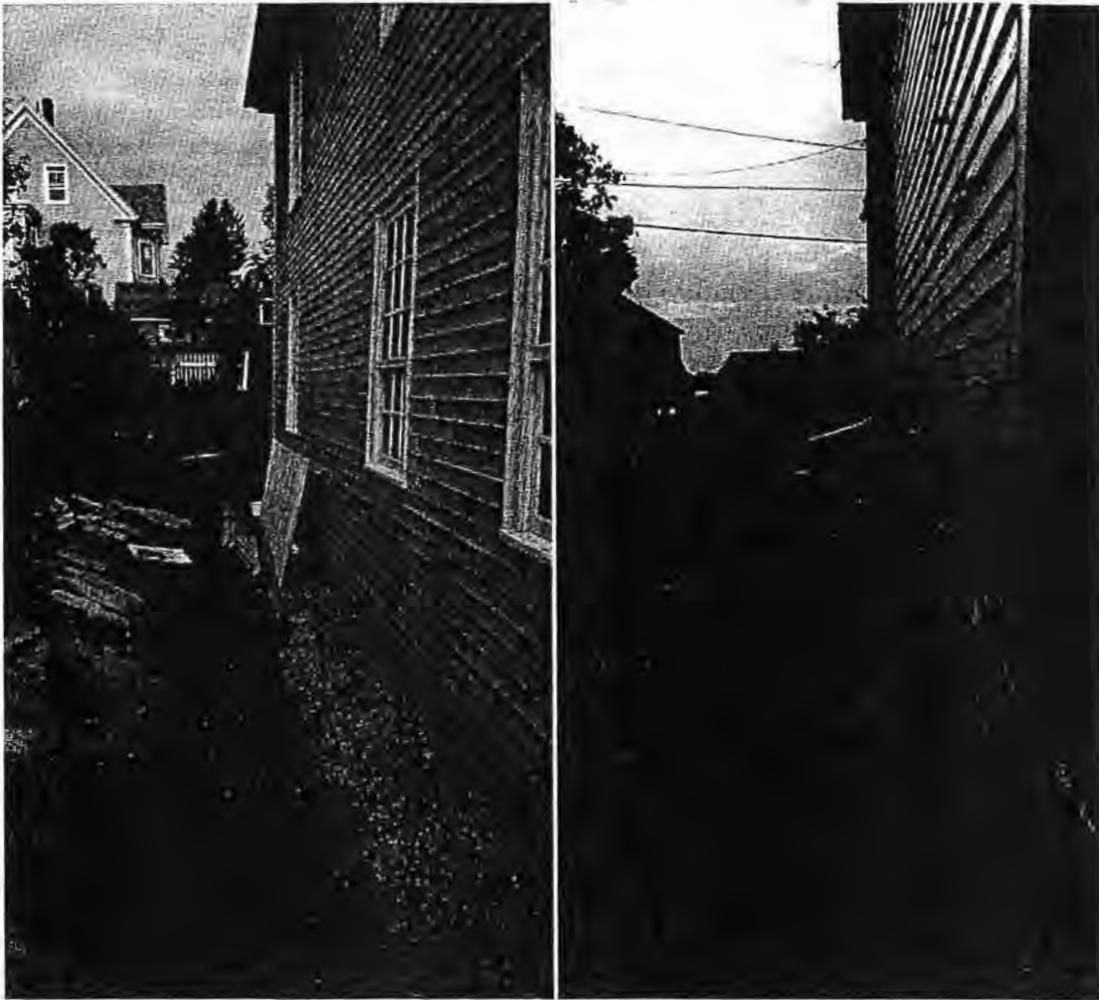
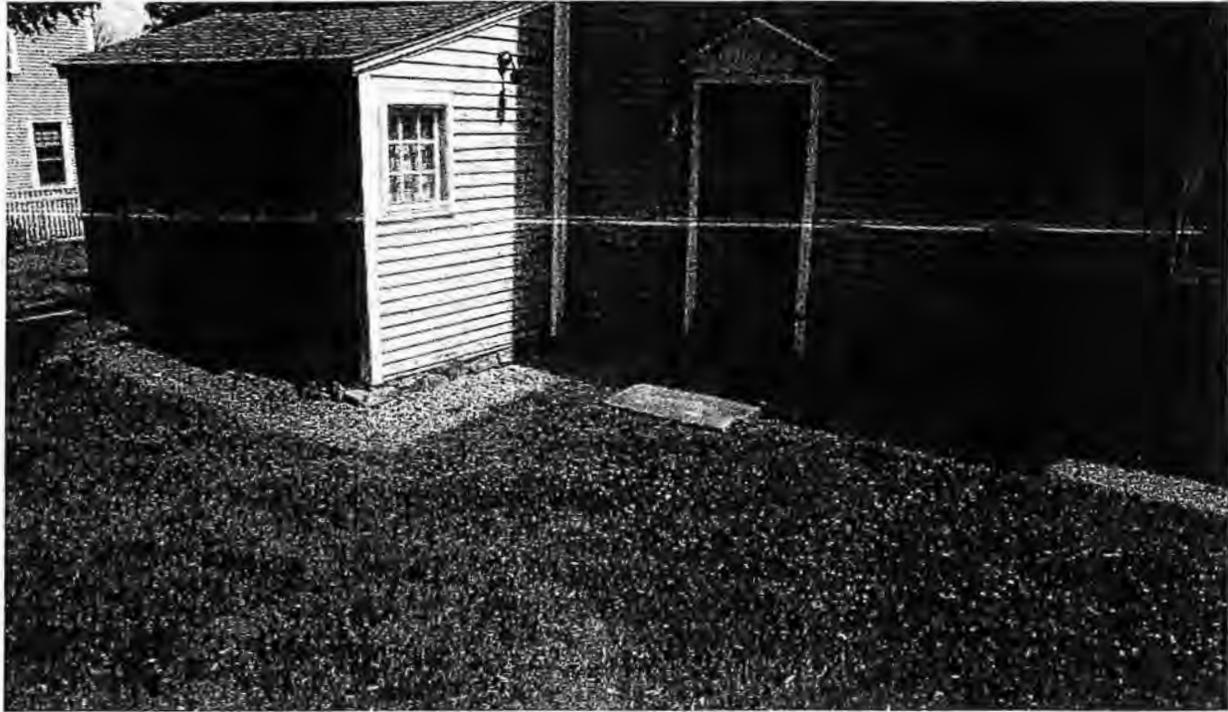
The general grade around the Tobias Lear House (TLH) is fair with the exception of the westerly and northerly sides of the building. Given the raised area of the westerly next door property, water from this area follows the grade towards the foundation of the TLH. Water coming off of this area, the raised area behind the house and water being discharged from the roof collects in the low area to the left of the back door/kitchen addition and then enters into the basement.

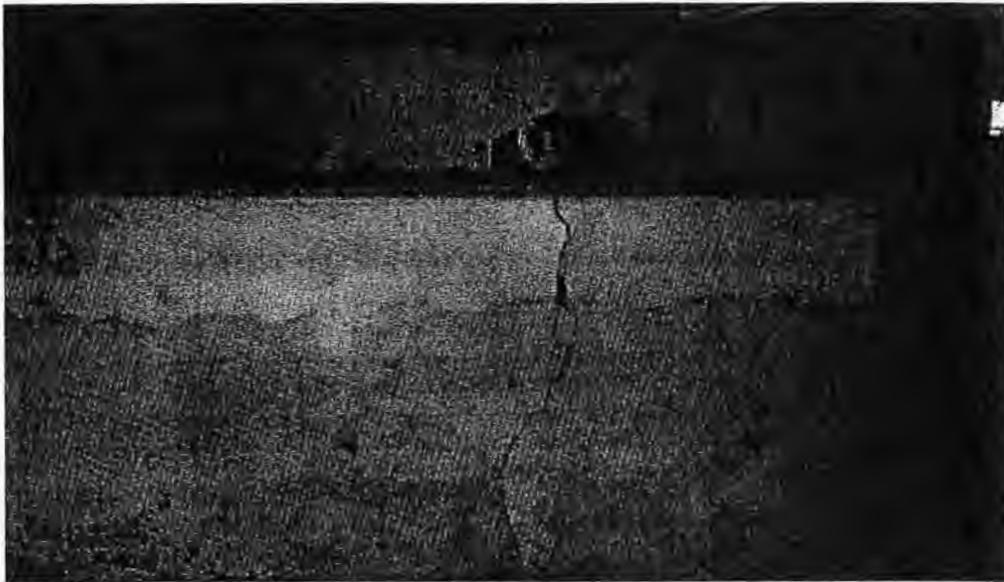
The photo above is the interior wall in the basement facing the back of the easterly chimney base. The horizontal lines represent the forming boards being stacked upon each other. The vertical line is a crack that has formed due to movement from water/freezing/thawing in the basement over the years as well as the fact that rebar/steel to strengthen the concrete was not typically used during this construction time period. The photo below shows a similar crack in the interior westerly chimney abutment.

The south, east and west foundations will require some minor re-pointing. The interior poured concrete walls that are up against the two chimneys should be taken down and removed. This will then entail the proper repair and bracing of the existing damaged chimney bases. Also, the northerly foundation with its long horizontal crack will require repair. At least two of the masonry columns will also need repair.

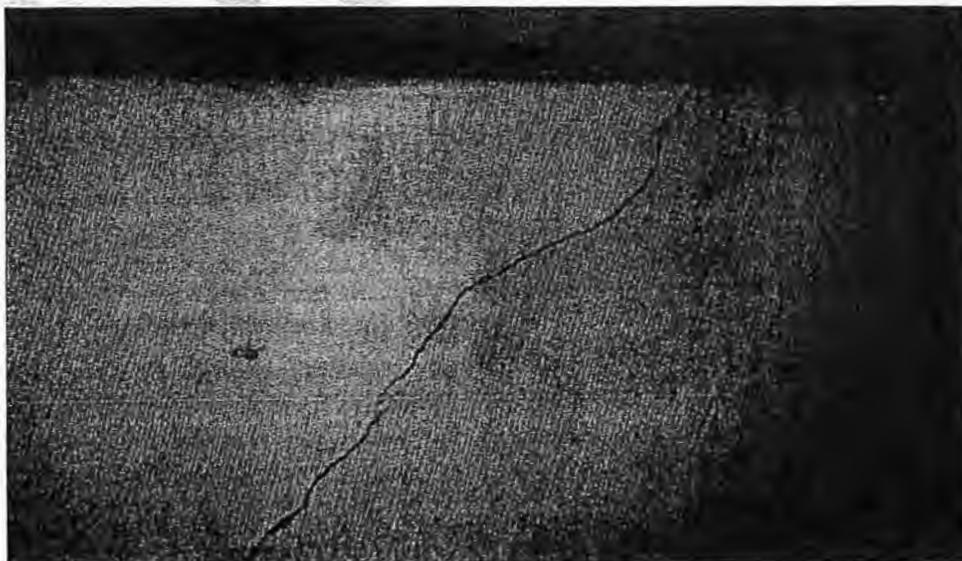
Apparently a decision was made to install concrete abutments around the back side of the easterly chimney base and three quarters of the way around the westerly chimney base. Sand was then in-filled between these concrete walls and the chimney bases. A thin layer of concrete was then poured on top.

Without the use of rebar/steel to hold the walls/caps together and with the water/freezing/thawing cycle in play, many of the walls have cracked and the poured caps have cracked and become misplaced.

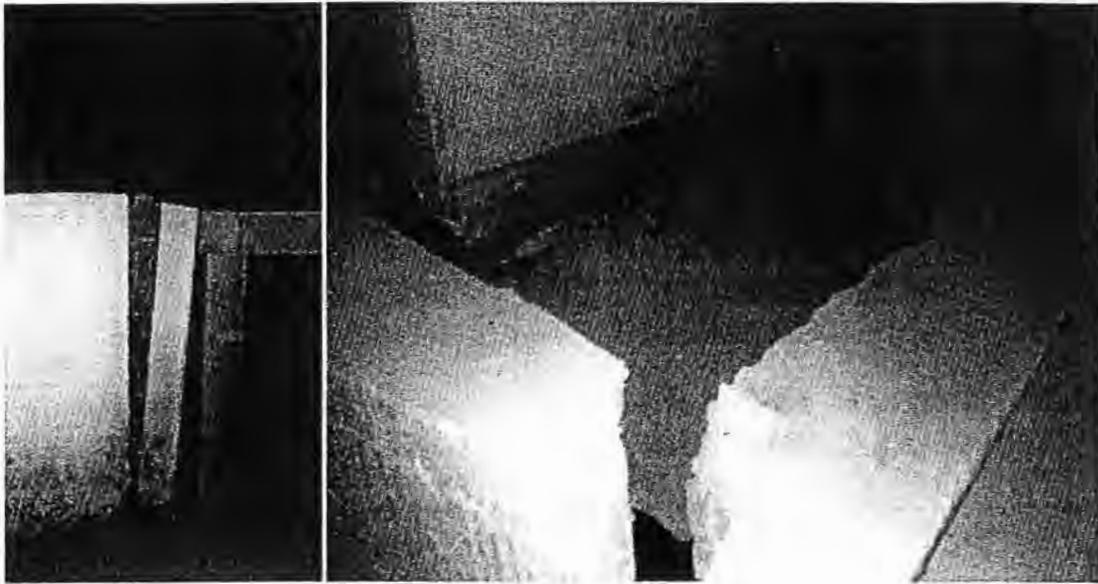
The poured wall behind the west chimney has broken away and is leaning towards the back side of the house. In the photograph below, a wooden bracing frame was built to stop the wall from collapsing onto the concrete floor.

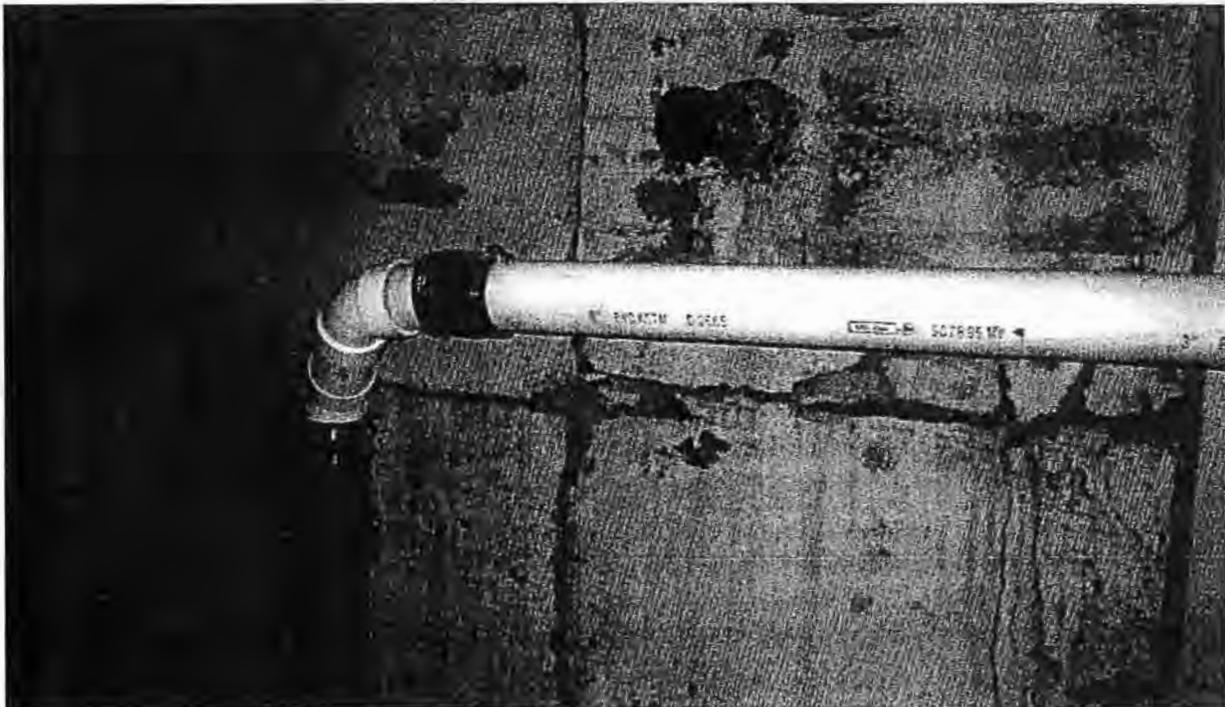
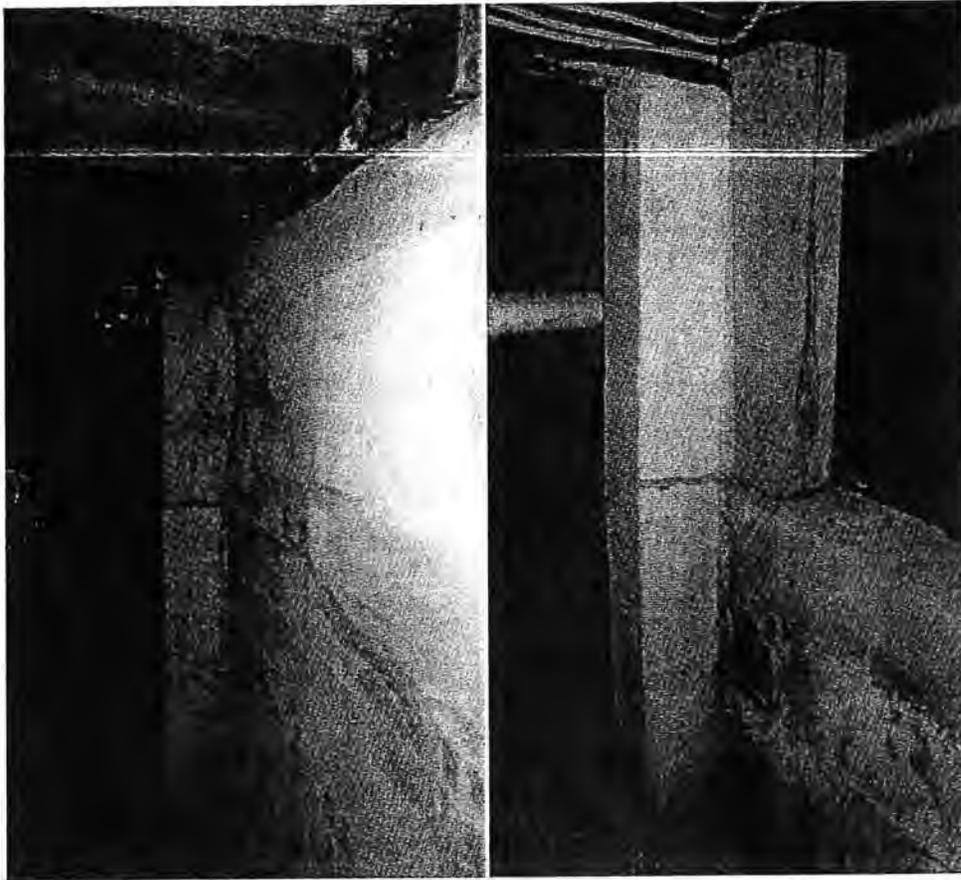
The back foundation wall has a long horizontal crack that runs along the length of the wall as well as several vertical cracks. These cracks are in the same line as the cracks in a few of the concrete piers as seen below.

All of these stress cracks in the foundation on the back side of TLH are most likely from the construction method utilized for the exterior walls. The method used was to stack up boards, leaving a space for concrete between the inside of these boards and the inside of the foundation wall. This space was filled with concrete and rubble stones etc. The thought was that the new concrete would bond with the stone work of the original concrete wall.

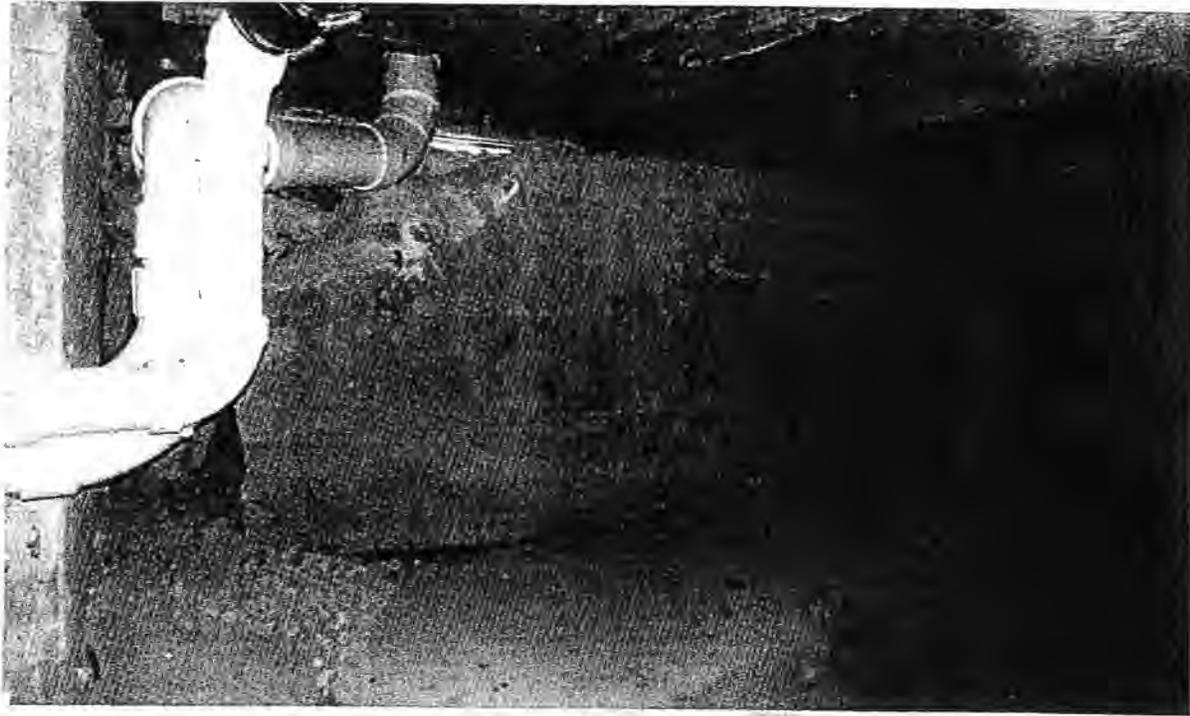
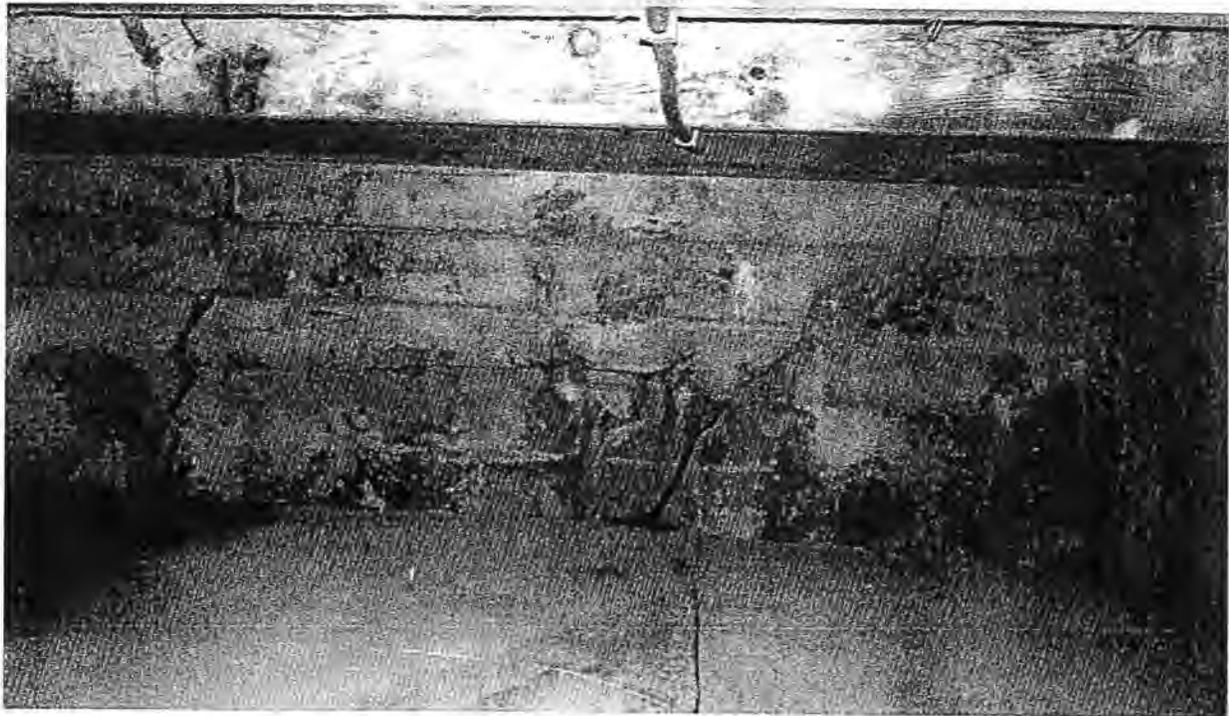
The poured concrete walls in the small shed foundation reveals the probable method/process used in the main house foundation. The photographs below show the foundation under the shed and what occurs when the new concrete walls are built in front of the existing wall, the walls are not built below

frost and there is a negative grade carrying the water from the surrounding higher areas (along with the roof water) towards the foundation. The floor joists are rotted in various areas.

As the water comes into this area between the old stone foundation wall and the newer poured wall it saturates this area continually. When below freezing temperatures occur, the area between the walls will freeze and in the spring subsequently thaw (which occurs each year). This freeze/thaw cycle will continually increase the space between the walls and then gradually push the concrete wall into the basement. The poured west shed foundation wall is now in that condition.

The small shed foundation needs to be completely replaced. This will require jacking up the building slightly to remove the existing foundation, excavation below frost (4') and then pouring a new footing with rebar. A new steel reinforced concrete wall would be built to slightly below grade and then salvaged stones from the excavation would be installed on top of the poured wall at the appropriate elevation.

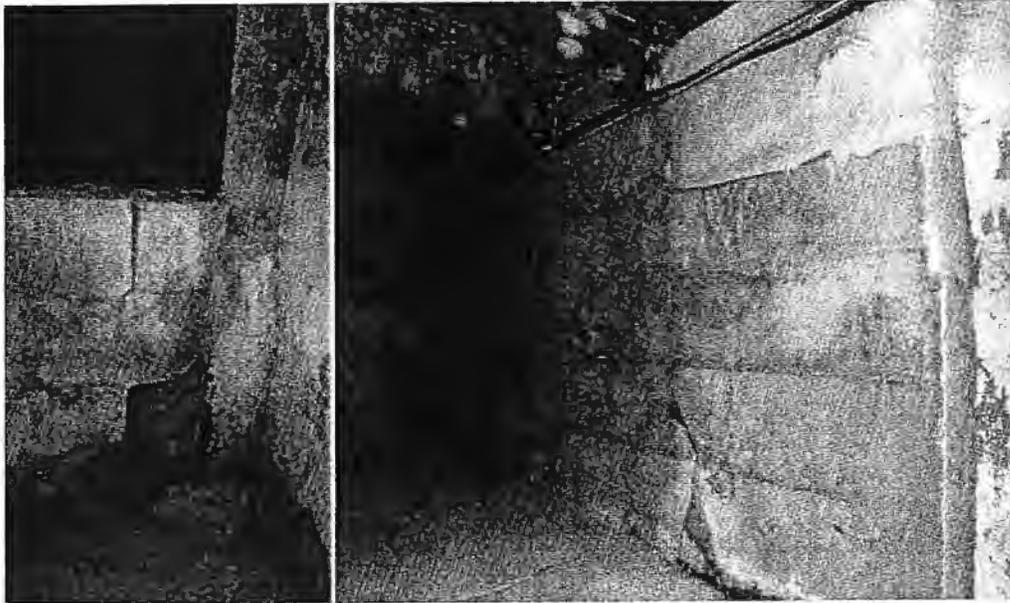
As water from the outside works its way past the inner foundation wall and across the pour floor, it will head towards the lowest spot. As can be seen in the photograph below, more water/concrete damage has occurred.

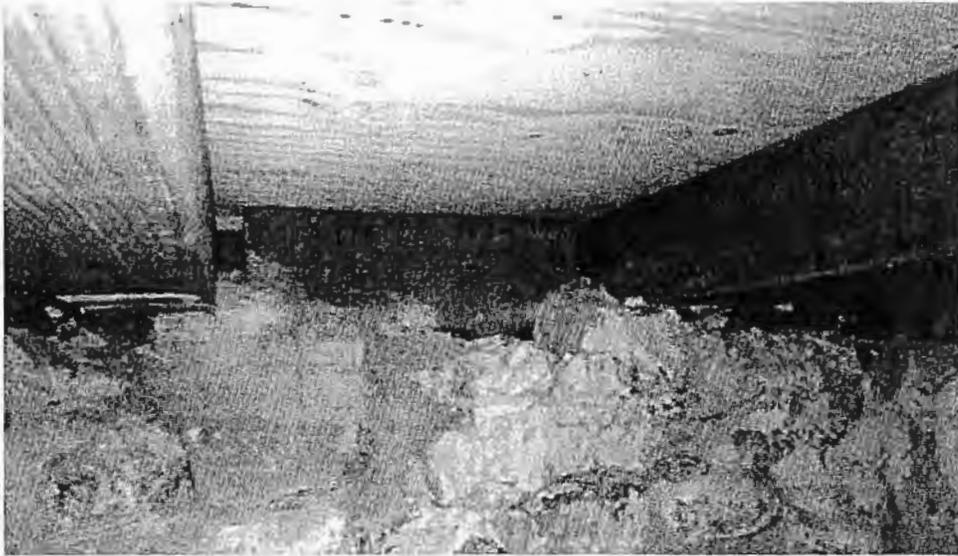
The vast majority of the sills of the TLH have been replaced as well as the original and second generation floor carriers, girts and joists. This work was said to have been accomplished sometime in the middle and/or late 20th century. The only apparent original sill from the 1740's section is a small section approximately 5 ft. long on the southerly façade towards the west gable end.

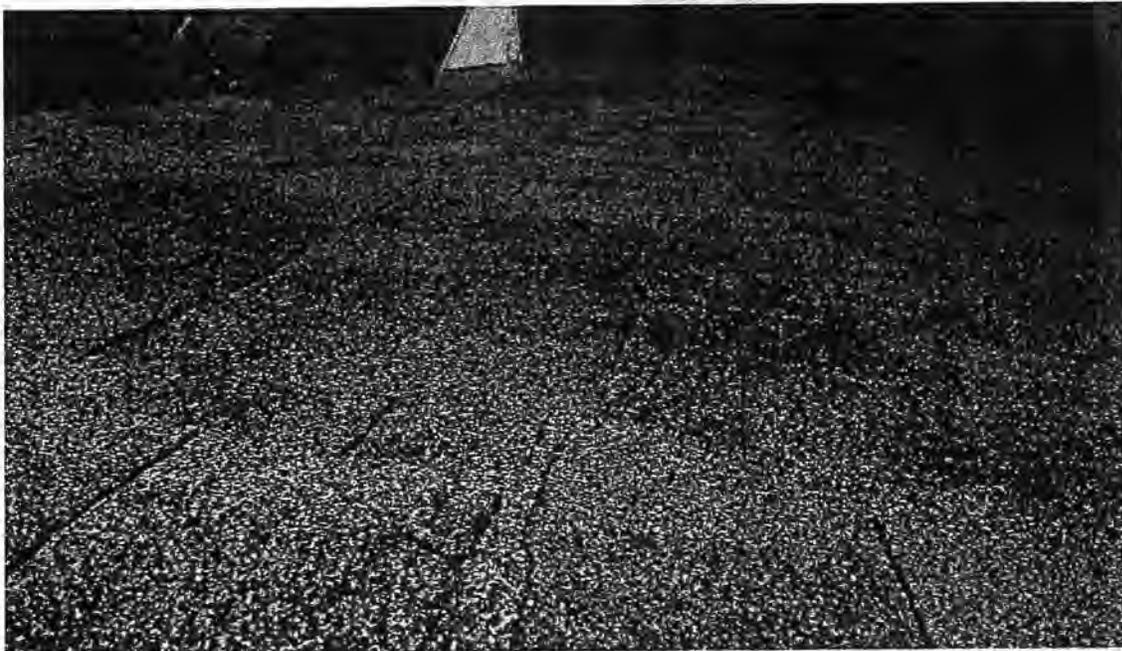
The asphalt roof of TLH is in reasonable condition given its age. While it currently does not appear to be leaking, it is headed towards the end of its life expectancy. The photographs below show a darker area of the shingles on the south side. This area is where the granular material on the shingle is actually now missing and the fiberglass/asphalt material is left exposed.

The roof on TLH needs to be replaced within the next couple of years. This work will include the removal of the existing asphalt shingles, the repair/replacement of any rotted roof sheathing, the installation of ½" cdx plywood on top of the sheathing, installation of ice and water shield at least two rows up from the eaves (approximately 6') as well as 3' on either side of the valleys and the covered with at least a 30 year architectural asphalt shingle. This work also includes roof work on the 4 dormers and the roof on the small ell addition.

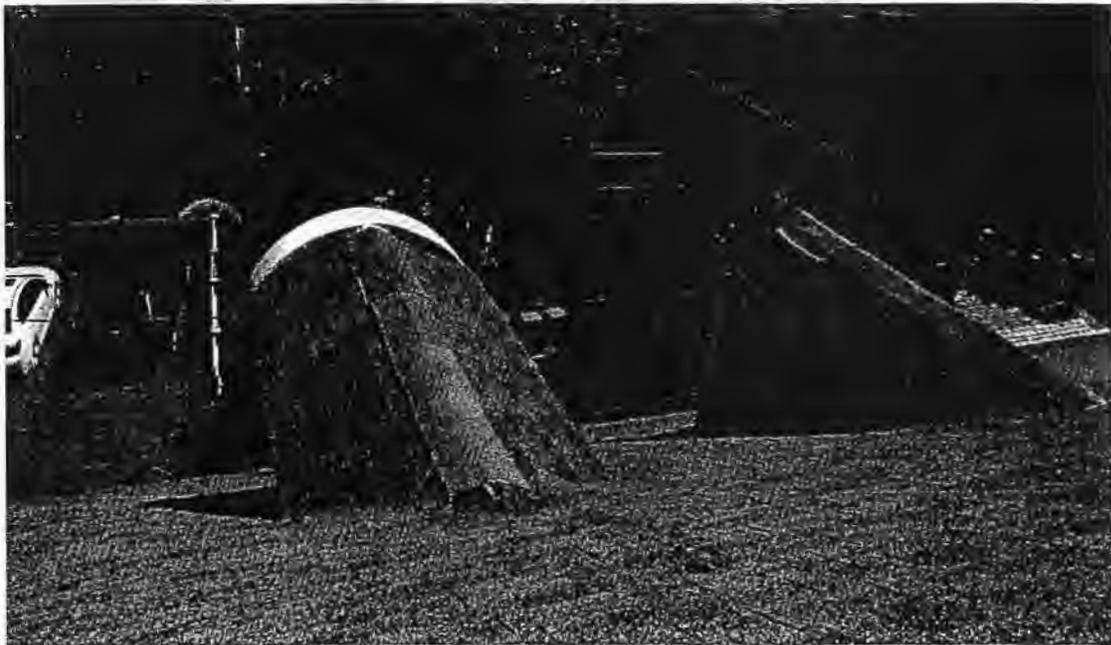
The roofs on the front dormers show some damage as can be seen on the right hand side dormer in the photograph below. The area of the green patches is not damage or repair but a venting mechanism for the dormers. Also, repairs have been made where the dormer roof meet the main roof. It would appear that the asphalt shingles split over this connection and a piece of lead flashing was added to stop leaks.

The roof portions of the 4 dormers are covered under the main roofing project. The trim, clapboards, windows and possibly some of the sheathing will need repairs. It is typically better to make these repairs in conjunction with the roofing project. This includes scraping, priming and painting of each of the 4 dormers. This also includes the 4 pairs of window sash.

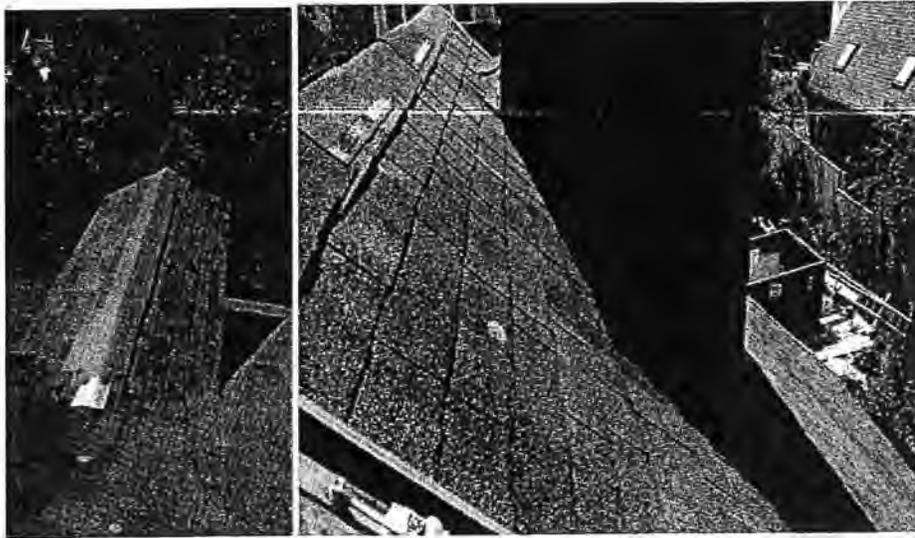
The dormer on the north side of the roof shows signs of repairs as well as shingles that are missing towards the edges.

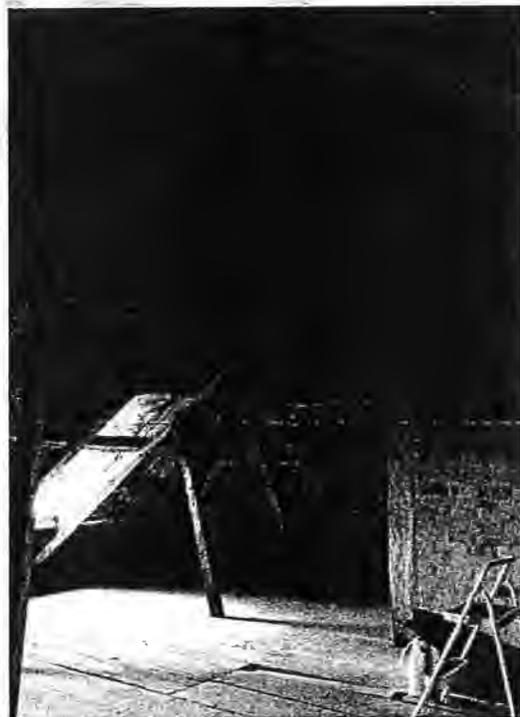
The roof framing as well as the roof sheathing boards are exposed in the attic with the exception of the finished room in the south east corner. The rafters, purlins and roof boards are in reasonable condition with some signs of deflection. The asphalt roofing appears to be nailed directly onto the exterior surface of the roof sheathing boards.

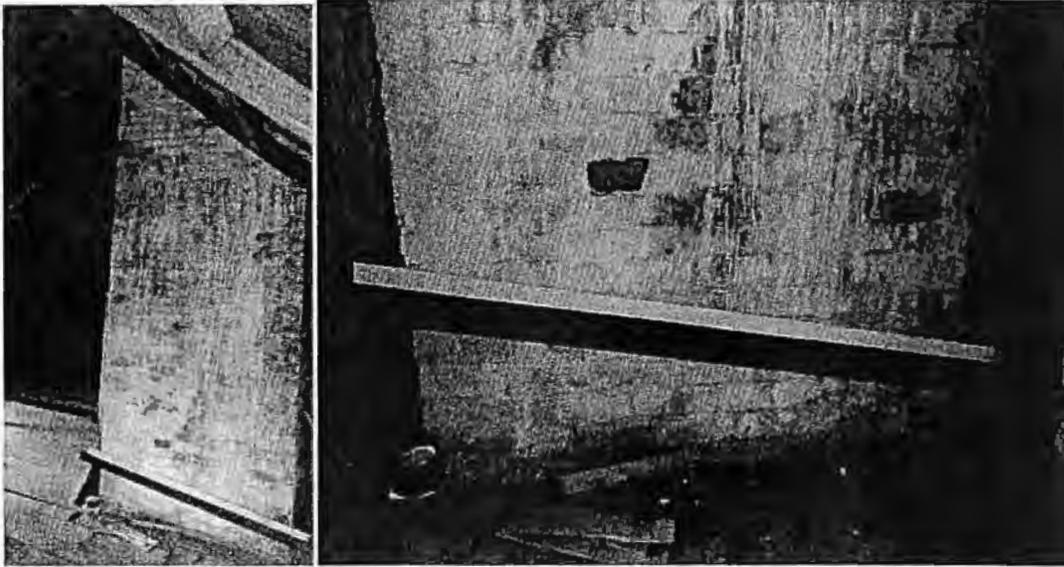
Chimneys and chimney flashing while appearing to be in reasonable condition, especially along the west chimney, is the source of leaking. In an effort to protect TLH from water damage a "make-do" arrangement has been made to collect water from the front and side of the chimney as can be seen in the photo below. Please notice the water marks on the chimney where water has gotten past the flashing and washed down the chimney.

The chimneys are in need of repairs including replacement of lead flashing in various areas. Some bricks may have to be removed between the attic floor and the roof line due to spalling. After the repairs are made those areas should be parged again and blended-in with the existing parging. A small cricket should be installed on the front side (southerly side) of the western chimney.

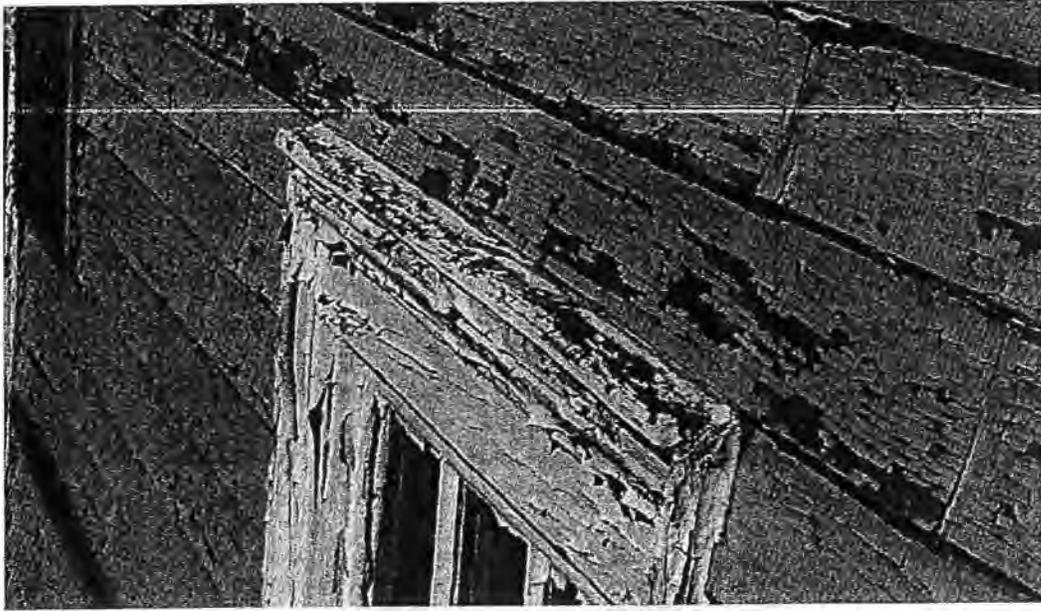
The small window caps on the lower windows are rotted and need to be replaced as well as the deteriorated lead flashing. See the photo below.

The small window caps on the two lower windows shall be replaced in kind and shall receive new lead flashing. Window frames and sills will be repaired as needed.

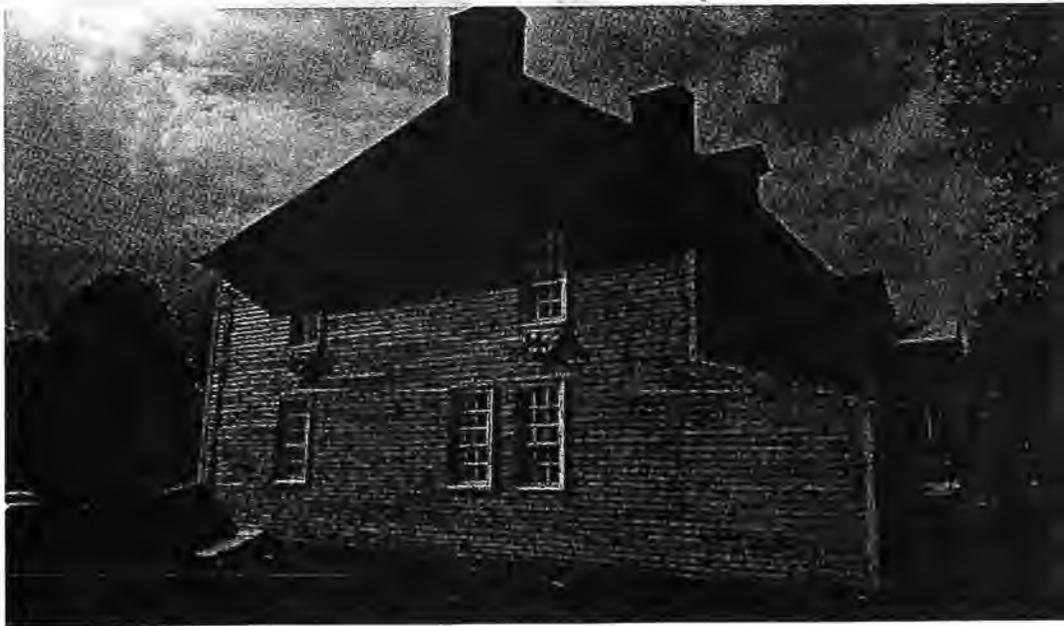
East Façade. The east façade is in reasonable condition concerning trim/clapboards and the paint is in fair condition. While some clapboards need to be repaired and/or replaced, the majority are still in serviceable condition.

East Façade: The east façade requires approximately 250 lineal ft. of clapboard replacement.

Trim, window frames and sills shall be repaired as needed.

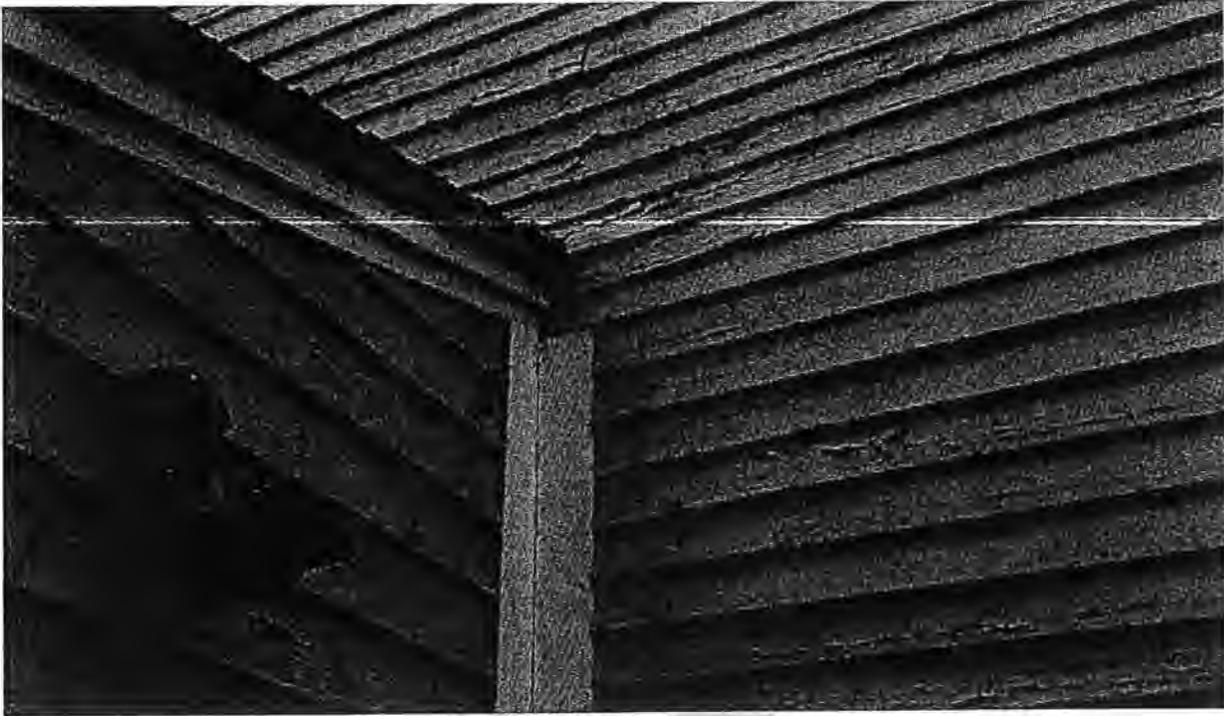
The clapboards above the small ell addition, the clapboards to the left of the door and the area along the sill line to the right of the door to the west gable end will need to be repaired and/or replaced. The photo below shows a close up of the area the corner and above the small shed addition that is need of clapboard repair and/or replacement. The trim in this area is also suspect.

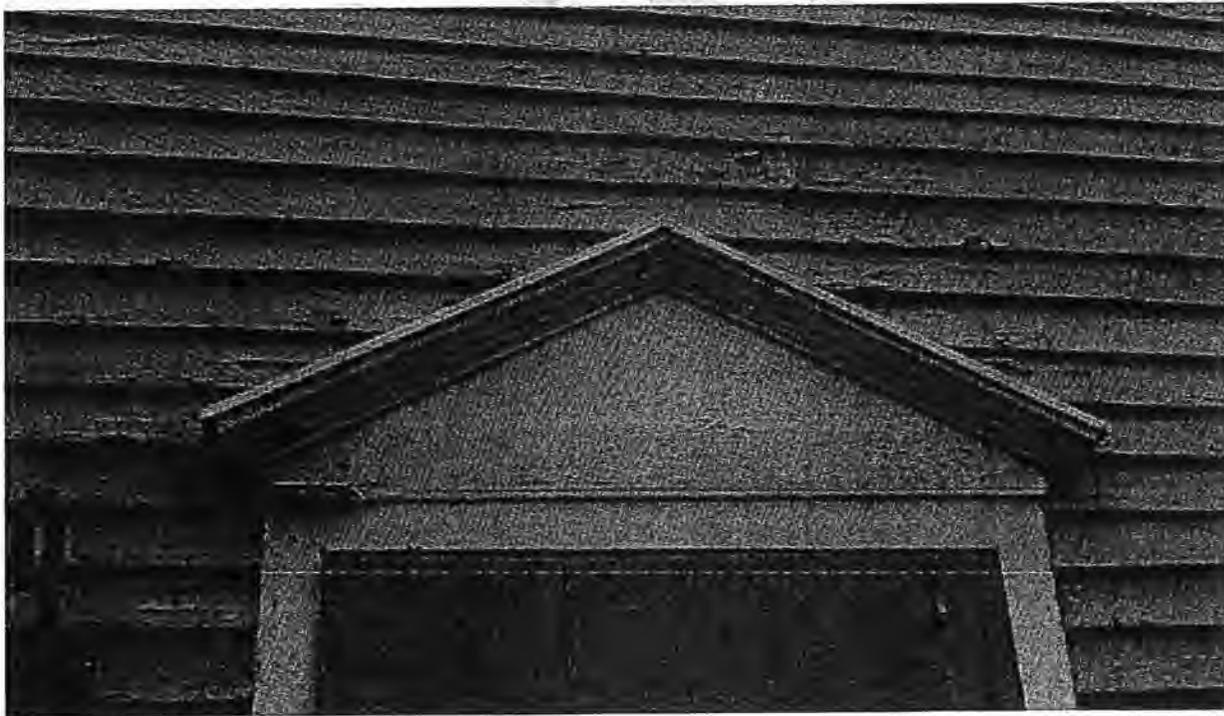
The crown molding return that helps form the pediment as well as the backer board for the pediment above the door are in need of repair. See below.

The bottom of the trim on either side of the door also needs repaired.

The area to the left and right of the back door of TLH will be repaired as needed.

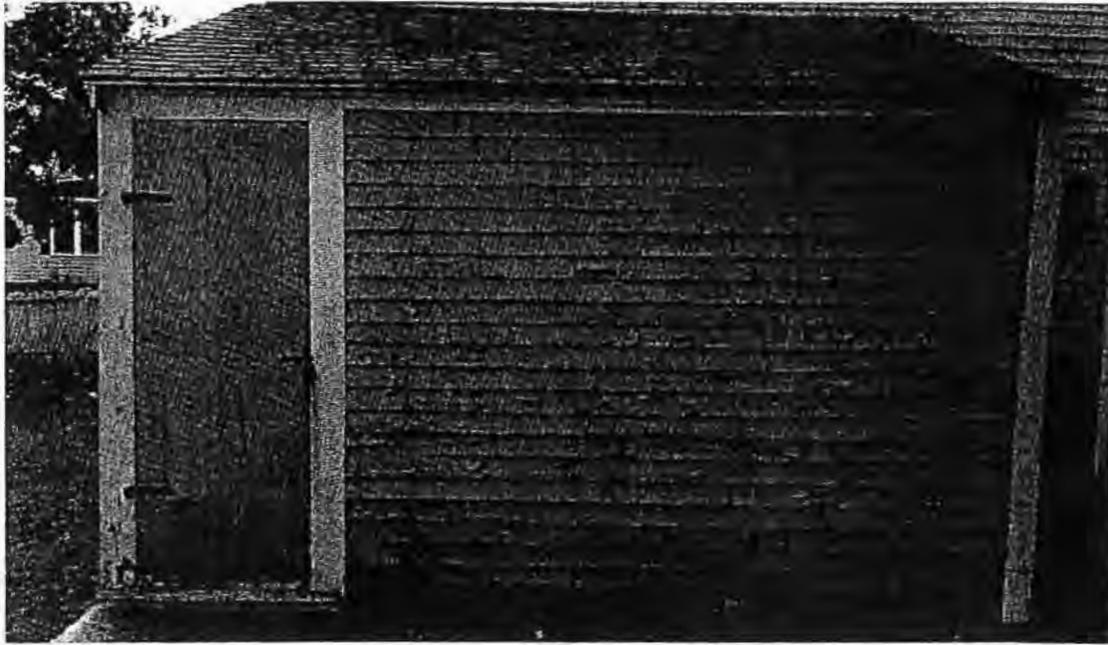
The small shed addition is in need of clapboard repair, especially along the sill line. This would also include replacing the sheathing in that area. The bottom of the exterior door trim needs to be repaired and the threshold and kick board also need to be repaired and/or replaced.

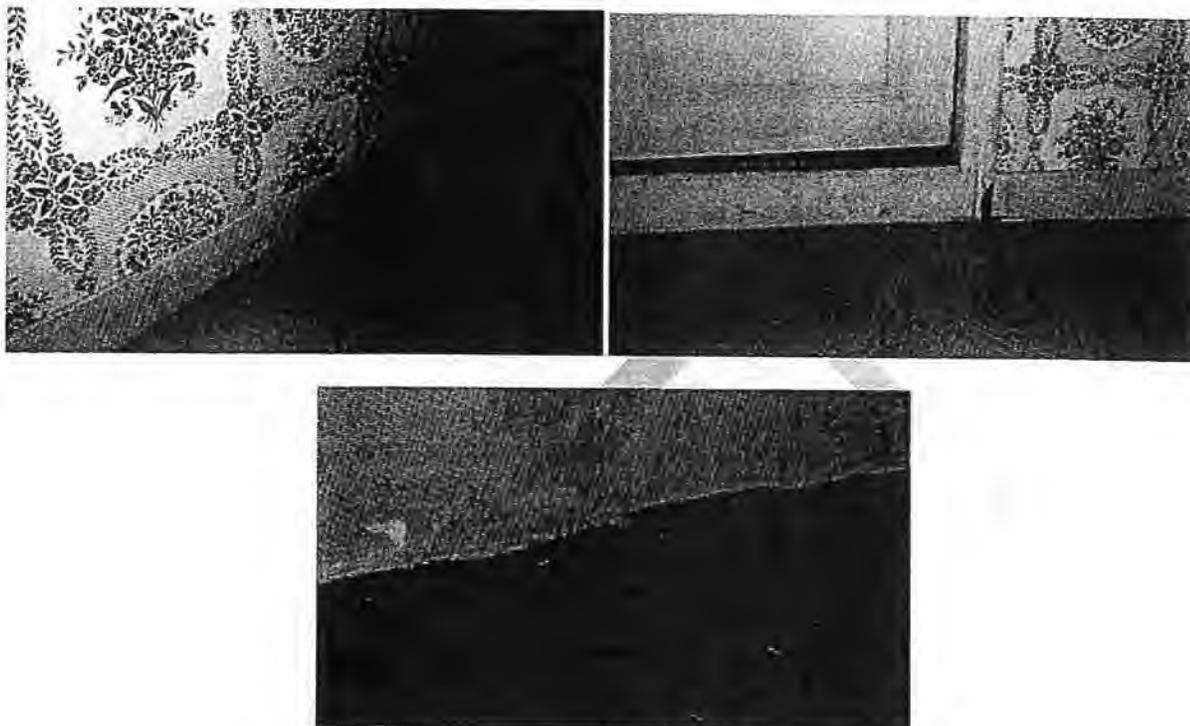
As can be seen in the photos below, the baseboard along the wall that is common with the northwest room is rotted where it meets the floor. This rot is most likely from moisture from the basement migrating up into the wall cavity. The third photo shows the damage to the baseboard on the other side of the wall in the Northwest room.

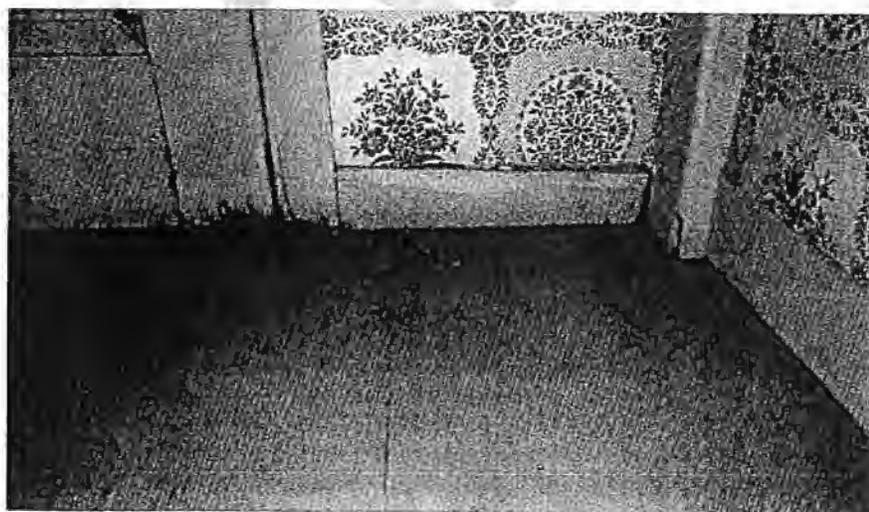
The area to the right of the front door along the baseboard also needs work

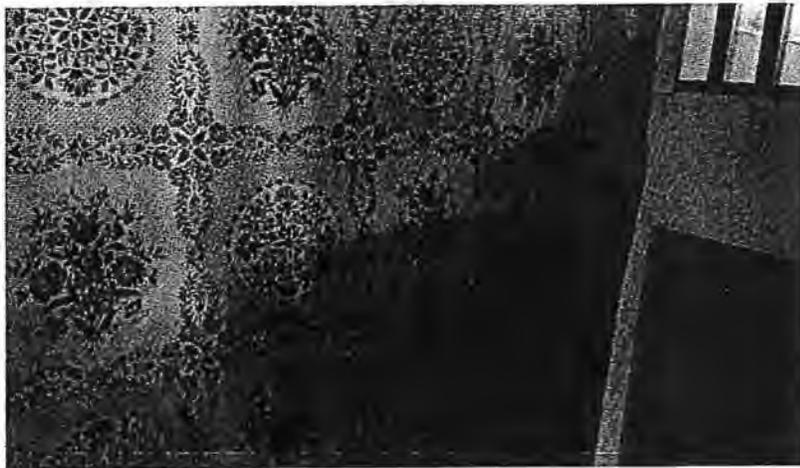
At the second floor framing plaster wall on the easterly side of the stairs there is a large bulge in the plaster wall.

This could be caused from a settling of the plaster/lath during the reconstruction of the first floor framing, a separation of the plaster from the lath and/or some other unknown cause.

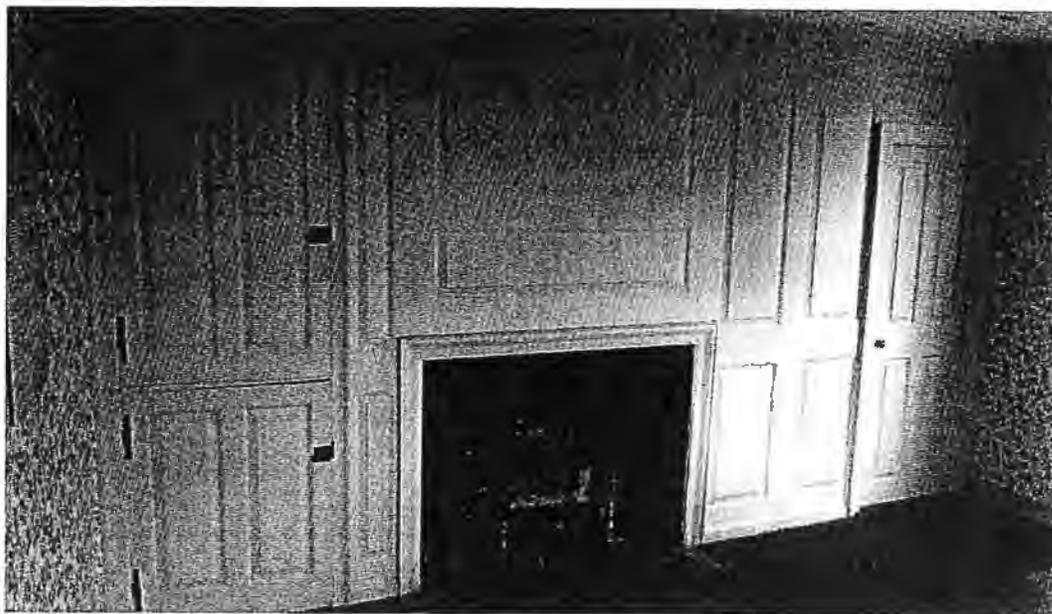
The front sitting room is in reasonable condition. The paneled wall and fireplace surround are in good condition.

The bricks on the back of the fireplace are in poor condition

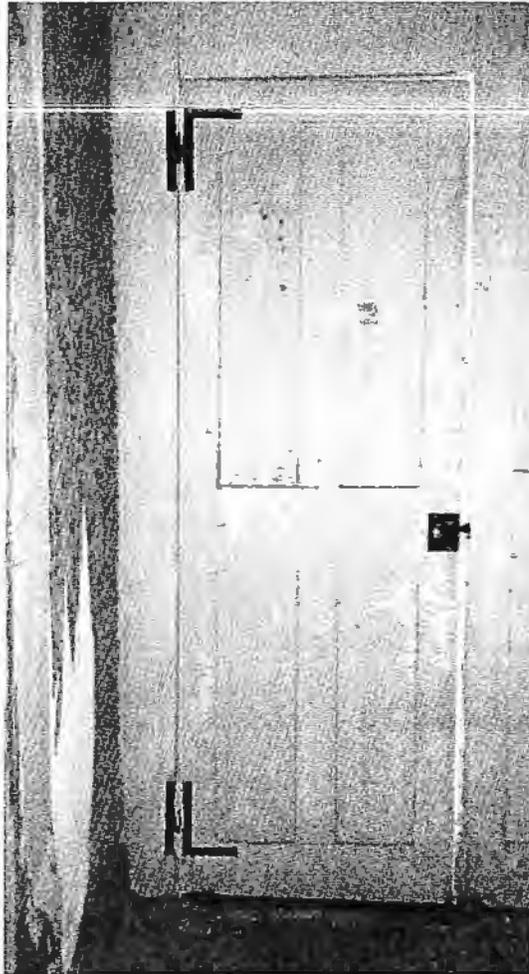
The exterior wall space in this area is in poor condition. At one point bead board sheathing was added to the wall surface in this space. This surface was then wallpapered.

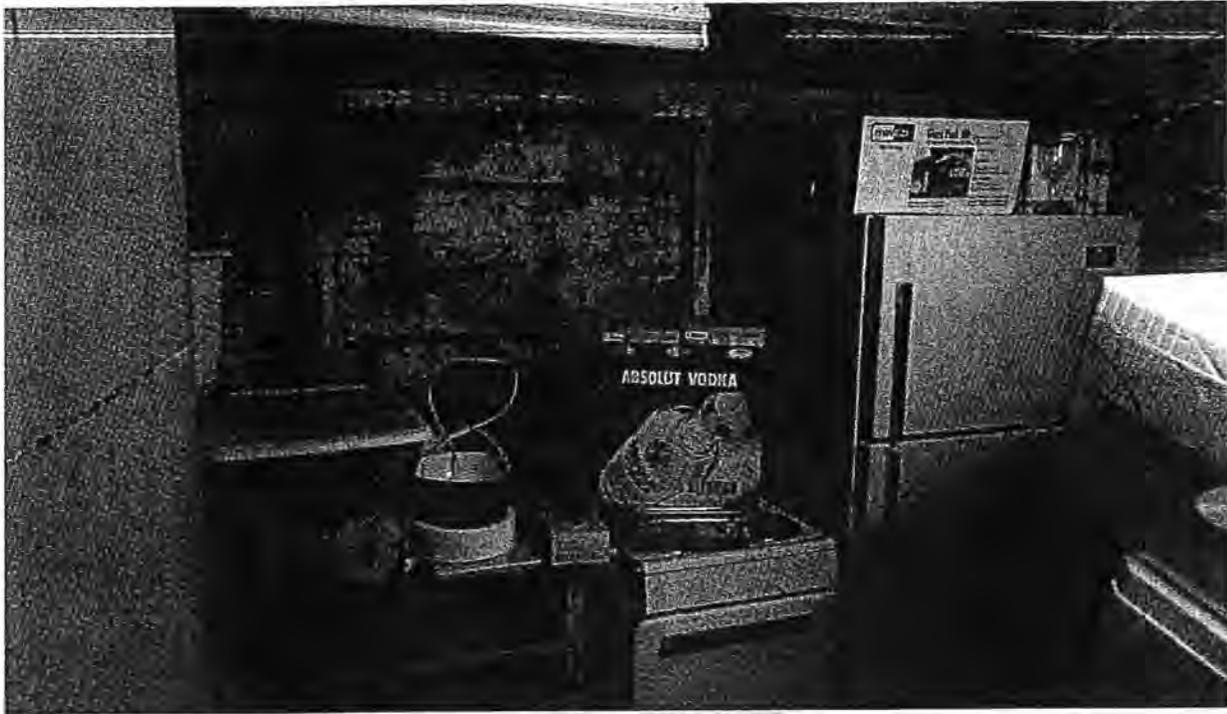
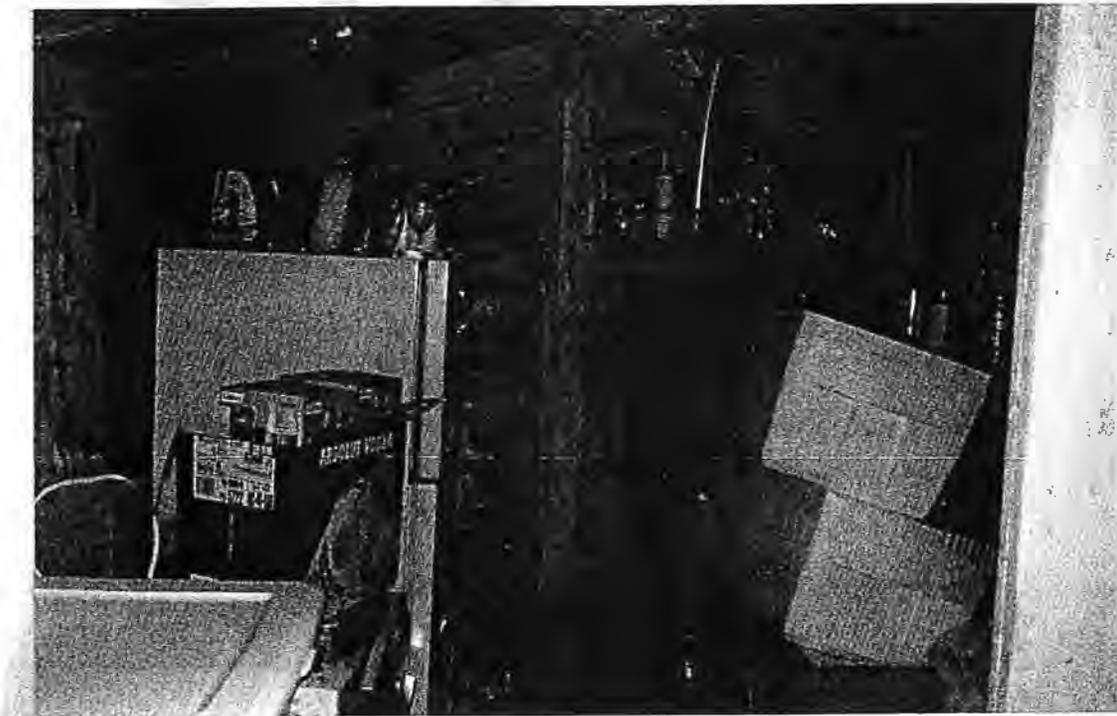
The small shed addition houses a sink, stove, refrigerator, work space and a separate half bathroom. The condition of the space that contains the sink, stove, refrigerator and workspace is in very poor condition.
