Re: Zoning Relief
Stephen M. Foster, Applicant
Wentworth-Gardner & Tobias Lear Historic Houses Association, Owner
Property: 49 Hunking Street
Tax Map 103, Lot 39
General Residence B (GRB District/Historic District)

The scope of work for the Historic Building Assessment shall include exterior existing conditions, interior existing conditions and estimates for the appropriate repairs/restoration based upon the Secretary of the Interior's Guidelines for the Treatment of Historic Properties.

Existing Exterior Conditions

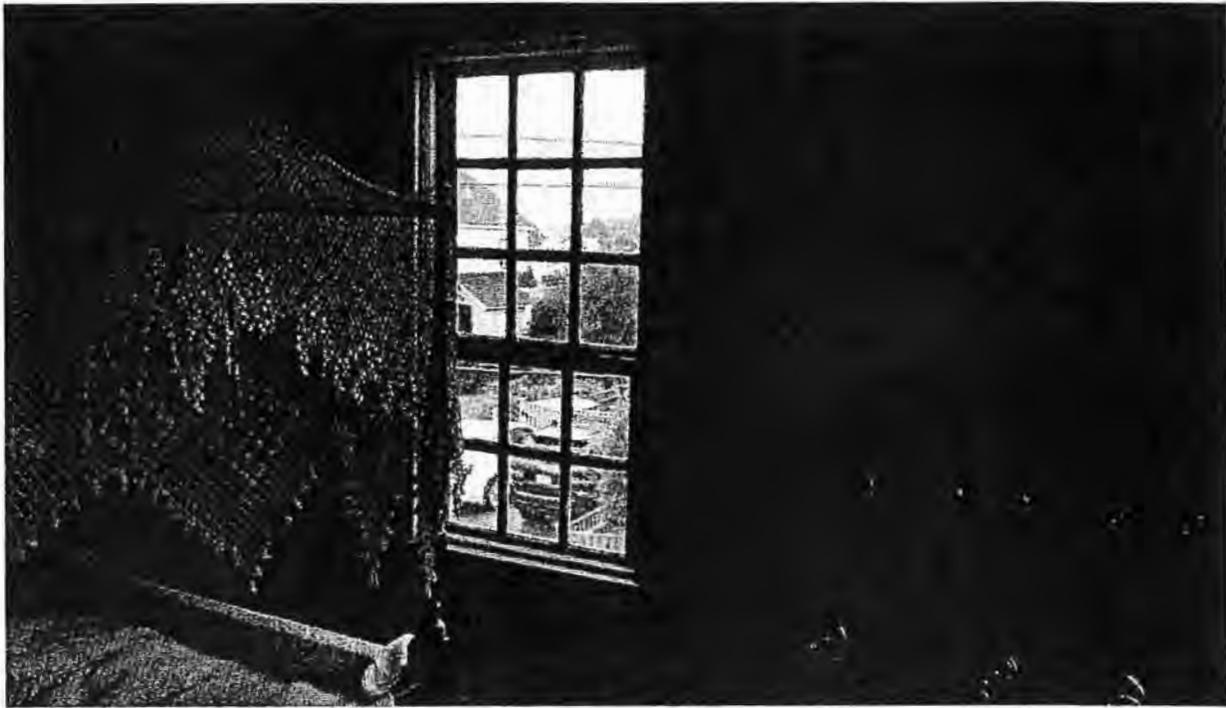
The plaster ceiling and walls of the parlor chamber are in poor condition. In the photograph below, the paint on the sash and window trim is peeling badly and water stains and cracking plaster can be seen below the window.

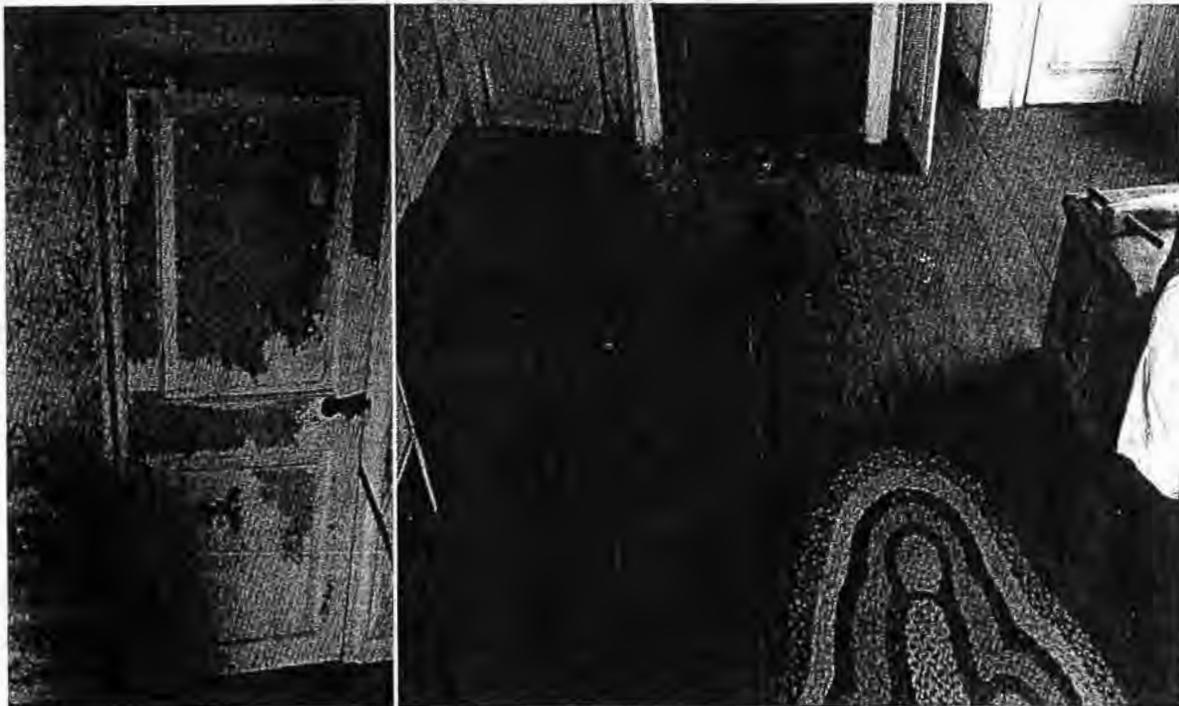
The plaster ceiling and walls of the sitting room chamber are in poor condition. The floors are of old painted pine and are in good condition.

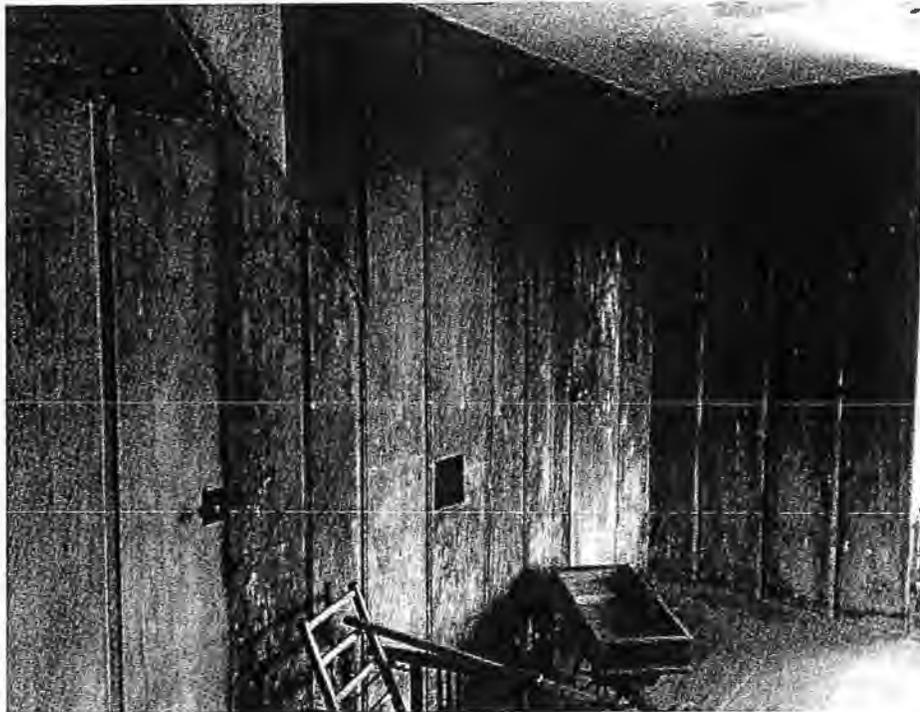
Kitchen Chamber. The kitchen chamber is in overall poor condition. The fireplace is to the right of the passageway from the sitting room chamber and the fireplace back is in need of repair. The area to the right of the fireplace is a closet that is located underneath the stairway to the attic.

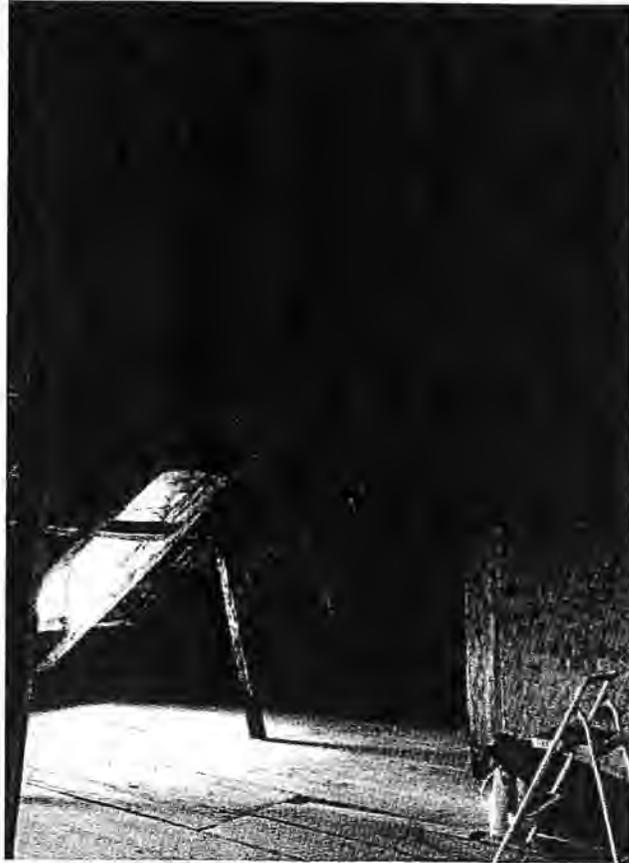
There is a stairway in the attic that leads to the roof hatch. This stairway at some point was deemed "too weak" and some 2 x 4's were added alongside for support.

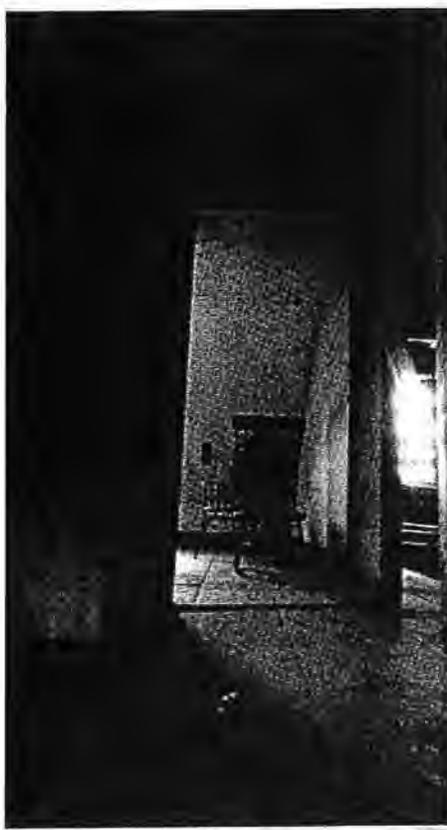
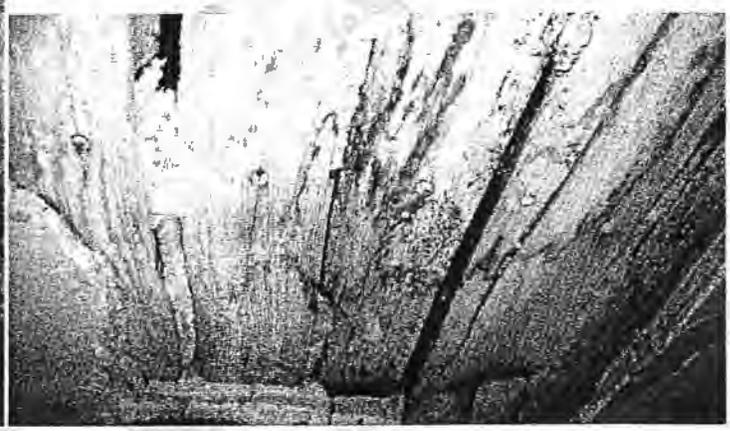
A plastered finished room is located in the southeasterly corner of the attic. The overall all condition of the room is fair, with needed plaster repairs to the ceiling and walls.
