Historic District Commission

14 Mechanic Street Portsmouth, NH

October 2019 Work Session Summary

Early features of this vernacular home

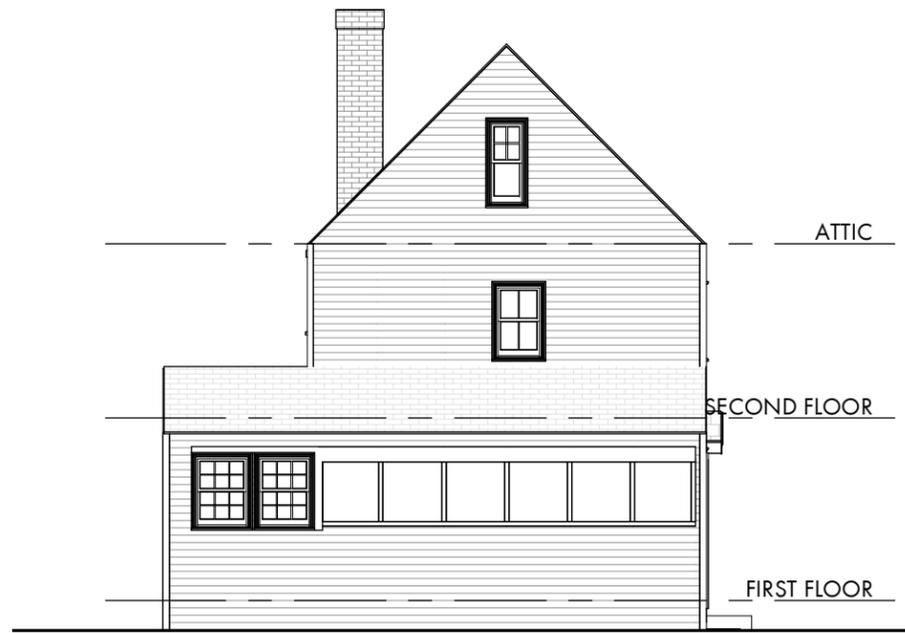
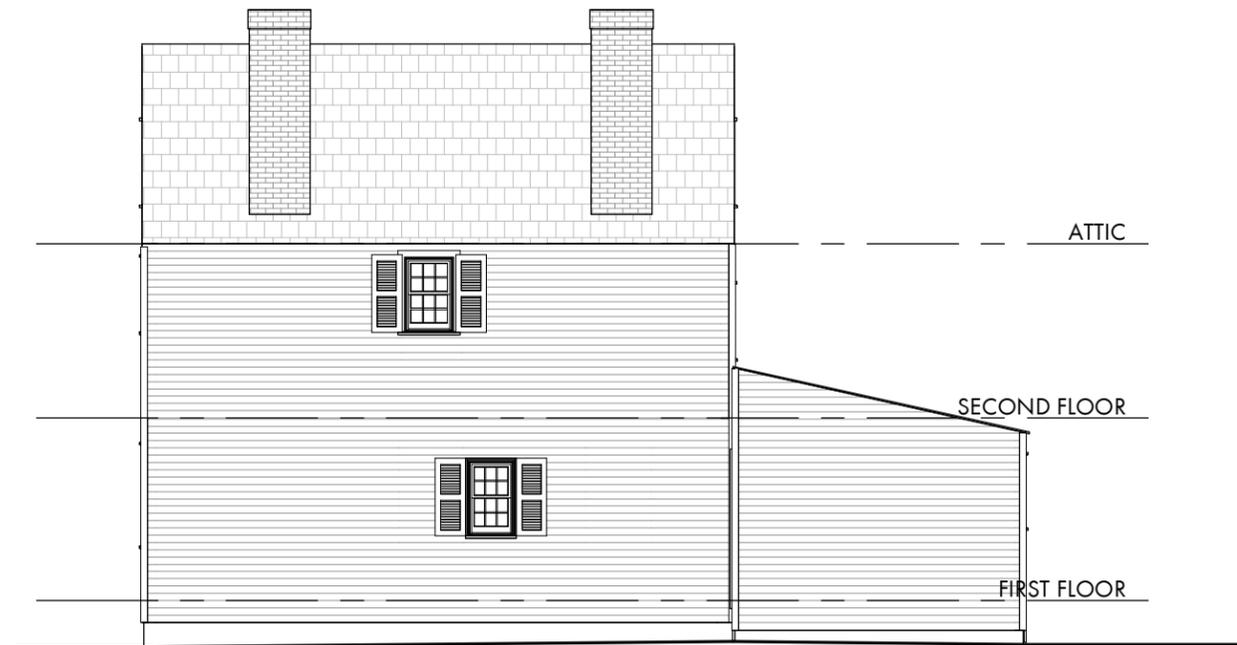
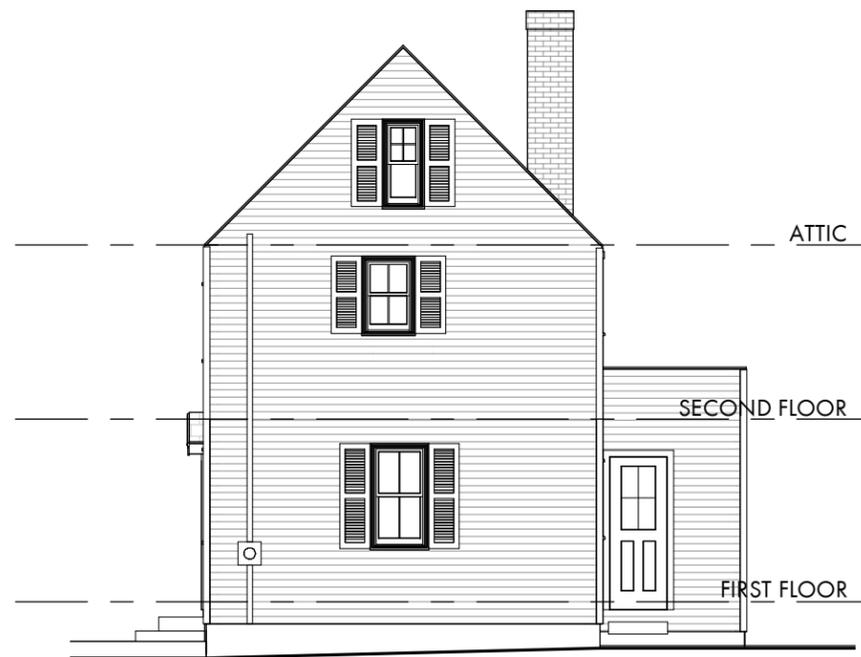
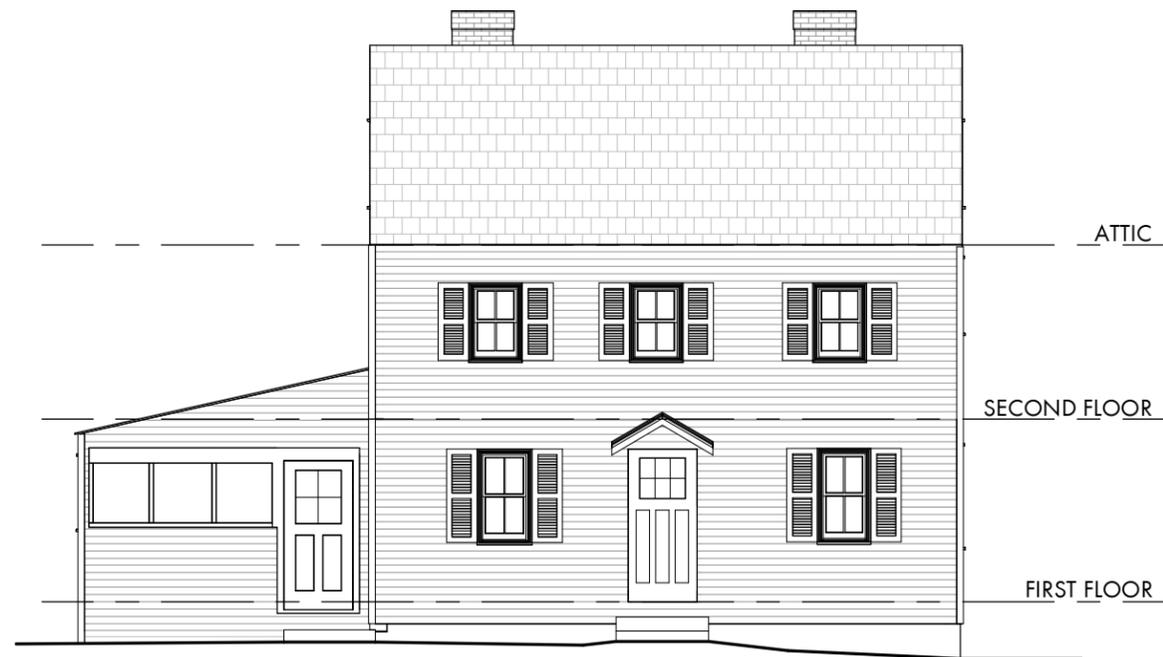
EXISTING ELEVATIONS

The existing home is clad with aluminum siding, and the original windows have been replaced with windows of varying age and levels of disrepair. The post and beam structure is largely intact but is also in disrepair. Our proposed work included relocating the antique portion of the home and repairing it with wood windows and clapboards and exterior detailing in keeping with neighboring homes.

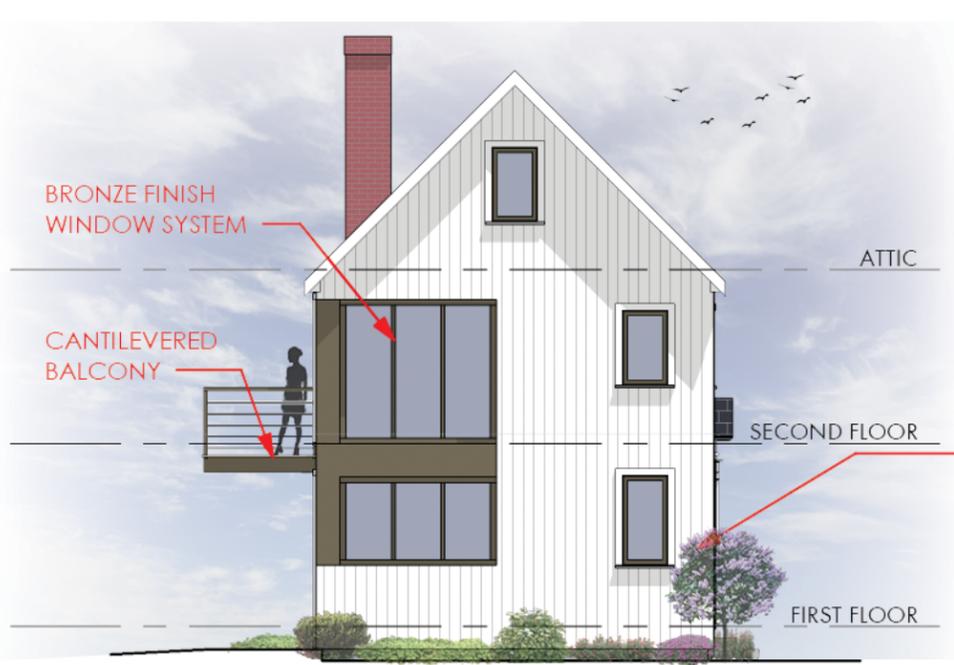
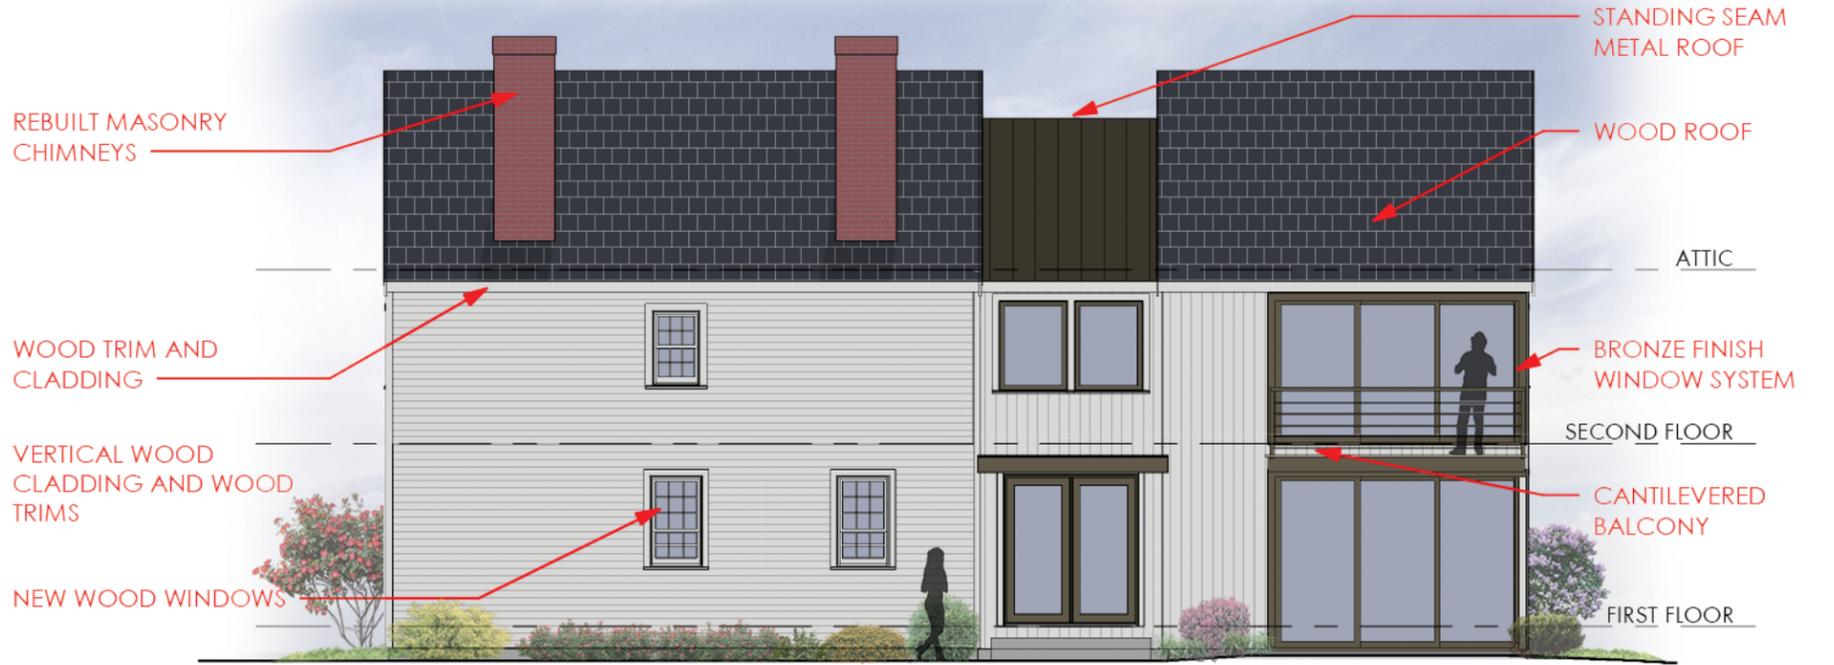
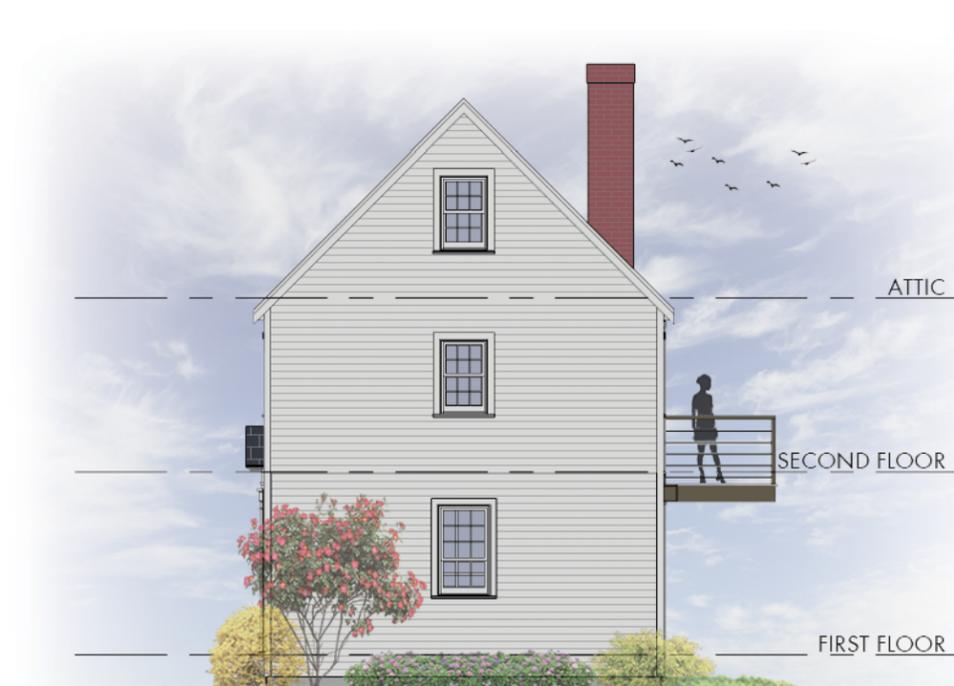
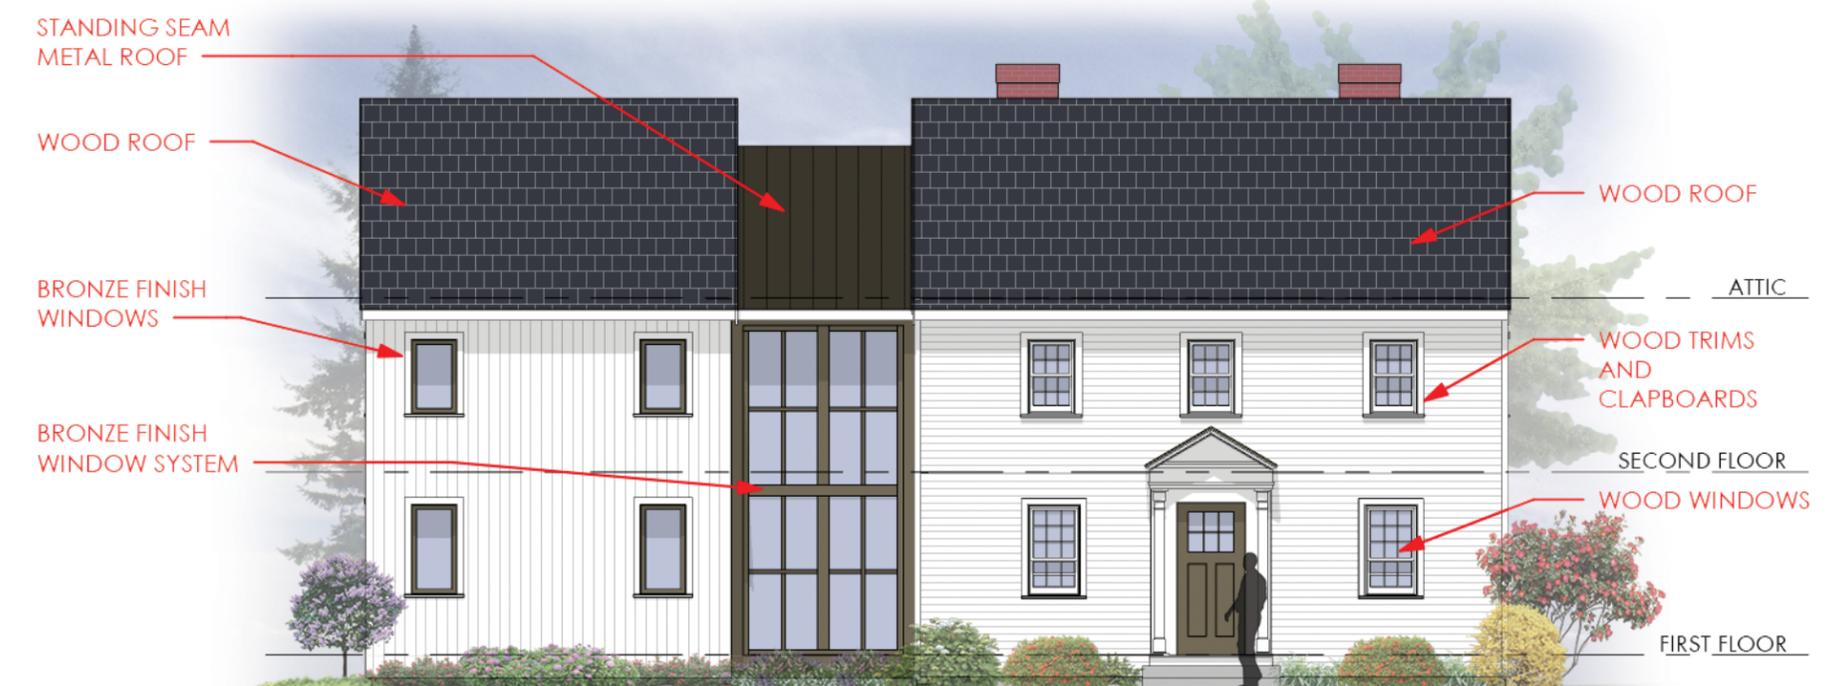
PROPOSED ELEVATIONS

With our understanding from Arron Sturgis of the best approach to properly repair the historic structure and with our desire to limit any additional disturbance within the cemetery buffer, we pursued the option of dismantling and rebuilding the antique home at the corner of Marcy and Mechanic. This portion of the home will be repaired and finished in keeping with its history and it's neighbors. The scope of work includes rebuilding both chimneys.

We designed an addition with similar scale and proportion to the historic home, smaller, with contemporary materials and finishes. Our approach aims to make a clear distinction between the old and new.

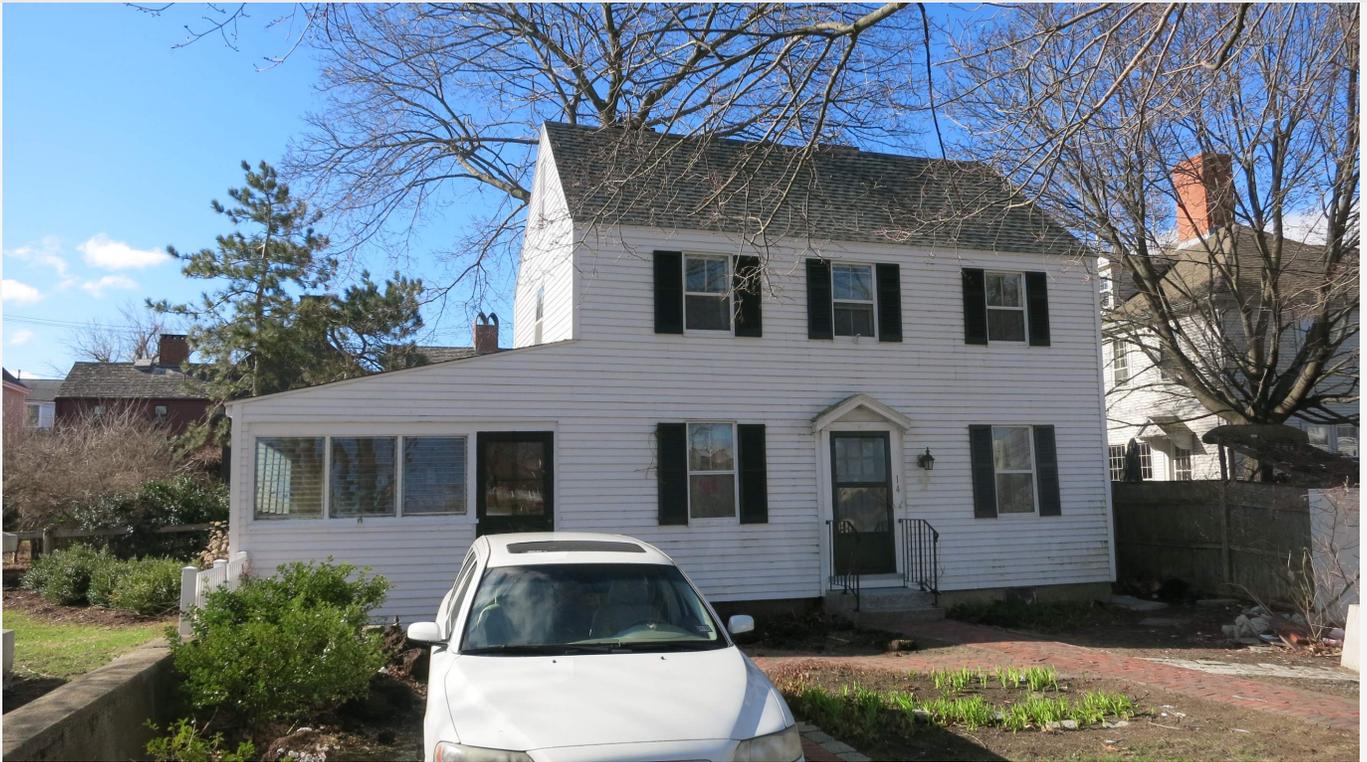
1 14 Mechanic street | Portsmouth, NH Apr 15, 2019 | 11:59 PM Arron Sturgis

14 mechanic street. Two story vernacular, double chimney single residence. Very early.

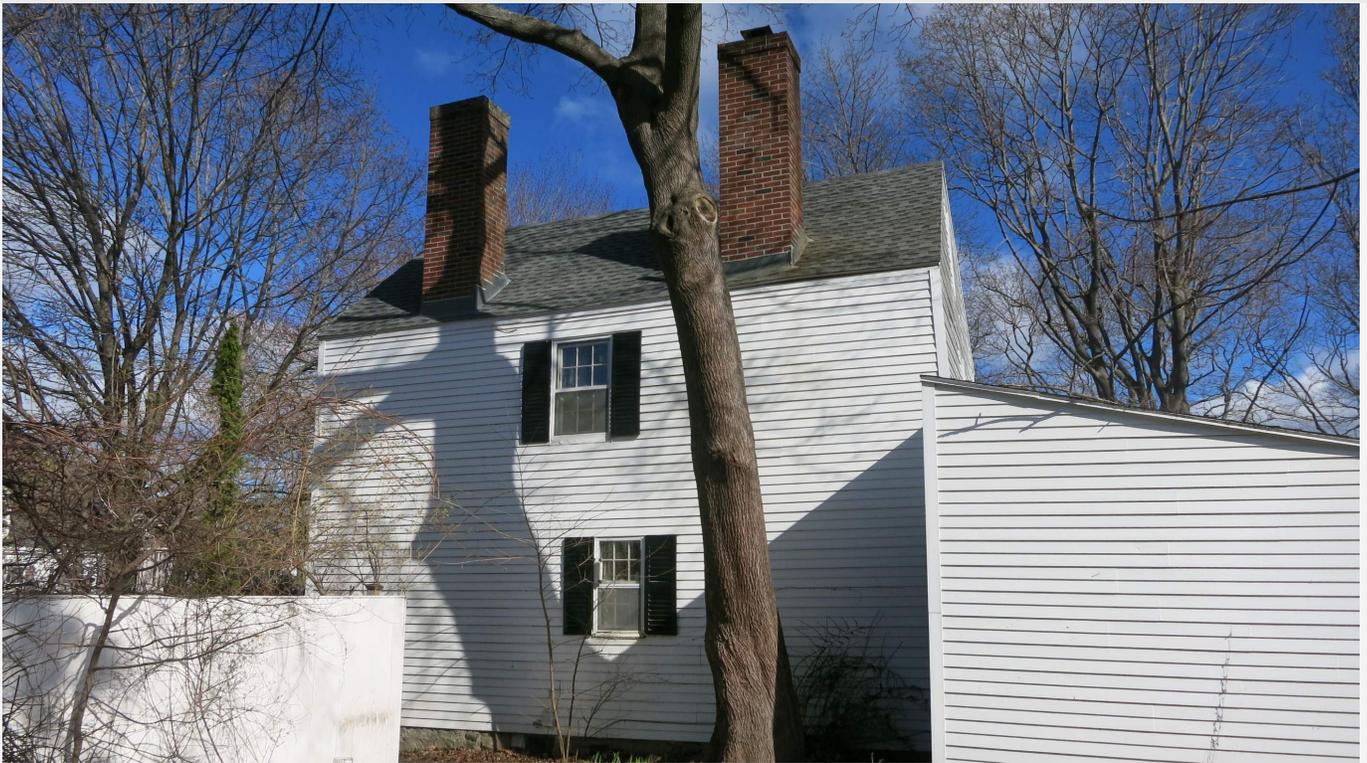
2 14 Mechanic street | Portsmouth, NH Apr 16, 2019 | 12:00 AM Arron Sturgis

Double chimneys rise at rear of structure. A very cozy simple home.

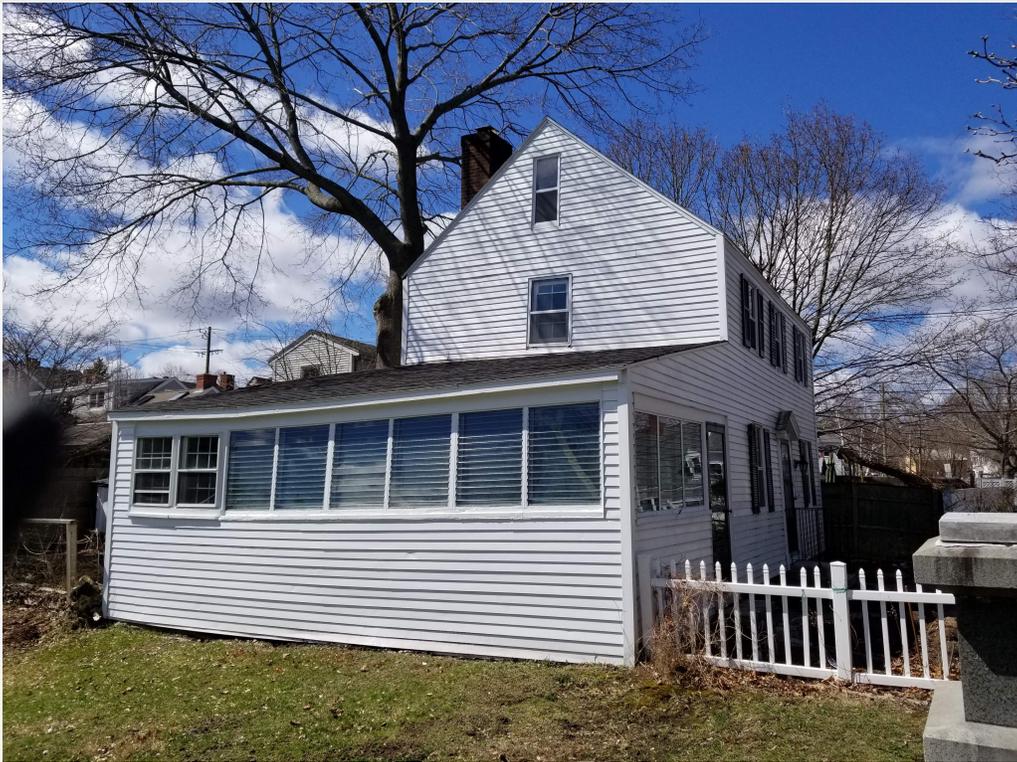
3

An attached ell has been added to the original house frame. It is much later.

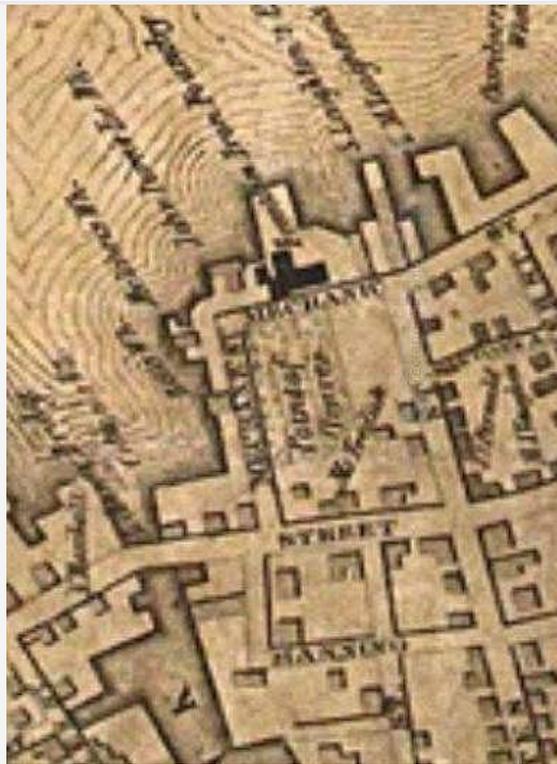
5 14 Mechanic street | Portsmouth, NH Jun 13, 2019 | 3:14 PM Arron Sturgis

The house abuts the cemetery and the house has sat in numerous positions on the lot.

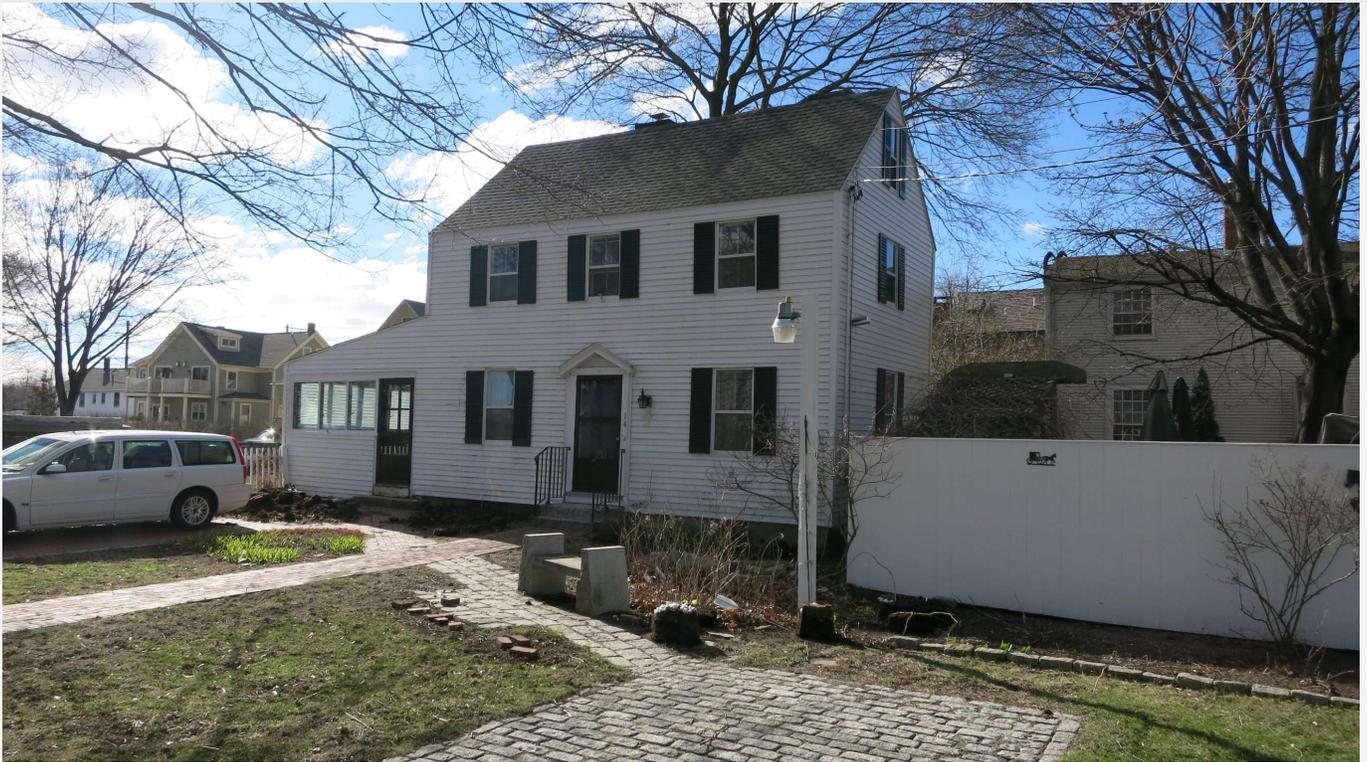
7 14 Mechanic street | Portsmouth, NH Apr 16, 2019 | 12:02 AM Arron Sturgis

Simple vernacular lines remain beneath the added aluminum siding.

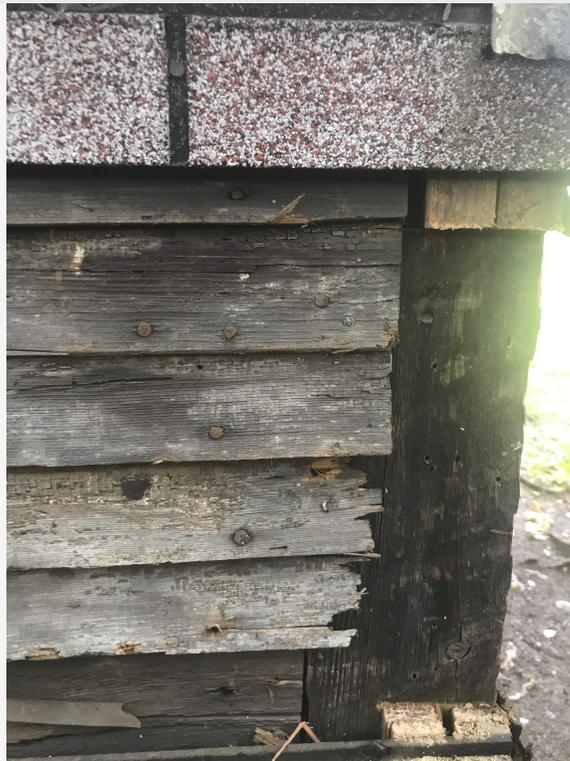
8 14 Mechanic street | Portsmouth, NH Sep 23, 2019 | 9:51 AM Arron Sturgis

Early original clapboards lie beneath a layer of faux brick face siding. Aluminum siding exists on the entire building facade.

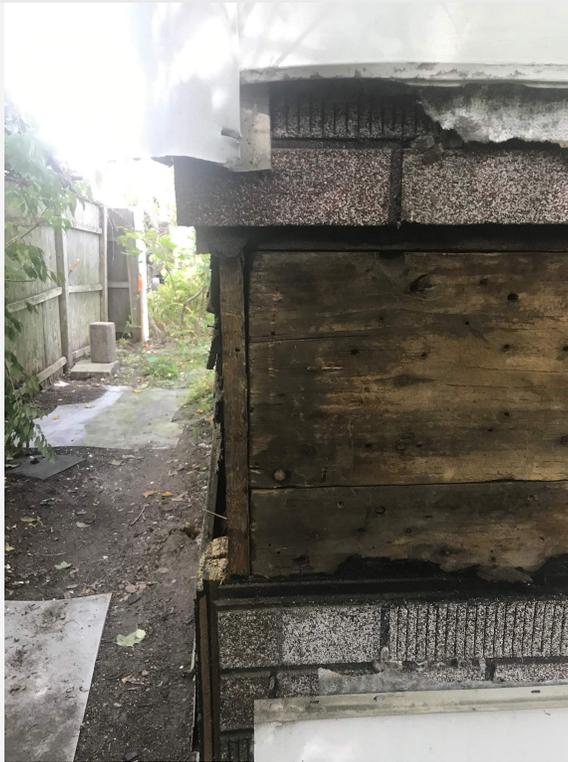
9

At the back eave it is clear that existing sheathing was clad with wood shingles. The nail pattern provides spacing of shingles.

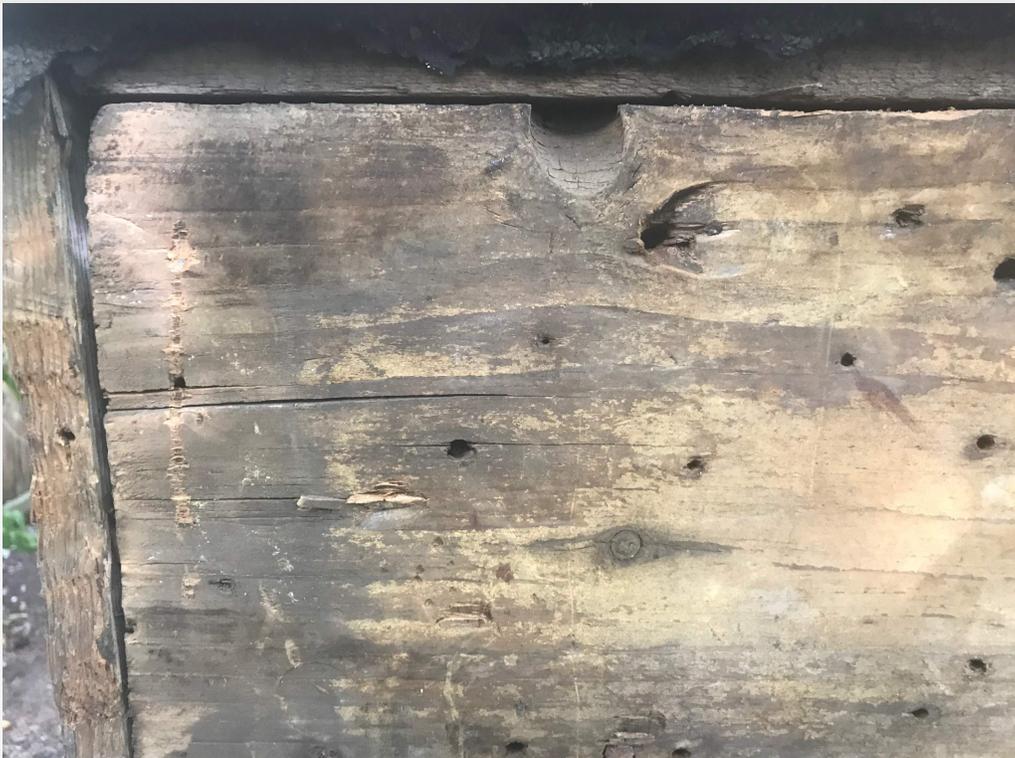
10

A close view of nail patterns indicating wood shingle siding along the back eave of the house.

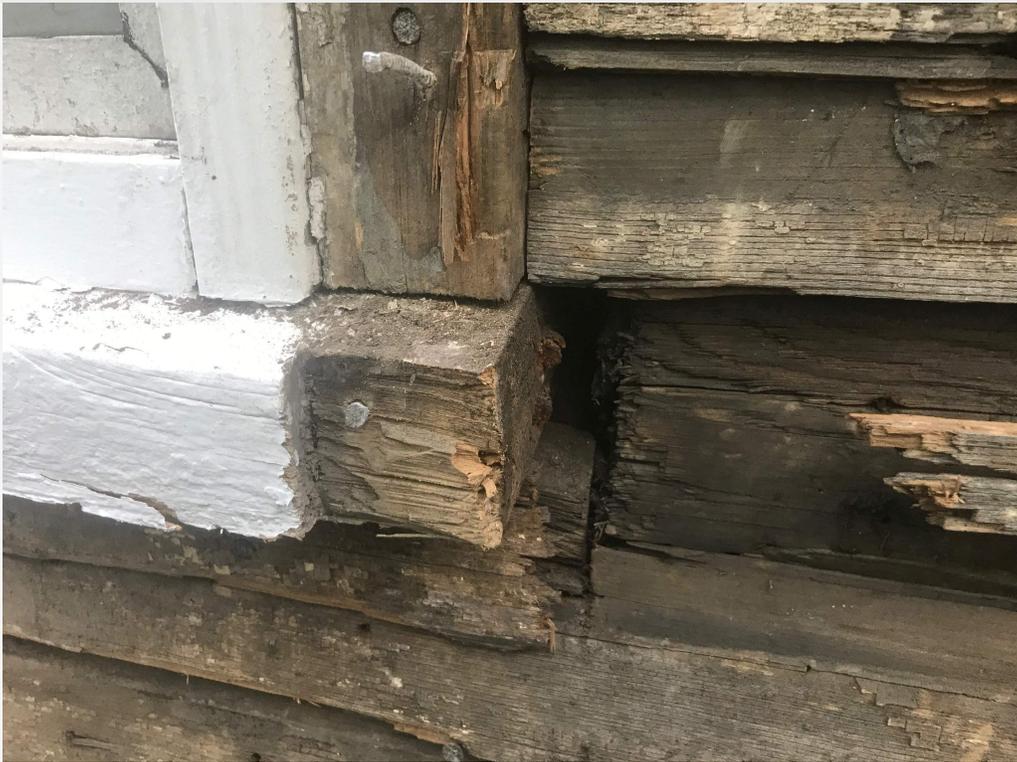
11

Window sash are not original. Window sills have been cut back to allow for aluminum siding installation. Window trim has been removed. Early clapboards butt up to the window jamb. It appears that the window sill nose would have extended into the clapboard profile.

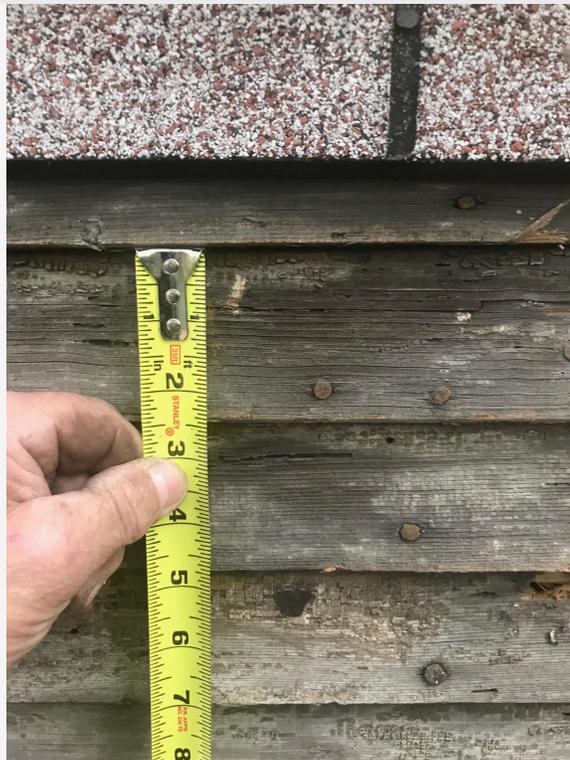
12

The clapboards show a reveal to weather of about 2-1/4 inch consistently. This is a small reveal by today's standards. The clapboards appear to be radially sawn pine. The nails are a very early version of cut nails with nail heads added to the shank after conversion.

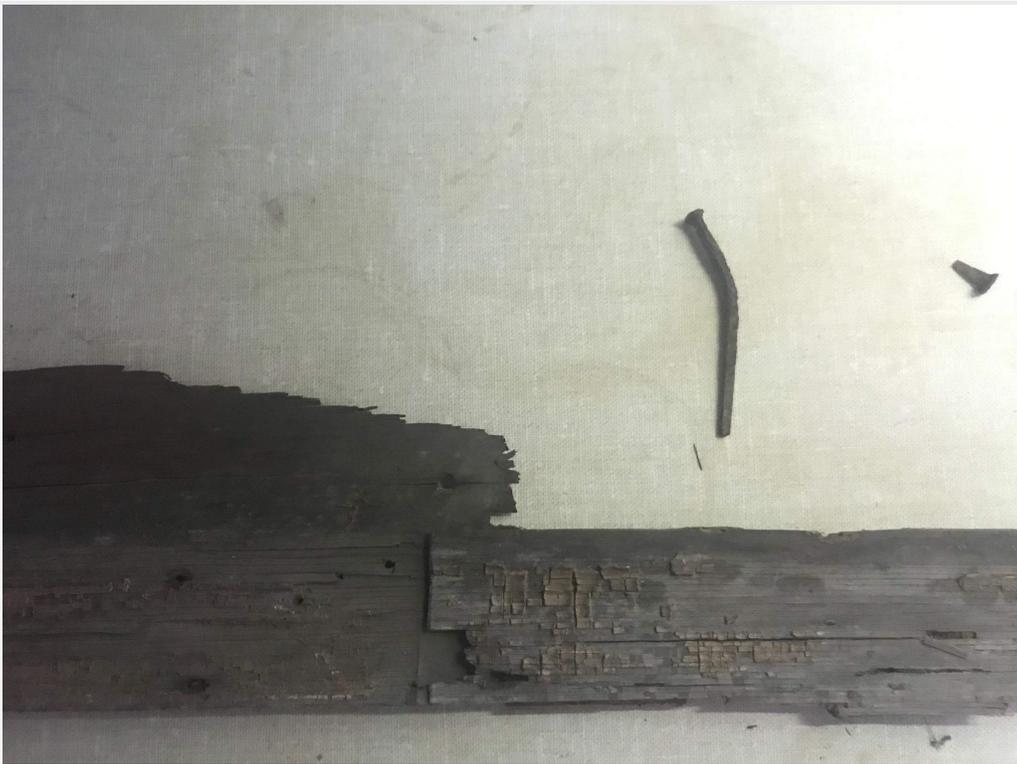
13

Original clapboards are skived and fastened with an early version of cut nail.

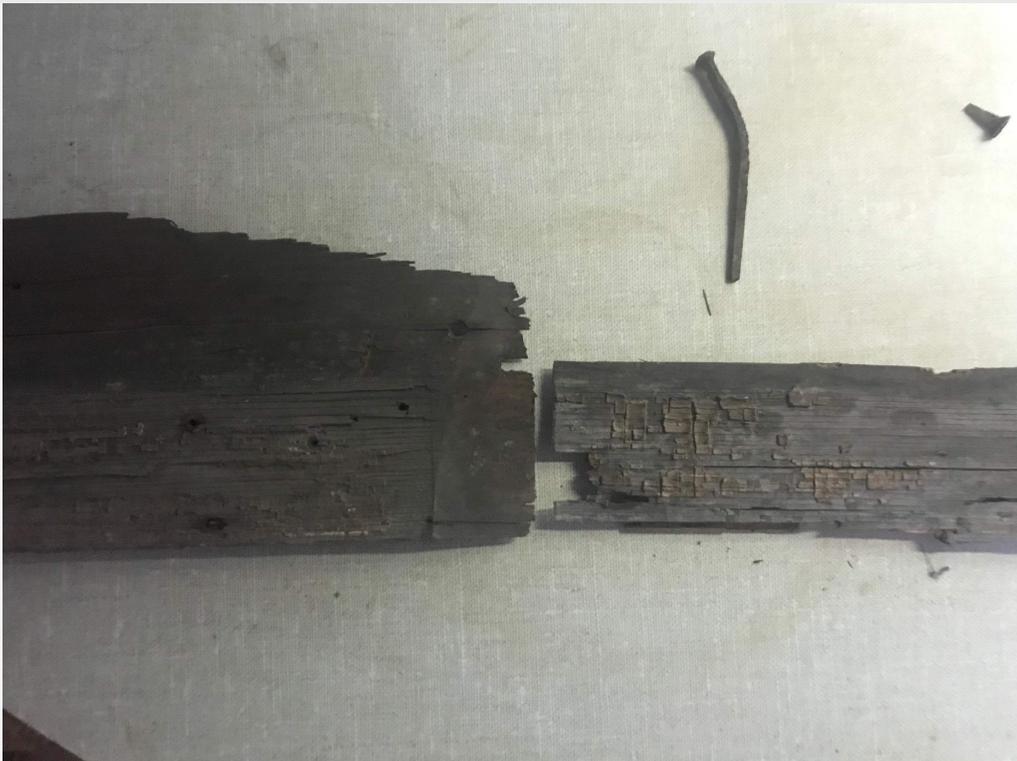
14

Pine clapboards overlap and they are skived where they meet. This is an early way to protect the sheathing behind the clapboards.

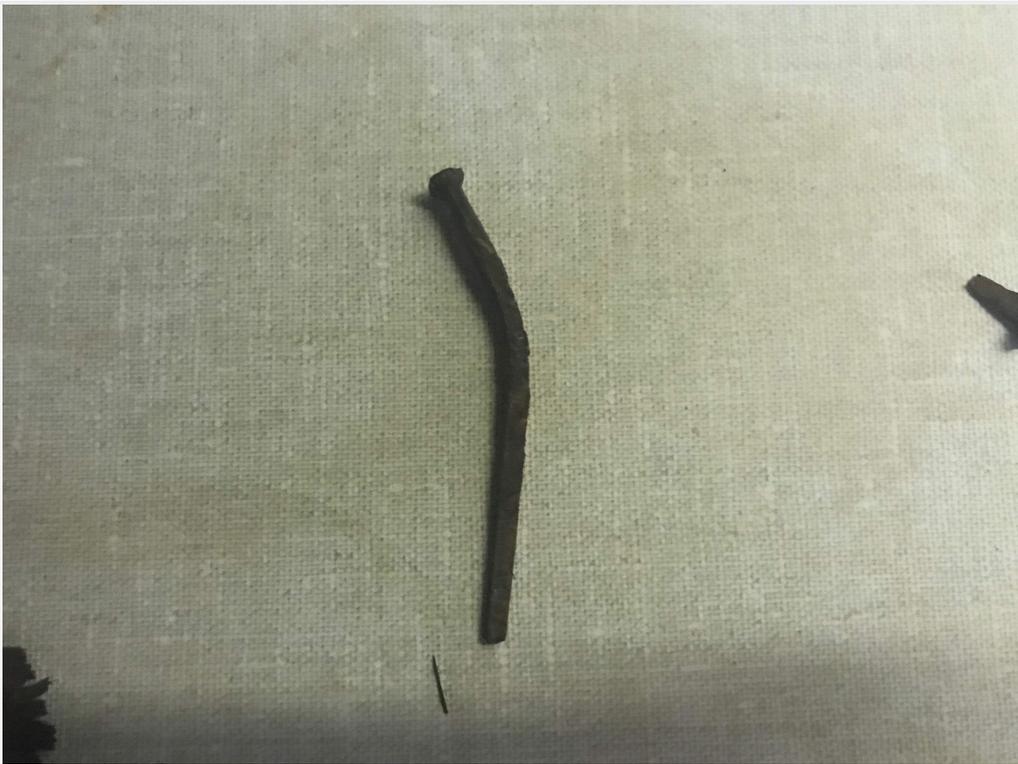
15

This is an early cut nail for the sheathing boards. It has a very narrowing shank with an added head.

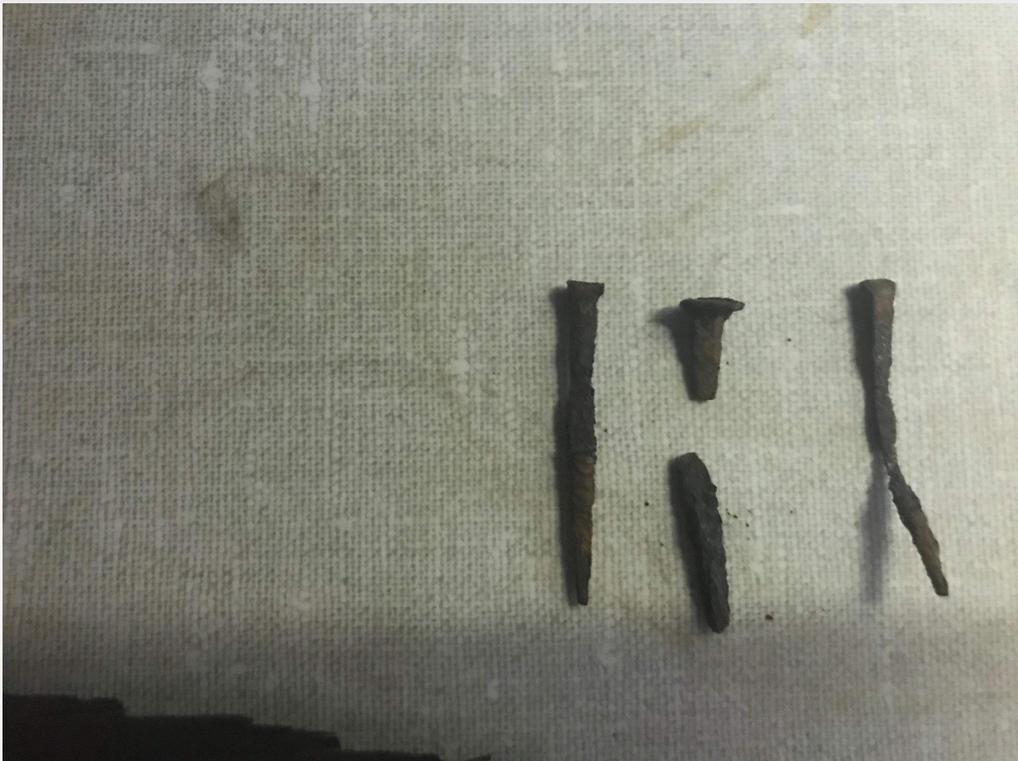
16

Clapboard nails also appear early with added heads on tapered shanks.

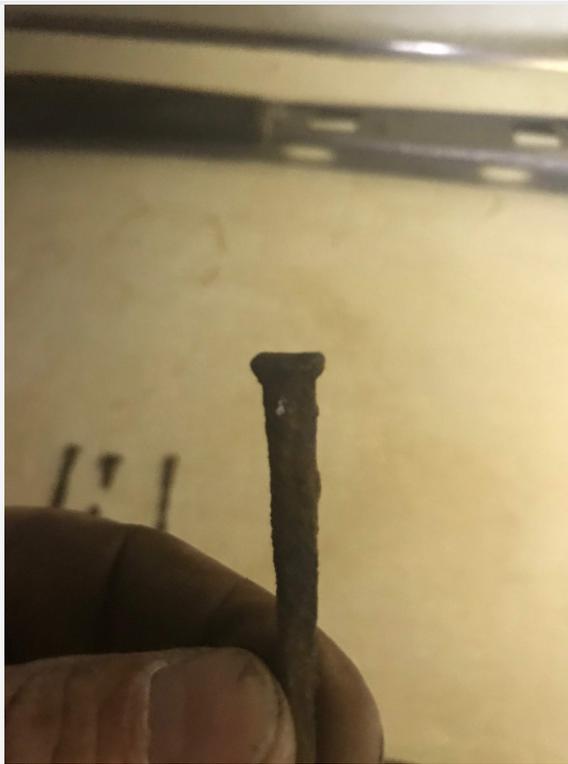
17

A close view shows the taper of the cut nail and a slight machine pinch where the each nail was individually headed after the shank was cut out of larger flat stock.

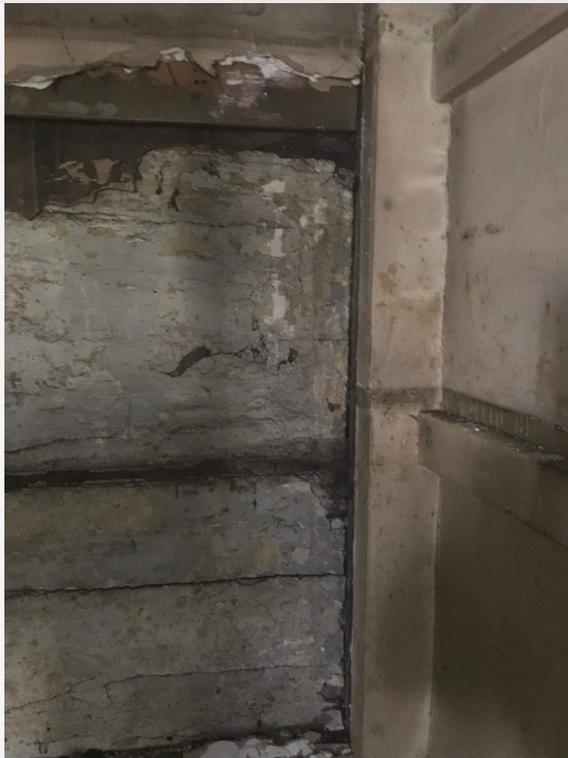
18

Interior: Right rear corner as viewed from the road. Plaster and lathe and a cased timber framed corner post.

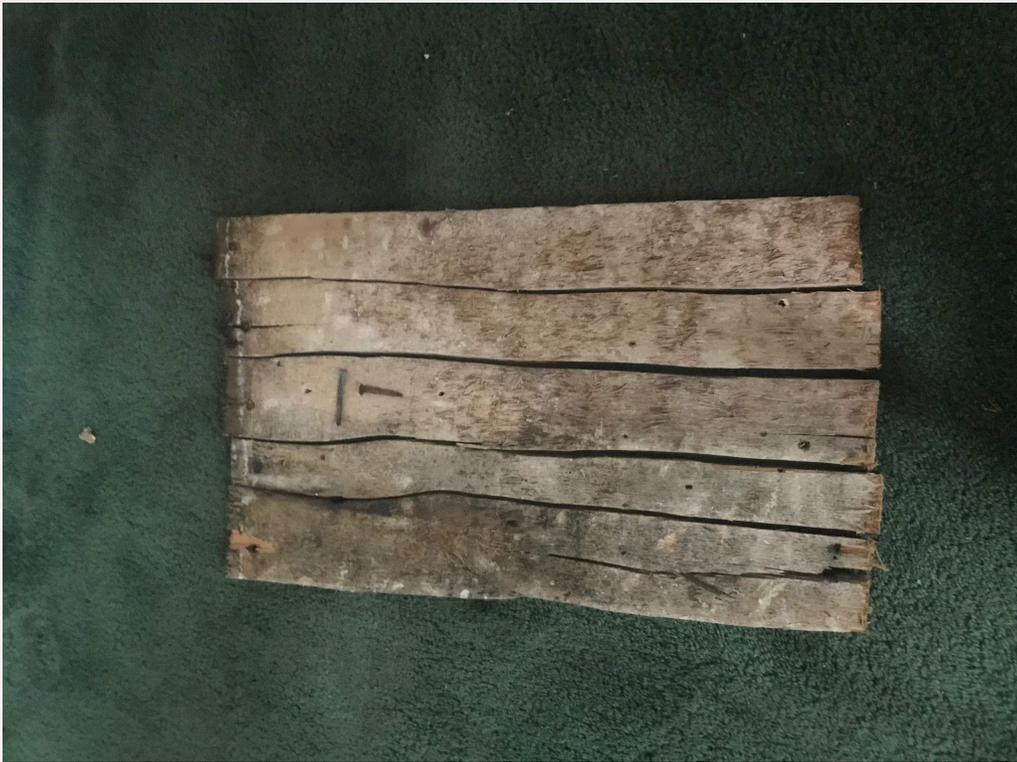
19

Interior: Early thick split lathe removed in section from the right rear corner of the structure to expose timber framing.

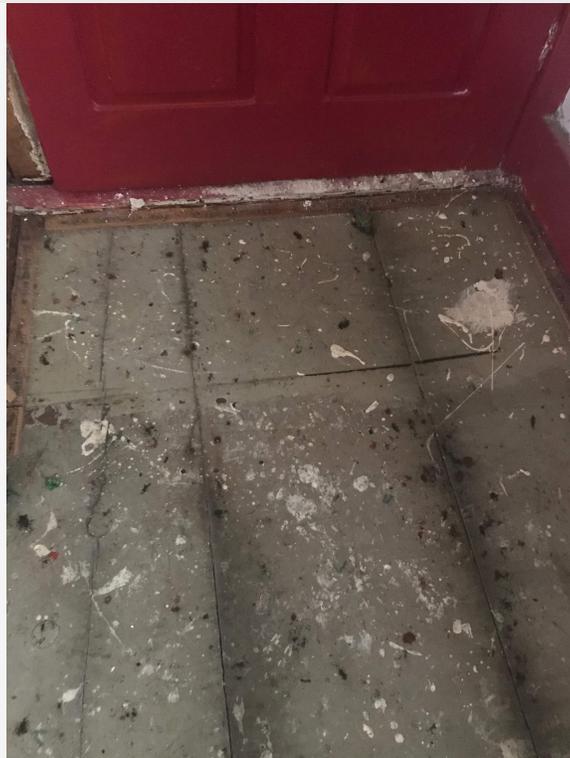
20

Wide pine painted floor boards beneath green carpeting. These floors are in good shape and appear to be original.

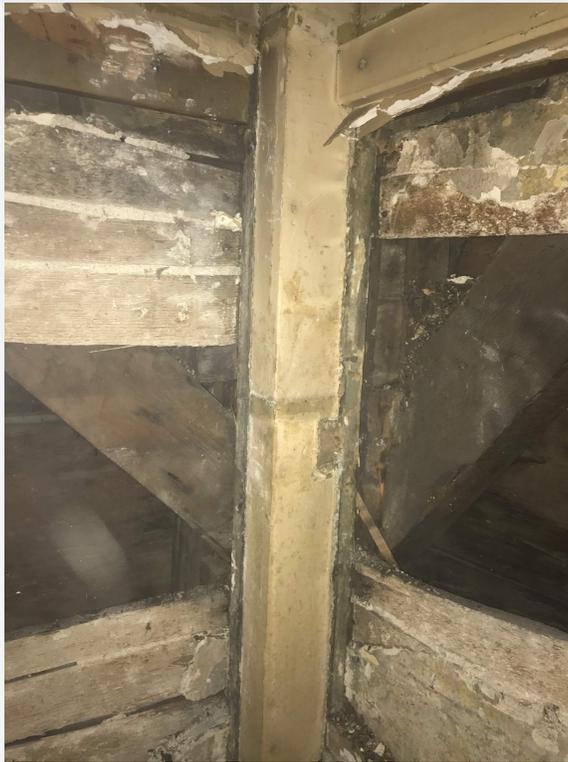
21

Interior: Right rear corner as viewed from the road. Split lathe removed to expose to ascending braces at the corner post. The posts and braces are hand hewn. The casing is plain flat stock and appears early.

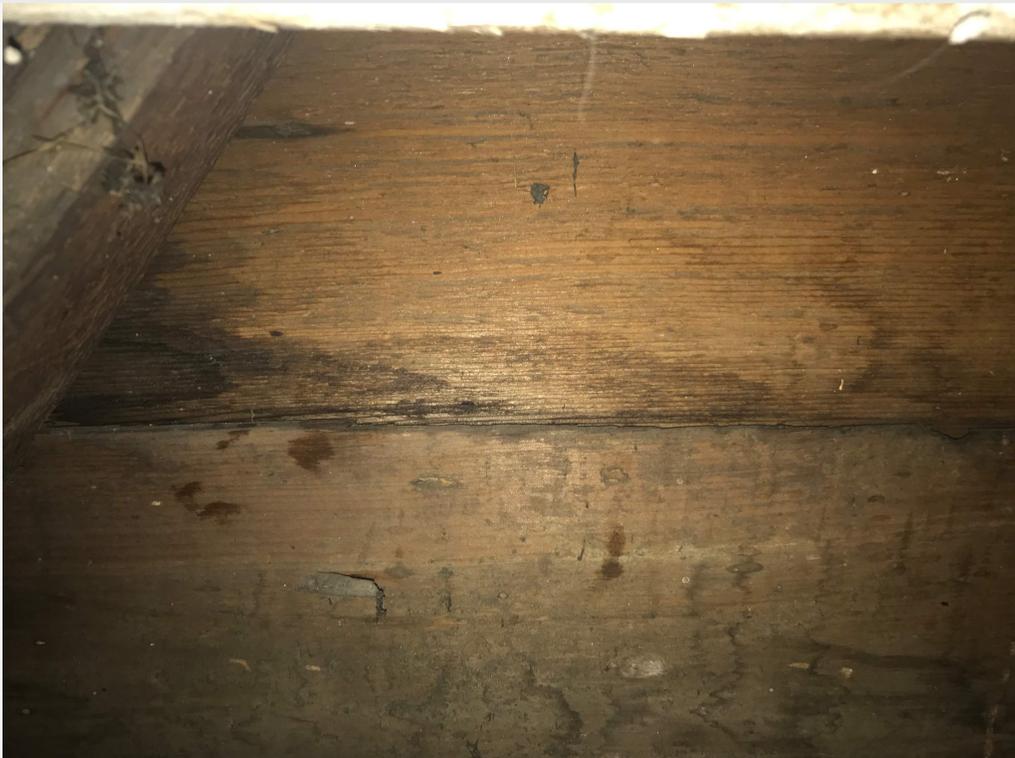
22

These are exterior horizontal sheathing boards. They are beveled at the edges to make the building water tight prior to siding.

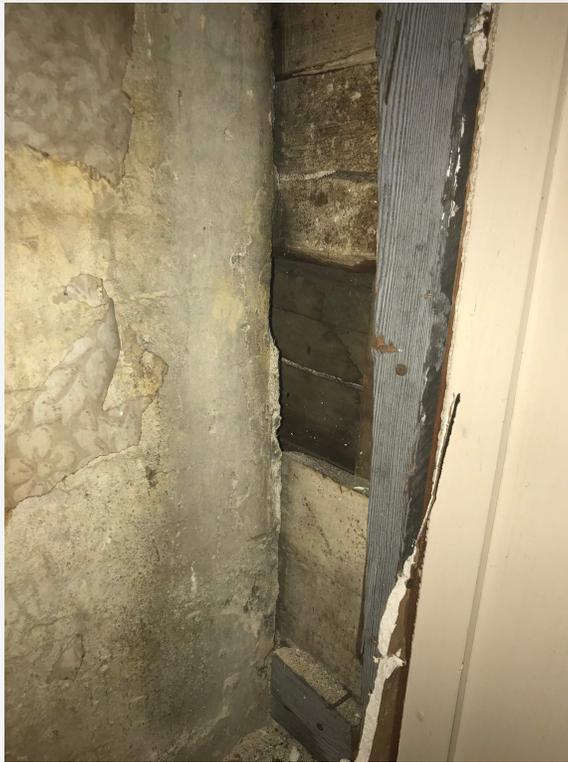
23

Split lathe, plaster and early wall papers in the closet.

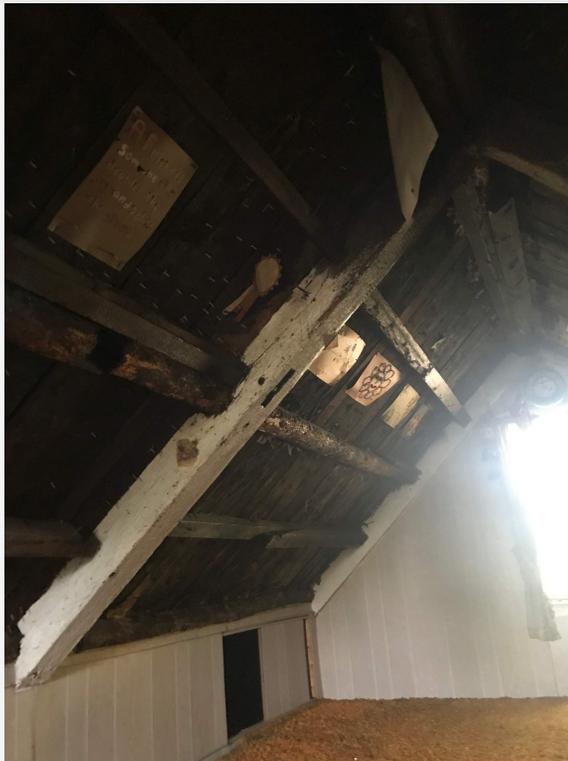
24

The roof frame can be defined as a principal rafter common purlin roof system. The elements are hewn and up and down sawn with vertical sheathing. An original collar tie has been cut out to make the room more livable. The space has also been white washed which indicates that it was used for living space while remaining largely unfinished.

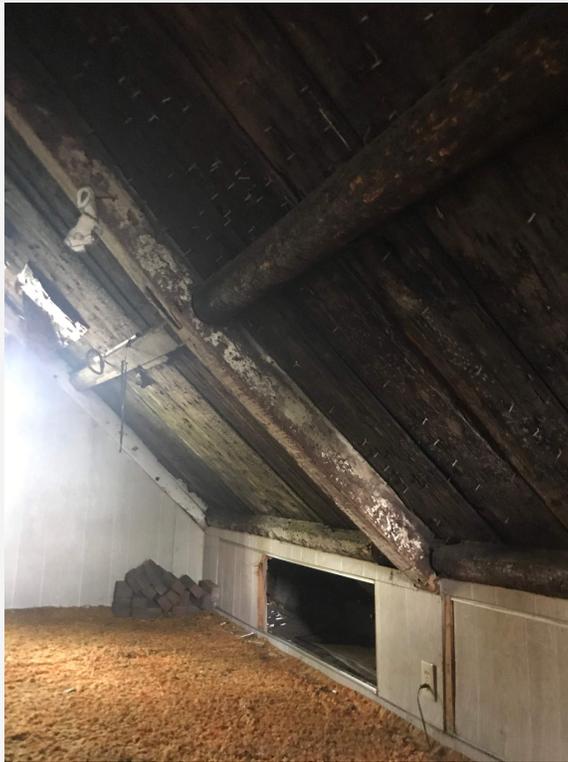
25

Common purlins span between the principal rafters. Added paneling closes in the room and orange carpet covers wide pine board flooring. This is finished living space with no insulation or heat source.

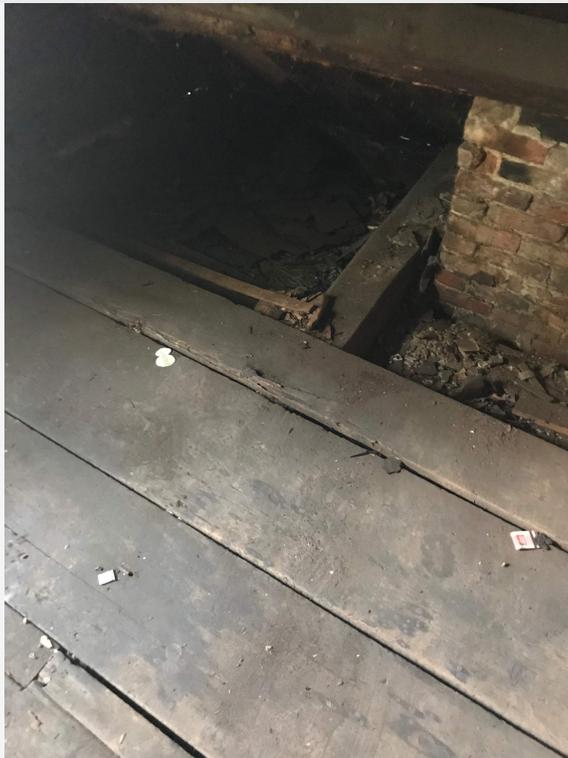
26

Full length tie beams cross from top plate to top plate and plate. Wide pine floors exist at all floor levels.
