Historic District Commission

14 Mechanic Street Portsmouth, NH

October 2019 Work Session Summary

Early features of this vernacular home

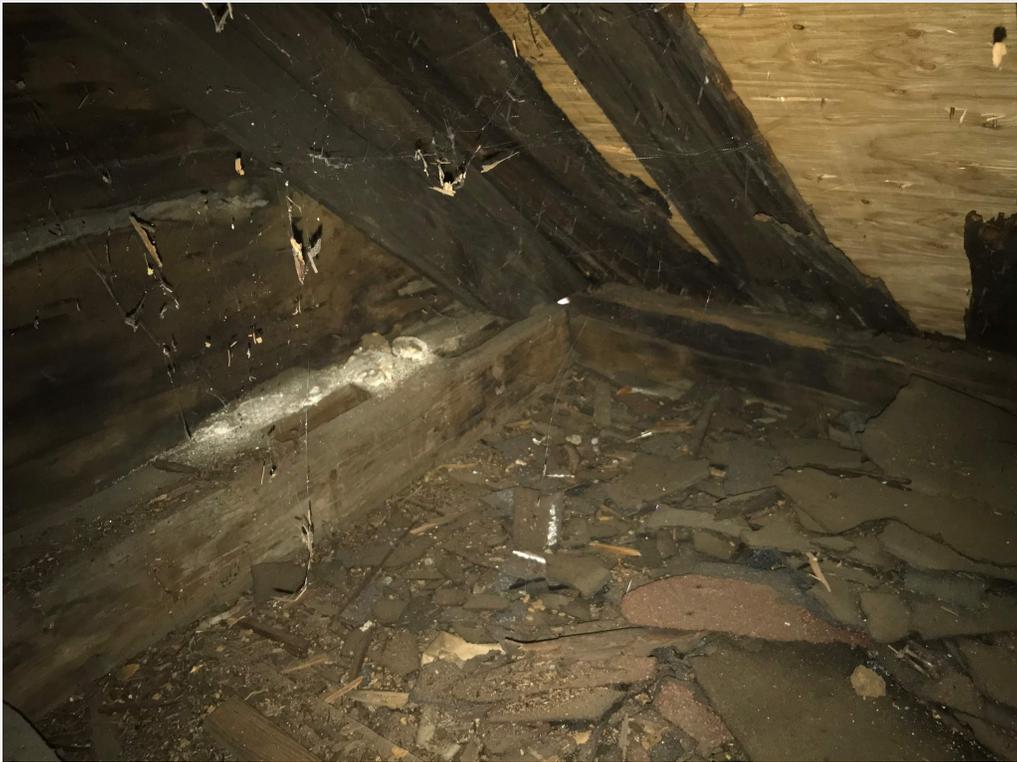
27

Principal rafters show a simple horizontal seat cut at the tie beam end. Empty mortises indicate recycled timbers were used to build this home. Plywood covers old worn vertical sheathing boards.

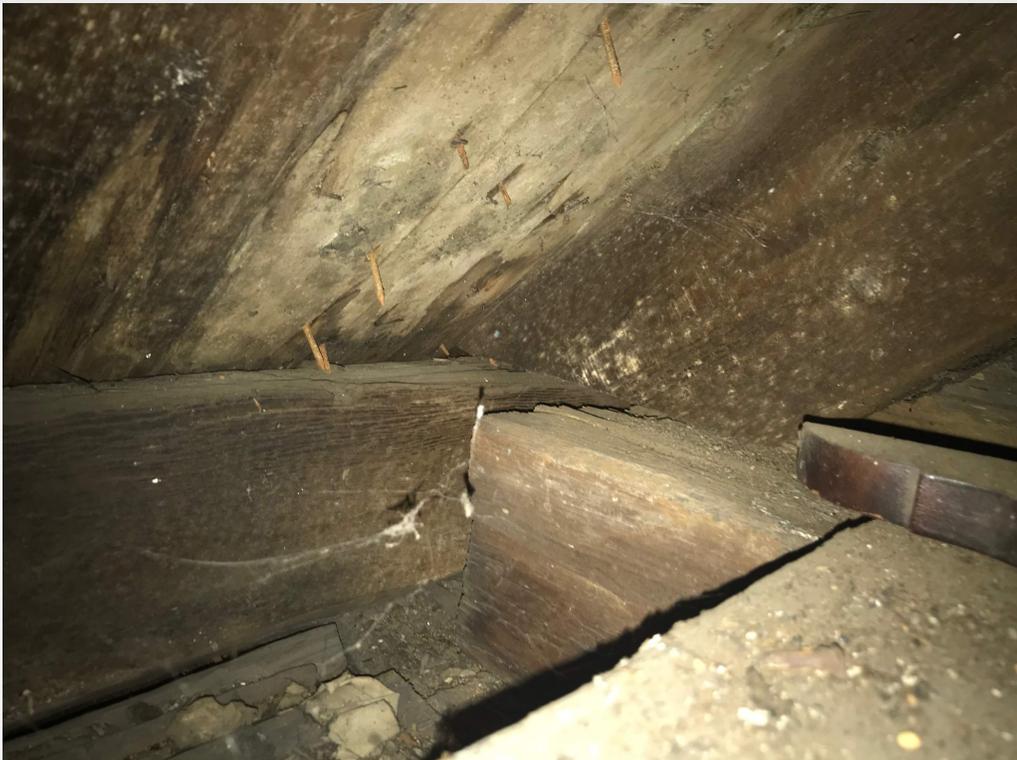
28

A close up of the rafter heel shows that it engages both tie beam and top plate with simple but effective connections. The tie beams are co-planar with the top plate. This is an early form of timber frame construction.

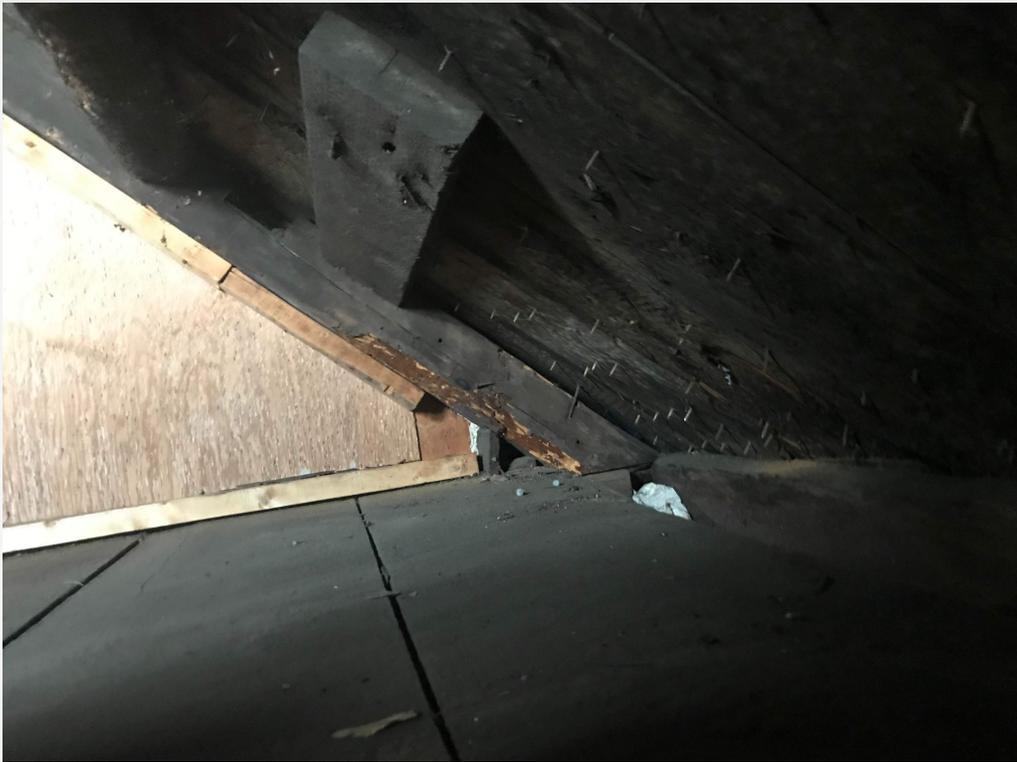
29

The top plate accepts the tie beam in plane. The rafter heel rests on both elements. Everything here is hand hewn. The plate is the full length of the building.

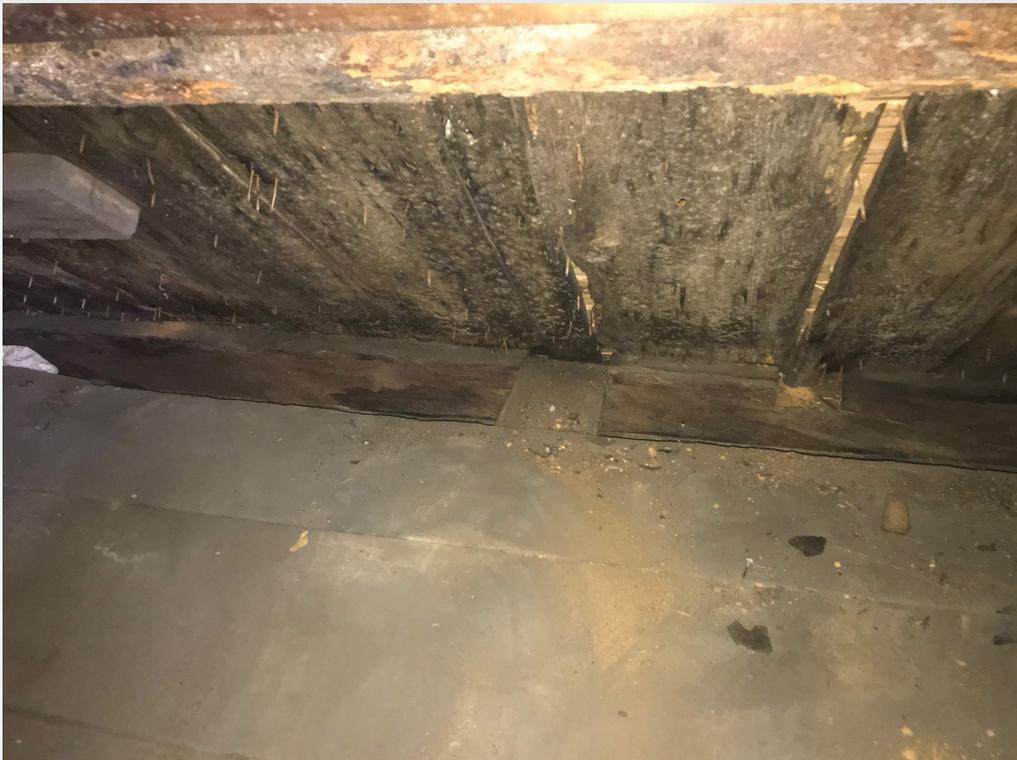
30

Intermediate full width tie beams pass from eave to eave to create attic floor joists. This creates a very strong structure.

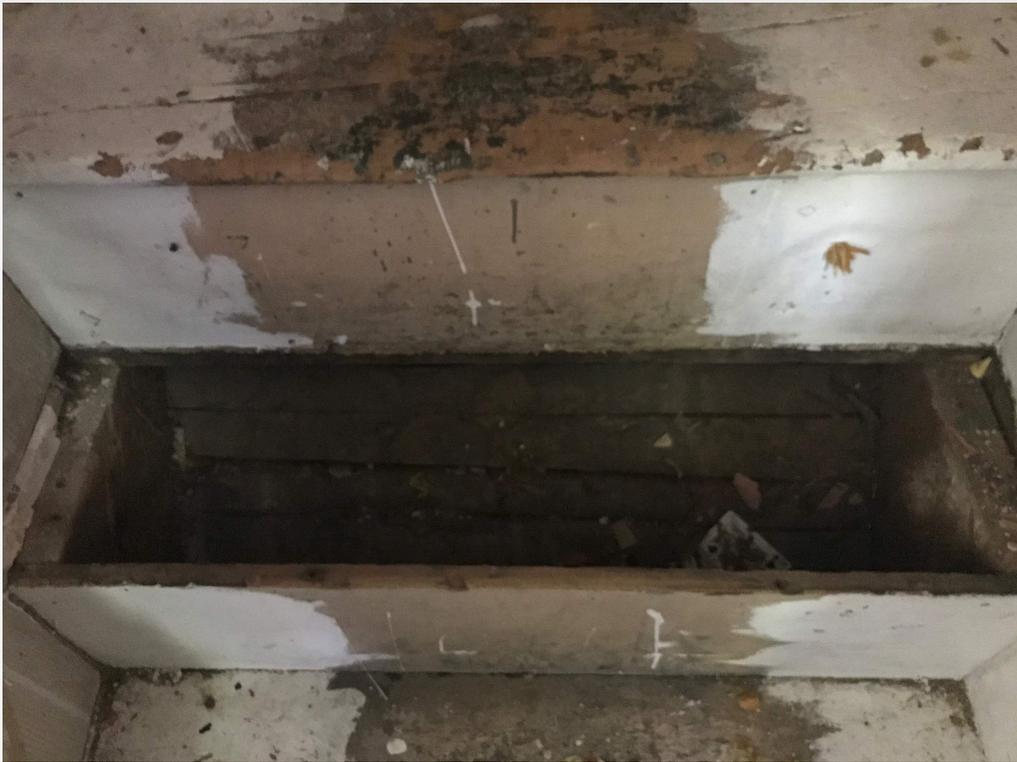
31

Split lathe behind the attic stairs indicate that the stairs remain in their original location within the home. The treads are pine with a vernacular nosing.

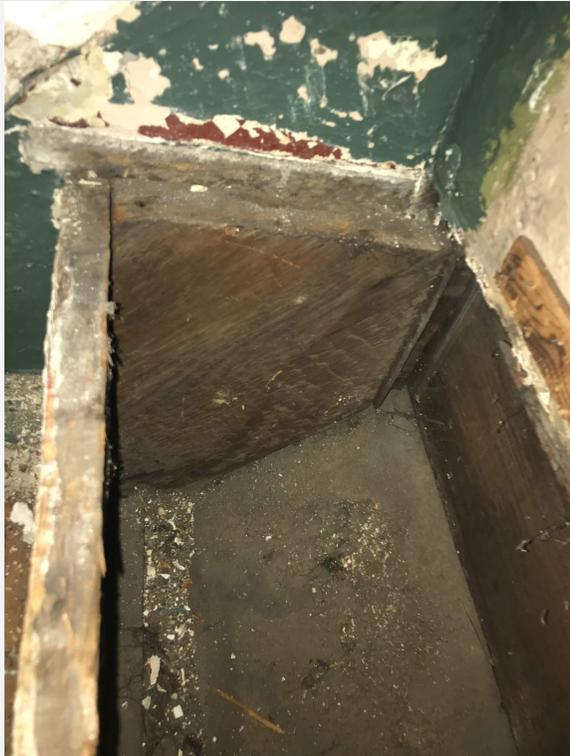
32

The stair stringers are up and down sawn rough lumber also indicating that they are original and in their original location.

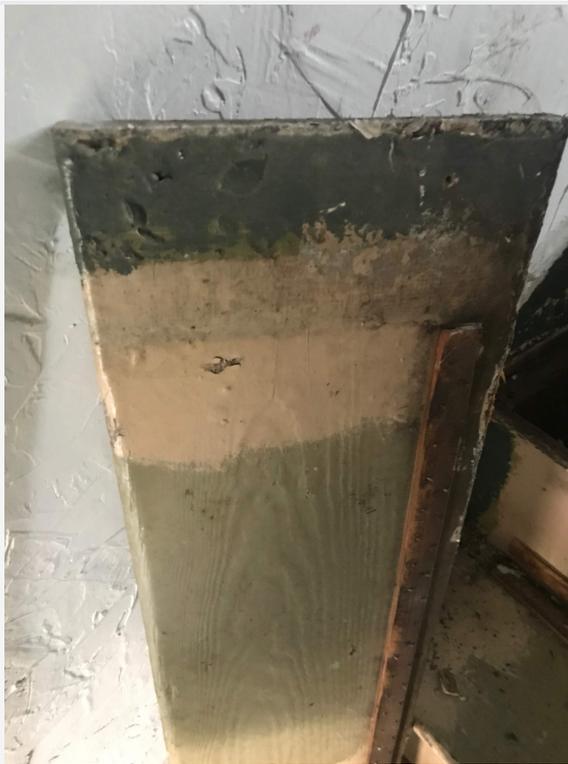
The stair treads of the first flight of stairs are made of hardwood. They are nailed with wire nails indicating that the treads have been changed over the years. They do however share a rounded nosing similar to the pine treads leading up into the attic space. A variety of paint colors exists on these treads.

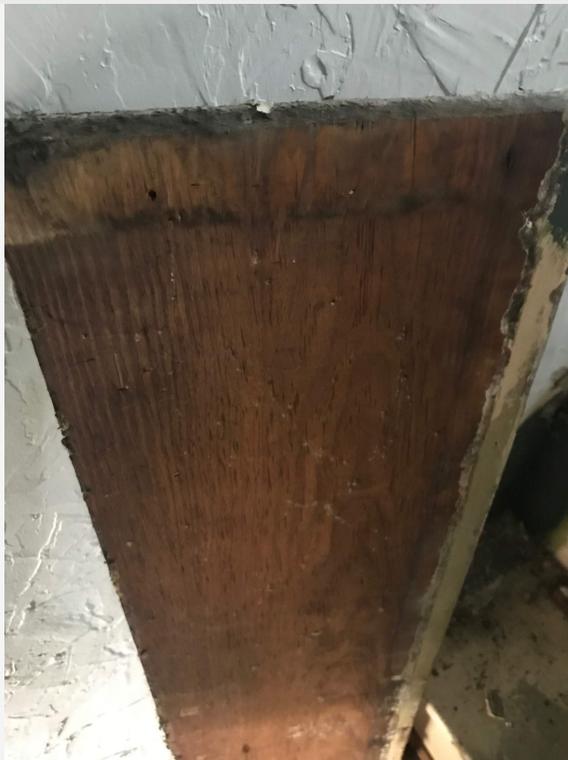
The underside of the first flight of stairs shows a rich hardwood color and texture.

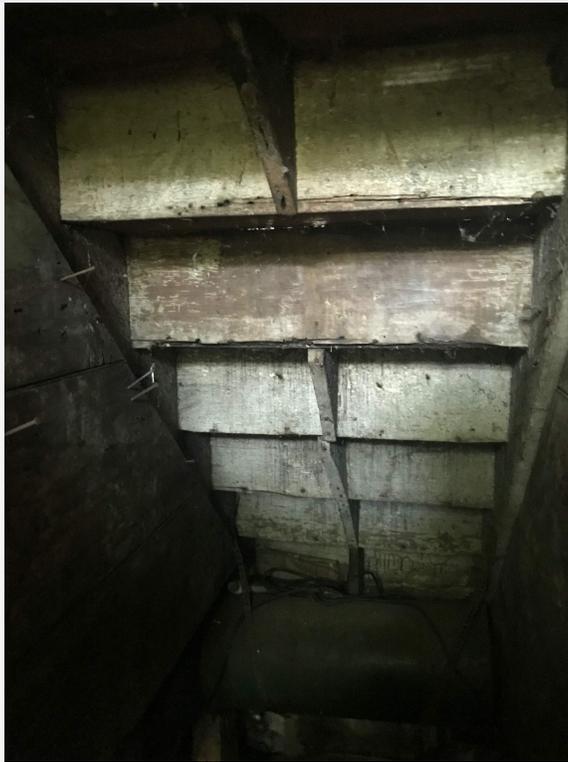
35

Stair stringers and risers indicate an original stair case at the first floor. This can be seen from the door leading down into the dirt floor basement.

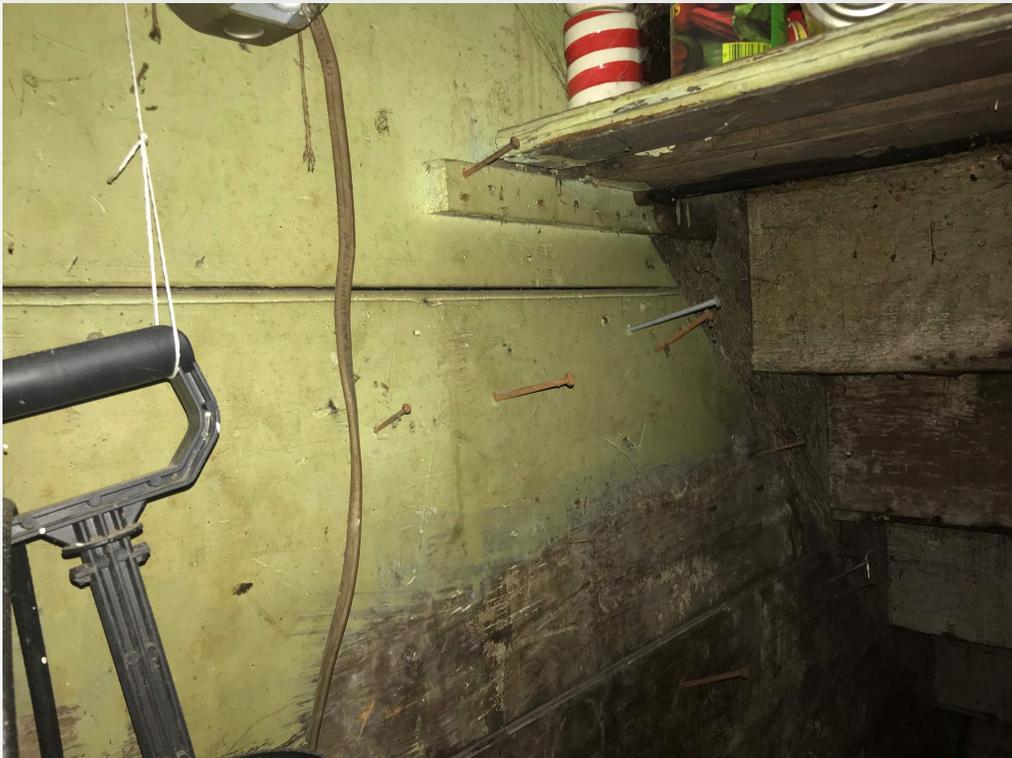
36

Early beaded wood paneling indicates an early stair opening and the beaded horizontal boards appear original with early colors as well.
