Recommendations for Coastal Restoration at the Tamaroff Property (70 Pleasant Point Drive,
Portsmouth, NH)

Tom Ballestero and Dave Burdick

12 December 2018

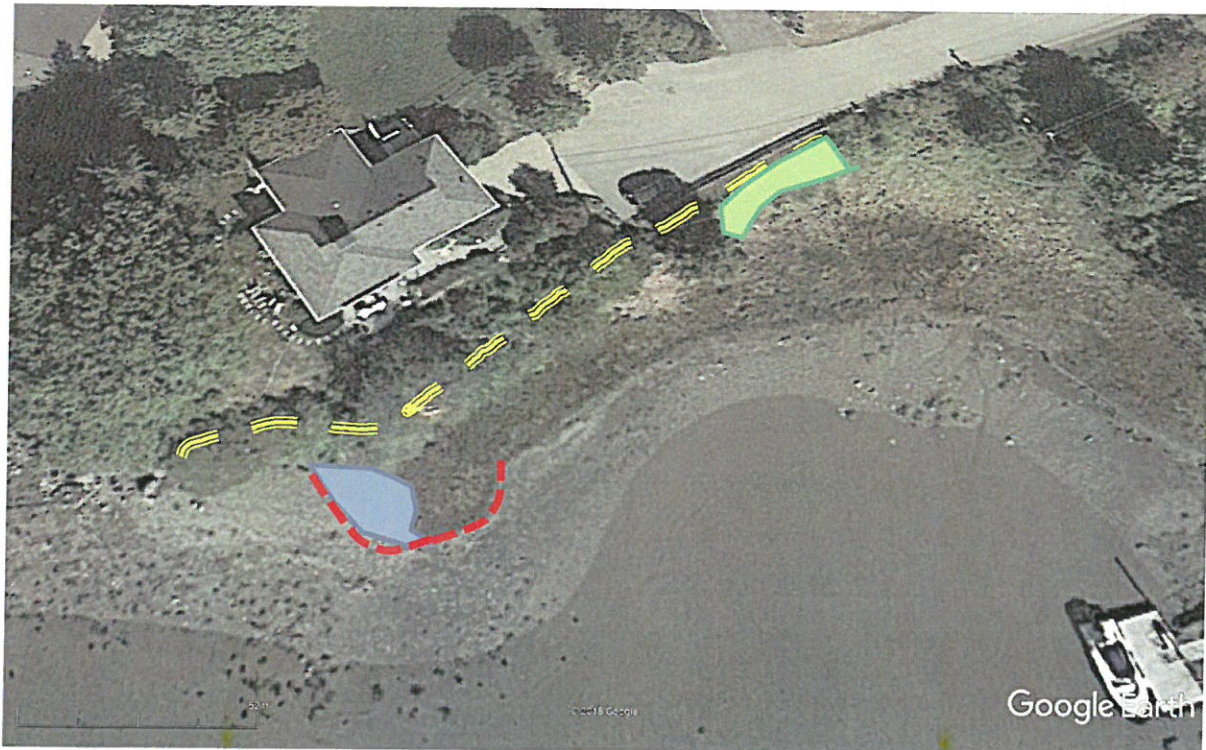
The homeowner has witnessed shoreline erosion along her property. Eroding shorelines include low marsh, high marsh, tidal buffer, and a rock outcrop.

We recommend the following methods to control marsh erosion and high bank erosion at the Tamaroff property. All of these methods may be found color-coded on the figure below.

1. Remove understory vegetation and re-seed with tidal buffer mix (dashed yellow line). This will allow in more light for the salt marsh and understory vegetation as well as possibly invite predators to control burrowing species. Species to be removed are bushes (e.g., Japanese Honeysuckle) and seedlings that have overgrown in the past decade. The undergrowth has supported burrowing animals as well as shaded out the adjacent salt marsh plants, leaving open soil subject to erosion.

2. Restore western salt marsh (blue-shaded area). This will replace lost salt marsh. We believe that grazers, snails, green crabs, and possibly birds over-grazed this area of salt marsh as they are still visible there. Although we do not have long term observational data, from our two site visits, overgrazing by the introduced common periwinkle seems to be a significant cause of salt marsh loss here. The restored marsh will have a rock sill that starts at the existing marsh on the east and extend westward to the first large rock outcrop. In addition, a gravel path (<6 ft wide) should connect the kayak storage to the water through the restored marsh.

3. Install a snail fence (red dashed line). This will prevent snails from grazing on the existing and restored salt marshes. This will be a galvanized fence of low height. The fence may be configured to allow kayak launching and may only need to be 8 to 12 inches high.

4. Marsh and tidal buffer restoration (green-shaded area). Here, the marsh is intact and the high bank is eroding. There are also listed plant species (high tide bush, *Iva frutescens*) at this location. If the high bank continues to erode, it will affect the road and buried utilities. Start two feet south of the existing fence, and grade towards the marsh at a slope of 15% (preferably flatter at 10%) down to the marsh. This will require excavation at the top of the slope and fill at the bottom. Before filling at the bottom of the slope, remove the existing salt marsh vegetation and re-use at the salt marsh restoration site to the west. At the bottom of this slope will be a staked coir log. By laying the slope to much flatter than it is now and revegetating, there is little need for an engineered embankment. After the slope is built, it will be seeded above the high high water line, then covered in a staked coir mesh blanket (keyed in on all edges), and then planted throughout its length. Below the high high water line, the new marsh surface will be planted with *Spartina* (high and low marsh plants). The need to lay back the slope is required to be able to successfully grow plants where there is now a vertical, eroded bank. Vegetation will not presently take hold on the vertical bank.

At this writing we do not believe that there is sufficient documented information on the bedrock retreat or marsh edge erosion to the east to offer solutions at this time, but rather we recommend these locations be monitored over the next few years to understand the nature, causation, and rate of retreat. The bedrock can be monitored by photography, and the salt marsh edge with erosion pins.
