# SAGAMORE CREEK

## WATER QUALITY SAMPLING PROGRAM

FINAL JULY 2018

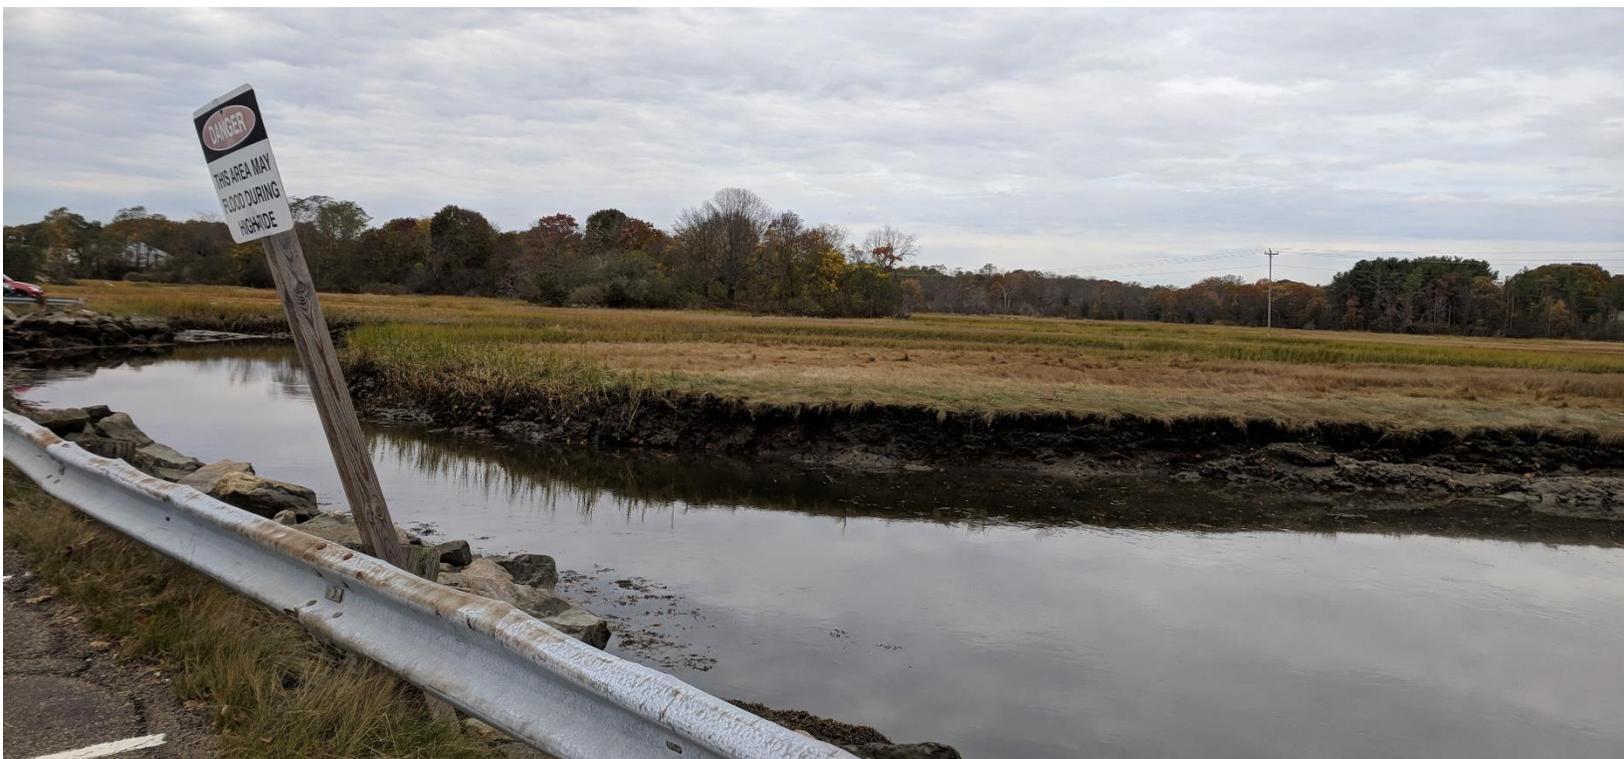
Parking lot at the Dinnerhorn restaurant just upstream of the Route 1 bridge abuts the Creek and floods during very high tides. Photo: FBE.

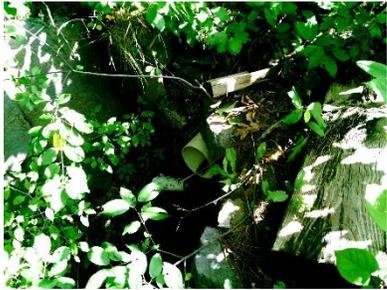
City ID	Pipe Diam. (in)	Sediment Burial Within Pipe	Water Submersion Within Pipe	Notes	Photo
5088	10	Open	No	Pipe constricted by rock; trash debris and floating green scum noted

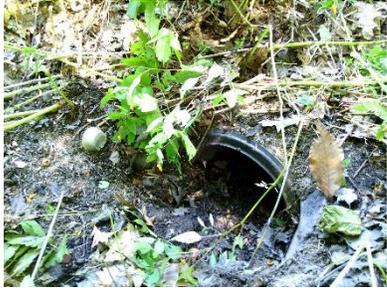
5193	10	1/2 full	No	Pipe clogged with sediment and debris

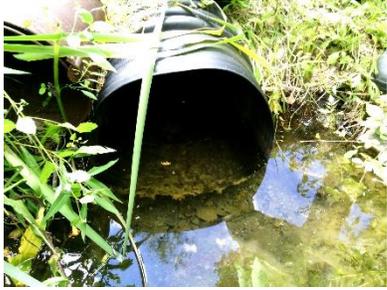
noID	15	Open	No	Sewage odor noted; warrants follow-up investigation	No photo available.
5182	15	Open	Partially	Algae film growing inside and near pipe

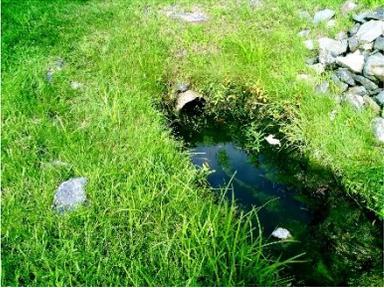
City ID	Pipe Diam. (in)	Sediment Burial Within Pipe	Water Submersion Within Pipe	Notes	Photo
1194	12	Open	Partially	Excessive green algae growth

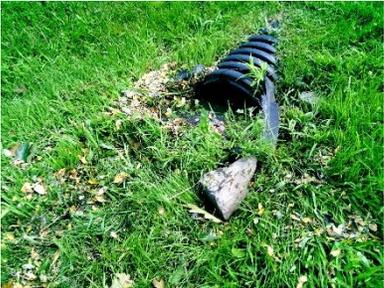
3883	12	1/2 full	Partially	Pipe clogged with sediment and debris

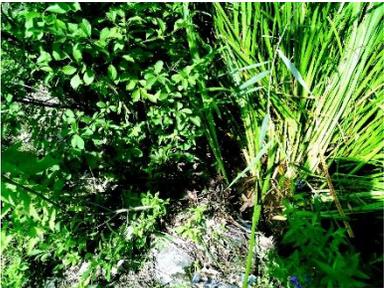
3884	15	1/2 full	Partially	Pipe clogged with sediment and debris

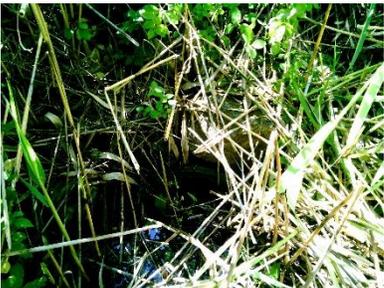
3898	12	1/2 full	Partially	Pipe clogged with sediment and debris

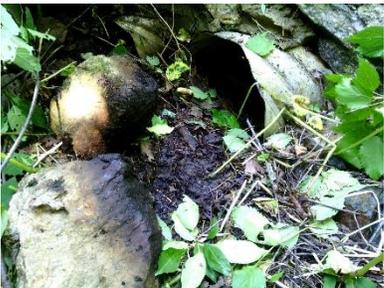
noID	12	1/2 full	No	Pipe clogged with sediment and debris

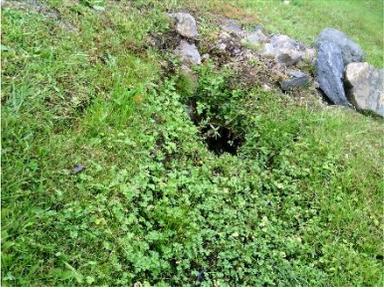
City ID	Pipe Diam. (in)	Sediment Burial Within Pipe	Water Submersion Within Pipe	Notes	Photo
1830	15	3/4 full	Partially	Vegetation overgrowth around pipe; pipe clogged with sediment and debris

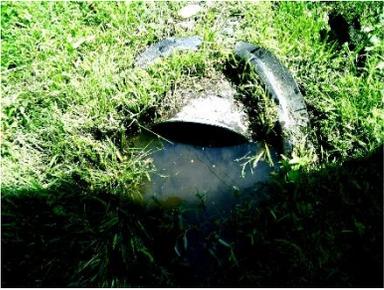
4042	12	1/2 full	Partially	Pipe clogged with sediment and debris; milky sheen in water

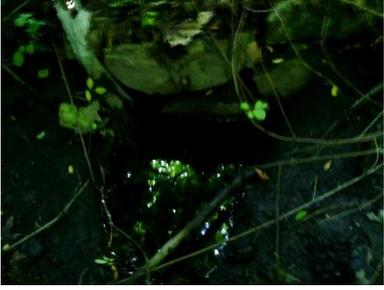
1168	--	--	Fully	Completely submerged; unable to inspect	No photo available.
11376	12	1/2 full	Fully	Pipe clogged with sediment and debris

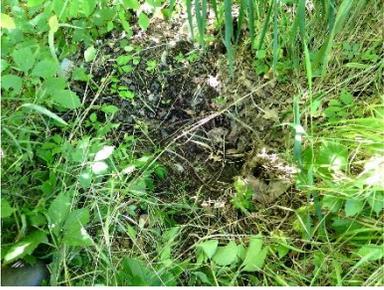
5435	6	Plugged	No	Pipe clogged with sediment and debris

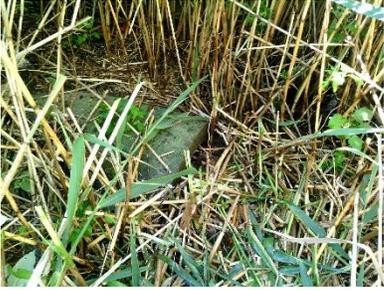
2279	18	1/2 full	Fully	Pipe clogged with sediment and debris

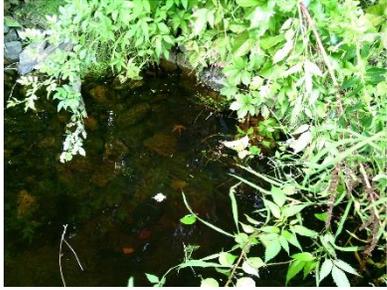
City ID	Pipe Diam. (in)	Sediment Burial Within Pipe	Water Submersion Within Pipe	Notes	Photo
2781	15	Open	Fully	Pipe broken allowing water out before outfall

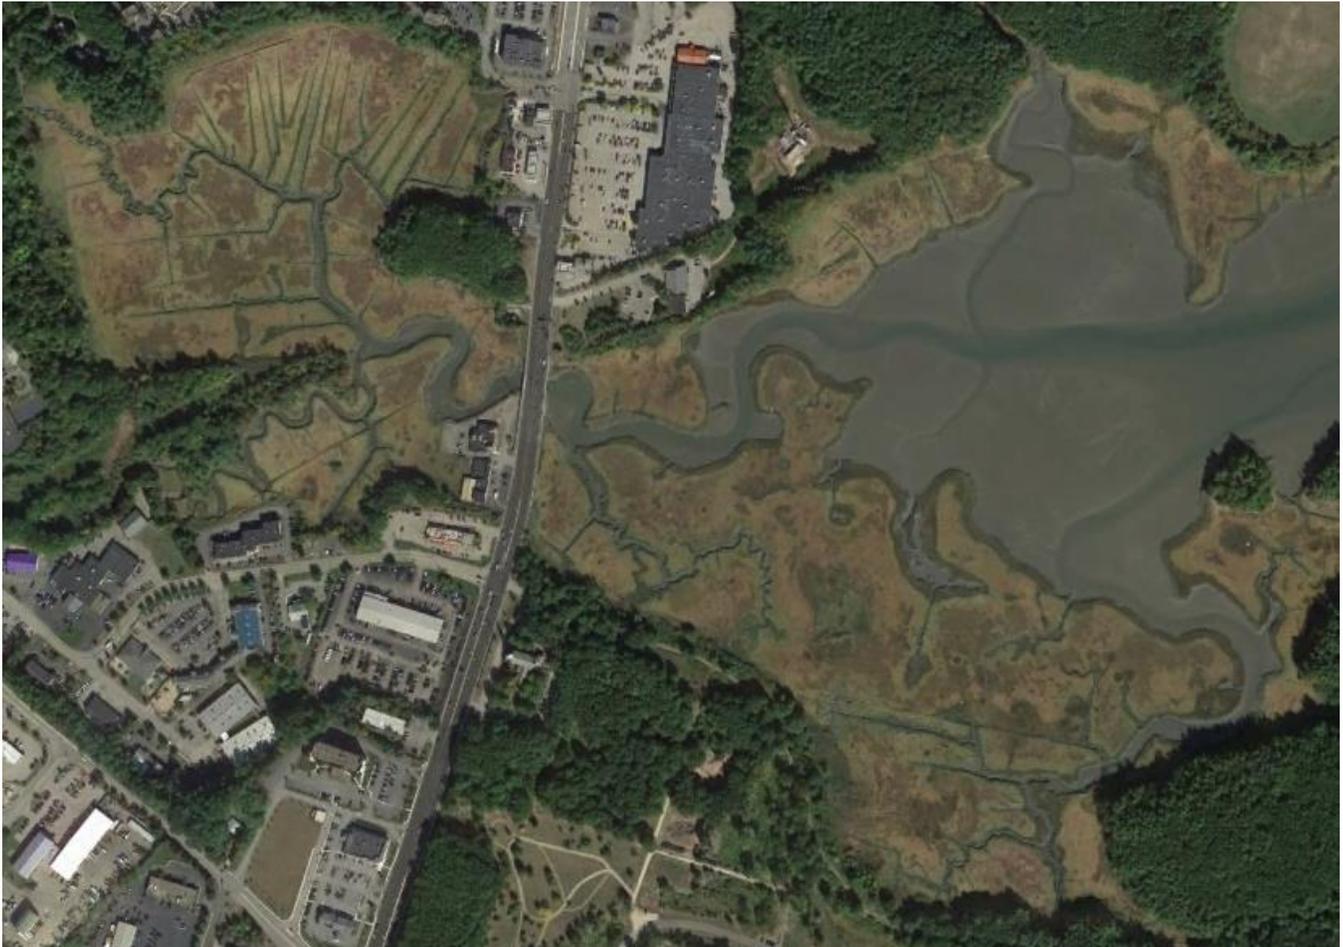
The salt marsh of Sagamore Creek provides evidence of historic ditching. Image obtained from GoogleEarth.

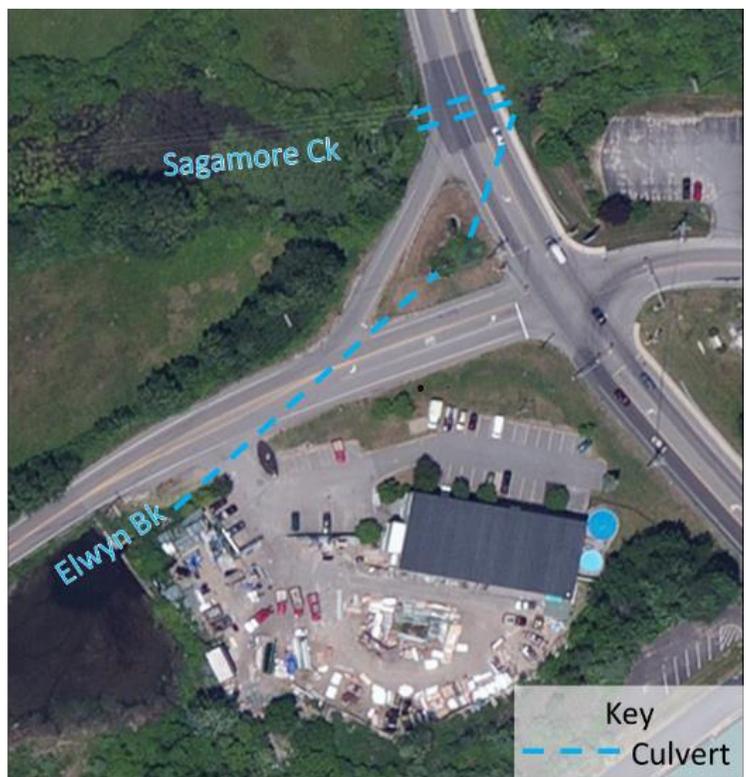
Depiction of flow routes for Sagamore Creek and Elwyn Brook through culverts under Banfield Road and Peverly Hill Road.

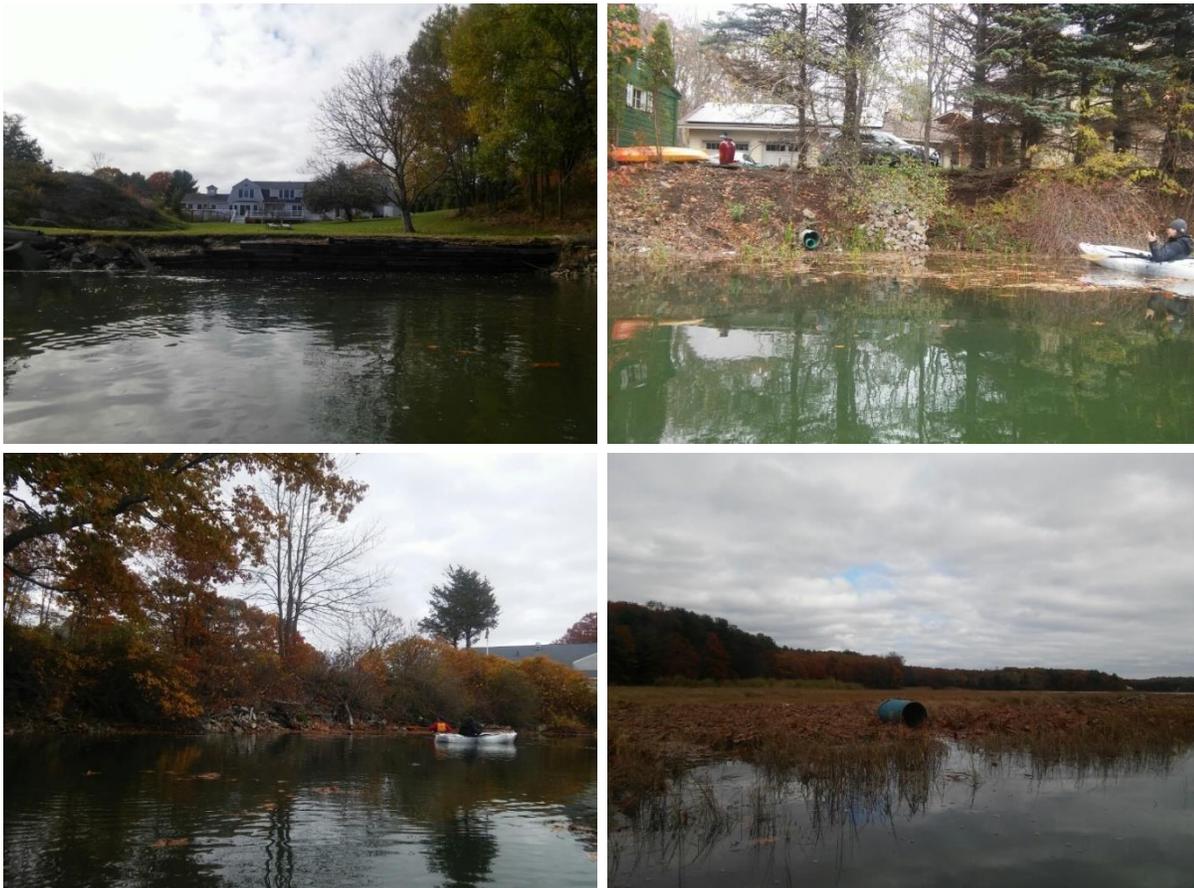
Example of collapsing retaining wall, lack of shoreline buffer, and green lawn (top left), eroding bank and unknown pipe discharge (top right), improper dumping area (bottom left), and trash/debris on marsh (bottom right). Photos taken by FBE on 11/7/2017 during the shoreline survey of Sagamore Creek.

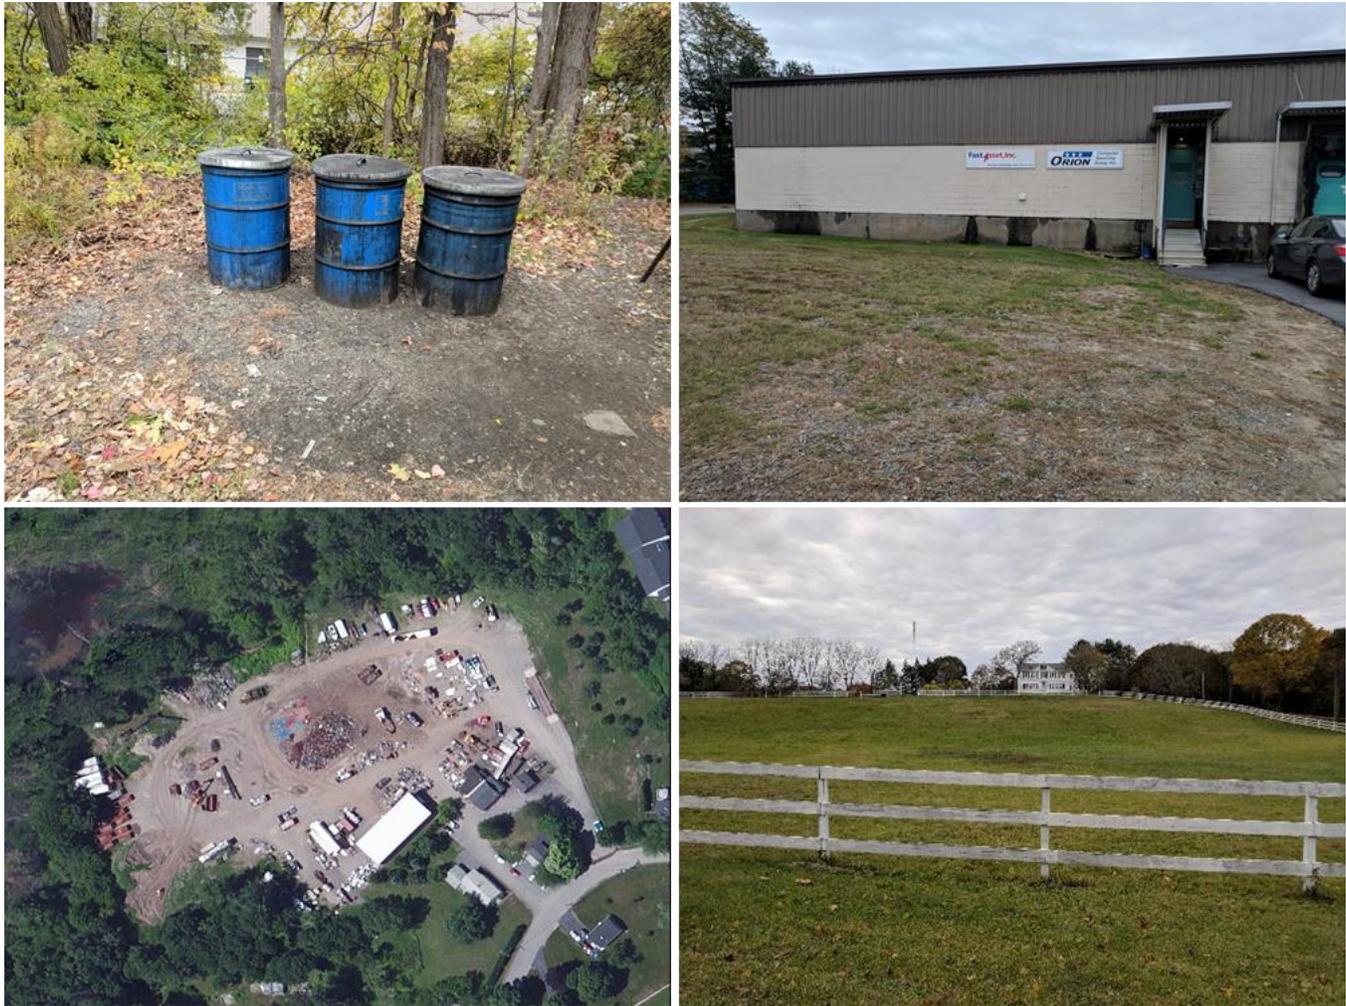
Examples of potential contamination sources identified during the 2017 watershed survey: unmarked drums outside restaurant on pervious surface (top left), seepage from unknown source identified along building foundation (top right), former scrap metal yard close to water resources (bottom left), and a horse farm on Peverly Hill Road (bottom right).
