**Request for Qualifications #43-19  
Replacement of the Maplewood Avenue Bridge over North Mill Pond  
NHDOT Bridge #231/103**

## 2.9 Maplewood Avenue over North Mill Pond (NHDOT Bridge No. 231/103)

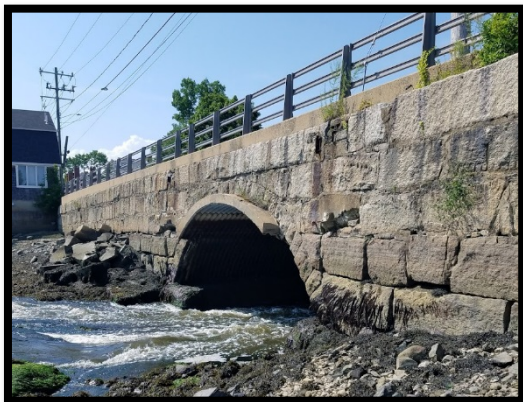
West Elevation

The existing bridge was constructed in 1940 and, and according to NHDOT records, rehabilitated in 1976. The structure consists of a single masonry arch with a grouted corrugated metal plate arch (CMPA) liner founded on concrete footings. The 1976 rehabilitation consisted of the installation of the CMPA liner and construction of the concrete footings. The bridge has a total span length of 25' and carries two lanes of traffic on a 32' wide paved roadway. A 5'-11" wide sidewalk is located on the west side of the bridge and a 6'-8" sidewalk is located on the east. The bridge has an 'E2' load restriction, and posting signs properly identifying this restriction are installed

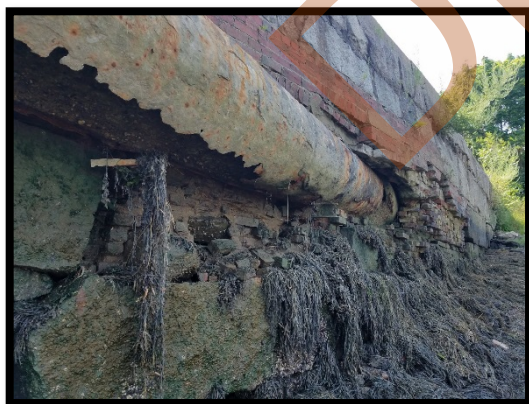
Northeast Seawall

sewer main is located within the hydraulic opening and there is evidence that roadway backfill material is migrating through the culvert walls at the sewer main penetration. Bricks used to infill voids in the granite block headwall and seawall are missing in areas of the northwest seawall. The MPA liner exhibits heavy corrosion and several scattered holes, with 100% section loss at the bottom 6". The bolt heads along the seams in the bottom two-thirds of the MPA liner exhibit section loss. The concrete pedestals have exposed rebar, heavy deterioration, and marine growth.

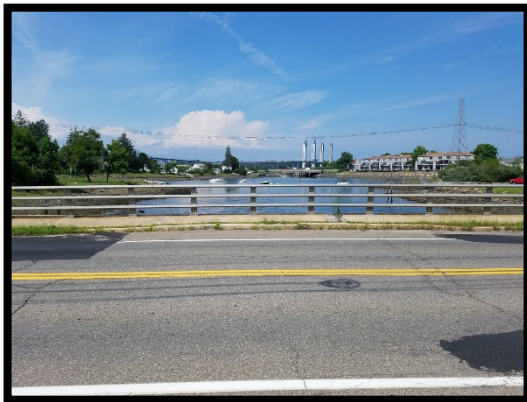
The pavement is in poor condition with cracking, settlement, and potholes throughout the approaches and on the bridge; pavement repairs have been completed in several locations. There is poor stormwater drainage at the bridge as evidenced by ponding on the west side and vegetation growth on and around the curbs. The sidewalks are rotating towards the road with significant settlement along both the west and east curb lines at the north and south ends. This settlement/rotation creates uneven walking surfaces on the sidewalk (i.e. tripping hazards). A

Typical Pavement Condition

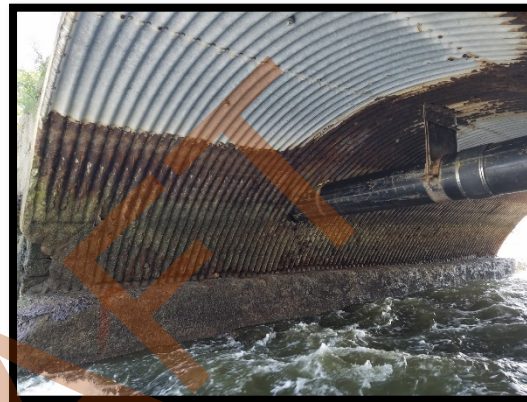
East Intrados of Arch

The bridge is in serious condition and should be replaced or repaired as soon as possible. Due to the complexity and cost of the project, it may not be feasible to design, permit and construct the replacement structure within the next 2 years; however, the process of replacing the bridge should begin as soon as possible.
