RE: **105 Bartlett St 05/13/20 Conservation Commission Meeting**

# **The State of the North Mill Pond**

## **Portsmouth, New Hampshire**

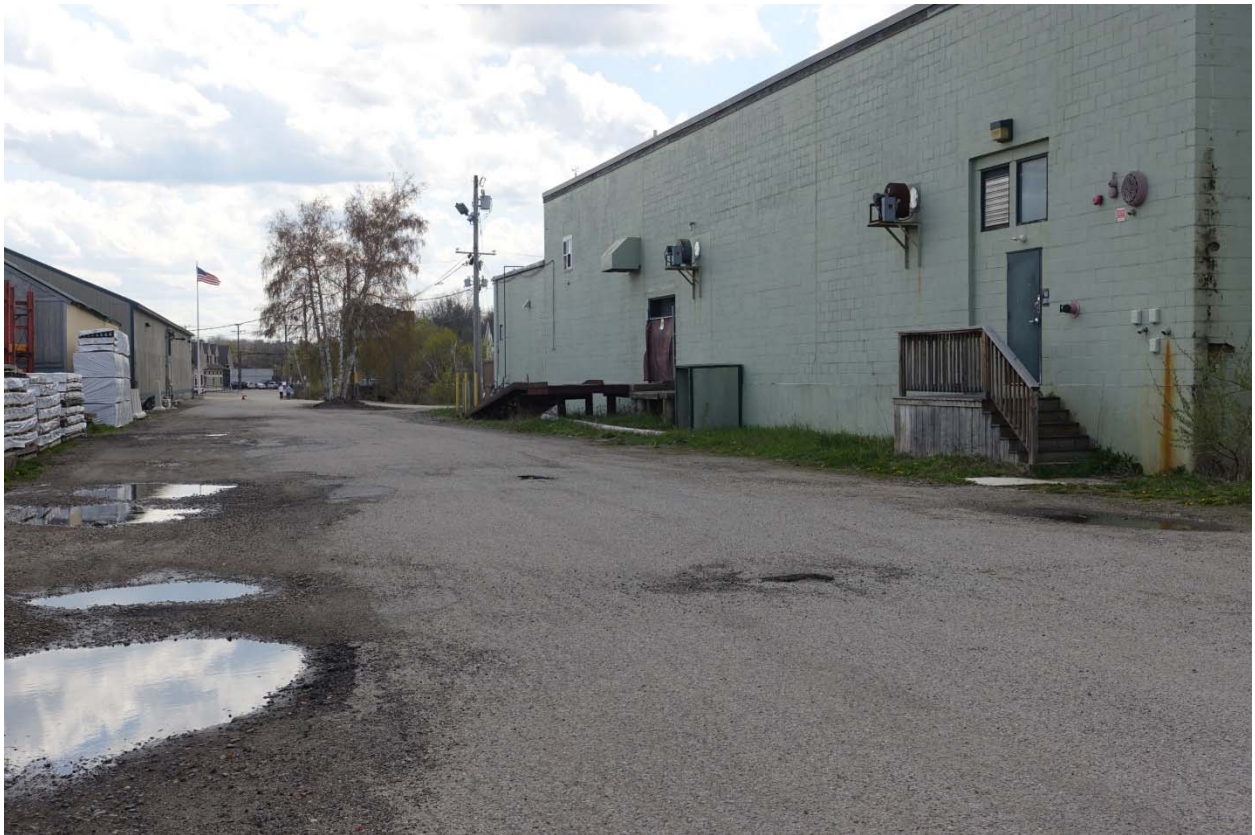
### #3

The rear of Lot 157-1 does not have a part of the building protruding about 60' X 40' as can be seen here. The proposed Building C is a new shape and size footprint. It is my understanding if a footprint is changed a nonconforming lot must become conforming. There is also an increase of the entire width of the building. There are two existing "bays": one next to Play all Day (near the ramp) and one is the receiving area for Great Rhythm Brewing, which are part of the existing footprint (#4) It seems the footprint has been changed to align those to areas.

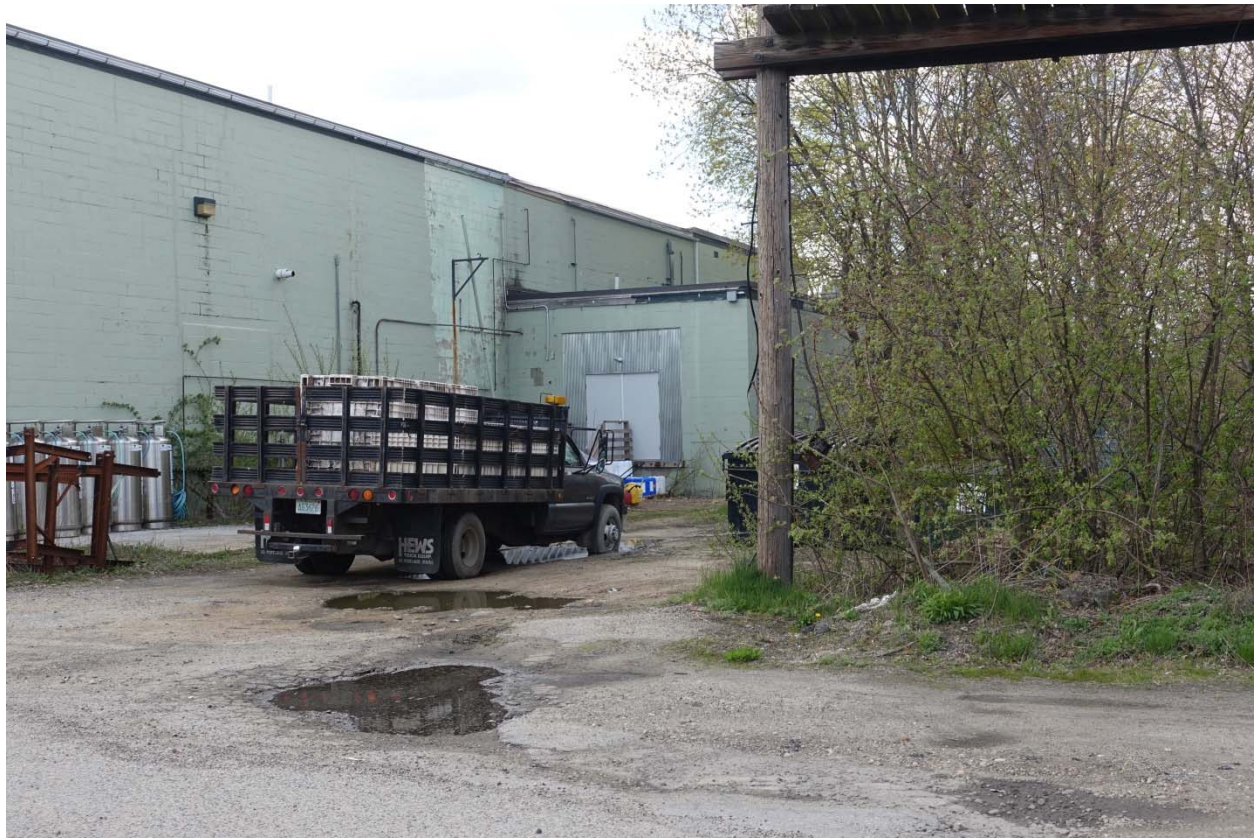
#4 Great Rhythm Brewing loading dock-structurally part of the building.

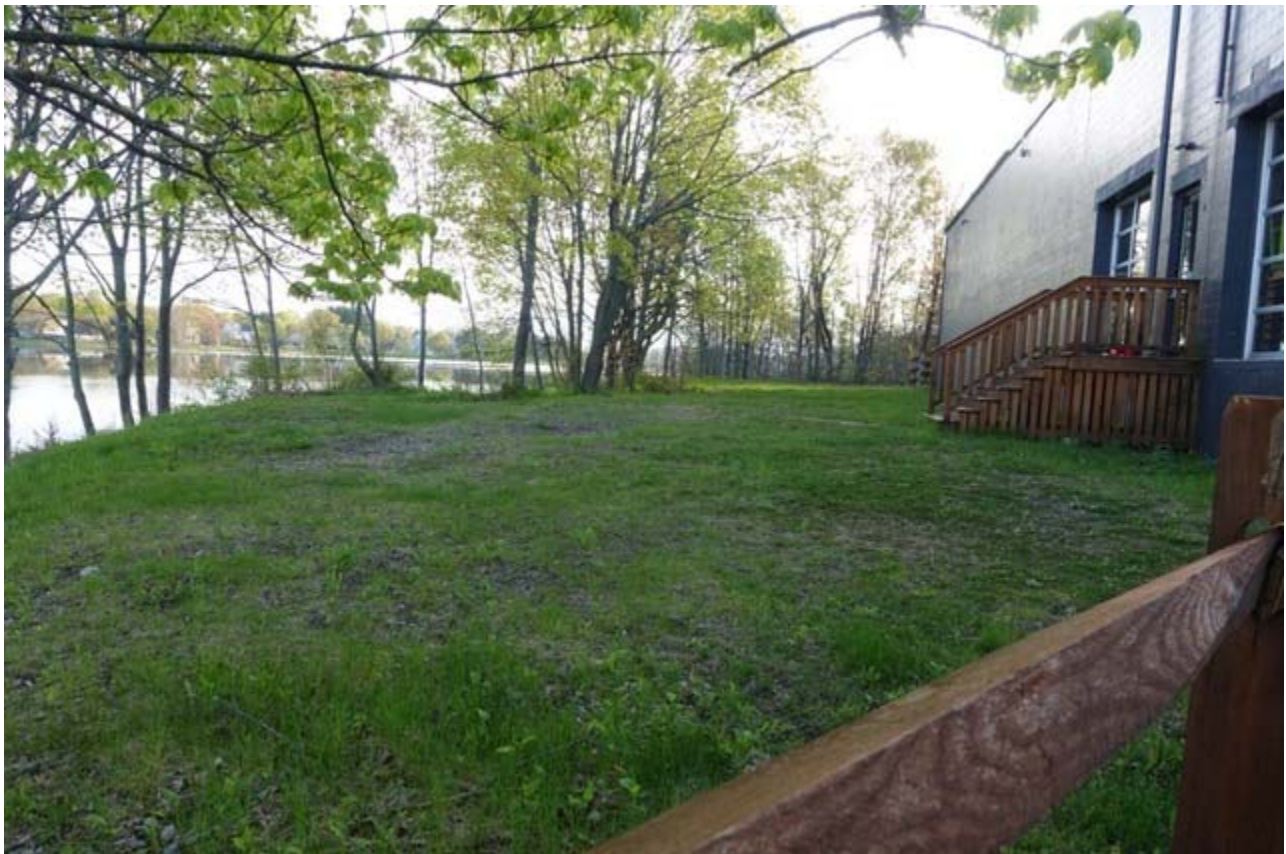
This was taken by me this summer BEFORE they got their variance. I took it to show how much erosion this area has.

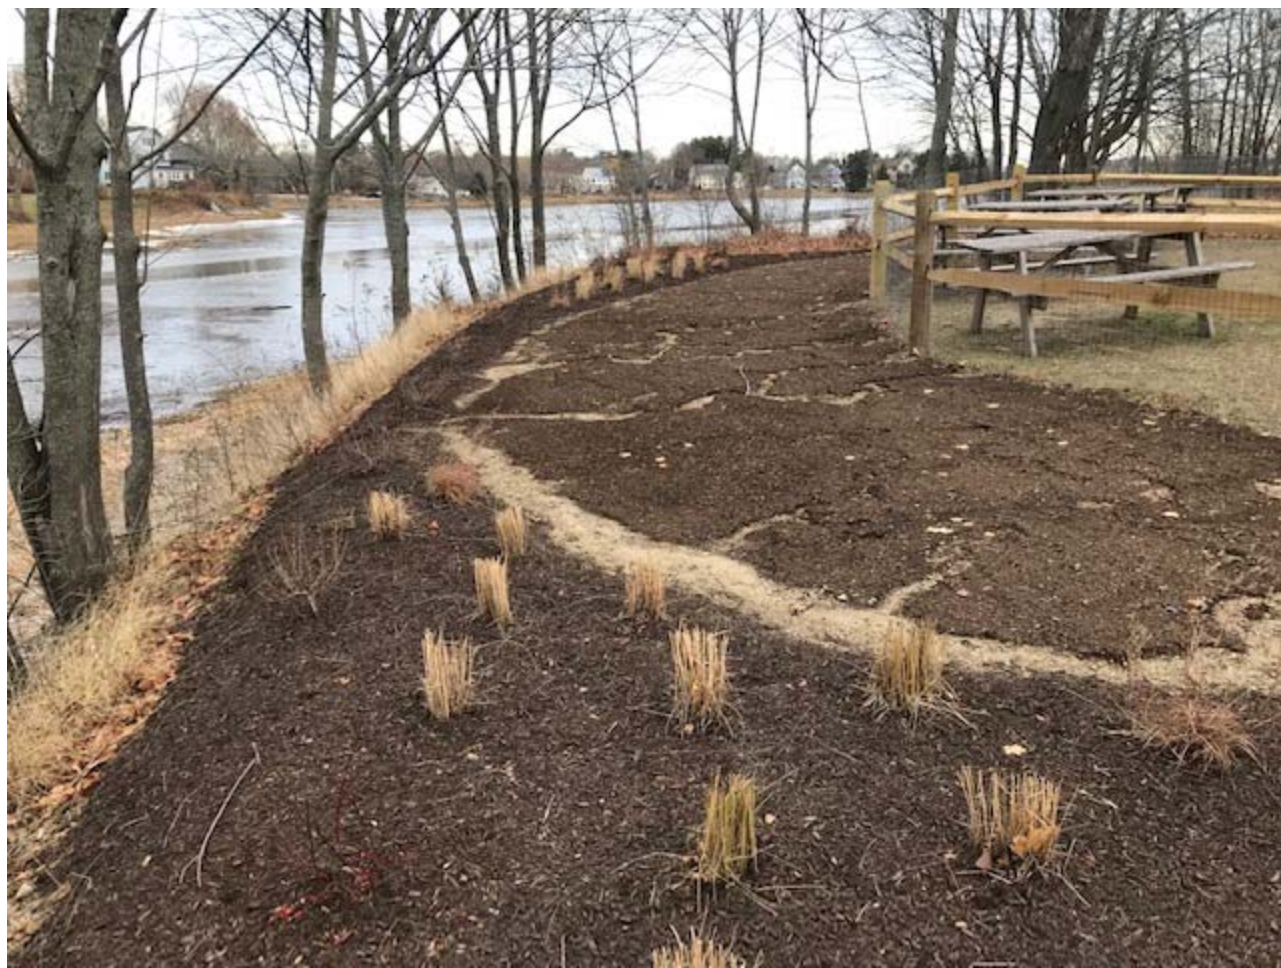
Peter,  
I would like the rest of the Conservation Commission to see the pictures of the "Mulch" washing away at Great Rhythm Brewery. Could you please forward them? Thank you.  
Kate Harris

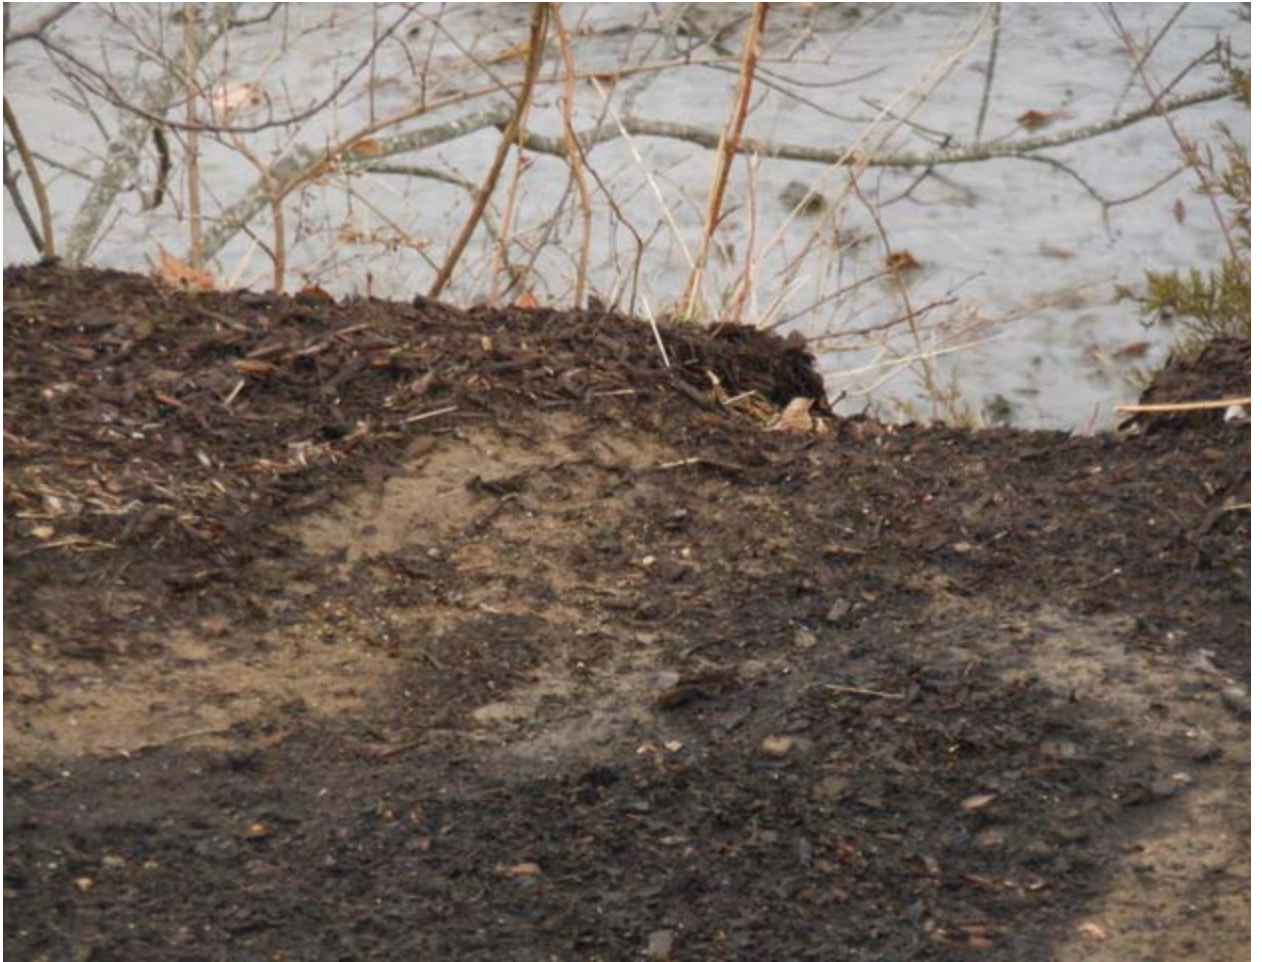
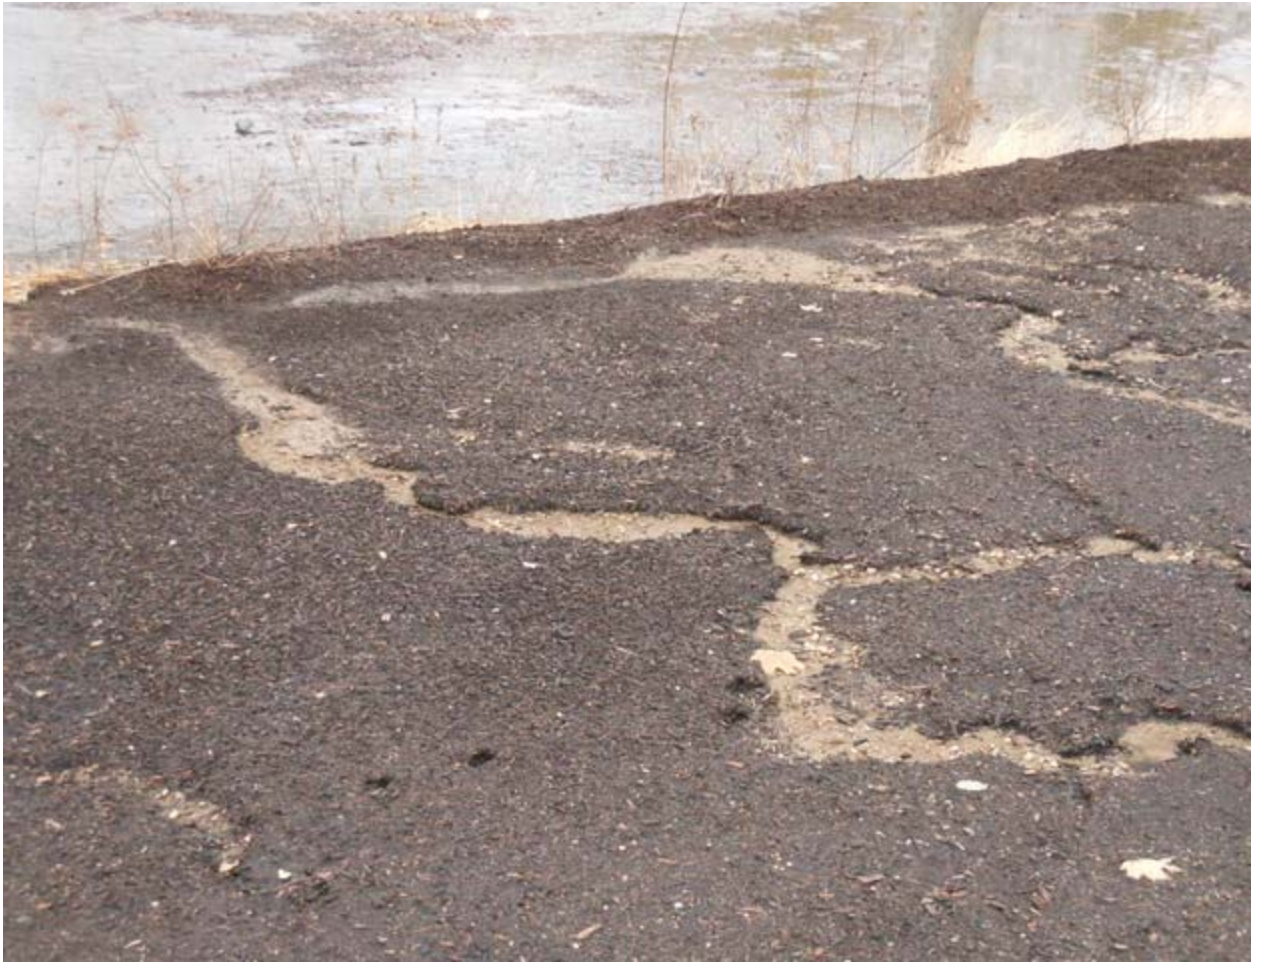
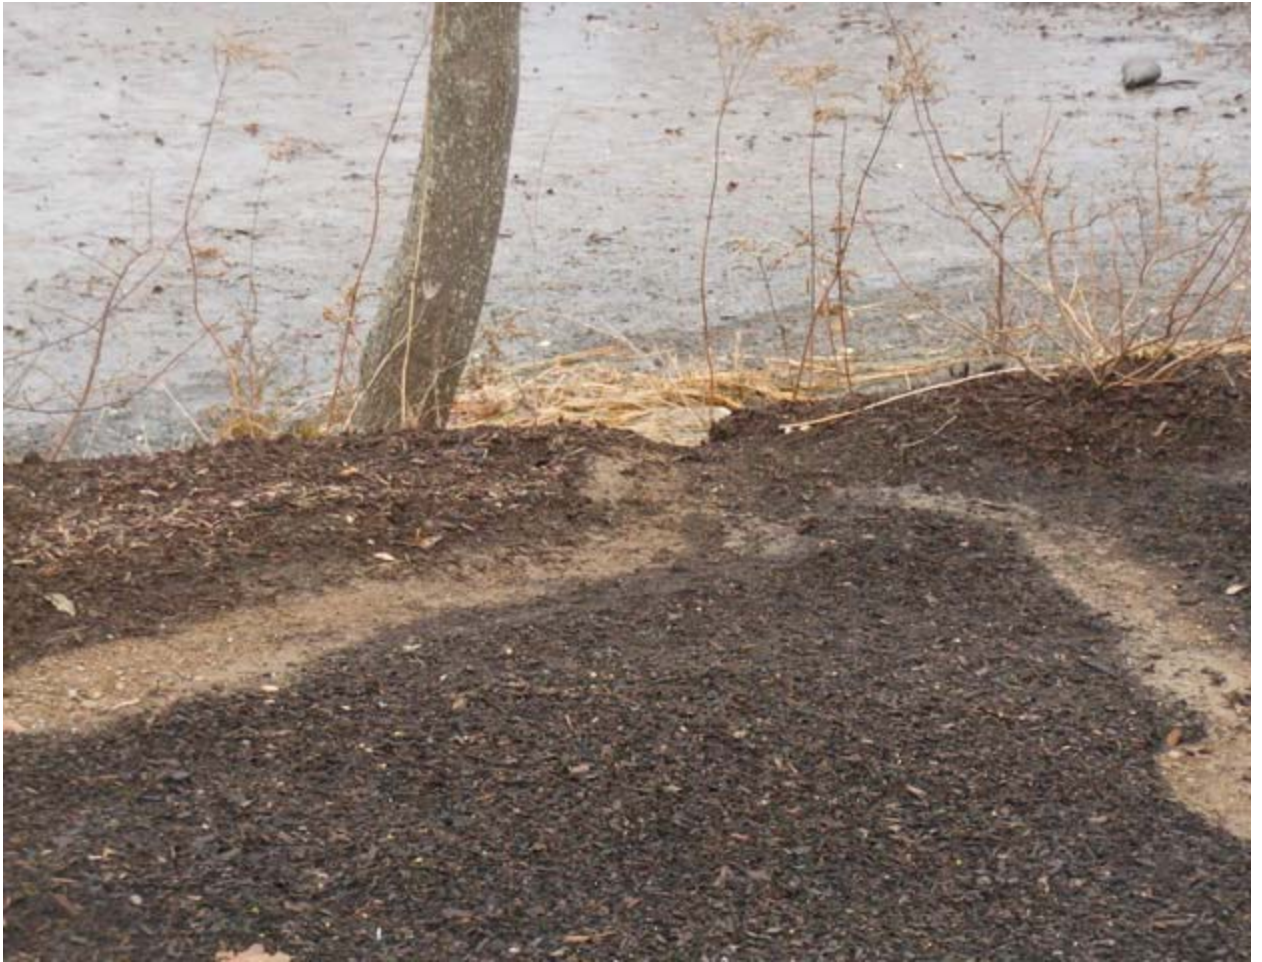
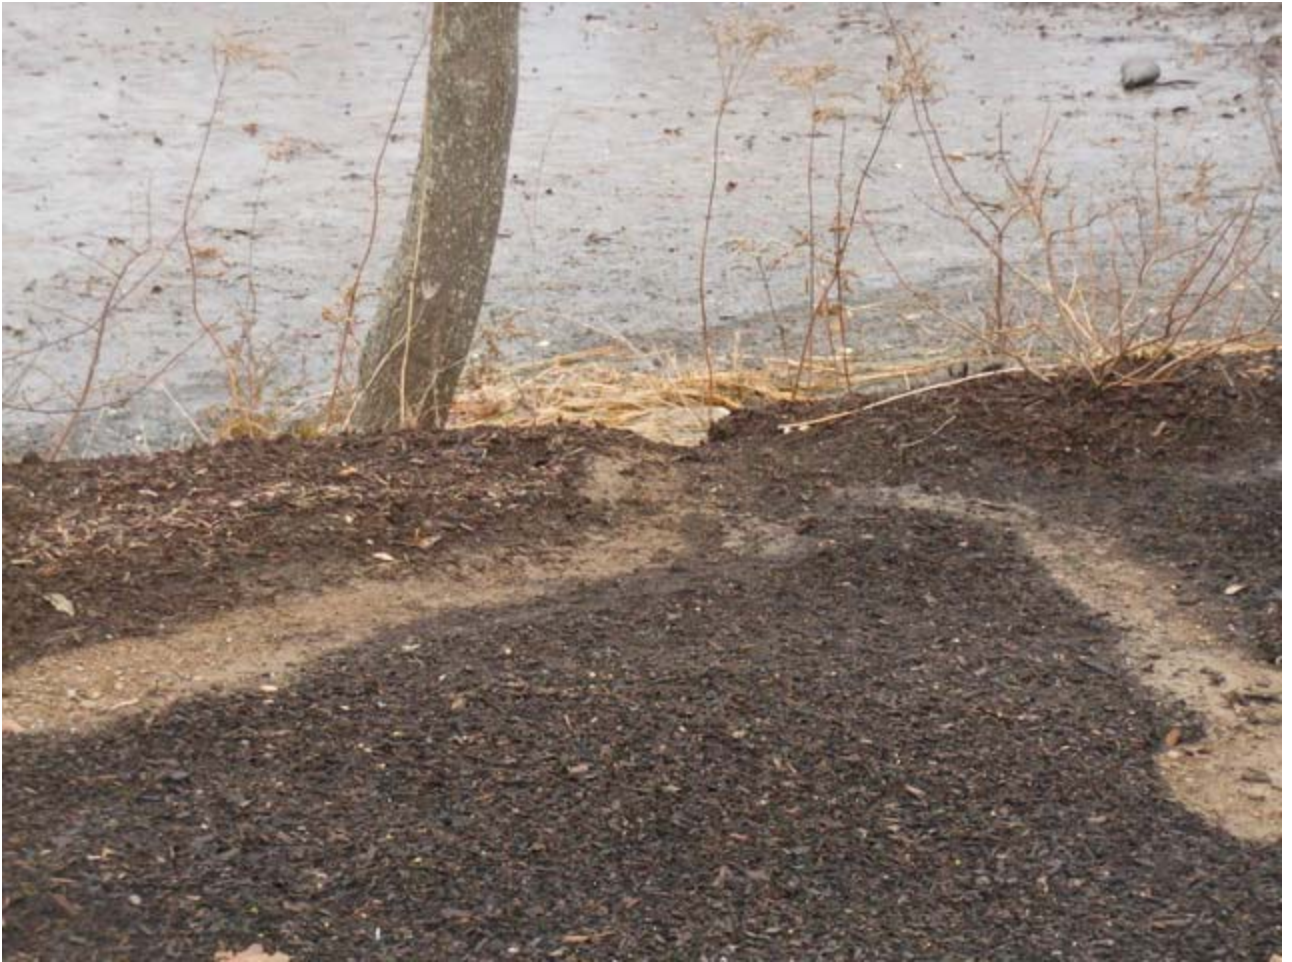
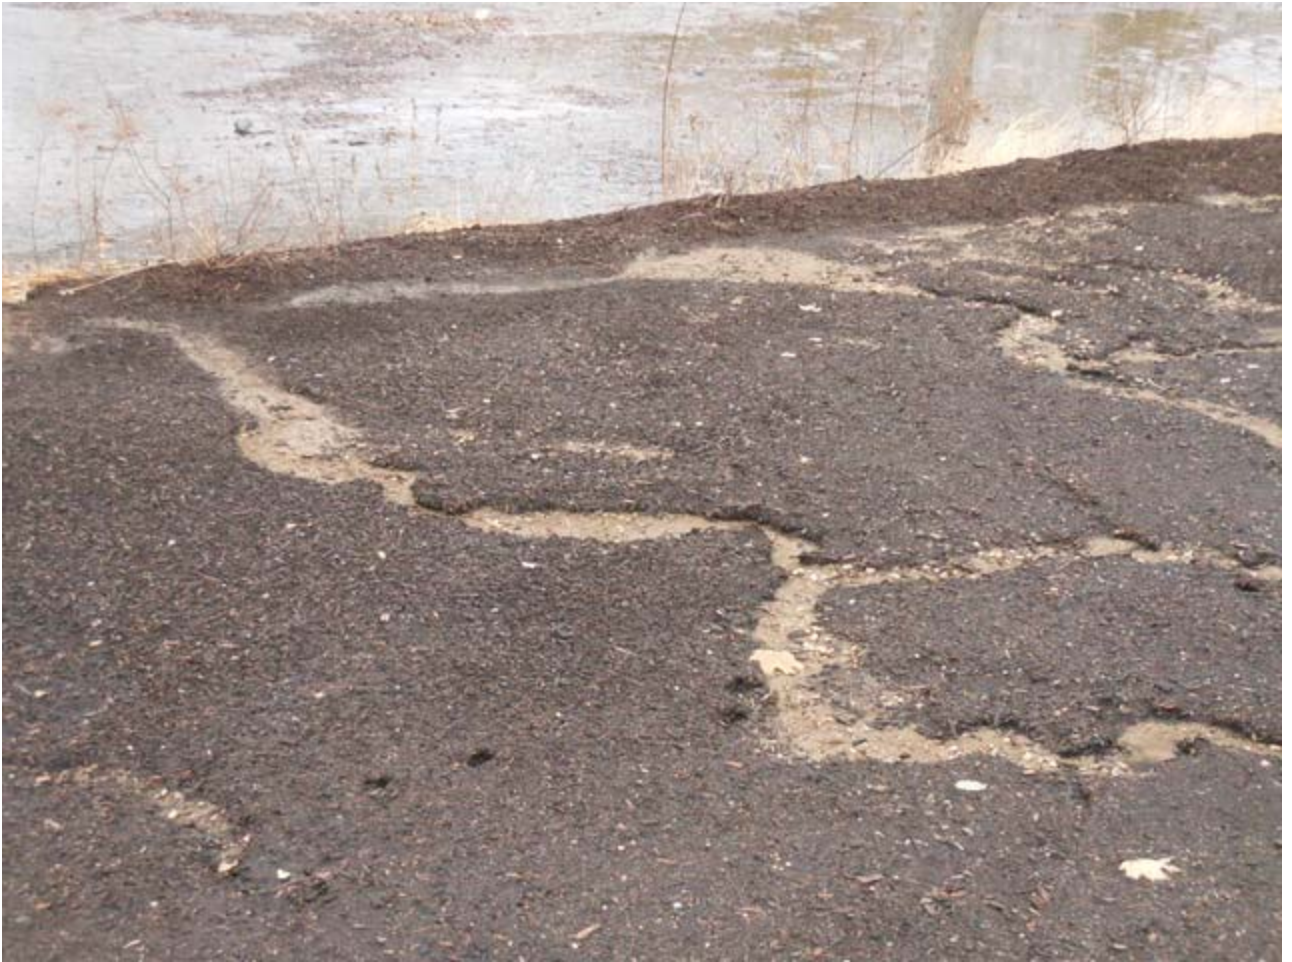
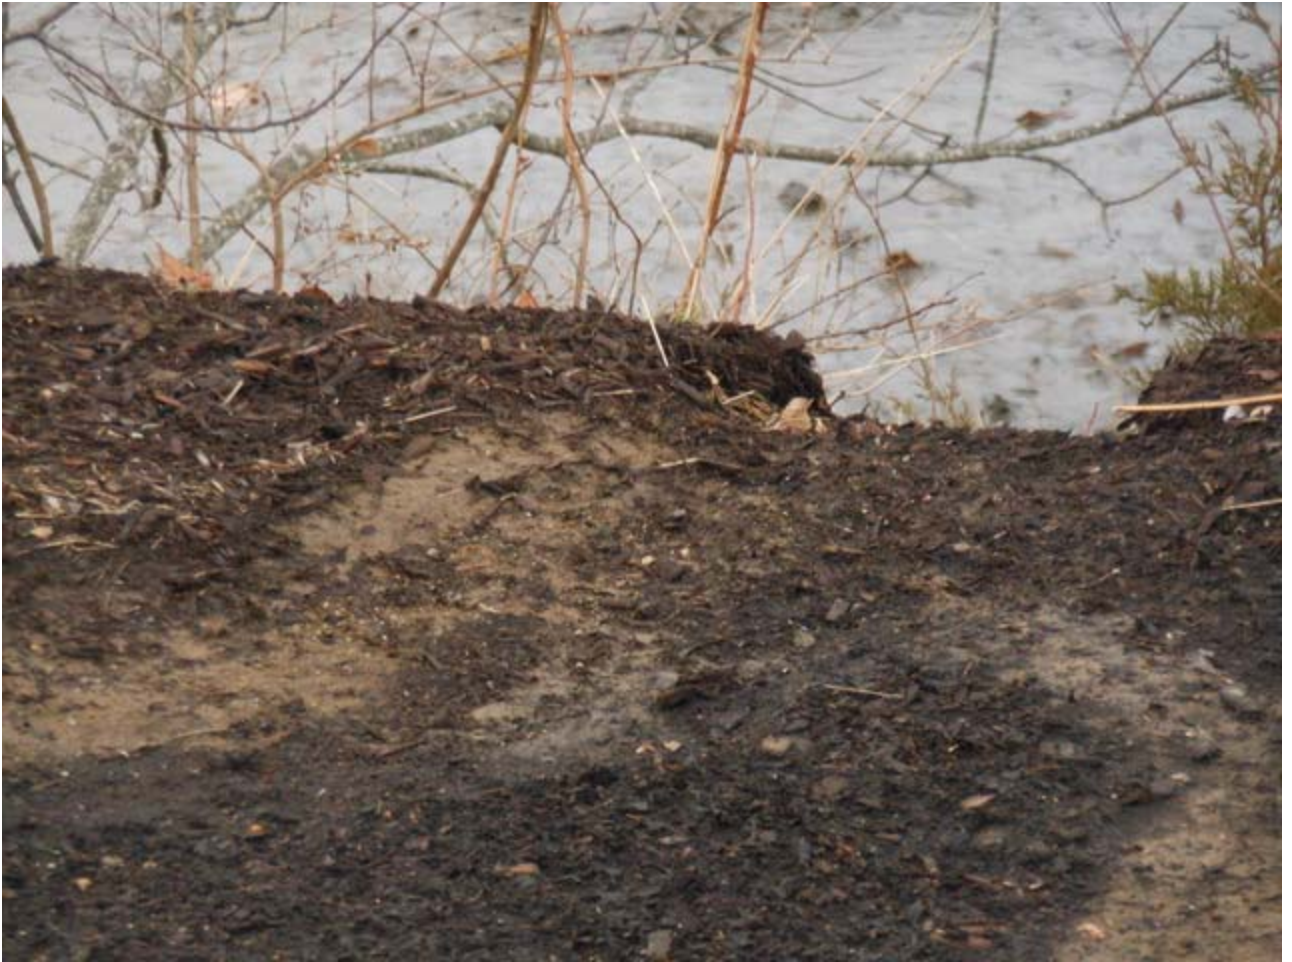
Silt Socks are relatively inexpensive and can be delivered in most cases. Mulch does not hold up at the mall over the winter, it definitely does not hold up at all near a slope of any kind without some kind of edging, even during the Spring and Summer months. It is not designed to hold back water, it just absorbs some water naturally. Please ask GRB to have the whole area raked and remove all the mulch within the 25' wetland buffer zone to the edge of the NMP and install silt socks. Respectfully, Liz
