# Strawbery Banke Museum

## Sherburne House Restoration Project

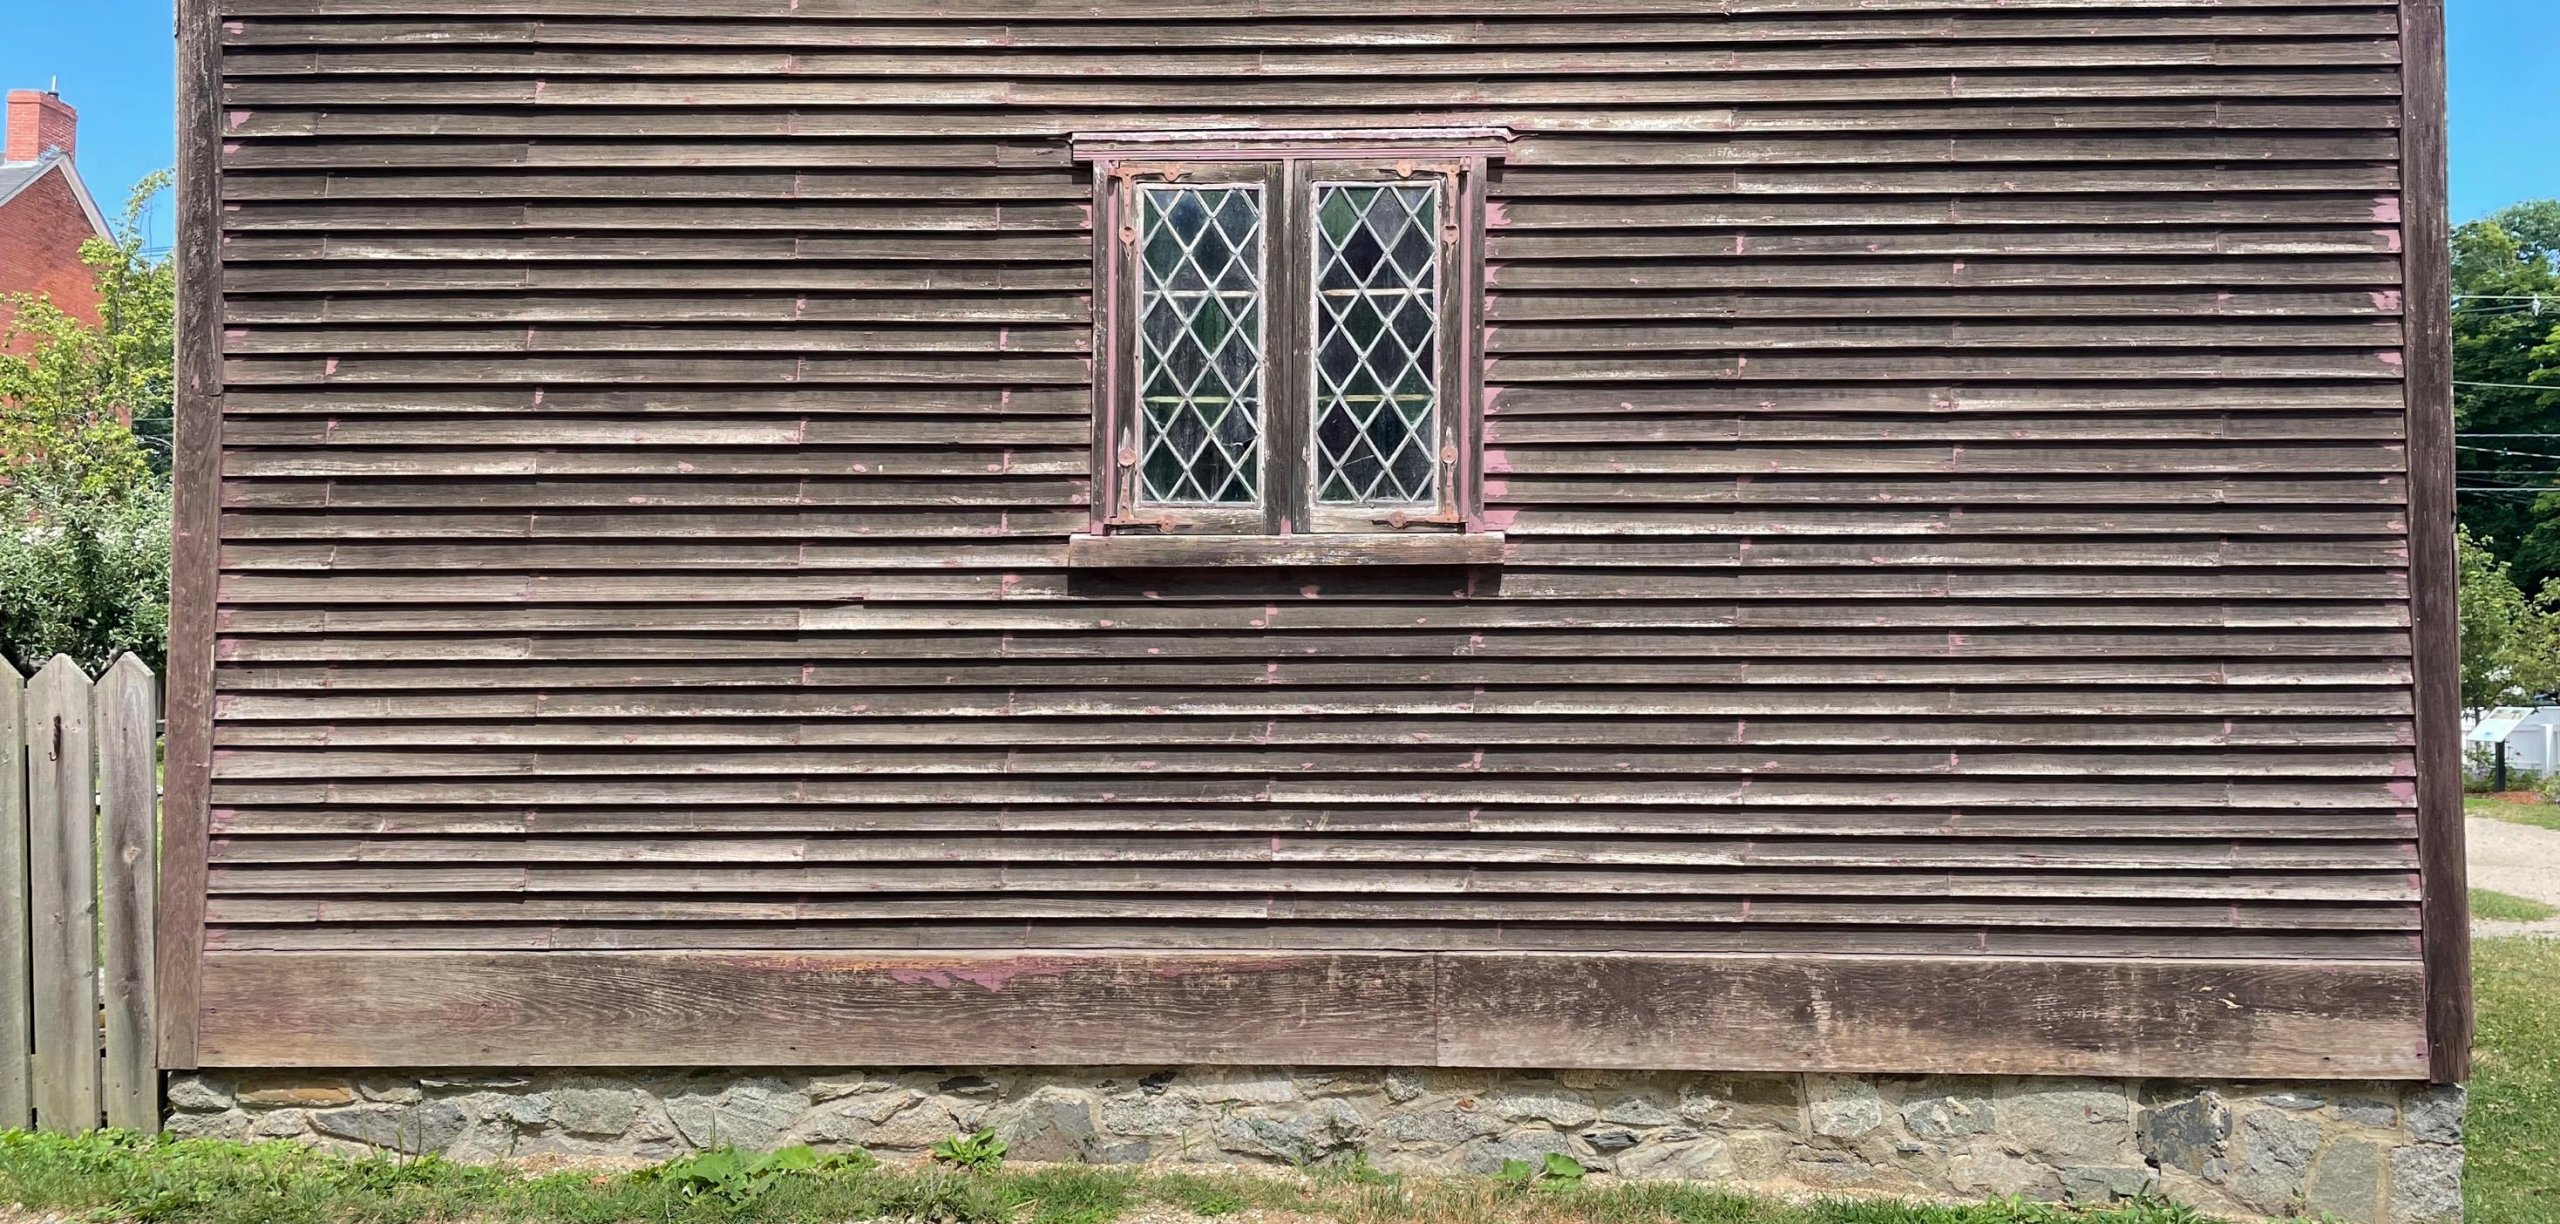
Existing West Window

The existing windows will be replaced with custom made sash. The openings will be unchanged. The overall design was achieved through extensive research and reviewing archeological evidence from the Sherburne House site as well as the Deer Street site, the Chadbourne site in South Berwick, ME, St. Mary's City and Colonial Williamsburg. The frames will be made by Strawberry Banke. The glass was produced by Verrerie de Saint-Just and will be cut into square quarrels based on archaeological and historical evidence. The leading will be done by Maine Art Glass Studio in Lisbon Falls, ME.

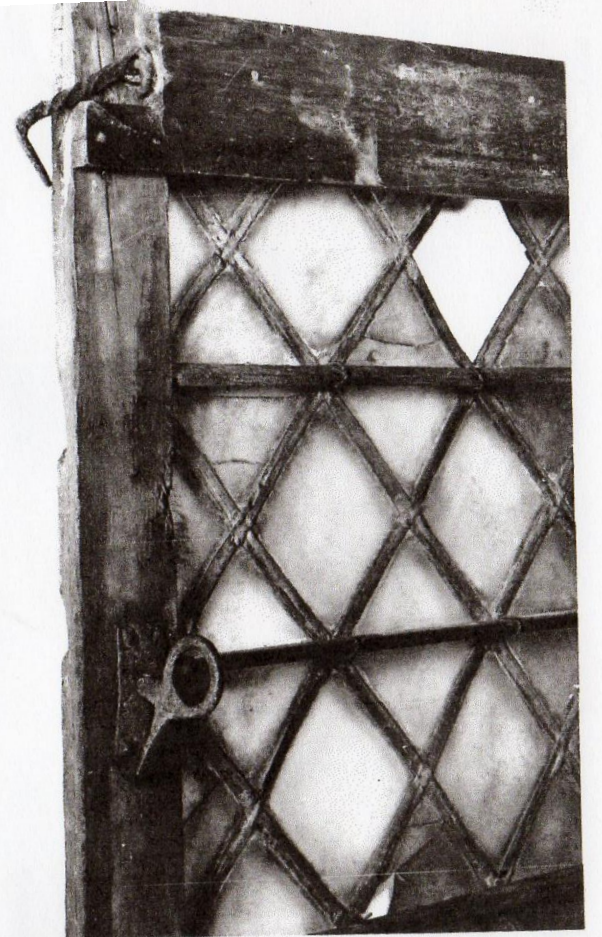
Figure 200B. Buffum house, Salem, Mass., probably seventeenth century. Demolished. Casement window sash, detail of interior surface (with later board reinforcement along upper rail). Photo, J. David Bohl, 1978.

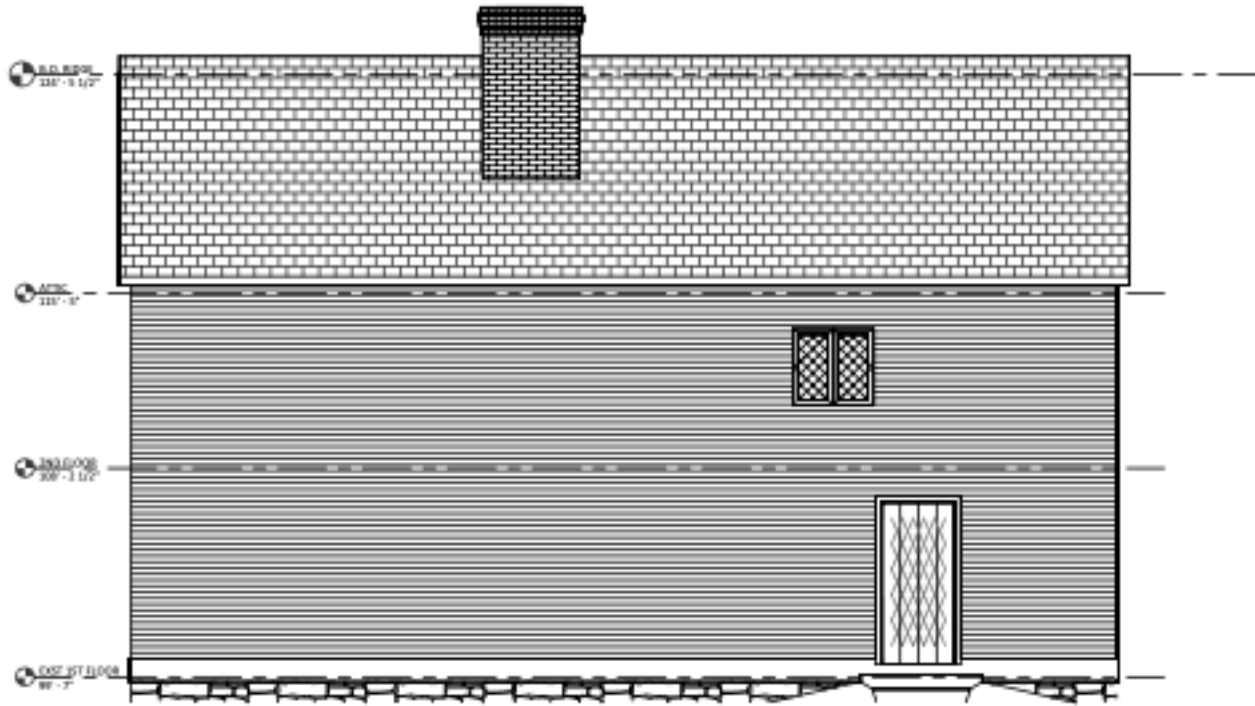
02 EXTERIOR ELEVATION - NORTH

Archaeological evidence clearly indicates the Sherburne House had a series of additions added to the rear elevation over the 18th century. For this reason, and for access to the Sherburne yard, we will be replacing an existing window with a door to the rear elevation as indicated on the architectural plans. This location was identified to correspond with an addition that was added to the house in 1728. The proposed door will duplicate the existing front door in every detail.

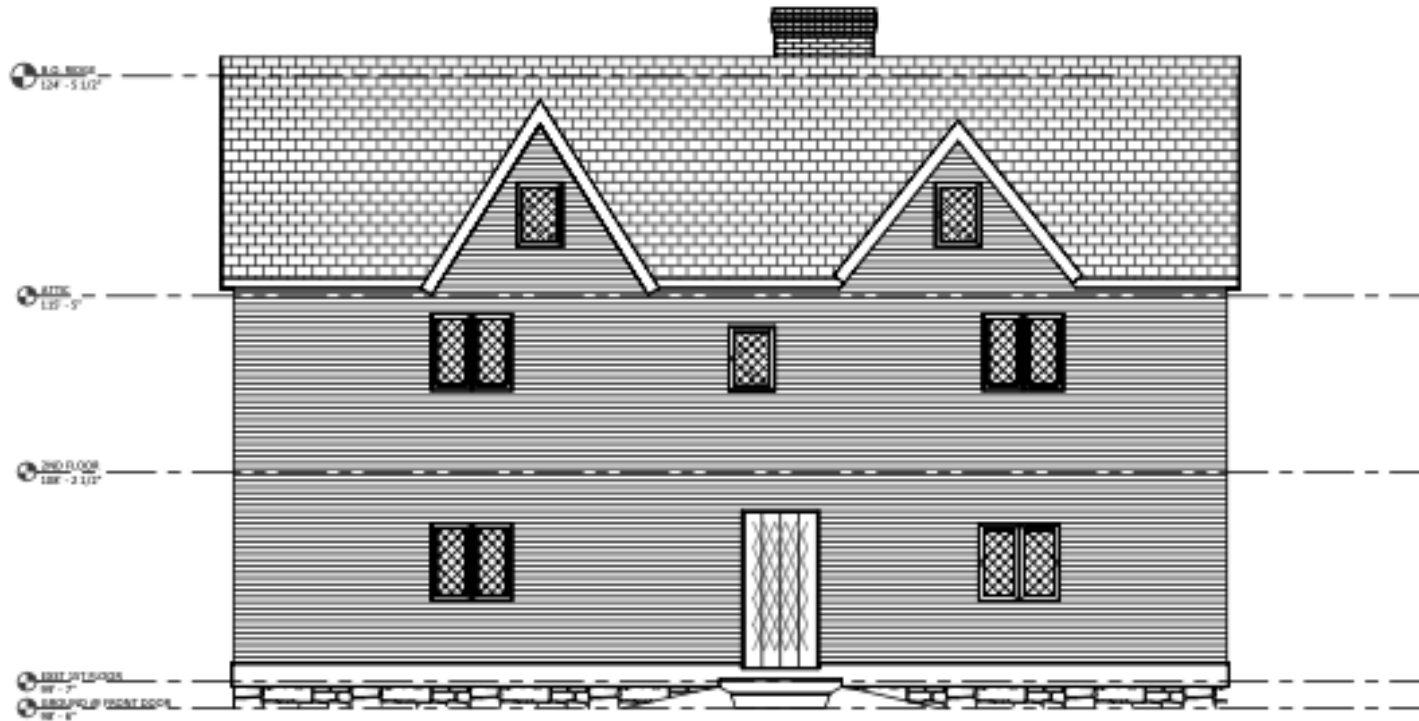
02 EXTERIOR ELEVATION - SOUTH  
1/4" = 1'-0"

The Sherburne chimney was reproduced during an earlier restoration effort in 1968. Evidence indicates this chimney was inaccurate in terms of massing and design. This chimney was also collapsing due to impacts from ground water and was removed after gaining Portsmouth HDC approval in 2019. The new chimney design is based on research of similar historic houses of the period and the massing is based on evidence in the structure. The "Colony Red" waterstruck brick is made by Morin Brick Company in Auburn, Maine.

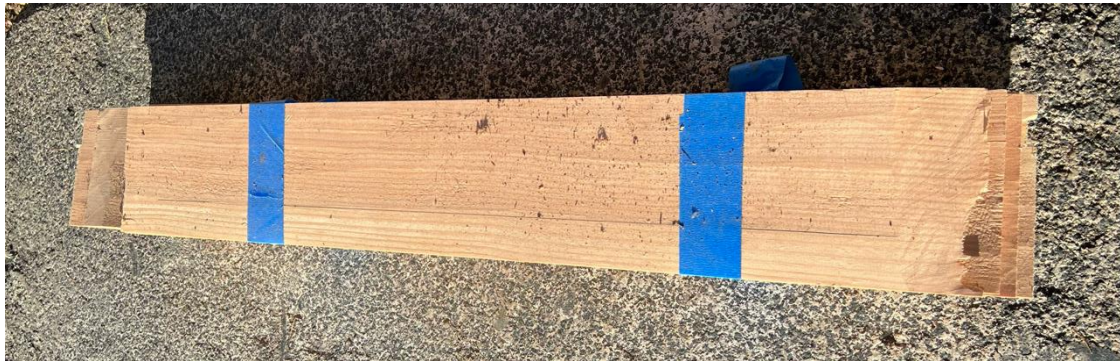
All the siding dates from the 1968 restoration and will be removed. The new siding will be made from custom hewn clapboards with scarfed ends. In keeping with evidence found at the Warner House, the corner boards will be removed and the clapboards terminated together using butt joints.

Existing corner boards
