## PENHALLOW HOUSE

CITY OF PORTSMOUTH
Historic District Commission

REVISED SUBMISSION August 18, 2023

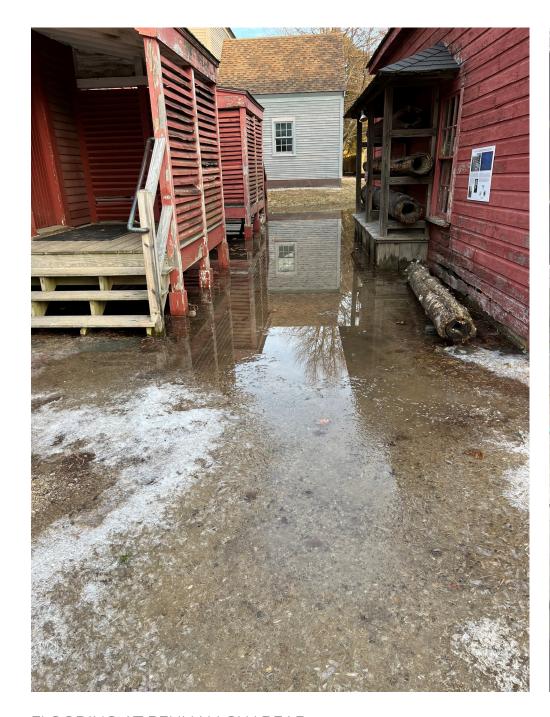
FLOODING AT PENHALLOW REAR

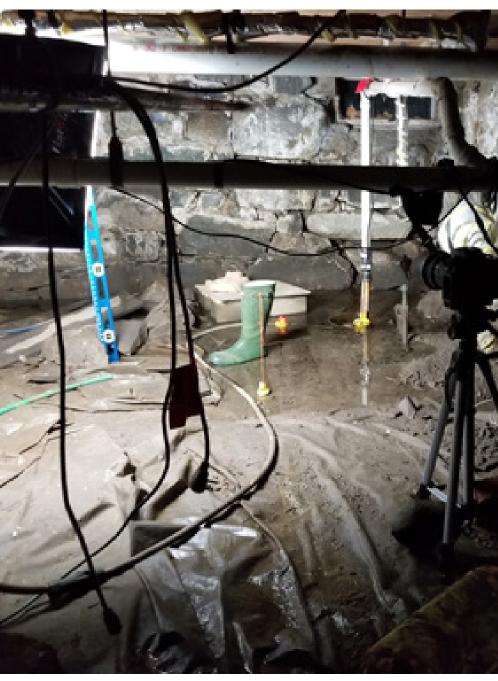
FLOODING AT PENHALLOW REAR

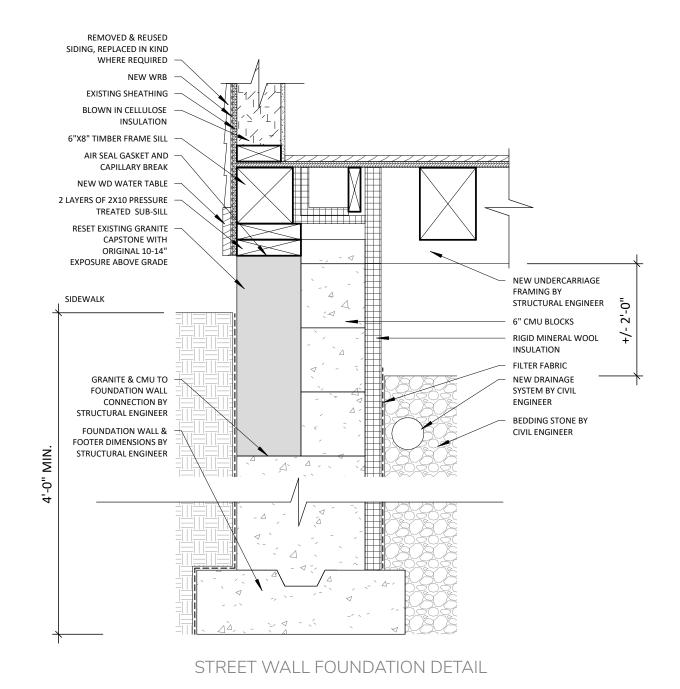
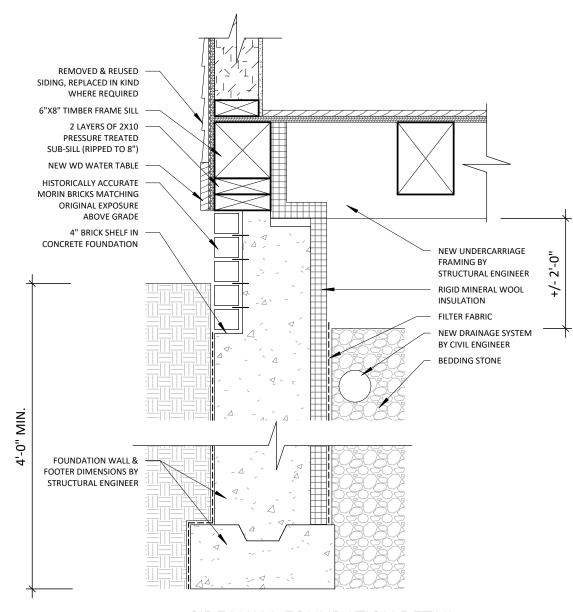
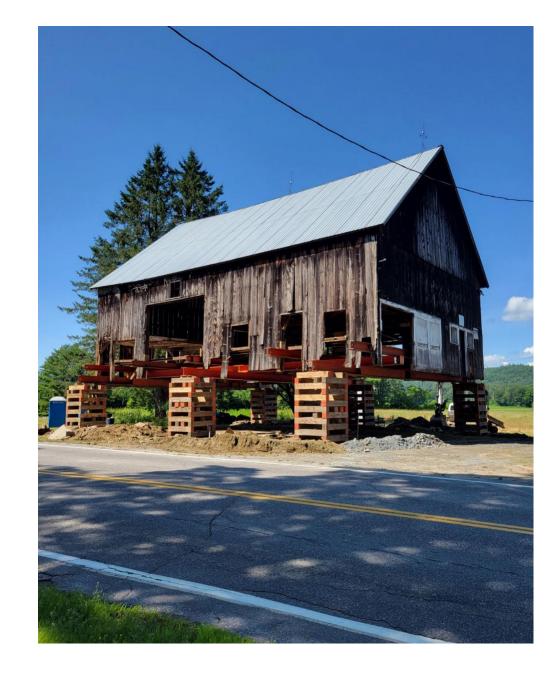
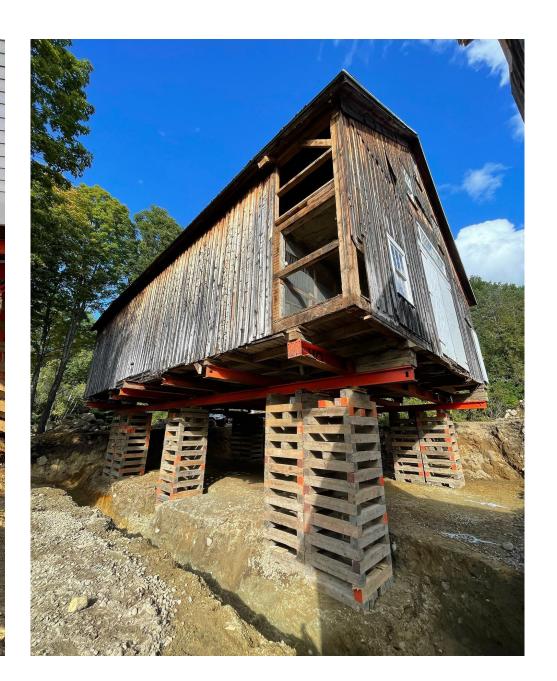
### **FOUNDATION WALL DETAILS**

SIDE WALL FOUNDATION DETAIL
