We are requesting a HDC Certificate of Approval to replace our current circa 1980s wooden window sashes and jambs with Jeld Wen Siteline window sash replacement kits.

Current Window Sashes are Circa 1980s, not Historic, & Purpose of Sash Replacement

We are requesting approval to install new high quality K style seamless aluminum gutters and 3X4 downspouts in an off white shade to match our house trim. All of our current gutters are wood and the front downspouts are also wood, the rear downspouts are round copper.

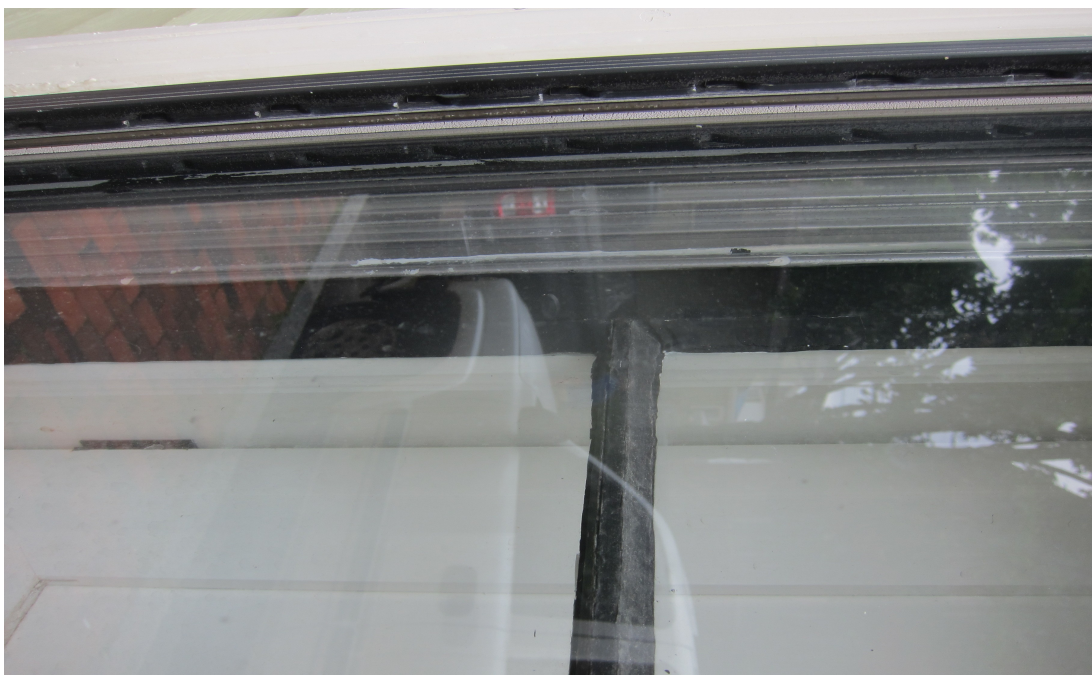
Exterior Photo of example window – shows circa 1980s aluminum jambs – turn paper 90 degrees clockwise to see proper orientation.

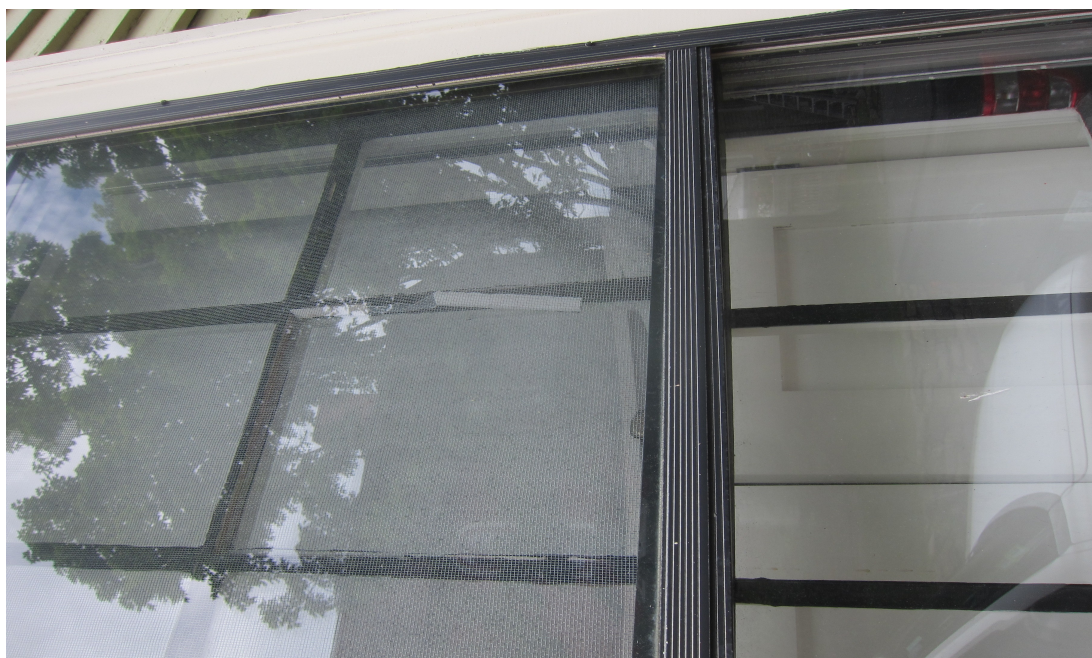
We are seeking this replacement because, despite frequent reglazing, our circa 1980 windows sashes are falling apart. The hot sun baking behind the storm windows and wind blown rain continually cause damage. We can not rebuild the current window sashes on the majority of the windows because removing the sashes will bend and damage the aluminum jambs (6 windows on the addition are more recent and have plastic jambs and could be rebuilt). We are not certain of the age of the frames, sills and trim on the current windows. The aluminum jambs on the sash kits indicate they are not historic, but rather circa 1980s, consistent with the fact there was a major renovation on the house in 1984/1985. It is possible that during this renovation only the sashes were replaced rather than the entire window sills, frames and trim. By replacing just the sash kits, we not only save money but retain any elements of the window trim that might be historic. Putting in an entire new window would require a sacrifice of either the current window trim, which is lovely, or would reduce the size of the sashes and glass if inserted into the current trim and sills.

Exterior Photo of example window – shows constant deterioration of glazing – turn paper 90 degrees clockwise to see proper orientation.

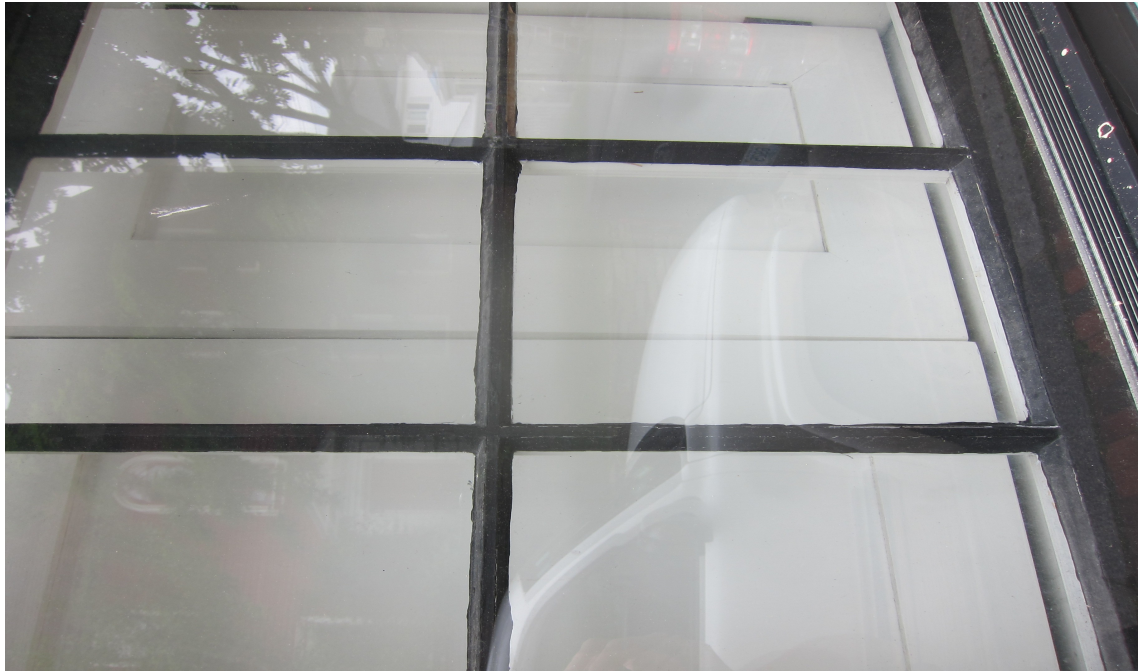
Example of recent reglazing, damaged already by the elements

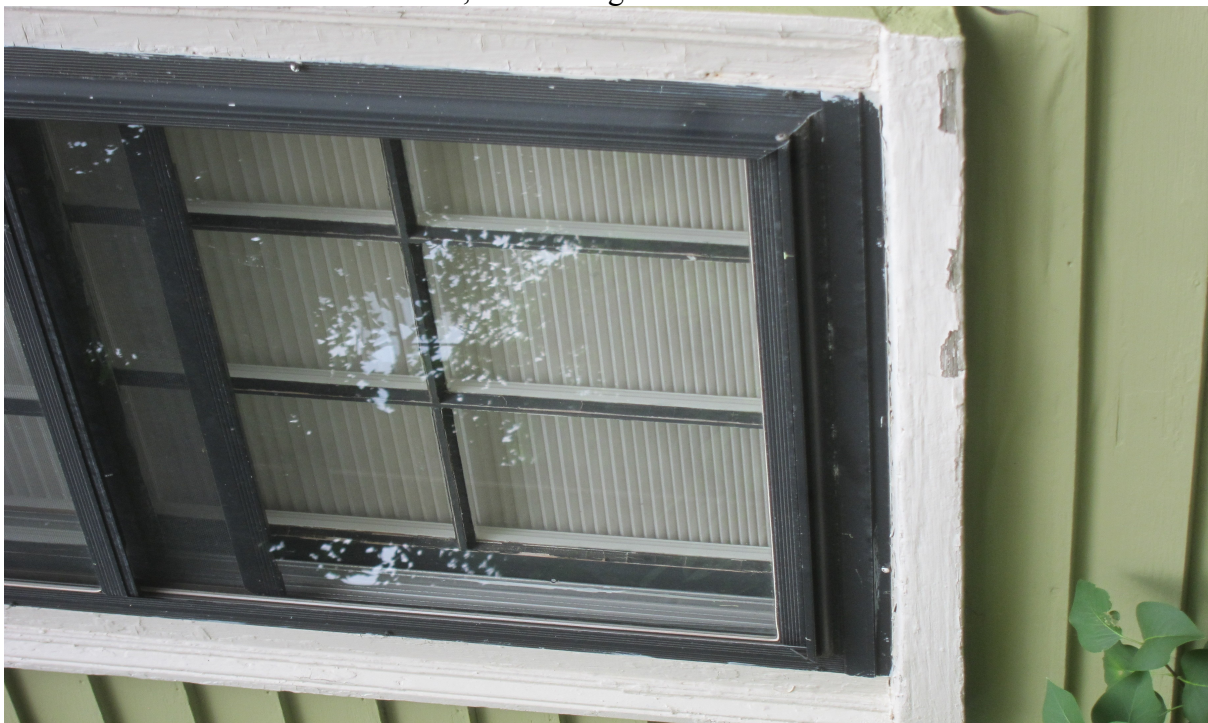
Street view of one of the better windows, turn 90 degrees clockwise for correct orientation

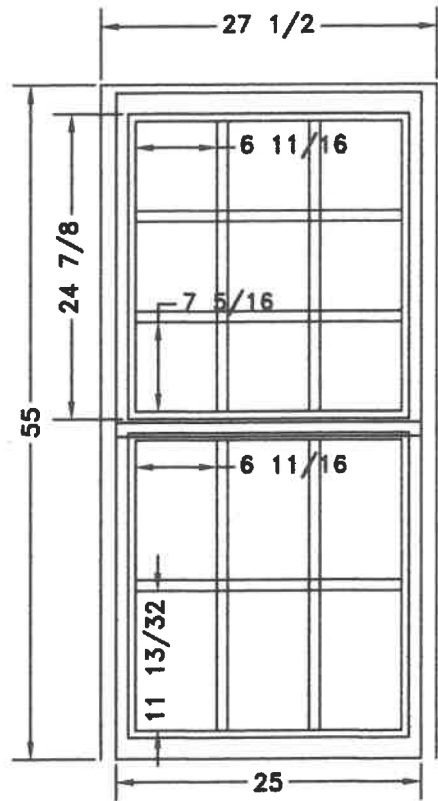
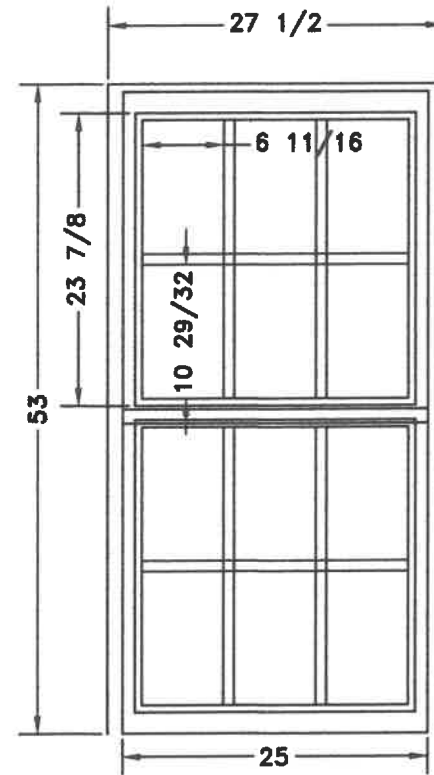
14 DEGREE SILL

SPECS:
SITELINE CLAD DOUBLE HUNG
REPLACEMENT SASH KIT
14 DEGREE SILL
7/8" SDL

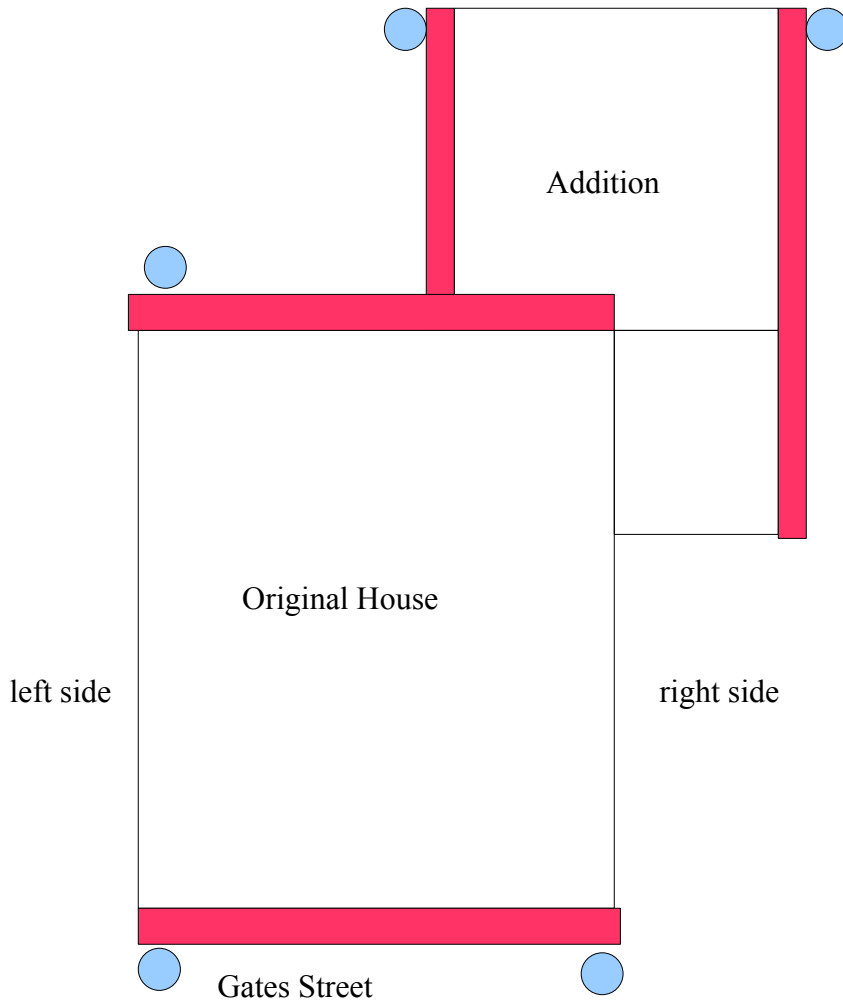
We propose to locate new gutters and downspouts in the same locations as the old ones

Gutter Locations Marked in Red

Downspouts indicated by blue circles

Our vendor, Joe Kuchman, at Affordable Gutter Guy, identified a K style with 3x4 downspouts as appropriate. The current gutter and downspout locations will be maintained and structures will match the trim color (Ben Moore Ivory Tusk - the swatch was a dead-on match). The same vendor just installed this same product just a block away at the 1790 Capt. Drisco House at 11 Meeting House Hill Rd.

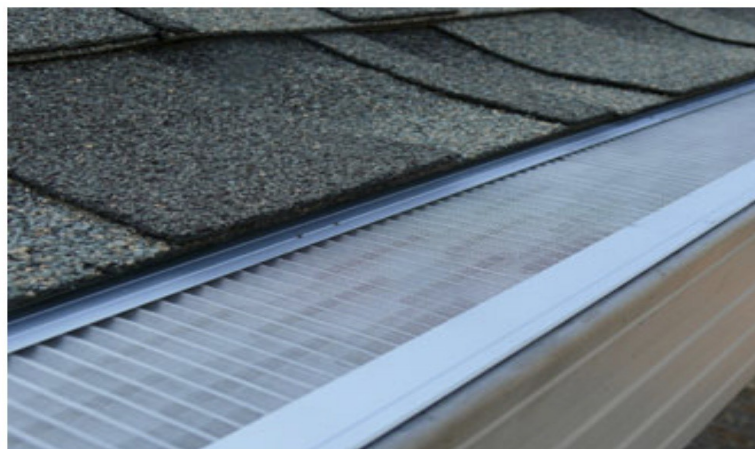
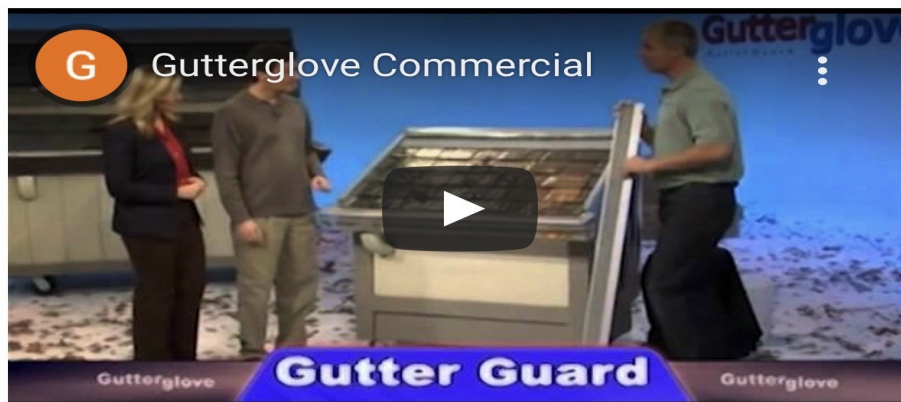
The design is both simple and effective. Gutterglove has a hardened aluminum honey comb body covered by a stainless steel micro mesh. This mesh is made out of 316 surgical grade stainless steel and is capable of filtering up to 200 inches of rainfall per hour. The gutter glove frame spans from the drip edge under the shingles to the lip of the gutter while the mesh filters out all debris that is carried from the roof over the gutter.

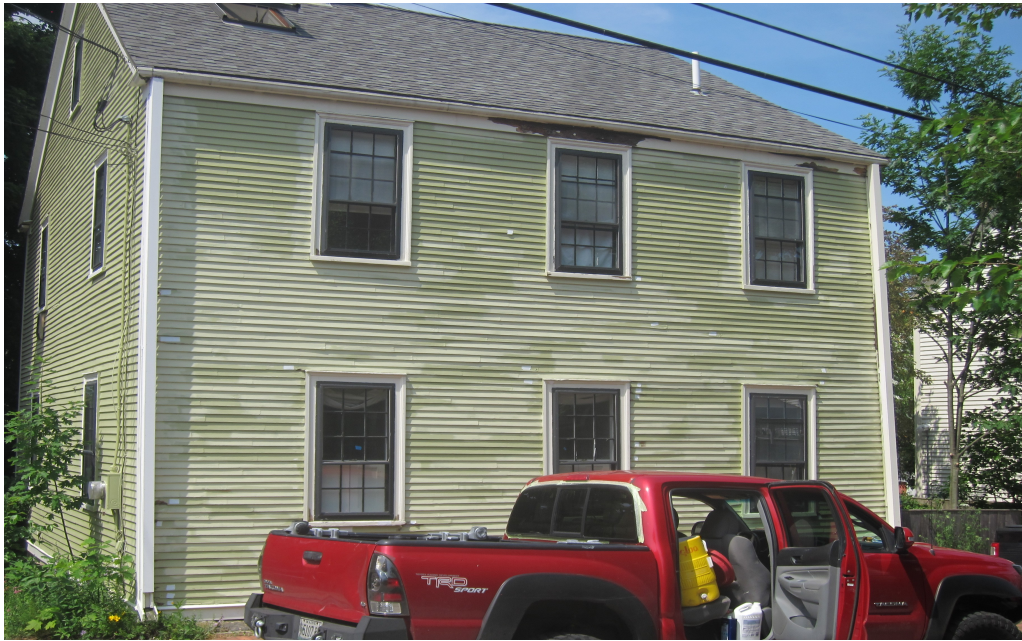
The capacity of the system is inadequate, and water flows over the gutters down the sides of the house, detaching the paint, ruining the glazing on the windows, and rotting the siding and window frames and trim. This has also rotted the trimboards and cornerboards under the gutters and downspouts. Strawberry Banke Museum's application for the Goodwin House gutter replacement requested larger capacity gutters for the same reason. In addition, a wooden downspout's interior capacity is much less than that of the same sized aluminum downspout's capacity because of the thickness of the wood. More downspout capacity is needed, because during these rain events the water pools at the top of the downspouts and flows over the gutter down the wall next to the downspout, again rotting and ruining the wood gutters and downspouts are intended to protect. As rain runs down the side of the house, it also pounds at the foundation, damaging it and creating puddles and floods in both the basement of the historic old structure and smaller new addition. Constant maintenance because of this includes siding and trim repainting, repair and replacement of gutters, trimboards, cornerboards, siding and window trim.

Front of House with rotting gutters, trimboard, siding and cornerboards

We would appreciate your approval of aluminum gutters and downspouts which we believe will significantly improve our never ending maintenance cycle and the significant damage and maintenance expense that water is causing to other parts of the home. Many historic homes in the historic district have aluminum gutters and downspouts, so we would not be an anomaly.

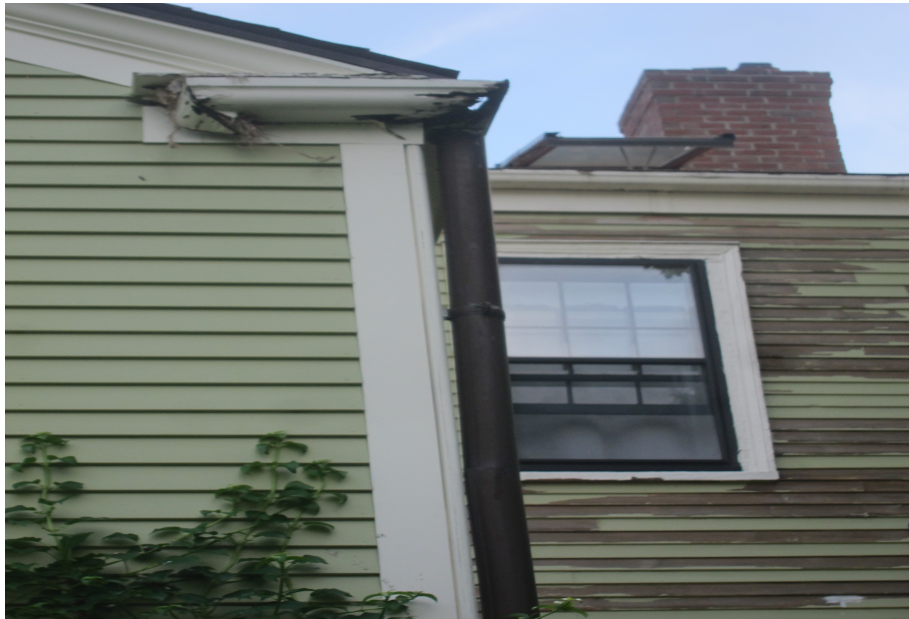
Rot on Back Addition Gutters and Main House siding, trim and window mouldings

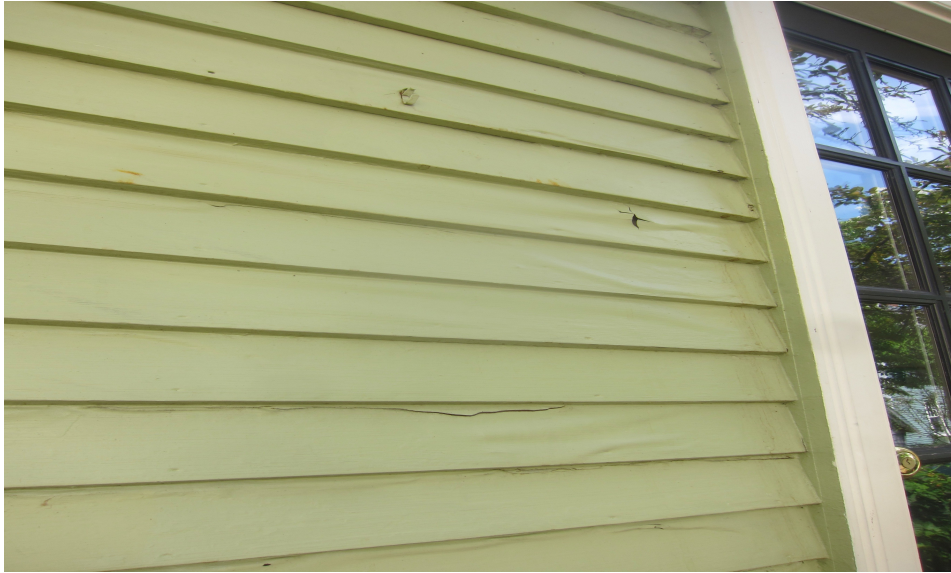
Paint Bubbling and Separating From House Where Water Overflows Gutters

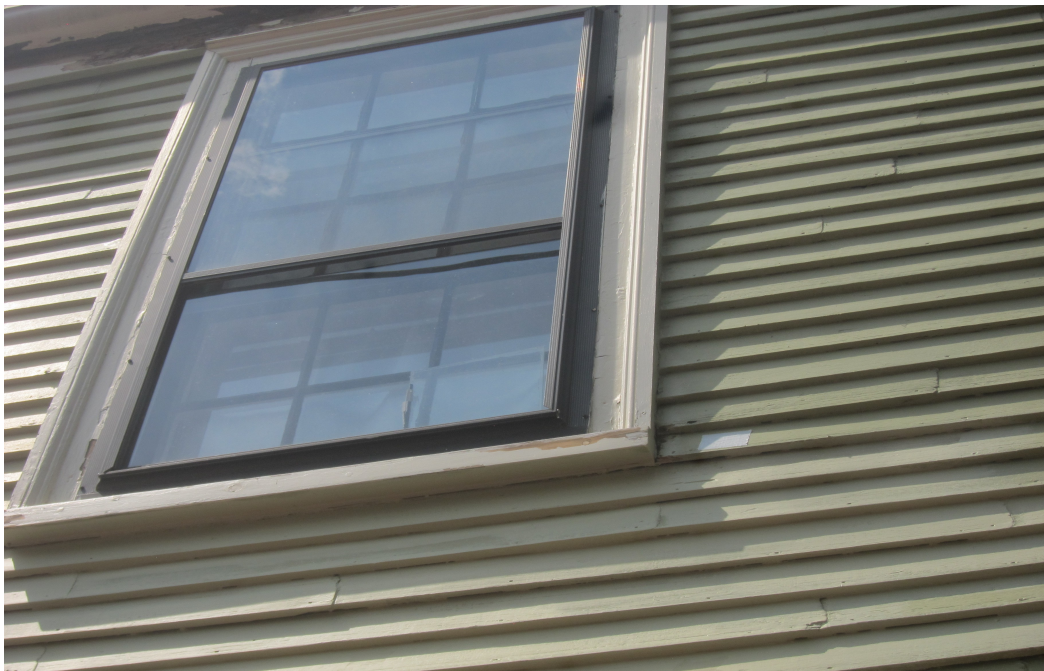
Trimboards Rotted Underneath Gutter, Overflowing water runs under storms, deteriorates windows, this one to the point where the pane has fallen out. Every window was reglazed within the last 5-6 years

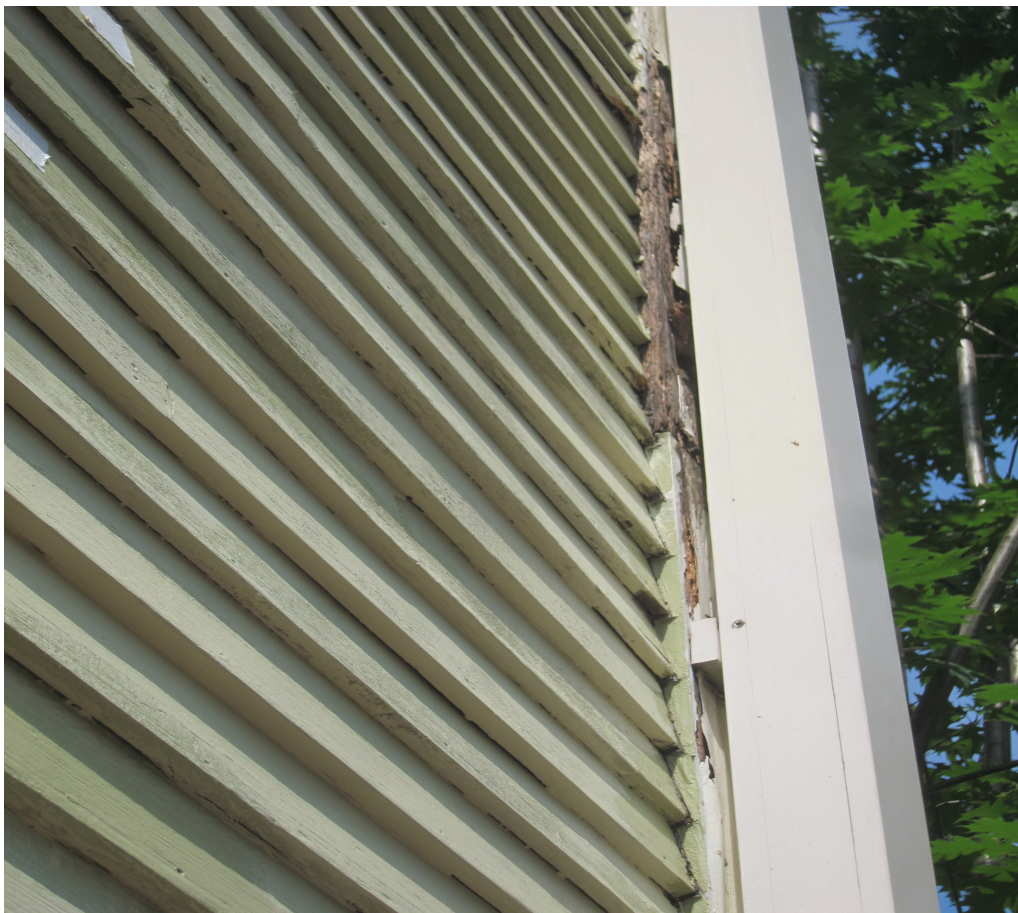
Rotted Cornerboard under front housedownspout. Low downspout capacity causes water to flow behind the downspout, rotting the board and siding underneath

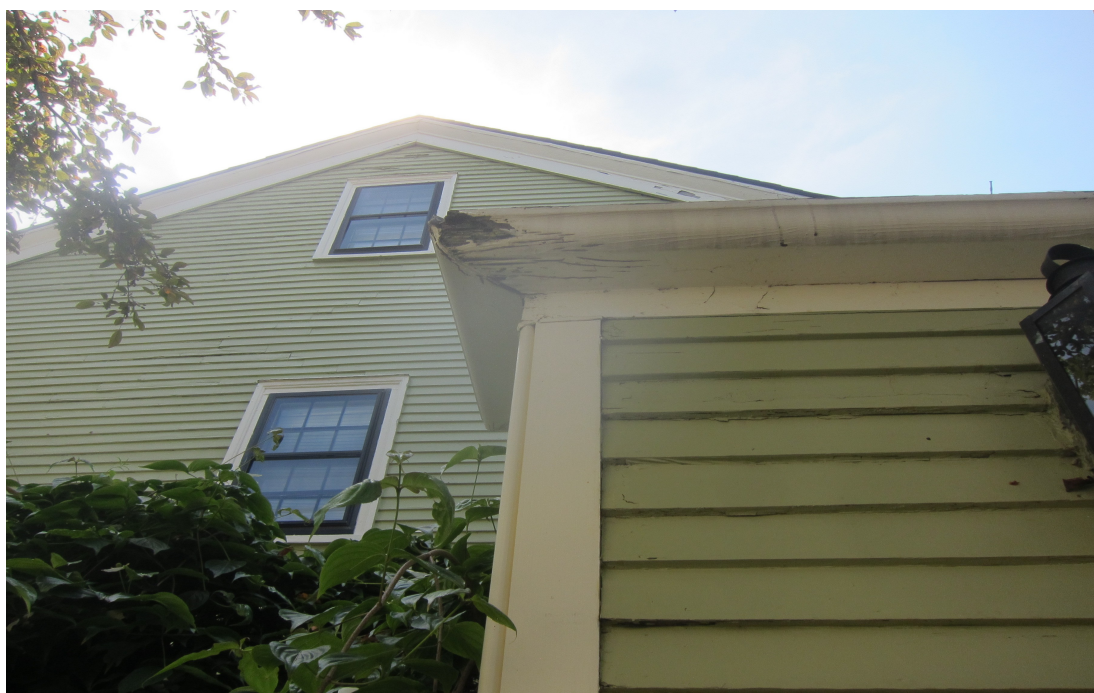
Rotted Gutter On Addition

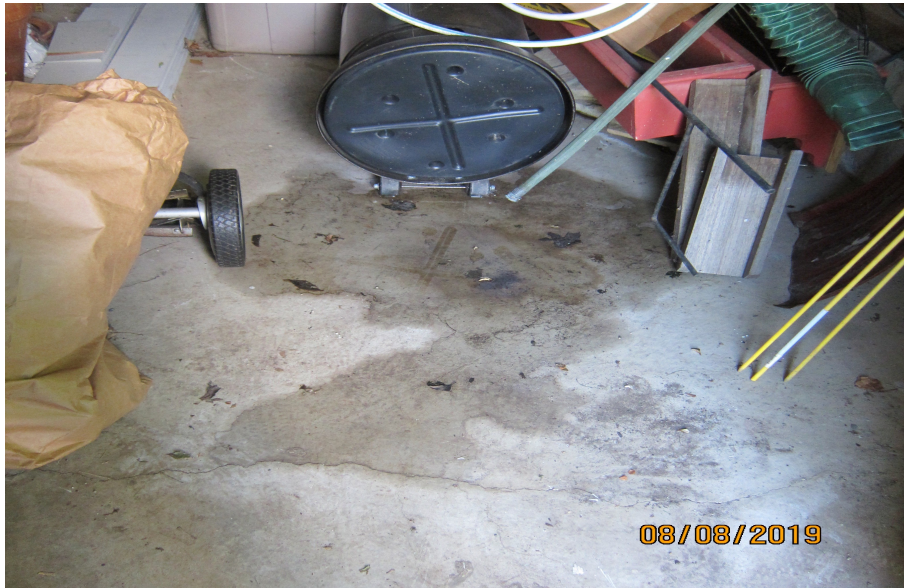
Constant Water Encroachment to Both Basements During Storms as Water Overflows Gutters

Illustration 1: Water in Basement Under New Addition

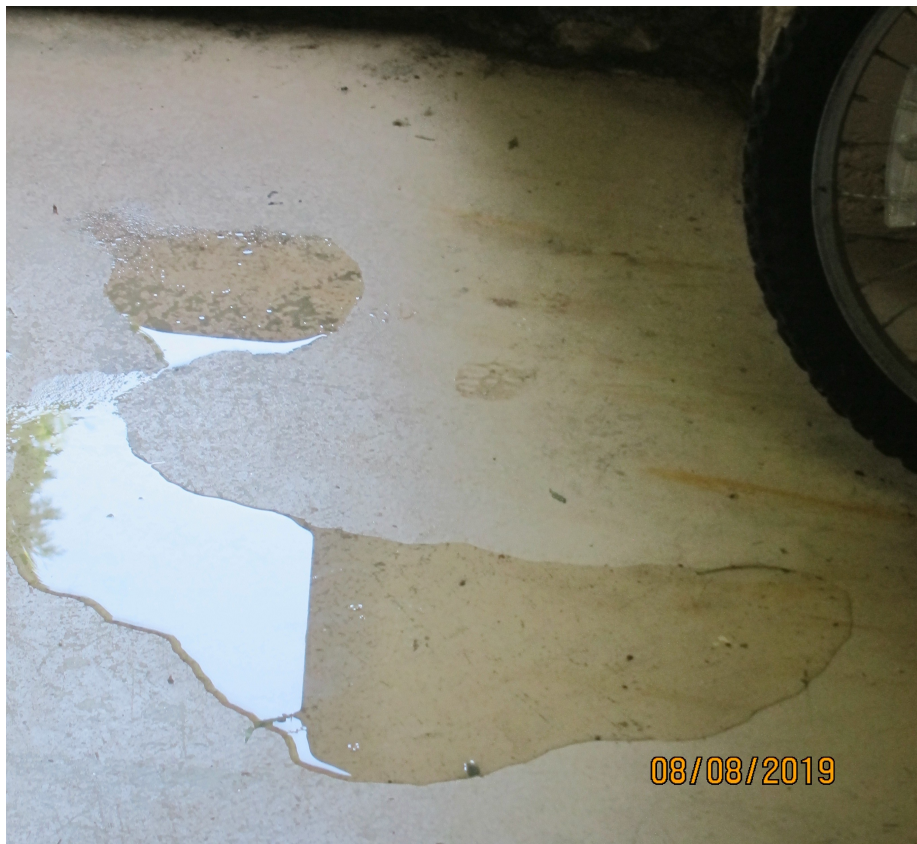
Illustration 2: Water in Basement Under the Main House
