Dear historical commission.

We are requesting your approval to remove the chimney in the southeast section of our property at 232 court / 93 pleasant St. We have 2 other chimneys that we are keeping and utilizing. We have included pictures of the subject chimney, as well as a highlighted section of our engineers' report after physical inspection of our property. Thank you for your time and consideration in this matter.

**BMC Engineering's comments/recommendations:**

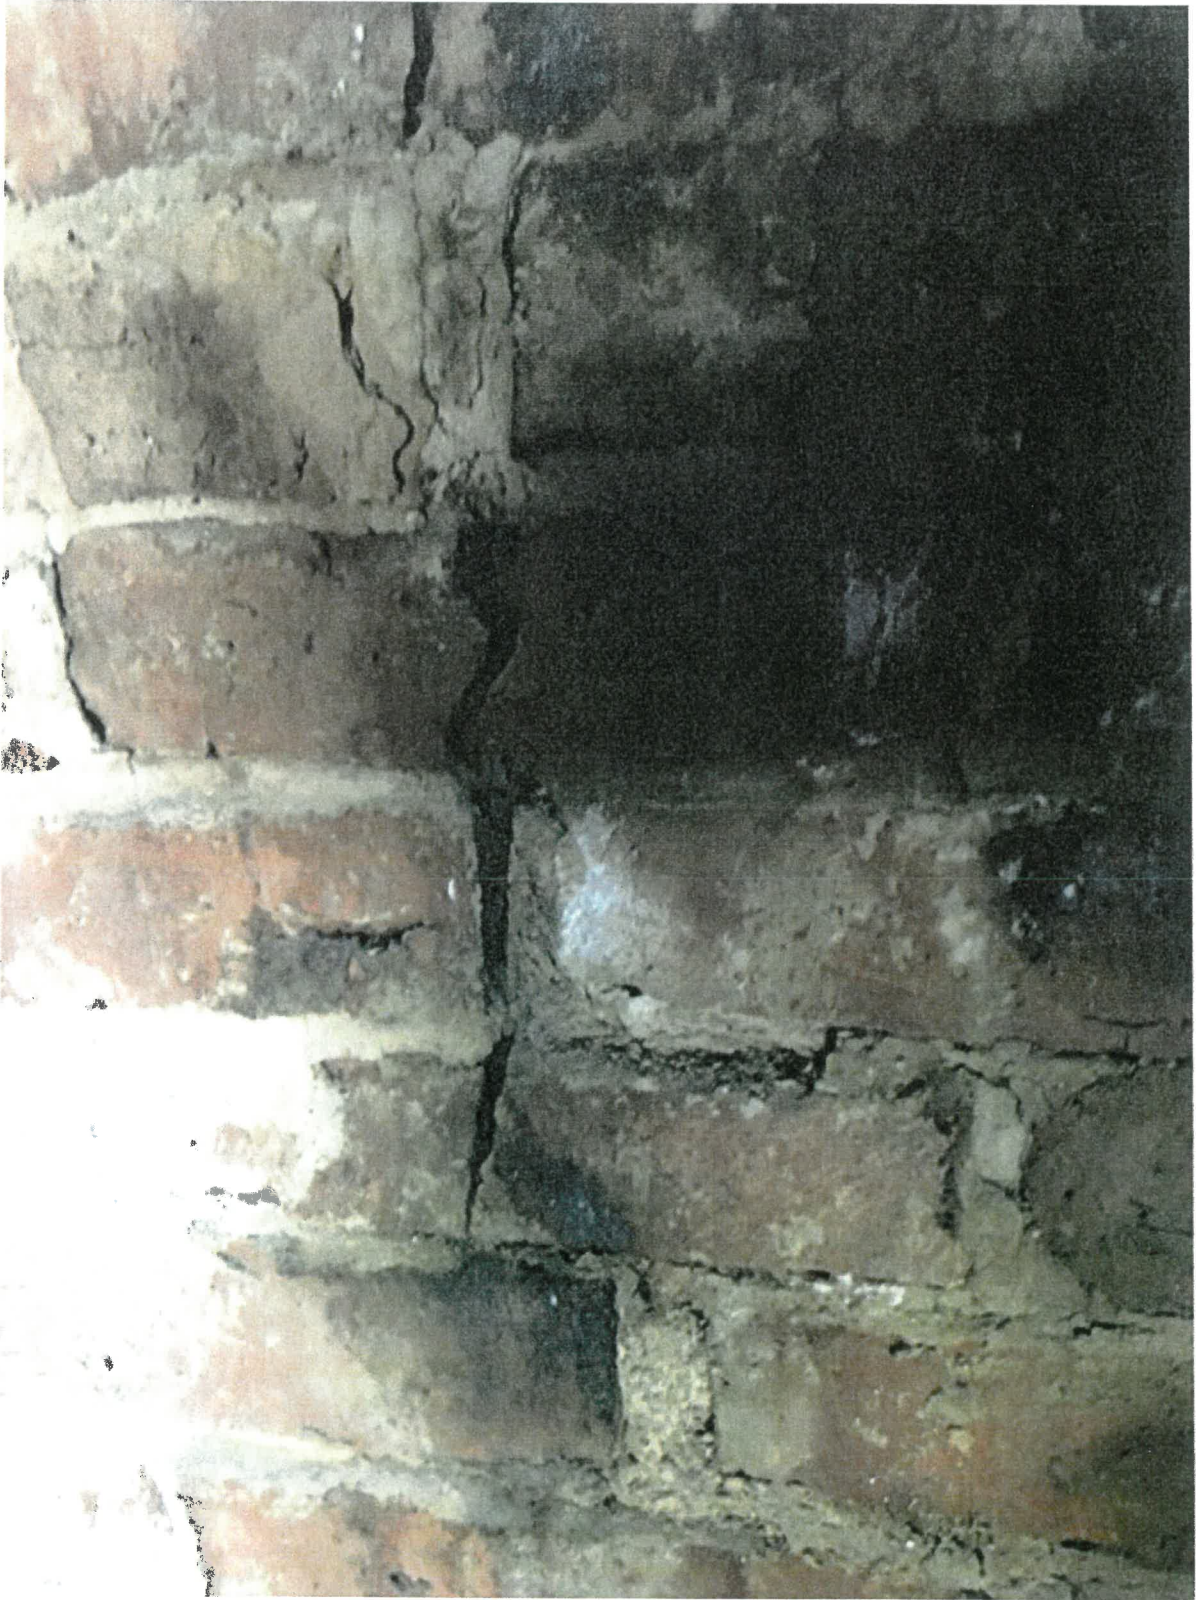
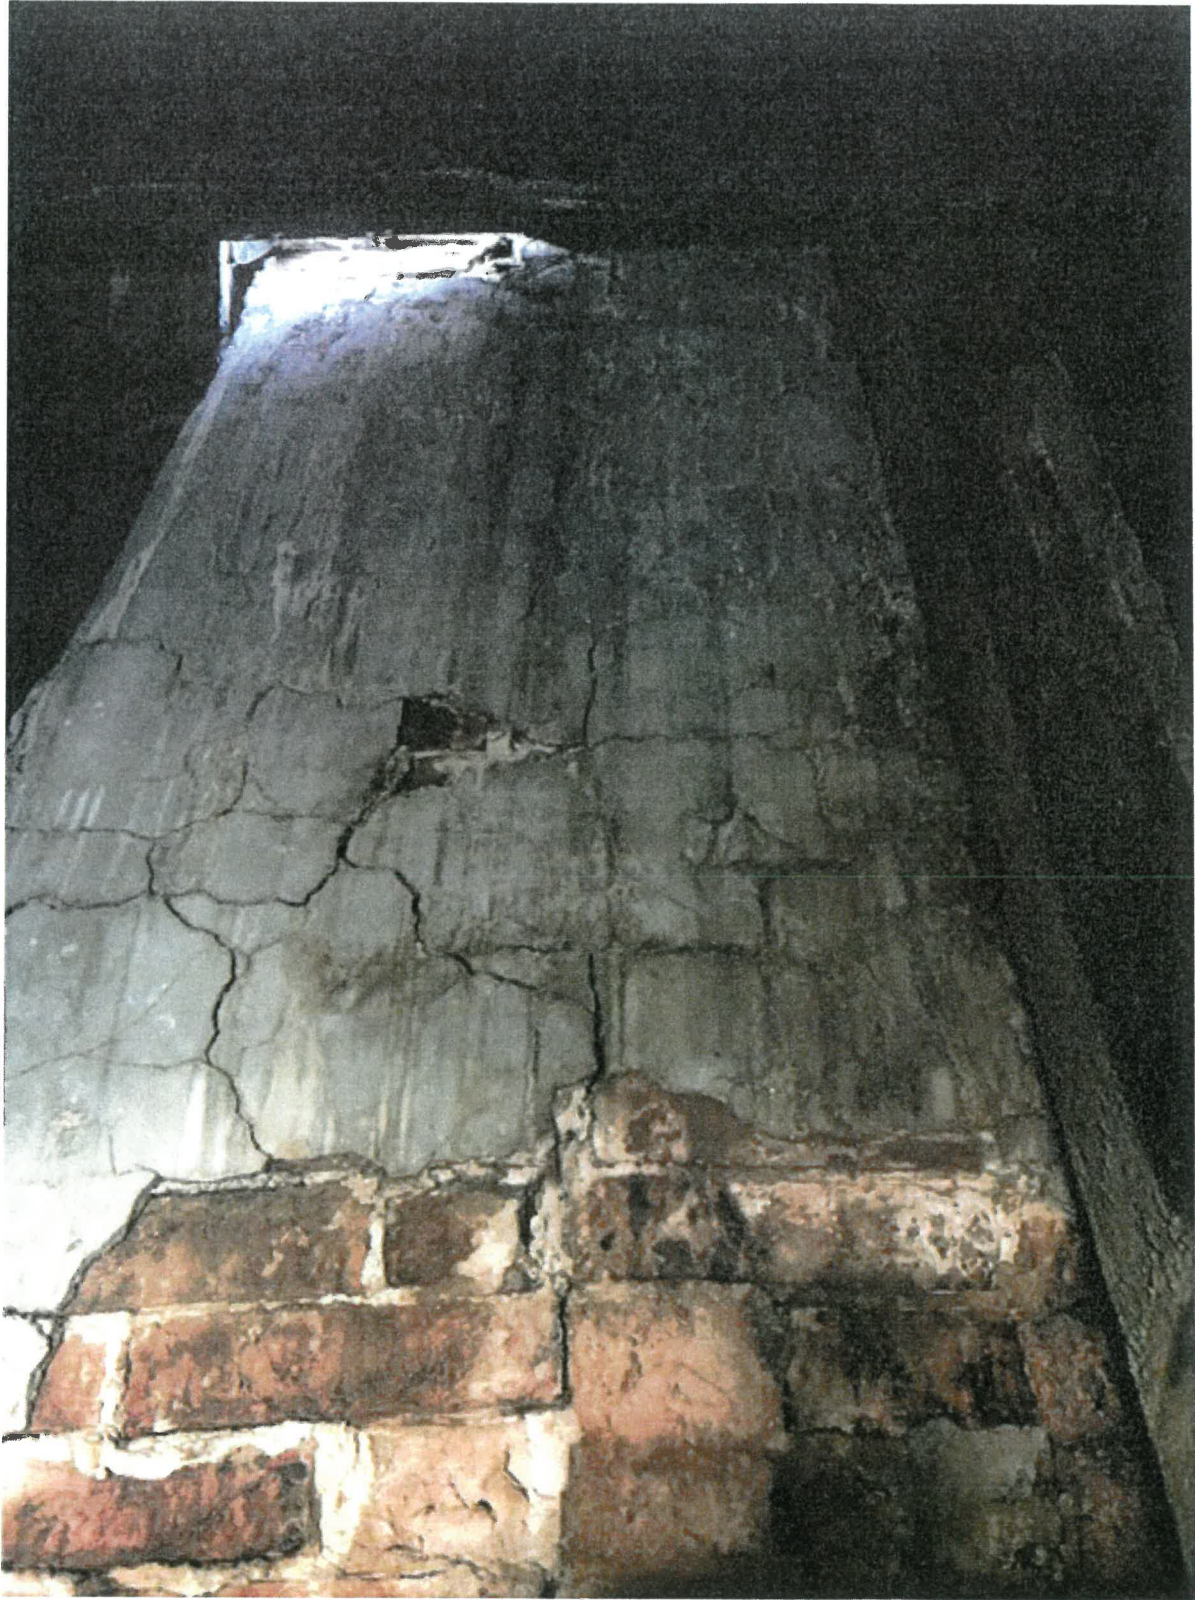
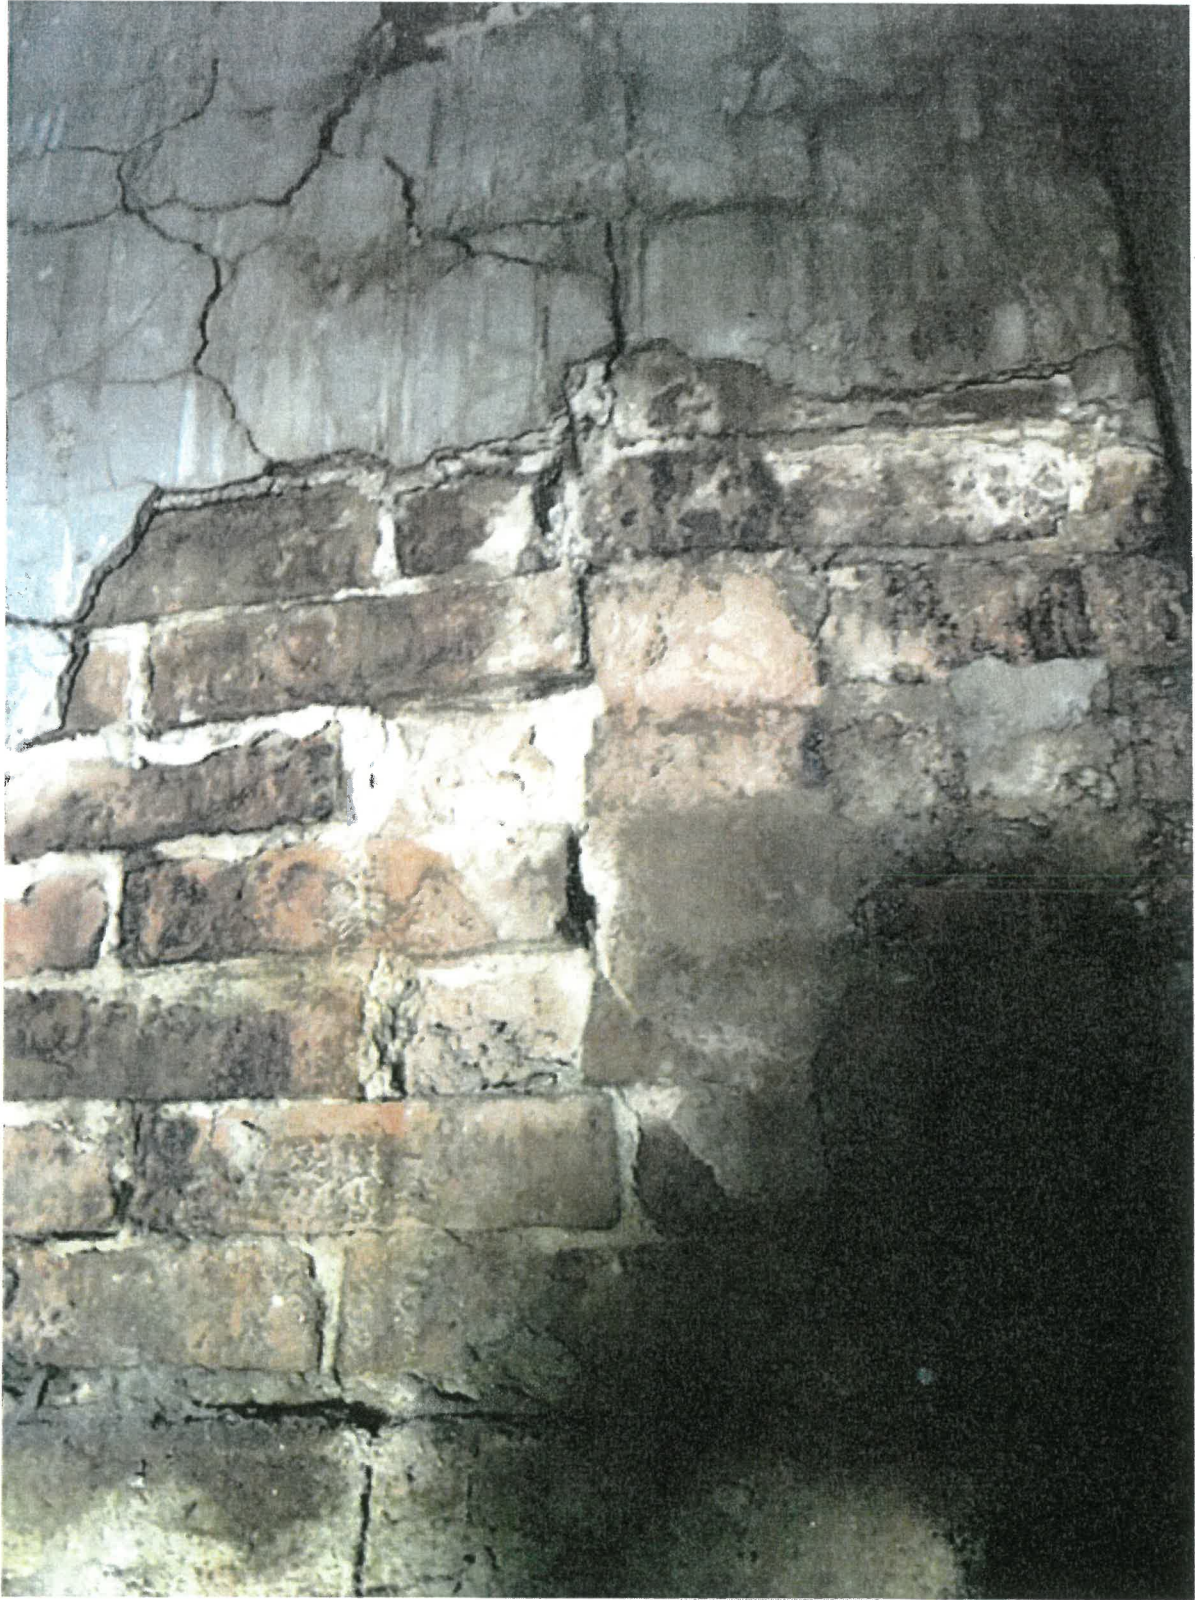
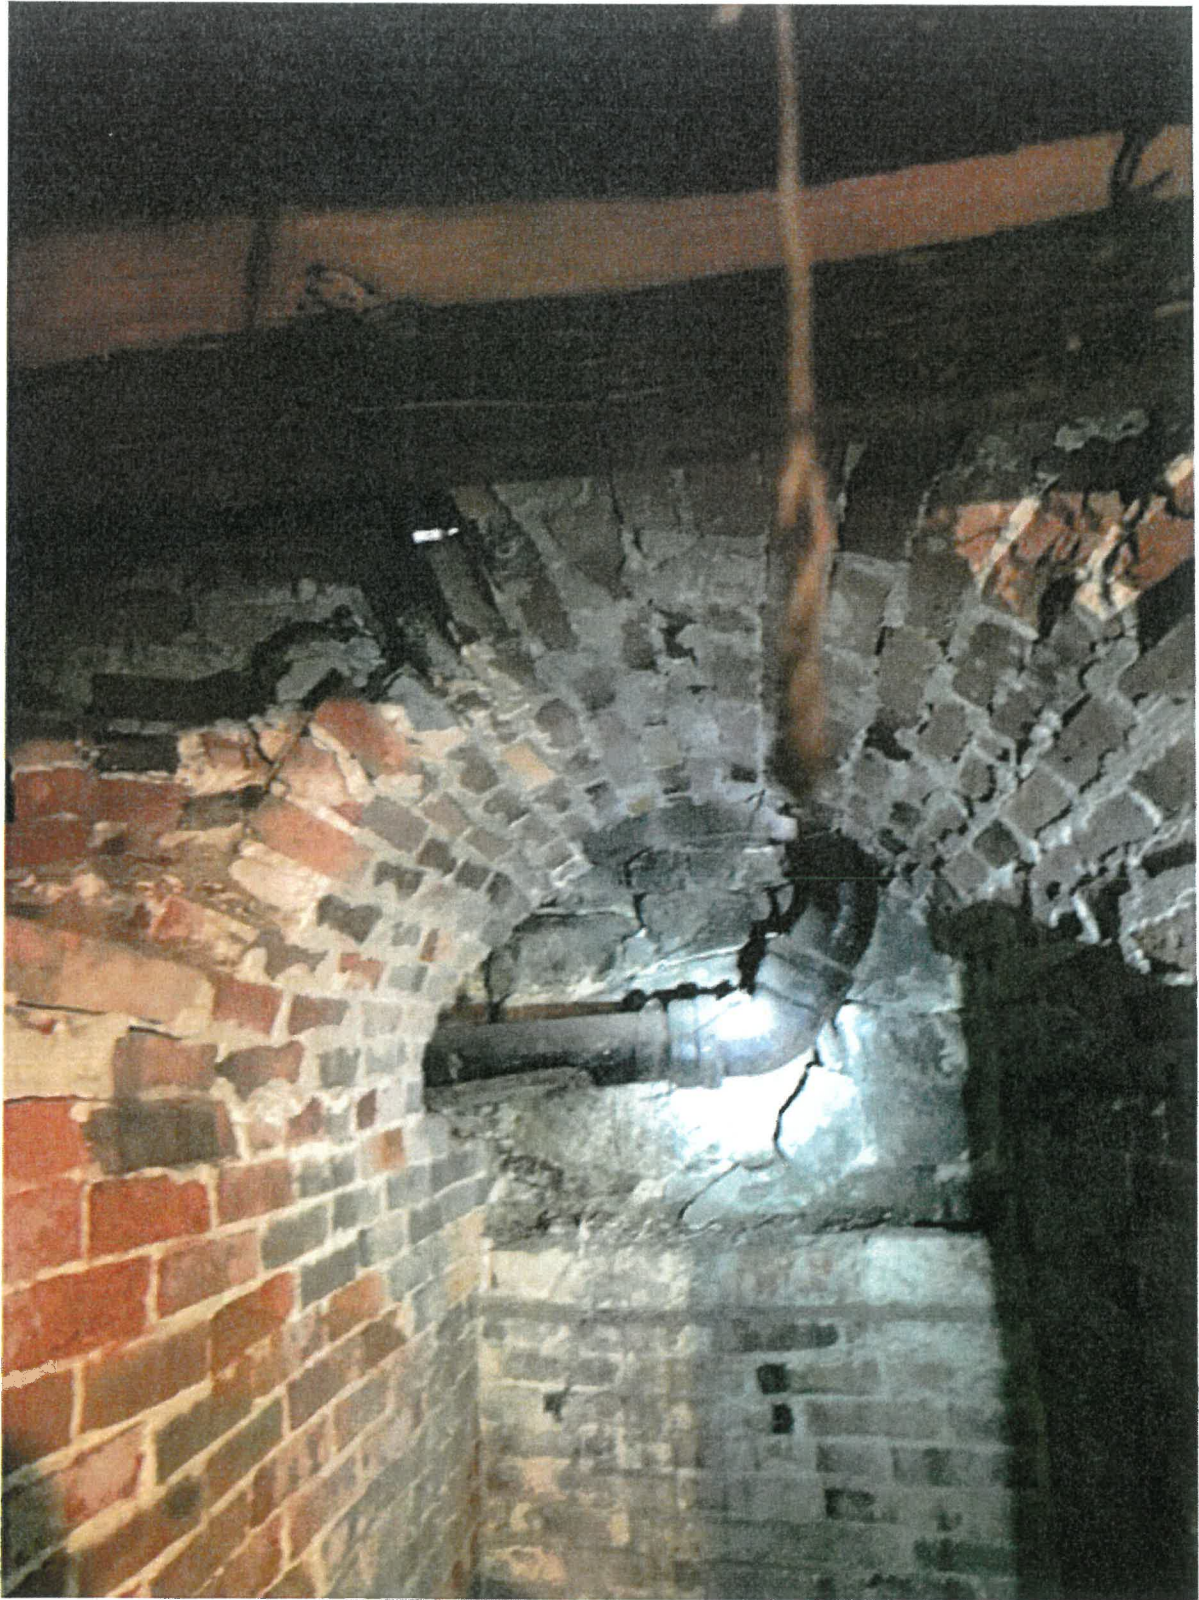
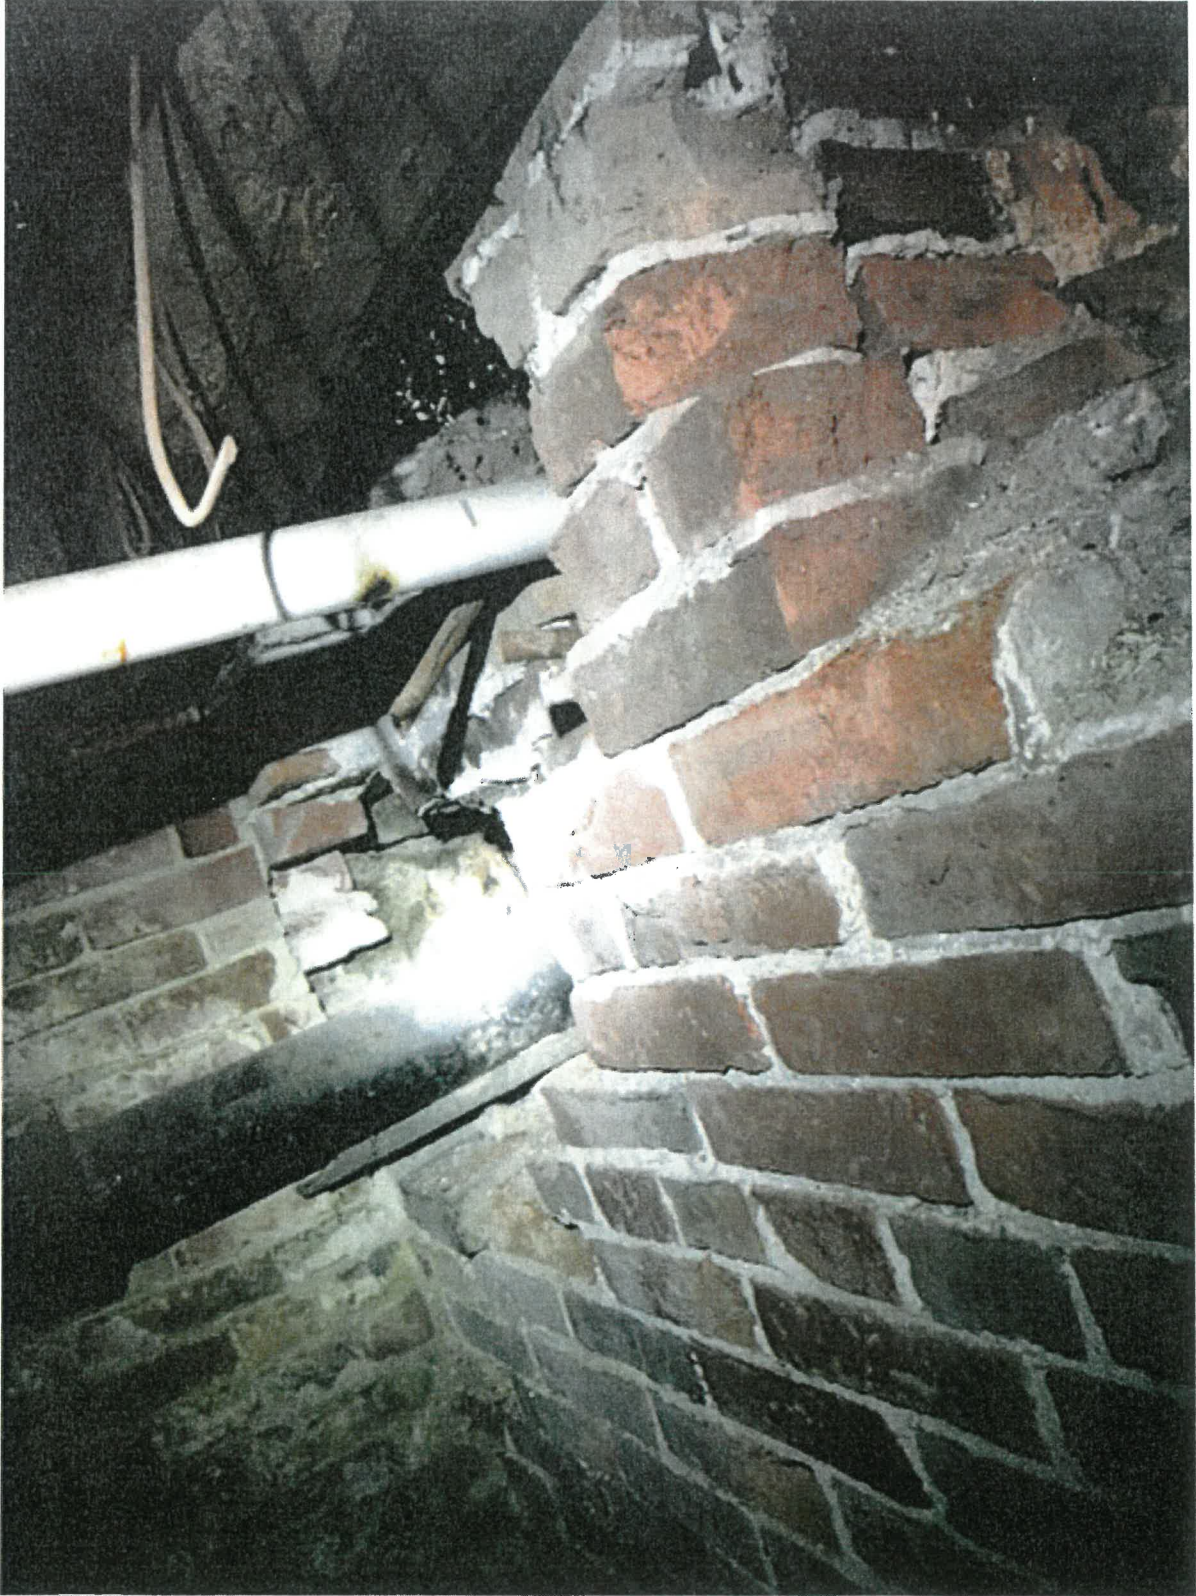
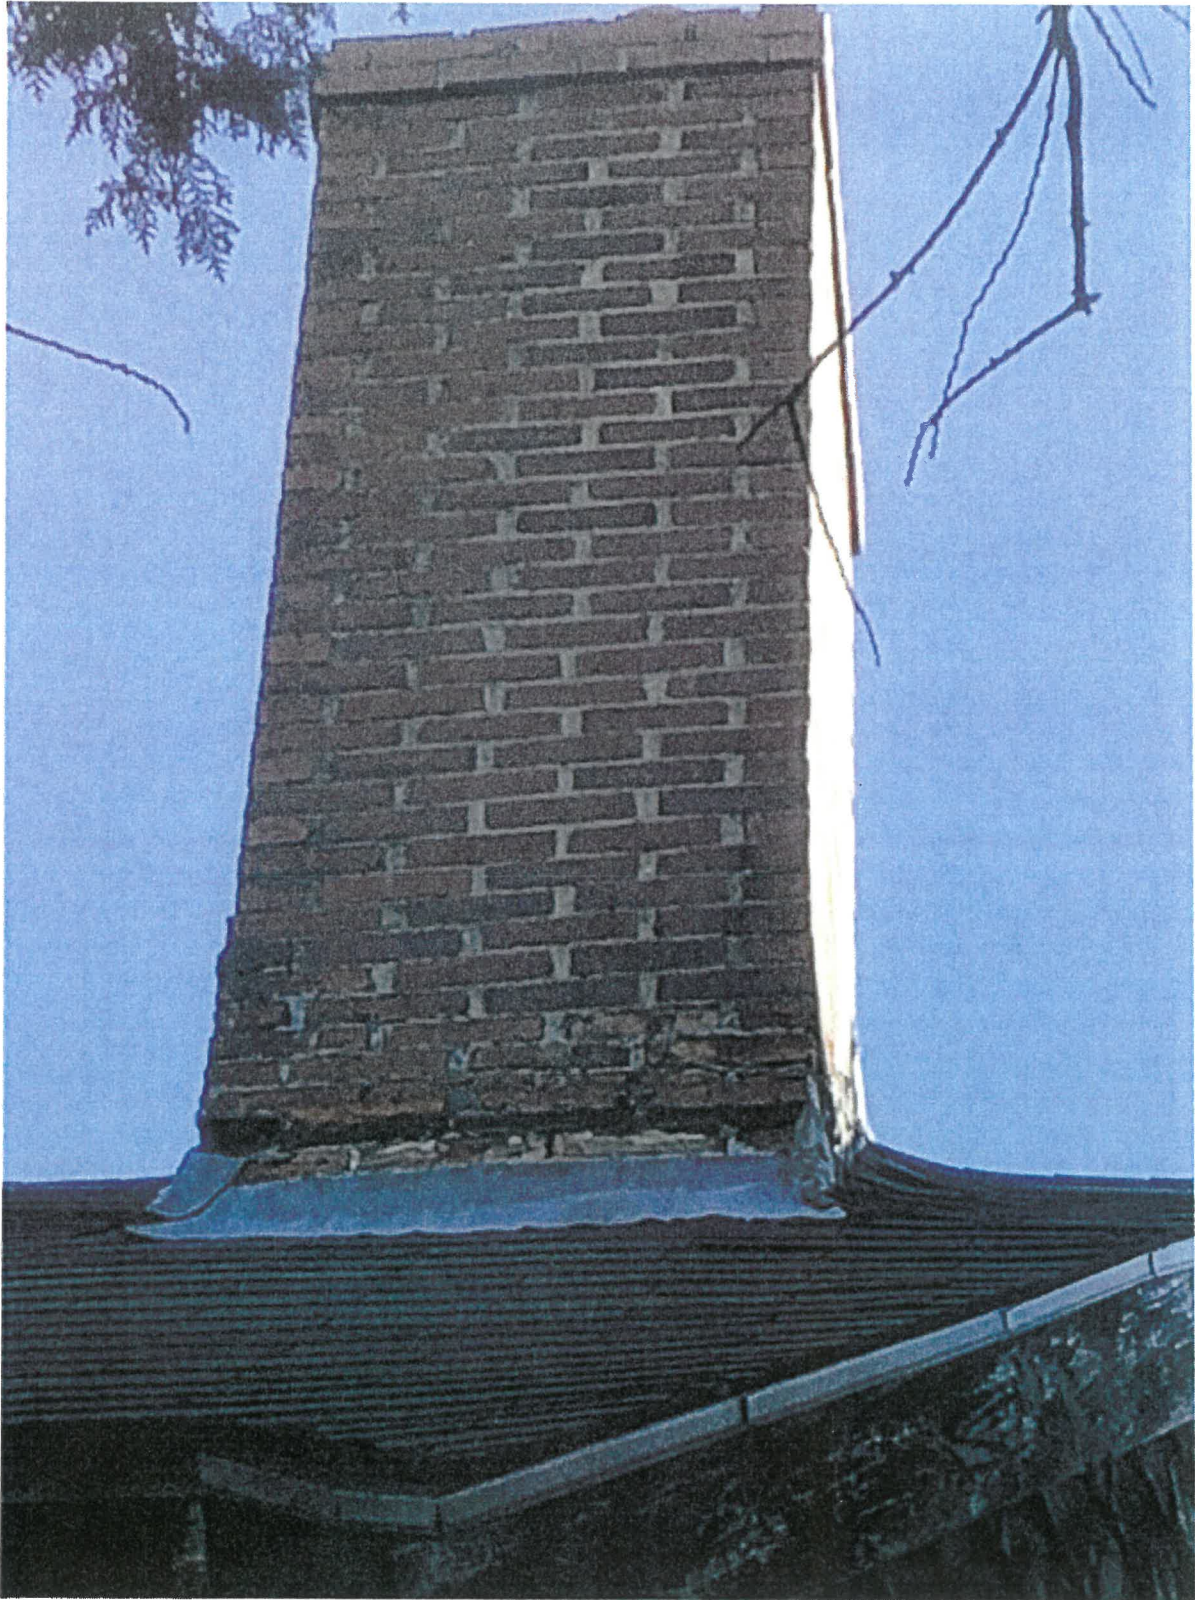
EXISTING CHIMNEY IS  
HEAVILY DETERIORATED  
AND IS RECOMMENDED  
TO BE REMOVED DOWN  
TO FIRST FLOOR
