DANIEL STREET BETWEEN HARBOUR PLACE & MEMORIAL BRIDGE

MAPLEWOOD AVENUE AT NORTH MILL POND

SOUTH MILL POND ADJACENT TO LIVERMORE STREET

SOUTH MILL POND ADJACENT TO POLICE STATION

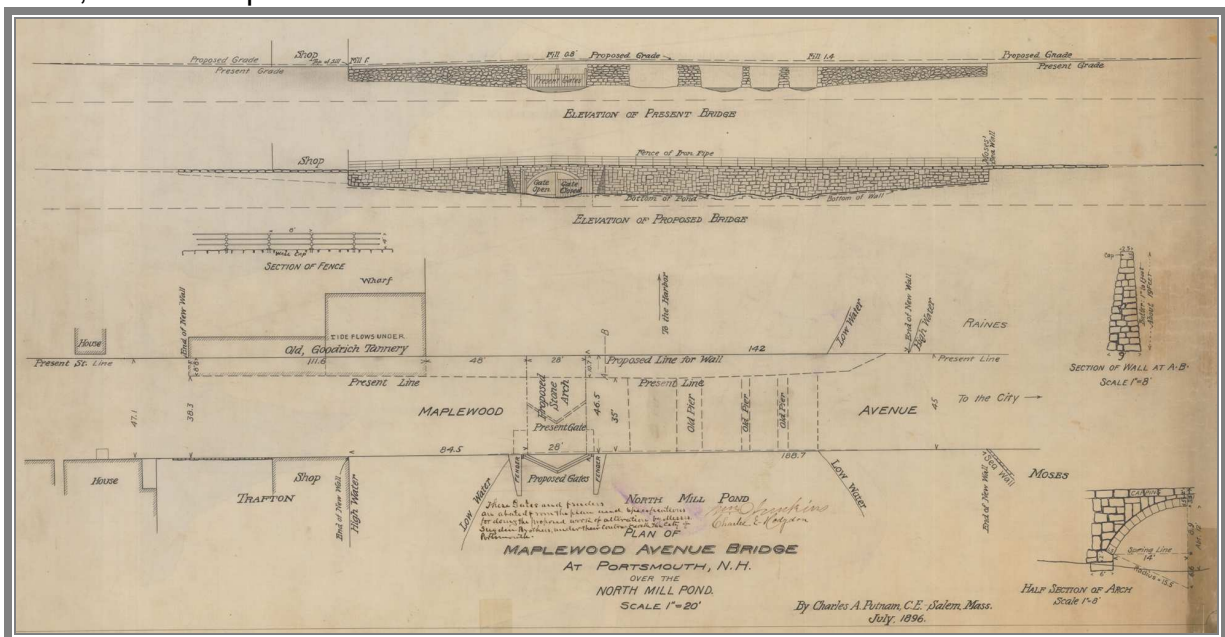
Review of archive documents show this structure as early as 1810 (“Plan of the Bridge at the North Part of the Town of Portsmouth”, Akerman, 1810, also referring to the John Bowles Mill and Gideon Walkers Mills, both on the north side of the bridge); and again in 1818. A detailed reconstruction drawing dated 1896 shows filling of 4 of the 5 flow openings (about where the north and south earth fill slopes are now) and proposed tide gates at the present arch opening. The north wall is shown as being reconstructed on this drawing with a wall cross section detail showing a 19 foot wall height, 9 foot base width, 2.5 foot cap width and 1H:12V front face batter.

The 1896 drawings that built the North wall indicates the outer face of the wall was to lean inshore at a 1H:12V batter, however the 9 foot base width of the wall footing was probably insufficient for a 19 foot high gravity wall founded in the tide zone and with modern highway vehicle loads. The North wall was probably also compromised by the sewer line penetrations (pipe now corroded through), which are almost parallel with the wall and have been patched in with brickwork, which is not a durable material in a salt water freeze/thaw environment.
