# appendix a

EXISTING INFRASTRUCTURE REPORTS AND MAPPING

Re: Prescott Park Master Plan

Subject: Summary of Subsurface Utility Conditions  
Prescott Park  
Portsmouth, New Hampshire

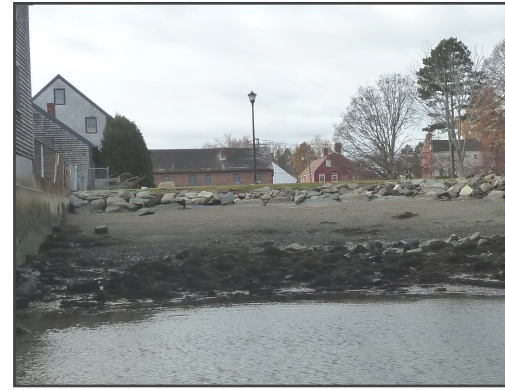
8. Stormwater outfall. (Player's ring theatre in background)

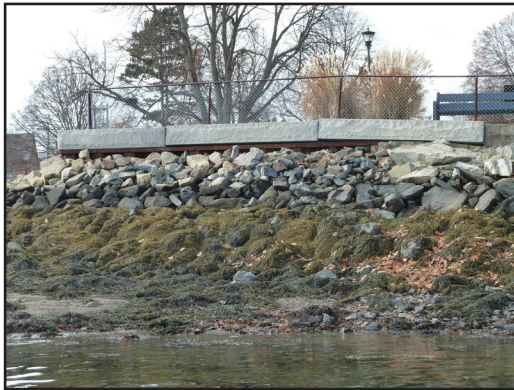
9. Adjacent to T-Head pier  
Steel sheeting with granite coping and placed rip rap armoring.

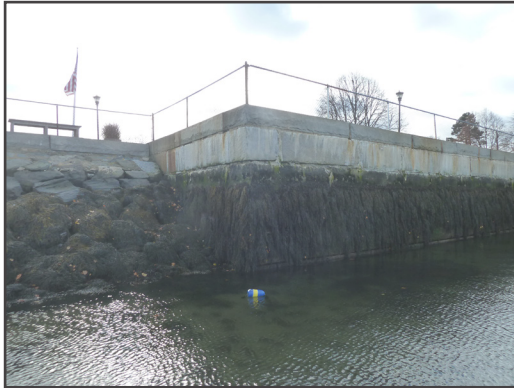
13. At T-Head pier  
Repoint existing blocks. Water  
very shallow here.

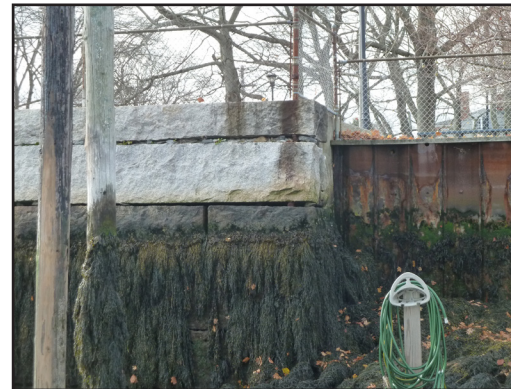
18. From quaywall to steel  
bulkhead  
Transition to steel sheeting.  
Estimated age 20 years.

note: Appledore estimated  
30 years service life  
remaining, and replacing  
the timber bracing within 5  
years.

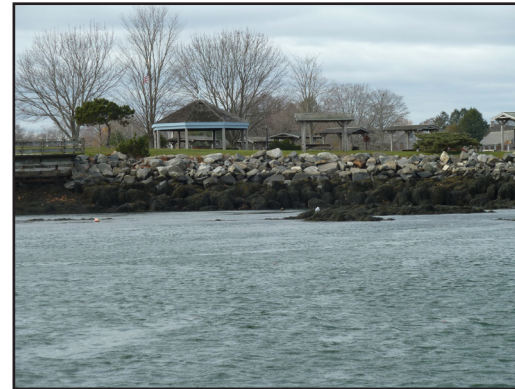
22. Four Tree Island  
Rip rap at north end of island.
