21 January 2022

Structural Condition Assessment - Annex  
Captain Thomas Thompson House  
179 Pleasant Street  
Portsmouth, New Hampshire

**ASSESSMENT OF HISTORIC INTEGRITY**

PROPOSED ANNEX SCOPE OF WORK  
SOUTH ELEVATION  
HDC WORK SESSION #2 APPLICATION TO AMEND PREVIOUS APPROVAL: FEBRUARY 2, 2022

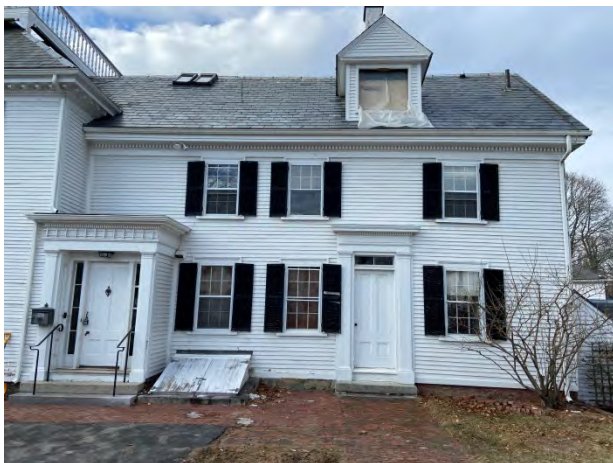
On the exterior, the building's foundation, siding, windows, roofing and chimneys are all in need of maintenance.

Annex south elevation

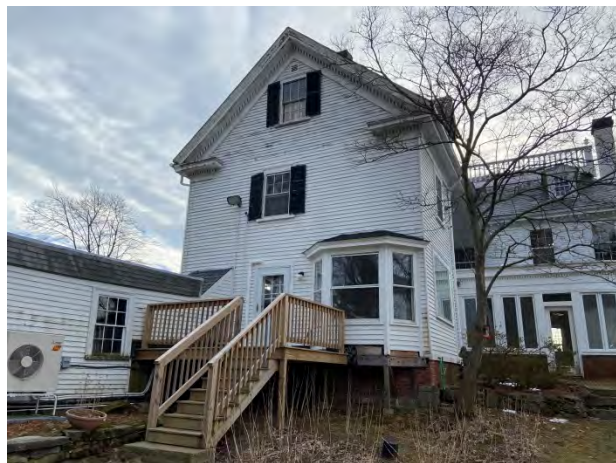
Annex east elevation

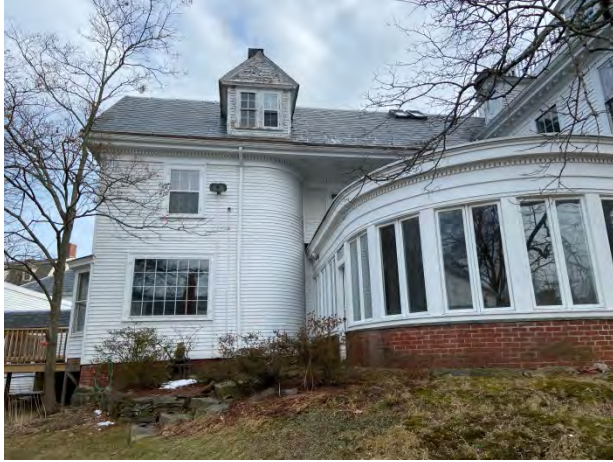
Annex north elevation

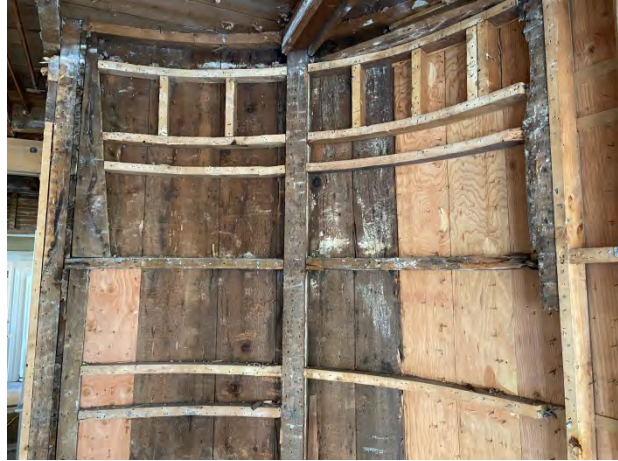
The first floor exterior wall framing appears to have been modified numerous times over the life of the building. Some areas which look original are framed with 3x3 studs spaced at 30" on center with 2x2 infill studs and sloped furring. In other areas, it appears that new windows were installed and significant, but structurally dubious, framing modifications have been made. Significant repairs have been made at the curved wall.

Curved wall framing

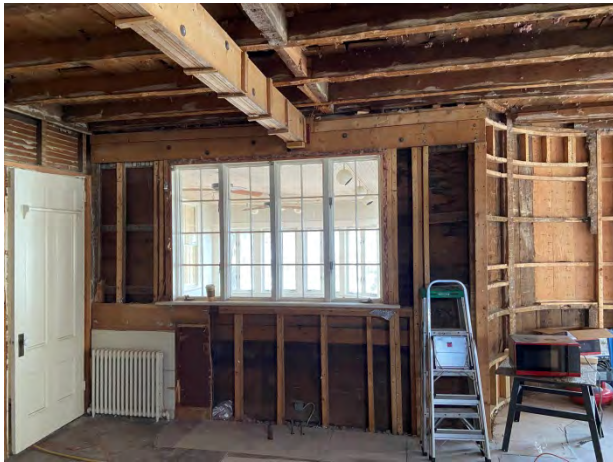
Wall framing at window

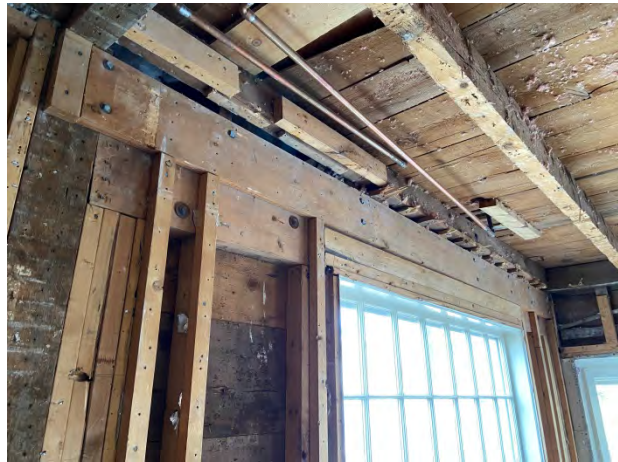
Wall framing at window

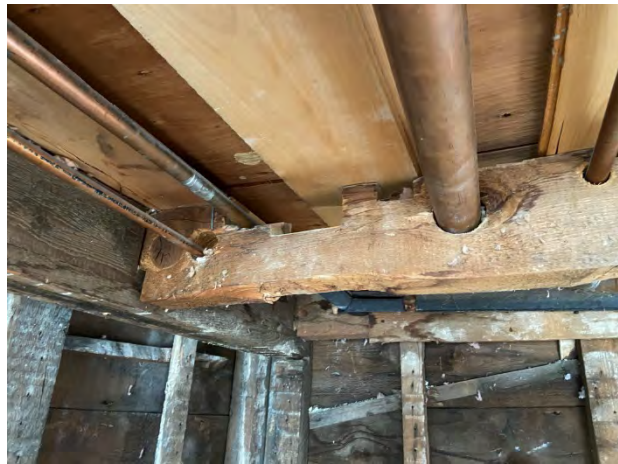
The second floor is framed using 3"x5½" joists spaced at 24" on center. See SK3 attached. The joists are supported at a (4)2x10 beam spanning 18-feet and a 3½"x7" beam which is supported at the chimney. Both beams are significantly overstressed. A number of the joists have been notched, drilled, or otherwise damaged to an extent that they have no tangible structural value. It was observed that one ply of the (4)2x10 beam is fractured. Assuming Hem-Fir material, the allowable total load for this floor system would be less than 5 psf. This floor must be considered unsafe in current condition and will require significant reinforcing or replacement.

Second floor joist

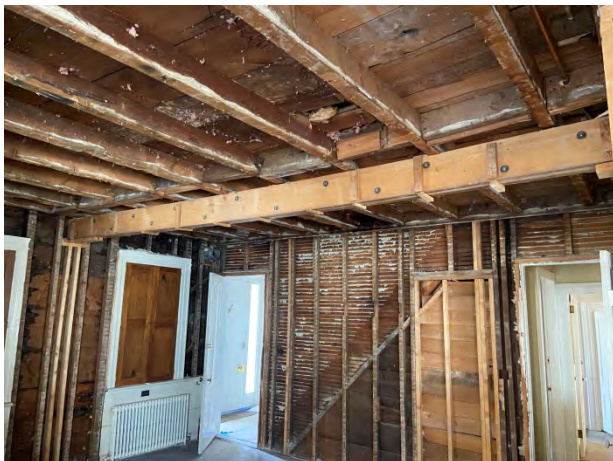
(4)2x10 beam at supporting second floor

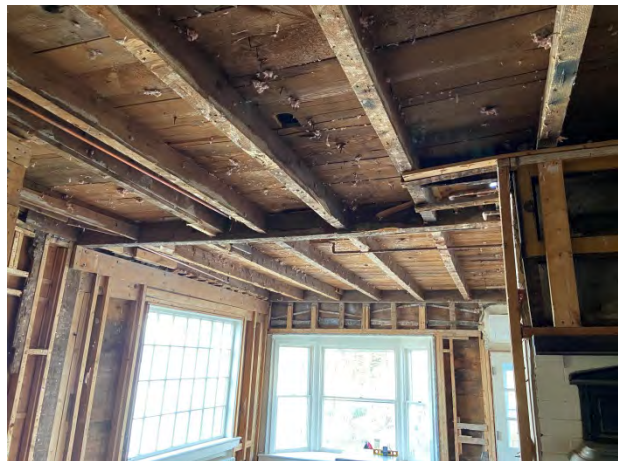
3"x7½" beam supporting second floor

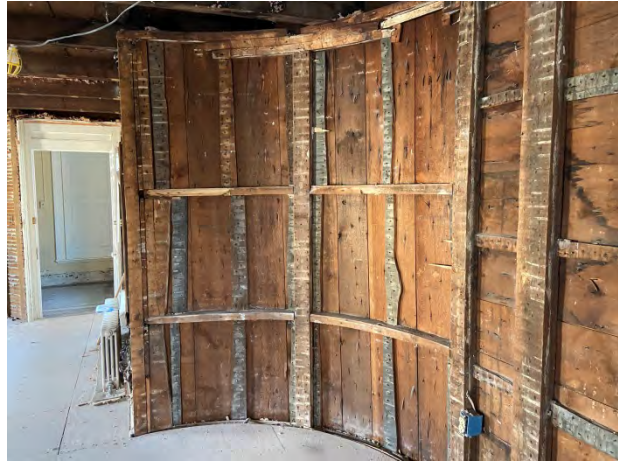
The second floor exterior walls are constructed using 3"x4" studs spaced at 32" on center and are in good condition.

Curved wall framing as second floor

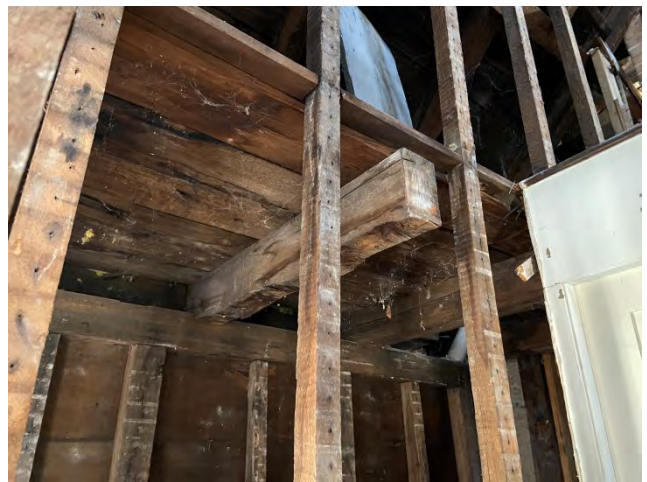
The third floor is framed using 4"x5 $\frac{3}{4}$ " wood joists spaced at 32" on center. See SK4 attached. Assuming Hem-Fir material, the allowable total load for this floor system would be approximately 10 psf. Joists are supported at the chimney and some joists are lacking adequate support, which are conditions that will need to be corrected.

Annex third floor unsupported framing

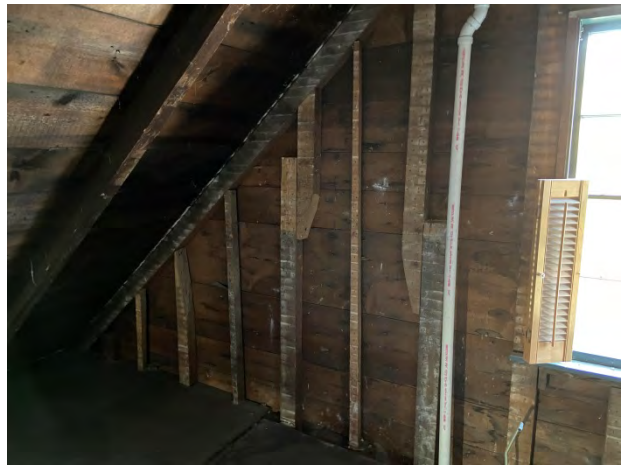
The annex roof is framed using 2 $\frac{3}{4}$ "x4 $\frac{3}{4}$ " rafters spaced at 32" on center with 3"x4" collar beams located about 7-feet above the floor. The large roof overhang along the north side is partially supported by vertical struts, aligned with the exterior wall below, and extending to the underside of the rafters. Some of the gable wall framing is spliced. Assuming Hem-Fir material, the allowable total load for this roof system would be approximately 20 psf. The roof will require significant reinforcing or replacement to increase load capacity.

Gable wall framing

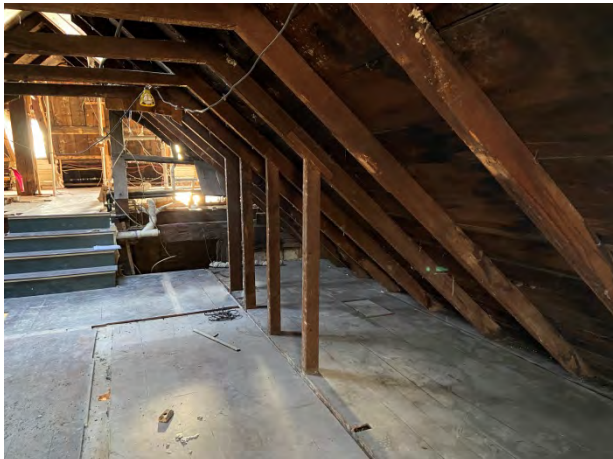
Vertical struts at curved wall and overhang

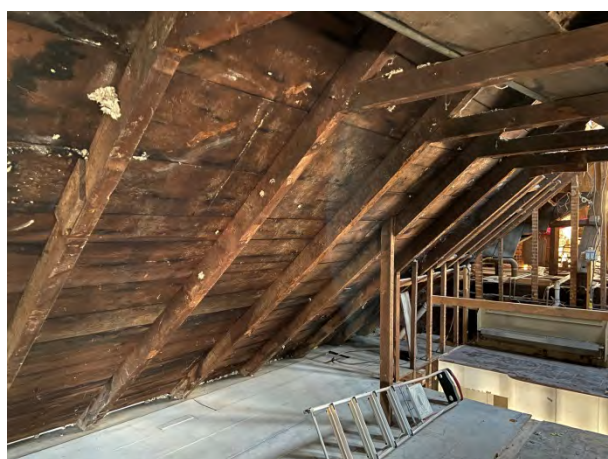
Roof framing looking toward Mansion

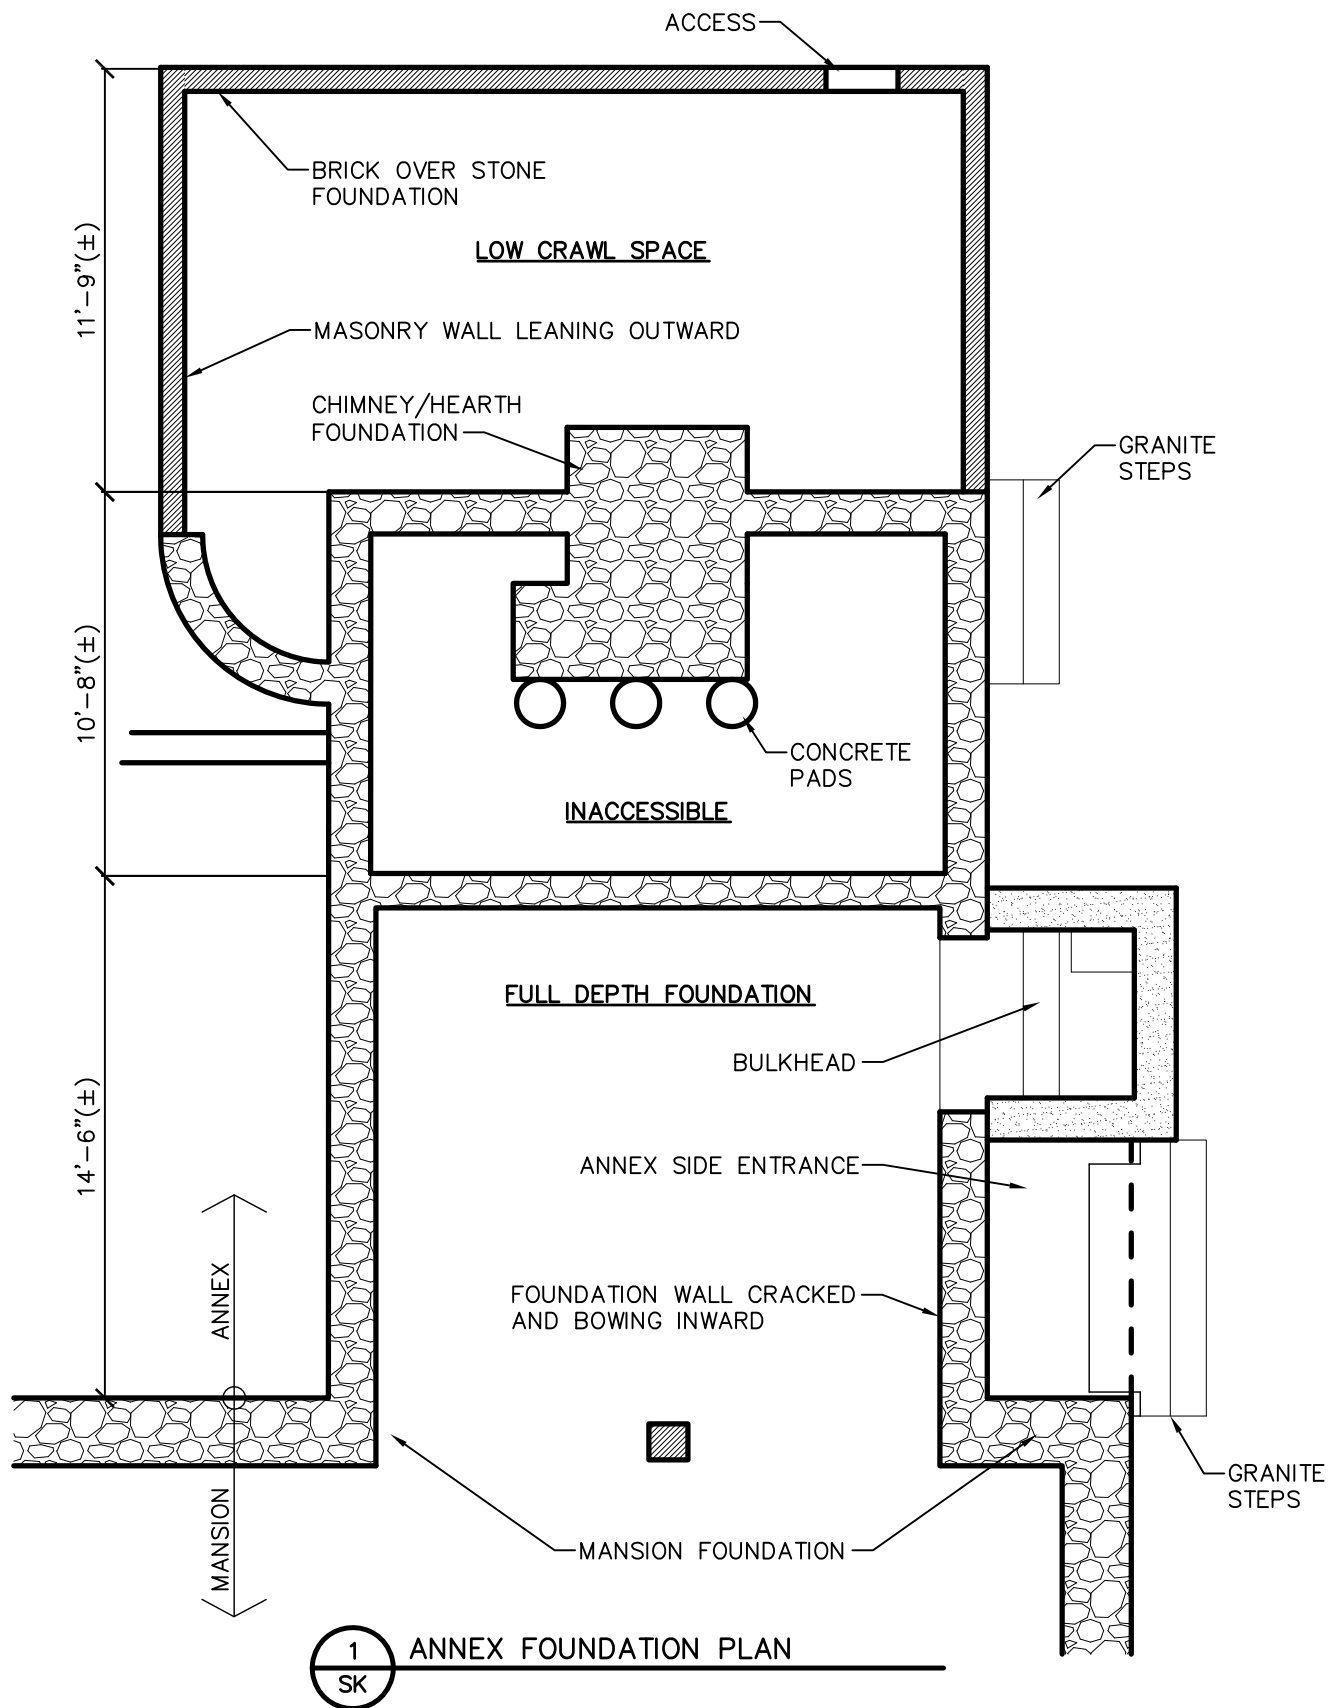
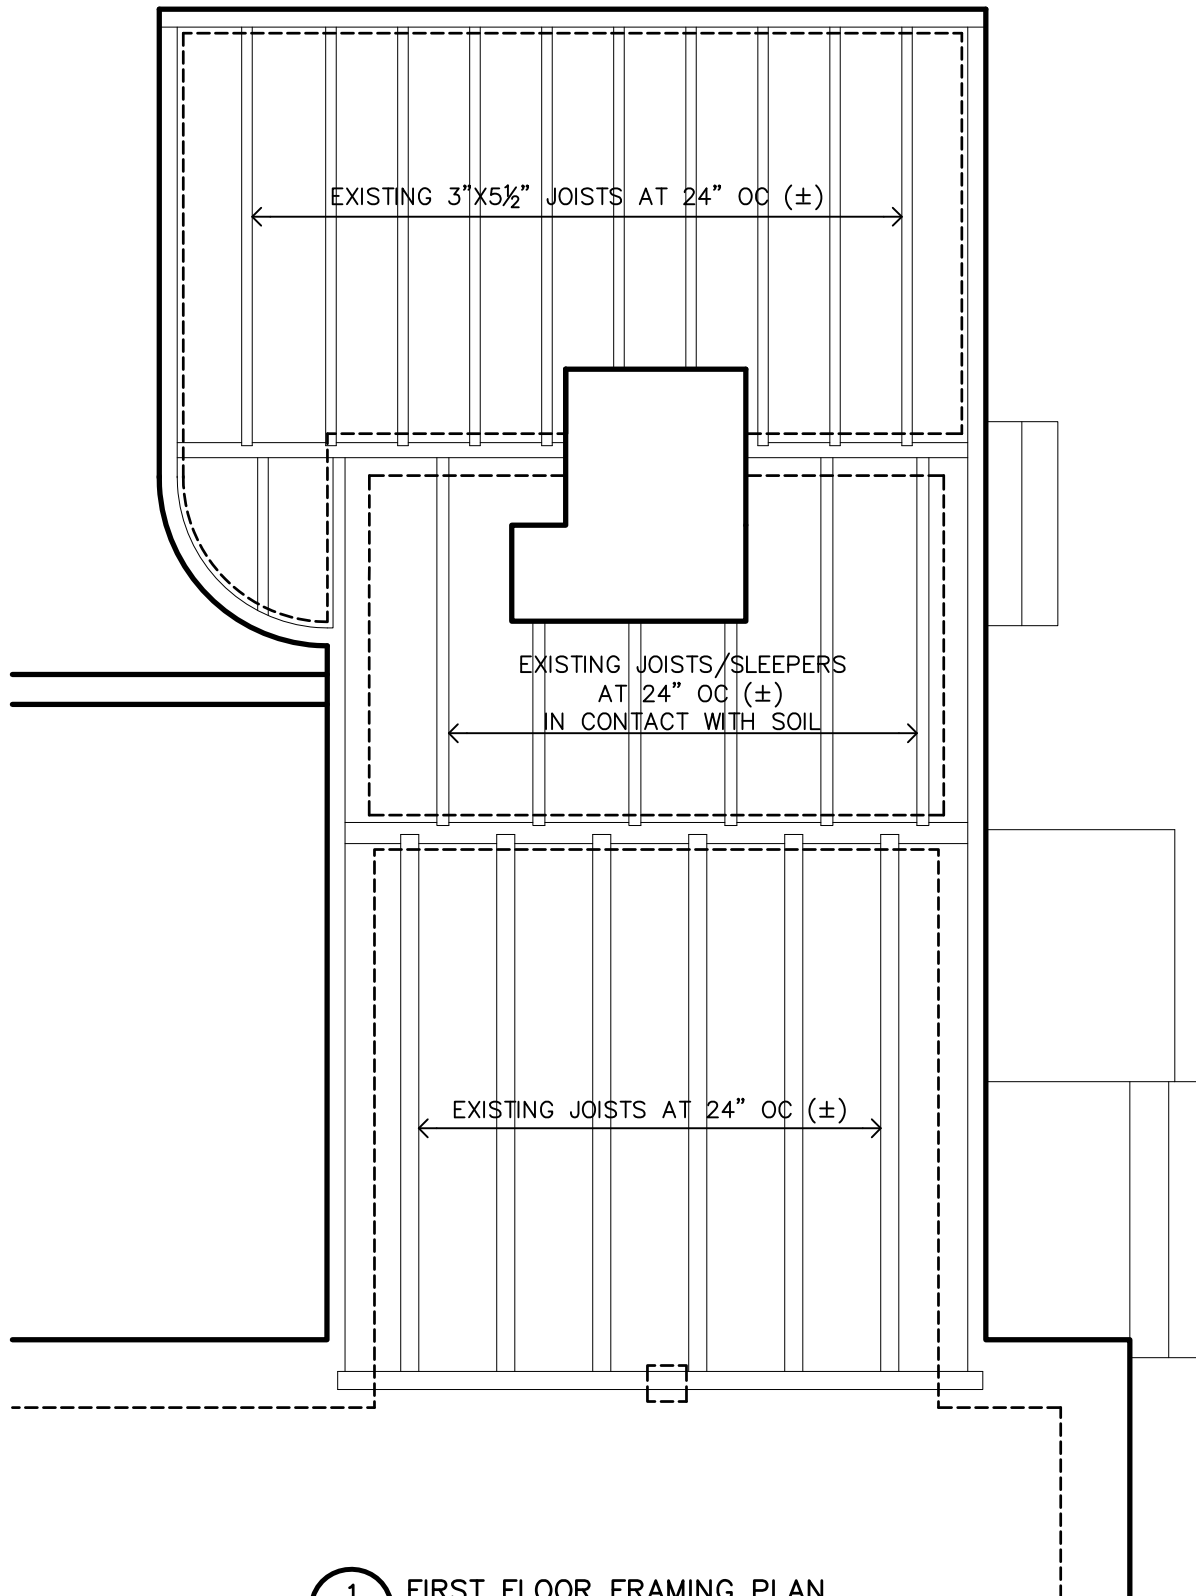
# FIRST FLOOR FRAMING PLAN

The annex first floor framing is a combination of heavy timber, wood framing in direct contact with soil, and timber joists over a crawl space. See SK2 attached. My opinion is that the first floor framing, over the crawl space areas, is in poor condition and may need to be removed to provide access to the crawl space so the foundation can be repaired, for the installation of a proper vapor barrier, and to install new MEP systems.

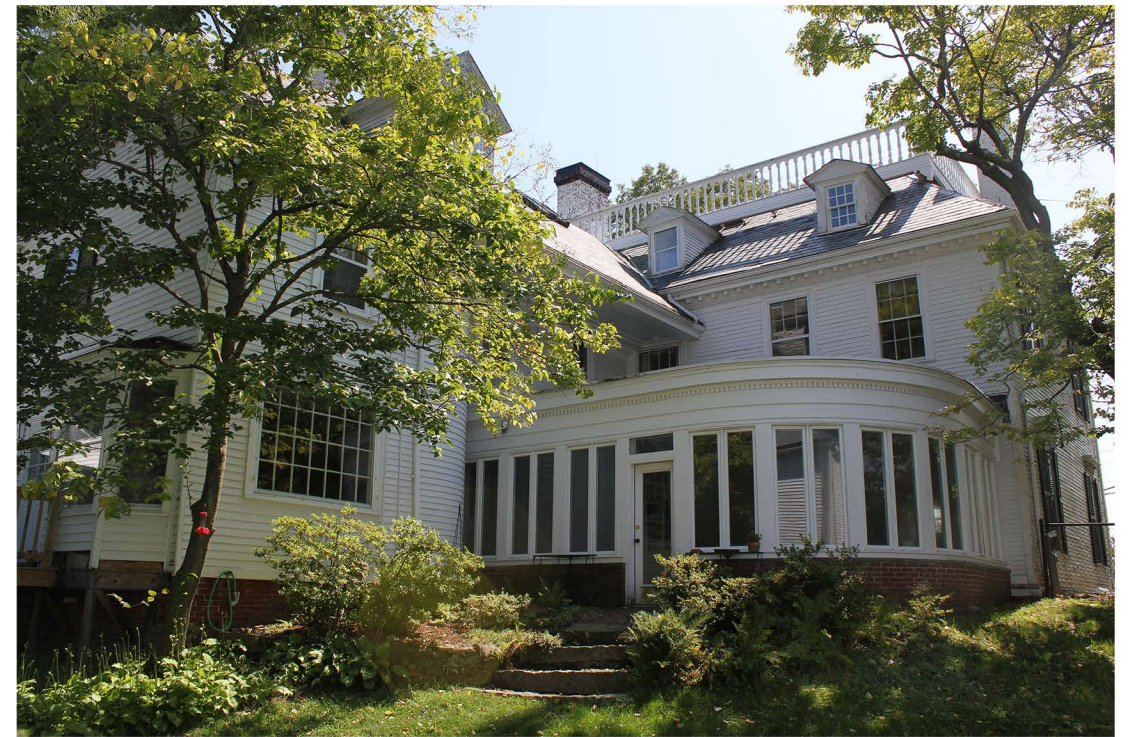
VIEW OF EXISTING NORTH ELEVATION

- Siding & Trim
  - Remove all siding on this side of the house to expose sheathing
    - There is a large bow in the center of the wall
    - Significant water infiltration visible on both exterior and interior surfaces

- Concerns for health of the wall system and chimney, which correlates with the bow in the wall mid-span
  - All siding removed will try to be salvaged and reused for repairs on other walls

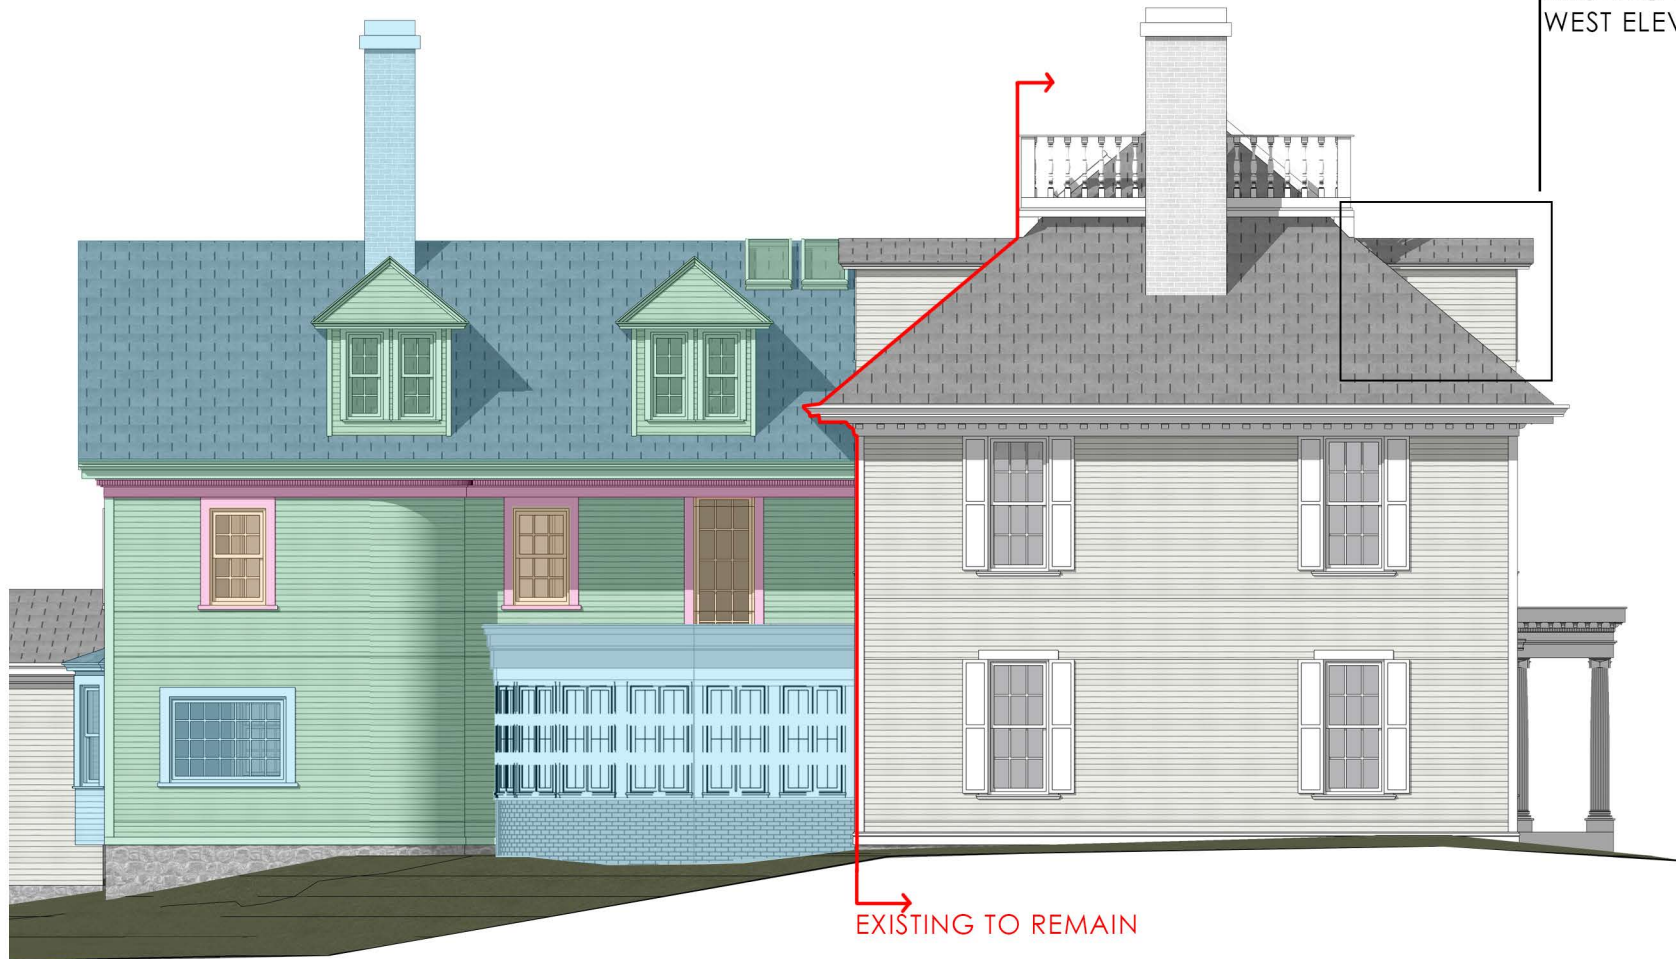
EXISTING NORTH ELEVATION

- The head casings on the 1<sup>st</sup> floor windows show signs of water infiltration and rot
  - Remove 2 courses of siding above the head units to properly flash

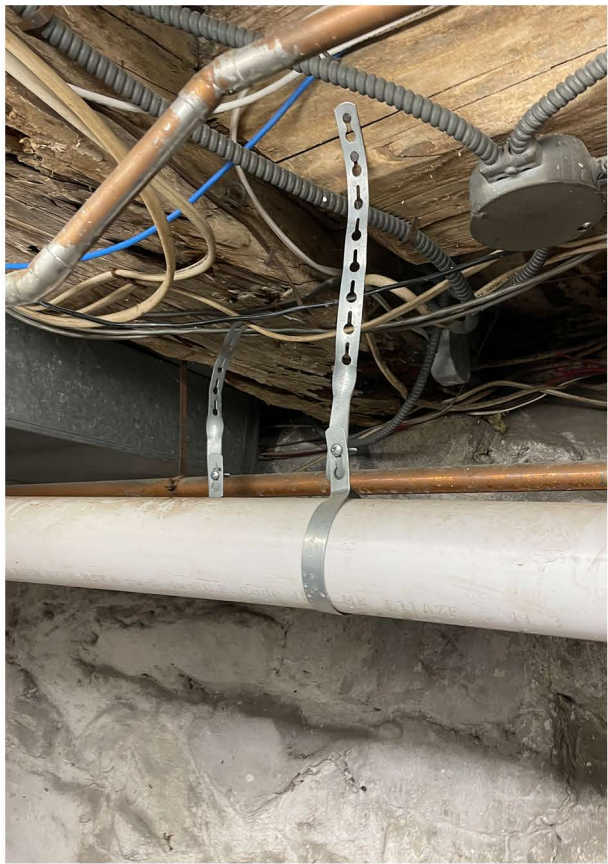
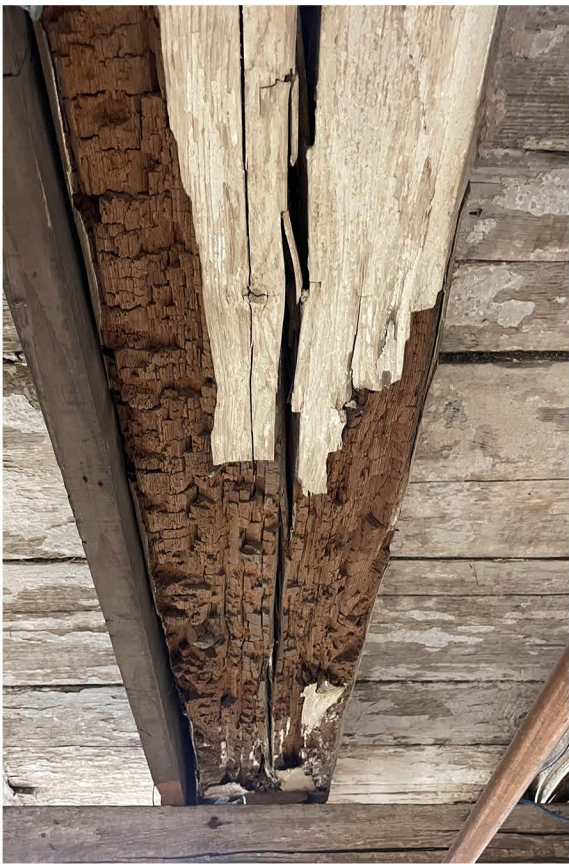
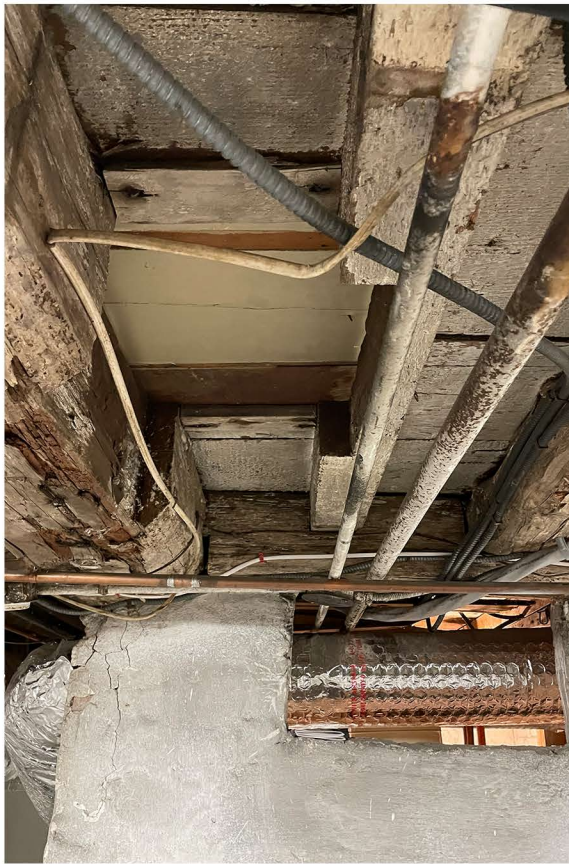
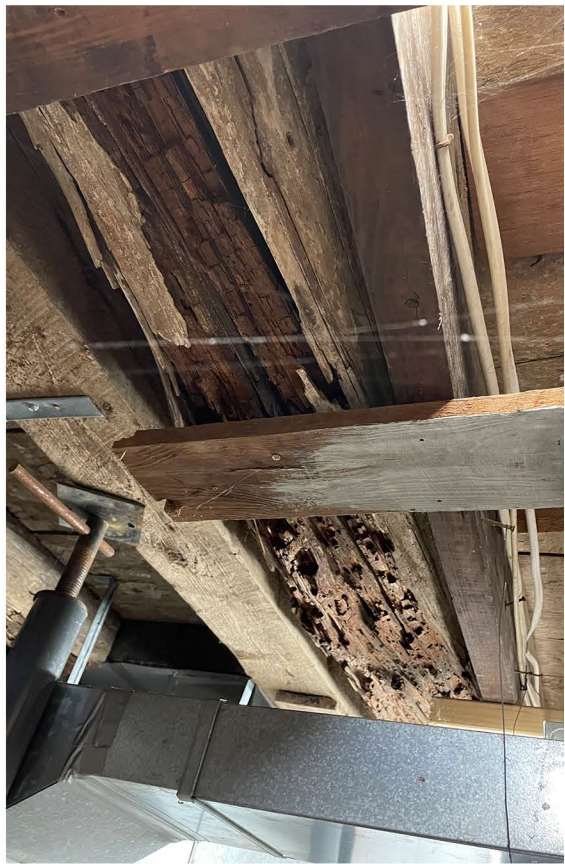
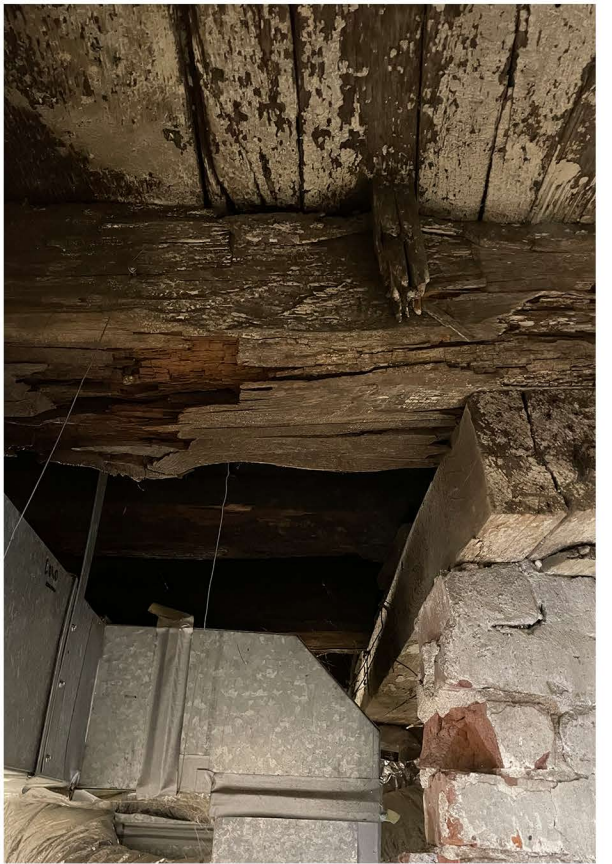
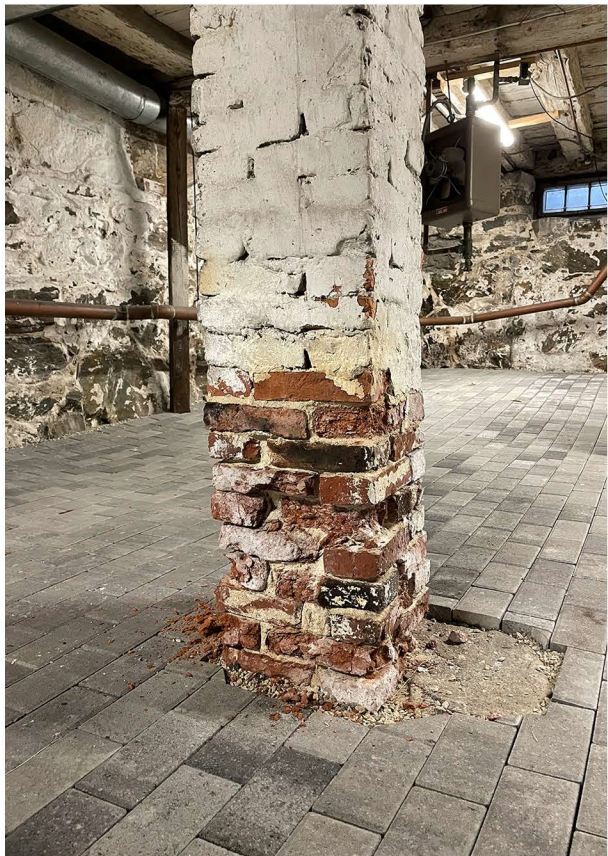
7.0

## STRUCTURAL FINDINGS FIRST FLOOR STRUCTURE - MANSION

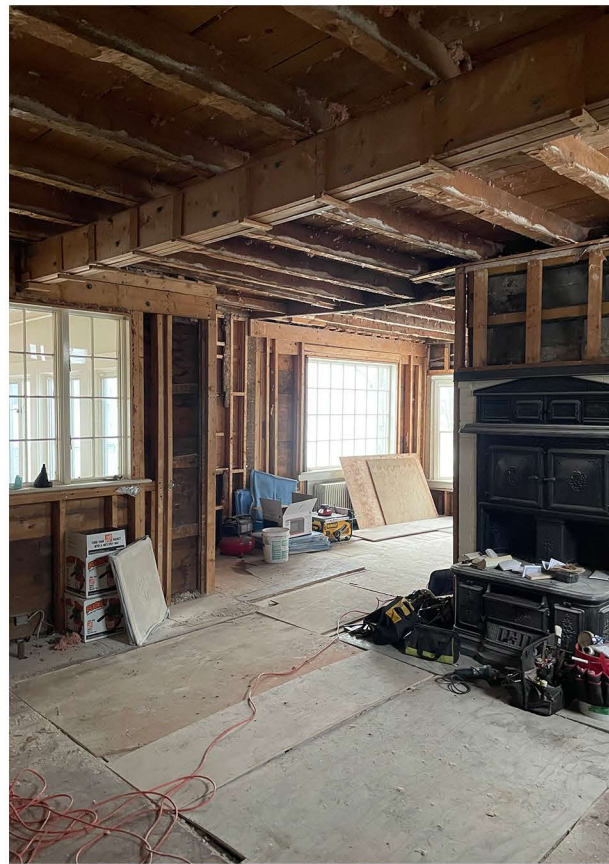
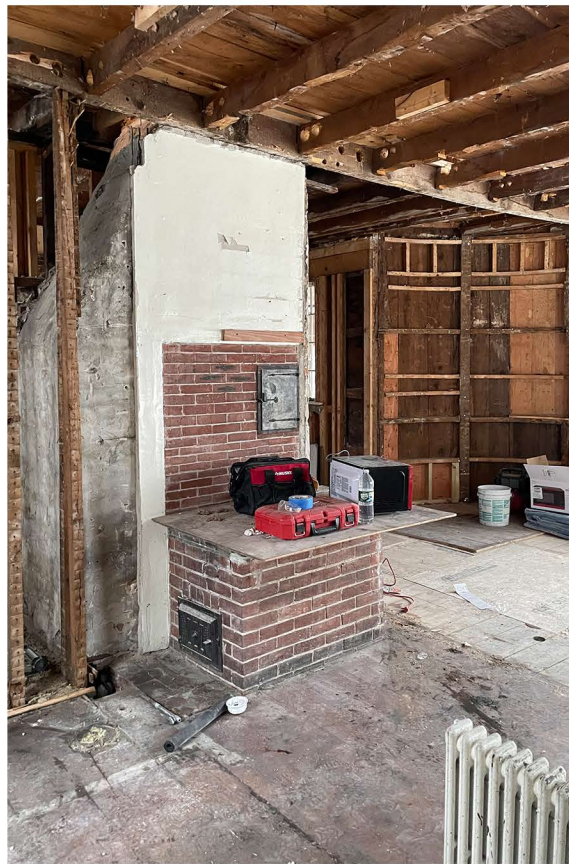
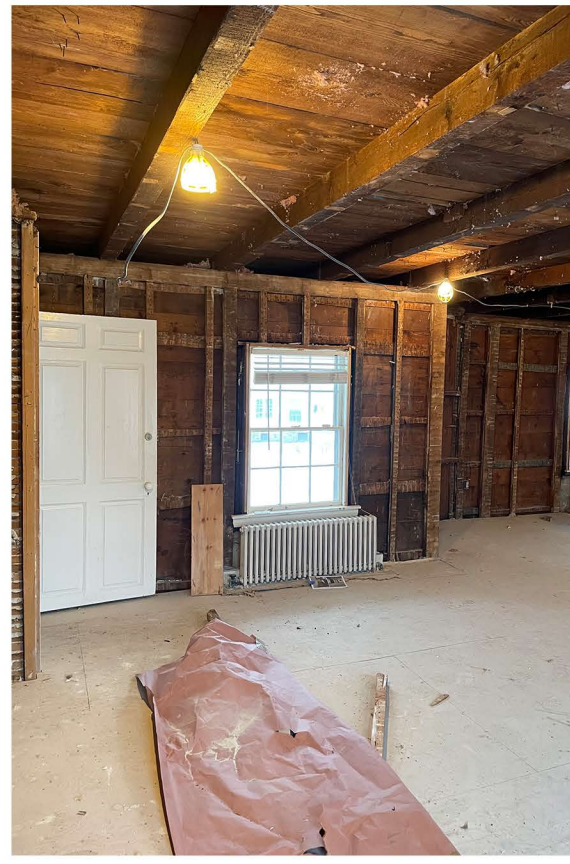
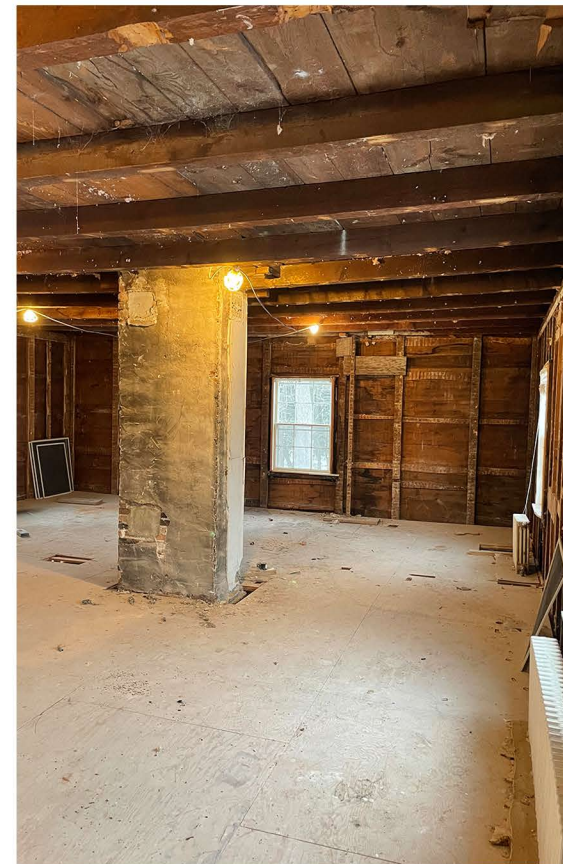
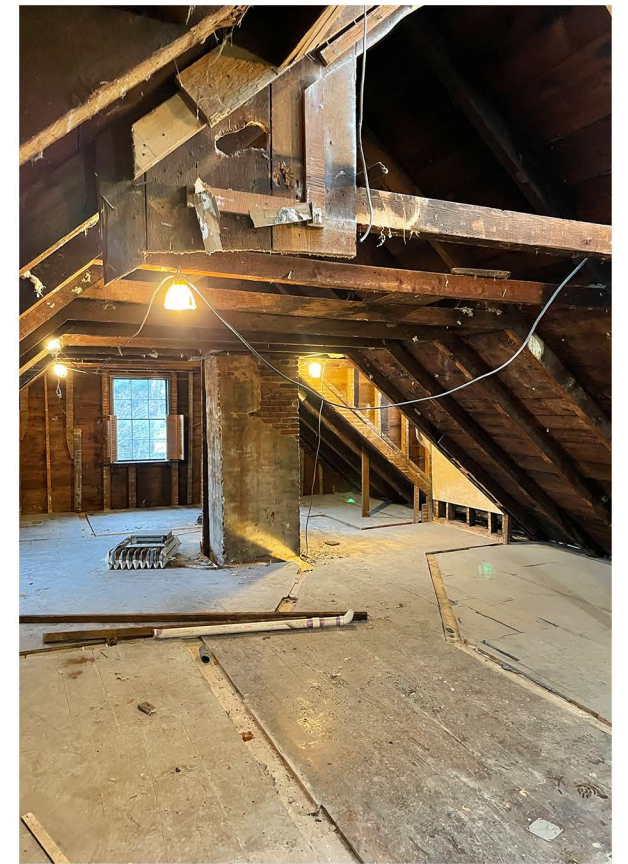
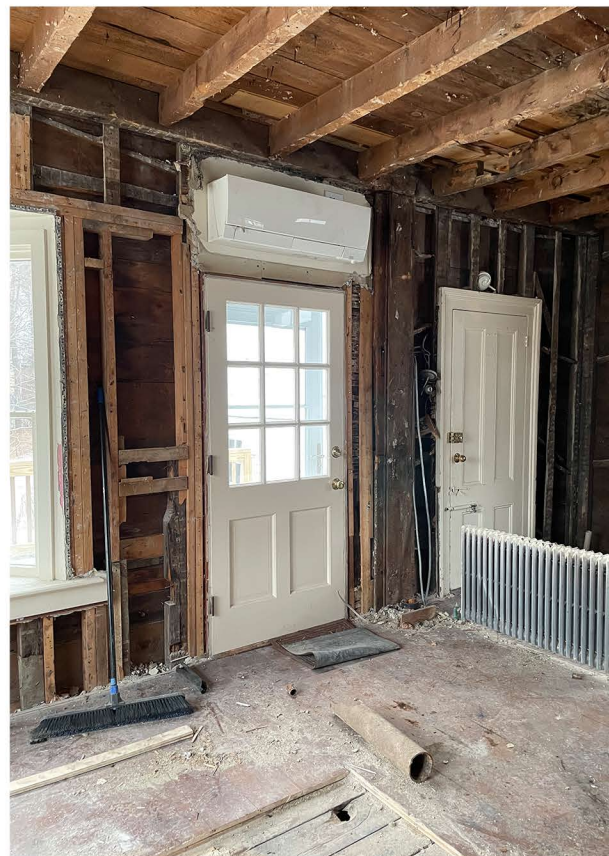
7.1

## STRUCTURAL FINDINGS ALL FLOORS - ANNEX

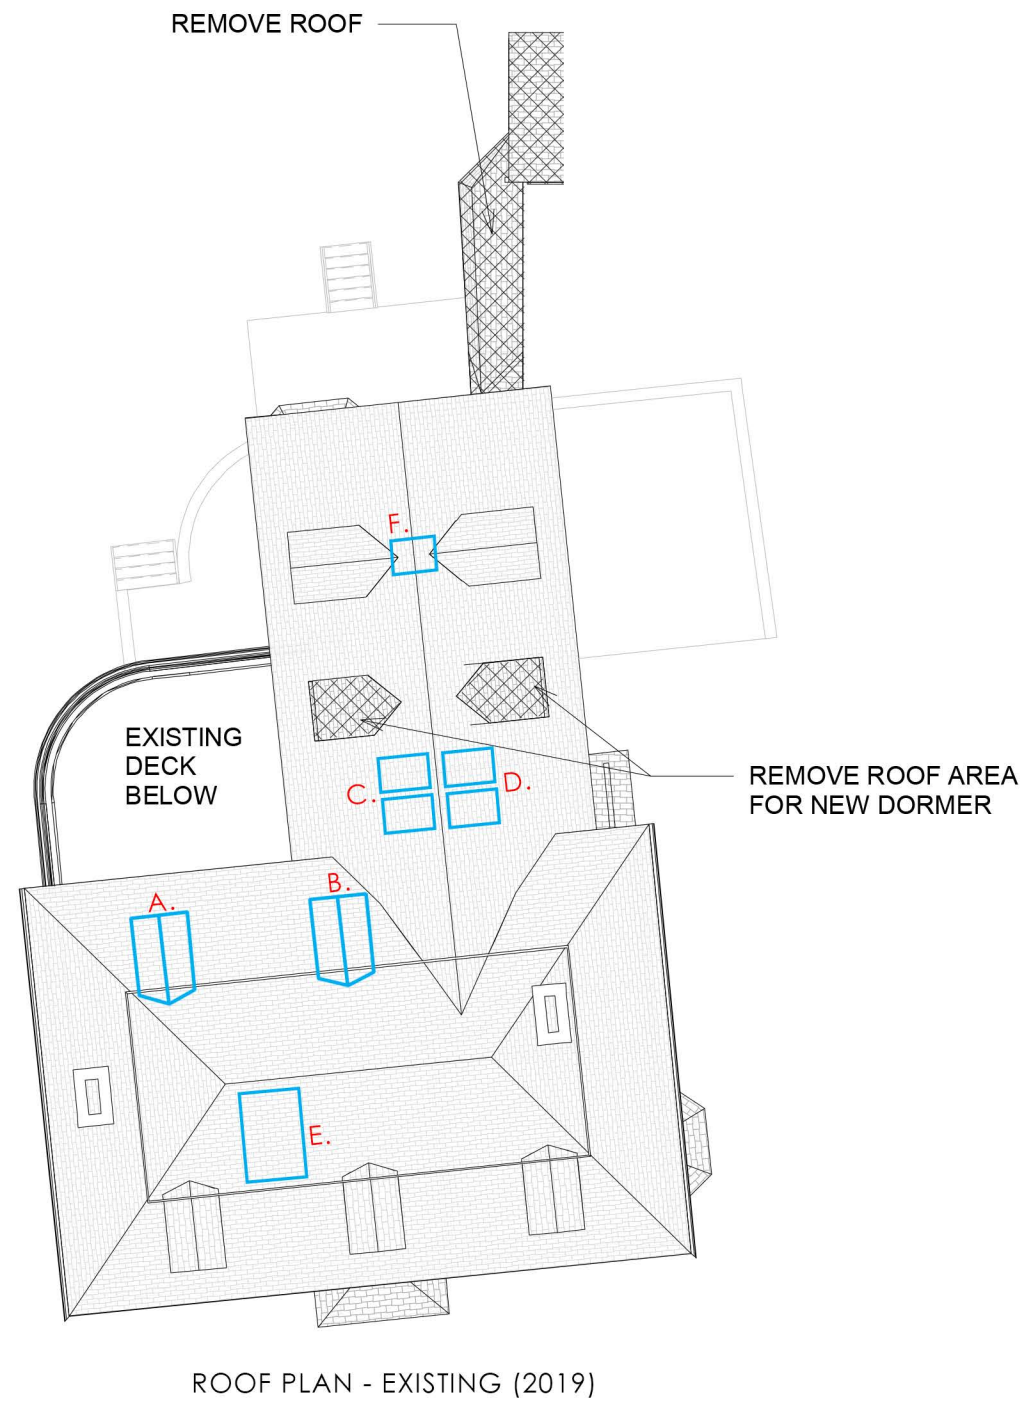
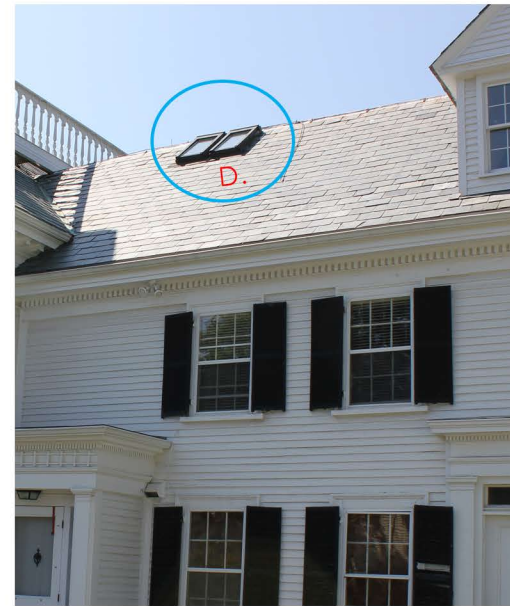
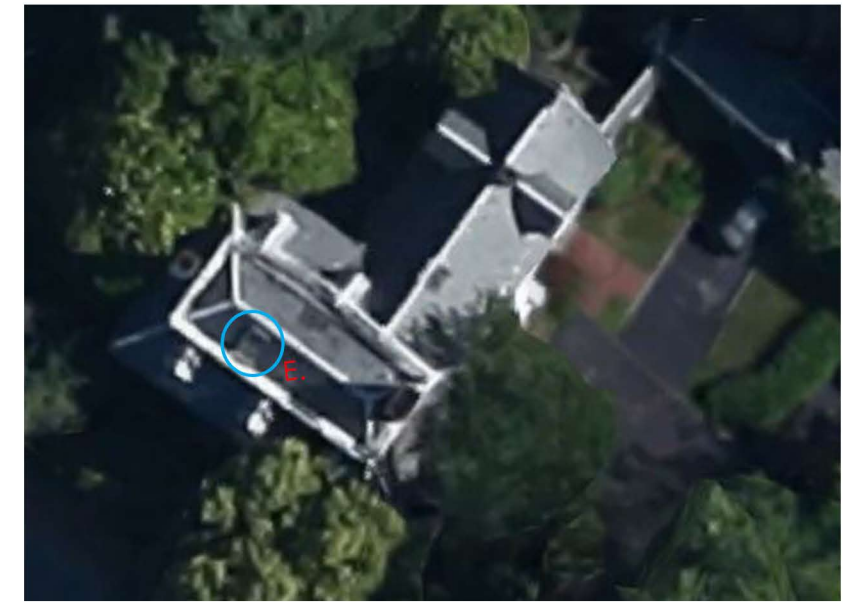
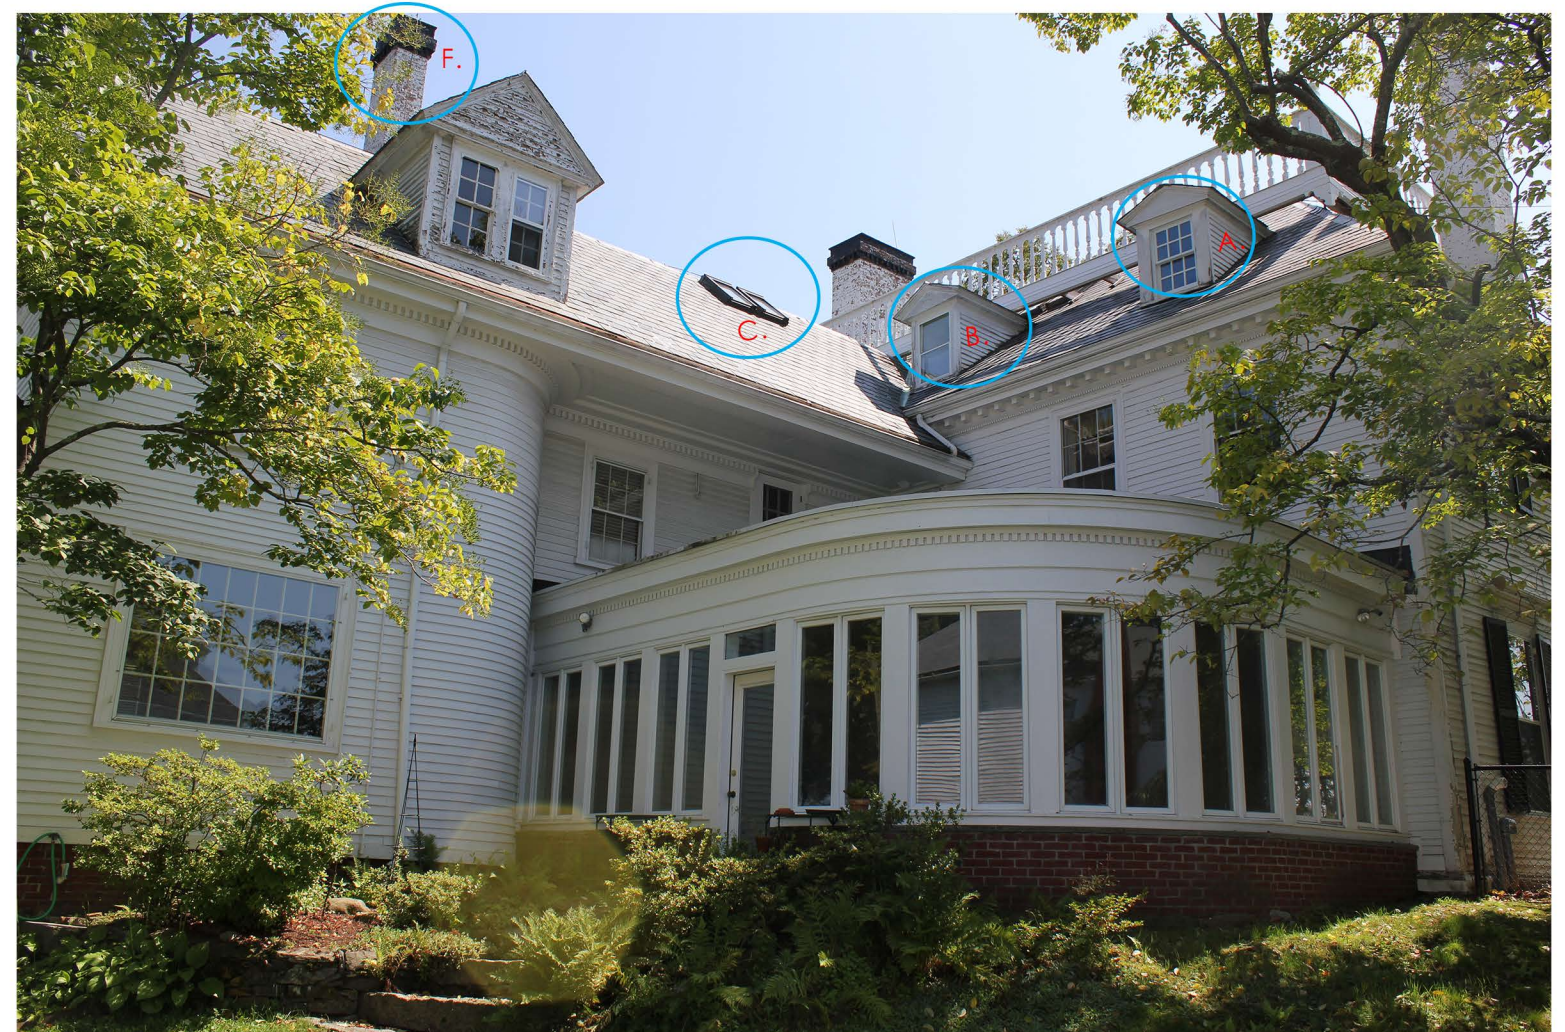
7.2

EXISTING CONDITION FINDINGS  
NOT SHOWN IN PREVIOUS APPROVAL DOCUMENTS  
HDC WORK SESSION #2 APPLICATION TO AMEND PREVIOUS APPROVAL: FEBRUARY 2, 2022
