179 PLEASANT STREET
PORTSMOUTH, NEW HAMPSHIRE

HDC APPLICATION TO AMEND PREVIOUS APPROVAL: SEPTEMBER 7, 2022

Structural Condition Assessment
Connector, Barn and Carriage House
Captain Thomas Thompson House
179 Pleasant Street
Portsmouth, New Hampshire

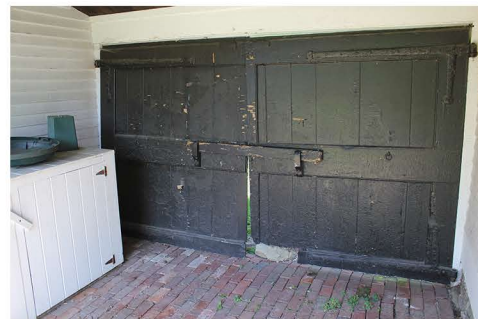
ORIGINAL HISTORIC DOORS TO BE REMOVED, RESTORED, AND REINSTALLED ON NEW CONNECTOR CONSTRUCTION

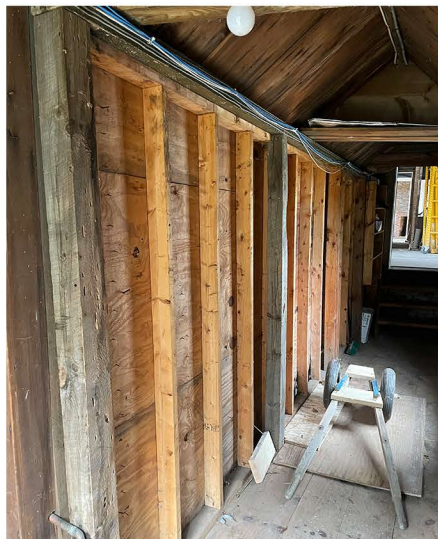
INTERIOR STUDS / PLYWOOD

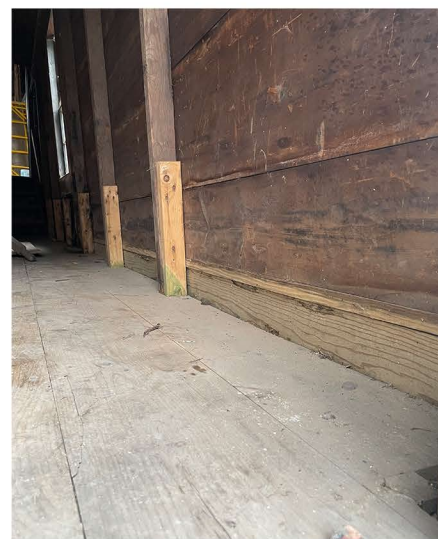
PRESSURE TREATED SILL REPAIR

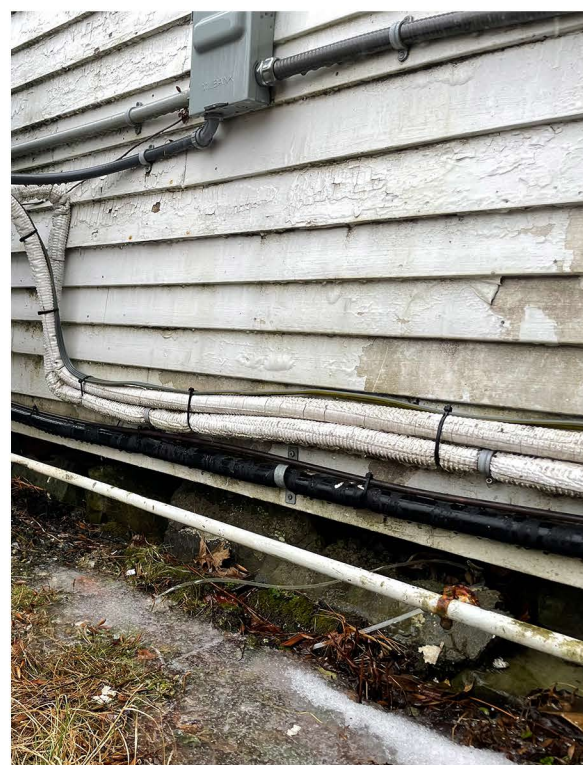
STONE RUBBLE FOUNDATION

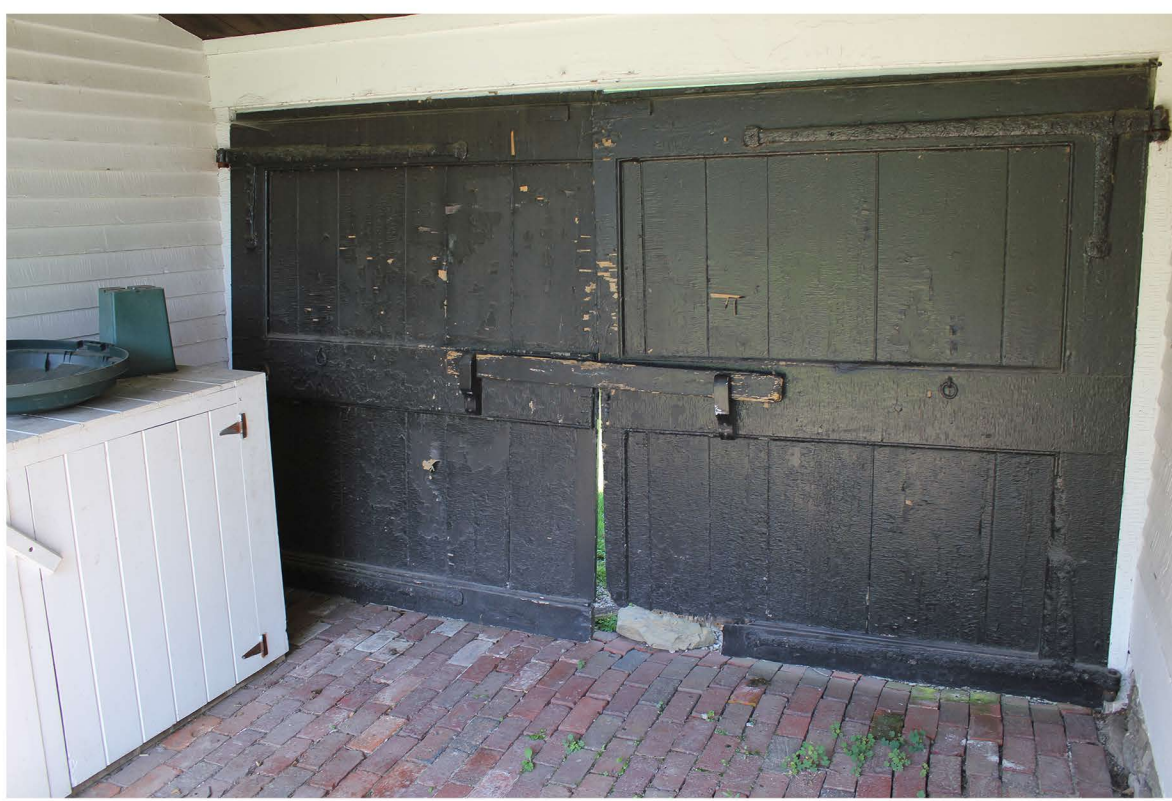
POSSIBLE HISTORIC DOOR WITH HISTORIC HINGES

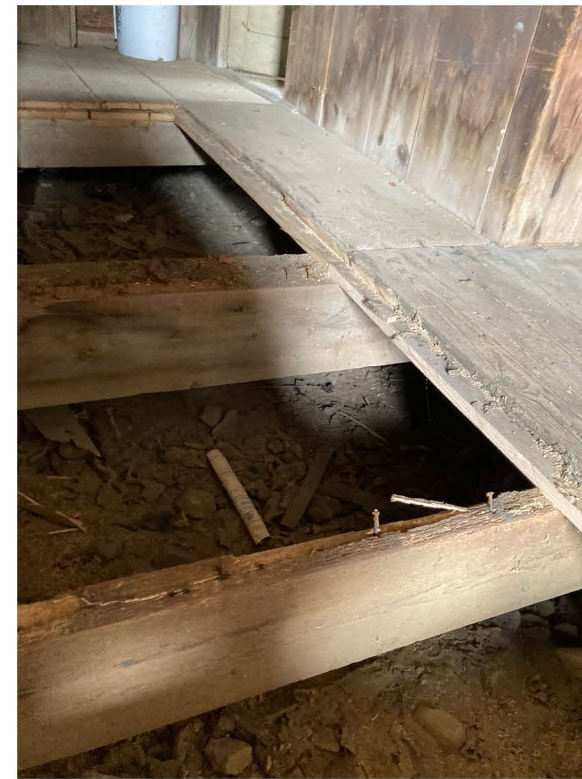
TYPICAL FLOOR FRAMING MADE UP OF REPURPOSED BEAMS

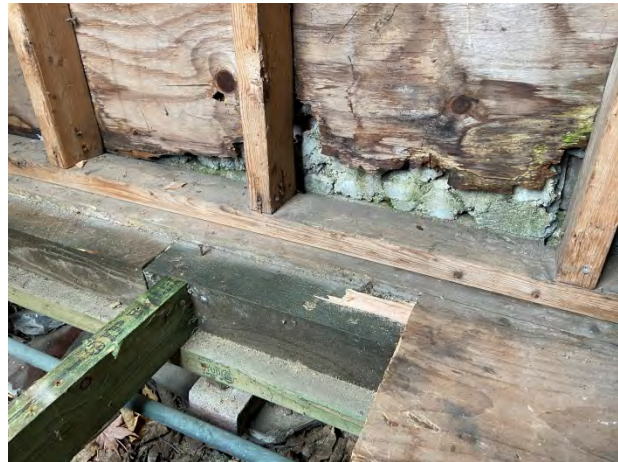
The connector foundation is made of loosely spaced stone supporting a timber plate. The exterior grade along the north side is about 1-foot below the top of the foundation wall. The exterior grade along the south side is approximately at the same elevation as the interior wood floor. Brick masonry cladding has been added along the outside face of the south wall in an attempt to provide some decay protection to the wall and timber sill. The top of this brick cladding is about 1-foot above the exterior grade and interior floor and covers decaying wall sheathing. (Images 1 – 5)

The connector construction is haphazard, with a sloping floor, walls out of plumb, and techniques that would be considered unconventional for any time period. The brick masonry cladding wall does not provide sufficient or appropriate decay protection for the wood framing materials.

4-Connector inside face of brick cladding

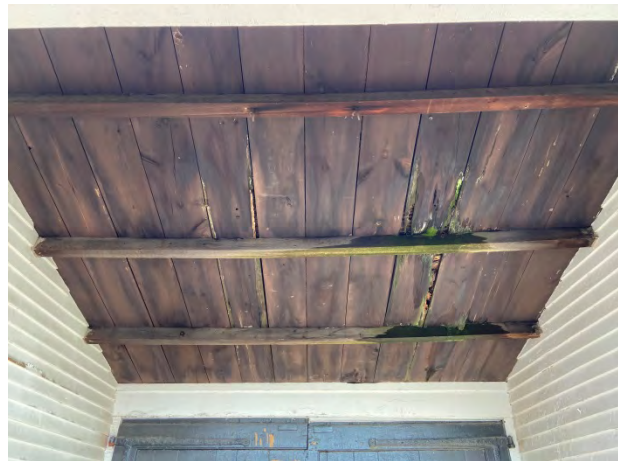
14-Connector roof sheathing and purlins

The original barn timber frame was constructed using reasonably sized members and techniques. The renovation that added the shed extension, and the wide sliding doors along the front of the building, damaged and structurally degraded the original framing system. Much of the original front wall framing, including a frame supporting post on line-3, was removed to create the current door opening. (SK-A and SK-D) The original front wall frame posts on lines 2 and 4 have also been removed and replaced. Where the back wall of the original barn was removed, the existing and added framing has been supported by a heavily notched 5x5 timber and a screw jack. (Image 13) The purlins spanning from the barn to the carriage house are grossly undersized. (Image 14)

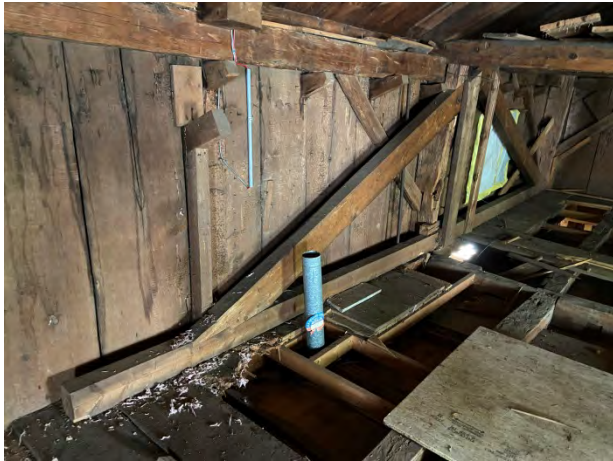
23-Modified framing to bridge over the removed post and wall at lower level

At the intersection of grid lines 8 and C, (SK-A) the balloon post was cut and removed at the first floor level. In an effort to compensate, truss-like diagonal framing was installed at the second floor wall along line C, to bridge over the removed post. (See image 23 and 3/SK-E)

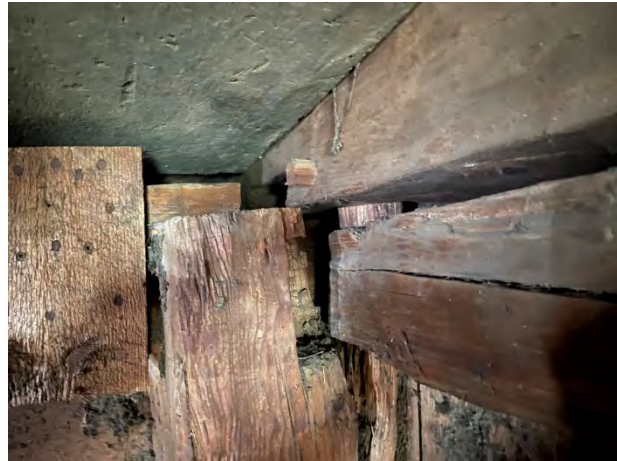
24-Vertical split at corner post

Looking at the building from outside, it can be observed that there is significant distortion, or deflection, along the ridge, the hips and in the plane of the roof itself. Looking inside the building at the top of the corner post, we can observe the vertical split in the post where the hip rafter is being pushed outward. (See image 24)
