John Wastrom – Masonry Consultant

Existing Conditions Assessment Report and Restoration Plan

Historic Burial Grounds and Cemeteries –
Portsmouth, NH

David Moore
Community Development Director
City of Portsmouth
10/25/13

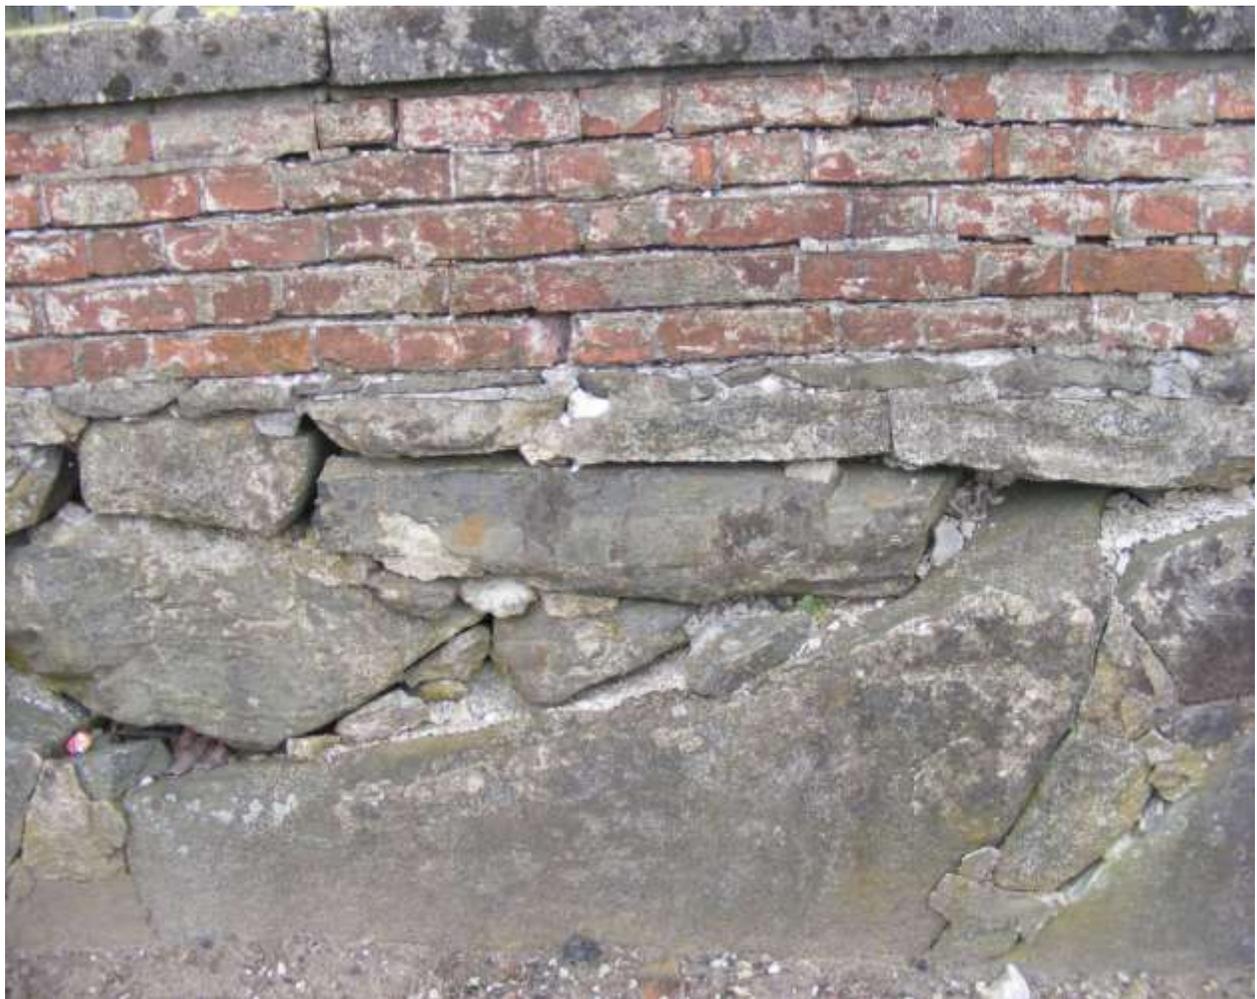
The front enclosure wall has been re pointed so many times it is impossible to comment on all the different types of repair mortar present except to say that none of them contained the original building material, lime. These Portland cement based repair mortars were too dense to allow moisture out of the wall's interior and only accelerated the deterioration of the soft old bed mortar. Virtually all the bricks and stones have lost their bonding and are now held together only by gravity and the weight of the concrete caps which are no longer bonded to the top of the wall either. The wall has settled over the years along with the surrounding landscape. That combined with the migration of deteriorated bed mortar from the interior of the wall, (due to water infiltration) has caused a large section of the wall to lean out over the sidewalk. It is very visible at its western end where a twenty foot long section of the wall appears to be close to collapse. The continued growth of the large trees behind the wall has also contributed to the outward movement of the wall.

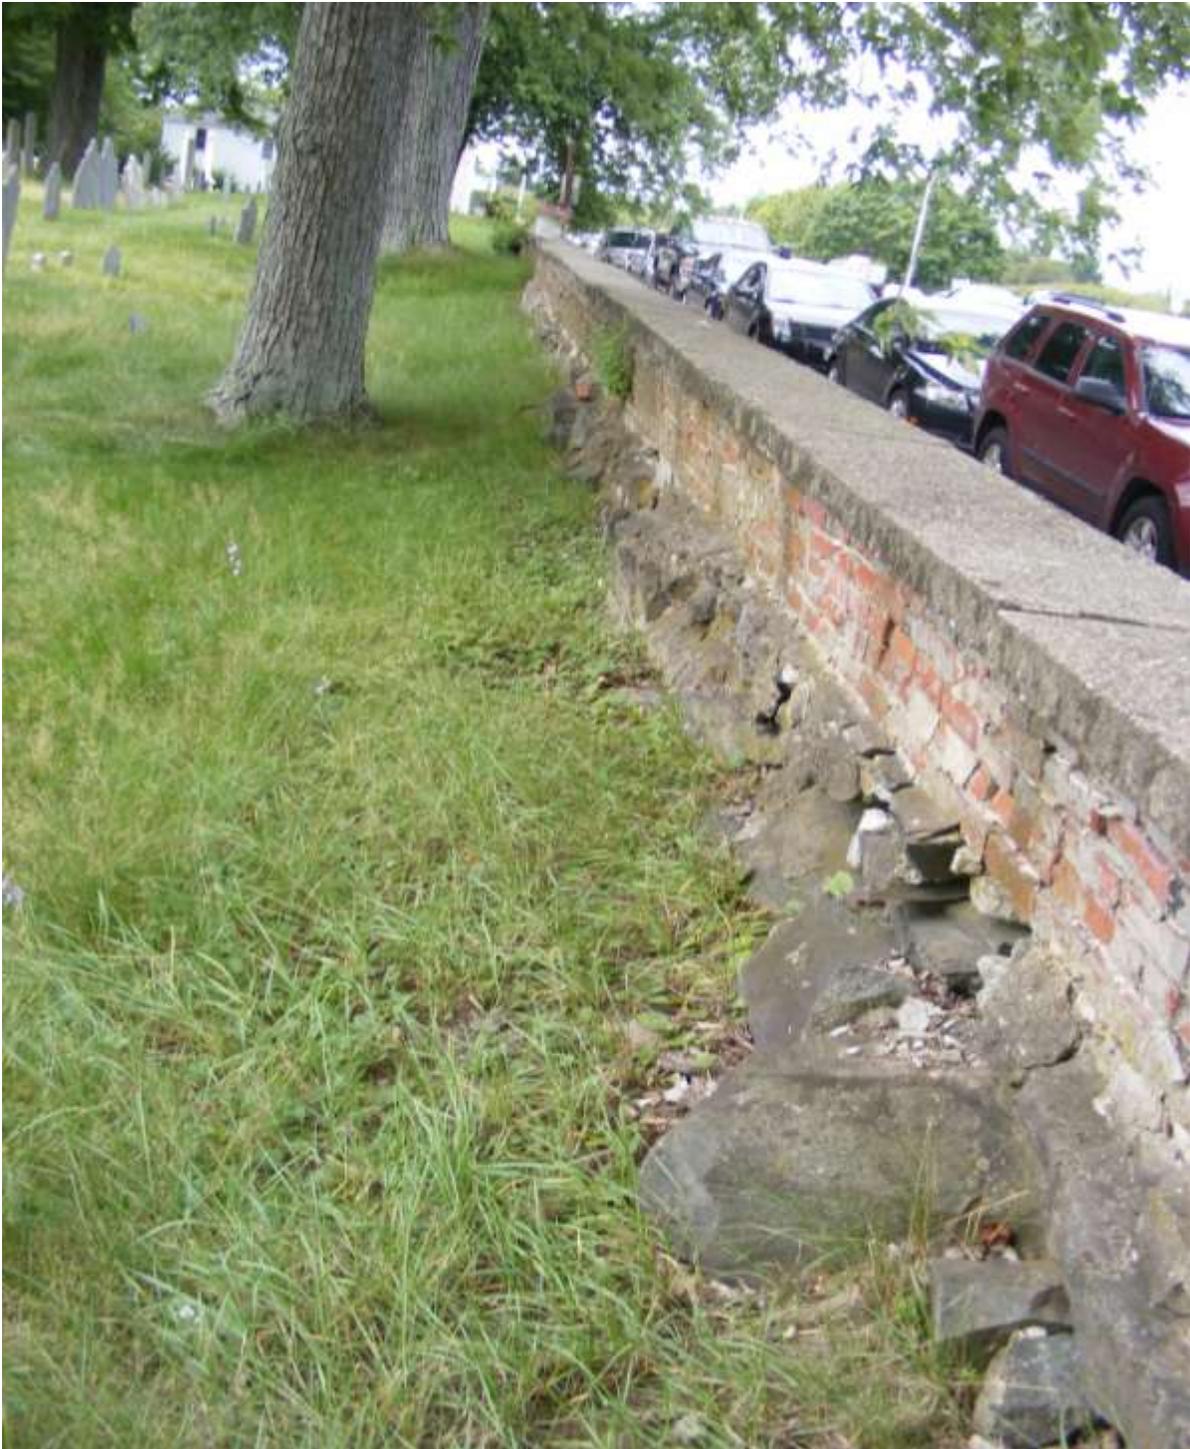
**Existing Conditions Assessment: North Cemetery – Maplewood Ave.
Front Enclosure Stone Wall**

The front enclosure wall has settled over the years along with the surrounding landscape. That combined with the migration of deteriorated bed mortar from the interior of the wall, (due to water infiltration) has caused a large section of the wall to lean out over the sidewalk. It is very visible at its western end where a twenty foot long section of the wall appears to be close to collapse. The continued growth of the large trees behind the wall has also contributed to the outward movement of the wall.

The reconstruction of the North Cemetery's front enclosure wall is the highest priority repair project in the city's historic cemeteries. The existing wall is in poor condition and has become unstable. It has deteriorated beyond the point of restoration or repair. It is recommended that the entire wall be carefully dismantled and rebuilt on a concrete footing using the original stones and concrete caps. The bricks should be sorted through and re used if possible. In kind replacement bricks should be acquired to replace the deteriorated ones. A lineal photo map can be created of both sides of the wall which can be used during the reconstruction process. Also the wall stones should be arranged in a lineal grid that has been set up near the site. The biggest challenges on this site will be logistics and the narrow work area. Based on my previous cemetery projects there can be no excavation beyond the footprint of the wall and no machinery or materials can be place on or near a gravesite.

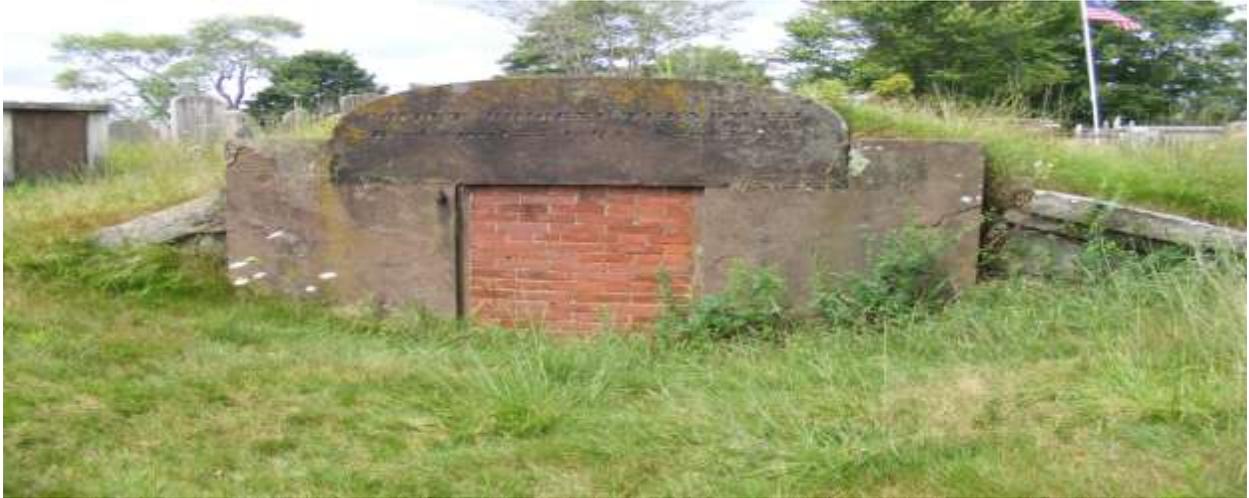
The Robert Odiorne Treadwell Tomb The inscription pediment stone appeared to be in good condition. The inscription lettering was in very good condition which is unusual for this kind of stone. Although the dry laid granite wing walls have settled and shifted over the years, there was no visible displacement of the three big brownstones. There was some lichen growth on the facade stones but there is no need to remove it. These brownstones are too fragile for any type of cleaning. The wrought iron support elements for the tomb's original door have been removed except for one pintel anchored on one of the lower wall stones. This type of exterior hinge arrangement was traditionally used to support a metal or iron door.

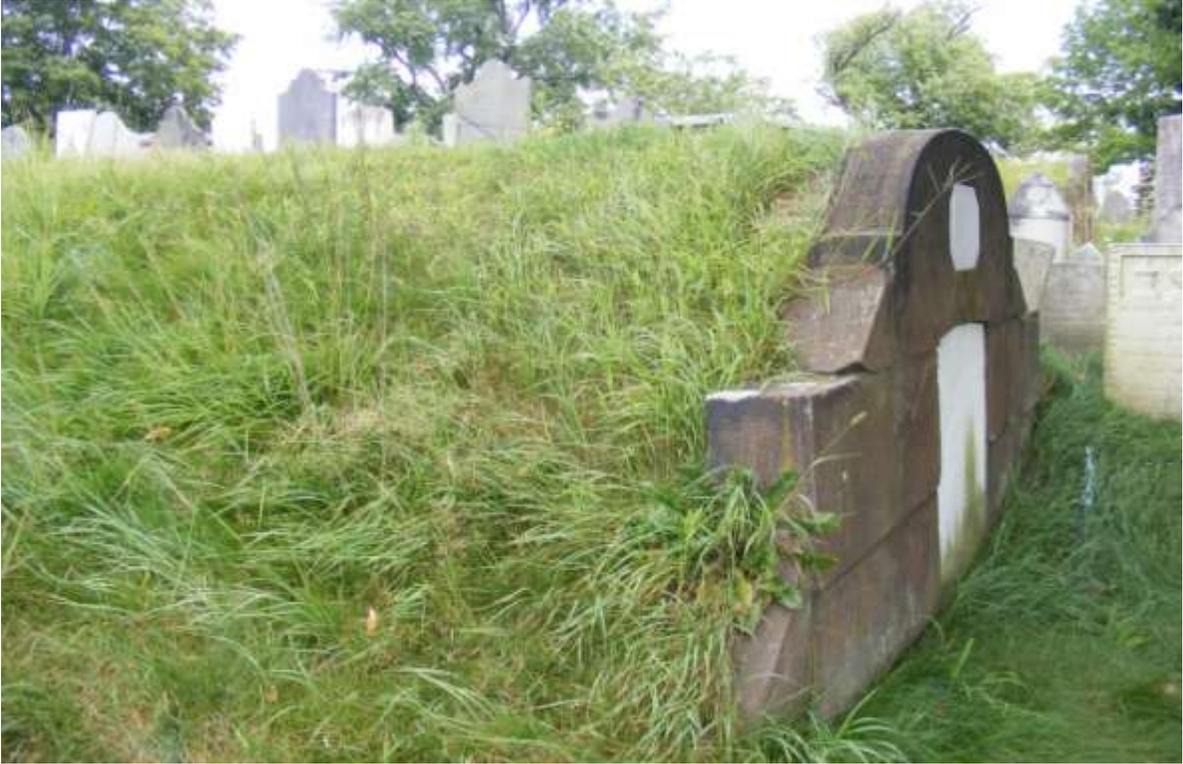
North Cemetery-Governor John Langdon Hill Tomb

The **Governor John Langdon Tomb's** facade was constructed with several large cut and finished brownstones. The lower walls were made of four rectangular blocks that supported an elliptical arched, (elliptical) pediment stone. The pediment stone was framed on either side by two small triangular blocks. All of these stones were fourteen inches thick. There are also two larger triangular blocks/wing walls that flank the base of the facade. The tomb's dimensions are 13 feet in width, 14 feet in length and 6 feet in height. There has been some shifting of the facade wall stones and there has been surface loss on the facade stones. There are no visible recent repairs but a partially exposed band of the vault brickwork behind the facade stones appeared to have been reconstructed with a modern bricks and mortar. An existing iron latch pinned in place on the right face of the tomb indicate an earlier exterior mounted metal or iron door similar to the Wendell Tomb. The condition these permanently sealed subterranean vaults cannot be completely assessed. There are no indications of soil displacement or settling on top of the tombs which would indicate a partial collapse or failure of the buried masonry.

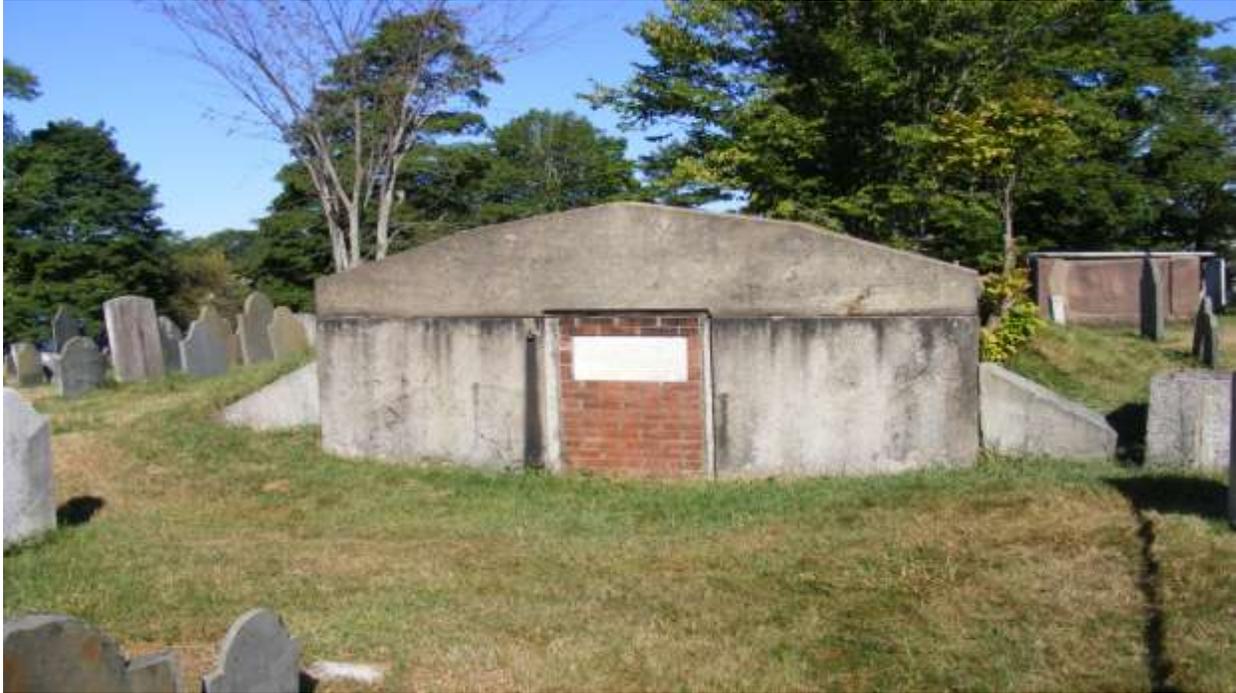
Behind the brownstone hill tombs, closer to the center of the cemetery are two hill tombs with granite facades. The **Woodbury Langdon Hill Tomb's** overall dimensions are 14 feet in width, 23 feet in length and 7 feet in height. Its facade was constructed out of three hammered finish granite blocks with two adjacent wing walls built with smaller triangular granite blocks. The original iron door appears to have been removed at some point in the 20th century although the iron pintel and latch pieces are still in place. These iron pieces have rusted and stained the granite facade stones. The marble inscription stone now imbedded in the brick doorway infill is a modern replacement. The granite facade has settled and leaned forward over the years. This process of stone displacement has also been helped along by the small tree growth between the wing walls and the facade

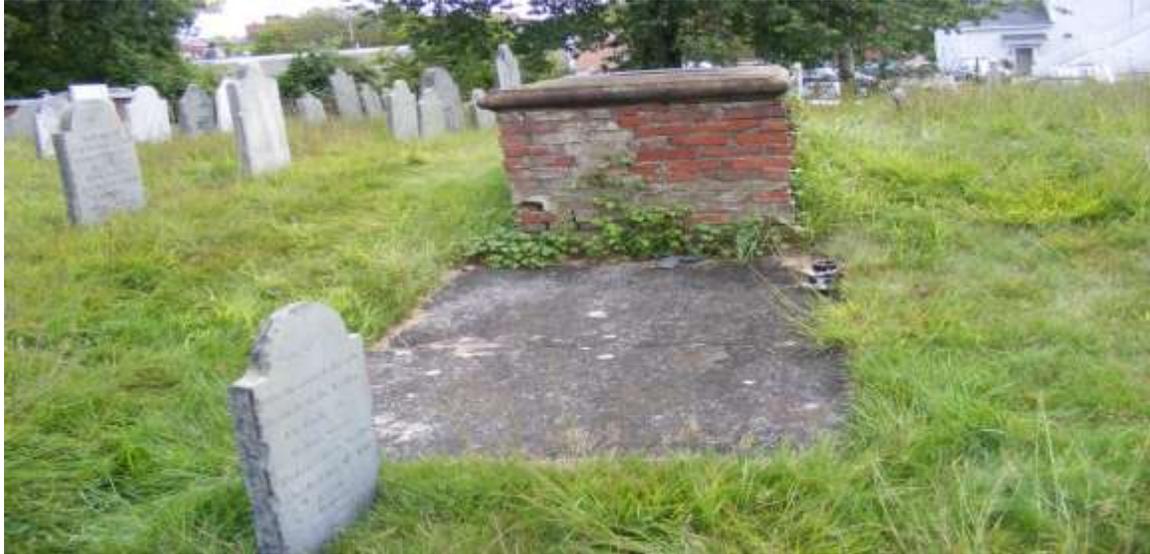
There are two brownstone chest tombs located just southeast of the Hill Chest Tomb. The **Wibird Penhallow Tomb** was almost completely reconstructed during early 20th century. The existing chest walls are composed of modern water struck bricks and Portland cement based mortar. The ten courses of badly installed bricks were originally parged with a mortar plaster. About half of this brickwork has lost its bonding because of water infiltration and weathering... The tomb has been partially buried in the hillside and overgrown with vines for many years. The rectangular layer of macadam at the lower end of the tomb may cover part of the burial vault

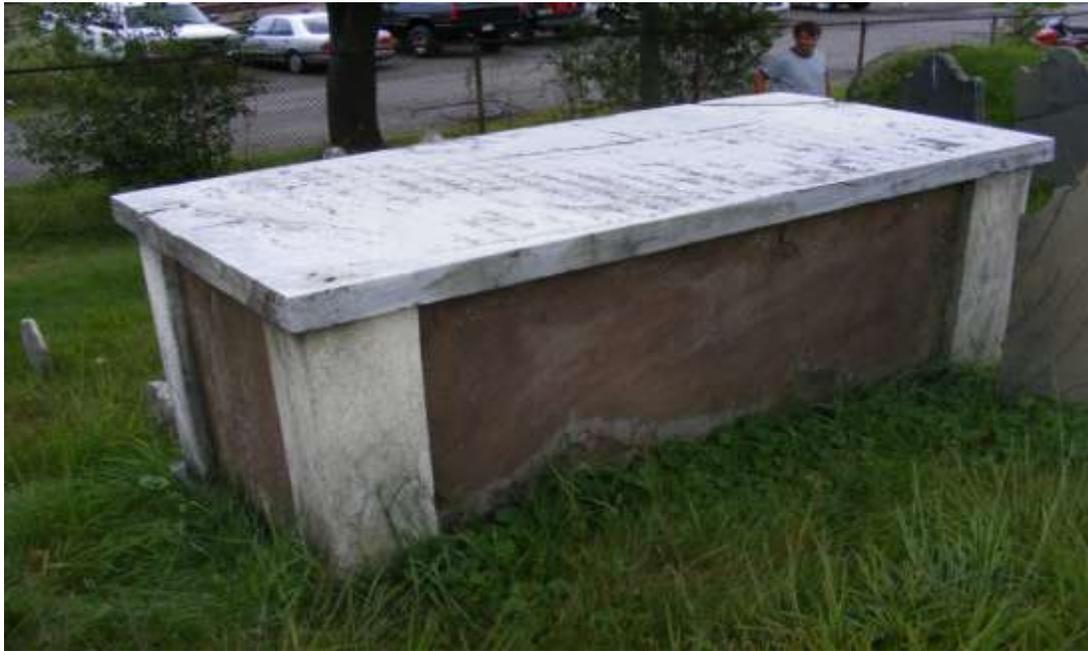
The **William Vaughn Tomb** was one of the cemetery's most ornate chest tombs. It was located between the two brownstone hill tombs. The thick square edged white marble slab inscription stone has been badly damaged by the weather. One corner of the marble slab is no longer attached to the rest of the stone.

The cracked marble inscription slab on the **William Vaughn Tomb** should be repaired and sealed using a mix of un-tinted hydraulic lime mortar and marble dust.

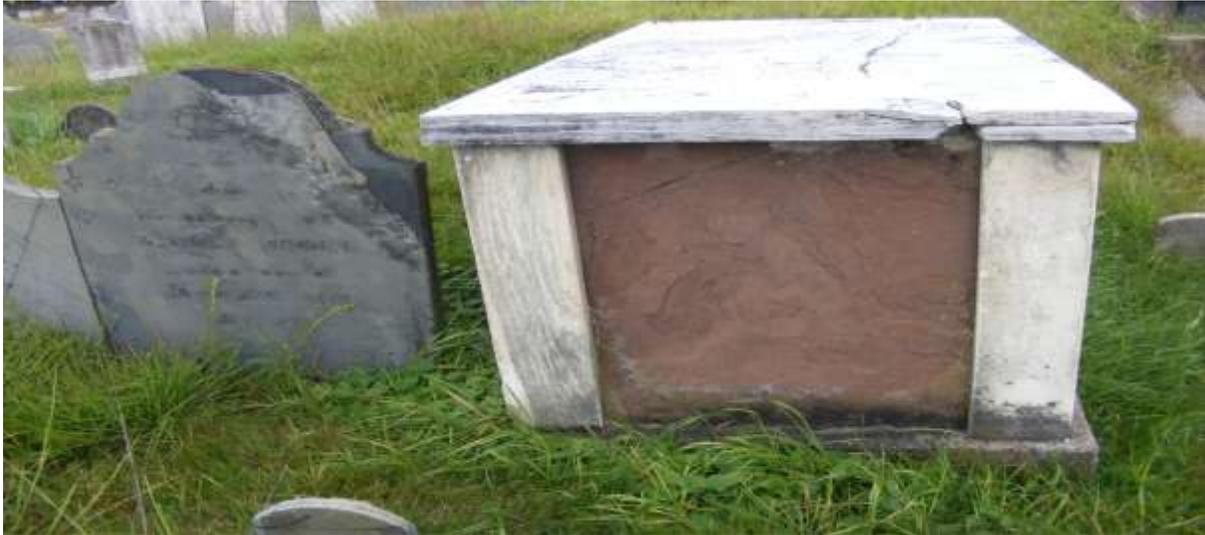
The walls of the **William Vaughn Tomb** were composed of white marble corner pillars and brownstone inset panels. These panels are badly eroded and have lost several outer layers. There is evidence of soluble salt encrustation on the brownstone panels just above the soil line which indicates ongoing rising damp conditions within this tomb. The subsurface re-crystallization of these salts which exist both in the soil and the stone, along with years of weathering have caused this surface loss. This tomb has been badly weathered and is in poor condition due to long term water infiltration.

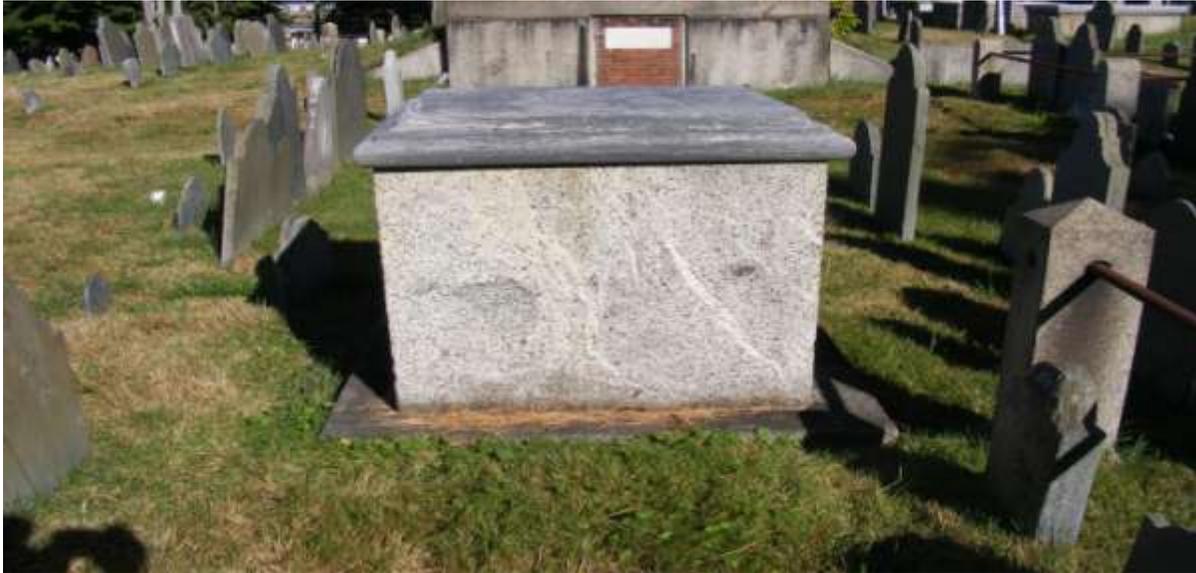
Scattered around the hill tombs are nine chest tombs and one dismantled pedestal tomb. Behind the Vaughn Tomb there is another very interesting chest tomb. The **Jeremiah Hill Tomb** was assembled with three finished stones above the soil line. While most of the chest tombs in the North Cemetery have interior masonry walls that anchor the stone walls and support the inscription slab, the Hill Tomb components are solid granite and marble. The tomb's solid hammered granite cube was set on a thick granite footing stone which covered the subterranean brick vault. The gray marble inscription stone did not weather as well as the tomb's other stones. It has started to delaminate along one of its horizontal bedding planes and there are vertical cracks through the molded edges of the slab.

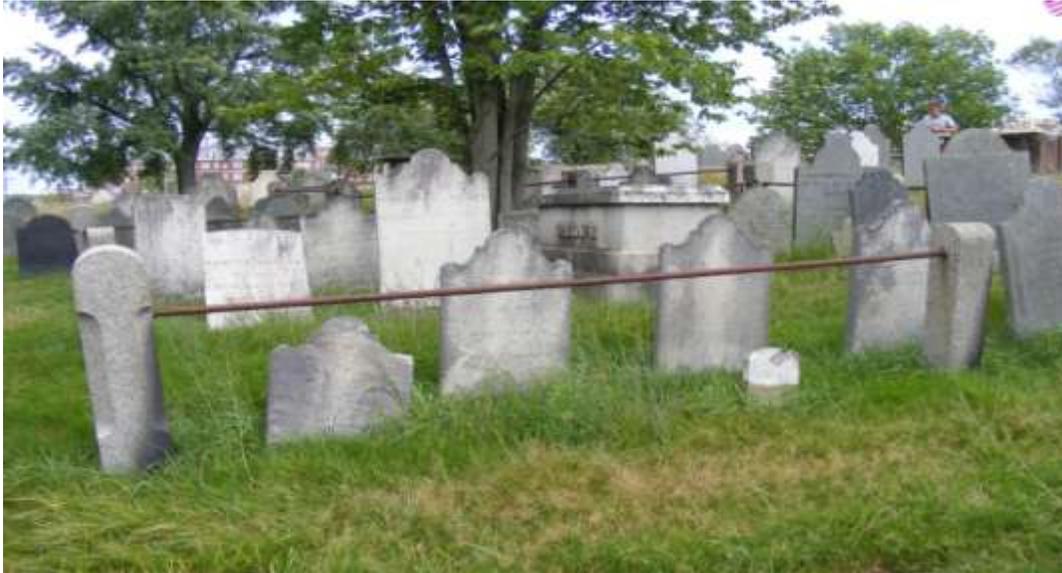
A similar solid granite memorial, the **Sheafe Tomb** was located on the opposite side of the hill closer to the Union Cemetery. This tomb which measured five feet long and three feet tall was assembled with three solid pieces of granite and crowned by a carved white marble slab. . The family name was depicted in raised block letters on either side of the chest stone. Except for some weathering on the marble inscription stone this tomb is in good condition.

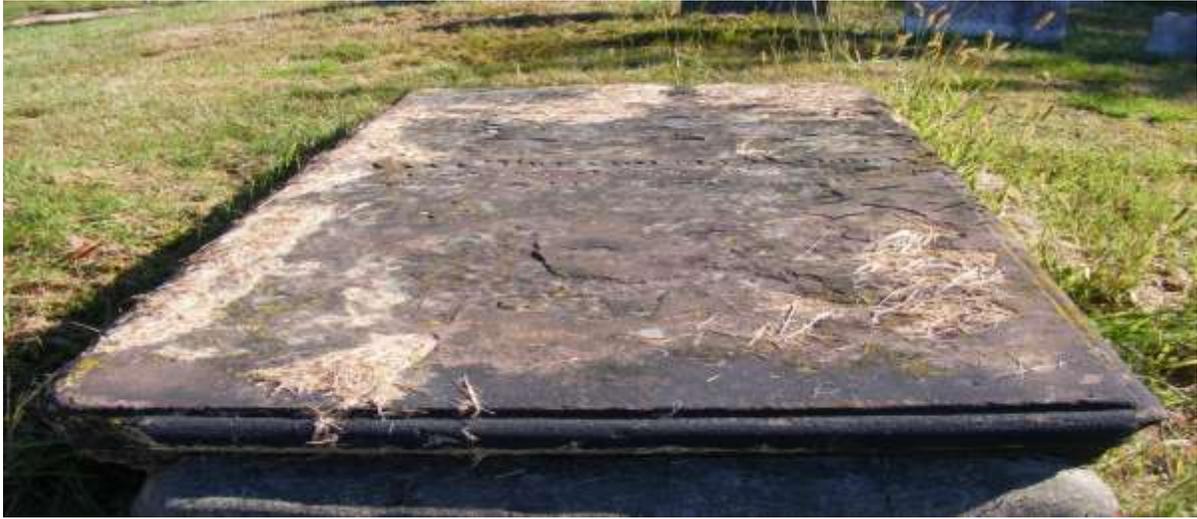
The **Anna Treadwell Walden Tomb** is in very poor condition in part because of the overgrown vegetation around it which encouraged water infiltration in to the brickwork. The succession of bad repairs that took place several decades ago and the removal of the original chest walls have seriously degraded this tomb. The existing, exposed breach in the burial vault could be a potential danger to the cemetery's visitors if there is an ongoing collapse of the subterranean brickwork.

The most important of these repairs would be to cover and stabilize the area around the partially collapsed subterranean vault associated with the Anna Treadwell Walden Tomb.

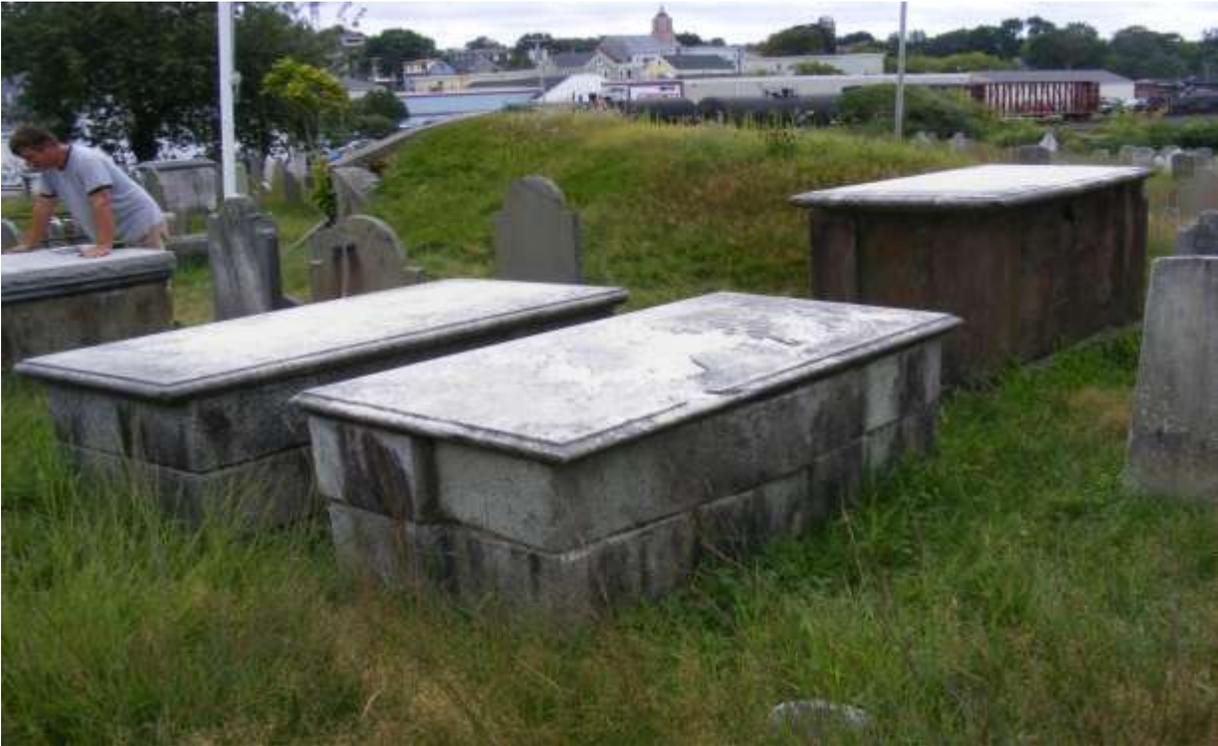
The **Joshua Bragdon and Harriet Bragdon Chest Tombs** were topped with finely carved but badly weathered white marble slabs. The dry laid granite block walls have settled and shifted over the years but the tombs are still stable. The marble slabs have lost most of their upper exterior surfaces and the inscriptions are almost illegible. Both of these chest tombs measure 6 feet in length, 3 feet in width and 2 feet in height. The Joshua Bragdon Tomb's granite chest stones were assembled on a granite footing slab. These dark granite blocks have a rough hammer finished surface which matched the exterior finish of the adjacent tomb's chest stones. The light gray granite chest blocks used to construct the Harriet Bragdon Tomb were also assembled on a granite footing. Both of these tombs have been heavily stained by a combination of biological and environmental agents, (lichens/algae and air pollution). Although this condition has been a factor in the deterioration of the marble slabs, it has not affected the granite blocks. These tombs are stable and in relatively good condition.

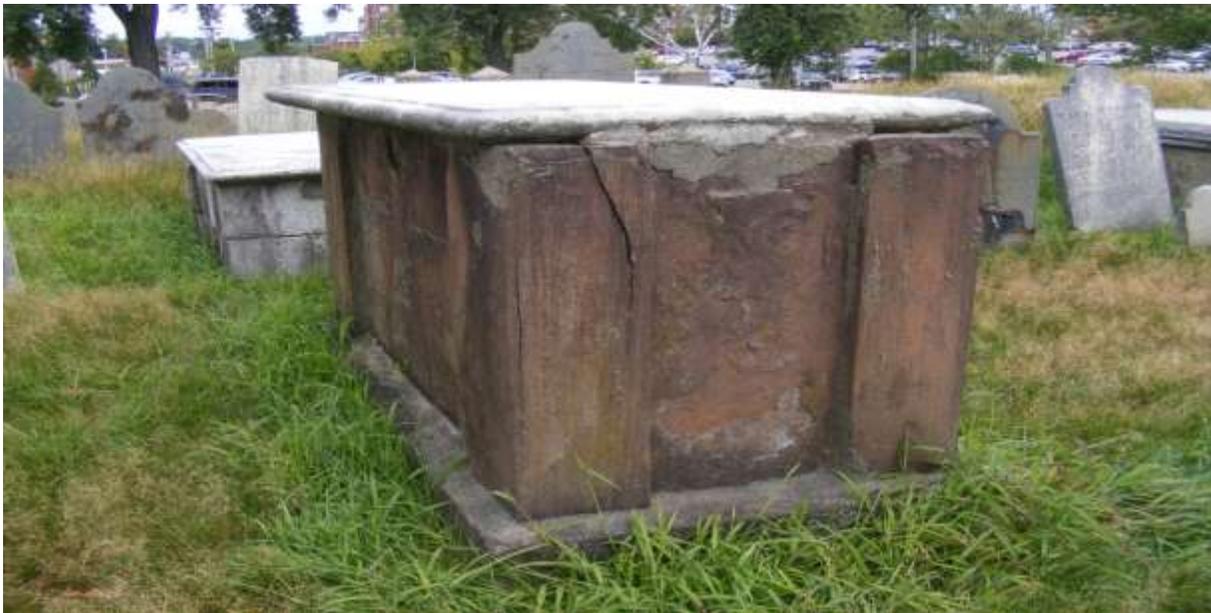
The design of the **Margret Thompson Tomb** was similar to the previous brownstone chest tomb. The only marble element on this tomb was the finely carved and polished inscription stone. Finished brownstone blocks were used as footing stones, the four corner columns and four inset panels. All of these brownstones are badly weathered and in poor condition. One of the cornerstones has a large vertical crack. At some point in the early 20th century, the chest stones were plastered over with a Portland cement based mortar. This inappropriate repair accelerated the deterioration of the brownstones. There are only a few surviving remnants of this repair mortar because most of it fell off along with the surface layers of the chest stones. The marble slab appeared to have been partially shifted from the top of the tomb. It was roughly mortared into its off center position during another more recent attempt to repair the tomb. This tomb is in poor condition mostly because of all the bad repairs. Adjacent to the Margret Thompson Tomb are three similar chest tombs built with hammer finish granite blocks. These granite blocks were at least two feet thick and when assembled created an almost solid support for the inscription slabs. Two of the tombs were composed of different types of gray granite. The third tomb was assembled with a type of brown granite traditionally quarried in the South Berwick, Maine area.

The marble slab on the **Margret Thompson Tomb** should be realigned and the cracked brownstone corner column repaired with a brownstone repair mortar, (Lithomix - made by Limeworks or Mimic -made by Conproco).

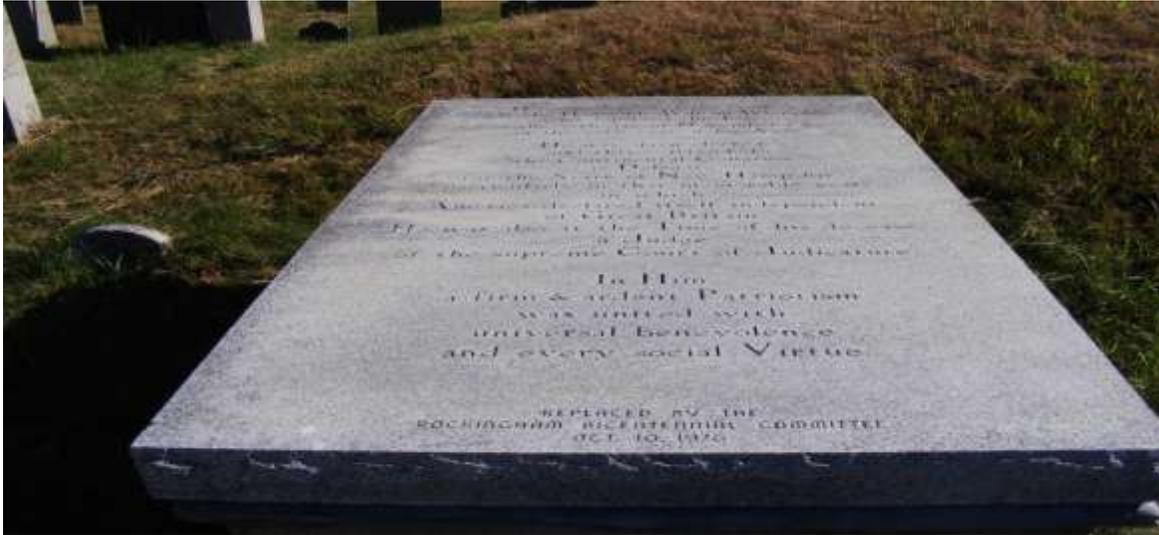
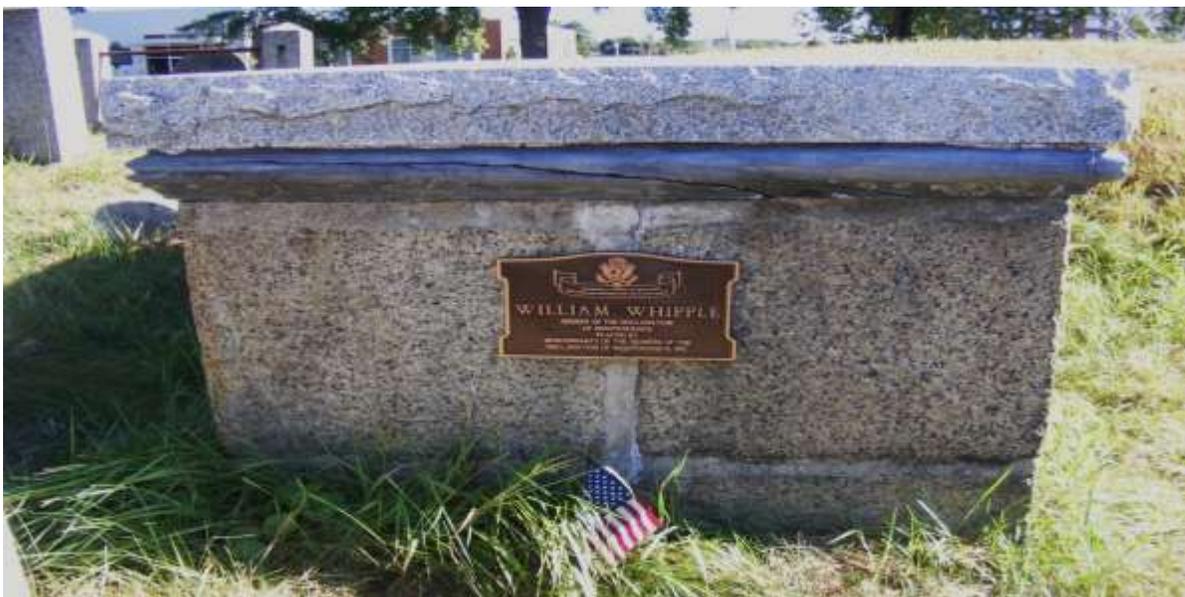
The William Whipple Tomb was composed of brown granite blocks and a four inch thick slate inscription slab. The granite walls were re pointed many years ago with a Portland cement based mortar. This tomb measured 6 feet in length, 3 feet in width and 2 feet in height. The slate slab must have become badly eroded because it was covered in 1976 with a 4 inch thick slab of light colored granite. The old slate slab appears have been partially crushed under the weight of the new stone. There are numerous horizontal cracks along its finely carved molded edge where the freeze and thaw of New England weather has caused this sedimentary stone to delaminate.

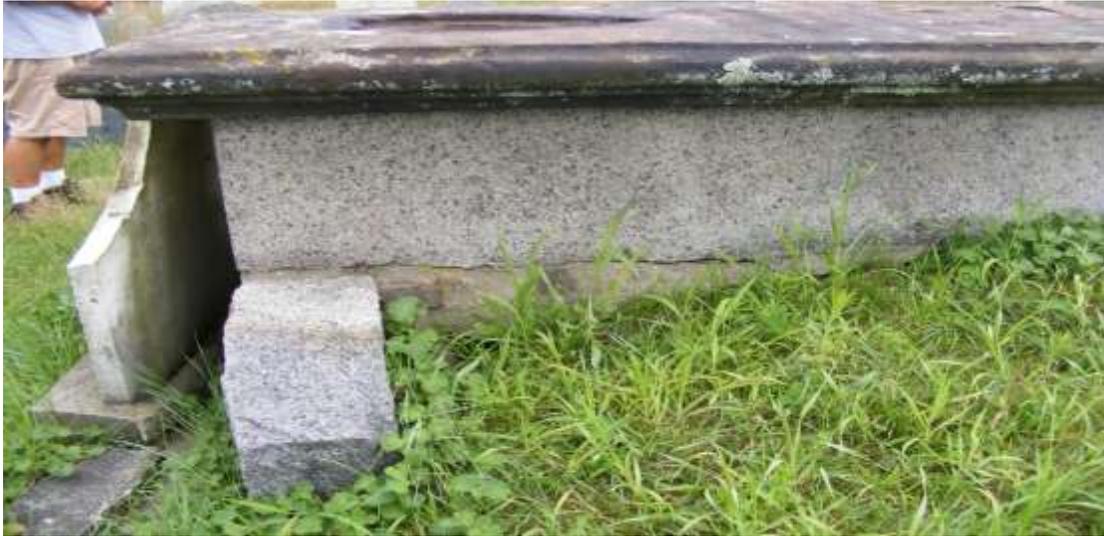
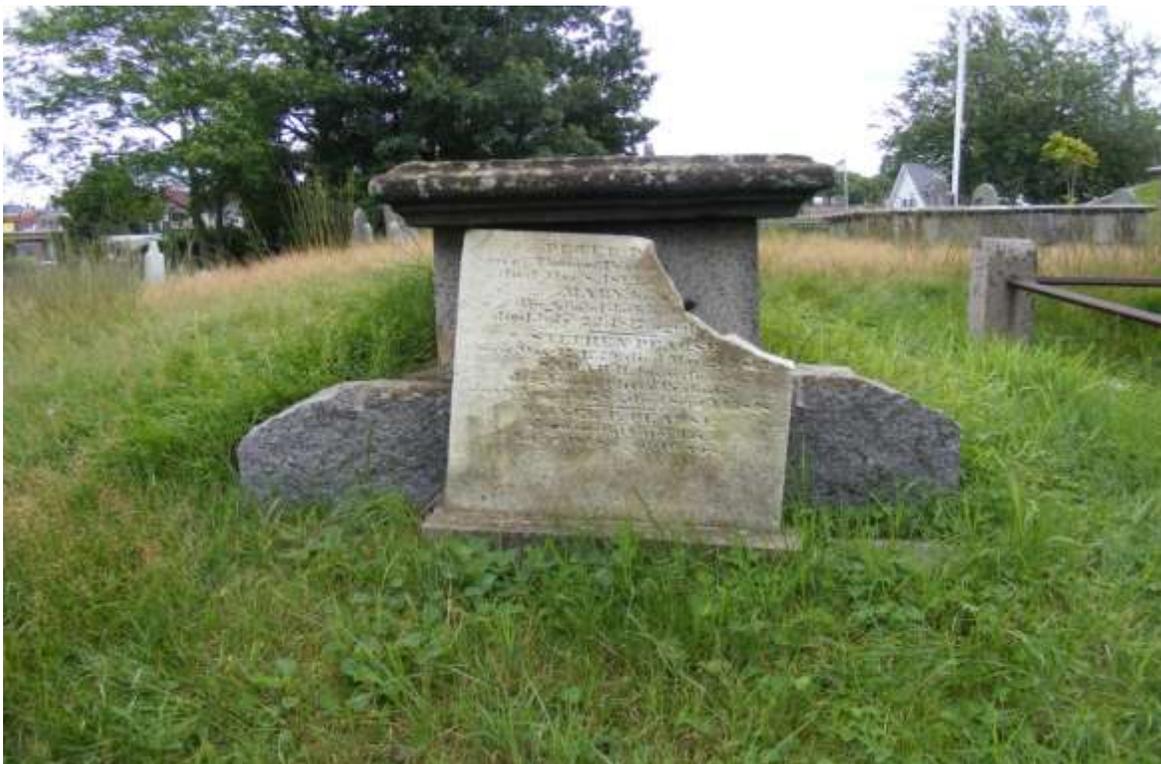
The **Jotham Odiorne Tomb**: The design and finish of the existing lichen covered brownstone inscription slab matched the other brownstone inscription stones in the cemetery. The heart shaped inscription stone has completely deteriorated or been removed. The remaining open void appeared to be constantly filled with standing water. There has been some surface loss on the top and along the molded edges of the brownstone due to weathering

The heart shaped open inset pocket on the **Jotham Odiorne Tomb's** brownstone slab should be filled with a piece of brownstone set in a bed of hydraulic lime.

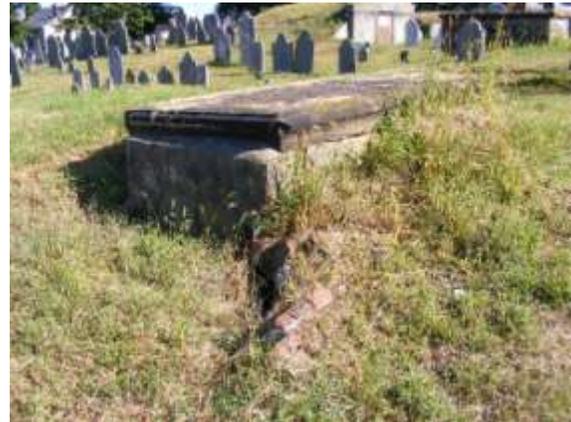
This is a potentially dangerous situation. With the help of an archaeologist the soil should be removed from around the exposed burial vault so the top of the brick vault can be rebuilt.

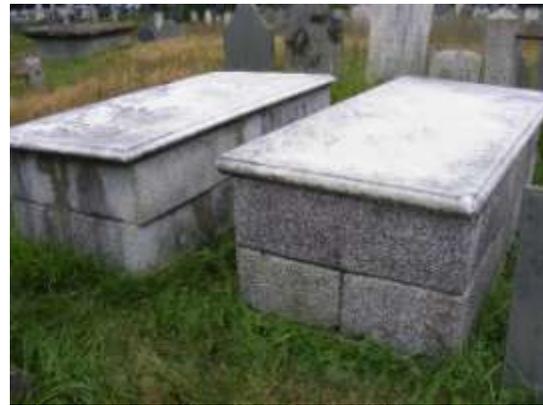
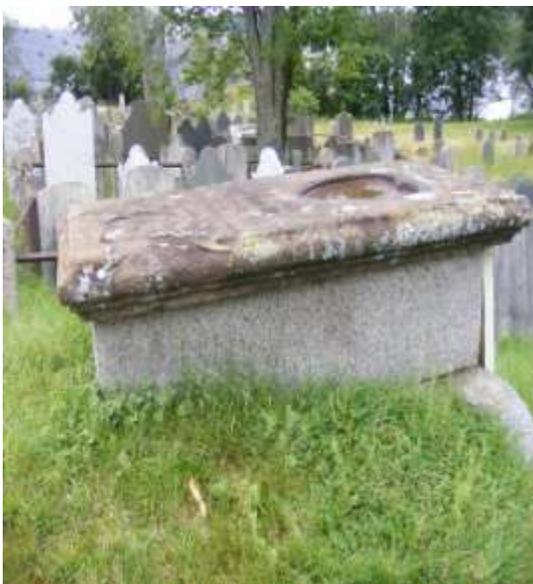
The Joshua and Harriet Bragdon Tombs need to have their granite chest stones realigned which could be done without removing the marble slabs.

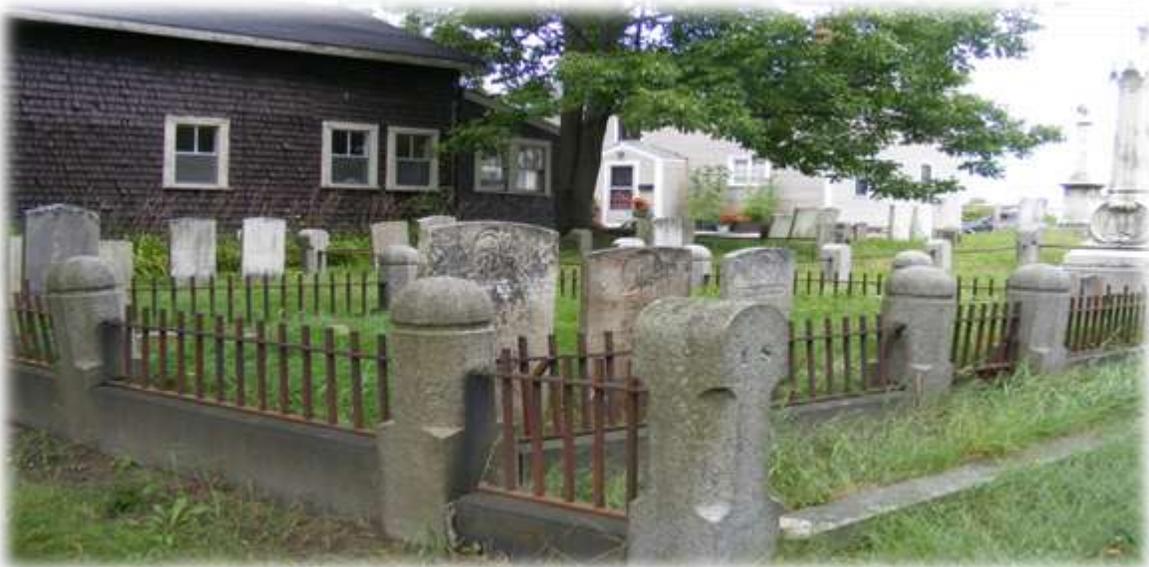
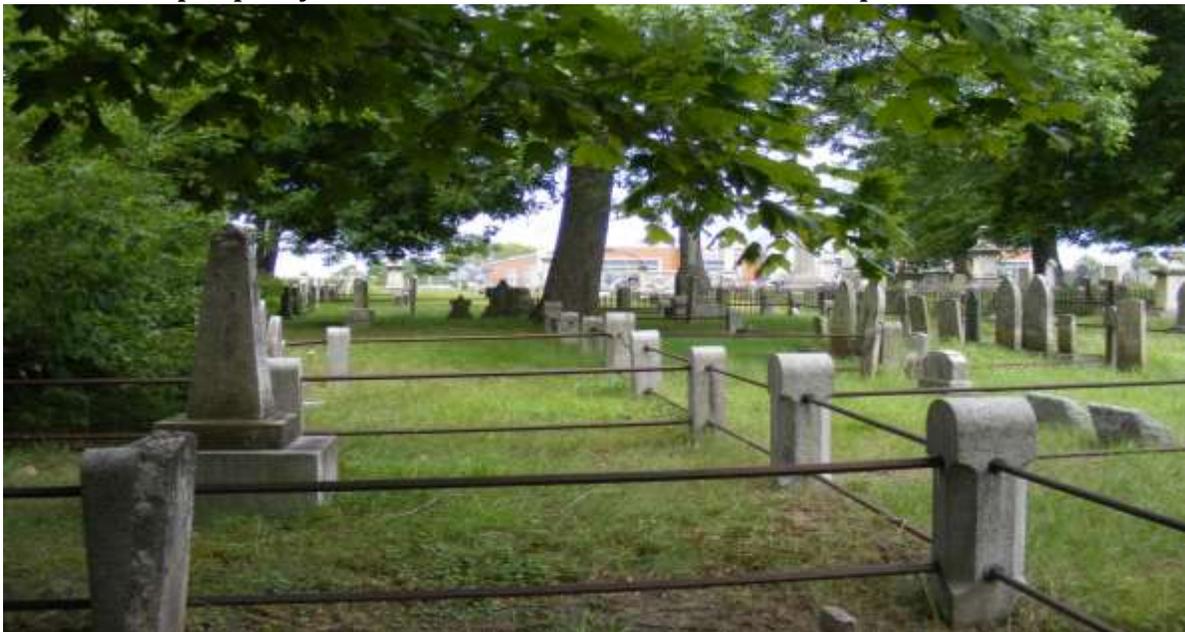
Granite Posts: These posts were intricately carved and their tops were finished with several different arched and faceted designs. Out of the 80 existing granite posts in the cemetery, nine of them have been cracked by the rust expansion or displacement of the iron fence rails. Three of these damaged stones are located in the first two family lots, (Fernald and Godfrey) beyond the front gate. The remaining six damaged posts are located at the rear of the property around the Fernald and Atkinson plots.

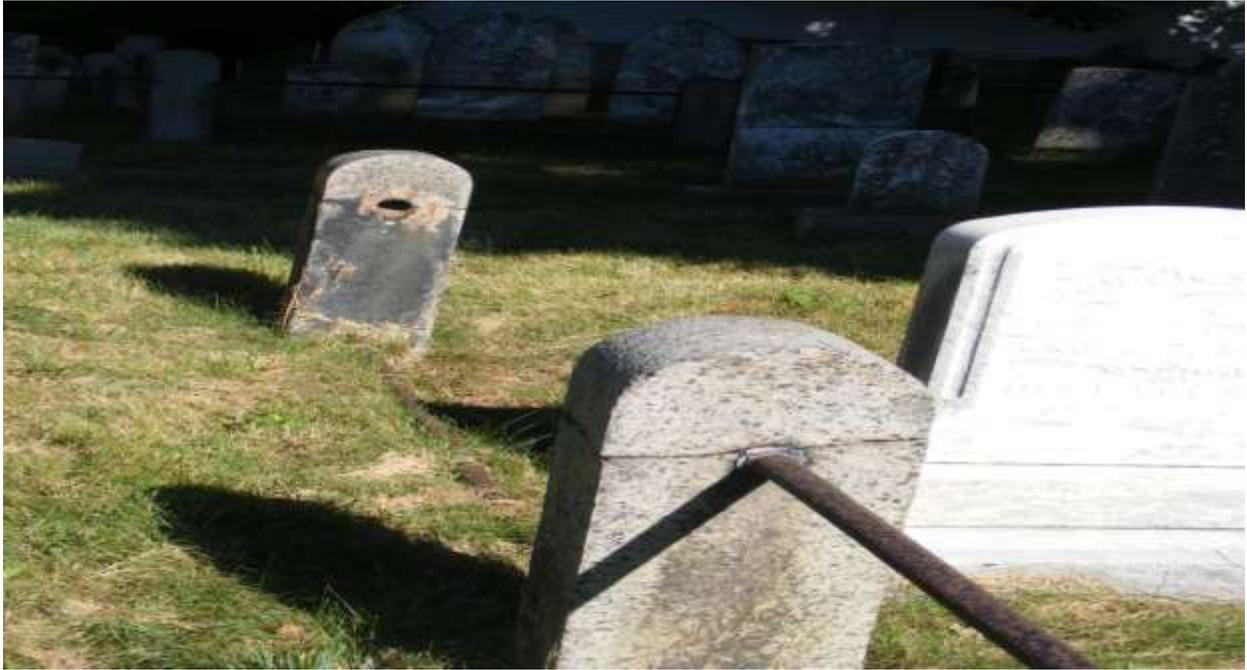
Granite Posts: Damage caused by expansion of rusted iron fence rail

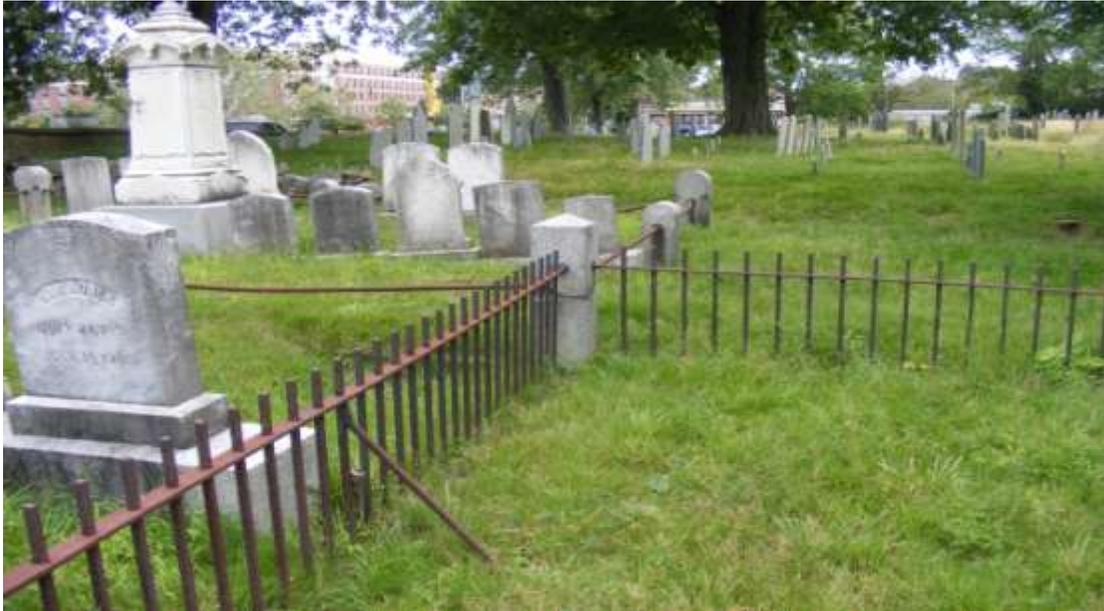
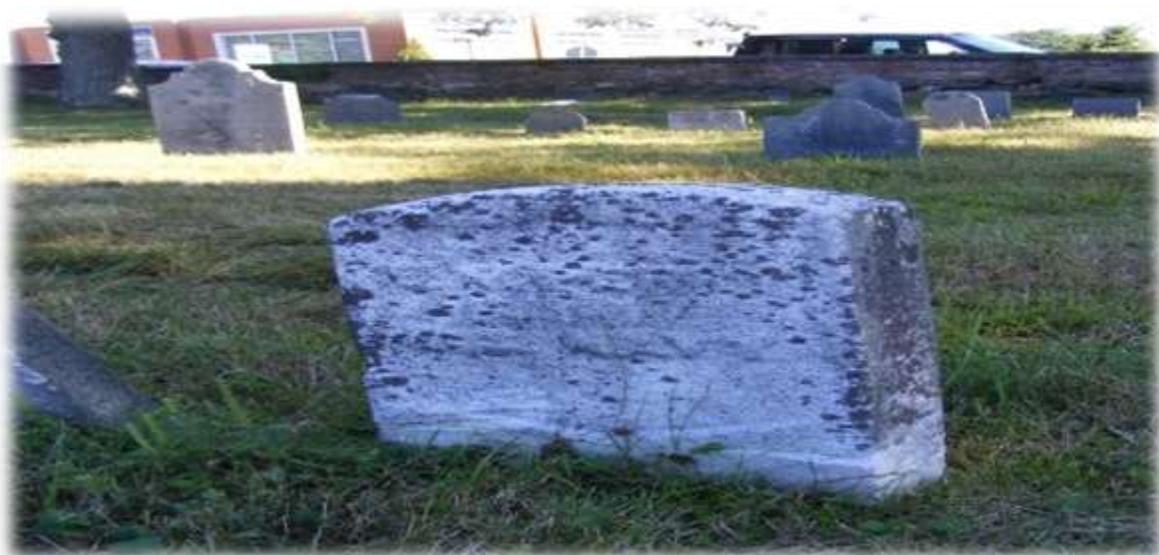
White marble was the stone of choice in the Union Cemetery. The existing marble gravestones and monuments are for the most part in fair to good condition although all of them have suffered from the New England climate. Because it is a soft porous stone, marble has been very susceptible to Biological and environmental staining which can be observed in this cemetery.
