John Wastrom – Masonry Consultant

Existing Conditions Assessment Report and Restoration Plan

Historic Burial Grounds and Cemeteries –
Portsmouth, NH

David Moore
Community Development Director
City of Portsmouth
10/25/13

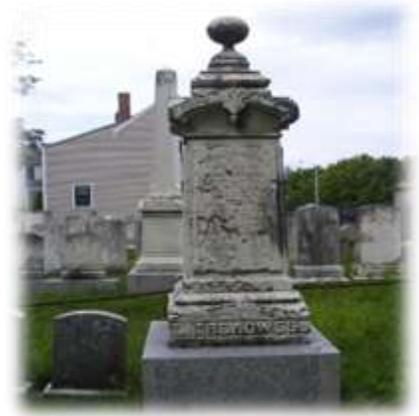
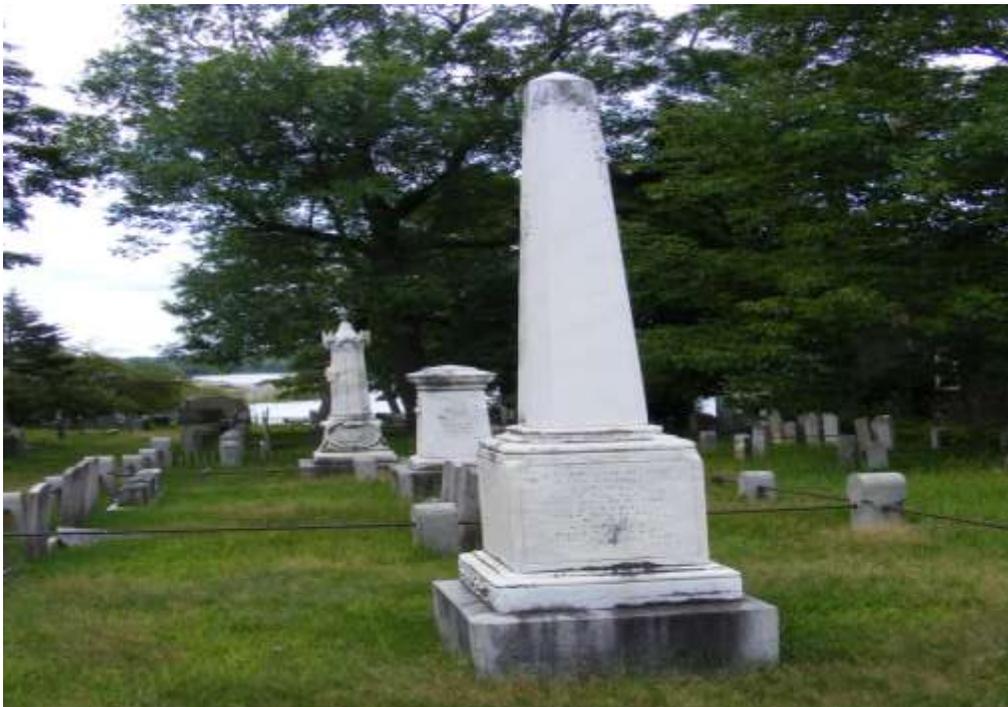
Granite and Marble Obelisks There are eleven marble and two granite obelisks. Most of these monuments have been installed on granite bases. They are badly weathered and stained but they have not settled or shifted.

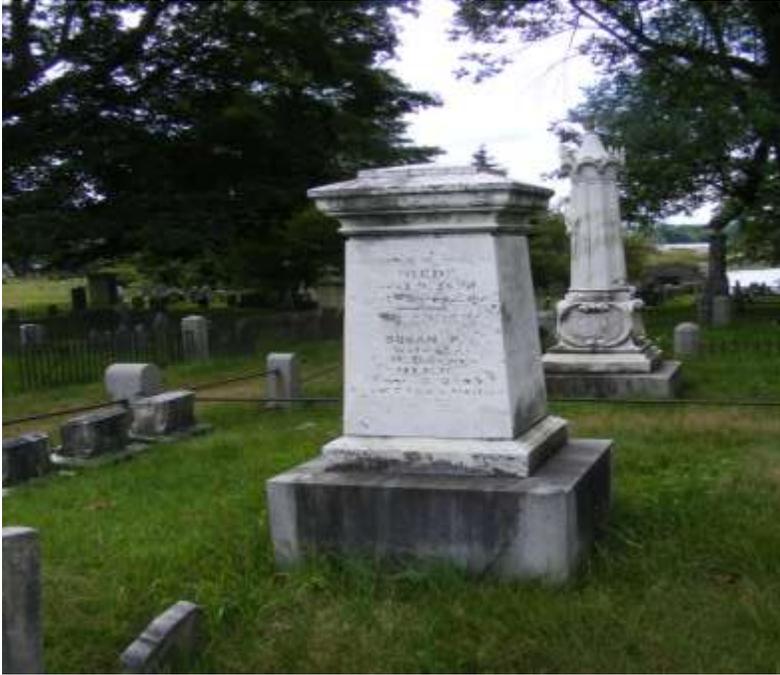
Granite and Marble Obelisks: Two of the obelisks have been vandalized and are missing the tops of their shafts.

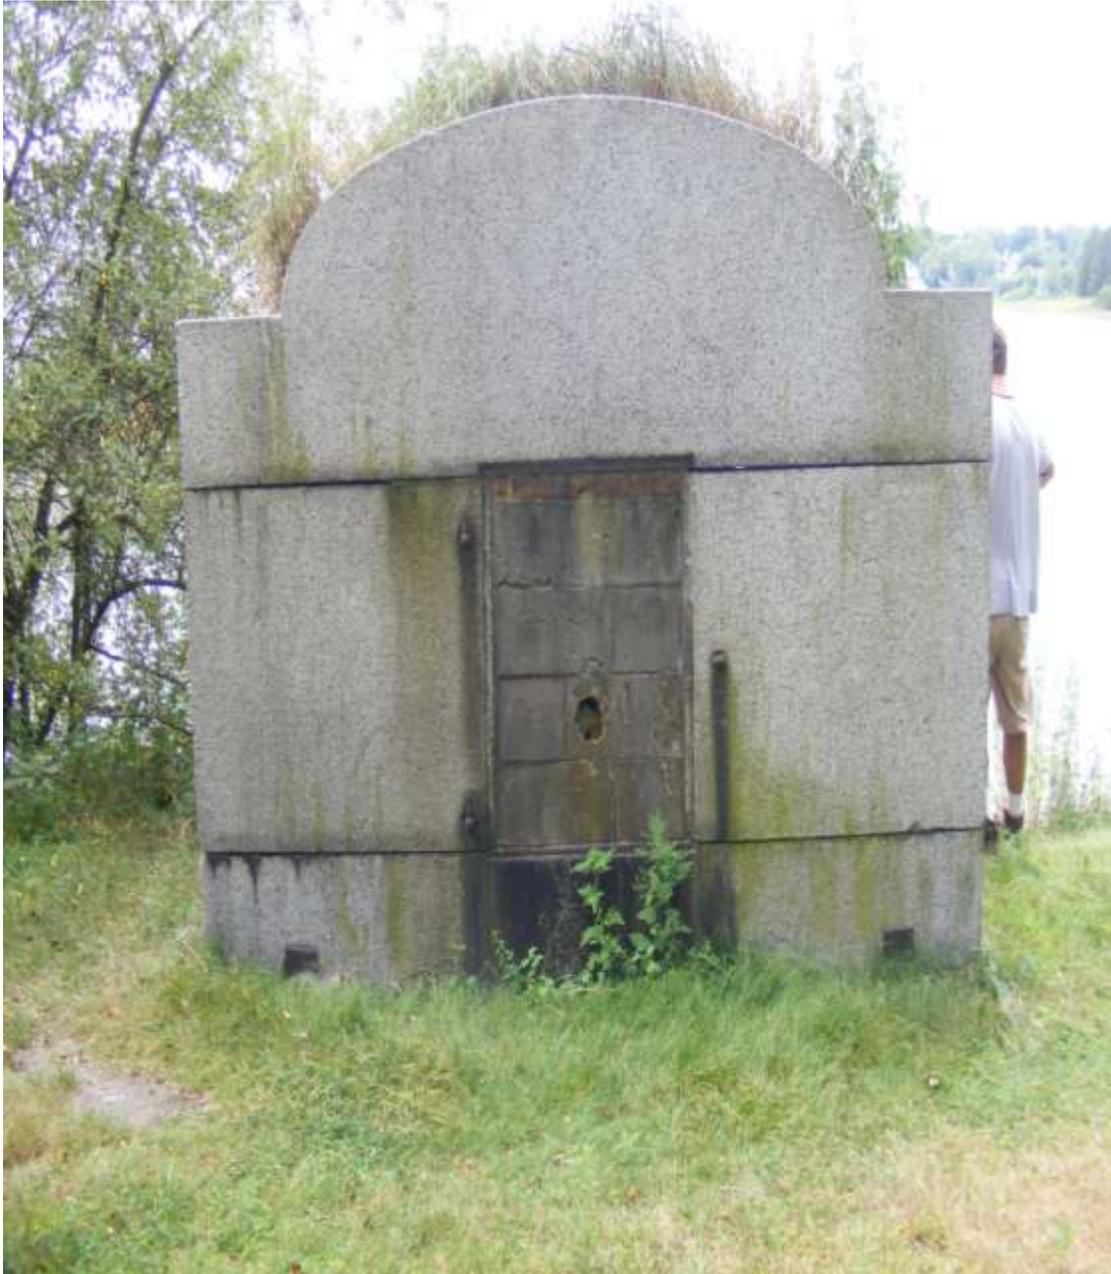
Receiving Tomb and Retaining Wall: Based on the documents and memos that related to this freestanding tomb, its survival has been a controversial subject for many years. The stone retaining wall that defined the western end of the cemetery also supported part of this tomb. The overall failure and partial collapse of this wall also played a part in this story.

Union Cemetery Receiving Tomb Restoration -This is another high priority project because the tomb's unstable masonry is a potential public safety hazard. Also the presence of people in the cemetery at night increases the chances of vandalism.

It is recommended that the North Cemetery's receiving tomb not be totally dismantled and removed. The highly visible granite facade of the tomb is important to the historic integrity of the cemetery. It can be seen as soon as one enters the front gate. There is a way to deal with the badly damaged tomb walls, prevent the tomb's use as gathering spot for the homeless and retain the original view shed of the cemetery. The receiving tomb's granite facade could be left in place while the rest of the tomb was dismantled. The granite roof stones could be re - used as support walls at either end of the granite facade to support the remaining stonework. The modern concrete block masonry in the doorway should also be removed. Besides two stonemasons, the project would require the use of a small excavator, a dump truck and one operator. The deteriorated brick walls could be recycled as clean fill behind the adjacent stone retaining. This would help to slow down the soil loss in this area and save on trucking costs. The granite roof stones from the tomb and the ones on the beach will be installed on compacted crushed stone footings to create two supporting wing walls behind the tomb's granite facade.

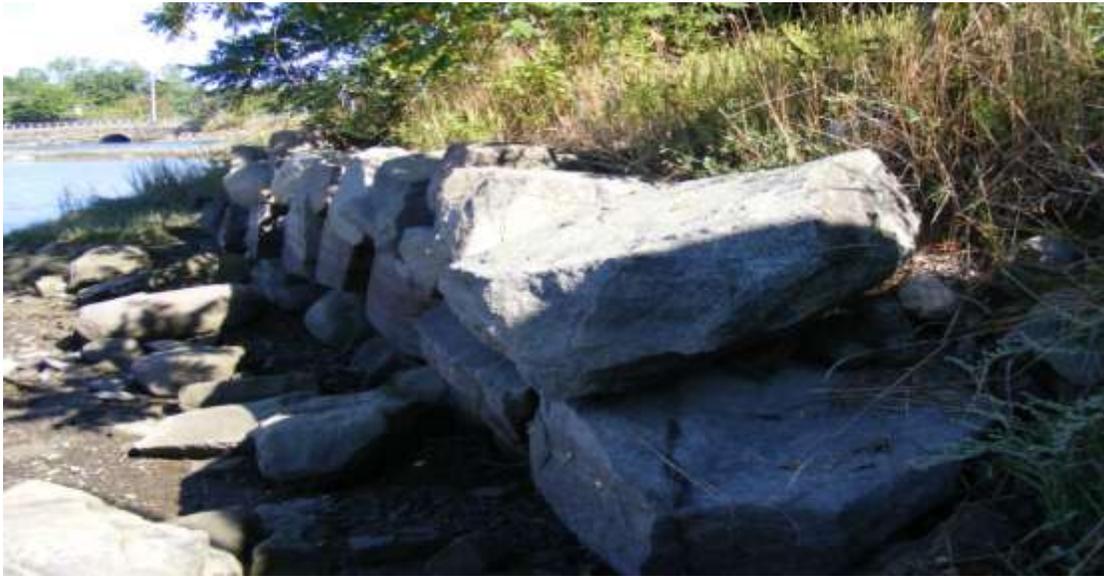
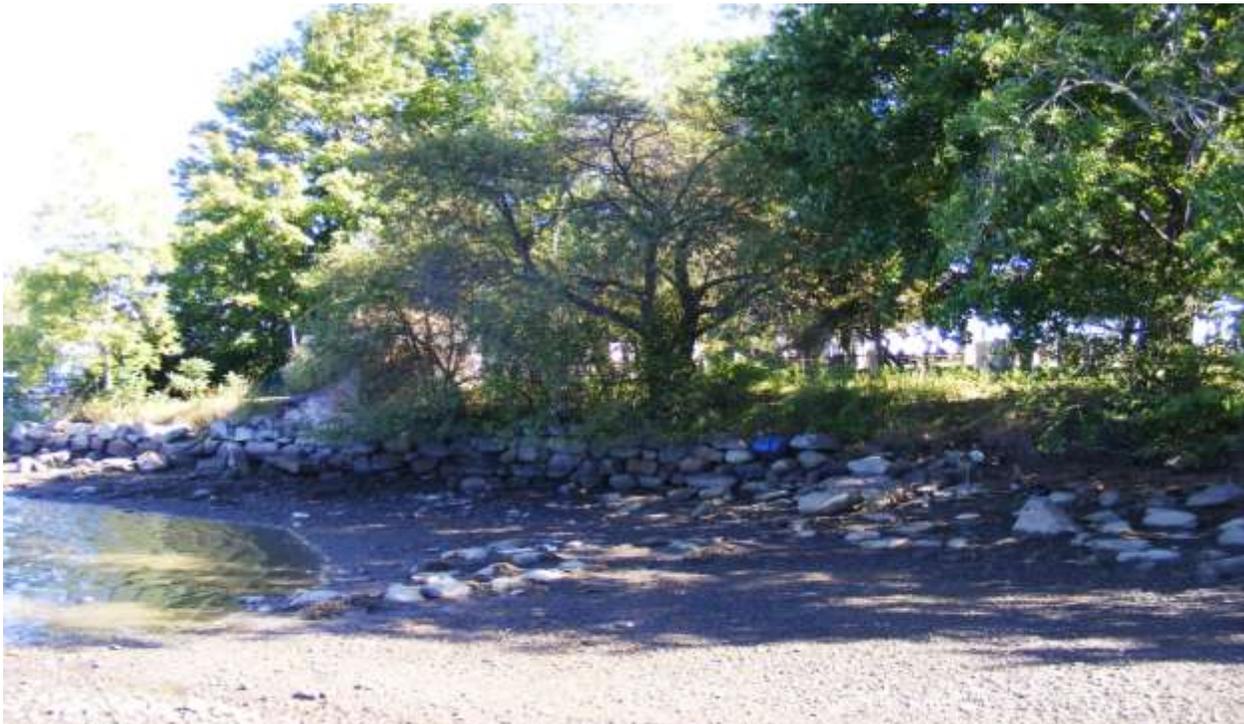
The stability problems of the receiving tomb can be traced to the stone wall that supported it. This mid-19th century wall also appeared to have long-term stability problems. The existing stone work measured 50 feet in length but was originally almost twice that length. Its present height averaged four feet but it must have been originally at least six feet tall.

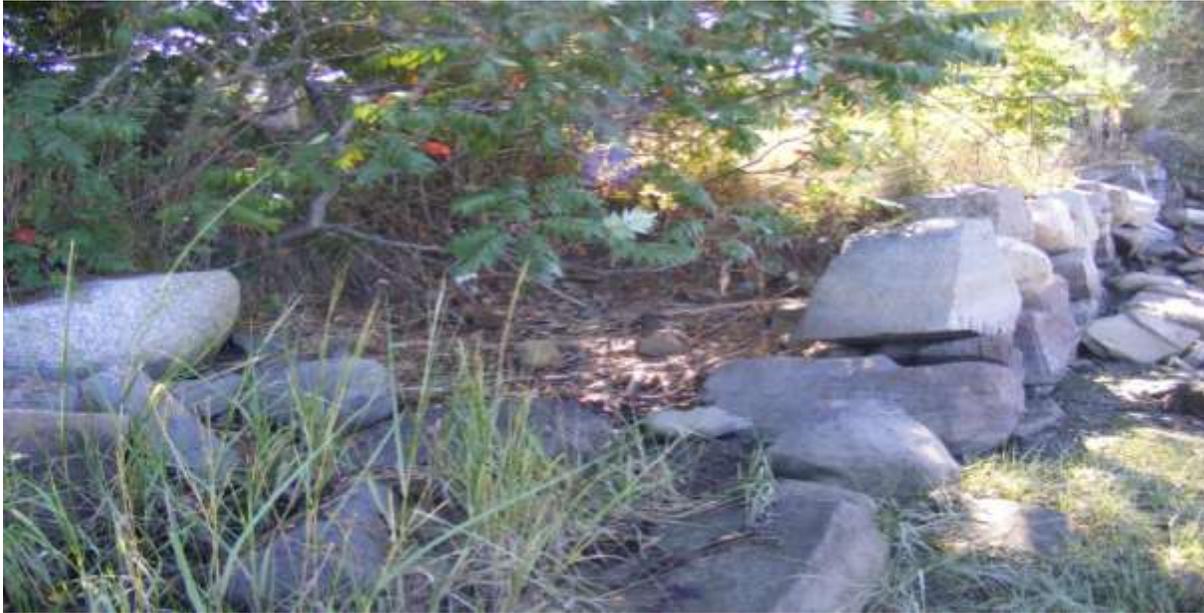
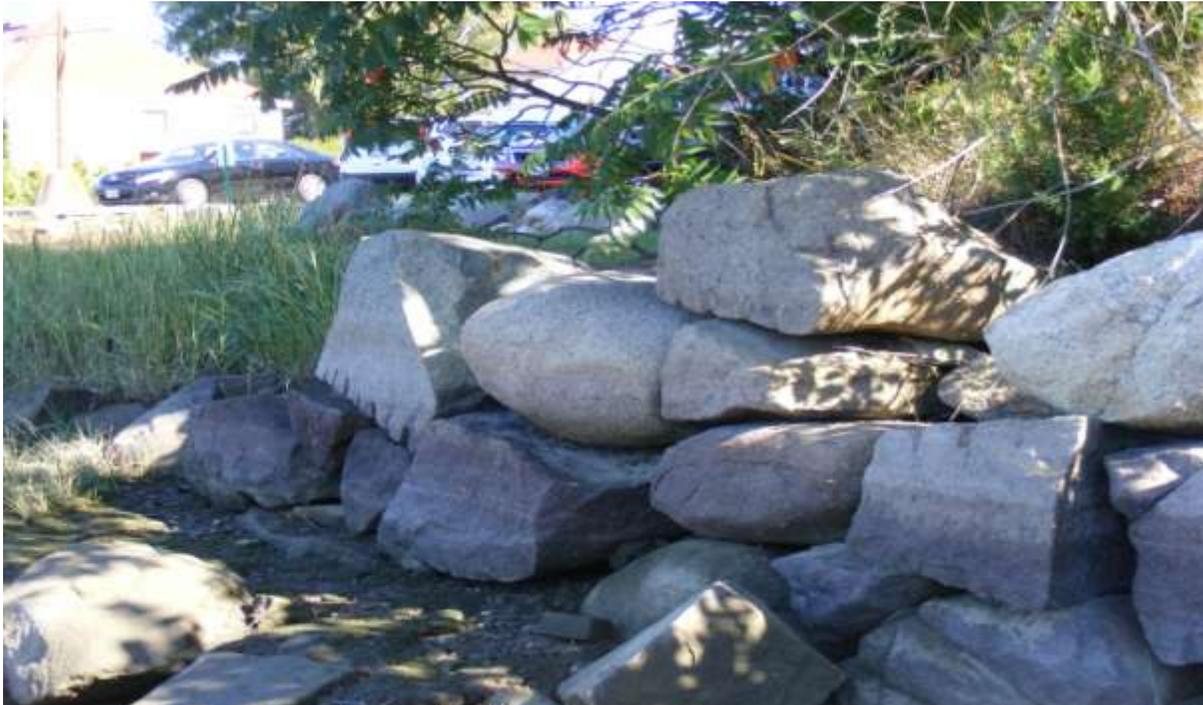
This wall has shifted and settled over the years. There has been a long term problem with erosion behind this wall. There are large sections at either end of the wall that have also collapsed into the pond. The top course of stones along the entire wall has fallen into the water. This retaining wall was probably built when the Union Cemetery was opened.

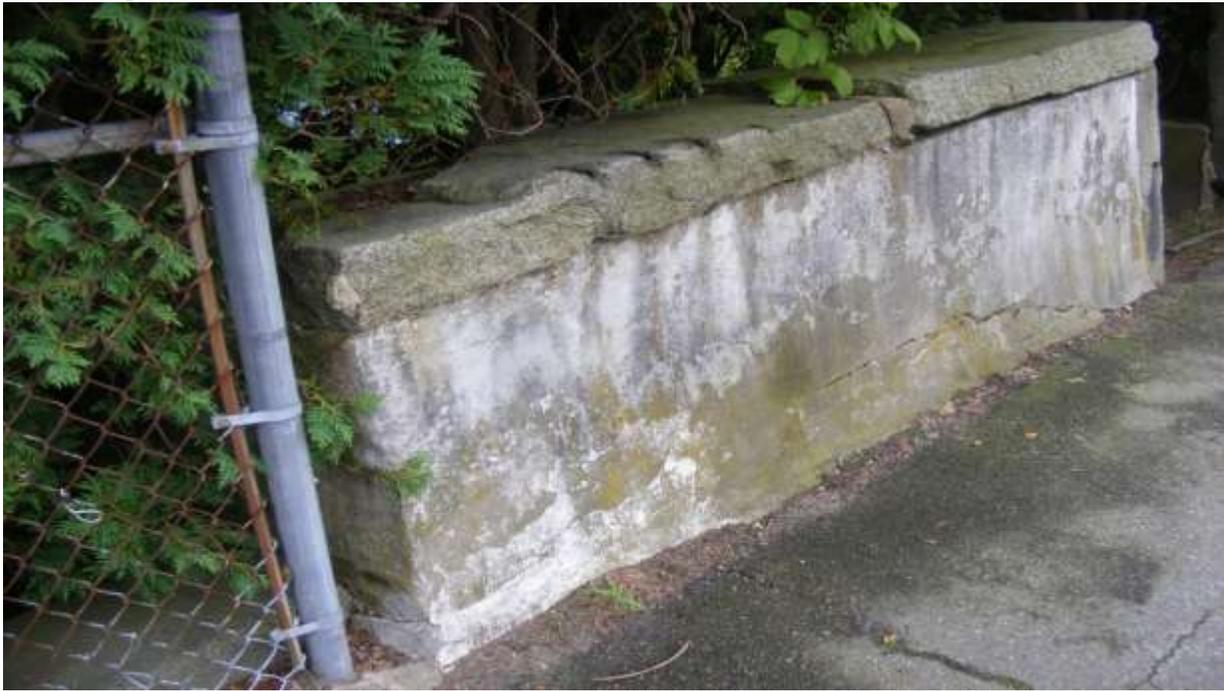
Pleasant Street Burial Ground Front Enclosure Wall: The Pleasant Street Burial Ground’s enclosure walls are essentially stable and intact. These masonry walls are 259 years old. They have definitely settled and moved since their original construction. These walls lean back slightly and the concrete bulkheads were probably installed to arrest this condition.

The Pleasant Street Front Wall: This wall is still intact enough to delay its restoration until the North and Union Cemetery walls are restored. When that time comes it is recommended that this wall be documented and then completely dismantled. Most of the existing bricks will be too deteriorated to re-use. The Morin Brick Company manufactures red - water struck bricks that are a close visual match for the wall's old bricks. Five thousand bricks will be needed to rebuild these walls. **The cost estimate to dismantle and rebuild the Pleasant Street enclosure walls is \$57,000.00 which includes all labor and material costs. This reconstruction project would be very similar to the reconstruction of the North Cemetery front enclosure wall.**

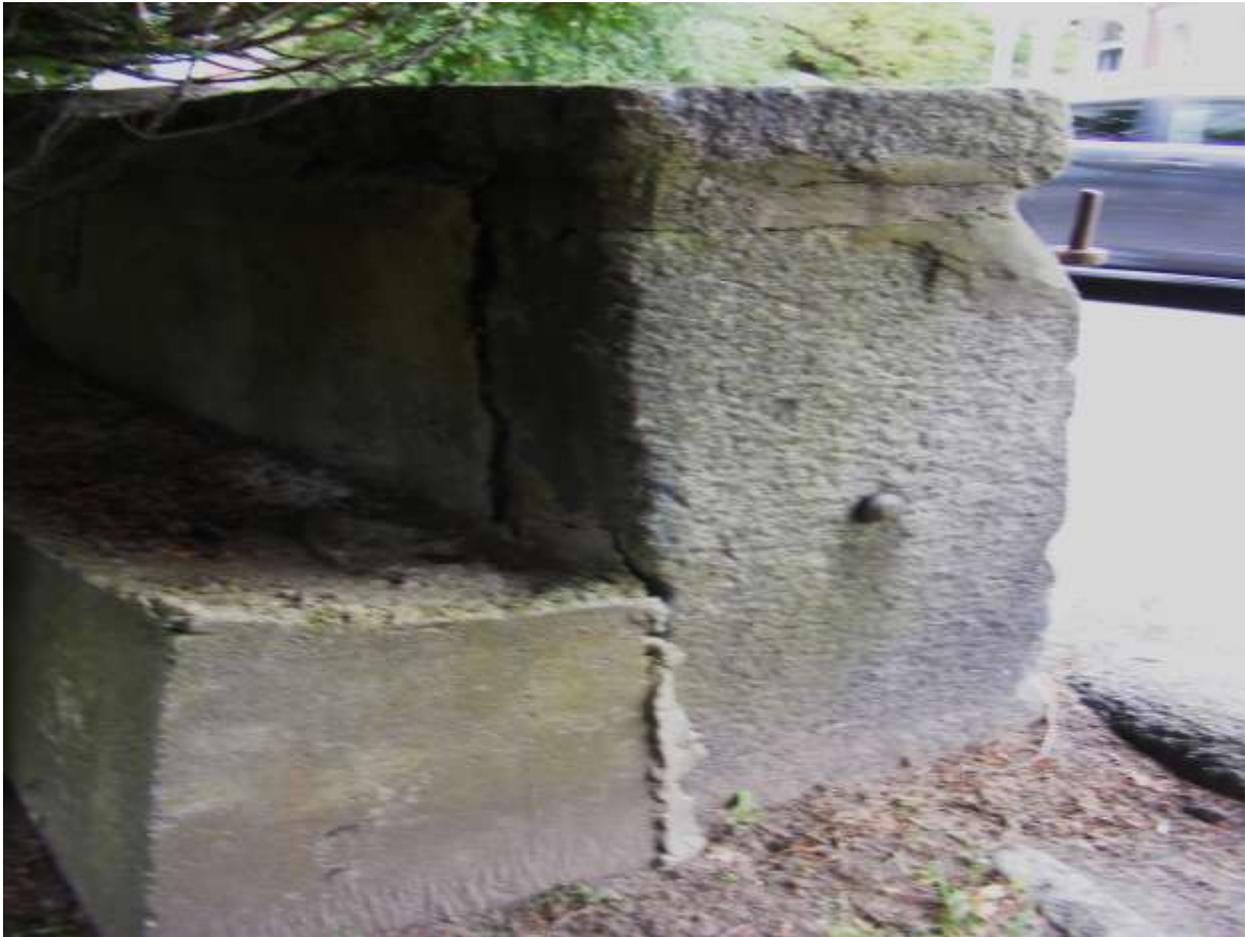
Based on the mortar samples collected from the city's oldest graveyards, there appeared to be a definite campaign during the first half of the 20th century to stabilize and repair the deteriorated tombs and walls. The installation of the concrete buttress behind the Pleasant Street Burial Ground's enclosure walls was part of this effort to shore up the aging infrastructure of the city's cemeteries and burial grounds. In addition to the installation of the concrete bulkhead, the masonry walls facing Pleasant Street were plastered with a thick layer of Portland cement based mortar and then painted with what looked like a combination of gypsum and lime whitewash. This rigid covering has developed many cracks and has lost its bonding to the old brickwork underneath

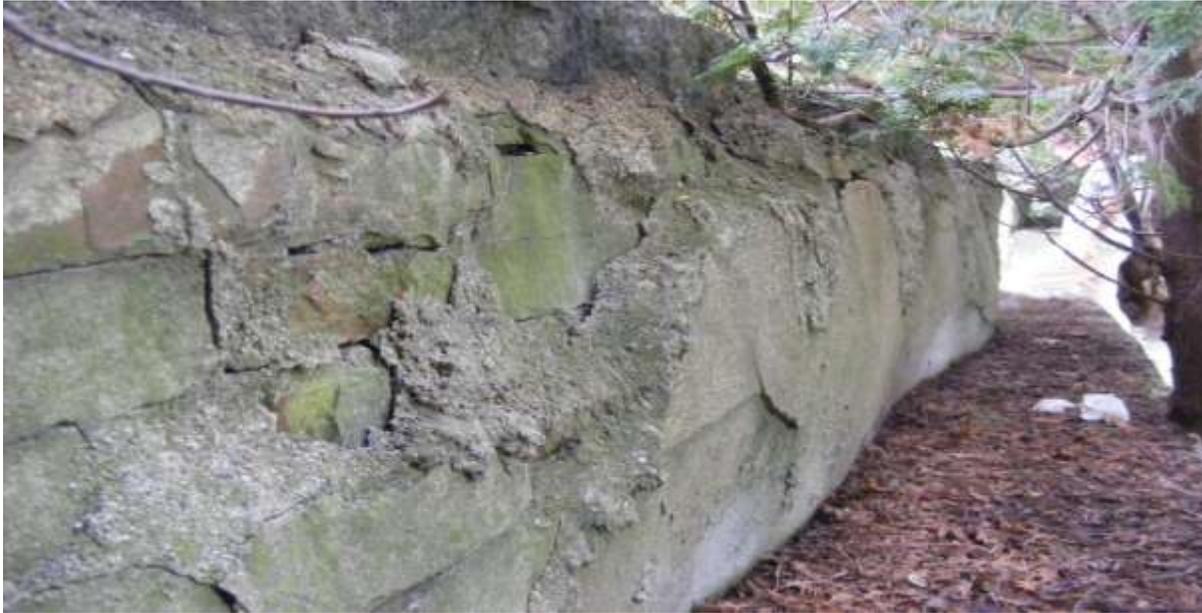
The exposed brickwork above the concrete bulkhead on the rear face of the wall appeared to have been removed and completely replaced with modern brickwork. The existing overgrown cedar hedges located directly behind the enclosure walls have also contributed to the masonry's ongoing deterioration by not allowing the masonry to ever dry out.

Although the Wendell Tomb is in need of attention there are no other high priority projects in the Pleasant Street Cemetery. A relatively simple project that could be carried out in this graveyard would be to remove the cedar hedge behind the front enclosure wall. This would allow the back of the walls to dry out and slow down the masonry's deterioration. It would also open up the view of the cemetery from the street and possibly prevent further acts of vandalism.

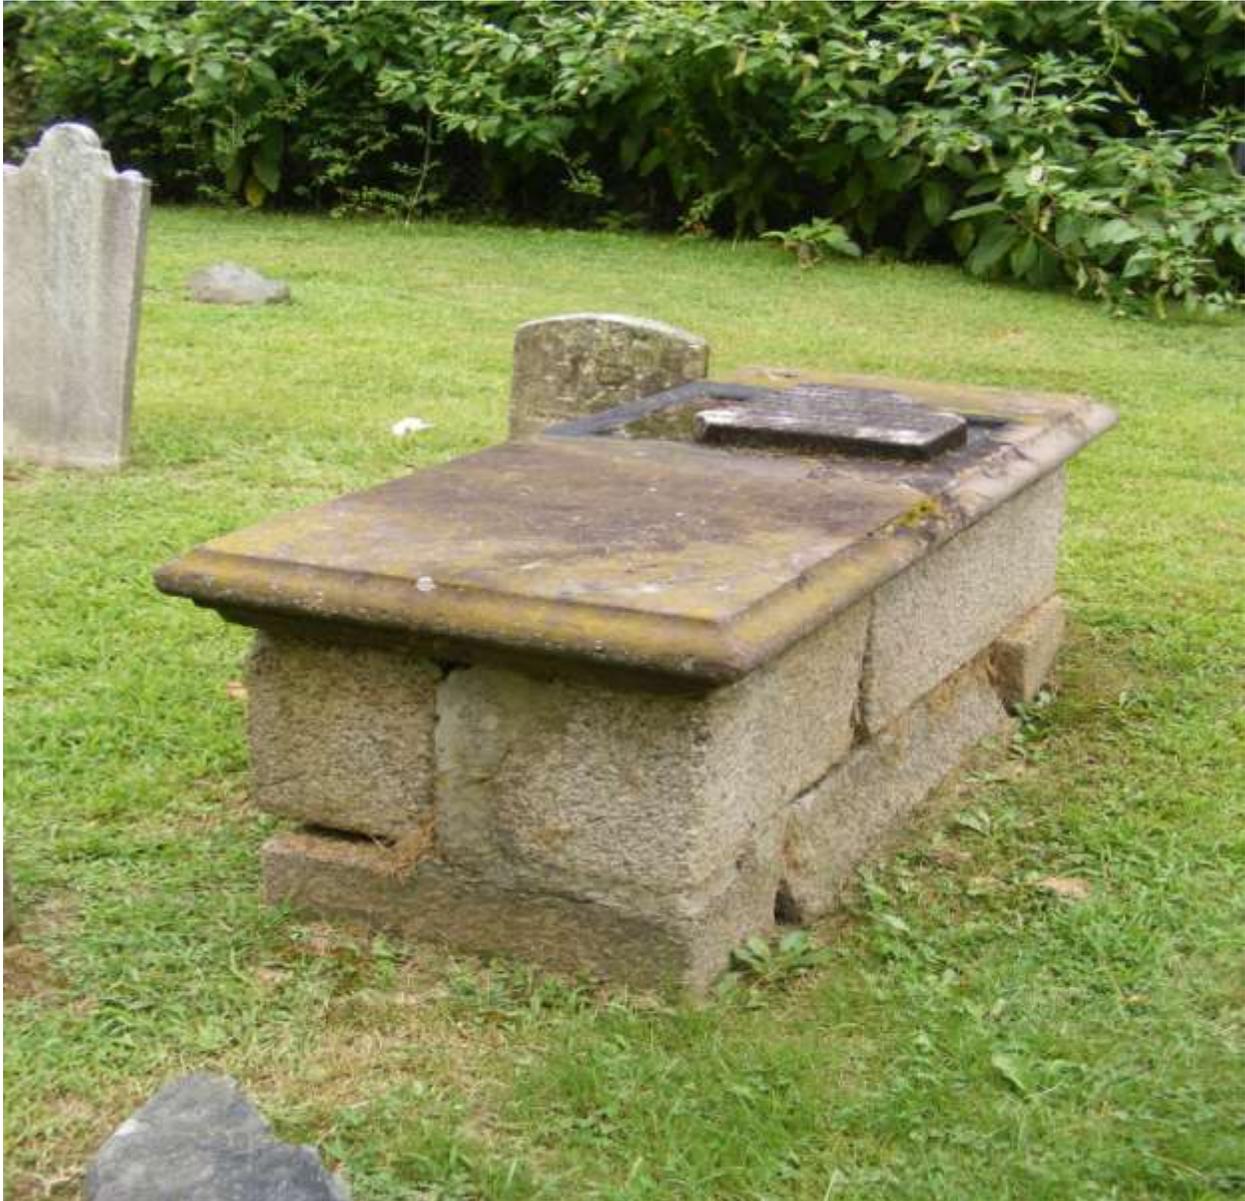
Pleasant Street Burial Ground - Tombs and Gravestones: There are two existing hill tombs and one brownstone chest tomb in the Pleasant Street Burial Ground. The early 19th century **Barrell Chest Tomb** closely matched the design and construction of the North Cemetery chest tombs. There were a number of late 18th and early 19th century stone carving shops located near the historic brownstone quarries in southern Connecticut who custom made these tomb components. Eight hammer finished brown granite chest stones provided a solid support stone platform for the carved brownstone inscription slab.

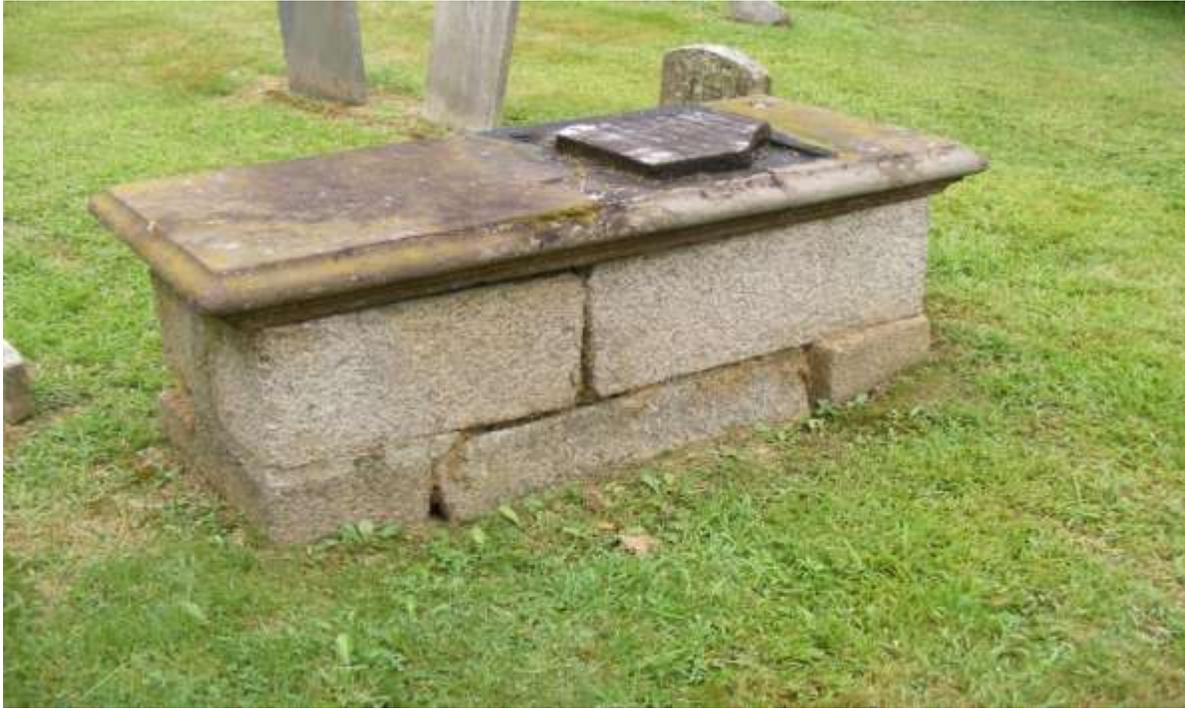
Pleasant Street Burial Ground - Tombs and Gravestones: These granite blocks were originally assembled without mortar but the tomb was badly re-pointed with a modern mortar at some point. These stones have settled and shifted over the years but the tomb is still intact and stable.

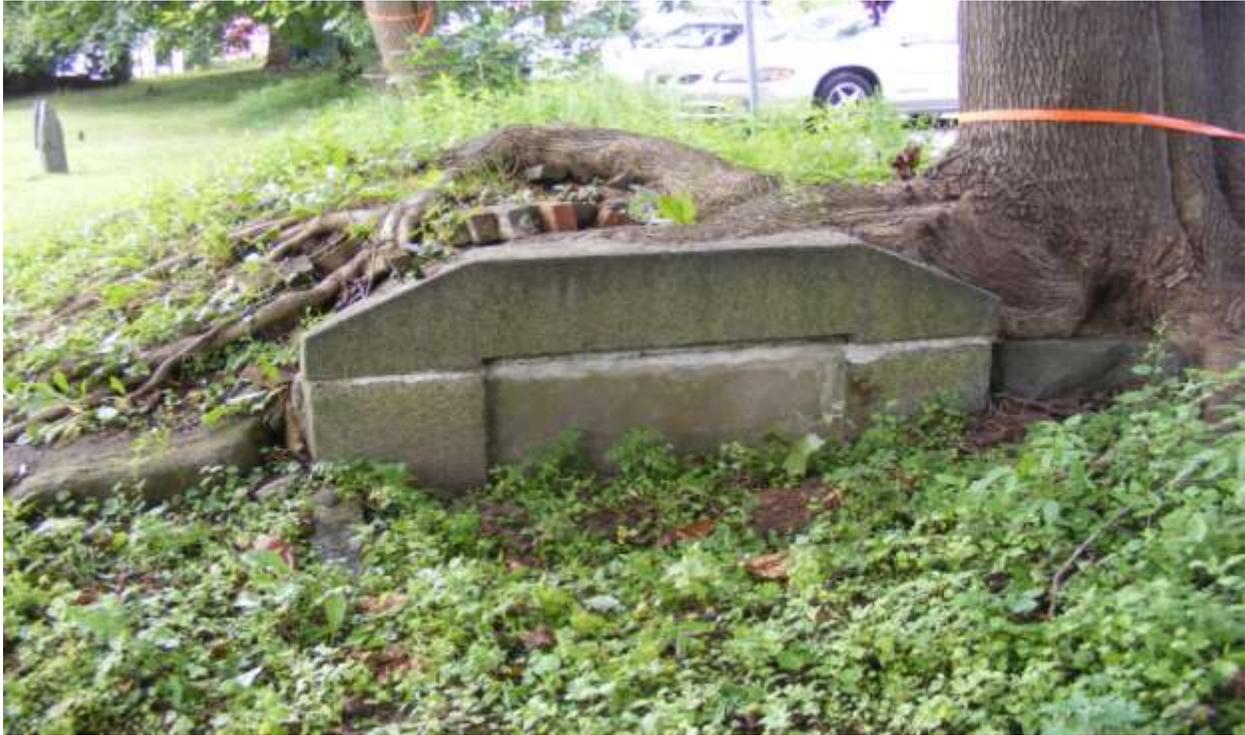
Pleasant Street Burial Ground - Tombs and Gravestones: Buried under the roots of one of the trees that line the burial ground's eastern border are the ruins of a small granite hill tomb. The top of a brick burial vault can be viewed among the roots.

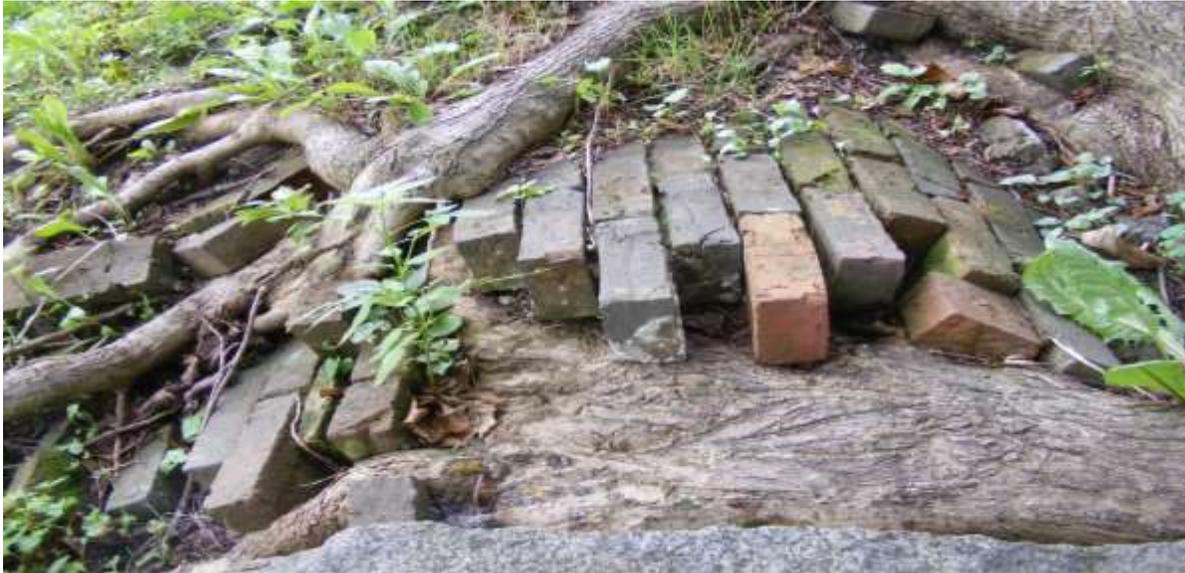
Pleasant Street Burial Ground - Tombs and Gravestones: The brick vault appeared to have been completely deteriorated and broken apart by the tree as it grew up alongside the tomb

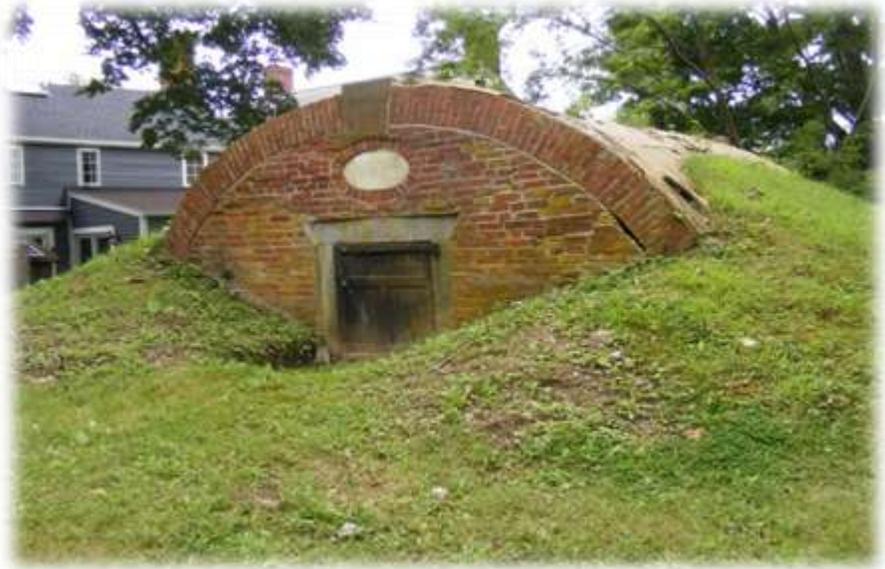
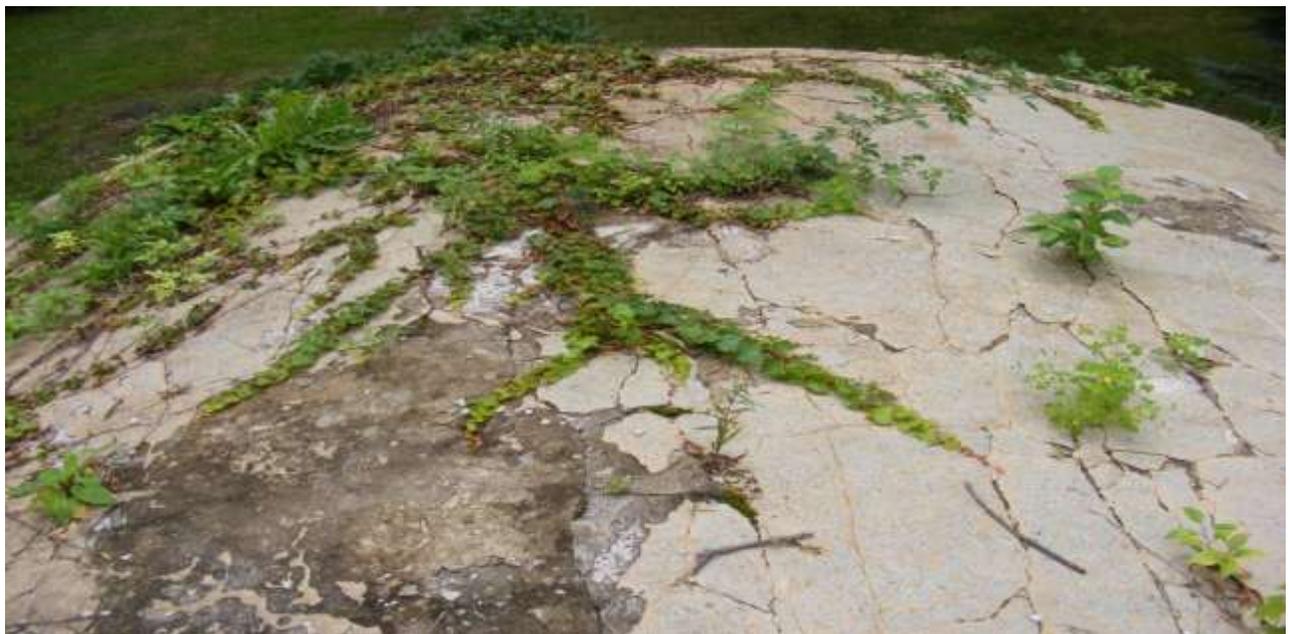
The existing barrel vaulted tomb was also unusual because it lacked a stone facade. The existing tomb appeared to be intact and stable despite the poor condition of its exterior surface. This tomb had suffered from water infiltration for most of its existence. The brick vault had been extensively

altered and repaired over the last 75 years. The tomb's original covering of lime mortar mixed with clay has long since weathered away and was replaced with multiple layers of cement based mortars. The last covering was applied less than a decade ago. All of these repairs have failed.

The initial removal of soil from the sides of this tomb should be done under the supervision of the state archaeologist. It is recommended that the existing brick front entrance wall be carefully dismantled to expose the original entrance wall behind it. Care should be taken when removing the original doorway stones, the iron door and the two inscription stones from the outer wall. These will be used to restore the tomb's end wall in its original position. The opposite end wall should be left intact and repaired. All the removed bricks should be sorted and re used if they match the tomb's original bricks. All the layers of deteriorated mortar should be carefully removed from the top of the brick burial vault. The exposed brickwork should then be cleaned and re pointed with a hydraulic lime mortar. Care should be taken during this work not to damage the structural integrity of the vault. After the exterior brickwork has been repaired and allowed to cure, the top of the vault should be covered with two coats of a mortar made from lime and Rosendale Cement. This repair mortar will be more weather resistant than a pure lime mortar but does not have as high a compressive strength as a Portland cement based mortars that were present on the vault. The plastered vault should be covered with canvas tarps and kept damp for a few weeks while it cures.

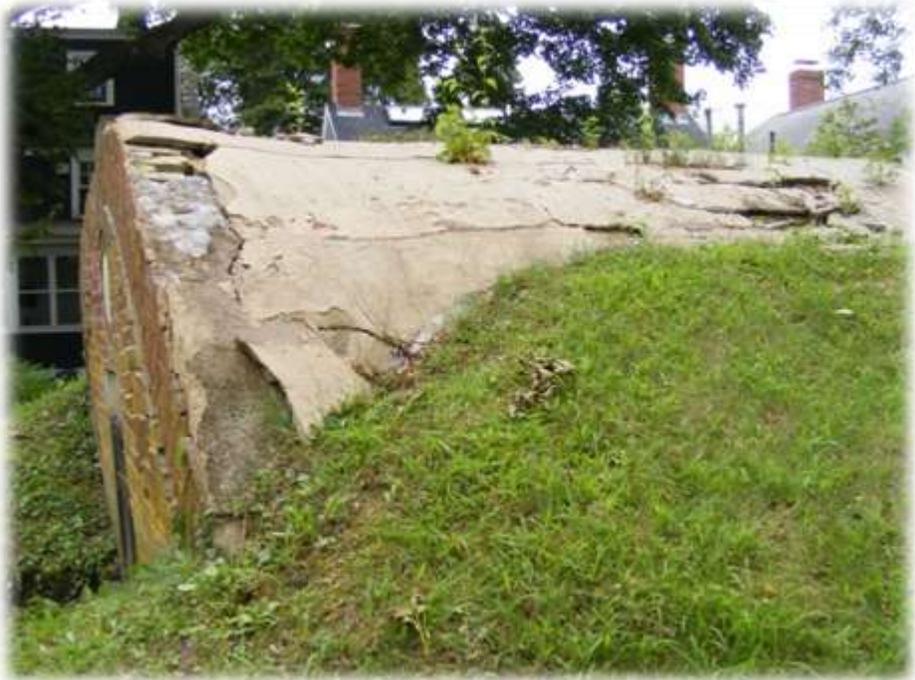
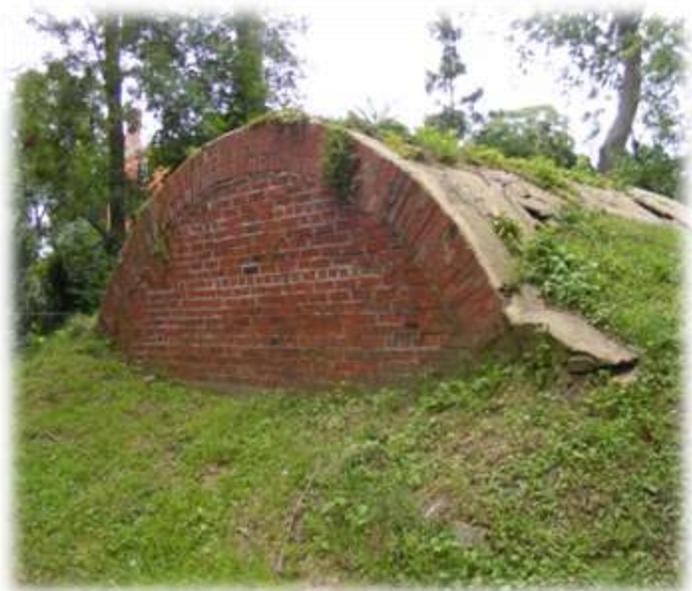
The vault's end walls were completely rebuilt using a mix of recycled and modern

bricks. The main entrance to the tomb has been completely reconstructed. The existing granite door frame, the old iron door, the brownstone date stone and the marble inscription stone had all been salvaged from the earlier deteriorated brick wall which is still there behind the rebuilt entrance wall. The reconstructed brickwork was not built on the tomb's original foundation. This lack of support and physical connection to the older masonry structure has allowed the newer brick wall to settle and lean away from the rest of the tomb. This gradual failure has caused a three to four inch wide gap between the back of the rebuilt wall and the tomb to open up. This has increased the already large amount of water infiltration into the tomb. The rear wall of the tomb was also dismantled and rebuilt but this wall aside from some deteriorated mortar joints appeared to be intact and stable.

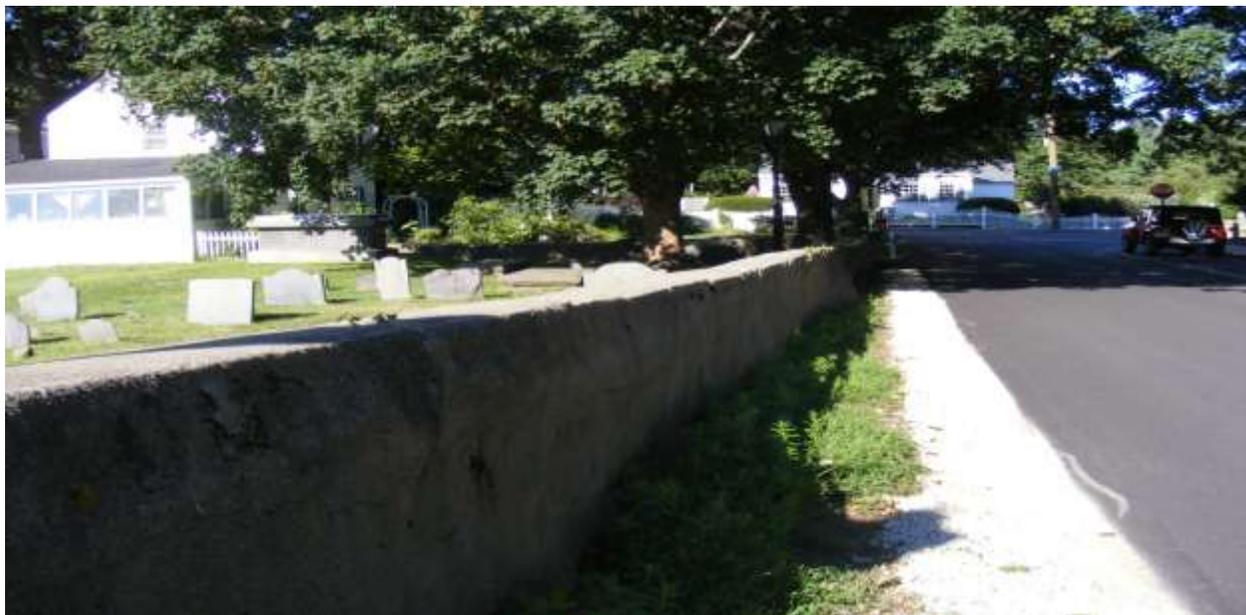
The most recent attempt to stabilize the wall took place over twenty years ago when the entire wall was covered with a sprayed on concrete. This rigid Concrete skin developed many cracks over the years and accelerated the deterioration of the old wall by trapping moisture inside the brick and stonework. The concrete skin's interior surface has lost its bond to the exterior of the old wall. There have been more recent attempts to seal the cracked concrete skin with a pre-mix masonry cement but these repairs have also failed. The early 20th

century reconstruction of the upper wall utilized red water struck bricks and Portland cement based mortar. The existing brickwork appeared to be in very poor condition. The type of "restoration" brick used here first became popular during the Colonial Revival Era and is still produced today by the Morin brickyard in southern Maine. A basic mortar analysis revealed the existing brick mortar to be a mix of sand, lime and Portland cement, (6 parts sand to one part lime and one part Portland cement). This mix was a traditional early 20th century brick mortar recipe.

The repair cost estimate to document, dismantle and rebuild the wall with the replacement of the existing concrete capstones with granite slabs is \$108,600.00. This estimate includes the in kind replacement bricks, all the other materials, (granite, sand and hydraulic lime), police detail, excavation costs and labor.

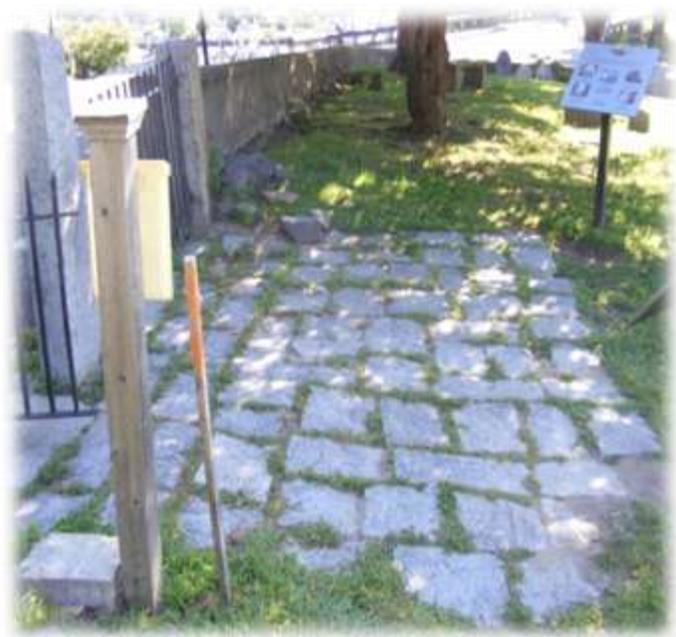
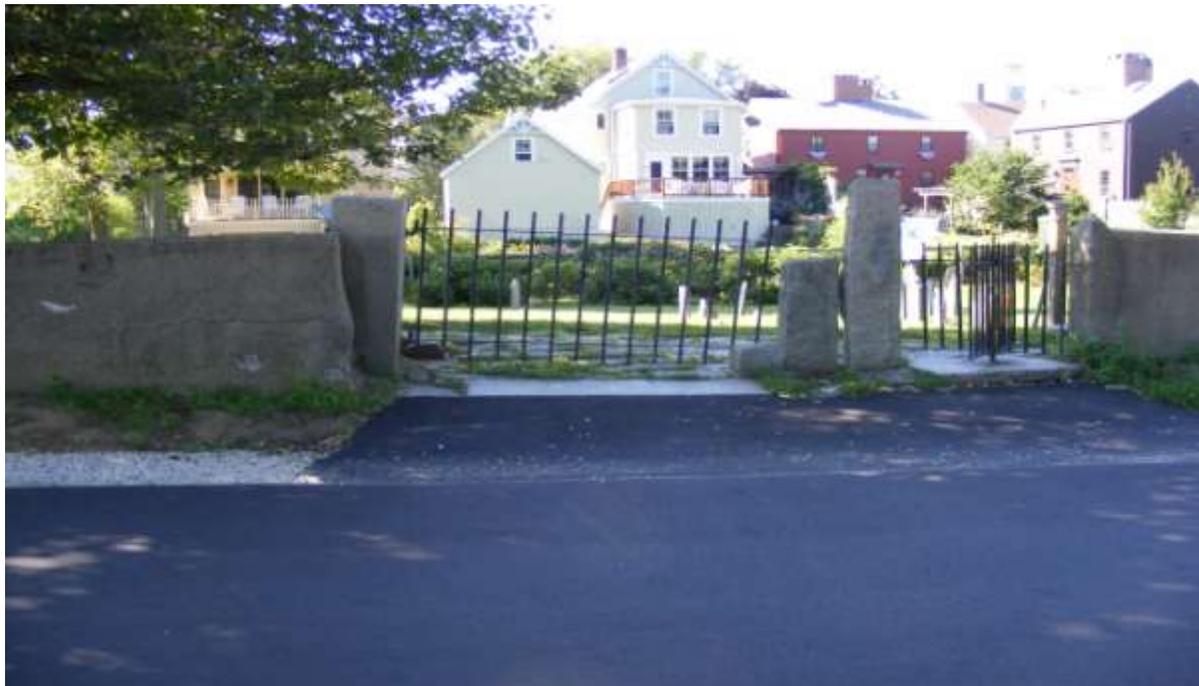
Wall: The existing entrance to the burial ground was located at the center of the perimeter wall facing Prescott Park. It was created by infilling a larger earlier entrance with four mismatched granite pillars, a short section of wrought iron fence and a wrought iron turnstile. This work appeared to have been installed during the late 19th century. The smooth granite landing stones in front of the gate and the cobble stone terrace located just inside the gate appear to be modern additions to this old burial ground. The nearby granite seat also is a recent installation although the granite slab looks old. It has an interesting set of random lines cut into its surface.

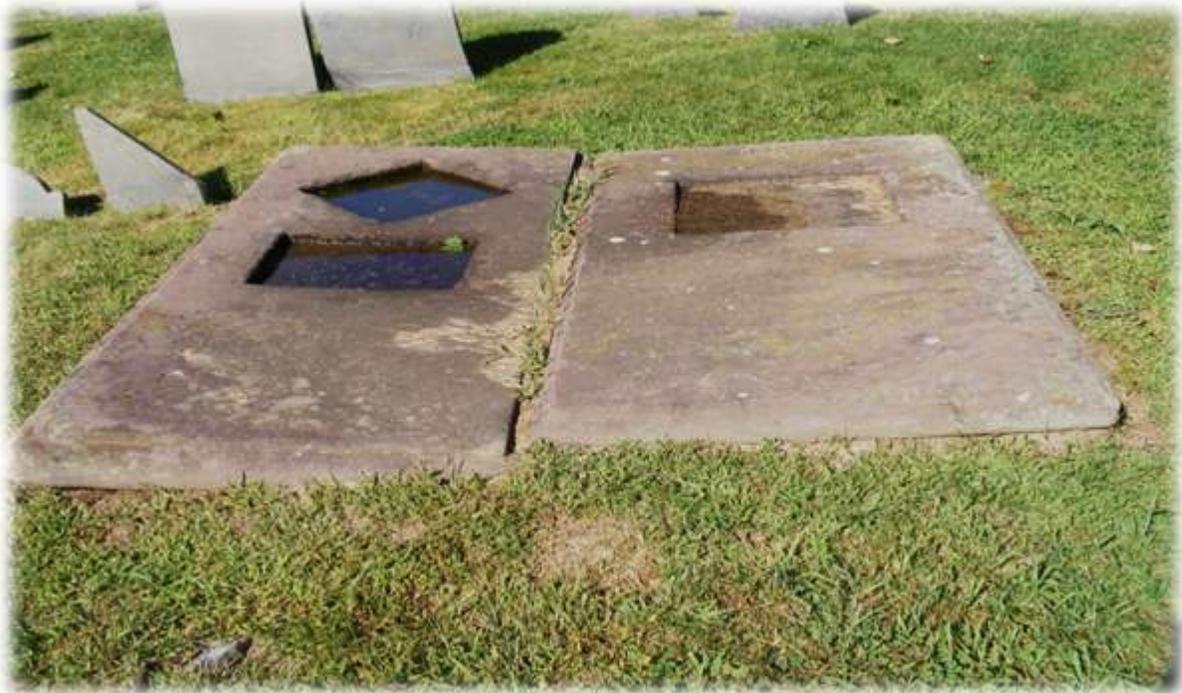
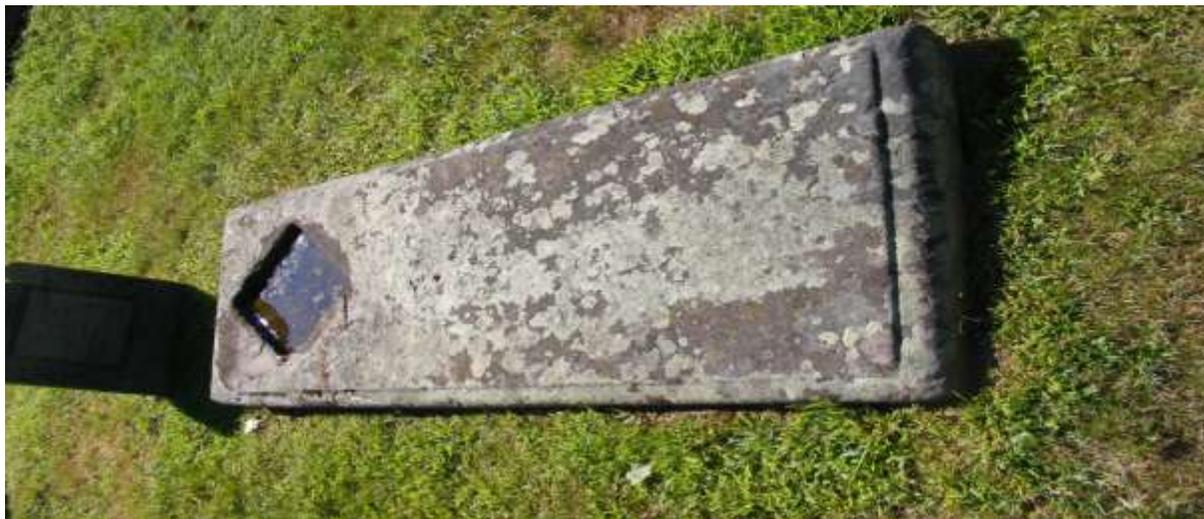
Brownstone Ledger Tombs: Four of the brownstone ledger tombs sit directly on the ground. Their inscription stones which were originally inset into the top of tombs have been removed. These small tablets were probably made of marble or slate. The ledger tombs are heavily incrustated with lichen growth and one of them is missing the lower portion of its slab. All of the brownstone slabs are badly weathered and have significant surface loss.

The four brownstone ledger tombs need a fairly simple repair to slow down their deterioration. The missing inscription stones should be replaced with an appropriate material to prevent the retention of rainwater in these pockets.

The best stone to use would be brownstone which can still be found in demolition and architectural salvage yards throughout New England. There are no working brownstone quarries left in the US. I recently found a large block of Connecticut brownstone. It is a simple procedure to cut and fit pieces of thin brownstone and then install them into the inscription stone pockets using a hydraulic lime mortar, (St. Astier from Limeworks or Virginia Lime). It is important not to use a much harder stone like granite and a modern Portland cement based mortar. These materials have a higher compressive strength than the brownstone and the lime mortar and would eventually accelerate the deterioration of the tombs. The repair cost estimate to seal the inscription pockets on these four tombs is \$1800.00
