John Wastrom – Masonry Consultant

Existing Conditions Assessment Report and Restoration Plan

Historic Burial Grounds and Cemeteries –
Portsmouth, NH

David Moore
Community Development Director
City of Portsmouth
10/25/13

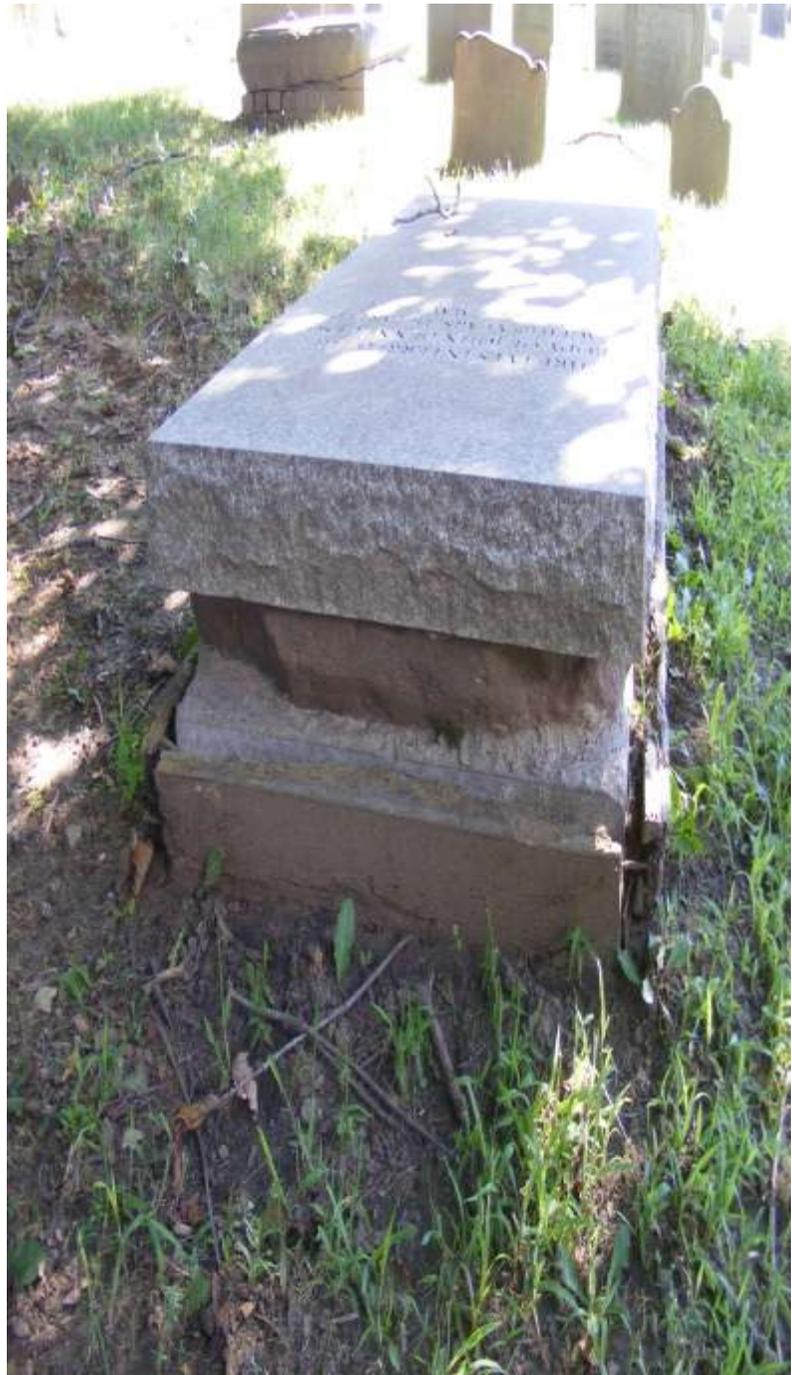
The adjacent brownstone **John Dennet, (d.1700) ledger tomb**, was extensively altered in 2000. The original brownstone slab was removed and rectangular wooden form was installed. This form was used to seal the top of the burial enclosure with concrete. The old slab was then reinstalled in the wet concrete and a new inscribed polished granite slab was placed on top of the older stone. The wooden form was never removed and has almost completely deteriorated, exposing the concrete infill. The weight of the granite slab has crushed the old brownstone tomb underneath it.

The repair cost estimate for this tomb is \$1000.00. There is not much that can be done to undo the inappropriate repairs of the John Dennet tomb except to remove the deteriorated wood from its concrete base.

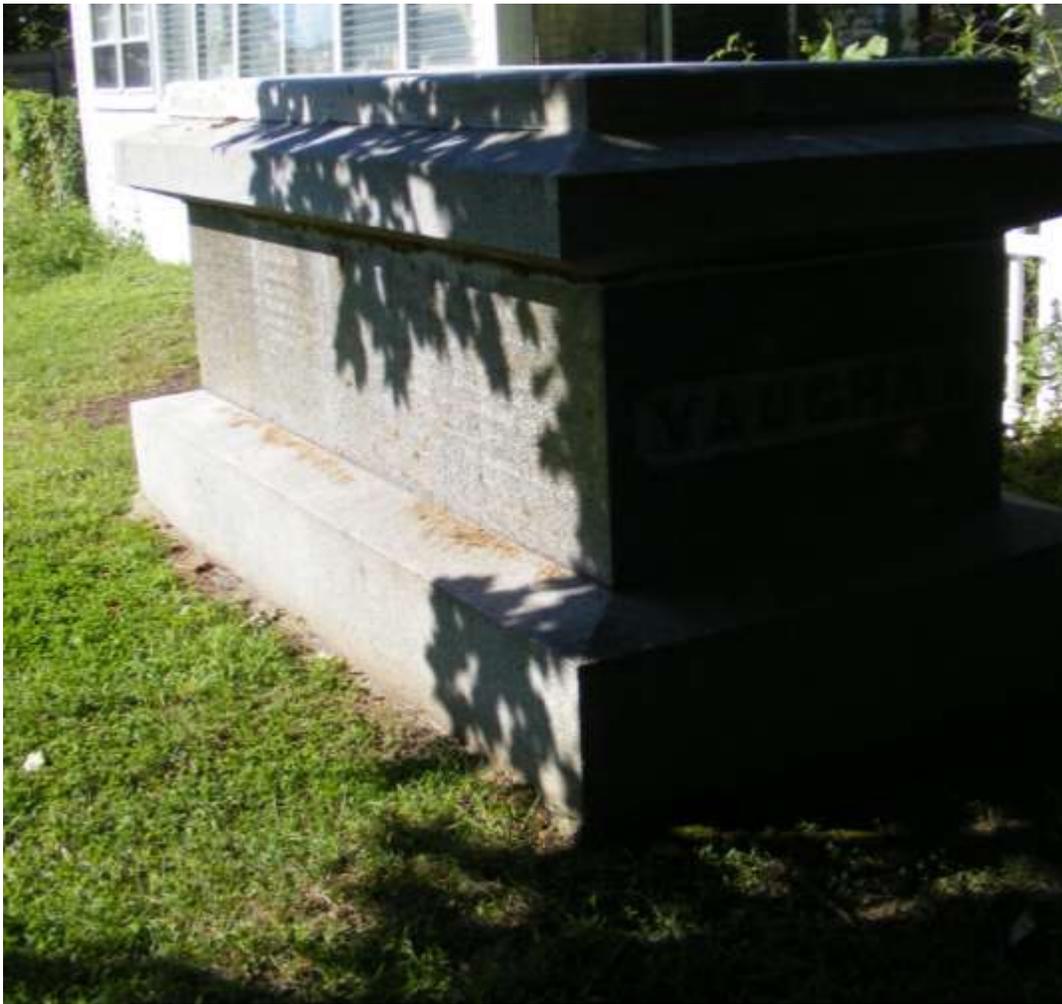
Mechanics Street: The **Vaughn Tomb** is the most elaborate gravesite in this old burial ground. The granite and marble chest tomb, located at the southern end of the Point of Graves was a 19th century re interment of a 17th century burial. It was not unusual for 19th century families to upgrade their ancestor's gravestones or burial sites. These chest tombs had interior brick walls which provided additional support and an anchoring point for the exterior stonework... The tomb's base and wall stones were granite which is very durable while the inscription slab was a thick piece of white marble which is very vulnerable to weathering. Although the lettering is still very clear, this stone is badly cracked and is allowing water infiltration into the interior of the tomb.

The cracked marble inscription slab on top of the Mary Vaughn box tomb should be repaired before the ongoing water infiltration into the tomb further affects the stability of the stones. This repair should be carried out using a mortar that is compatible with the softer marble but is still resistant to weathering., Epoxy adhesives even when mixed with an aggregate to create a mortar will not work in this situation. These products will cause moisture buildup within the marble slab especially in the repaired areas and will eventually fail and also accelerate the deterioration of the stone

I have recently started to work with a hydraulic lime based proprietary mortar created by the Limeworks Company called Lithomix. This weather resistant mortar can be thickened with marble dust and then used to fill the cracks in the tomb's horizontal inscription slab. Another traditional material, water-glass, (calcium silicate) can be used to strengthen the exposed broken edges of the slab before they are re-pointed. The repair cost estimate to re point the cracked marble slab with the Lithomix mortar is \$2700.00.

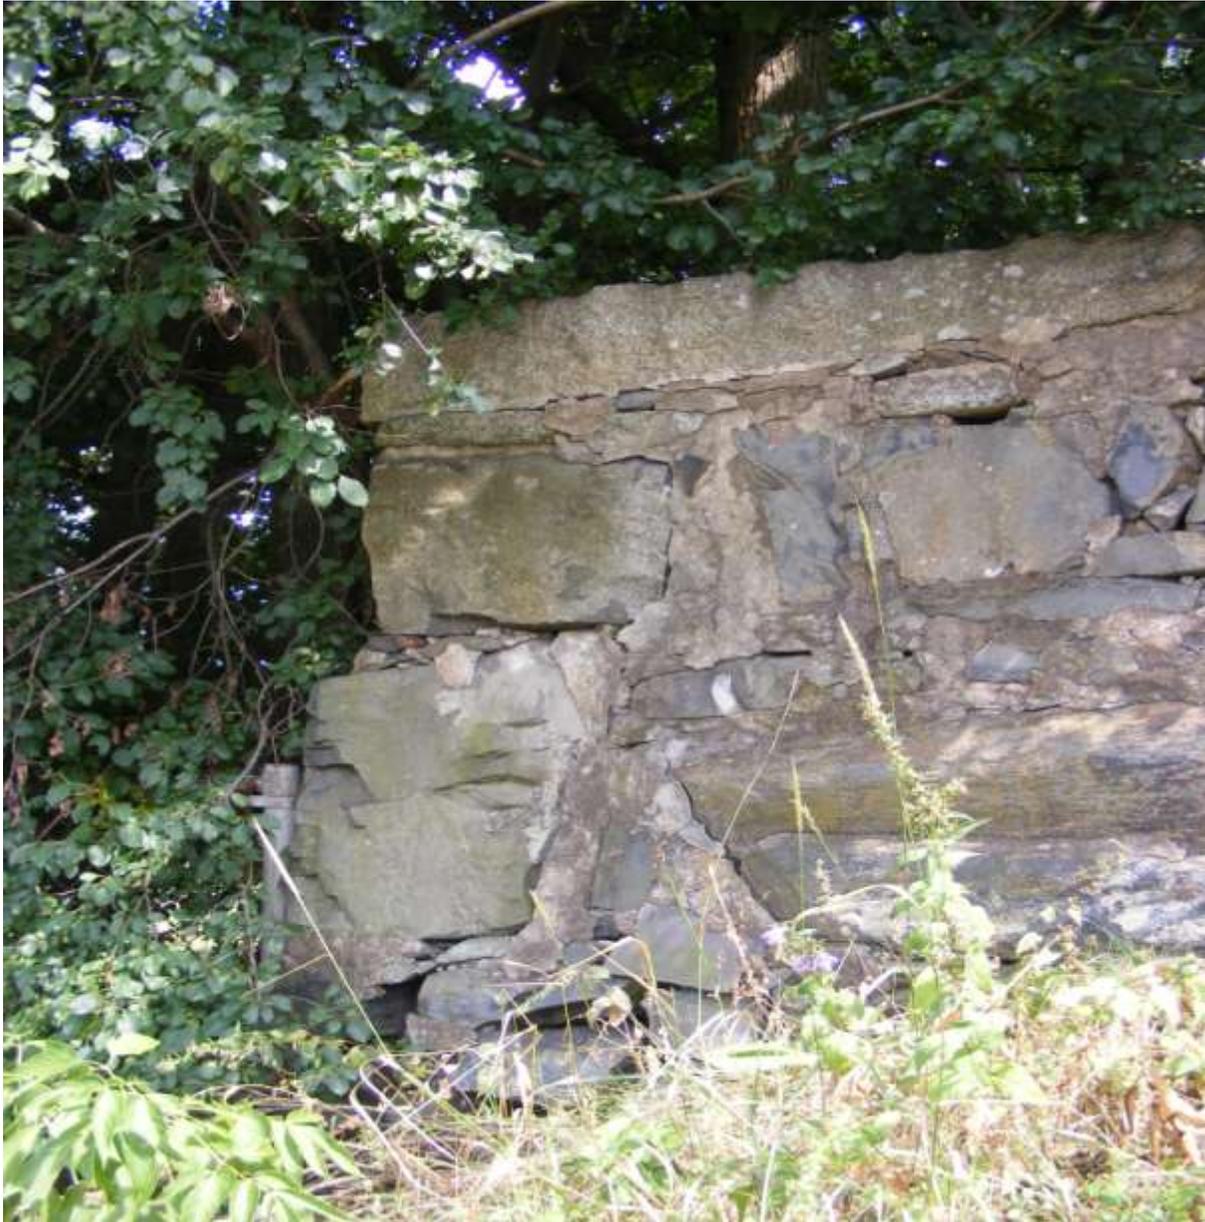
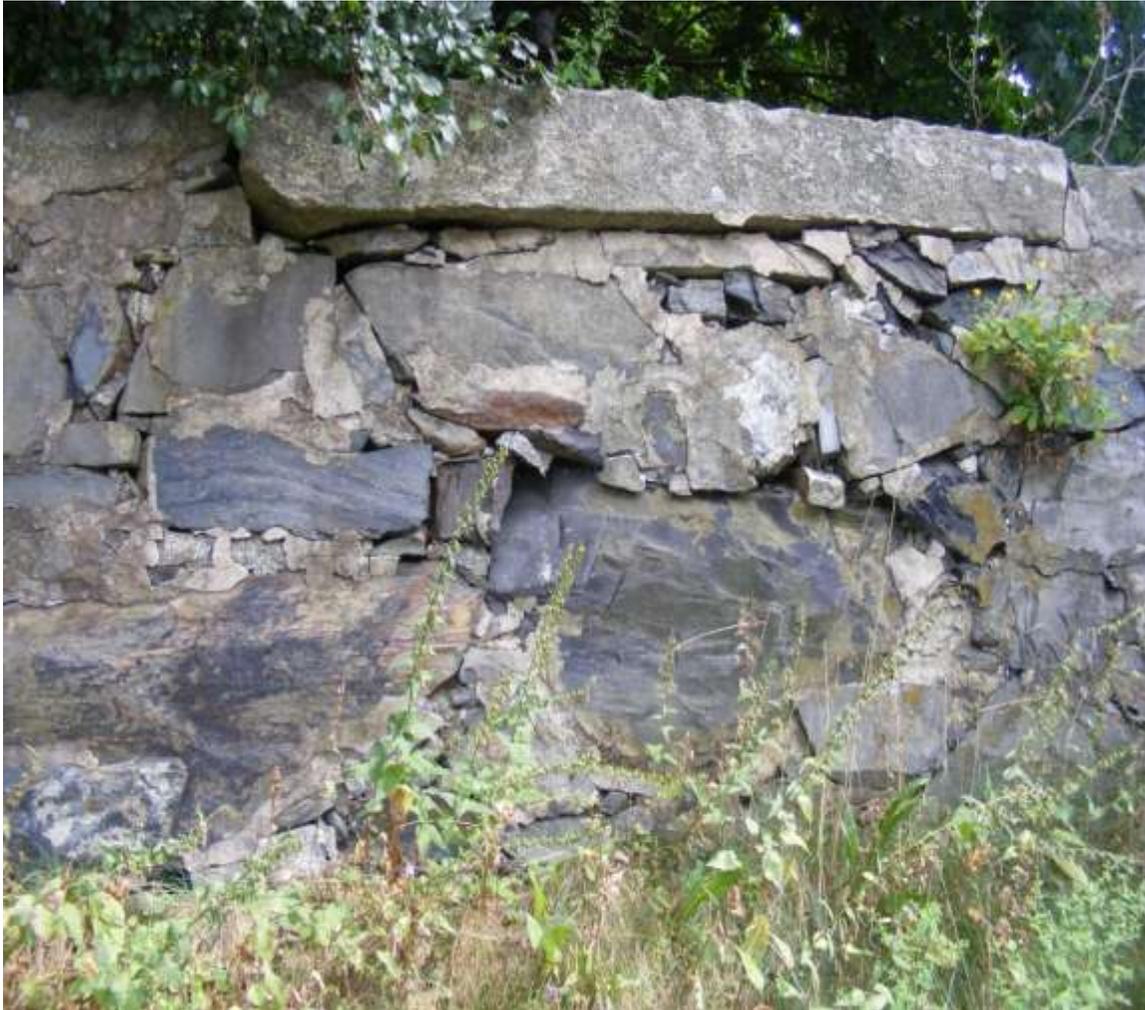
The wall is capped with rectangular 12 inch thick split granite slabs which averaged four to six feet in length. The 19th century stonemasons built this section of the wall near the top of the hillside. This stonework is in poor condition. The subsidence of the burial ground behind the wall has shifted the wall outward. This displacement allowed water infiltration into the wall's interior masonry which in turn deteriorated the stonework's bed mortar. Most of the stones in this wall have lost their bonding. There is a bulge in the wall near the NW corner which has shifted one of the large capstones out over the hillside. A collapse in this area would roll the capstone onto South Street. The Cotton Cemetery wall has been re pointed and repaired many times since its original construction. The repair mortars on the exterior of this wall represent at least three different types of early cements including a 19th century variant of hydraulic lime known as Rosendale cement.

The retaining wall on the South Street side of the Cotton Cemetery will need to be repaired but this project should not take place until the enclosure walls at the North and Union Cemeteries are restored.

This repair will be difficult. This retaining wall cannot be dismantled because there are burials directly behind the wall. State Laws prohibit the disturbance of any gravesite especially in an organized graveyard. The wall should be repaired in place by carefully removing all the failed repair mortars and then re pointing the wall with a mix of lime and Rosendale cement.

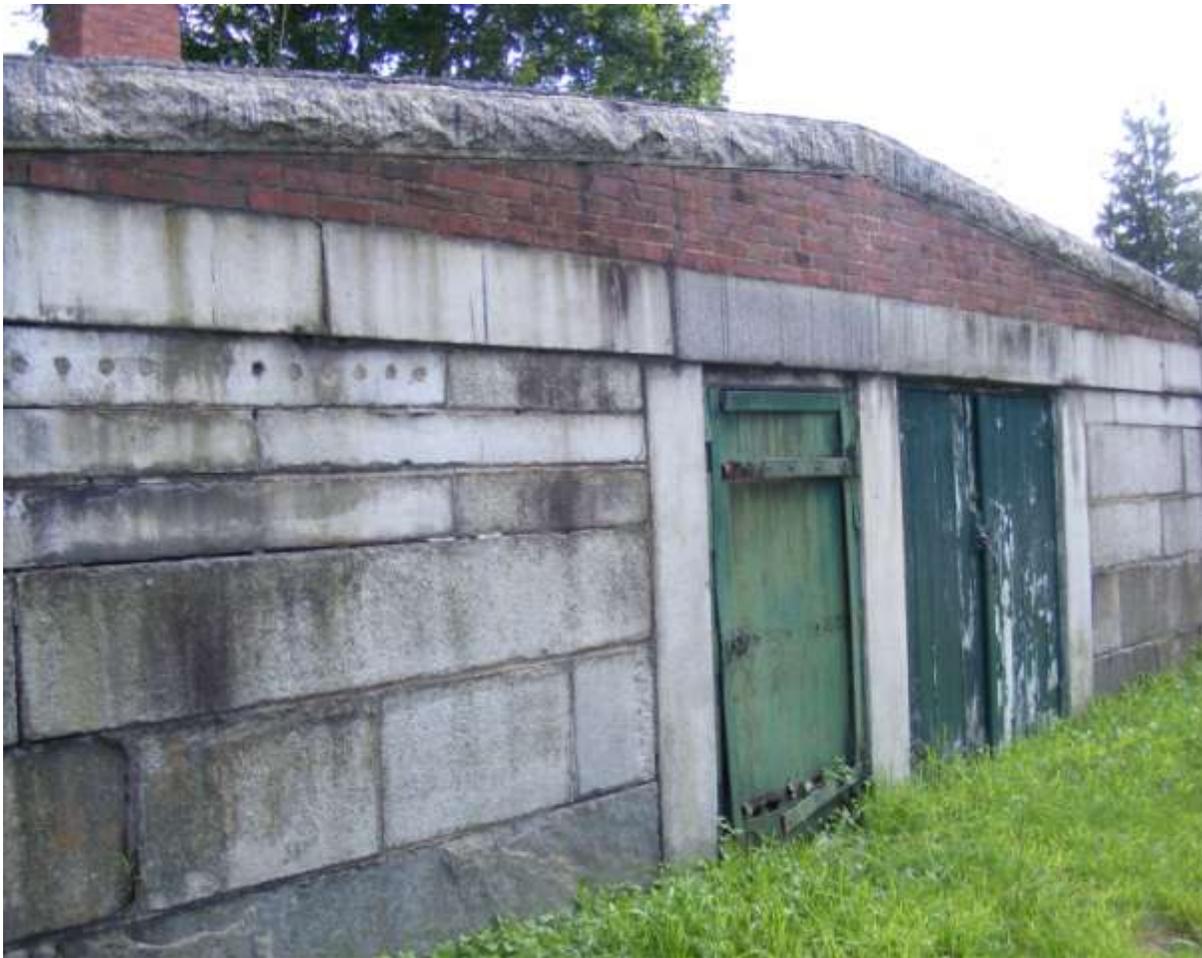
The other building was a crematorium. Its facade was constructed with a mix of different sized granite blocks. The granite wall was crowned by a pediment of red water struck bricks and rusticated granite. It is unclear what material was used to roof this structure because it is now covered with a thick layer of roofing tar. There was an existing brick single flue chimney located at the back of the building. It measured five feet in height above the roofline. It was capped with a metal cover. This mid-19th century structure appeared to be intact although the condition of the roof should be investigated further. There was a significant amount of plant growth on the roof and the flashing between the two buildings has completely deteriorated. The iron door to the crematorium was in poor condition. Its strap hinges have separated from the door panel. The chimney stack was in fair condition above the roofline. Unfortunately we could not get access to the interiors of these buildings.

The only other repair needed in the Cotton cemetery is to re -point the crematorium building's brick chimney. Hydraulic lime should be used for this repair since the existing chimney bricks are soft. The cost estimate for this repair is \$1200.00.

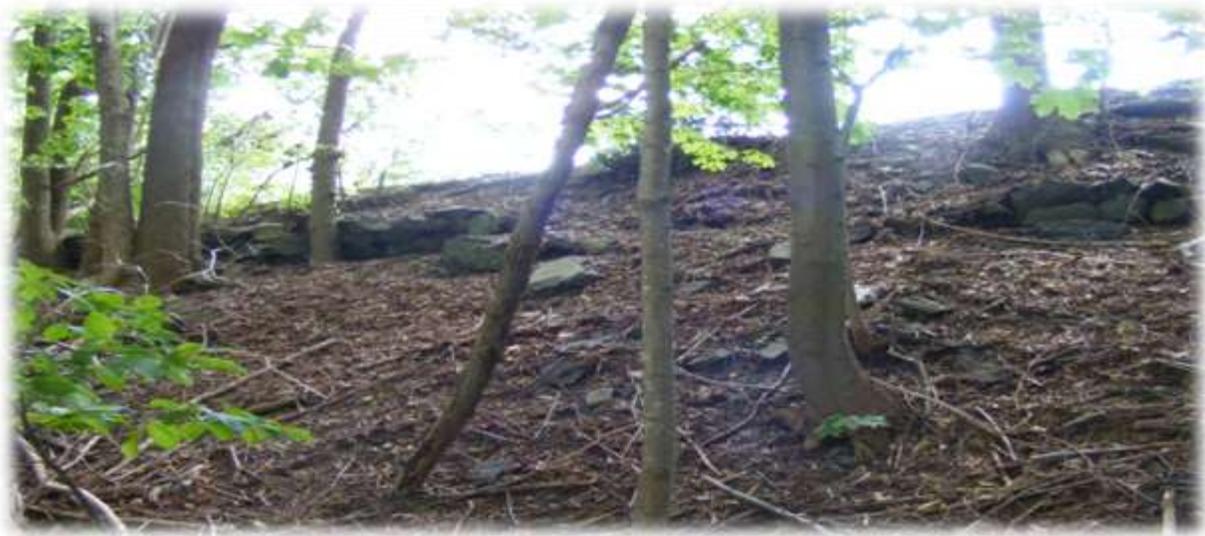
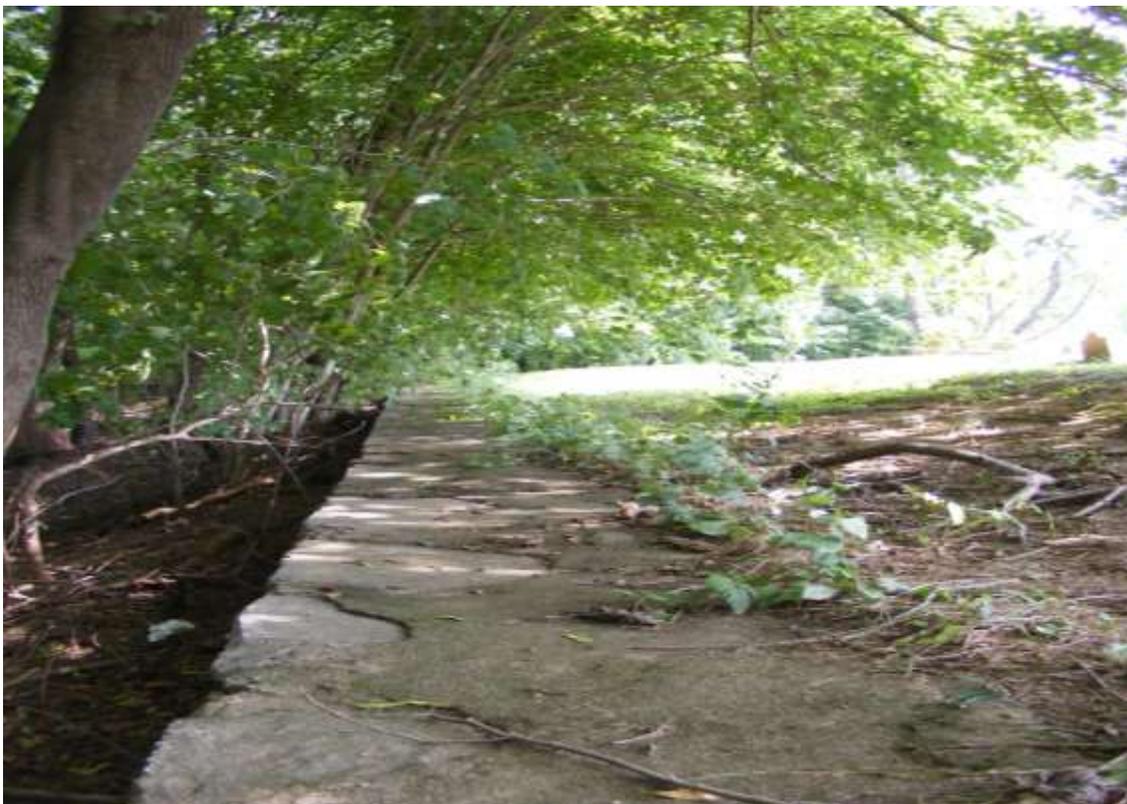
Beyond the early 19th century part of the wall there was a long section of dry laid stonework that had almost completely collapsed and fallen down the hillside. This low stonewall may have been part of an earlier enclosure wall. At the far end of this side of the cemetery, a low modern freestanding wall was constructed composed of granite blocks and Portland cement based mortar.
