Re: Stephen H. Roberts, Trustee, The ADL 325 Little Harbor Road Trust,
Owner/Applicant
325 Little Harbor Road
Tax Map 205, Lot 2
Rural (R) District
LU 21-220

Belle Island Barn

Existing Conditions Assessment (Part 1 of 2):

Conditions Assessment April 2018

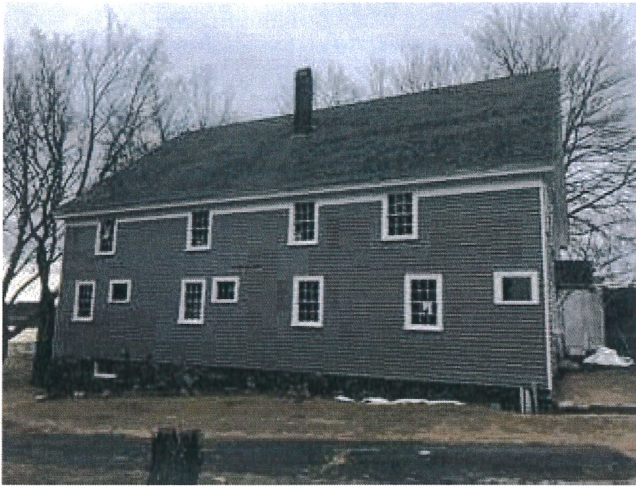
North Eave Wall:

An asphalt roof covers original rough board sheathing. The wide frieze board is interrupted by added windows. Clapboards protect vertical sheathing on the eave wall.

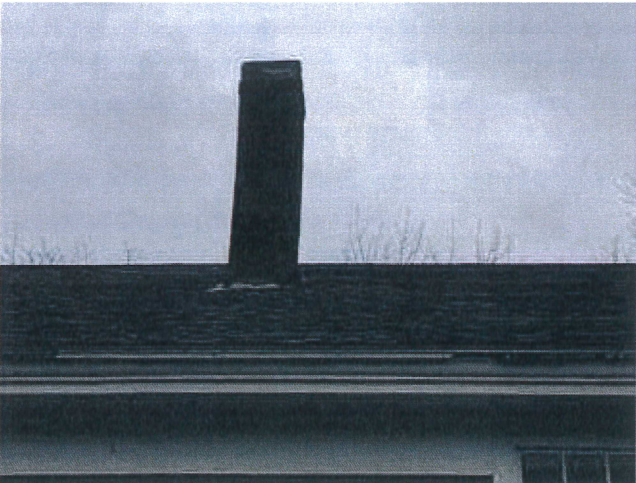
Chimney

A newer chimney rises from the barn roof. It is not original.

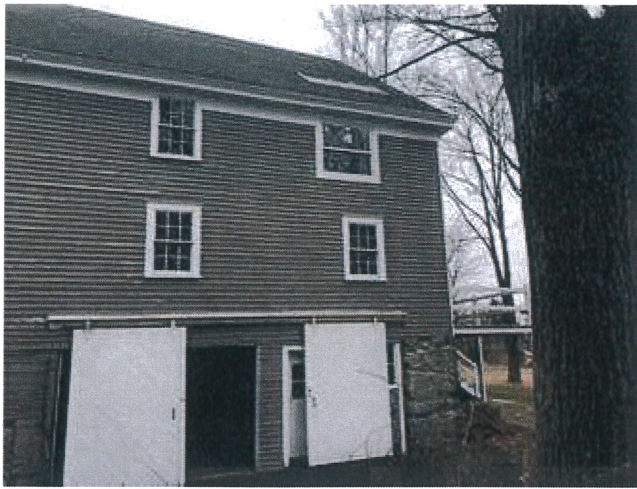
South Eave Wall:

A recent roof patch keeps water from the barn. Tree branches were impacting the roof covering. Windows are of many varieties and not original to the barn.

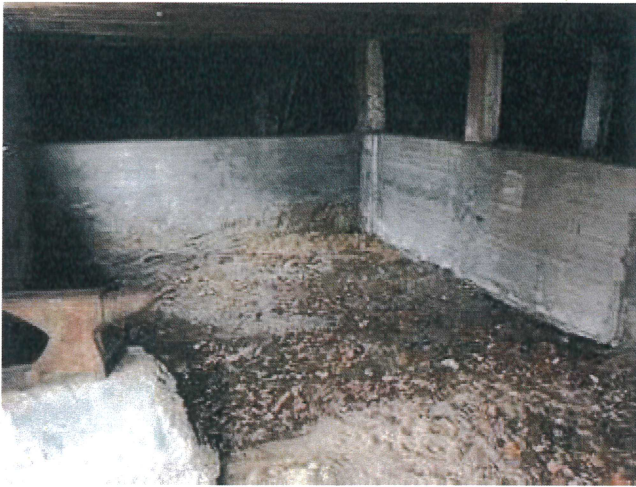
Concrete Corral:

A good woodchuck hole undermines the inside corner of the concrete corral. The concrete is not structural and can be removed.

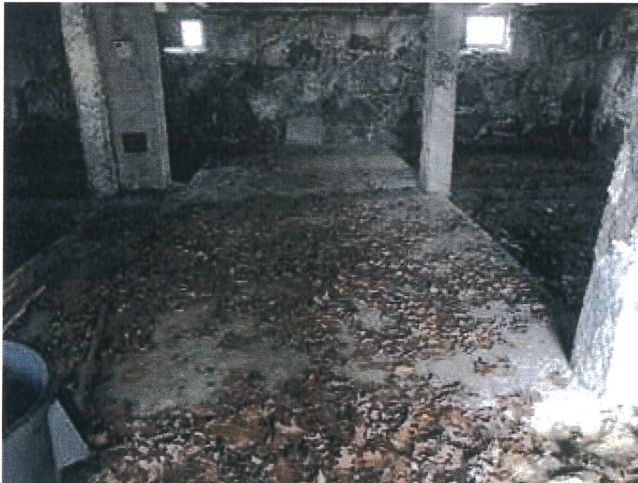
Cellar Slab:

Partial slabs should be removed and a new continuous slab poured in the basement.

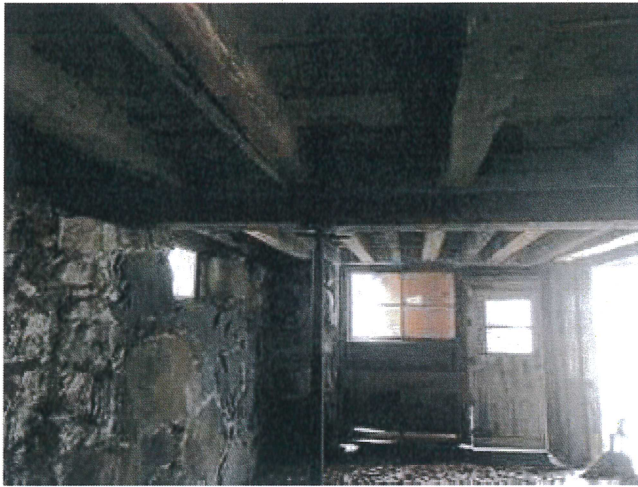
South Eave From Inside the Basement:

Strong corners and well built openings with post piers allow for access to the cellar. Some bays are studded in with doors and windows. This work is newer and of poor quality.

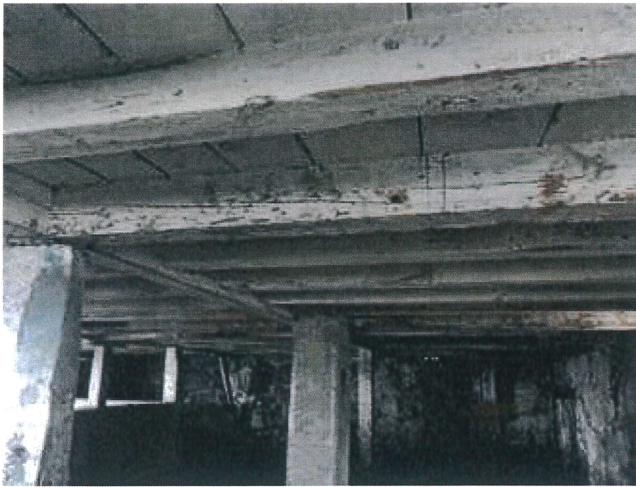
Whitewashed Joists:

A lime wash coats the undercarriage of the barn. Likely for animal sanitation, the lime wash protects the beams from insects and indicates areas where animals were kept.

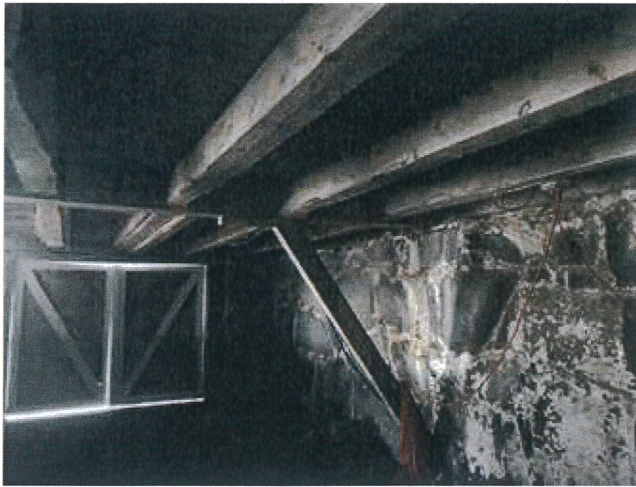
West Gable Sills:

The gable sills, bents 1 & 5, are rotten and will need to be replaced in kind. Carrying timber ends have also rotted where they meet the sills and new ends will need to be created to support the floor system. A large section of the South eave wall sill will also need to be replaced. Some of the floor system is whitewashed indicating animal husbandry in the basement level of the barn.

Some shoring is in place to hold up the rotten ends of the carrying timbers where they engage rotten sills along the West gable.

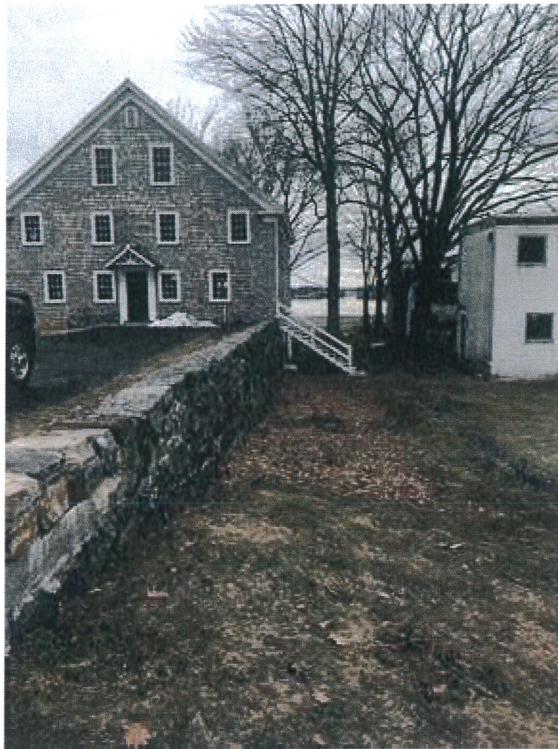
The View Scape:

The concrete buildings and tall trees shade the south wall of the barn. The buildings removed will much improve the view down to the water. Some trimming of the trees will protect and shade the barn roof.

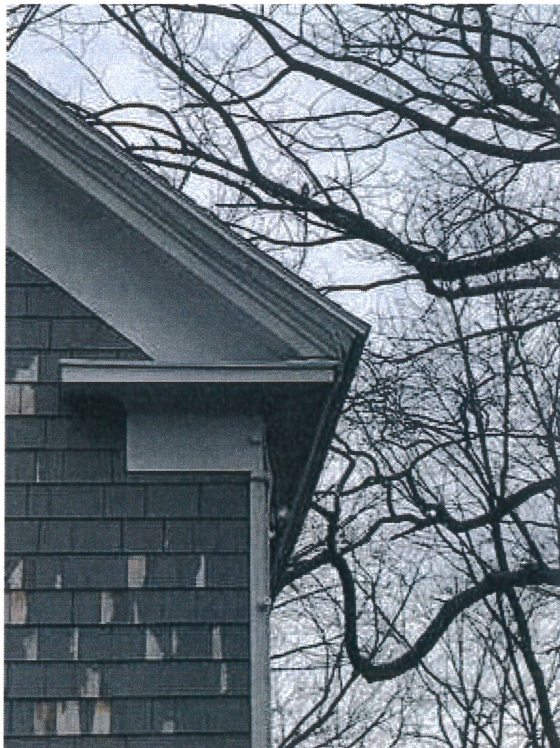
Cornice Trim and Return:

A high style trim detail exists on the barn. The common rafters overhang the top plate making the overhang possible. With exterior insulation this detail can be retained but the rafter tails would be modified to accommodate the enlargement of the envelope.

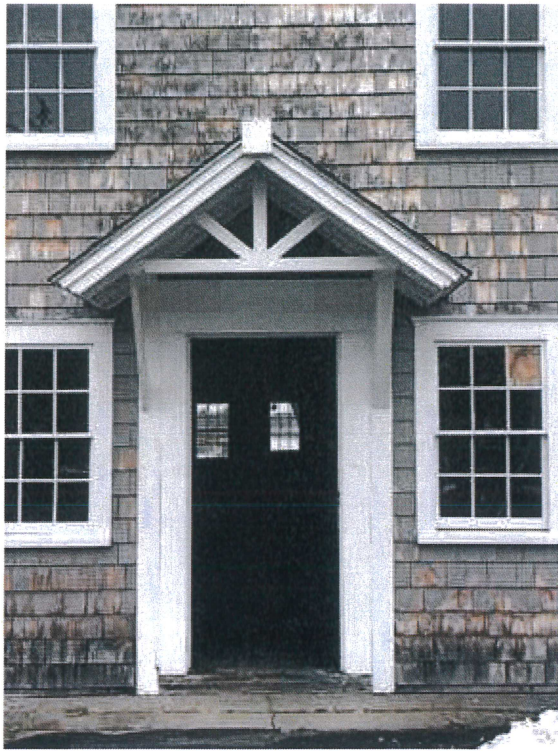
West Entry:

The West entry door while decorative is not original to the barn. Originally there was an interior pocket door to allow the center drive to be opened up at each end for wagons and hay. The framing for the interior door remains in place. Window placement is not original.

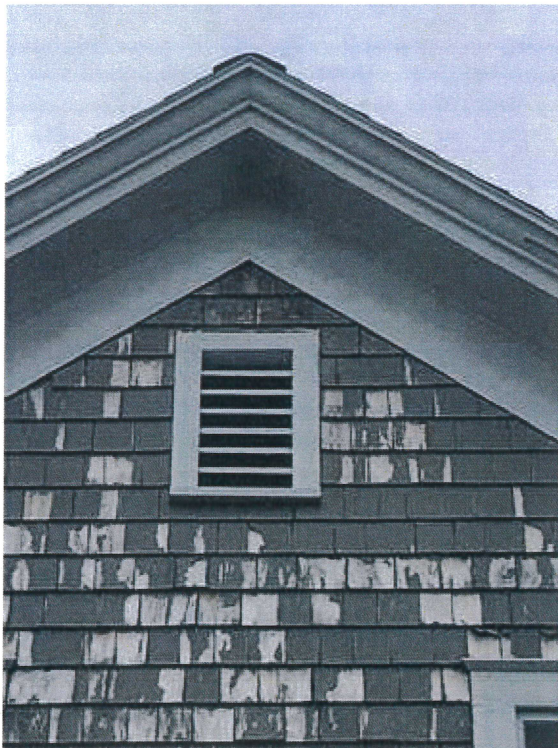
West Gable Peak:

A wide rake with crown molding terminates at the peak. This overhang protects the barn walls beneath. The vent is added and is not original.

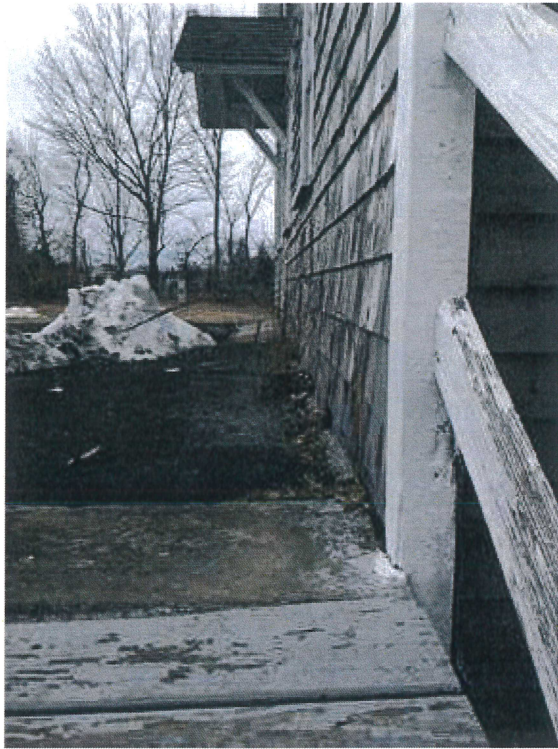
West Gable High Grade:

Asphalt pavement was poured right up over the shingles along the west gable end. This rots the shingles, sheathing and the sills buried below.

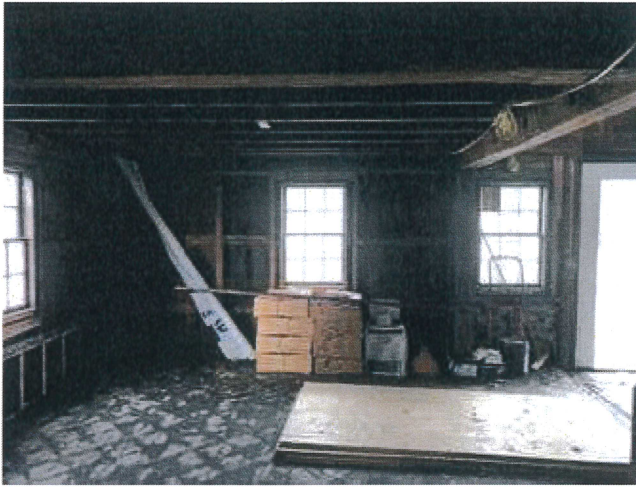
Looking West:

Asbestos flooring covers original wood decking on the first floor. Although the tiles have been removed, the mastic remains full of asbestos and must be disposed of properly.

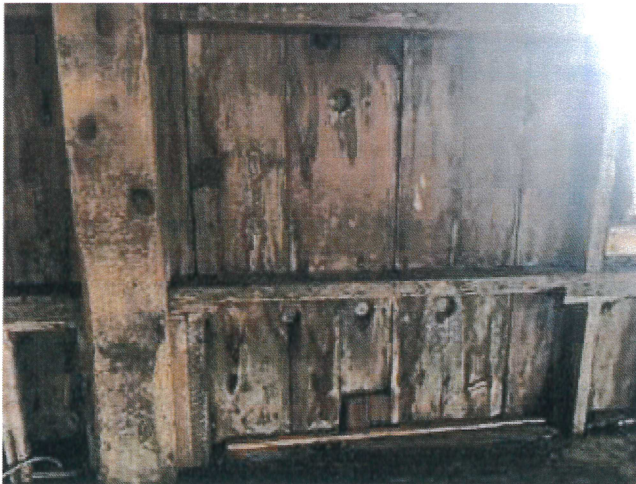
Exterior Sheathing:

The exterior sheathing is created with wide pine boards original to the frame. Unfortunately these boards were drilled with multiple two inch holes to direct blown in insulation into the wall cavities. Options for filling the holes and or replacing the boards in kind can be discussed.

PTF can repair and or replace the exterior sheathing on the barn. Due to the extensive drilling done to the exterior sheathing it is likely that much of the sheathing will need to be replaced in kind. We can obtain wide pine boards for this purpose once decisions have been made regarding the use of the existing sheathing in the re-design of the barn interior.

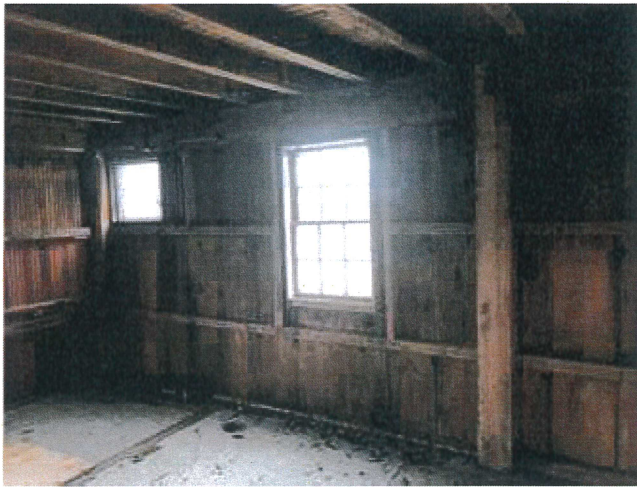
Looking North:

The north eave wall is almost fully intact save where new windows interrupt original wall nailers.

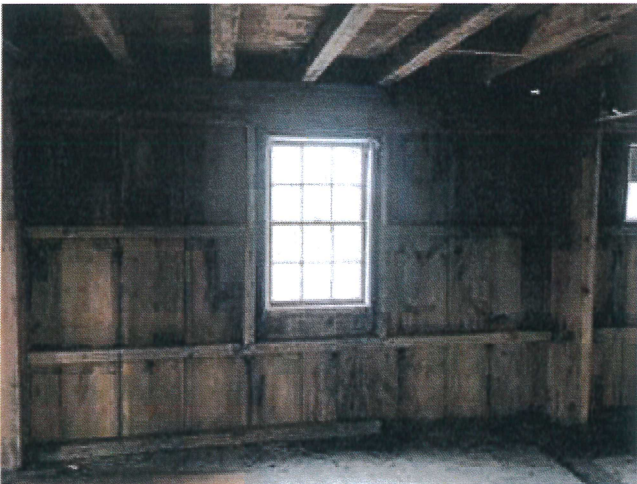
Loft Joists and Loft Decking:

A mix of older and new joists are decked with plywood patches at the second floor along the north loft. The joists are undersized and the plywood is not appropriate.

We will remove the third floor decking entirely to open up the barn from below. We will also remove the undersized loft joists and decking and replace both second floor lofts with age appropriate timbers and flooring that match the character of the barn while also creating code compliant living space.

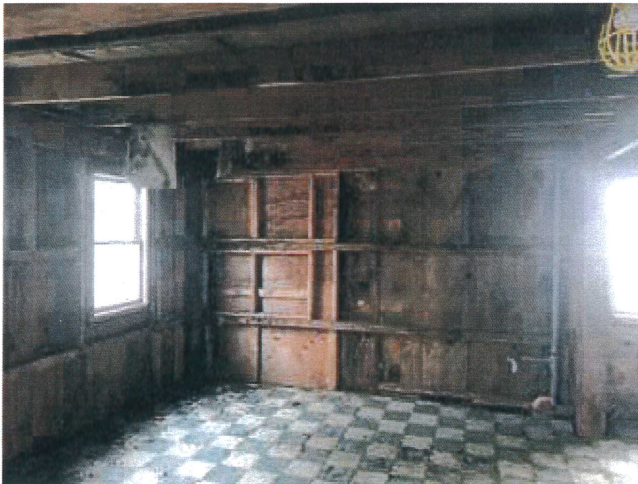
Looking East:

A plywood corner denotes decay in the exterior sheathing. There is evidence of considerable damage to the frame in the East gable.

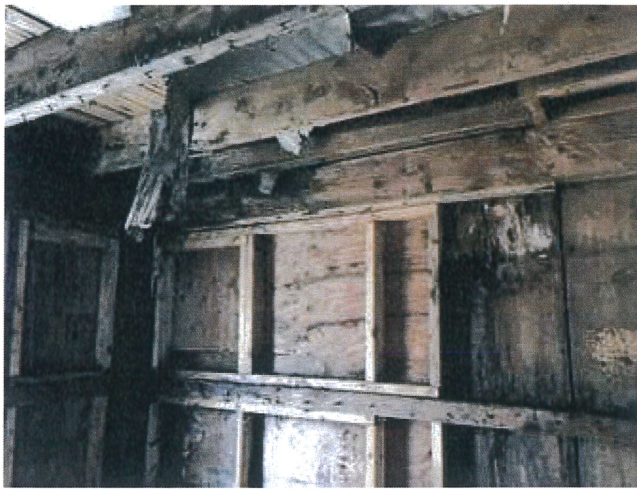
North East Corner:

Sections of the North Eave wall and the East Gable wall have been replaced with modern materials. The post is rotten here and will need to be replaced.

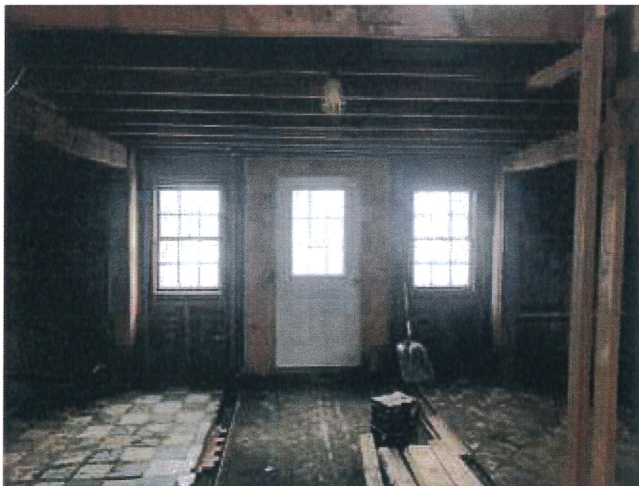
The Center Drive Looking East:

The original large door opening in the East gable has been framed in with modern lumber with modern doors and windows leading to exterior decks.

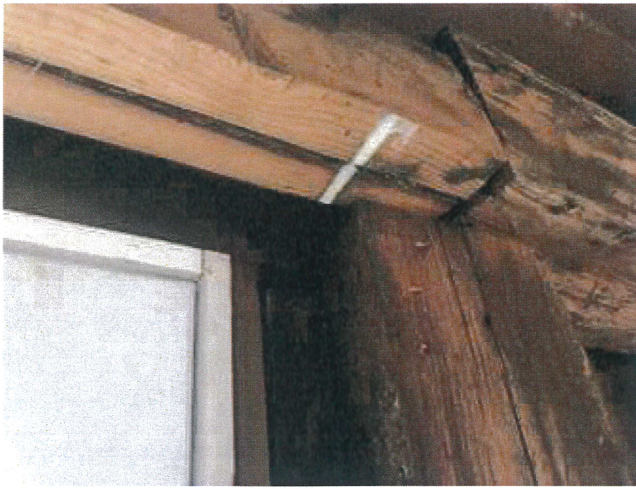
East Gable:

Many of the beams in the East gable are severed and rotten. They have been patched with later materials and do not provide structural integrity. These beams need to be spliced properly and the barn structure regained.

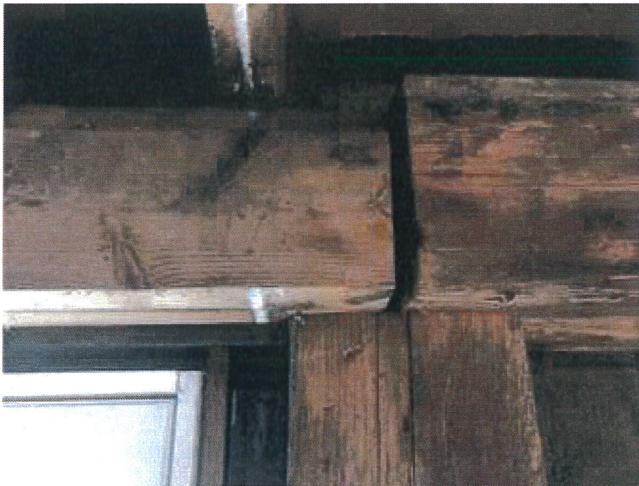
Gable Tie Beam:

The tie beam is cut over the door in the east gable. A new section of tie beam can be cut and spliced into the original material to make the barn structurally and historically sound.

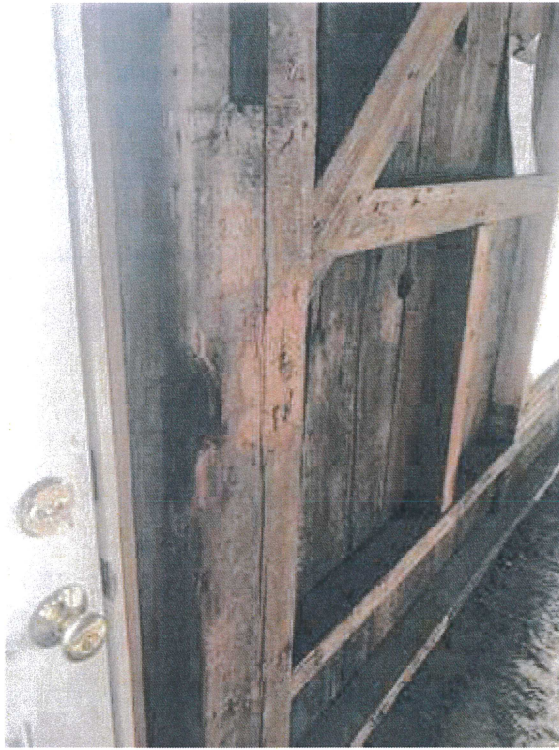
Gable End Posts:

Close examination of the East gable end posts show center rot in both drive posts where weather has penetrated through the siding.

In kind replacement of timbers here will match the size and species of the original timber frame.

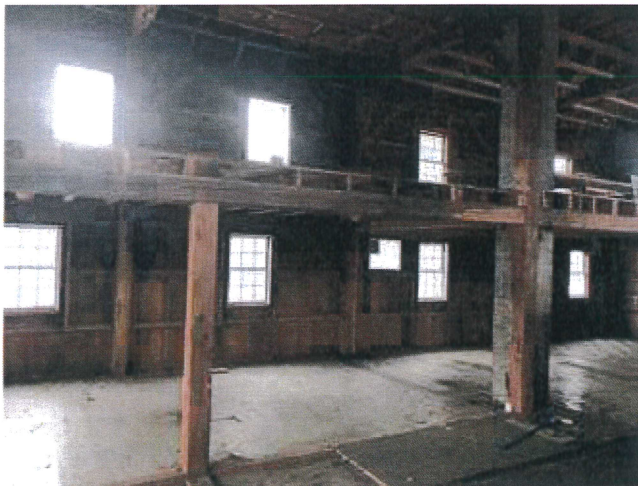
Bent Two Alterations:

At some point the bent two North drive post was removed and a long girt spans from bent one to bent three. A dimensional post was added to support the midspan of this long girt.

The post should be replaced in kind and the girts reestablished here to make the barn structural and more authentic.

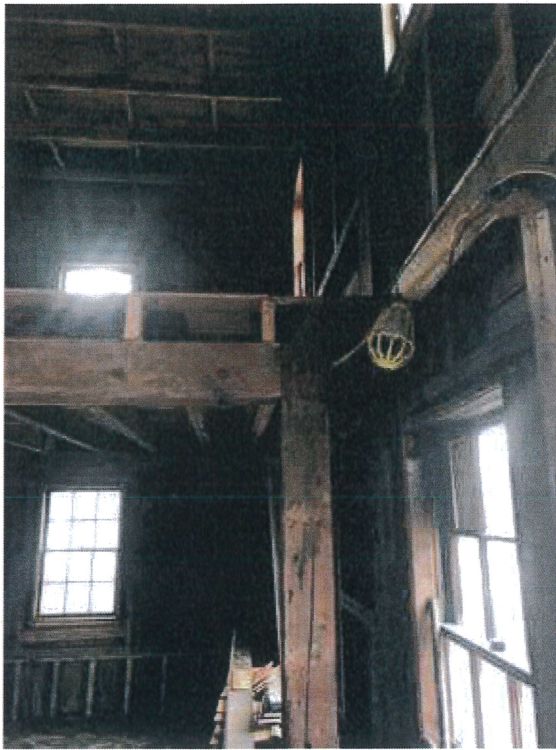
West Door Post:

The West door post has been cut in half. It used to extend up to the top of the original rolling door and connect back into the gable post in bent one. This allowed a large rolling door to remain interior.

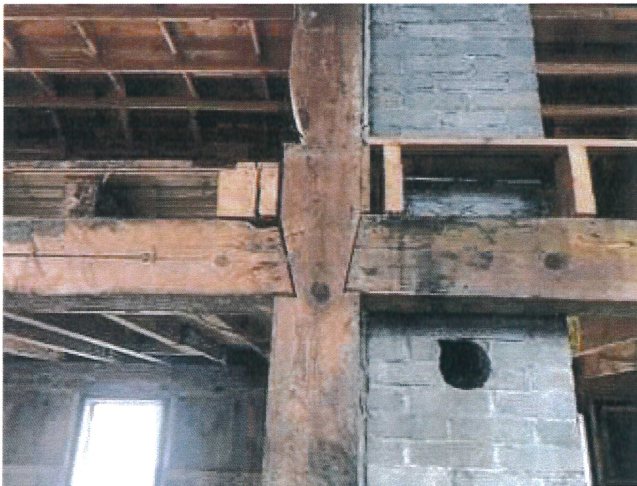
North Side Center Drive Girts:

Drive posts have been let in to accept horizontal drive girts. This framing emulates the South Drive posts and girts but the joinery is nailed along this side of the barn. This indicates an original barn form with a loft only on one side and the north side used for loose hay storage.

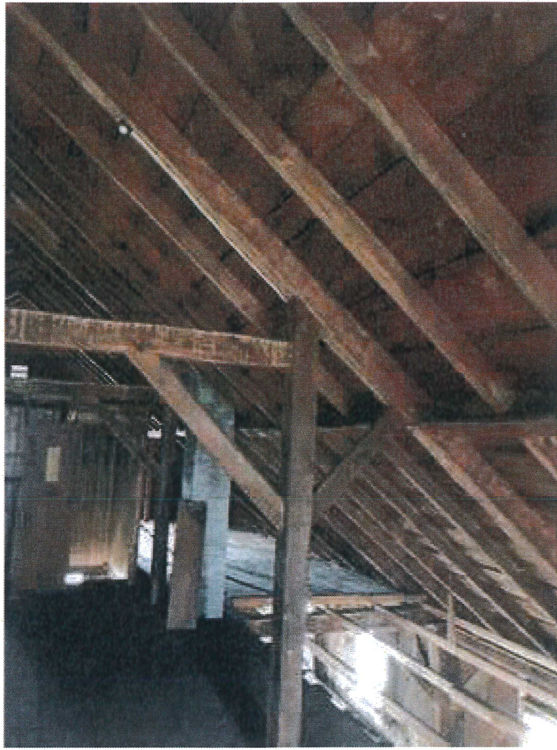
North Roof Frame:

Roof framing along the north roof pitch is in excellent shape.

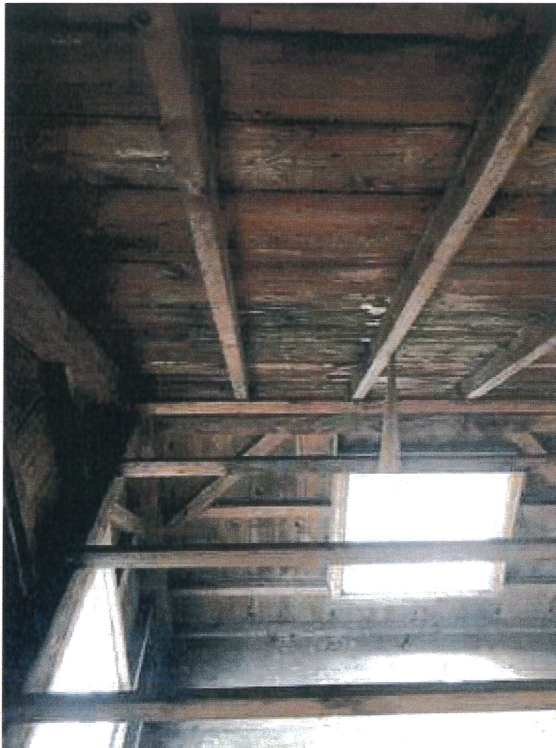
South Roof Framing:

Water penetration has caused rot in a number of areas along the South roof pitch. Roof sheathing and some common rafters have been improperly replaced over time. New common rafters with in kind roof sheathing will be integrated into the South eave roof pitch.

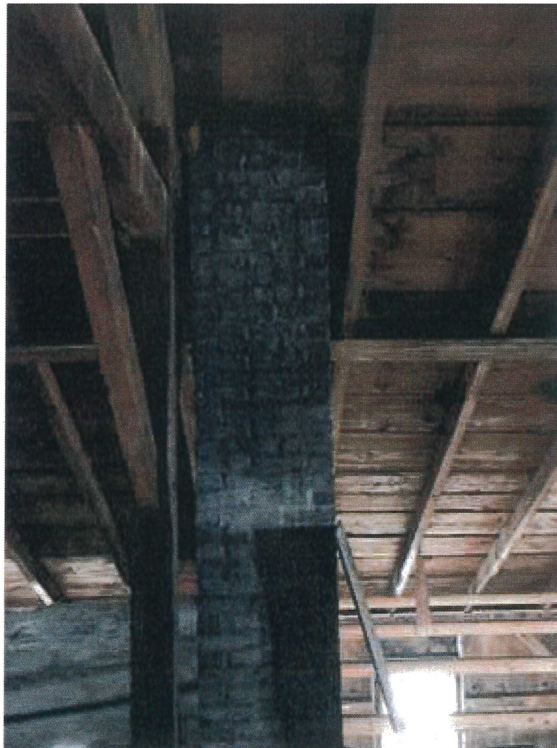
Chimney:

A chimney was added to the frame. It is not original and will need to be removed.

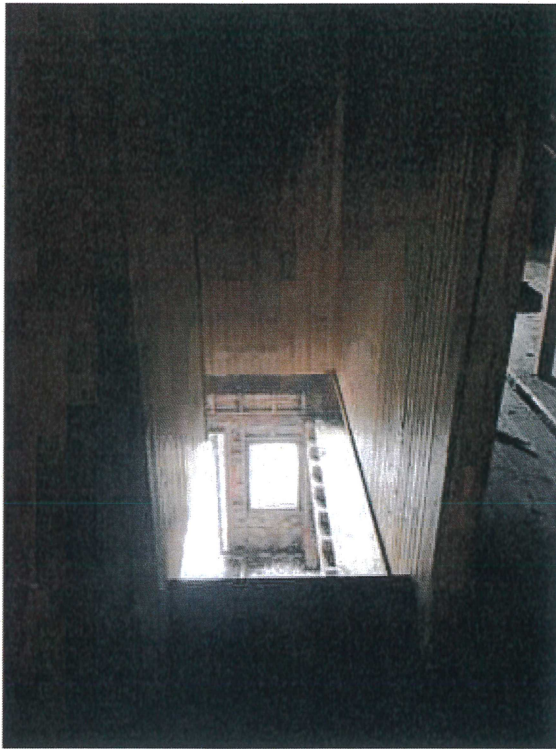
Stair well:

An early stair well remains in place leading up to the upper loft from the floors below. This feature will be removed during the repair process. New stairs will be designed for the new use of the spaces.

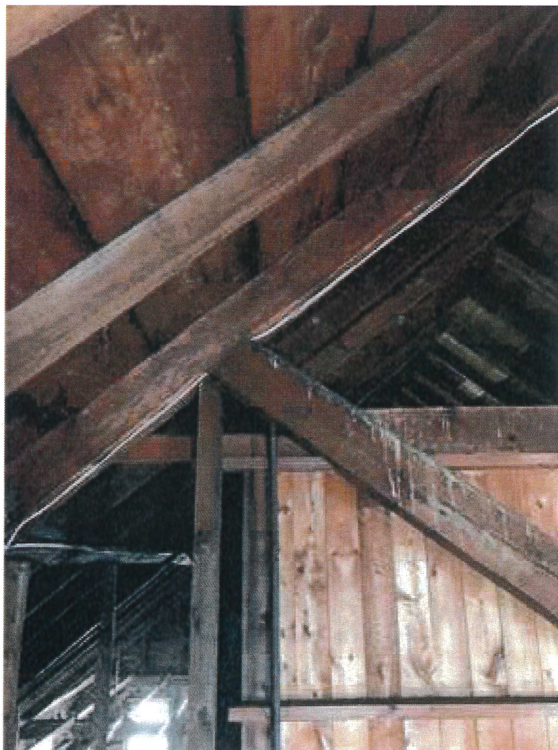
Added Truss:

Bent two hosts a truss that was installed to provide an open space below at the first floor level. At a later date the space under the truss was posted negating its use.

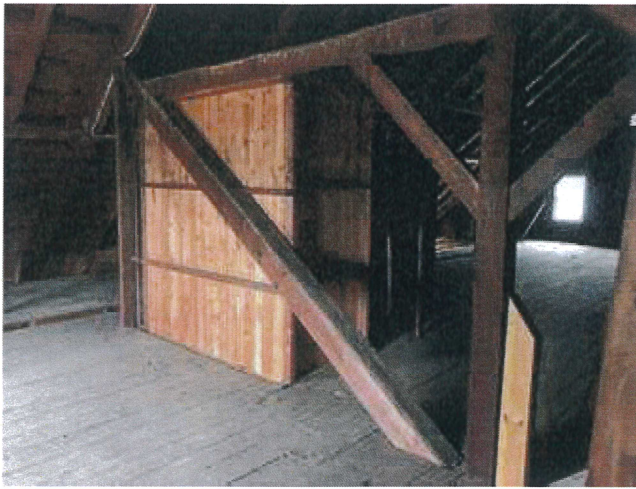
Added Truss:

While the truss was designed for a specific use, it is not built well and very likely performed poorly. It is not a part of the original frame and should be removed with the adjacent loft girts repaired and a new post reinstalled to match the rest of the barn.

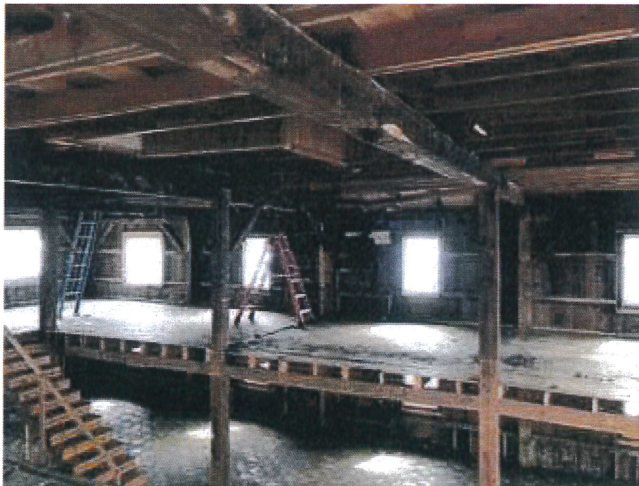
Barn Interior:

The barn has wide open spaces that can be designed for optimal use and living space. Many of the components of the lofts are added to the frame. The high drive loft on top of the tie beams is not original. New lofts can be created to provide code compliance and optimal living conditions.

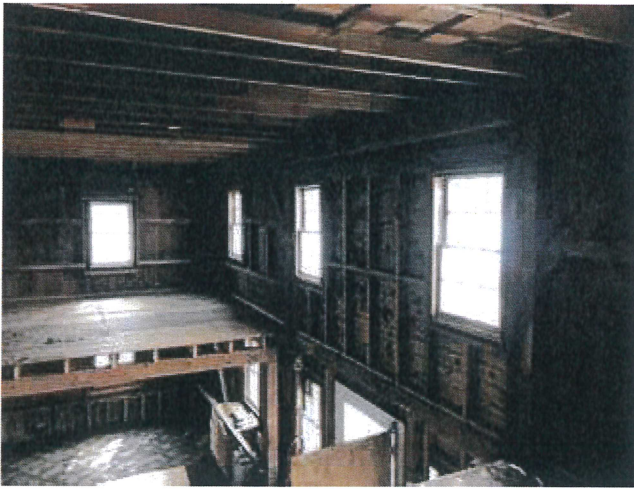
East Gable:

Most of the east gable is rotten. New studding has been placed between rotten posts. The posts suffer weather penetration from the ocean side of the barn but new doors and windows have leaked allowing water to accelerate damage to the framing members.

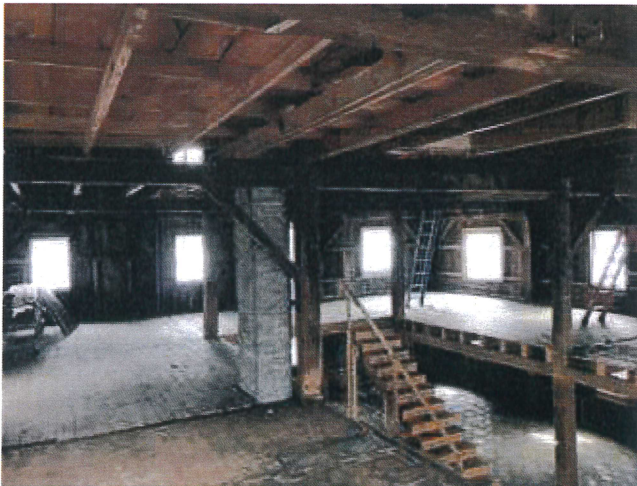
Interior Framing:

At the top right of this photo you see an empty mortise in the tie beam that at one time held the tenon of a drive post. The added truss installed above allowed for the removal of the post, but the truss is not built strong enough to withstand the floor loads. A new post will be fabricated to match original fabric and regain this load path to the drive floor.

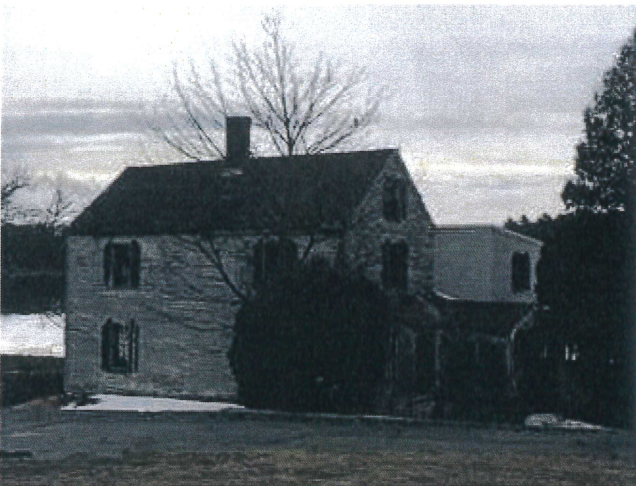
Early 18th Century House:

While on site we viewed perhaps the earliest building on the site. Much of the early house is obscured by overgrown bushes and later additions all to be removed.

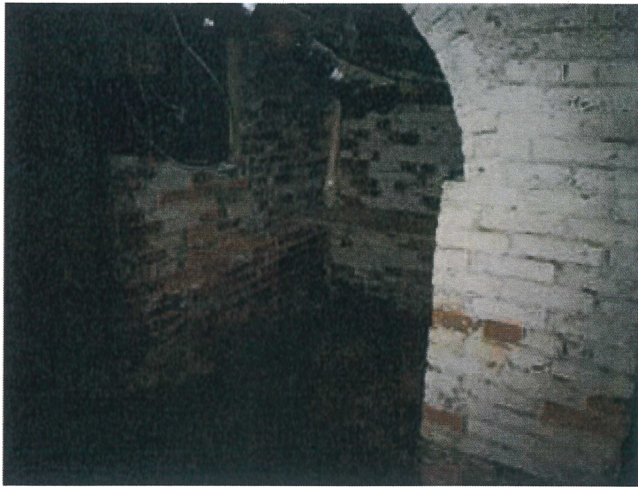
Historic House Frame:

The foundation of the little house is in amazing shape as is the original center chimney arch made of brick.
