IRock Condominium
Located 4 & 6 Rock Street and 125 Islington St.

Summary: As President and Treasurer of the IRock Condo Association, and owning 86% interest in the building, on behalf of the association we would like to replace the windows in the building. The windows are mismatched with three different ages and materials. The majority of the windows were replaced in the 1940's and are historically inaccurate. There are also a few vinyl replacement windows. We have identified 5 original windows, located in the back of the building. Those windows have some replacement glass. The reason for this request is due to terrible condition of the windows and also to restore the building to make it more architecturally historically accurate by replacing the current 2 over 2 windows and old rusty storm windows with historically accurate wood 6 over 6 windows, consistent with Greek Revival buildings constructed in the 1840's. There will be no light loss with the replacement of the windows because only the sashes will be replaced.

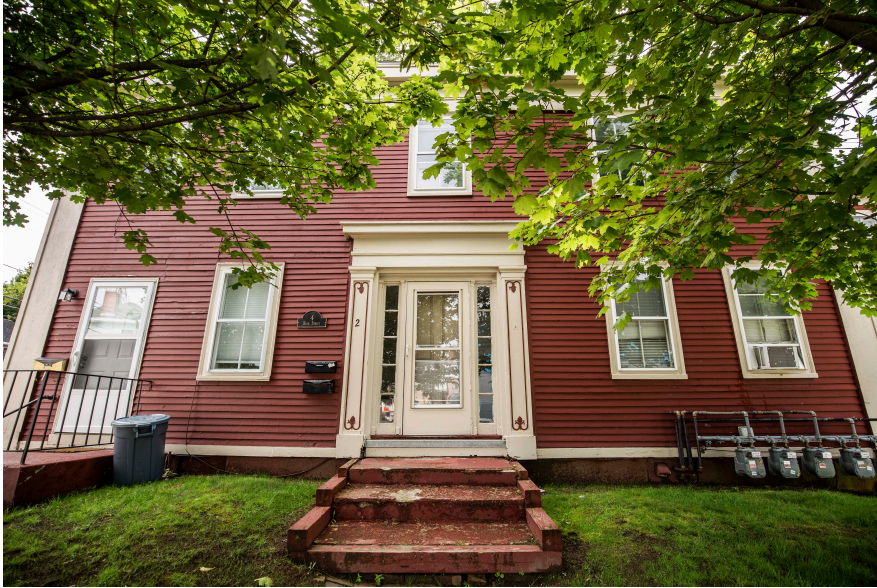
View from Rock Street

Windows 1-8: These windows were all replaced in the 1940's. They are 2 over 2. Our proposal is to replace the sashes only with double hung style 6 over 6. There will be NO light loss with this replacement. The approximate size of these windows are 32"x 58" for the first floor (windows #1-3) and 32" x 54" for the second floor (windows #4-7).

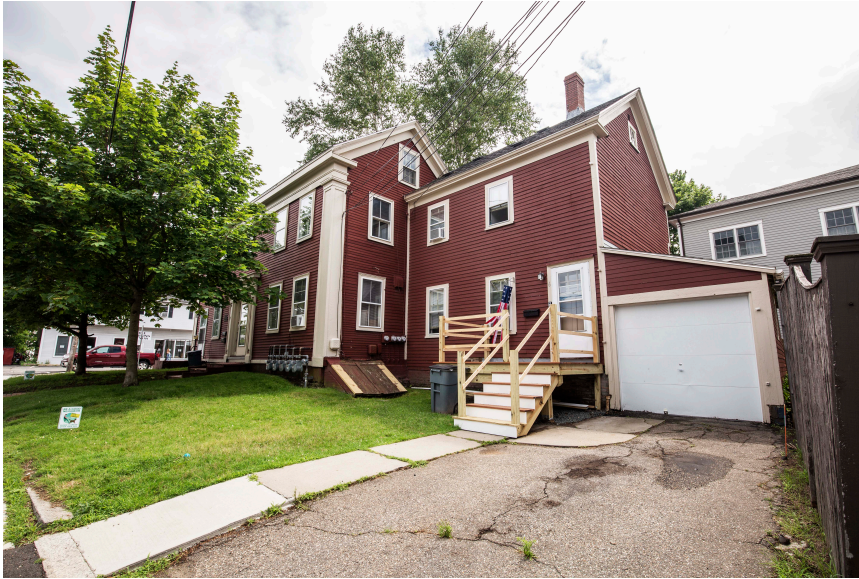
View from Rock Street

Windows 15-18, 20 and 21 were replaced in the 1940's. They are 2 over 2. They are not original sashes and there is no wavy glass. Our proposal is to replace the sashes only with double hung style 6 over 6. There will be NO light loss with this replacement. The approximate size for windows #15-16 is 25" x 46" and 32" x 58" for windows 17-18, 21. The approximate size for window #20 is 32" x 54".

Window #19 is original. We would propose restoring this window. The sash is 6 over 6 with at least one pane of wavy glass.

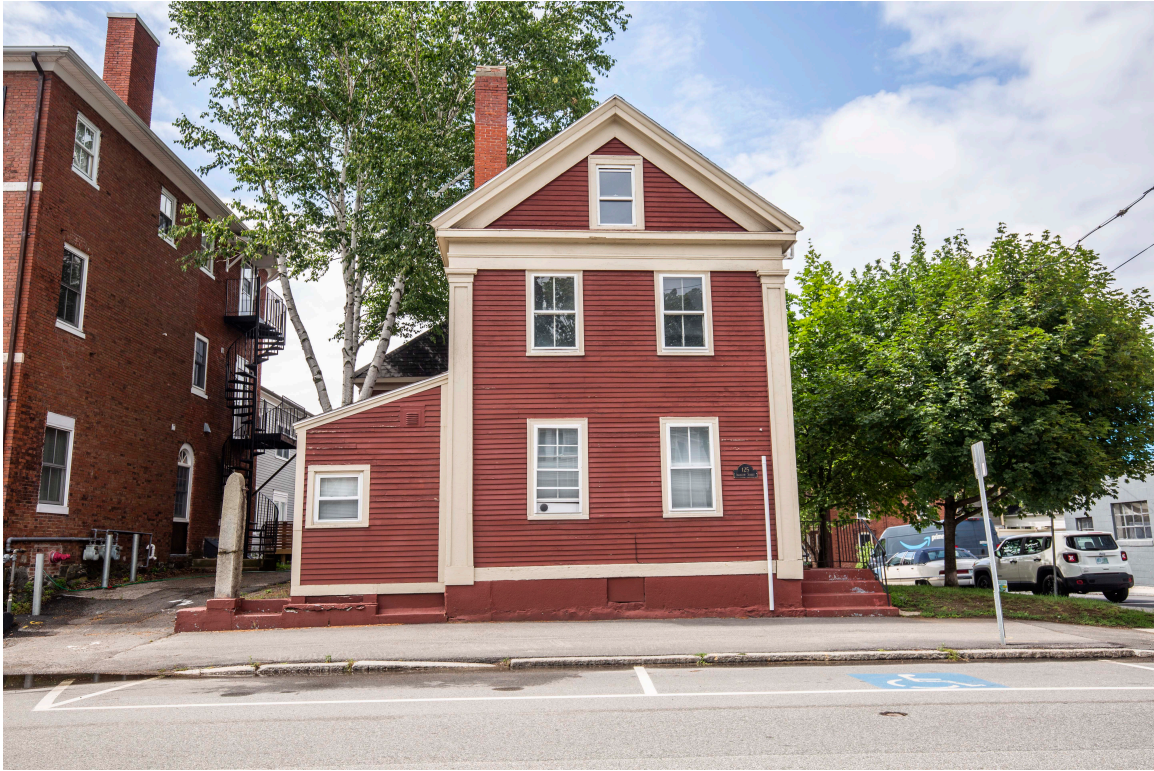
View from Islington St.

Window #9 is a vinyl replacement window installed in the 1980s. It is 1 over 1. We would propose replacing the frame in order to install a casement window with a double hung 6 over 6 appearance. This window size is 32" x 54"

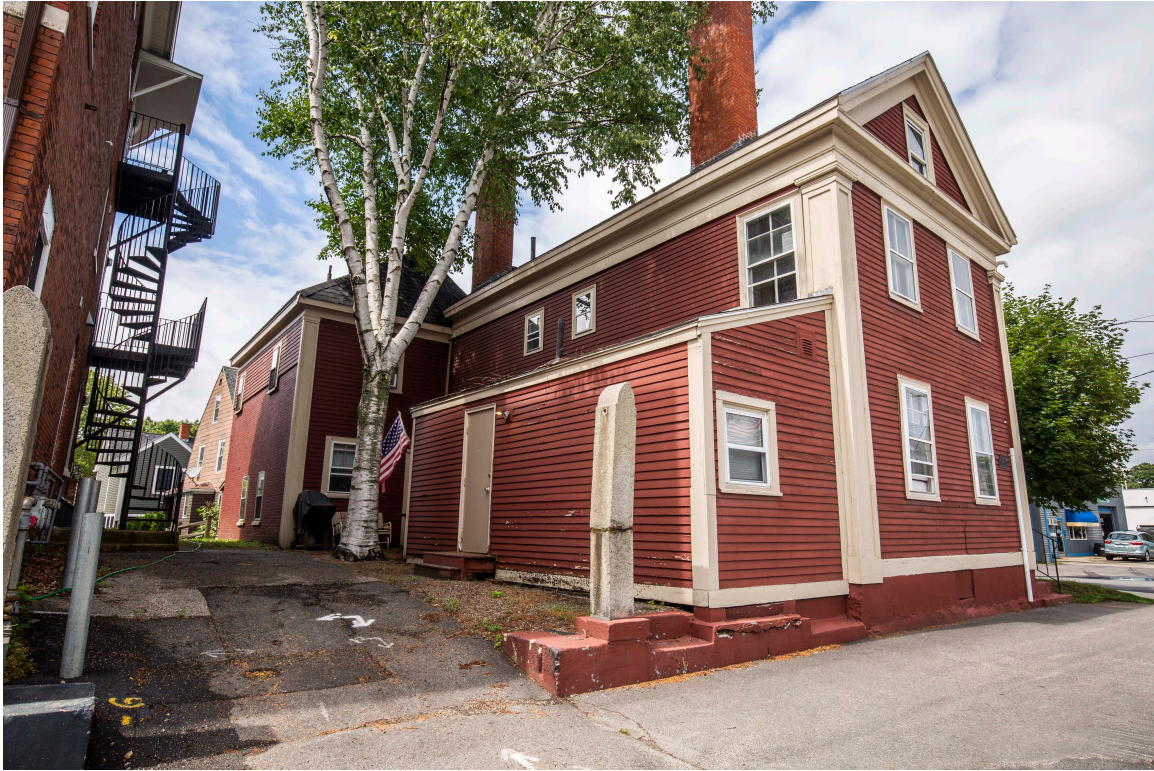
Back Alley as viewed from Islington St.

Windows #23-24 are 1960's vinyl windows. Our proposal is to replace the sashes only with double hung style 6 over 6. There will be NO light loss with this replacement. The approximate size of these windows are 25" x 46".

Window #25: This window was replaced in the 1940's. It 2 over 2. Our proposal is to replace the sashes only with double hung style 6 over 6. There will be NO light loss with this replacement. The approximate size of this window 32" x 54".

Window #22: There is no existing window. It appears someone merely cut a whole in the siding and installed a storm window. We would propose to replace the storm with a double hung window style 6 over 6. There will be NO light loss with this replacement. The approximate size of this window 25" x 46".

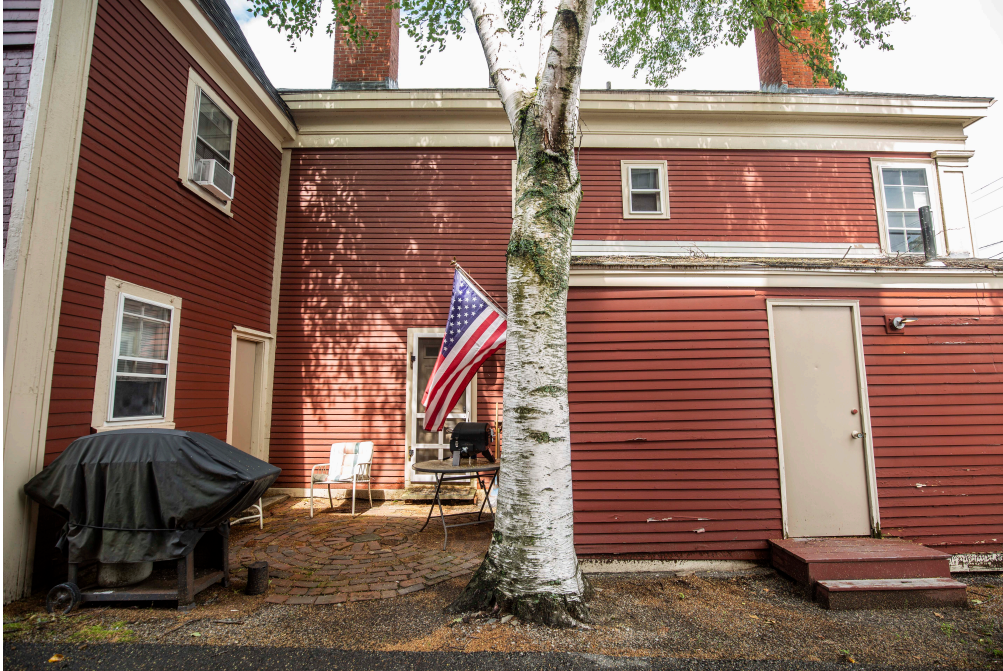
Back Alley

Windows #26, 29, and 30 were replaced in the 1940's. They are 2 over 2. They are not original sashes and there is no wavy glass. Our proposal is to replace the sashes only with double hung style 6 over 6. There will be NO light loss with this replacement. The approximate size of window #26 is 32"x 58". The approximate size of windows #29 and 30 is 32"x 54".
