Appledore Marine Engineering Inc.

Re: Prescott Park Waterfront Inspection – Letter Report
Location: Portsmouth, New Hampshire
Appledore Project No. 5122

PRESCOTT PARK PORTSMOUTH, NH FIG. NO.
WATERFRONT CONDITION PLAN 1

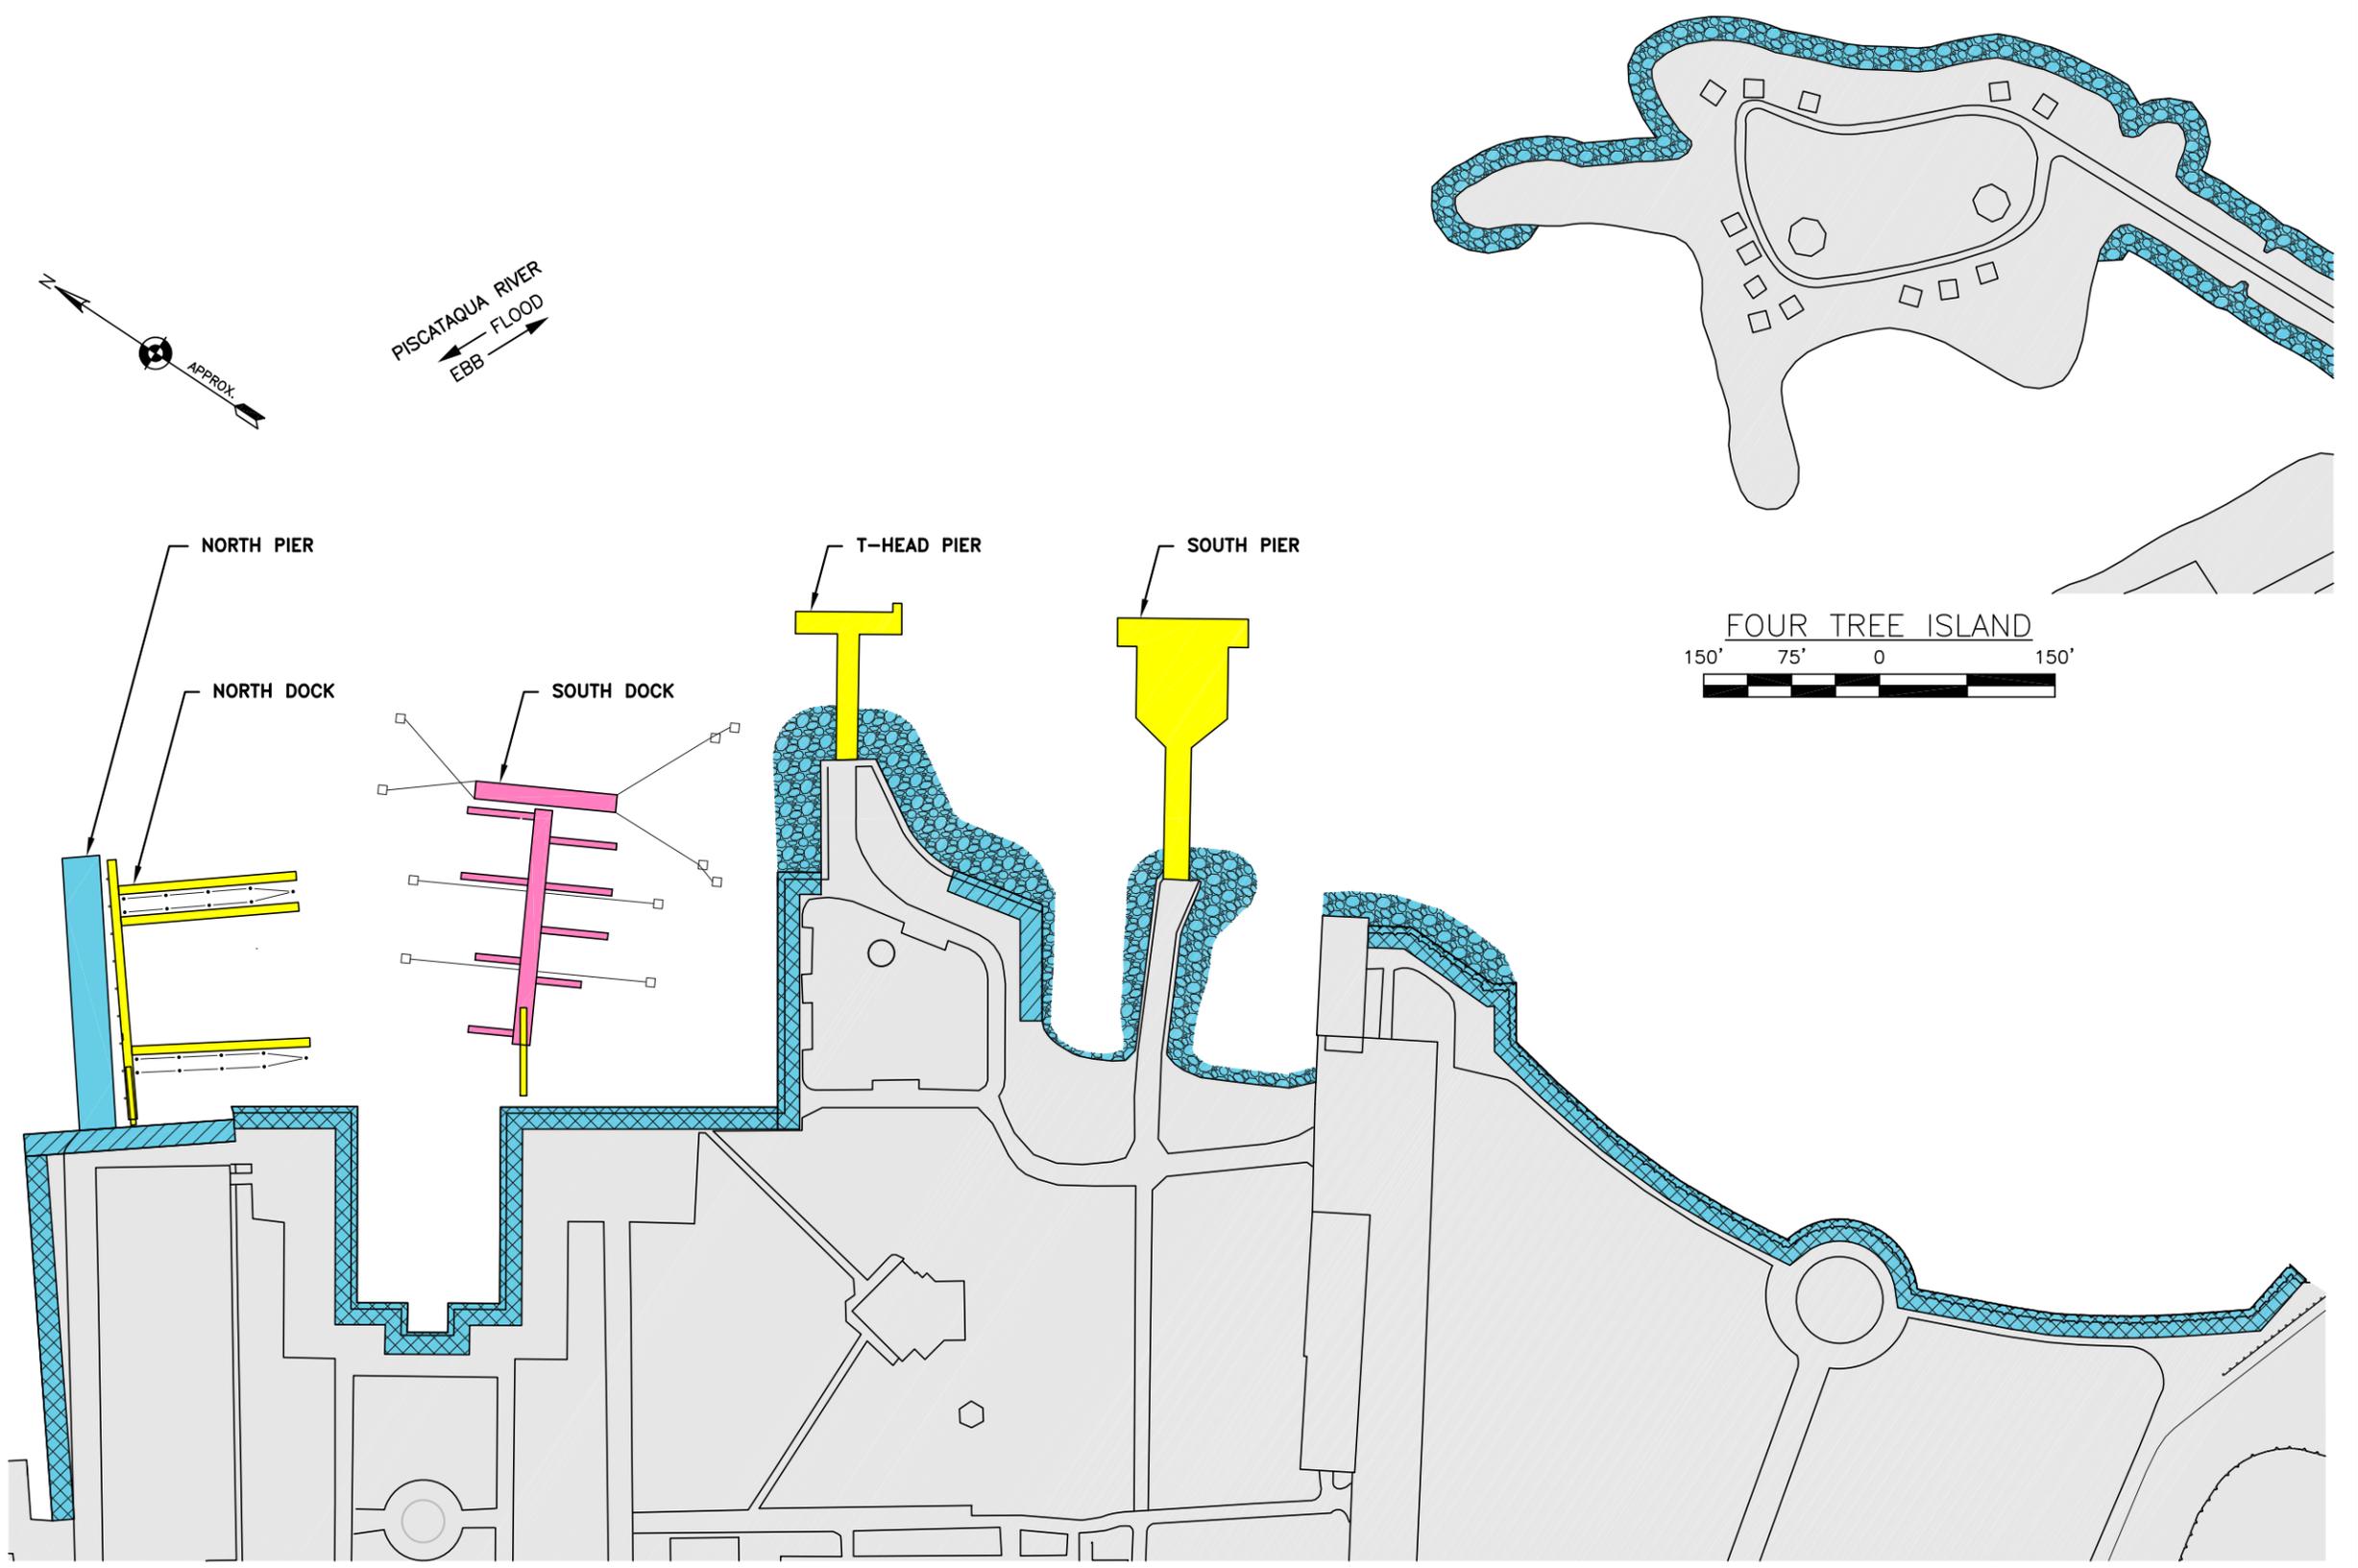
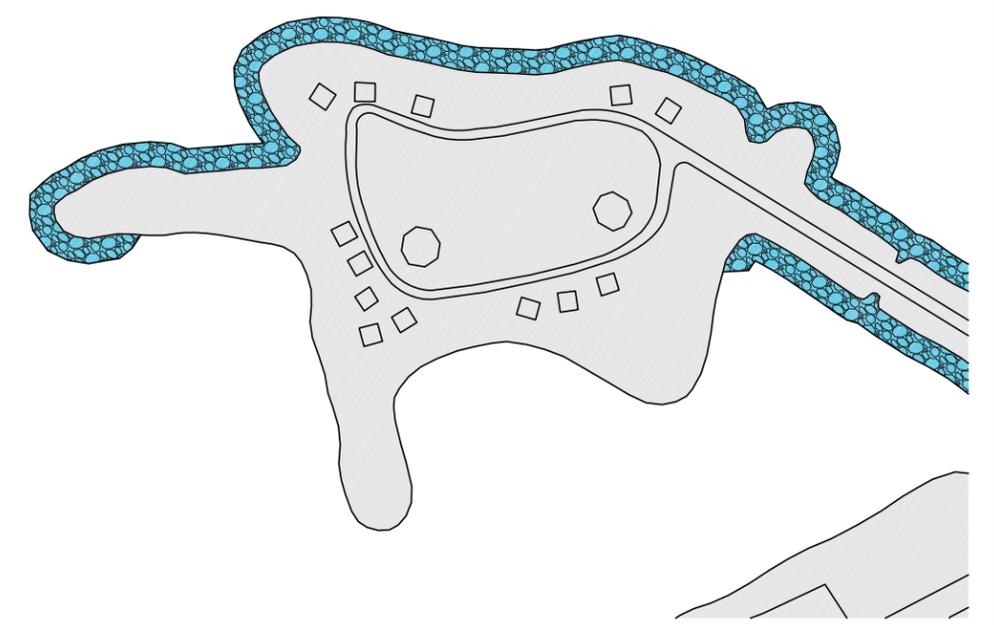
The waterfront facilities at Prescott Park were generally found to be in Fair to Satisfactory condition with the South Dock and one guide pile on the North Dock representing the only components where immediate replacement is recommended.
