PORTSMOUTH IDDE | REPORT

TO: Terry Desmarais & Ray Pezzullo, City of Portsmouth
FROM: Laura Diemer, FB Environmental Associates
SUBJECT: **Portsmouth IDDE Summary Report for Marcy St/Prescott Park**
DATE: May 10, 2017
CC: Forrest Bell, FB Environmental Associates

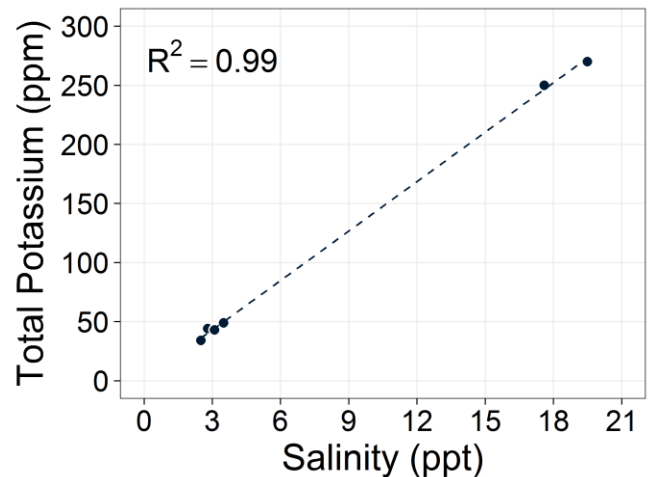
It is important to note that IDDE work is particularly challenging in tidally-influenced stormwater systems. The high salt concentrations (i.e., salinity) interfere with fluoride analyses, complicate the interpretation of potassium as an indicator of industrial discharge, and impact fecal indicator bacteria survival. Figure 2 displays the high collinearity of salinity and total potassium in collected samples, indicating that much of the potassium measured was likely sourced naturally from marine waters. However, the chemical ions contributing to salinity always occur in the same relative proportion to each other. Using in-field salinity measurements, we can calculate the expected concentration of potassium and fluoride from seawater; the difference between measured and expected concentrations of potassium and fluoride give us the possible human-sourced component.

Figure 2. Total potassium is highly related to the salinity of each sample. Potassium is one of several contributing ions to salinity.
