Application: Obtaining Real Property for Historic Monument Purposes Thomas J. McIntyre Federal Building

Thomas J. McIntyre Federal Building 80 Daniel Street, Portsmouth, NH November 2018

4. Narrative Description

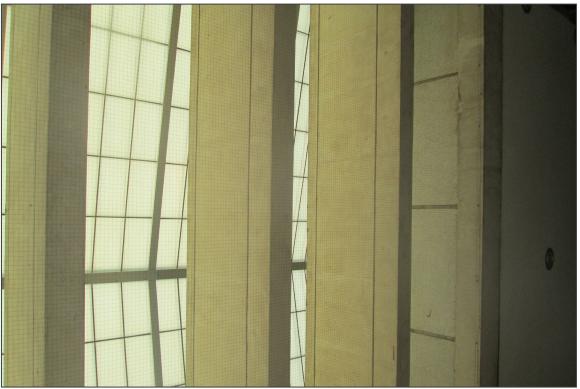
25. West elevation entrance covering

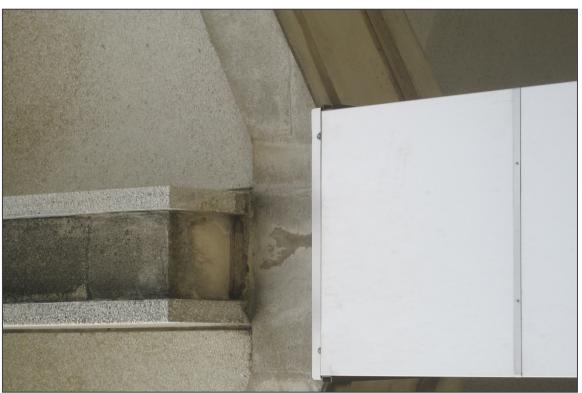
28. South elevation column detail

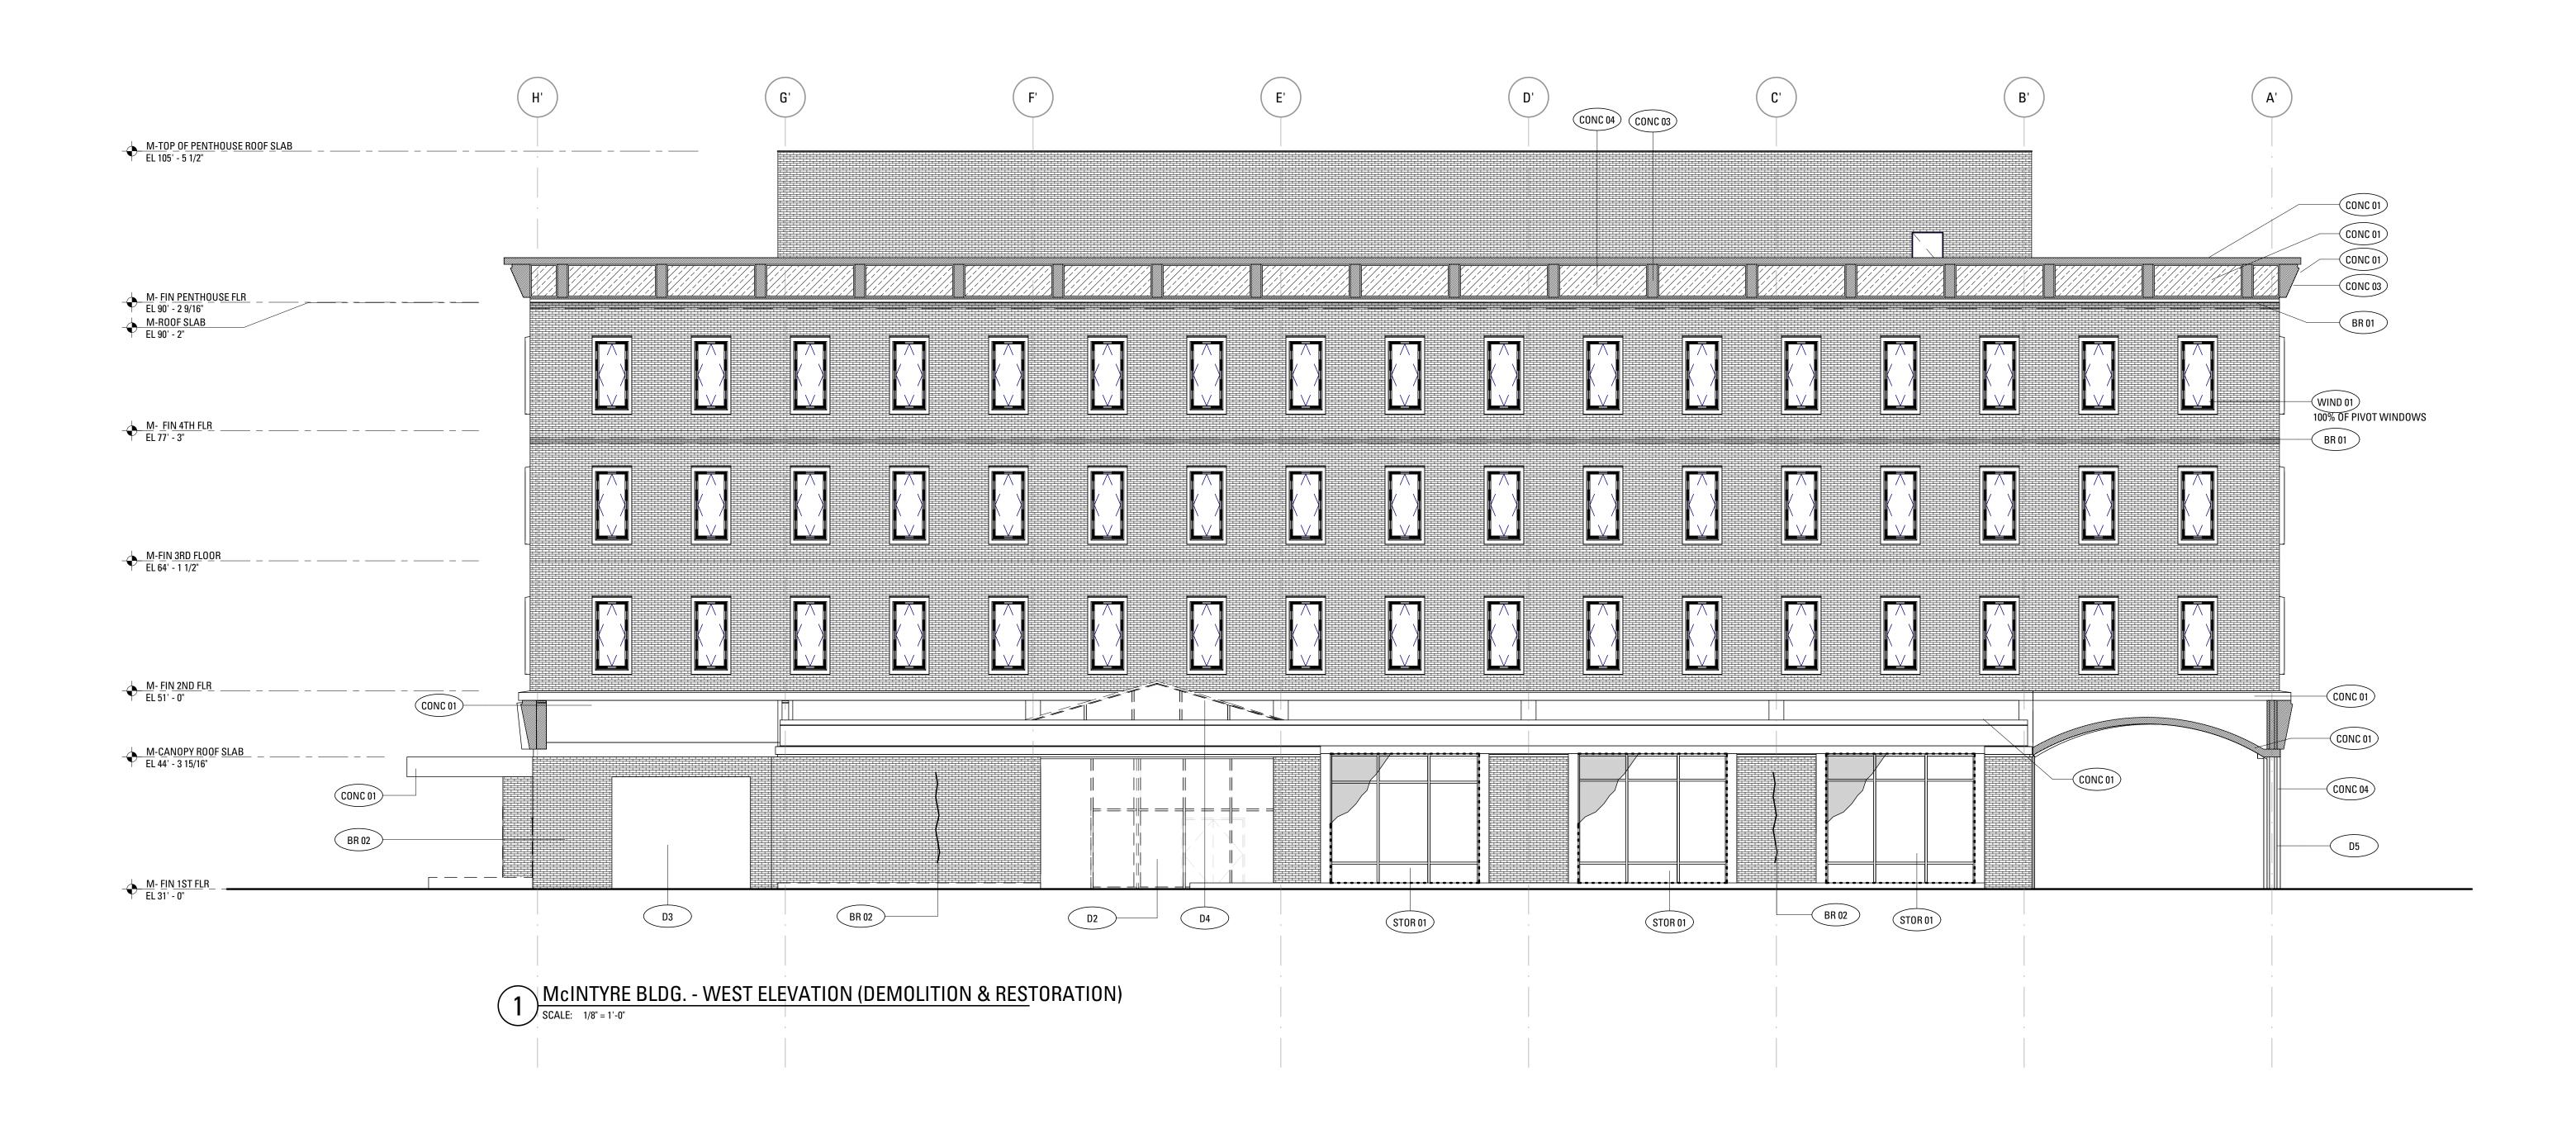
DEMOLITION & RESTORATION-WEST ELEVATION

RESTORATION KEY		
ID CODE	RESTORATION ITEM		
BR 01	BRICK REPOINTING - ALLOW FOR CUTTING OUT AND REPOINTING CONTINUOUSLY AT 3RD FLOOR RELIEVING ANGLE, AT BASE OF CONCRETE CORNICE, AND ABOVE AND BELOW PROJECTING SLAB BELOW 2ND FLOOR WINDOWS (2000 LF TOTAL). ASSUME REPOINTING FOR 20% OF PRECAST WINDOW SURROUNDS (500 LF).		
BR 02	BRICK REPAIR - CUT OUT AND REPLACE-TO-MATCH 100 EA. BRICKS AT VERTICAL FRACTURE AND REMOVAL OF WALL-MOUNTED ELECTRIC CONDUIT BRACKETS IN WEST WING EXTERIOR WALL, AT REMOVAL OF METAL PLAQUES AND LETTERING ON SOUTH. REPAIR ADJACENT BRICK WALL AREAS WHERE NEW OPENINGS ARE CREATED IN PENHALLOW STREET FRONTAGE AT RECESSED ENTRANCE, SOUTHWEST CORNER, AND MAILING PLATFORM AND DANIEL STREET WHERE POST OFFICE ENTRANCES ARE ALTERED, AND AT DEMOLITION MARGIN ON EAST FACADE. ASSUME 120 SF.		
CONC 01	CONCRETE CLEANING - CLEAN ALL EXPOSED CONCRETE AT THE ARCADE, ABOVE SINGLE-STORY WINGS, AT FACES OF MAILING PLATFORM ROOF SLAB, AT SLAB PROJECTING BELOW 2ND FLOOR WINDOWS. CLEAN EXPOSED CAST-IN-PLACE CONCRETE CORE SUPPORTS FOR ALL CORNICE BRACKETS. CLEAN PRECAST WINDOW SURROUNDS AT SINGLE STORY EAST WING.

CONC 03	CONCRETE BRACKET REPAIR - DETACH AND REINSTALL FACE-MOUNTED "CAST STONE" CORNICE BRACKET PANELS. ALLOW FOR 5 LOCATIONS.		
CONC 04	CONCRETE SURFACE REPAIR - REPAIR SPALLED AND CRACKED PRECAST SURFACES TO MATCH EXISTING. REPAIR ANCHORAGE LOCATIONS AT STAINLESS STEEL COLUMN ENCASEMENT LOCATIONS ON FOUR ARCADE COLUMNS AND RESTORE CONCRETE COLUMN FACES.		
IR-01	CLEAN AND PROTECT POLISHED MARBLE WALL PANELS.		
IR-02	CLEAN AND PROTECT TERRAZZO FLOOR AND ZINC DIVIDERS.		
IR-04	PROTECT AND RETAIN PLASTER CEILING SOFFIT AND VAULT IN ELEVATOR LOBBY AND VESTIBULE.		
IR-05	CLEAN AND PROTECT STAINLESS STEEL ELEVATOR DOORS AND FRAME.		
IR-06	PROTECT AND RETAIN EXISTING GLAZED PARTITION IN ORIGINAL OPENING.		
IR-07	RETAIN AND RELOCATE BRONZE DEDICATION/RE-DEDICATION PLAQUE.		
STOR 01	STOREFRONT - RETAIN ALUMINUM 'STOREFRONT', FIXED GLAZING AT 6-PANEL BOWED AND FLAT WINDOWS TO REMAIN AT GROUND FLOOR (8 EA.) INSTALL CLEAR SAFETY FILM ON ALL PANES (2'-6" X 13'-0" HIGH) INCLUDING SPANDREL GLASS.

WIND 01	WINDOW - ALUMINUM PIVOT WINDOWS IN OFFICES (144 EA.) AND POST OFFICE (2 EA.) INSTALL NEW ALUMINUM INTERIOR STORM SASHES TO MATCH EXISTING CLEAR FINISH WITH ALUMINUM FRAME. DEMOUNTABLE. APPROXIMATE PANEL SIZE 1/2" THICK X 2'-10" WIDE X 7'-9" HIGH. NEW LOW-EMISSIVITY GLASS WILL DIFFER BETWEEN TWO SETS OF ELEVATIONS. ASSUME ABATEMENT OF EXISTING GLAZING SEALANT. REPLACE NEOPRENE DRAFT STOPS AROUND EACH SASH.

- 4 REMOVE EXISTING PLASTIC SKYLIGHT AND PROTECT EXPOSED CONCRETE BEAMS.
- D5 CAREFULLY REMOVE EXISTING STAINLESS STEEL CASING AT CONCRETE COLUMNS.
- D6 REMOVE AND SALVAGE PHOTOVOLTAIC PANELS.

- D7 REMOVE BRICK OUTDOOR VESTIBULE INCLUDING FOUNDATIONS.
- D8 REMOVE LOADING DOCK BRICK WALL AND OVERHEAD DOORS. PROTECT COLUMNS AND CANOPY ROOF.
- D9 REMOVE EXISTING PARTITIONS, FLOOR COVERINGS, WALL TILE, CEILINGS, TOILET FIXTURES, AND BUILDING SYSTEMS.

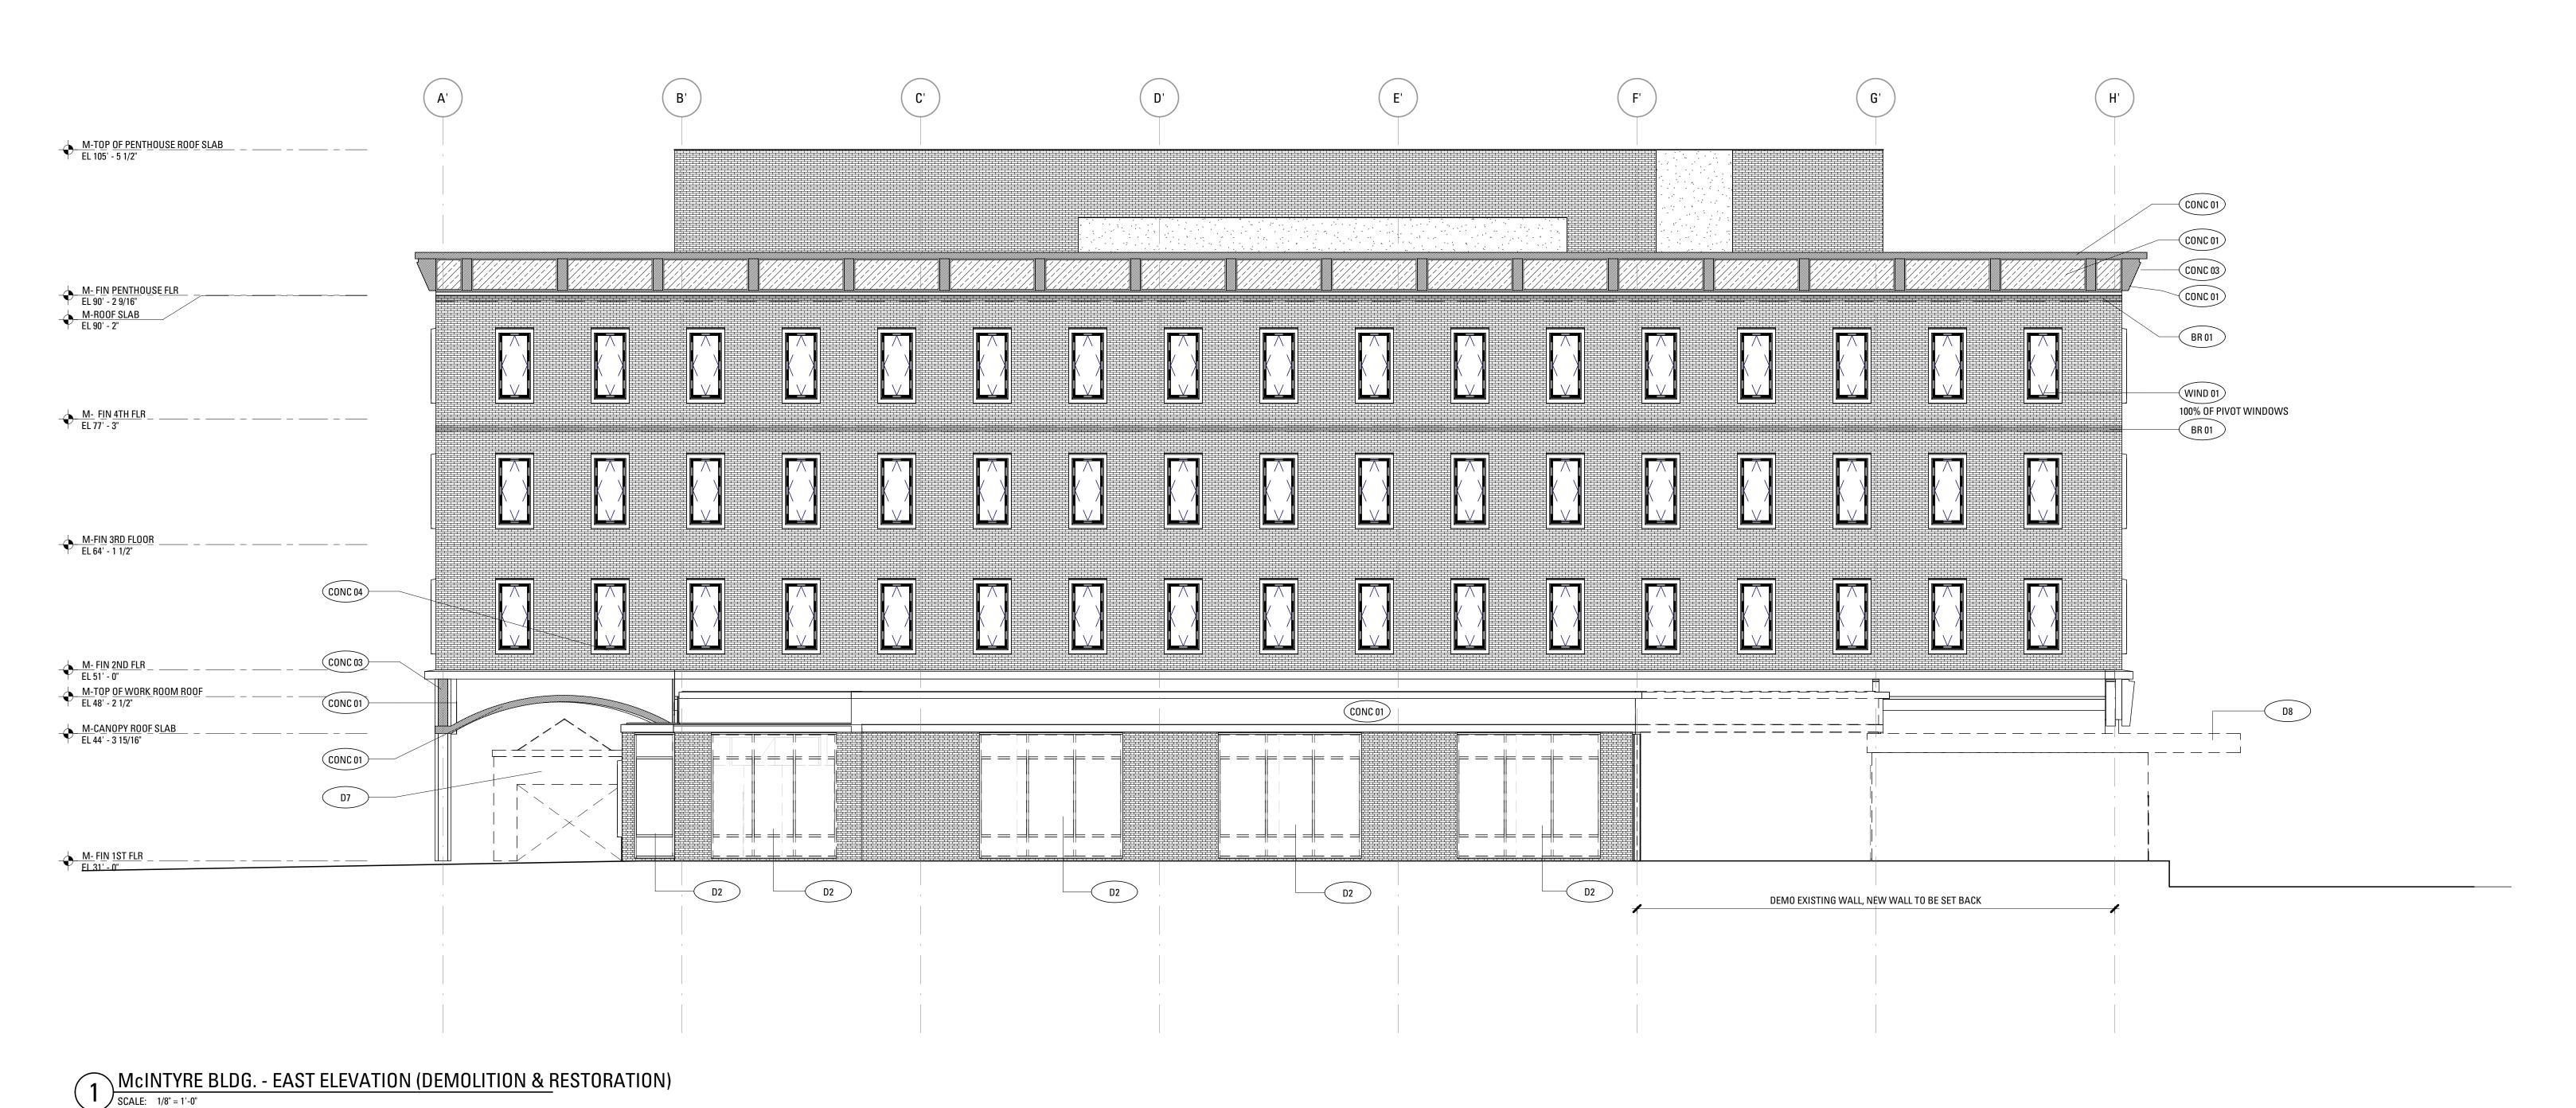
DEMOLITION & RESTORATION-EAST ELEVATION

RESTORATION KEY		
ID CODE	RESTORATION ITEM		
BR 01	BRICK REPOINTING - ALLOW FOR CUTTING OUT AND REPOINTING CONTINUOUSLY AT 3RD FLOOR RELIEVING ANGLE, AT BASE OF CONCRETE CORNICE, AND ABOVE AND BELOW PROJECTING SLAB BELOW 2ND FLOOR WINDOWS (2000 LF TOTAL). ASSUME REPOINTING FOR 20% OF PRECAST WINDOW SURROUNDS (500 LF).		
BR 02	BRICK REPAIR - CUT OUT AND REPLACE-TO-MATCH 100 EA. BRICKS AT VERTICAL FRACTURE AND REMOVAL OF WALL-MOUNTED ELECTRIC CONDUIT BRACKETS IN WEST WING EXTERIOR WALL, AT REMOVAL OF METAL PLAQUES AND LETTERING ON SOUTH. REPAIR ADJACENT BRICK WALL AREAS WHERE NEW OPENINGS ARE CREATED IN PENHALLOW STREET FRONTAGE AT RECESSED ENTRANCE, SOUTHWEST CORNER, AND MAILING PLATFORM AND DANIEL STREET WHERE POST OFFICE ENTRANCES ARE ALTERED, AND AT DEMOLITION MARGIN ON EAST FACADE. ASSUME 120 SF.		
CONC 01	CONCRETE CLEANING - CLEAN ALL EXPOSED CONCRETE AT THE ARCADE, ABOVE SINGLE-STORY WINGS, AT FACES OF MAILING PLATFORM ROOF SLAB, AT SLAB PROJECTING BELOW 2ND FLOOR WINDOWS. CLEAN EXPOSED CAST-IN-PLACE CONCRETE CORE SUPPORTS FOR ALL CORNICE BRACKETS. CLEAN PRECAST WINDOW SURROUNDS AT SINGLE STORY EAST WING.

CONC 03	CONCRETE BRACKET REPAIR - DETACH AND REINSTALL FACE-MOUNTED "CAST STONE" CORNICE BRACKET PANELS. ALLOW FOR 5 LOCATIONS.		
CONC 04	CONCRETE SURFACE REPAIR - REPAIR SPALLED AND CRACKED PRECAST SURFACES TO MATCH EXISTING. REPAIR ANCHORAGE LOCATIONS AT STAINLESS STEEL COLUMN ENCASEMENT LOCATIONS ON FOUR ARCADE COLUMNS AND RESTORE CONCRETE COLUMN FACES.		
IR-01	CLEAN AND PROTECT POLISHED MARBLE WALL PANELS.		
IR-02	CLEAN AND PROTECT TERRAZZO FLOOR AND ZINC DIVIDERS.		
IR-04	PROTECT AND RETAIN PLASTER CEILING SOFFIT AND VAULT IN ELEVATOR LOBBY AND VESTIBULE.		
IR-05	CLEAN AND PROTECT STAINLESS STEEL ELEVATOR DOORS AND FRAME.		
IR-06	PROTECT AND RETAIN EXISTING GLAZED PARTITION IN ORIGINAL OPENING.		
IR-07	RETAIN AND RELOCATE BRONZE DEDICATION/RE-DEDICATION PLAQUE.		
STOR 01	STOREFRONT - RETAIN ALUMINUM 'STOREFRONT' , FIXED GLAZING AT 6-PANEL BOWED AND FLAT WINDOWS TO REMAIN AT GROUND FLOOR (8 EA.) INSTALL CLEAR SAFETY FILM ON ALL PANES (2'-6" X 13'-0" HIGH) INCLUDING SPANDREL GLASS.

LOW-EMISSIVITY GLASS WILL DIFFER BETWEEN TWO SETS OF ELEVATIONS. ASSUME ABATEMENT OF EXISTING GLAZING SEALANT. REPLACE NEOPRENE

- REMOVE ALL CONSTRUCTED ASSEMBLIES INCLUDING STRUCTURE, BUILDING ENVELOPE, SLAB AND ALL BUILDING SYSTEMS. SUPPORT AND PROTECT ADJACENT STRUCTURES TO REMAIN.
- D2 CAREFULLY REMOVE EXISTING ALUMINUM CURTAIN WALL AND PROTECT OPENING FOR NEW CURTAIN WALL INSTALLATION.
- CUT OPENING AND REMOVE BRICK WALL CLADDING TO ALLOW FOR CONSTRUCTION OF NEW BRICK OPENING.
- 4 REMOVE EXISTING PLASTIC SKYLIGHT AND PROTECT EXPOSED CONCRETE BEAMS.
- D5 CAREFULLY REMOVE EXISTING STAINLESS STEEL CASING AT CONCRETE COLUMNS.
- D6 REMOVE AND SALVAGE PHOTOVOLTAIC PANELS.
- D6 REMOVE AND SALVAGE PHOTOVOLTAIC PANELS.
- REMOVE BRICK OUTDOOR VESTIBULE INCLUDING FOUNDATIONS.

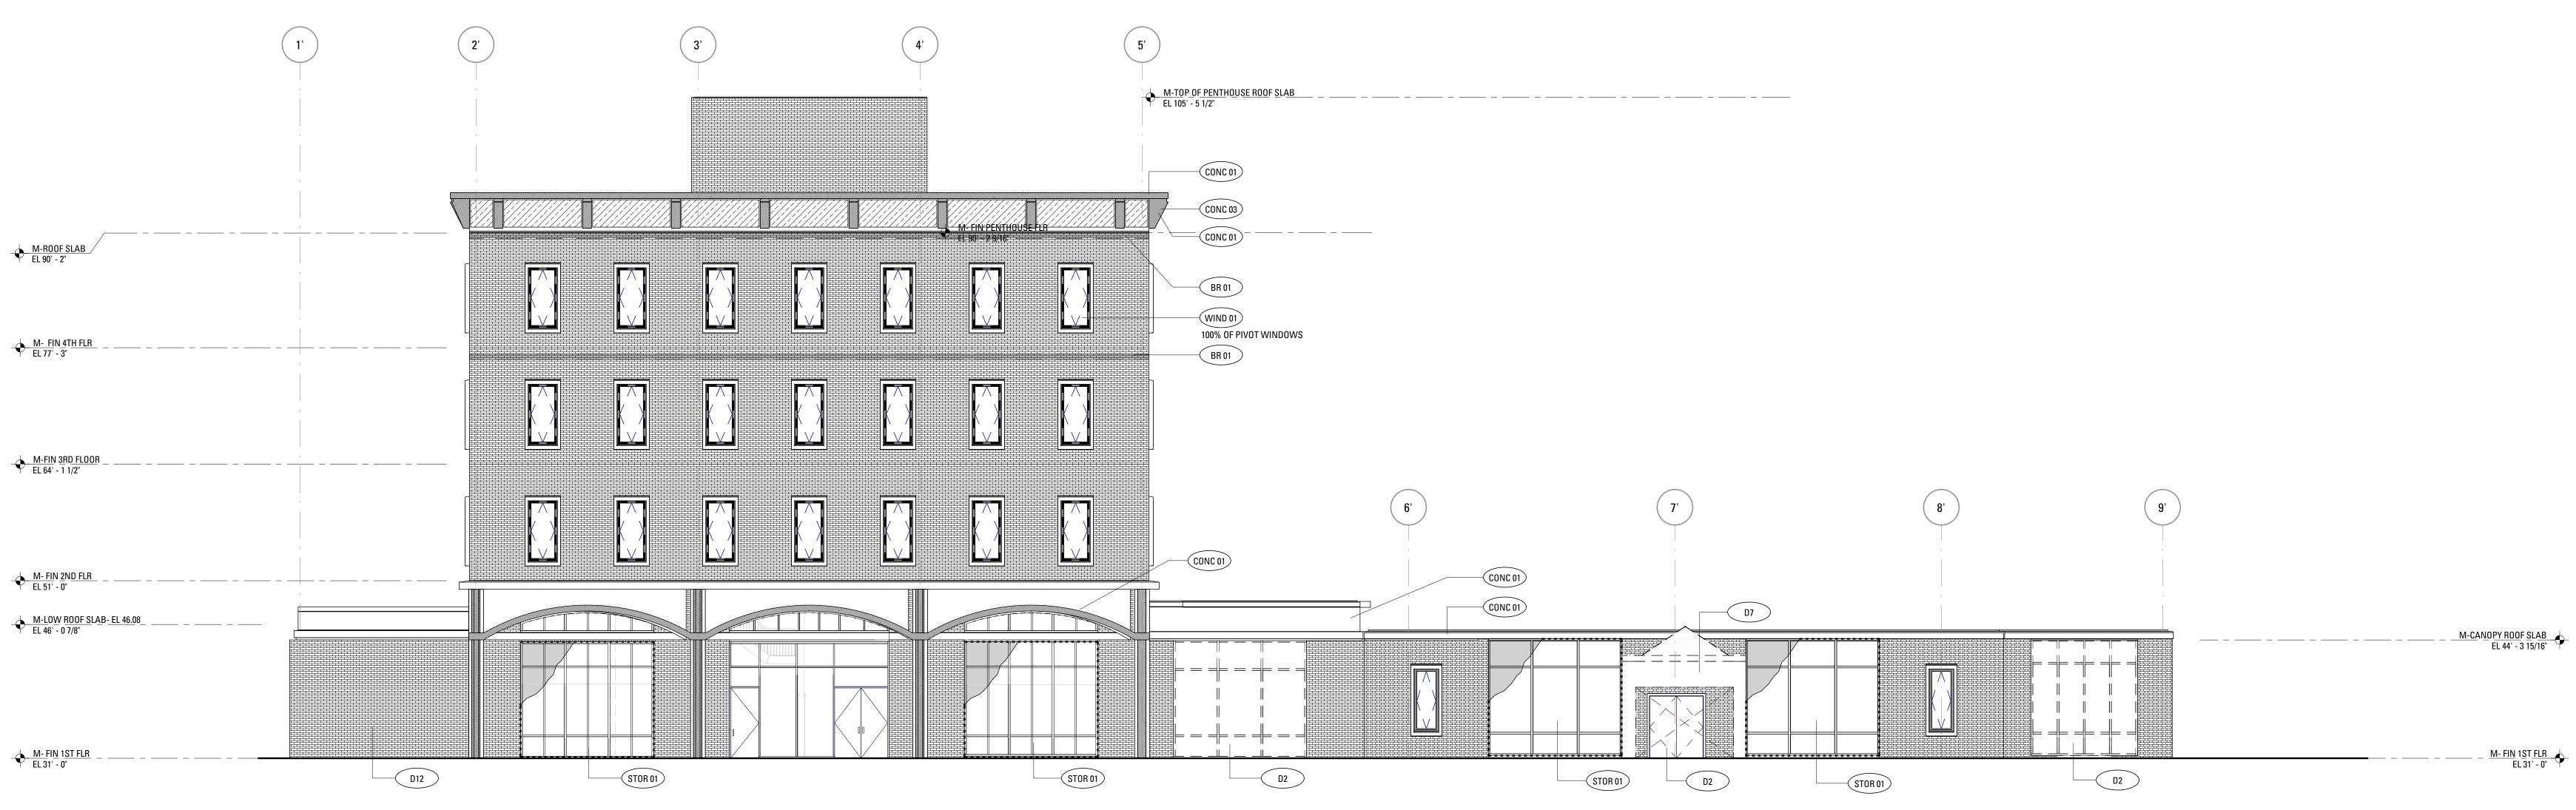
McINTYRE BLDG. - SOUTH ELEVATION (DEMOLITION & RESTORATION)

RESTORATION KEY
ID CODE	RESTORATION ITEM
BR 01	BRICK REPOINTING - ALLOW FOR CUTTING OUT AND REPOINTING CONTINUOUSLY AT 3RD FLOOR RELIEVING ANGLE, AT BASE OF CONCRETE CORNICE, AND ABOVE AND BELOW PROJECTING SLAB BELOW 2ND FLOOR WINDOWS (2000 LF TOTAL). ASSUME REPOINTING FOR 20% OF PRECAST WINDOW SURROUNDS (500 LF).
BR 02	BRICK REPAIR - CUT OUT AND REPLACE-TO-MATCH 100 EA. BRICKS AT VERTICAL FRACTURE AND REMOVAL OF WALL-MOUNTED ELECTRIC CONDUIT BRACKETS IN WEST WING EXTERIOR WALL, AT REMOVAL OF METAL PLAQUES AND LETTERING ON SOUTH. REPAIR ADJACENT BRICK WALL AREAS WHERE NEW OPENINGS ARE CREATED IN PENHALLOW STREET FRONTAGE AT RECESSED ENTRANCE, SOUTHWEST CORNER, AND MAILING PLATFORM AND DANIEL STREET WHERE POST OFFICE ENTRANCES ARE ALTERED, AND AT DEMOLITION MARGIN ON EAST FACADE. ASSUME 120 SF.
CONC 01	CONCRETE CLEANING - CLEAN ALL EXPOSED CONCRETE AT THE ARCADE, ABOVE SINGLE-STORY WINGS, AT FACES OF MAILING PLATFORM ROOF SLAB, AT SLAB PROJECTING BELOW 2ND FLOOR WINDOWS. CLEAN EXPOSED CAST-IN-PLACE CONCRETE CORE SUPPORTS FOR ALL CORNICE BRACKETS. CLEAN PRECAST WINDOW SURROUNDS AT SINGLE STORY EAST WING.

CONC 03	CONCRETE BRACKET REPAIR - DETACH AND REINSTALL FACE-MOUNTED "CAST STONE" CORNICE BRACKET PANELS. ALLOW FOR 5 LOCATIONS.
CONC 04	CONCRETE SURFACE REPAIR - REPAIR SPALLED AND CRACKED PRECAST SURFACES TO MATCH EXISTING. REPAIR ANCHORAGE LOCATIONS AT STAINLESS STEEL COLUMN ENCASEMENT LOCATIONS ON FOUR ARCADE COLUMNS AND RESTORE CONCRETE COLUMN FACES.
IR-01	CLEAN AND PROTECT POLISHED MARBLE WALL PANELS.
IR-02	CLEAN AND PROTECT TERRAZZO FLOOR AND ZINC DIVIDERS.
IR-04	PROTECT AND RETAIN PLASTER CEILING SOFFIT AND VAULT IN ELEVATOR LOBBY AND VESTIBULE.
IR-05	CLEAN AND PROTECT STAINLESS STEEL ELEVATOR DOORS AND FRAME.
IR-06	PROTECT AND RETAIN EXISTING GLAZED PARTITION IN ORIGINAL OPENING.
IR-07	RETAIN AND RELOCATE BRONZE DEDICATION/RE-DEDICATION PLAQUE.
STOR 01	STOREFRONT - RETAIN ALUMINUM 'STOREFRONT' , FIXED GLAZING AT 6-PANEL BOWED AND FLAT WINDOWS TO REMAIN AT GROUND FLOOR (8 EA.) INSTALL CLEAR SAFETY FILM ON ALL PANES (2'-6" X 13'-0" HIGH) INCLUDING SPANDREL GLASS.

WIND 01	WINDOW - ALUMINUM PIVOT WINDOWS IN OFFICES (144 EA.) AND POST OFFICE (2 EA.) INSTALL NEW ALUMINUM INTERIOR STORM SASHES TO MATCH EXISTING CLEAR FINISH WITH ALUMINUM FRAME. DEMOUNTABLE. APPROXIMATE PANEL SIZE 1/2" THICK X 2'-10" WIDE X 7'-9" HIGH. NEW LOW-EMISSIVITY GLASS WILL DIFFER BETWEEN TWO SETS OF ELEVATIONS. ASSUME ABATEMENT OF EXISTING GLAZING SEALANT. REPLACE NEOPRENE DRAFT STOPS AROUND EACH SASH.

- D4 REMOVE EXISTING PLASTIC SKYLIGHT AND PROTECT EXPOSED CONCRETE BEAMS.
- CAREFULLY REMOVE EXISTING STAINLESS STEEL CASING AT CONCRETE COLUMNS.
- D6 REMOVE AND SALVAGE PHOTOVOLTAIC PANELS.

- D7 REMOVE BRICK OUTDOOR VESTIBULE INCLUDING FOUNDATIONS.
- REMOVE LOADING DOCK BRICK WALL AND OVERHEAD DOORS. PROTECT COLUMNS AND CANOPY ROOF.
- 9 REMOVE EXISTING PARTITIONS, FLOOR COVERINGS, WALL TILE, CEILINGS, TOILET FIXTURES, AND BUILDING SYSTEMS.

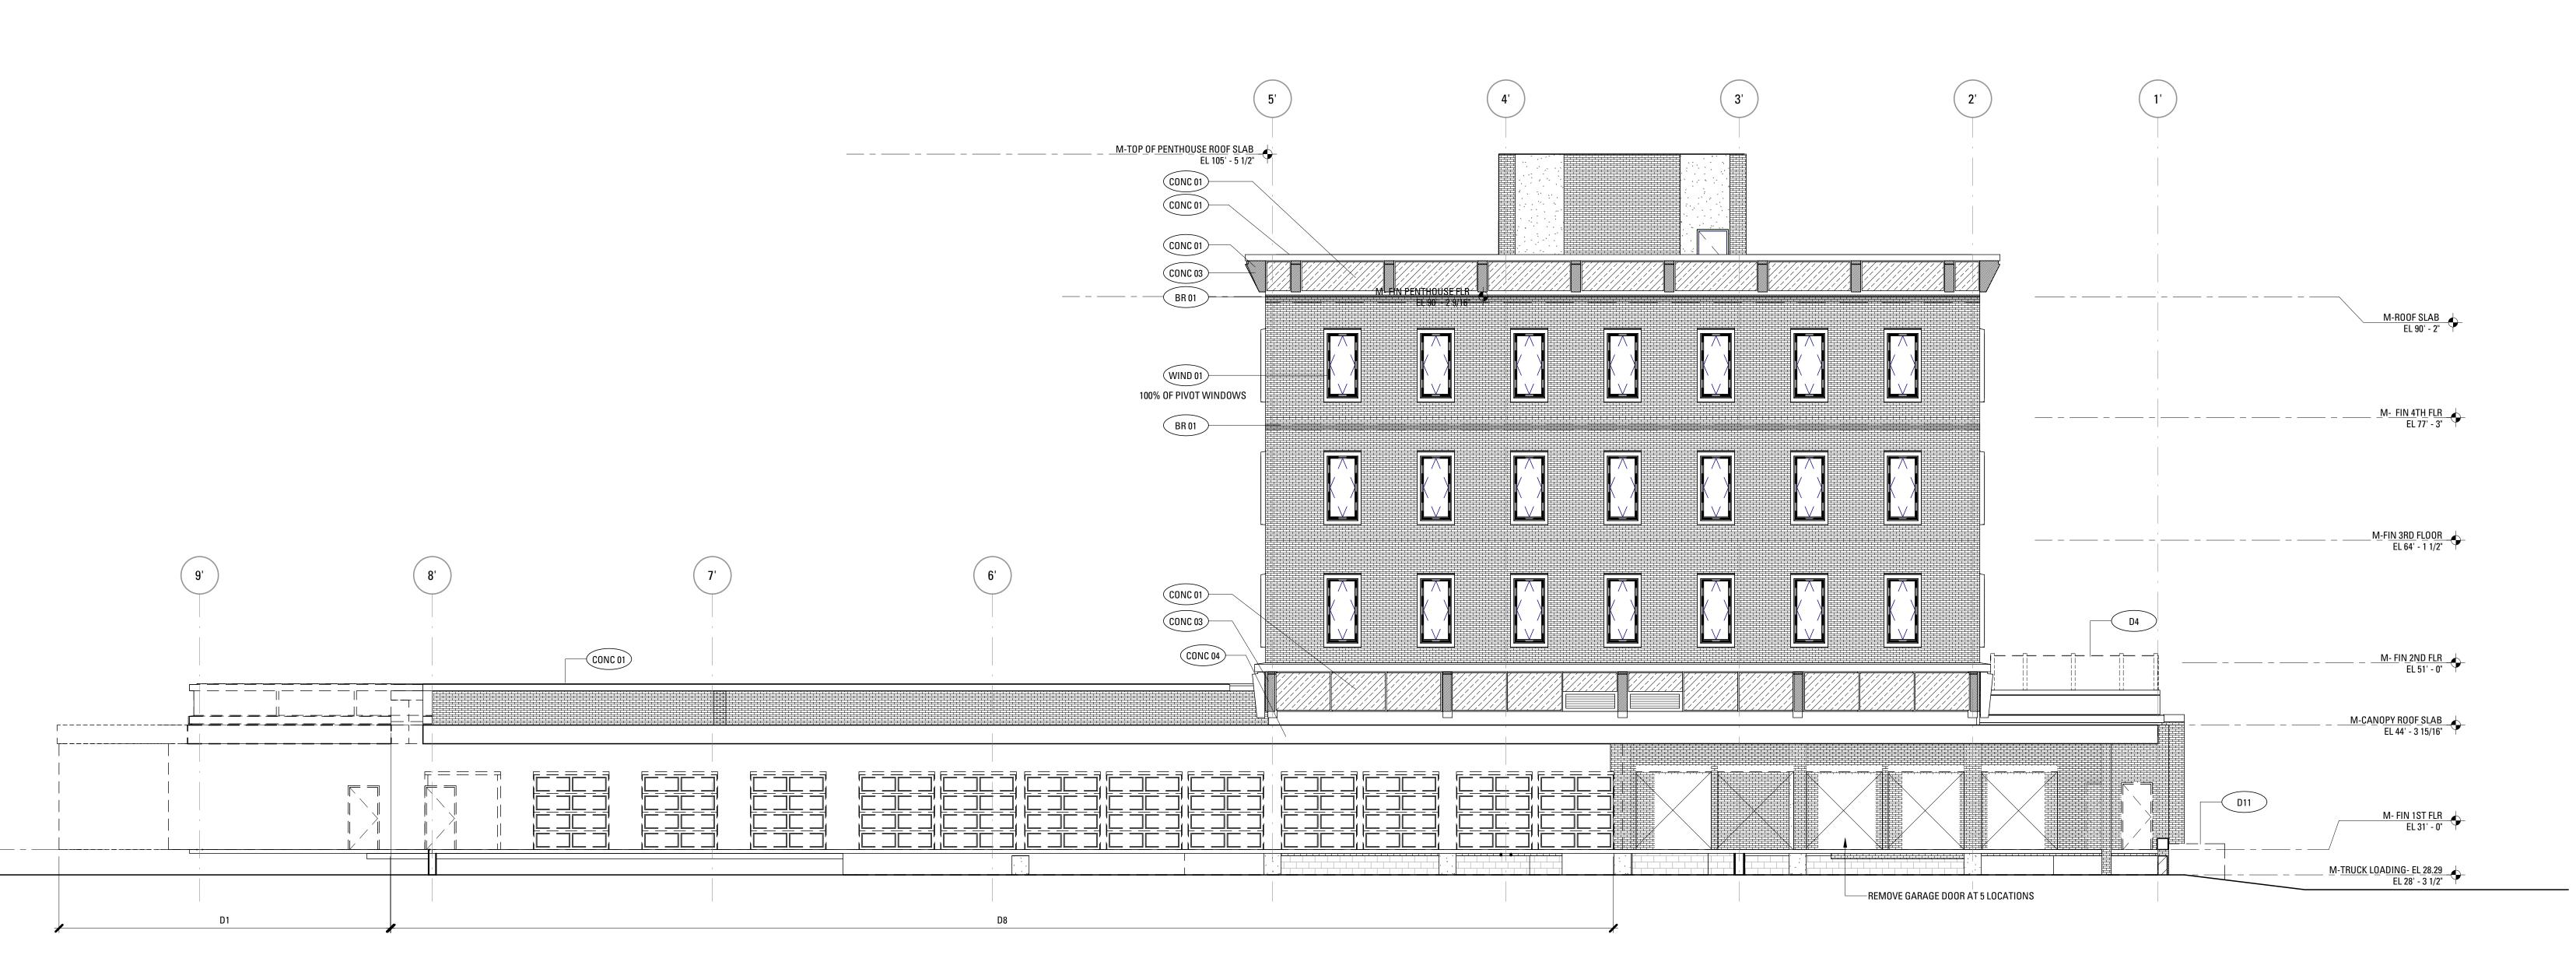
McINTYRE BLDG. - NORTH ELEVATION (DEMOLITION & RESTORATION)

RESTORATION KEY
ID CODE	RESTORATION ITEM
BR 01	BRICK REPOINTING - ALLOW FOR CUTTING OUT AND REPOINTING CONTINUOUSLY AT 3RD FLOOR RELIEVING ANGLE, AT BASE OF CONCRETE CORNICE, AND ABOVE AND BELOW PROJECTING SLAB BELOW 2ND FLOOR WINDOWS (2000 LF TOTAL). ASSUME REPOINTING FOR 20% OF PRECAST WINDOW SURROUNDS (500 LF).
BR 02	BRICK REPAIR - CUT OUT AND REPLACE-TO-MATCH 100 EA. BRICKS AT VERTICAL FRACTURE AND REMOVAL OF WALL-MOUNTED ELECTRIC CONDUIT BRACKETS IN WEST WING EXTERIOR WALL, AT REMOVAL OF METAL PLAQUES AND LETTERING ON SOUTH. REPAIR ADJACENT BRICK WALL AREAS WHERE NEW OPENINGS ARE CREATED IN PENHALLOW STREET FRONTAGE AT RECESSED ENTRANCE, SOUTHWEST CORNER, AND MAILING PLATFORM AND DANIEL STREET WHERE POST OFFICE ENTRANCES ARE ALTERED, AND AT DEMOLITION MARGIN ON EAST FACADE. ASSUME 120 SF.
CONC 01	CONCRETE CLEANING - CLEAN ALL EXPOSED CONCRETE AT THE ARCADE, ABOVE SINGLE-STORY WINGS, AT FACES OF MAILING PLATFORM ROOF SLAB, AT SLAB PROJECTING BELOW 2ND FLOOR WINDOWS. CLEAN EXPOSED CAST-IN-PLACE CONCRETE CORE SUPPORTS FOR ALL CORNICE BRACKETS. CLEAN PRECAST WINDOW SURROUNDS AT SINGLE STORY EAST WING.

CONC 03	CONCRETE BRACKET REPAIR - DETACH AND REINSTALL FACE-MOUNTED "CAST STONE" CORNICE BRACKET PANELS. ALLOW FOR 5 LOCATIONS.
CONC 04	CONCRETE SURFACE REPAIR - REPAIR SPALLED AND CRACKED PRECAST SURFACES TO MATCH EXISTING. REPAIR ANCHORAGE LOCATIONS AT STAINLESS STEEL COLUMN ENCASEMENT LOCATIONS ON FOUR ARCADE COLUMNS AND RESTORE CONCRETE COLUMN FACES.
IR-01	CLEAN AND PROTECT POLISHED MARBLE WALL PANELS.
IR-02	CLEAN AND PROTECT TERRAZZO FLOOR AND ZINC DIVIDERS.
IR-04	PROTECT AND RETAIN PLASTER CEILING SOFFIT AND VAULT IN ELEVATOR LOBBY AND VESTIBULE.
IR-05	CLEAN AND PROTECT STAINLESS STEEL ELEVATOR DOORS AND FRAME.
IR-06	PROTECT AND RETAIN EXISTING GLAZED PARTITION IN ORIGINAL OPENING.
IR-07	RETAIN AND RELOCATE BRONZE DEDICATION/RE-DEDICATION PLAQUE.
STOR 01	STOREFRONT - RETAIN ALUMINUM 'STOREFRONT' , FIXED GLAZING AT 6-PANEL BOWED AND FLAT WINDOWS TO REMAIN AT GROUND FLOOR (8 EA.) INSTALL CLEAR SAFETY FILM ON ALL PANES (2'-6" X 13'-0" HIGH) INCLUDING SPANDREL GLASS.

WIND 01	WINDOW - ALUMINUM PIVOT WINDOWS IN OFFICES (144 EA.) AND POST OFFICE (2 EA.) INSTALL NEW ALUMINUM INTERIOR STORM SASHES TO MATCH EXISTING CLEAR FINISH WITH ALUMINUM FRAME. DEMOUNTABLE. APPROXIMATE PANEL SIZE 1/2" THICK X 2'-10" WIDE X 7'-9" HIGH. NEW LOW-EMISSIVITY GLASS WILL DIFFER BETWEEN TWO SETS OF ELEVATIONS. ASSUME ABATEMENT OF EXISTING GLAZING SEALANT. REPLACE NEOPRENE DRAFT STOPS AROUND EACH SASH.

- D4 REMOVE EXISTING PLASTIC SKYLIGHT AND PROTECT EXPOSED CONCRETE BEAMS.
- D5 CAREFULLY REMOVE EXISTING STAINLESS STEEL CASING AT CONCRETE COLUMNS.
- D6 REMOVE AND SALVAGE PHOTOVOLTAIC PANELS.

- PREMOVE BRICK OUTDOOR VESTIBULE INCLUDING FOUNDATIONS.
- D8 REMOVE LOADING DOCK BRICK WALL AND OVERHEAD DOORS. PROTECT COLUMNS AND CANOPY ROOF.
- D9 REMOVE EXISTING PARTITIONS, FLOOR COVERINGS, WALL TILE, CEILINGS, TOILET FIXTURES, AND BUILDING SYSTEMS.
