PORTSMOUTH, NEW HAMPSHIRE

JULY 2019

# Wastewater Pump Station Master Plan

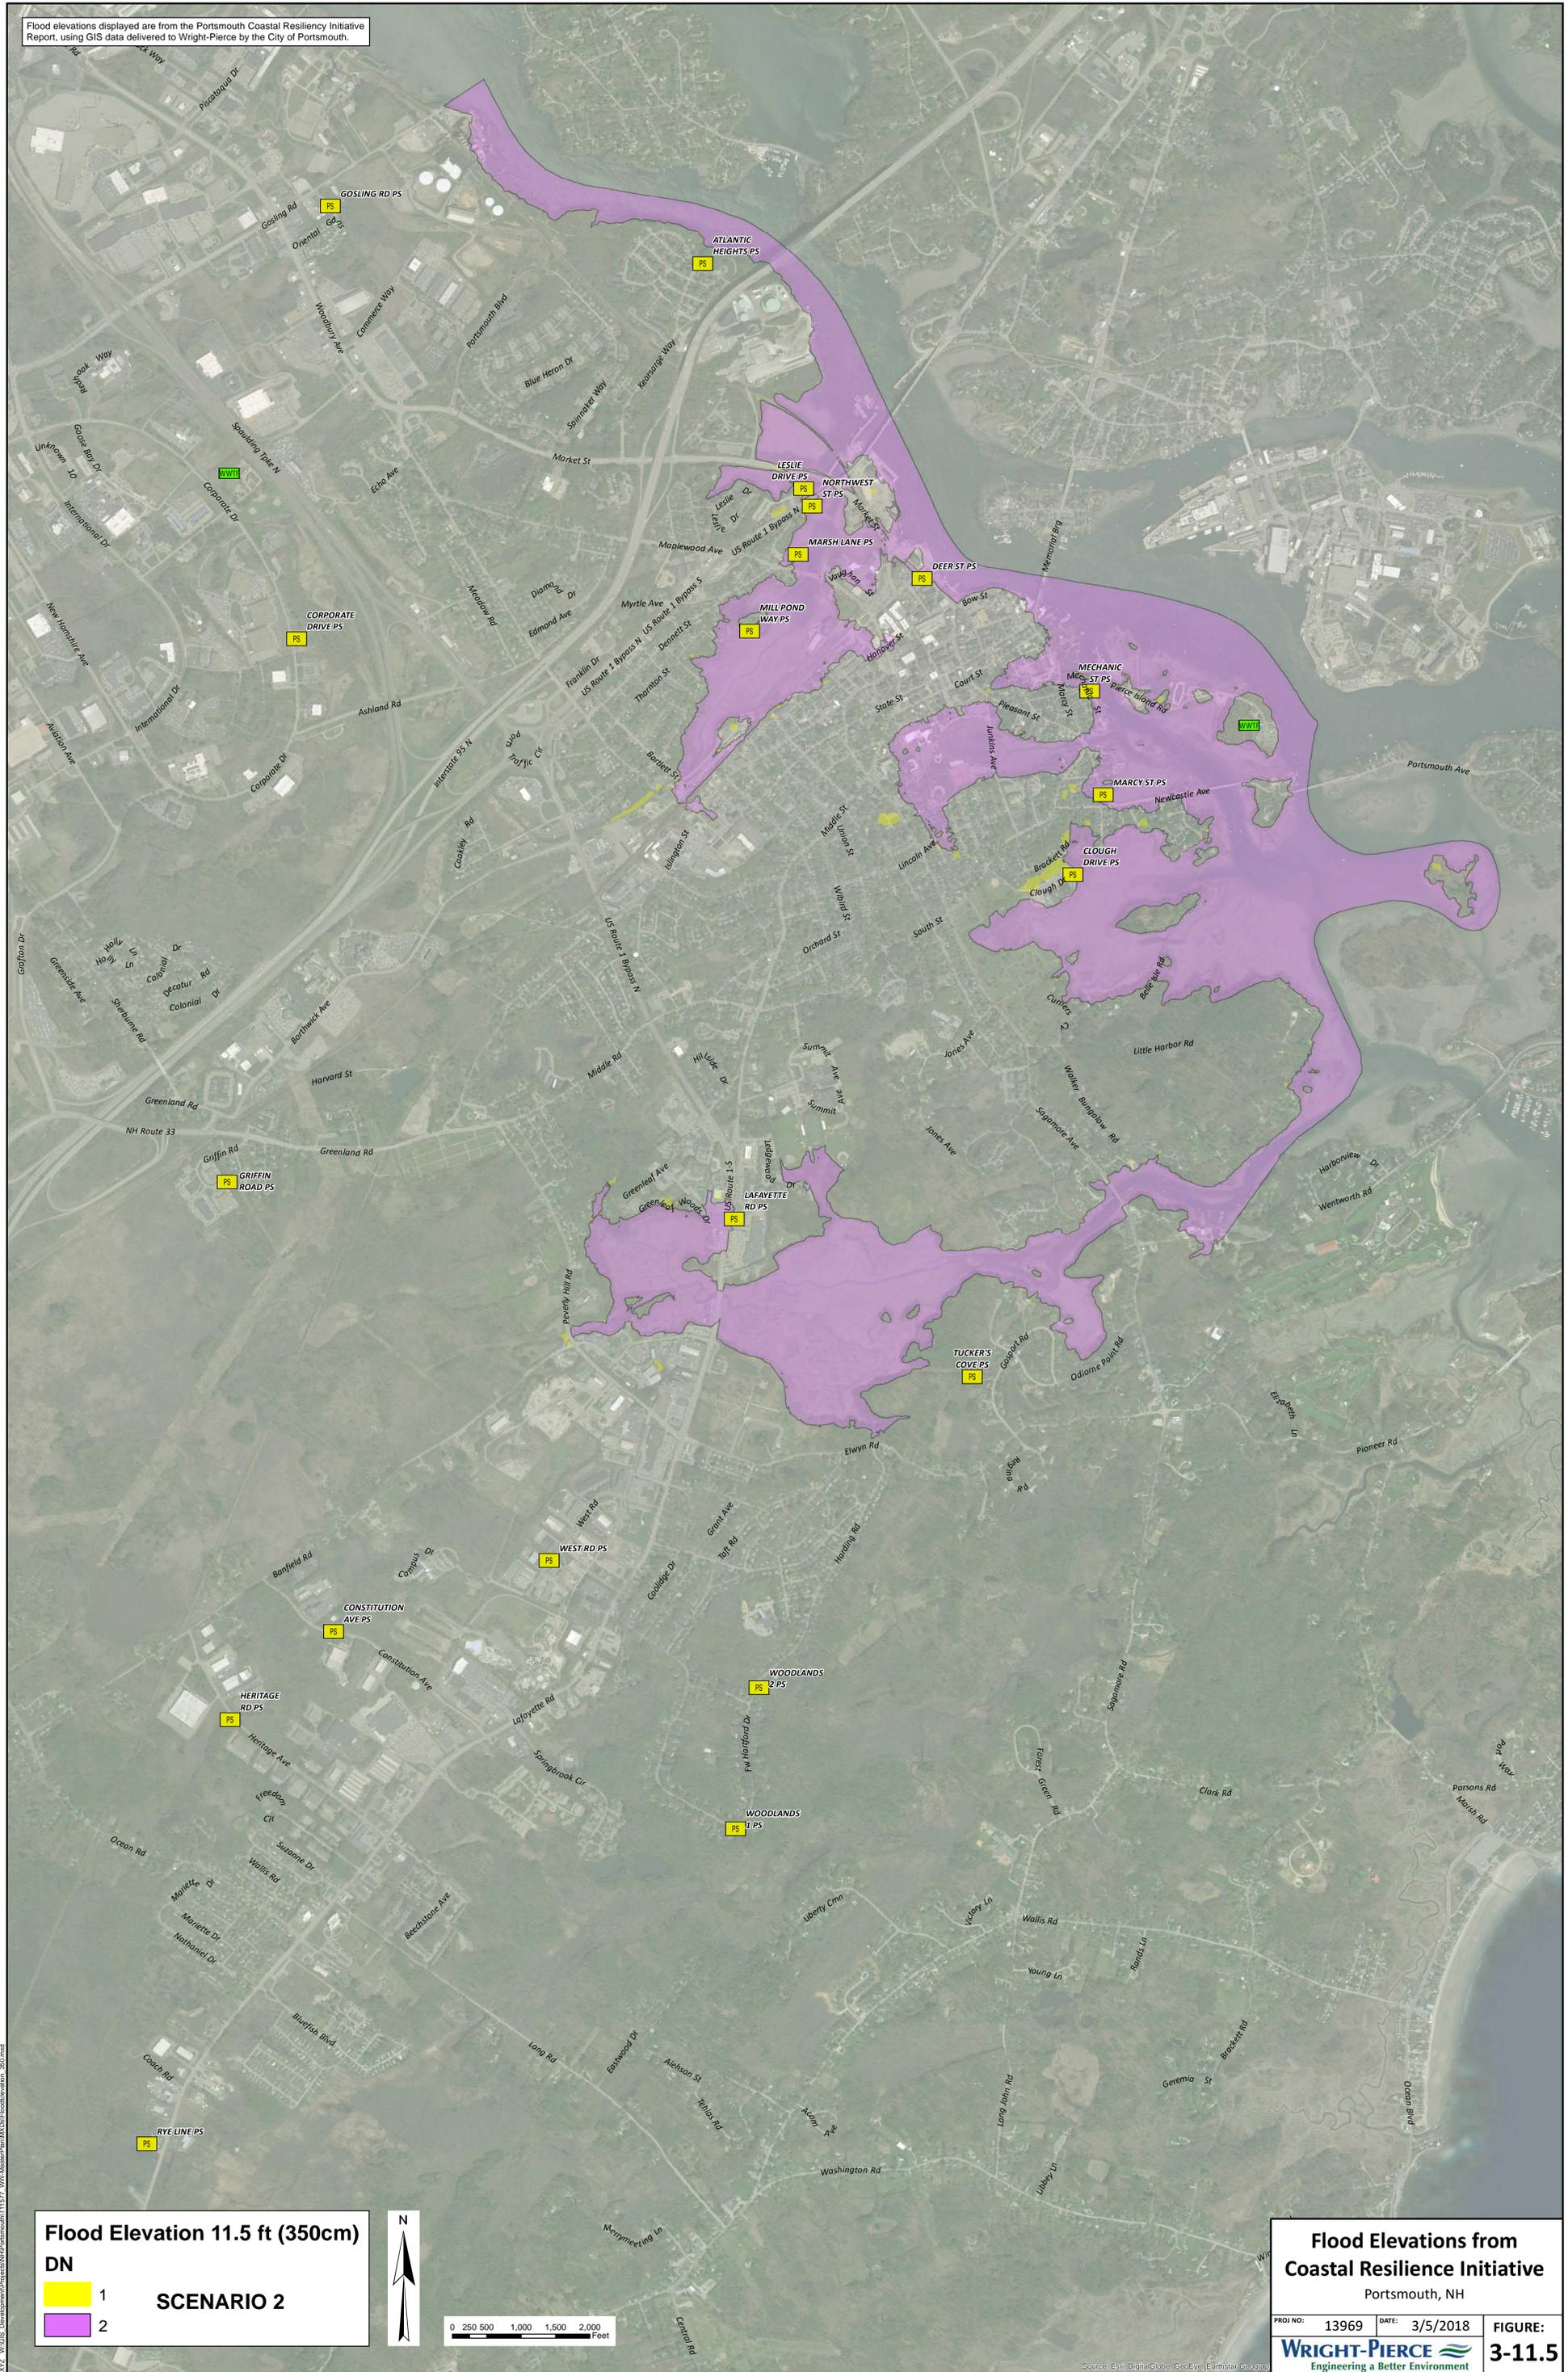
**Flood Elevation 11.5 ft (350cm)**  
**DN**

Flood elevations displayed are from the Portsmouth Coastal Resiliency Initiative Report, using GIS data delivered to Wright-Pierce by the City of Portsmouth.

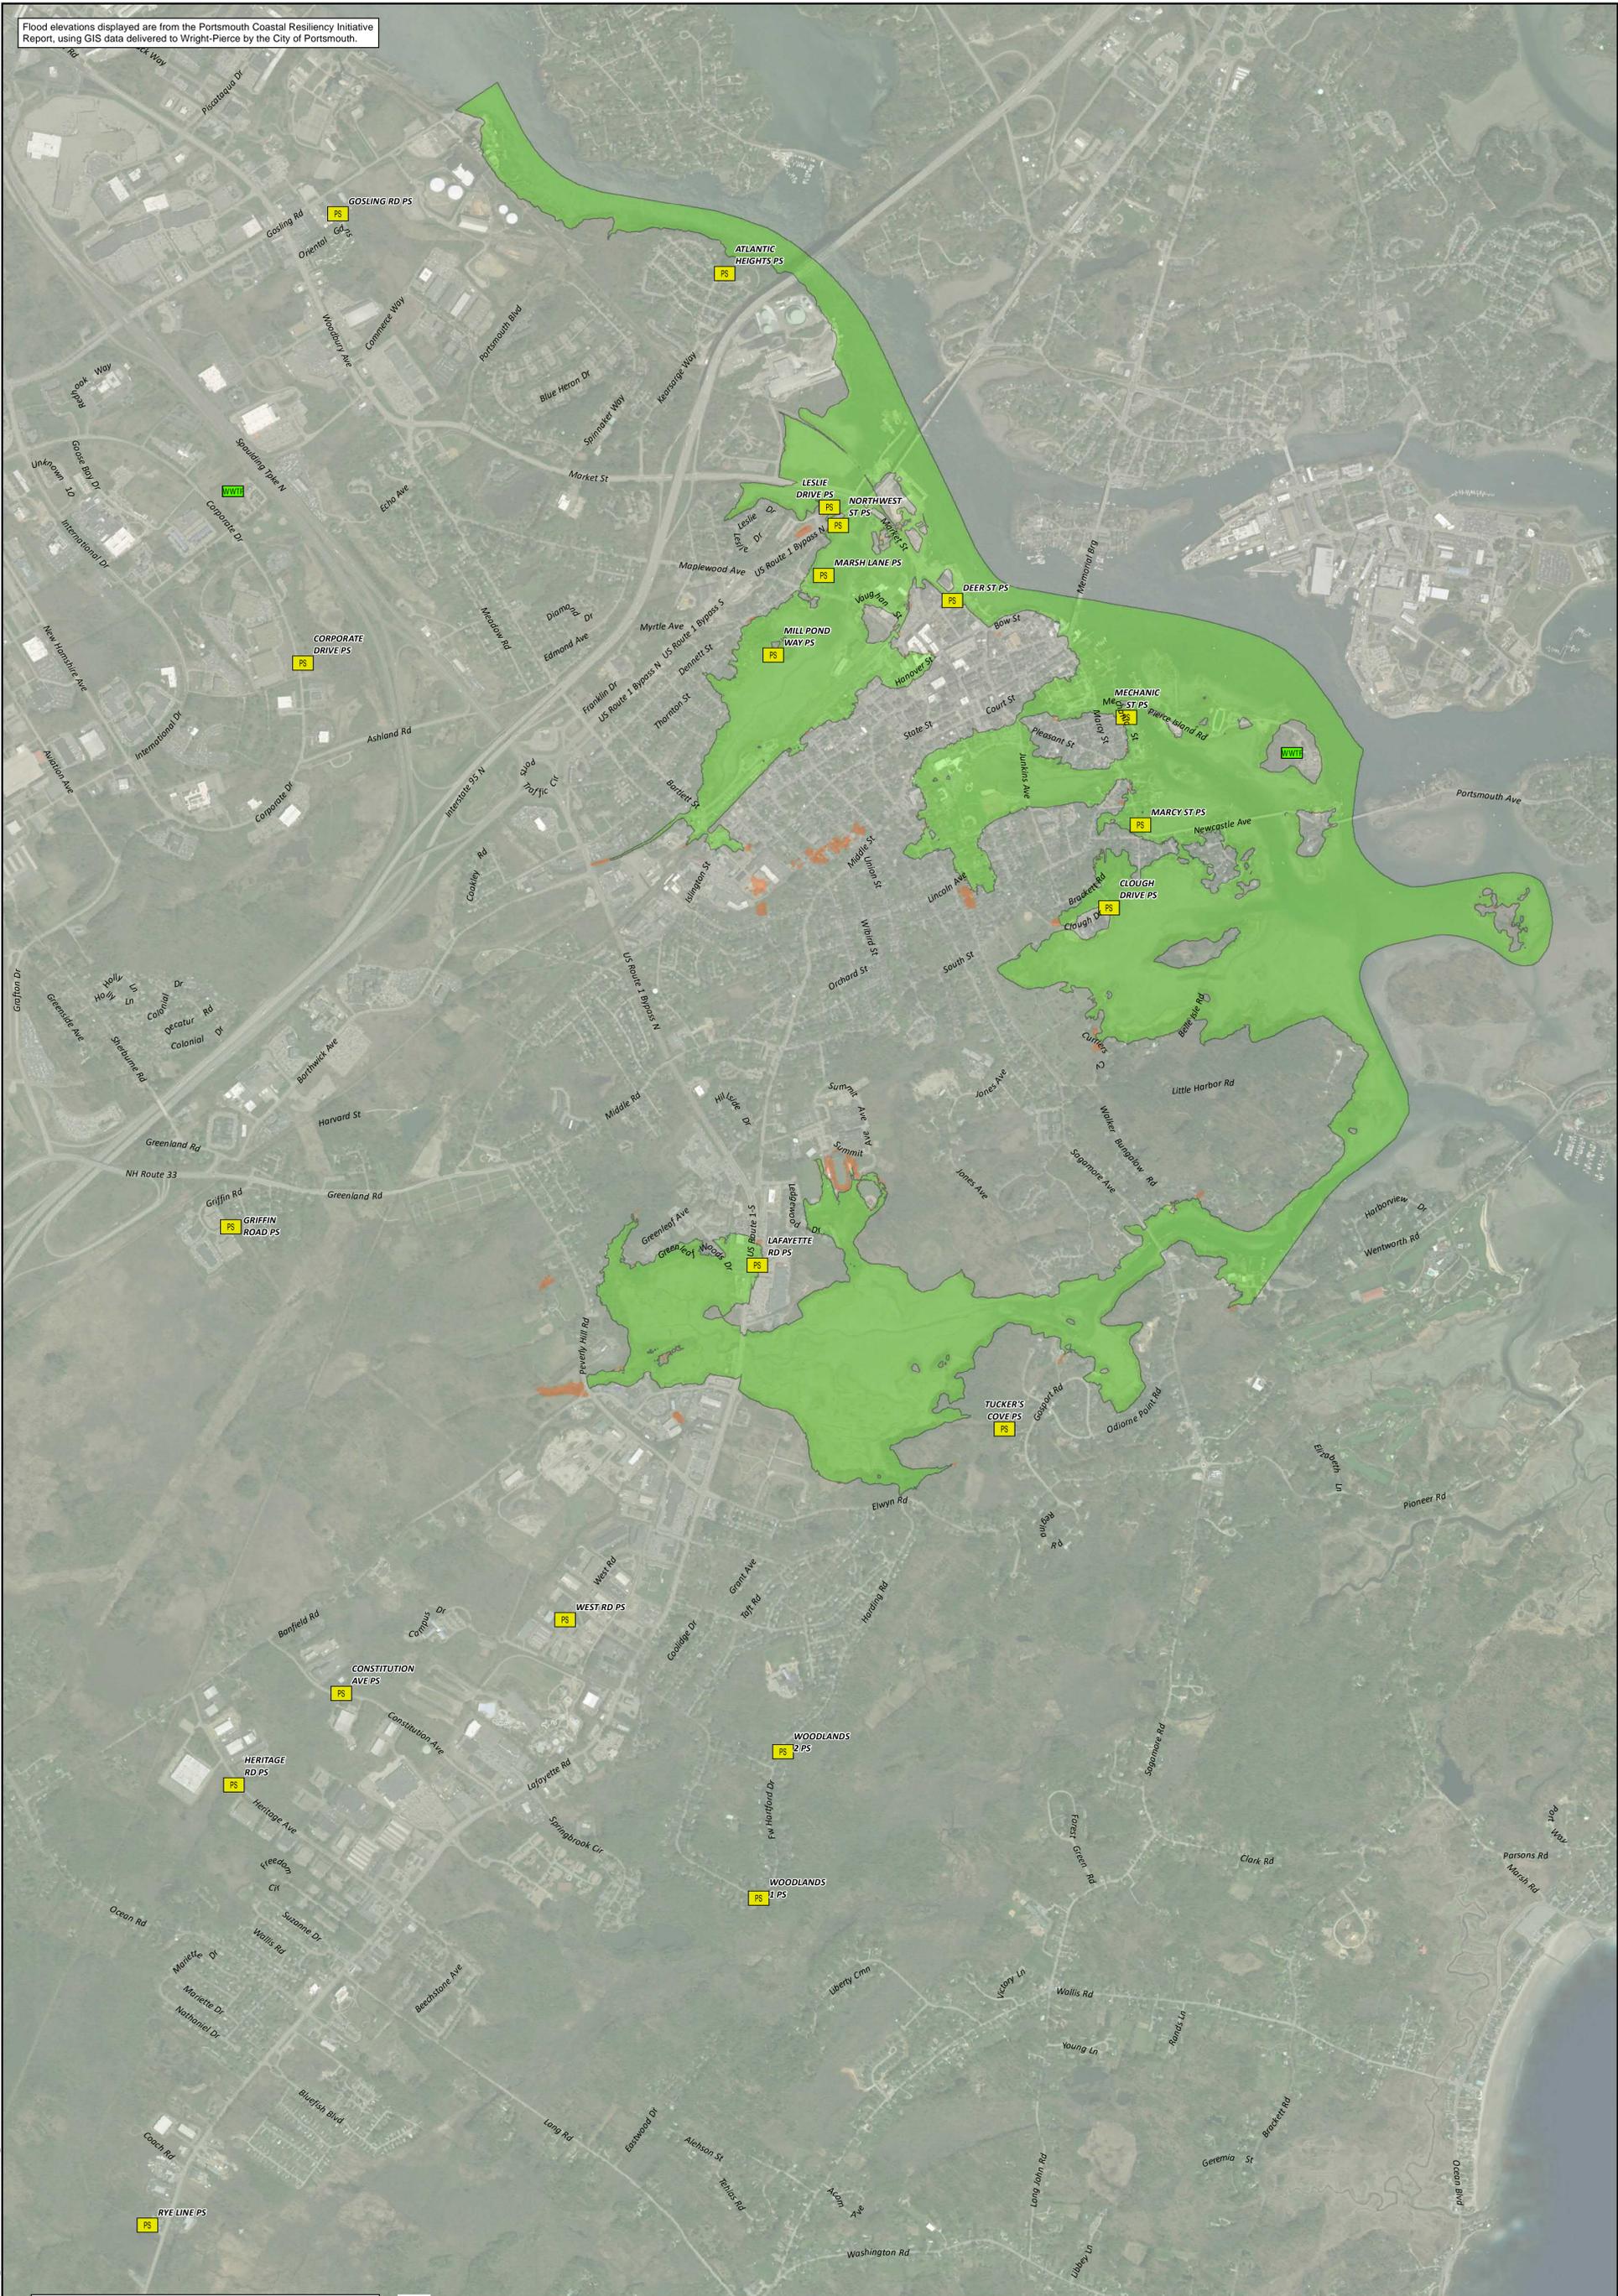
**Flood Elevation 13.5 ft (410cm)**  
**DN**

Flood elevations displayed are from the Portsmouth Coastal Resiliency Initiative Report, using GIS data delivered to Wright-Pierce by the City of Portsmouth.

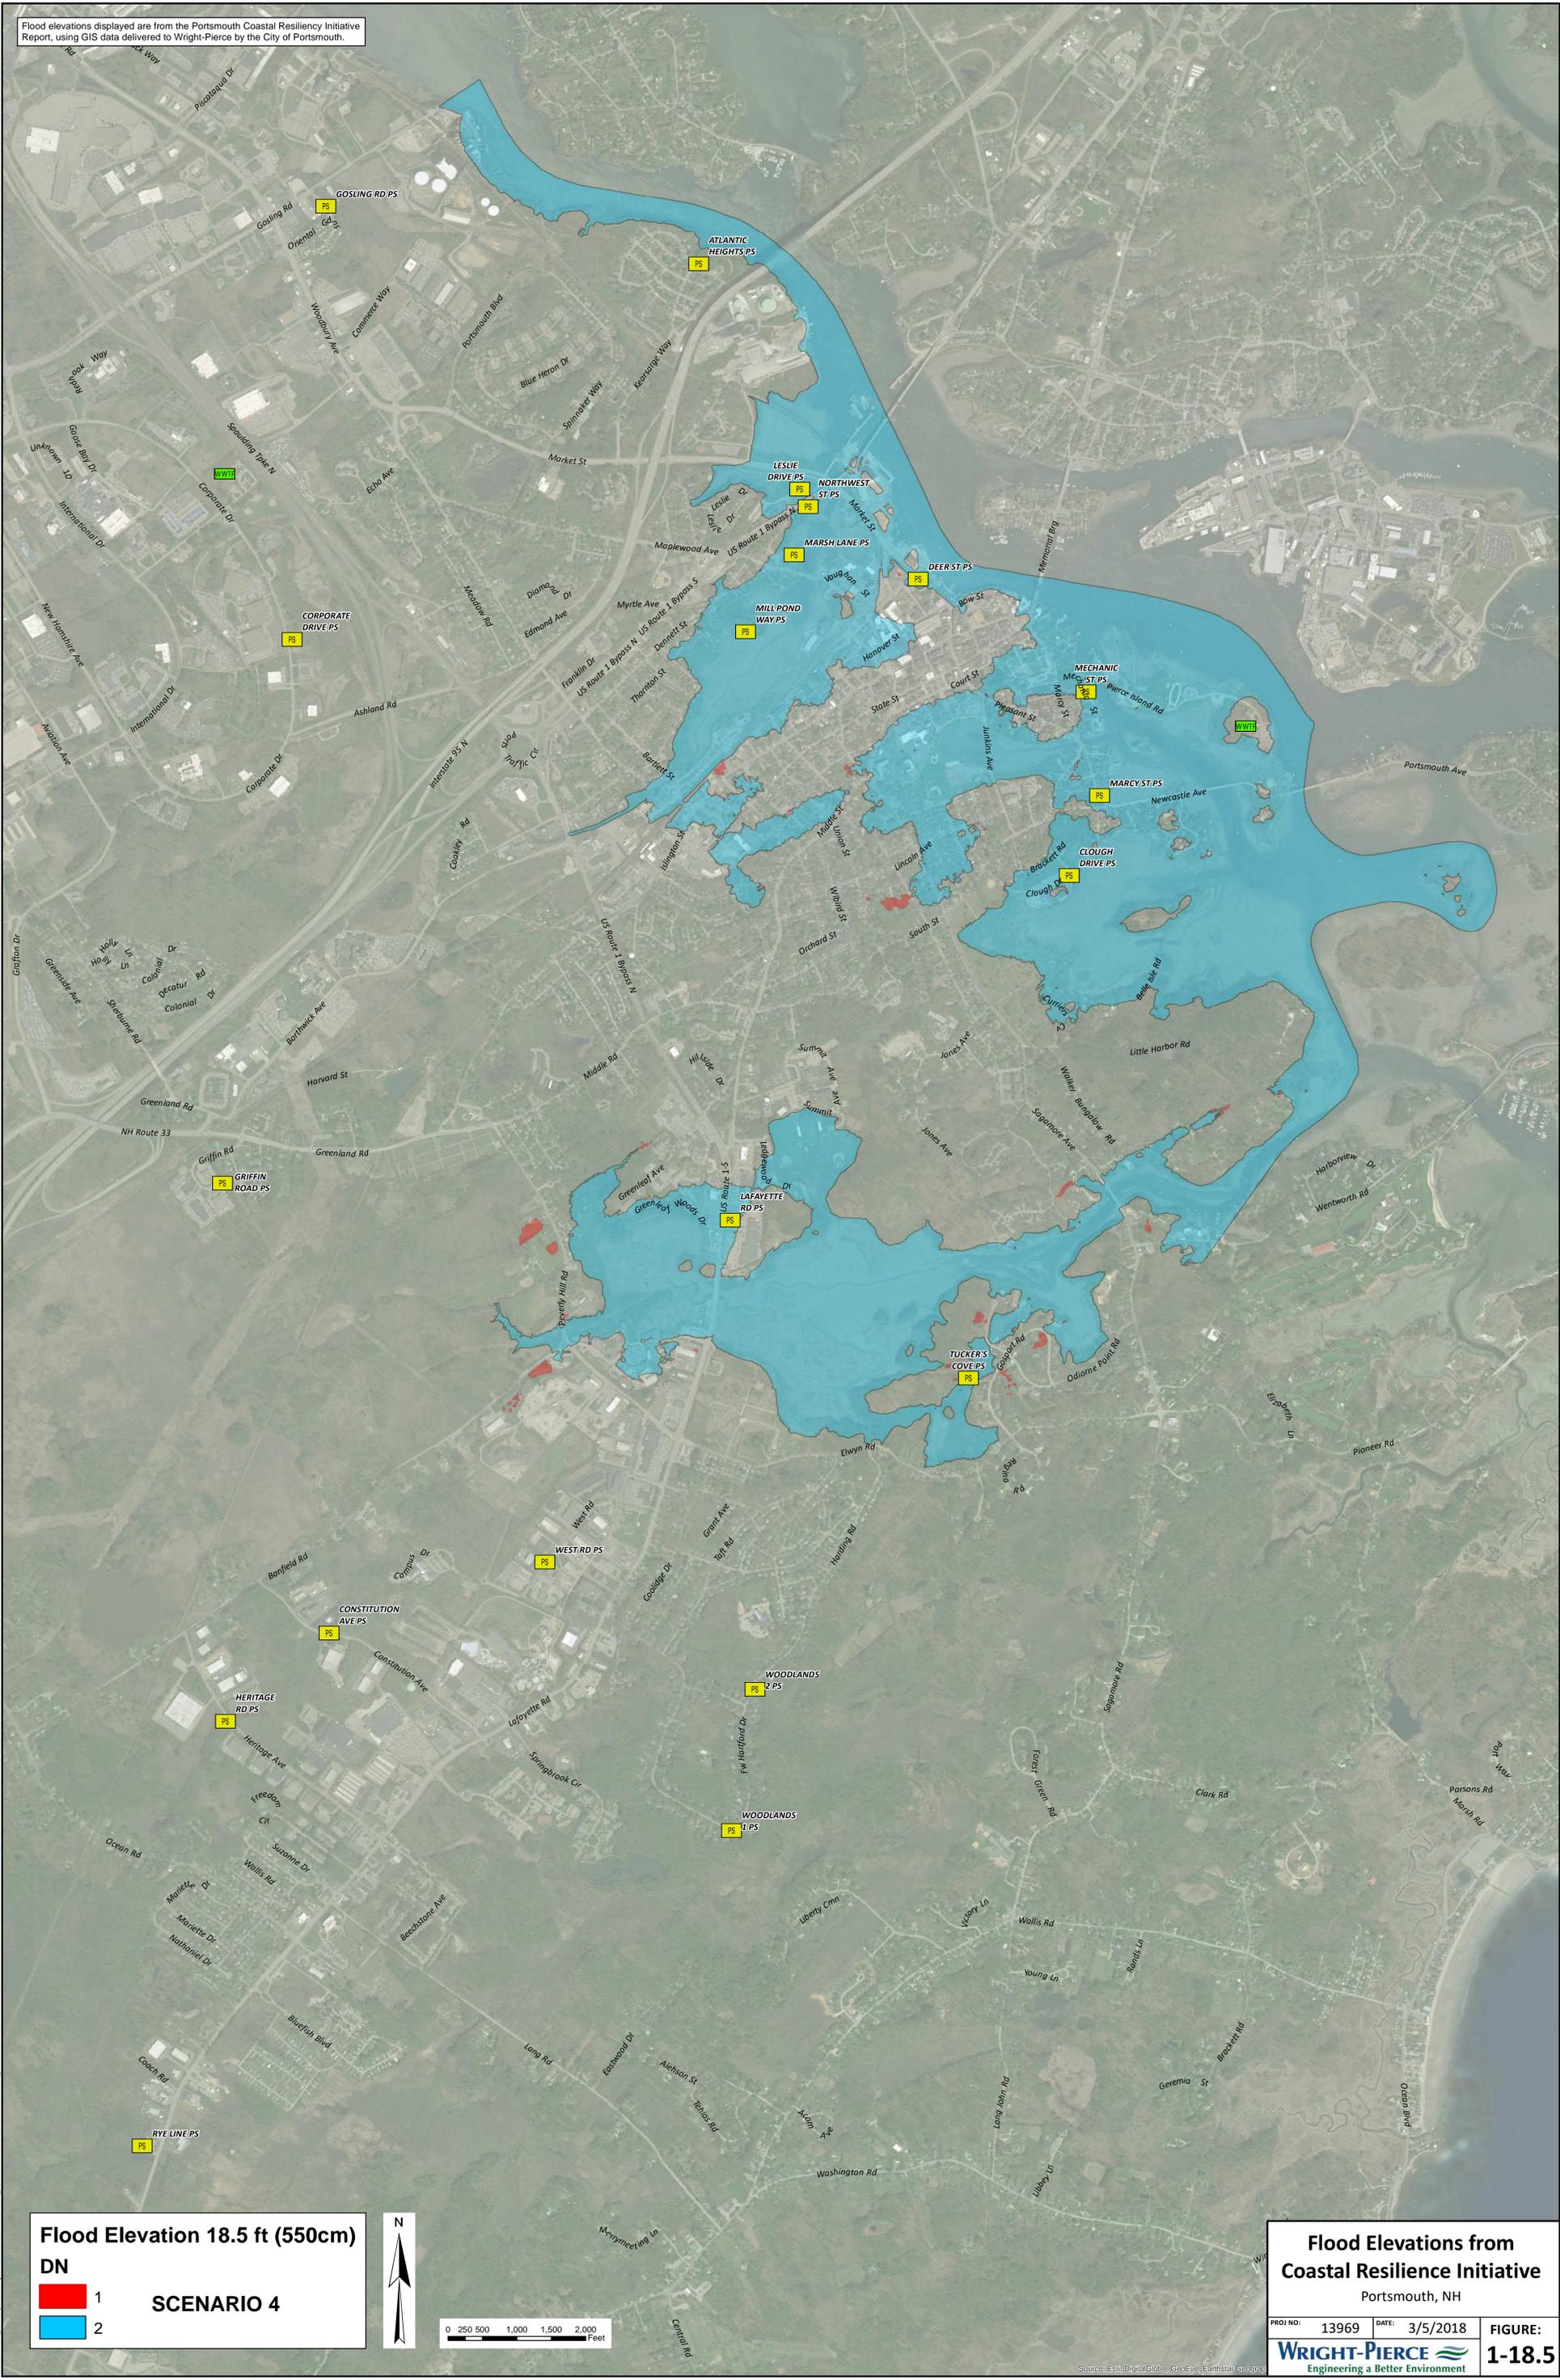
**Flood Elevation 18.5 ft (550cm)**  
**DN**  
 1  
 2  
**SCENARIO 4**

Flood elevations displayed are from the Portsmouth Coastal Resiliency Initiative Report, using GIS data delivered to Wright-Pierce by the City of Portsmouth.

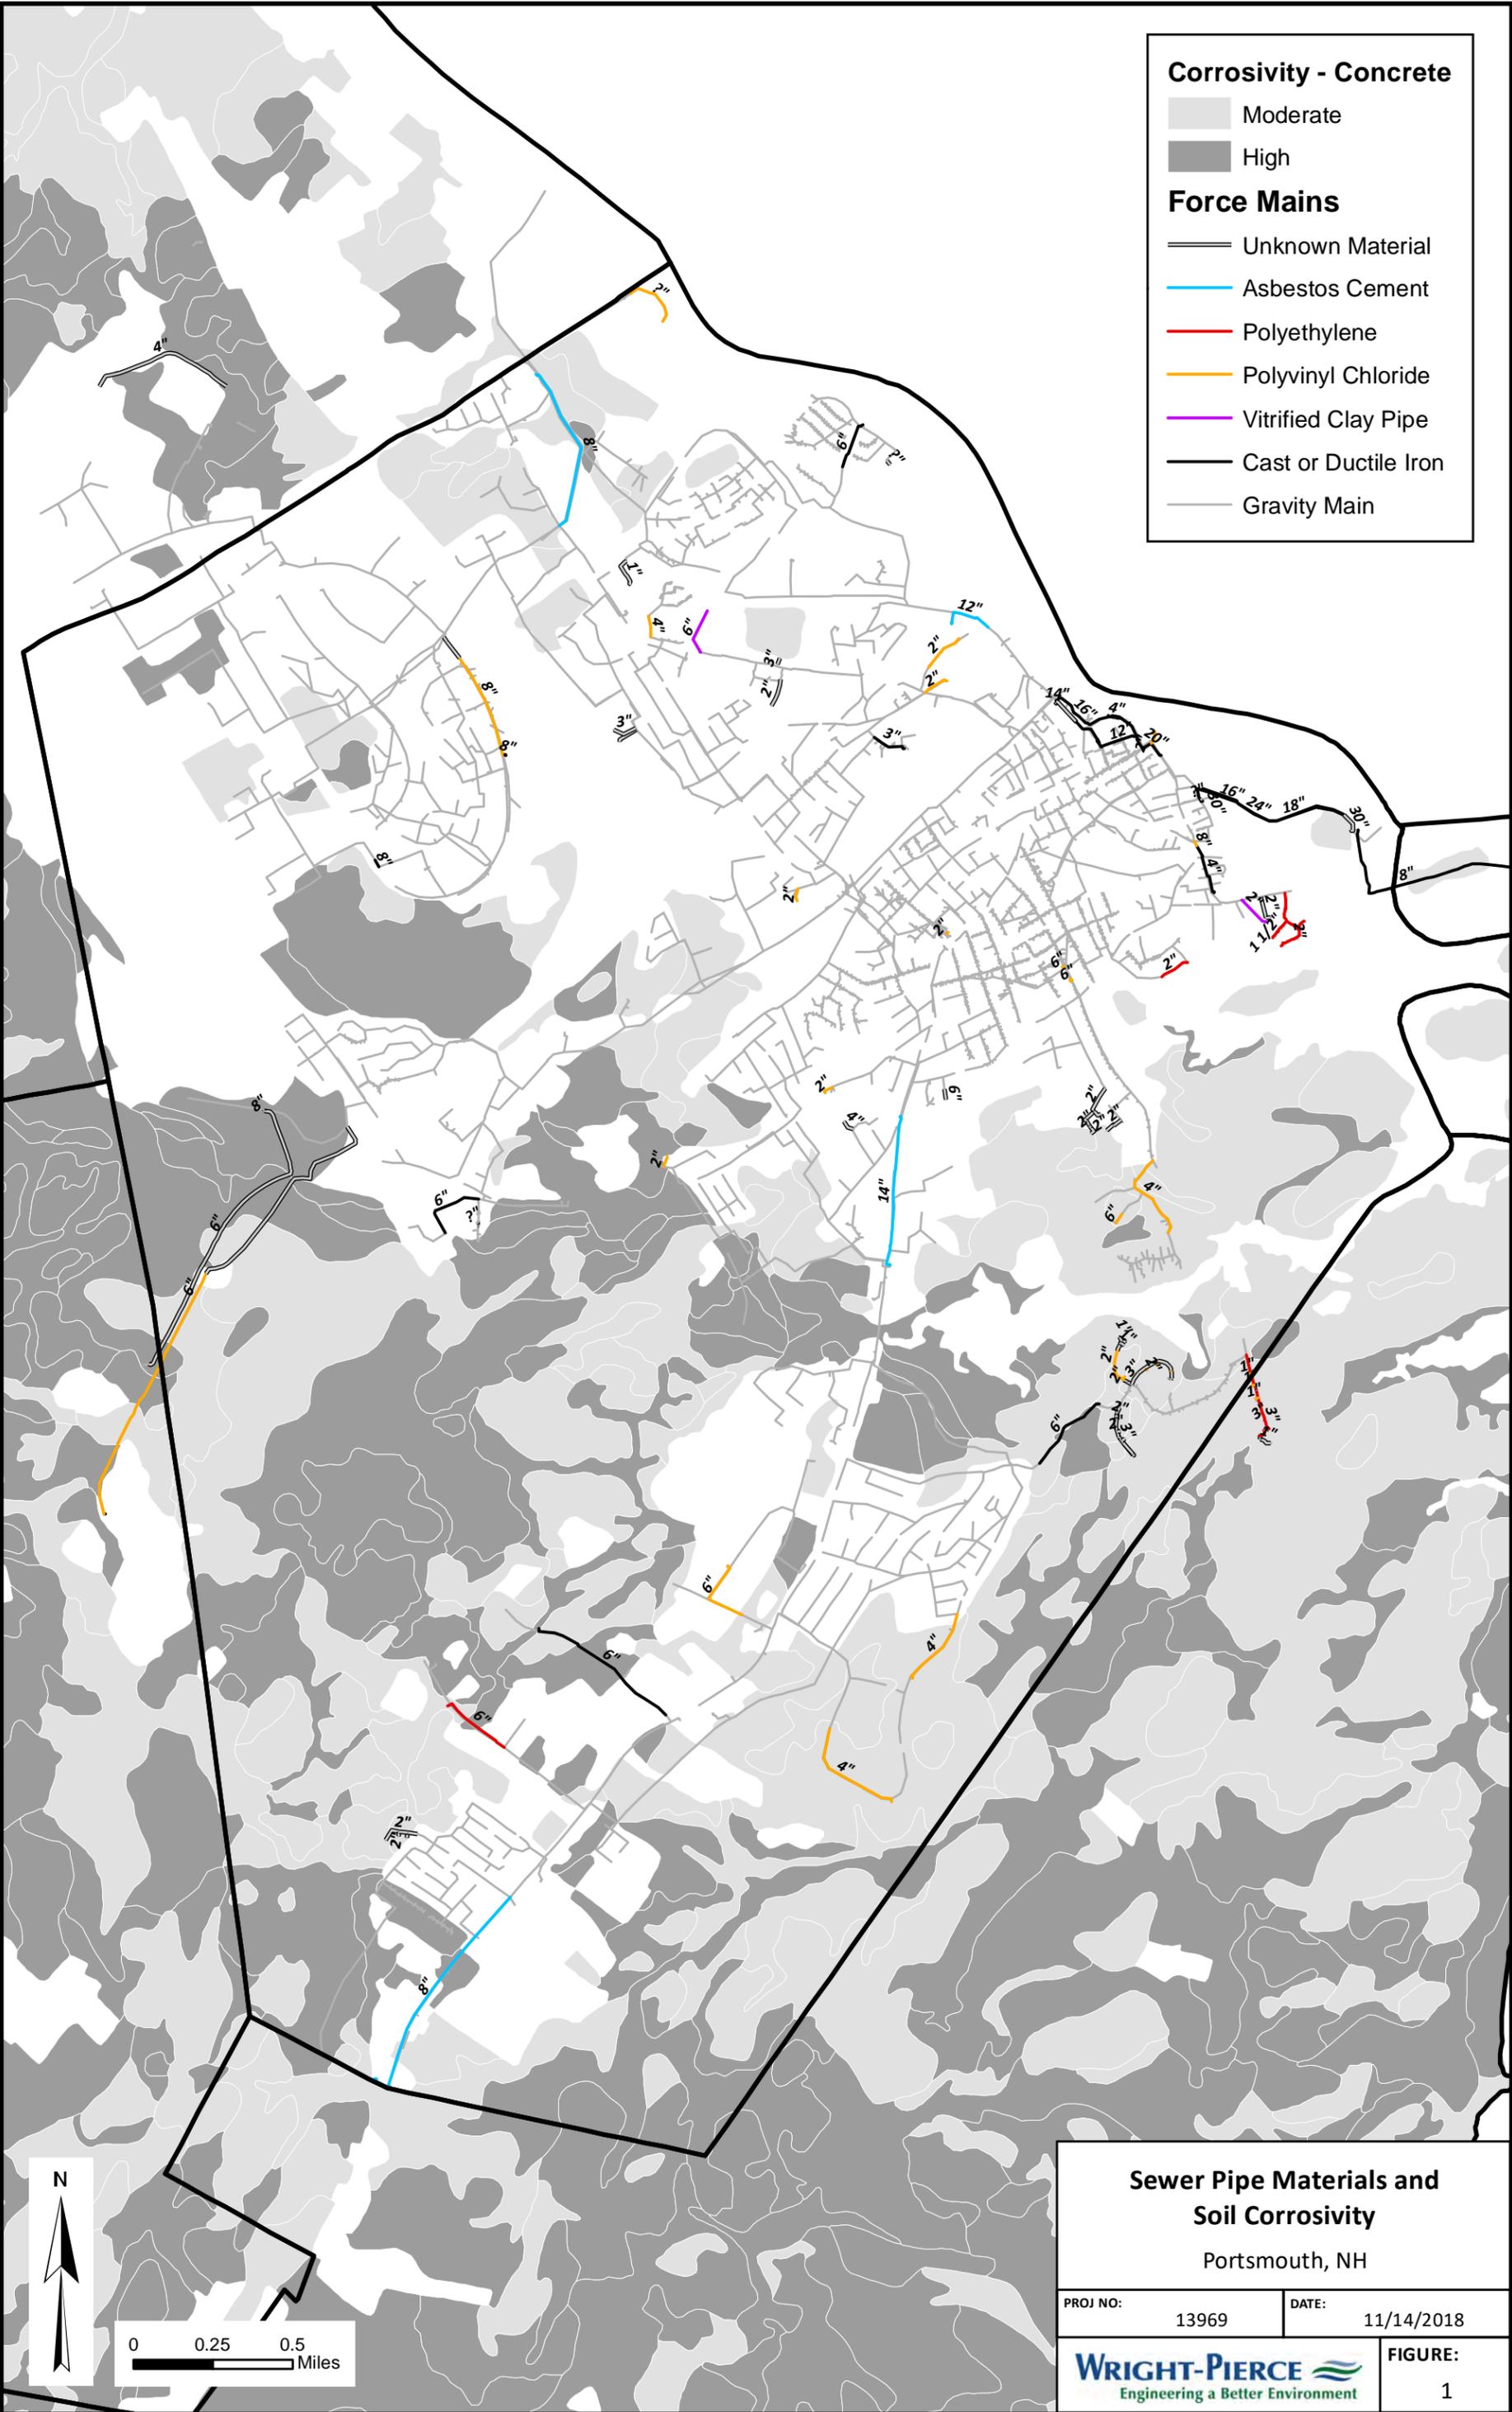
**Corrosivity - Concrete**

- Moderate
- High

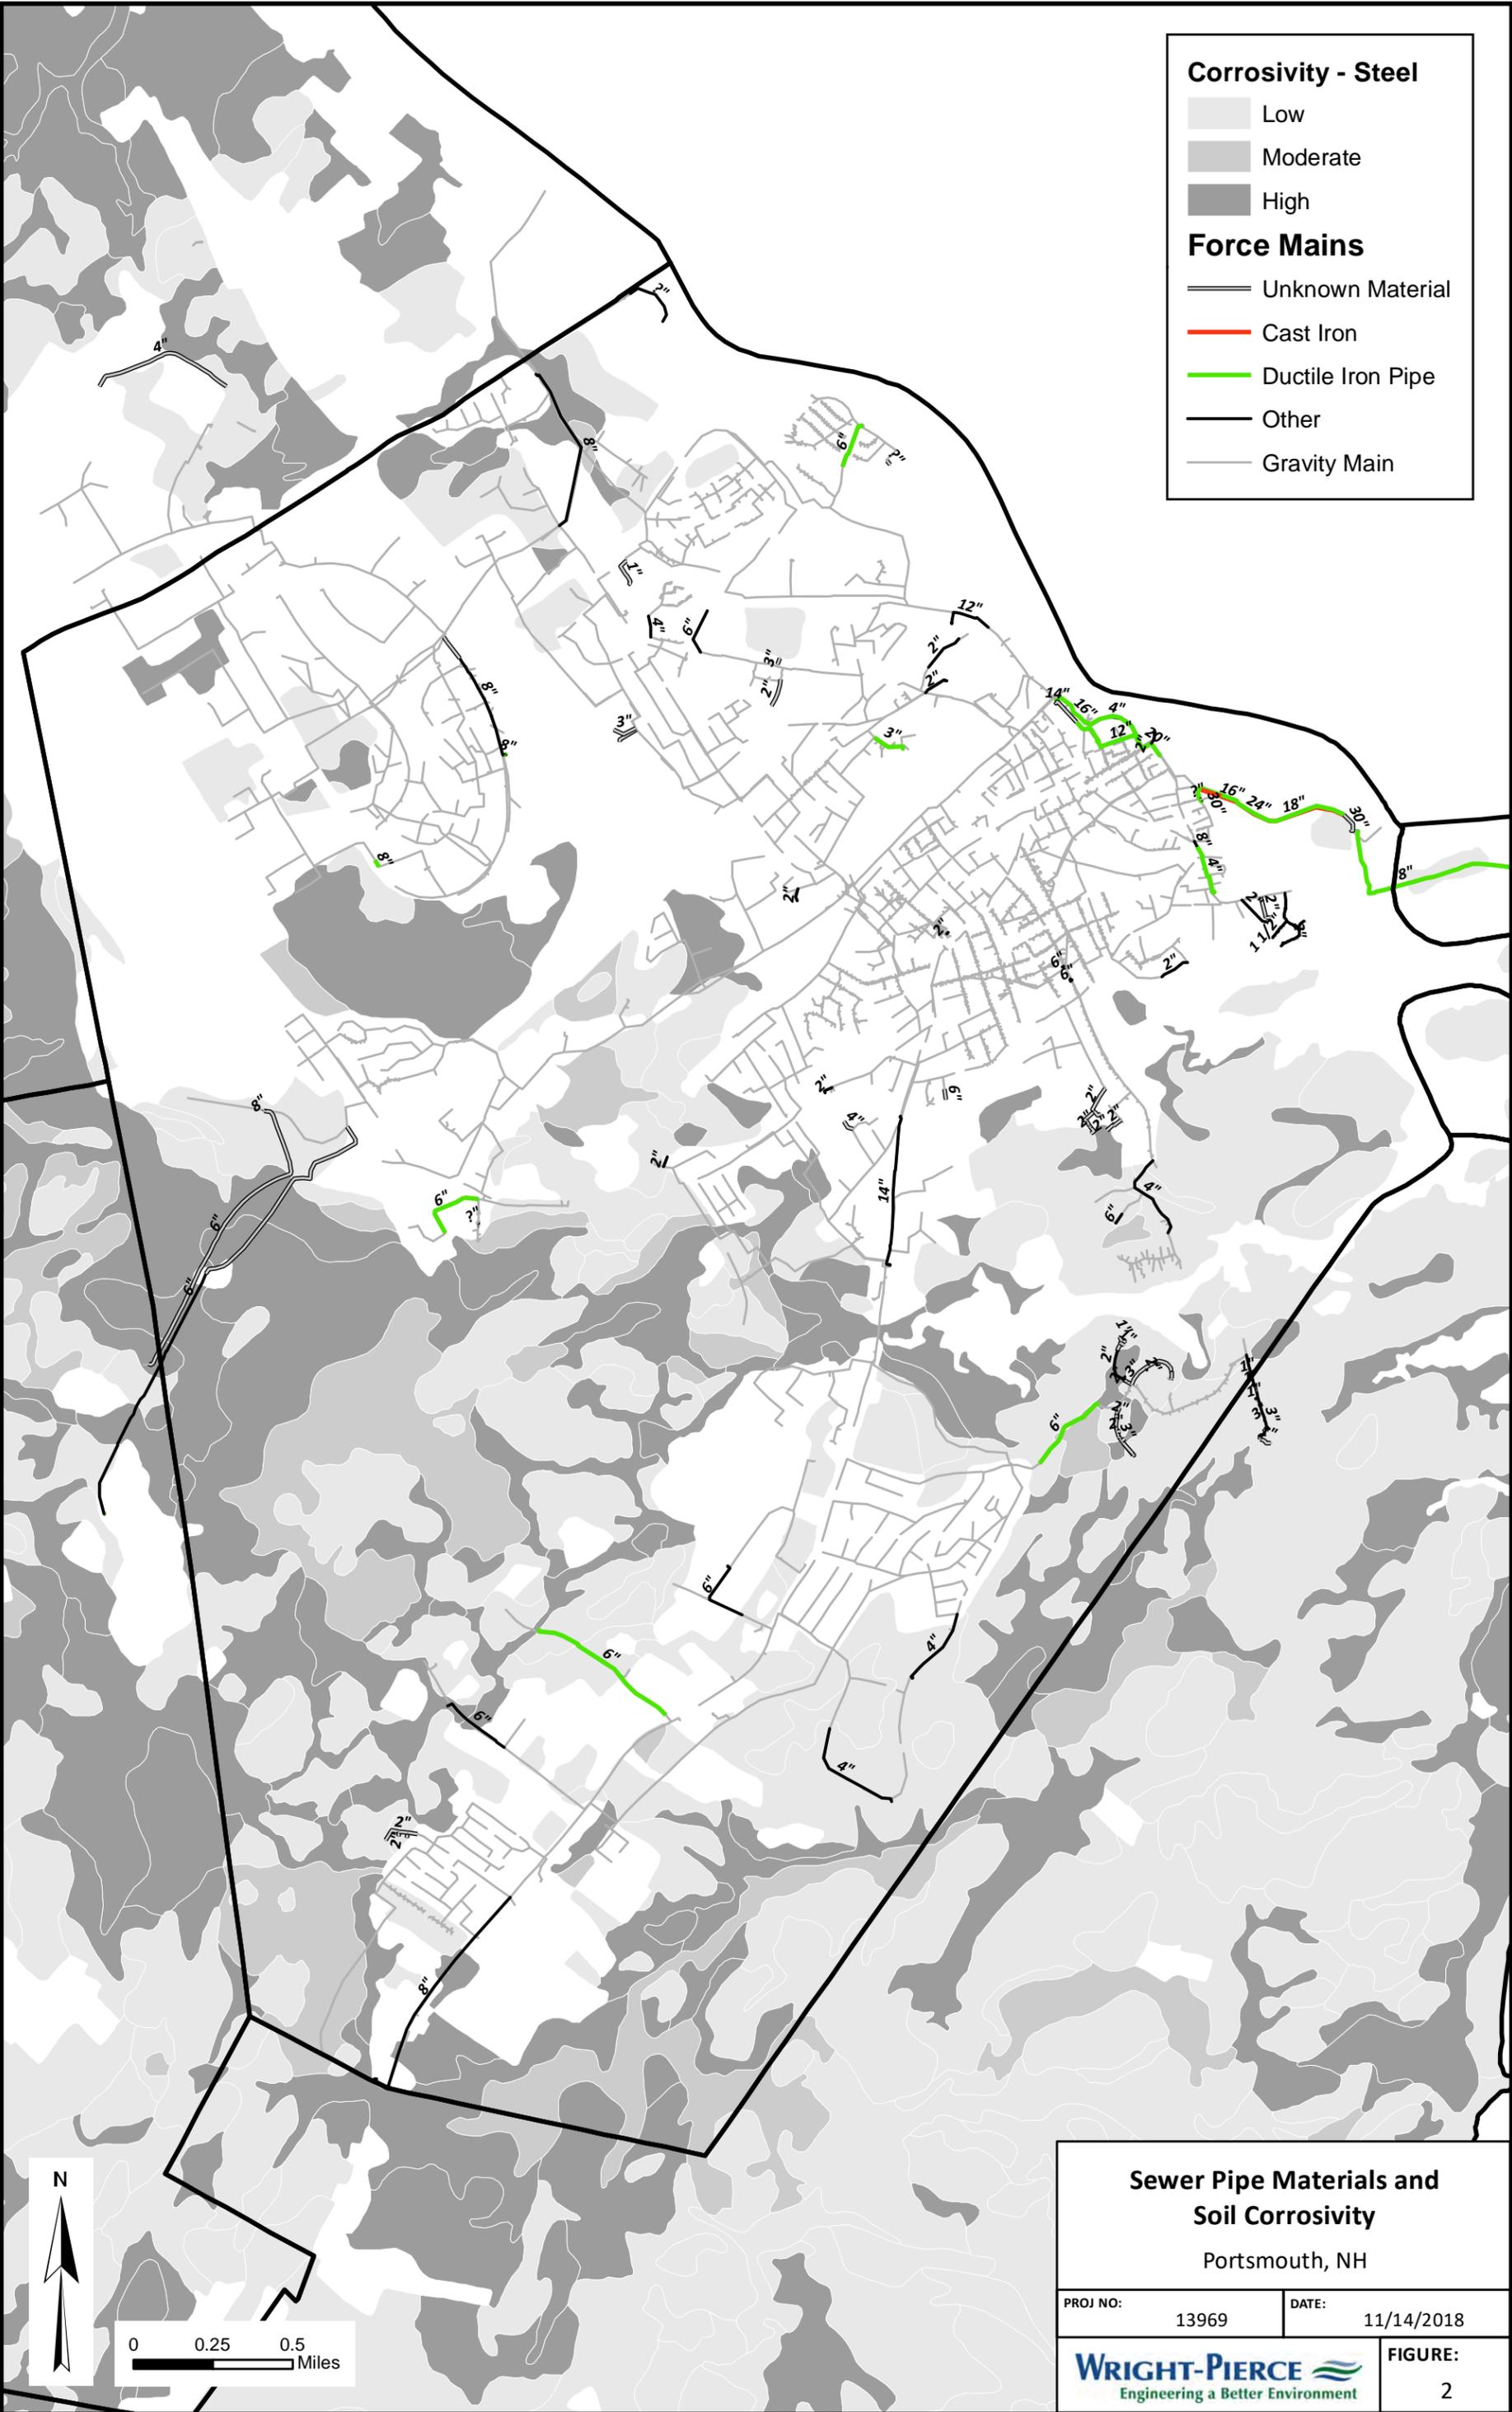
**Corrosivity - Steel**

- Low
- Moderate
- High
