# Sewer System Evaluation Survey (SSES) Infiltration Study

227950.01  
City of Portsmouth, NH  
July 2020

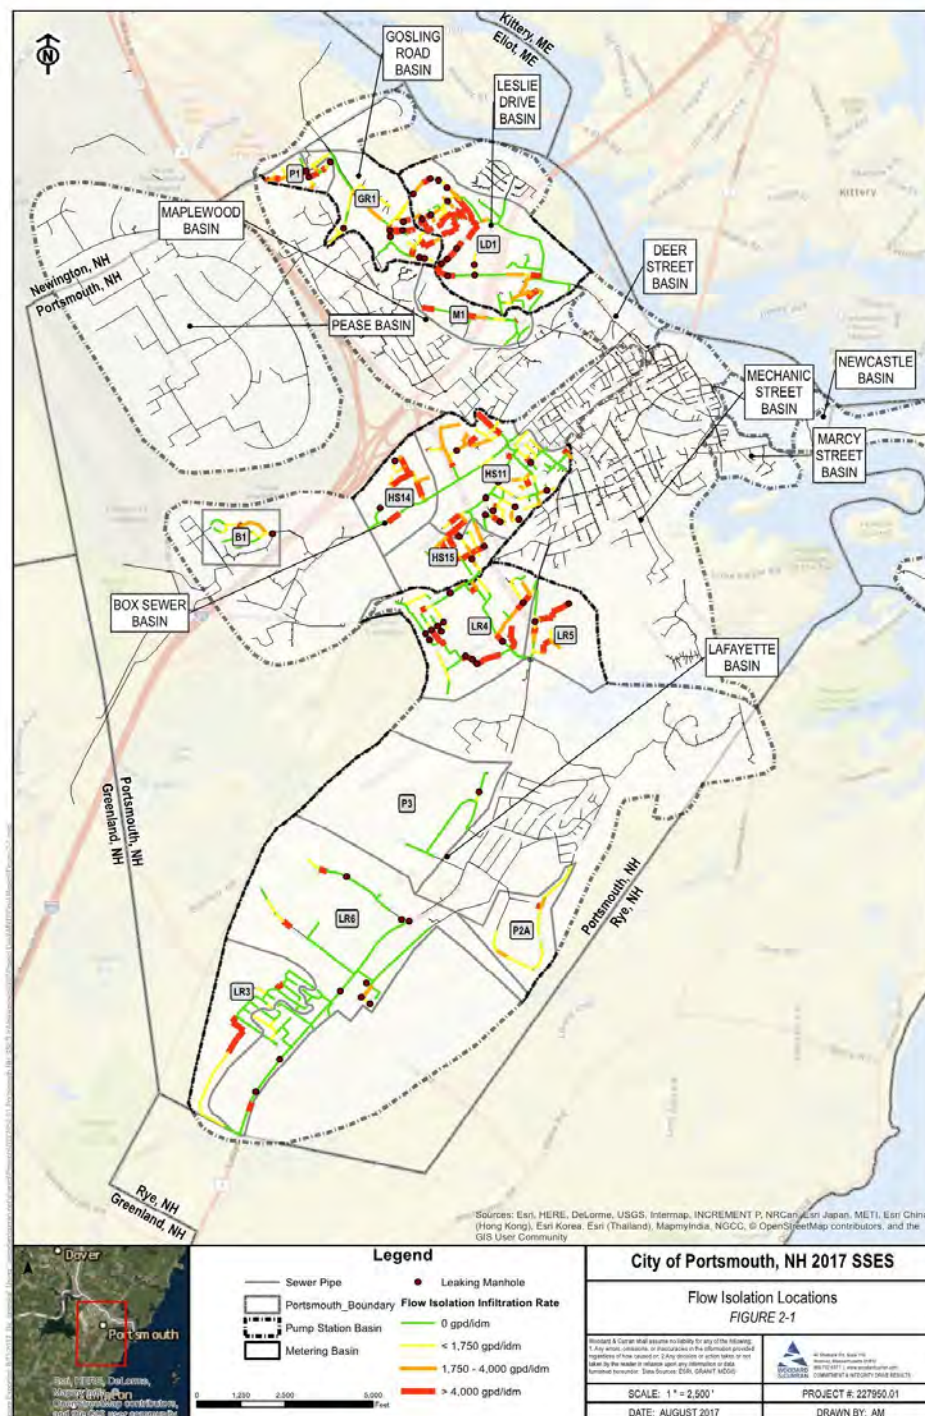
Figure 2-1: Flow Isolation Locations

Figure 2-1: *Flow Isolation Results* illustrates sewer pipes investigated during the flow isolation program along with those pipe segments with infiltration rates in excess of 1,750, and 4,000 gpd/idm.

Flow isolation measurements and observations successfully located sewer pipes and manholes with excessive infiltration. The investigations following flow isolation, and described in the sections below, are aimed to locate, assess, and recommend rehabilitation for the specific defects that cause infiltration in the City's sanitary sewer system. Sewer pipe that was measured to have infiltration rates greater than 1,750 gpd/ldm were recommended for CCTV inspection and manholes that were observed to have infiltration were recommended for surface manhole inspection.

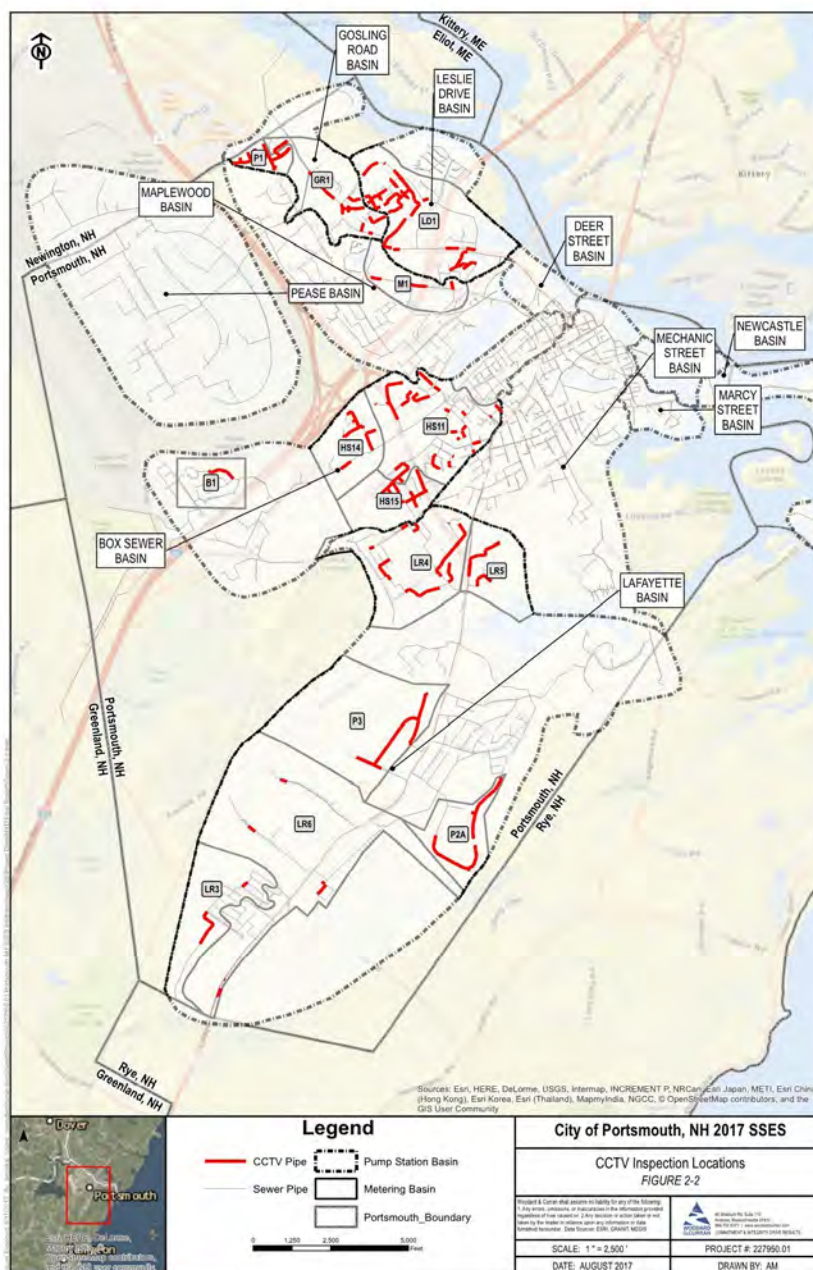
Figure 2-2: CCTV Inspection Locations

CCTV inspection revealed structural and O&M issues throughout the City's sewer system. A total of 46,066 LF of sewer pipe was successfully inspected, which is approximately 9% of the City's sewer system. Of the pipe investigated, CCTV inspection pinpointed infiltration defects as well as structural defects such as fractures and broken pipes as well as O&M issues such as grease and root intrusion. Structural damage such as collapsed pipes, or maintenance issues such as large root masses, can severely limit the hydraulic capacity of sewer pipes and cause backups or SSOs. Figure 2-2– *CCTV Inspection Locations* illustrates the locations of pipe segments that were inspected. All inspections were digitally recorded onto external hard drives and will be delivered to the Portsmouth Department of Public Works for incorporation into the City's GIS. CCTV inspection reports are included in Appendix D, and provide the following information for inspected pipe segments: unique pipe identification (ID) number, street name, inspection date, inspected length, pipe size and material, location of service connections, location and severity of defects, photos of pipe condition, and NASSCO ratings.

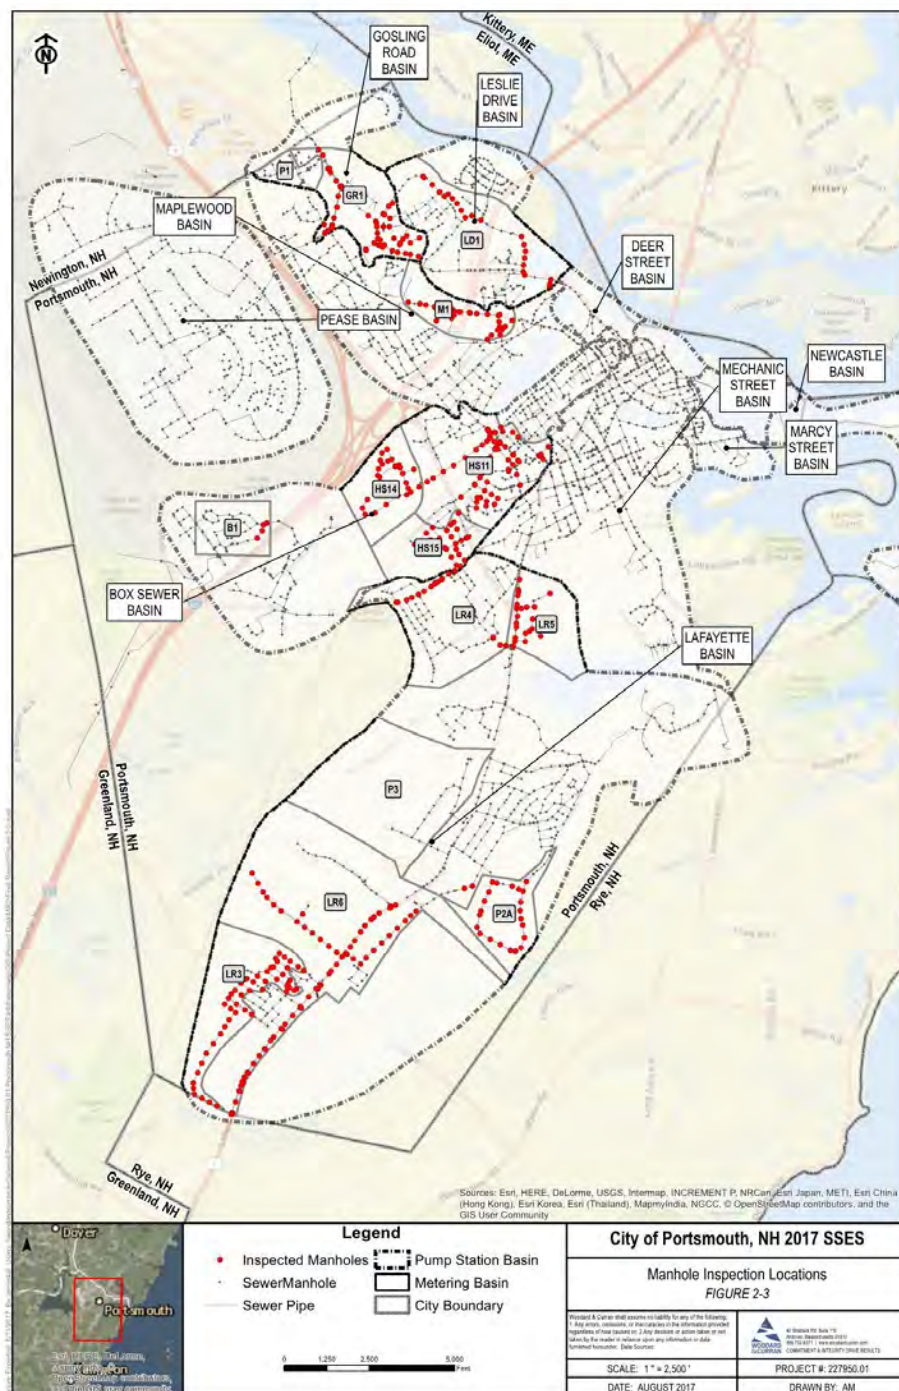
Figure 2-3: Manhole Inspection Locations

Figure 2-3 – *Manhole Inspection Locations*. Of the 428 inspected manholes, approximately 74 manholes showed signs of infiltration during manhole inspection, totaling an estimated 143,136 gallons per day. Inspection reports are included in Appendix C.

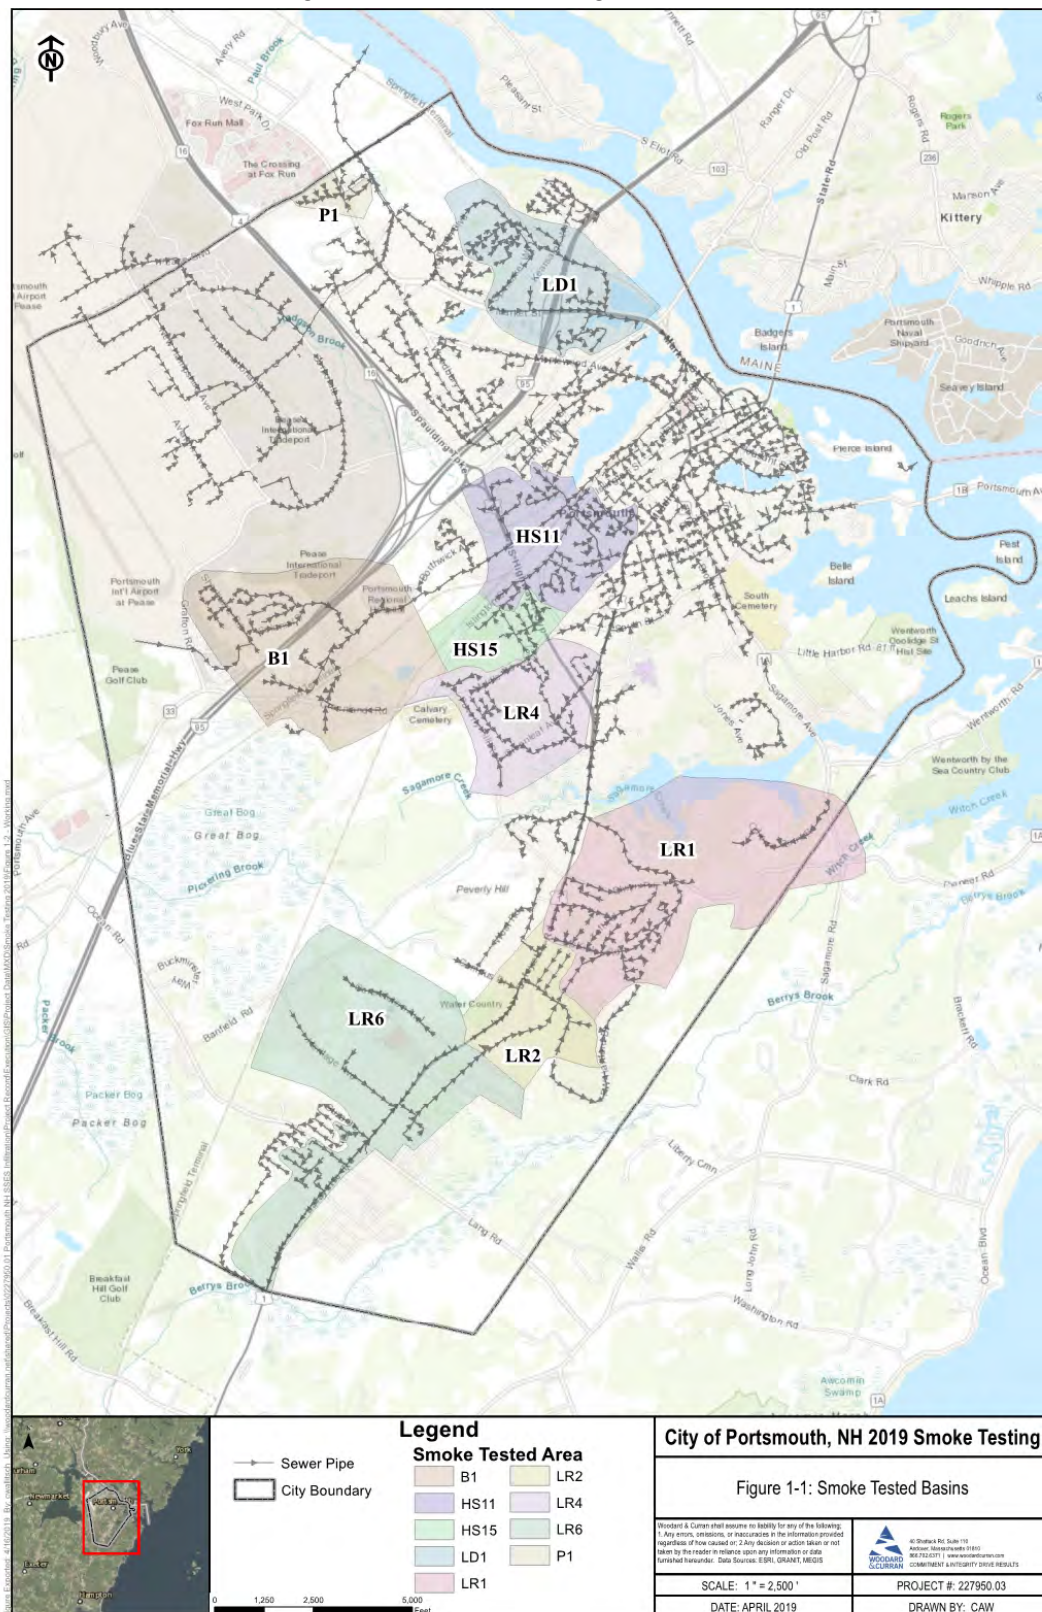
Figure 2-4: Smoke Testing Subareas

The smoke testing program recommended in the 2015 I/I Report included the testing of approximately 202,510 linear feet of pipe in nine subareas of the wastewater collection system. These areas are shown in Figure 2-4. The field program was completed by Flow Assessment Services, LLC during the months of September and October 2018. Smoke testing is ideally conducted on sewer pipes during dry weather and low groundwater to identify points in the system that allow inflow to enter the sewer. These point sources can be cracked manhole covers, broken cleanouts, storm drains incorrectly connected to the sewer system, roof leaders, and yard drains.

The smoke testing involved the introduction of a non-toxic smoke into the sewer system using a container of smoke-producing liquid and a blower. The smoke travels through the pipe and service connections, typically exiting through building vent stacks and from non-waterproof manhole covers. Where service cleanouts are broken; manholes have cover or corbel cracks; drains are directly connected to the sewer, etc. smoke will be observed exiting from them and these sources are easily identified as being potential contributors of inflow to the sewer system. In cases where smoke is emanating from drain structures, dye water testing and flooding of the suspect drain system can be used to verify the presence of an inflow-contributing source.

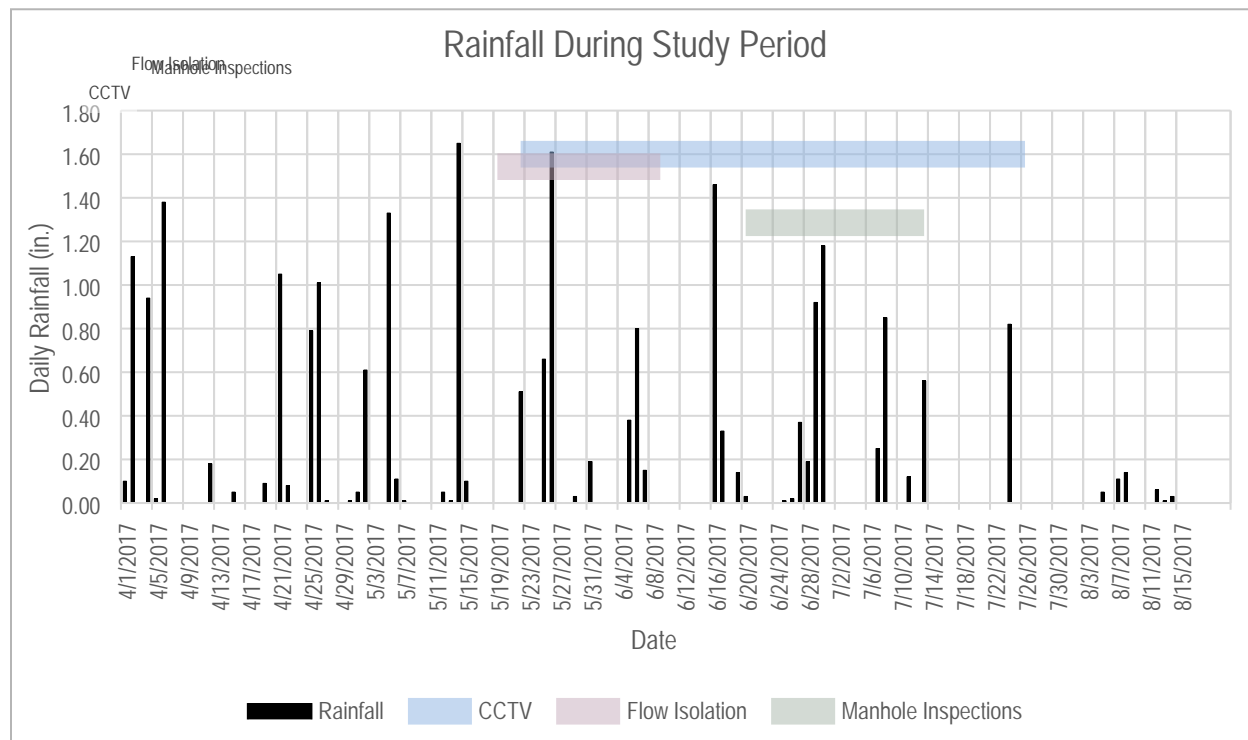
Figure 2-5: Measured Rainfall During the Study Period

During the study period, a total of 23-inches of rainfall occurred over approximately 19 storm events. Figure 2-5 shows the measured rainfall over the course of the study period. All flow isolation activities were restricted to dry-weather, defined by at least 24 hours of dry weather following a rainfall of 0.5 inches or greater to mitigate any inflow impacts. For example, during the period of May 25-27, approximately 2.3 inches of rain fell, and flow isolation activities were halted until a dry period of 24 hours had passed. Where rainfall occurred in lesser intensities (<0.5-inches/event), flow isolation was completed under the standard operating procedure. No infiltration investigations were scheduled during rain events.

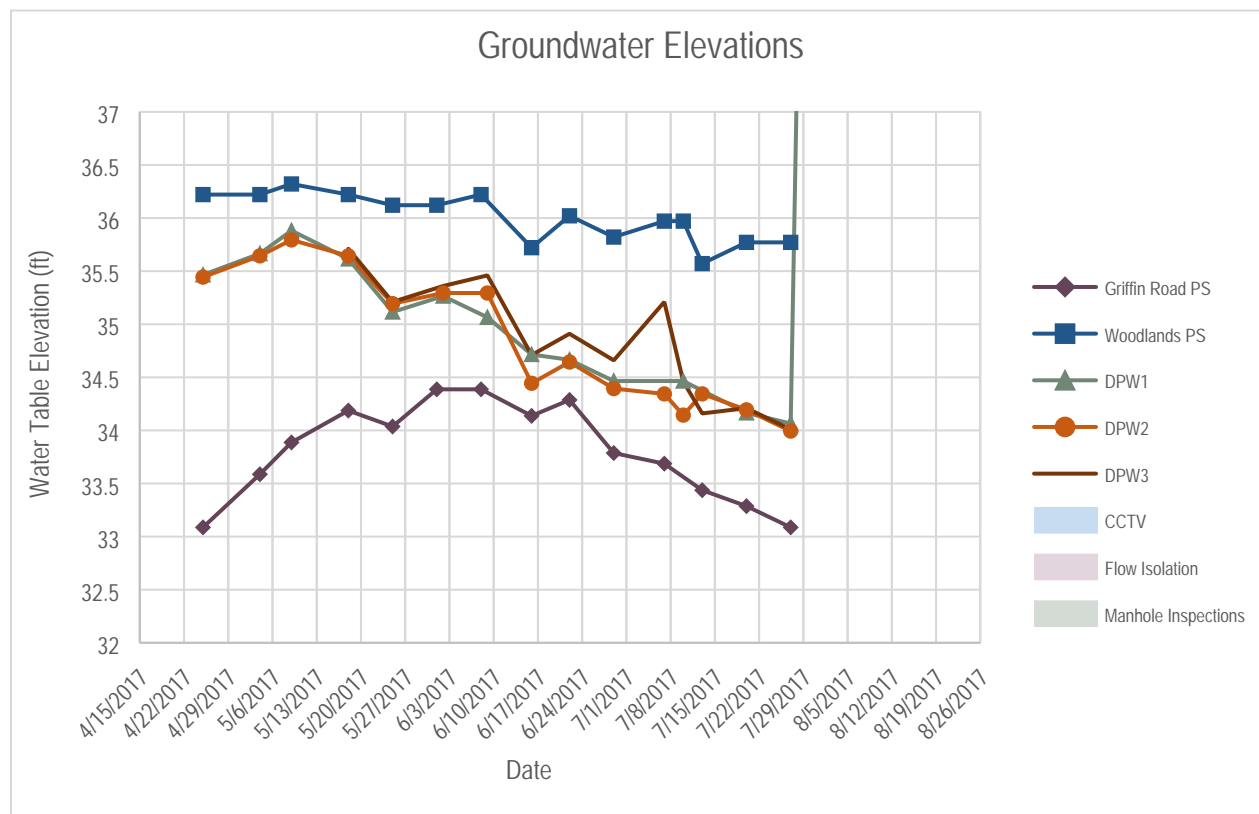
Figure 2-6: Groundwater Well Readings

Groundwater levels were monitored at several sites for the duration of the field investigations to gauge groundwater levels in the sewered areas. Groundwater elevations can fluctuate throughout the year and are estimated to be at the highest point during the springtime and gradually recede when temperatures rise during the summer. In order to measure peak infiltration rates, it is important to understand the elevation of the groundwater relative to the sewer system. In general, higher groundwater elevation leads to increased infiltration rates as the hydrostatic pressure surrounding the sewer system increases. Lower infiltration rates will be observed when the groundwater recedes below the level of the sewer system. Five groundwater monitoring wells were used for the study. The wells were located at the Woodlands 2 Pump Station, the Griffin Road Pump Station, and three wells located within the Peverly Hill Road DPW Yard.

Figure 2-6 shows a plot of the groundwater elevation for each well over the study period. Groundwater elevations at the Griffin Road PS well rose steadily from late April to mid-May to an elevation of 34.4-feet, then receded steadily through the remainder of the study period to an elevation of 33.2-feet. Woodlands PS remained fairly constant at near 36-feet throughout the study period. Levels at DPW-1, 2, and 3 peaked at 35.9-feet around May 8<sup>th</sup> then receded steadily throughout the study period to a level of 34.2-feet. Groundwater levels remained were highest near the beginning of the field investigations (for flow isolation) and receded during the end of the field investigations (for portions of the CCTV and manhole investigations). This corresponded to varying levels of infiltration rates observed – flow isolation measured more infiltration more than what was observed during the corresponding later-season CCTV investigation due to lower groundwater elevations and smaller inspected quantities. Although it would be optimal to perform CCTV inspection during the highest recorded groundwater elevation in order to maximum observed infiltration, it was not possible for the entirety of this study due to scheduling and warm-dry weather.

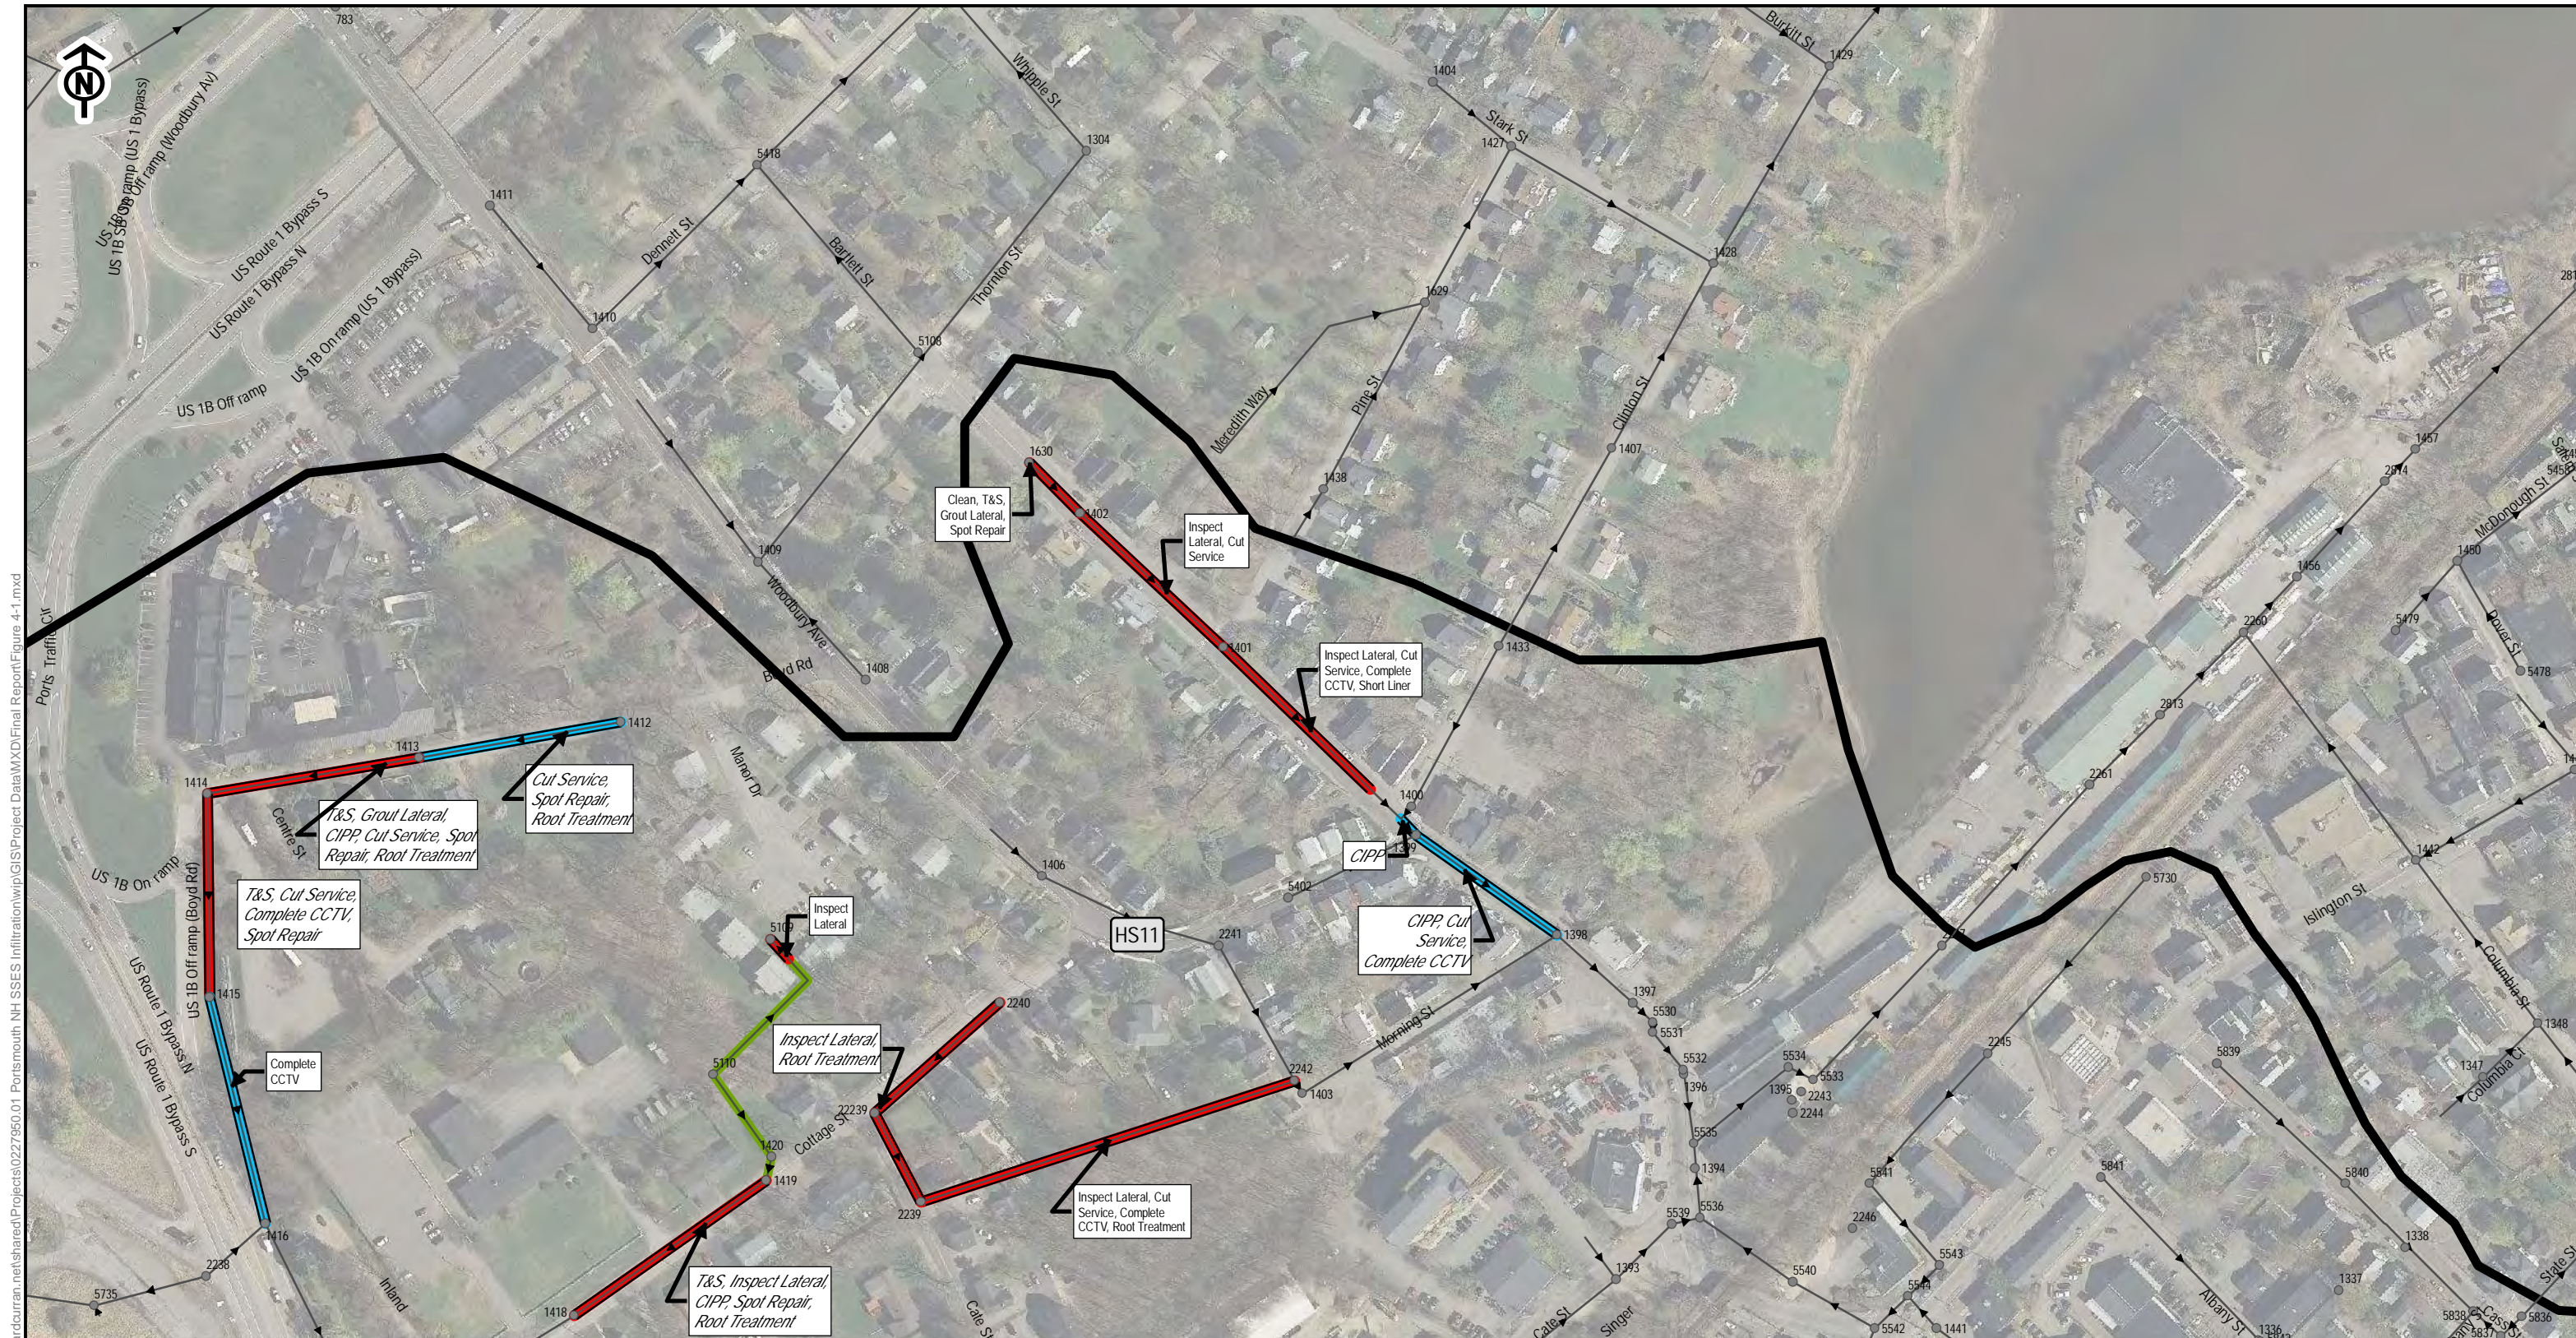
● Sewer Manhole	<b>SewerLine</b>	<b>Sanitary Sewer System Features</b>
→ SewerLine		▭ Metering Basin
<b>Rehabilitation Type</b>	<b>Geographical Features</b>	
Red Line: Infiltration	▭ City/Town Boundary	
Blue Line: Structural/O&M		
Green Line: Monitor

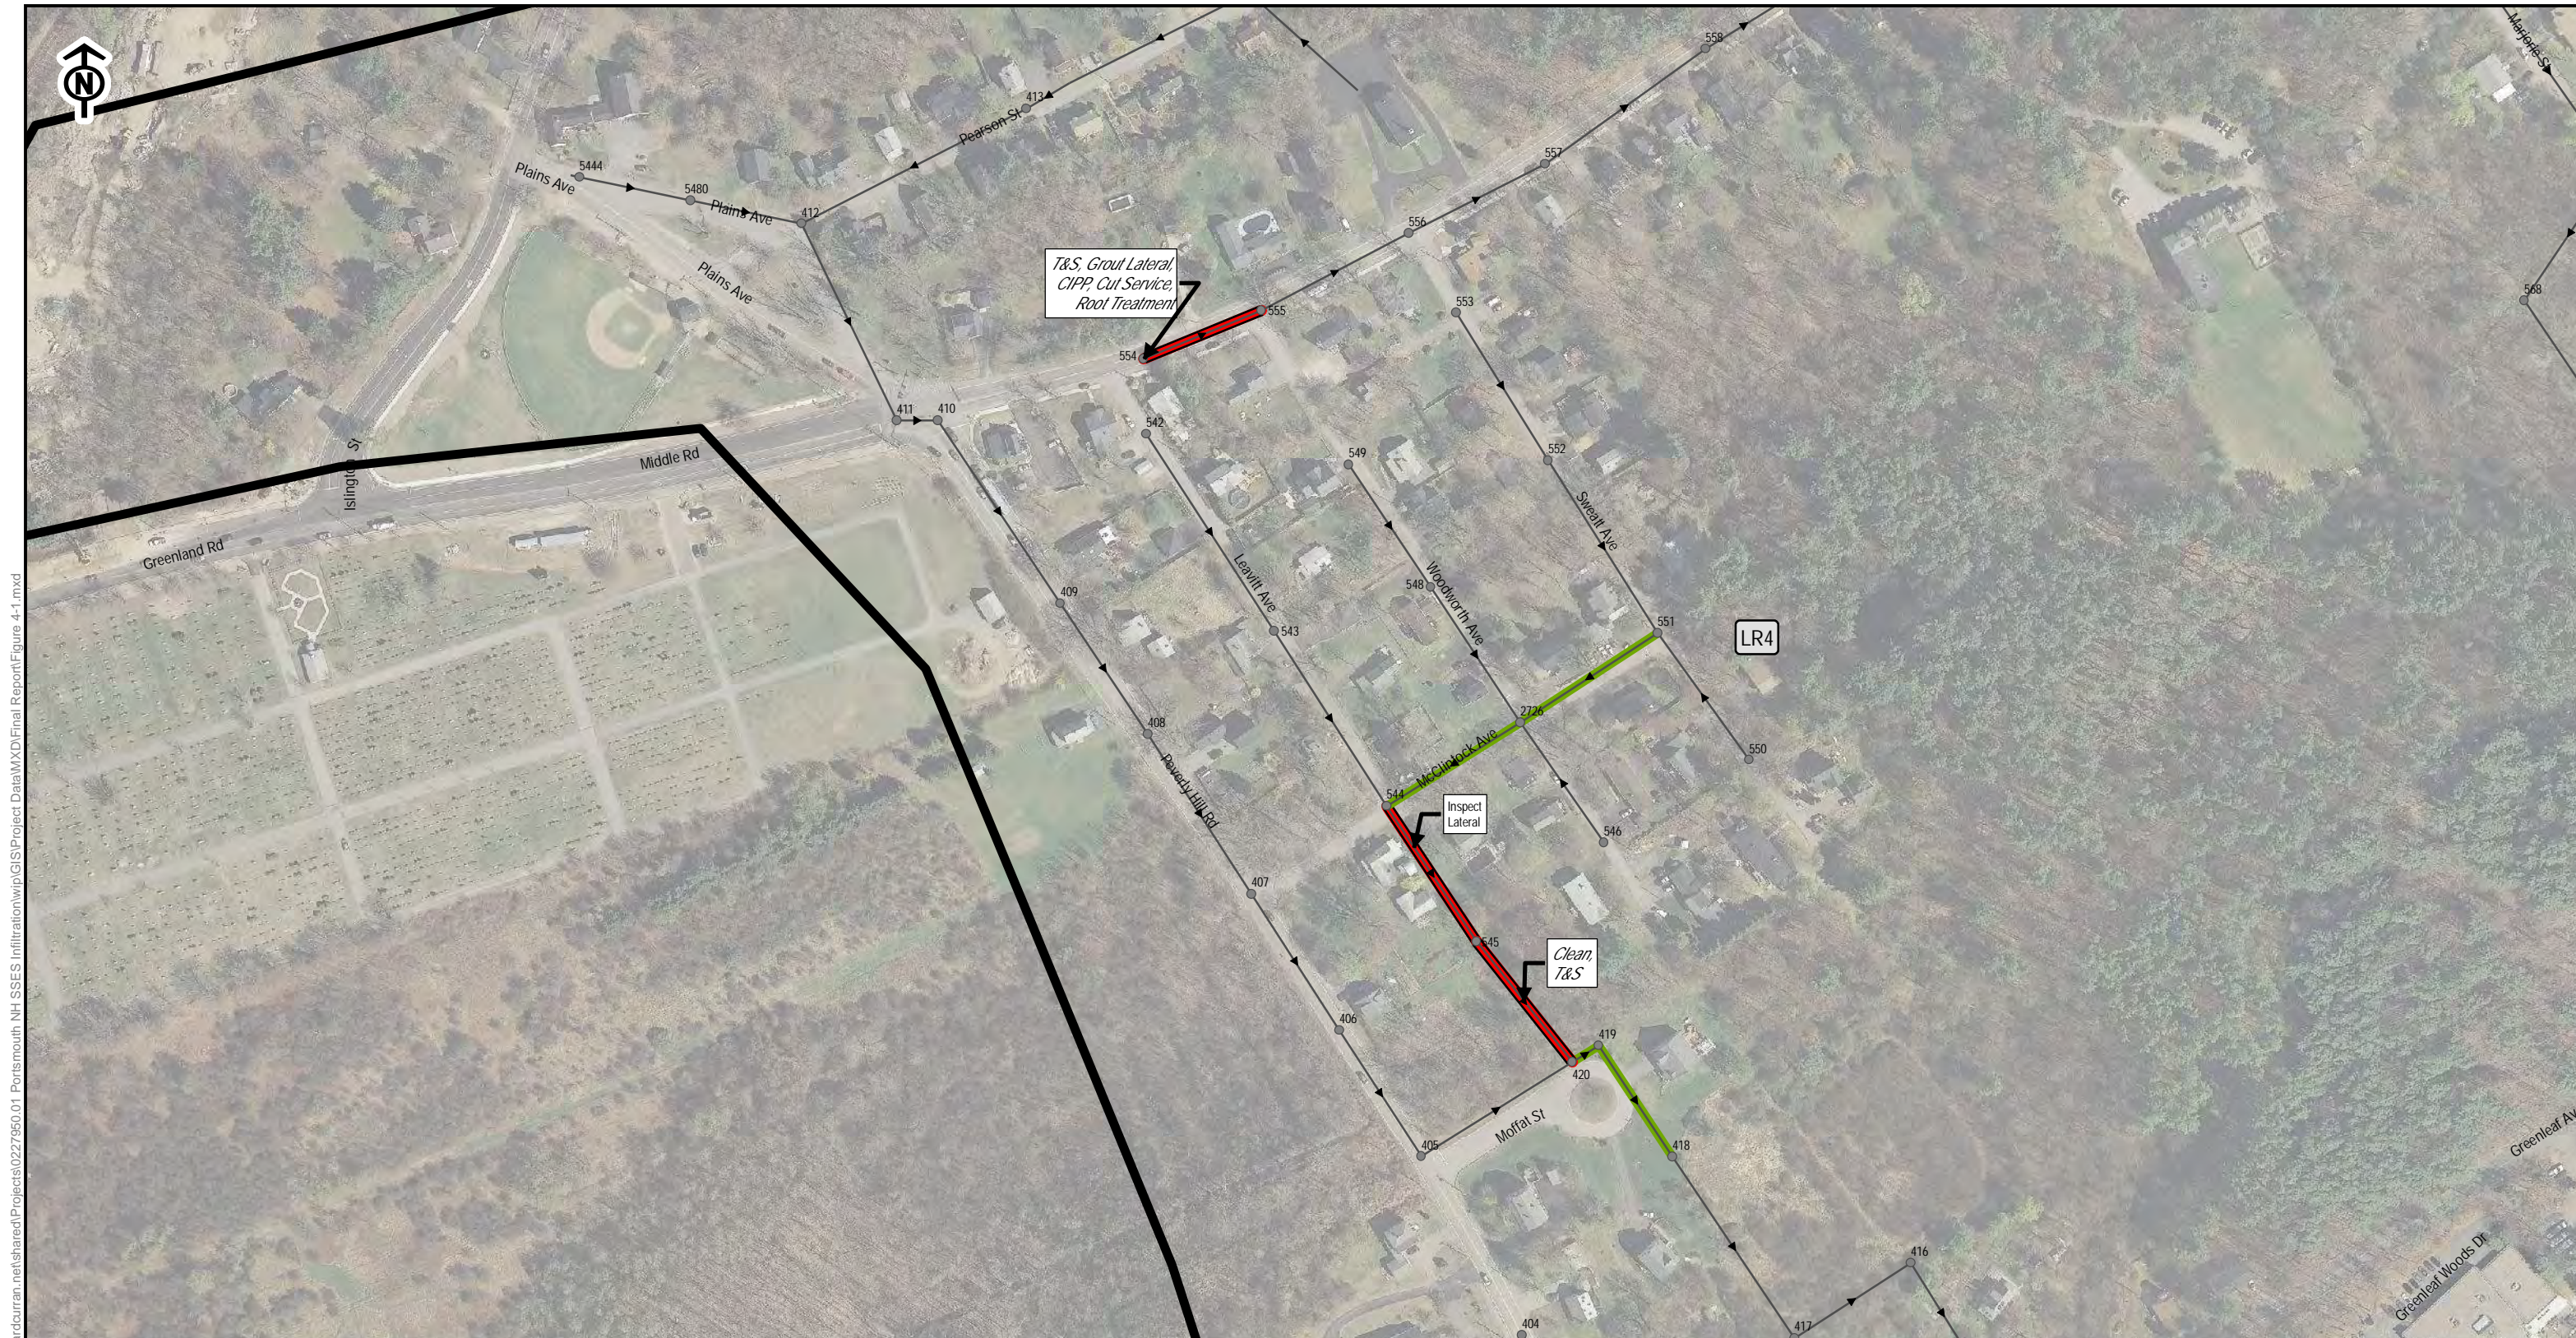
- Assets labeled in italic text reflect those with higher rehabilitation priority
- Symbology does not reflect actual position of defect and/or recommended repair.
- Refer to recommended rehabilitation tables for detailed quantities and location(s) of defects.
- Not for construction.

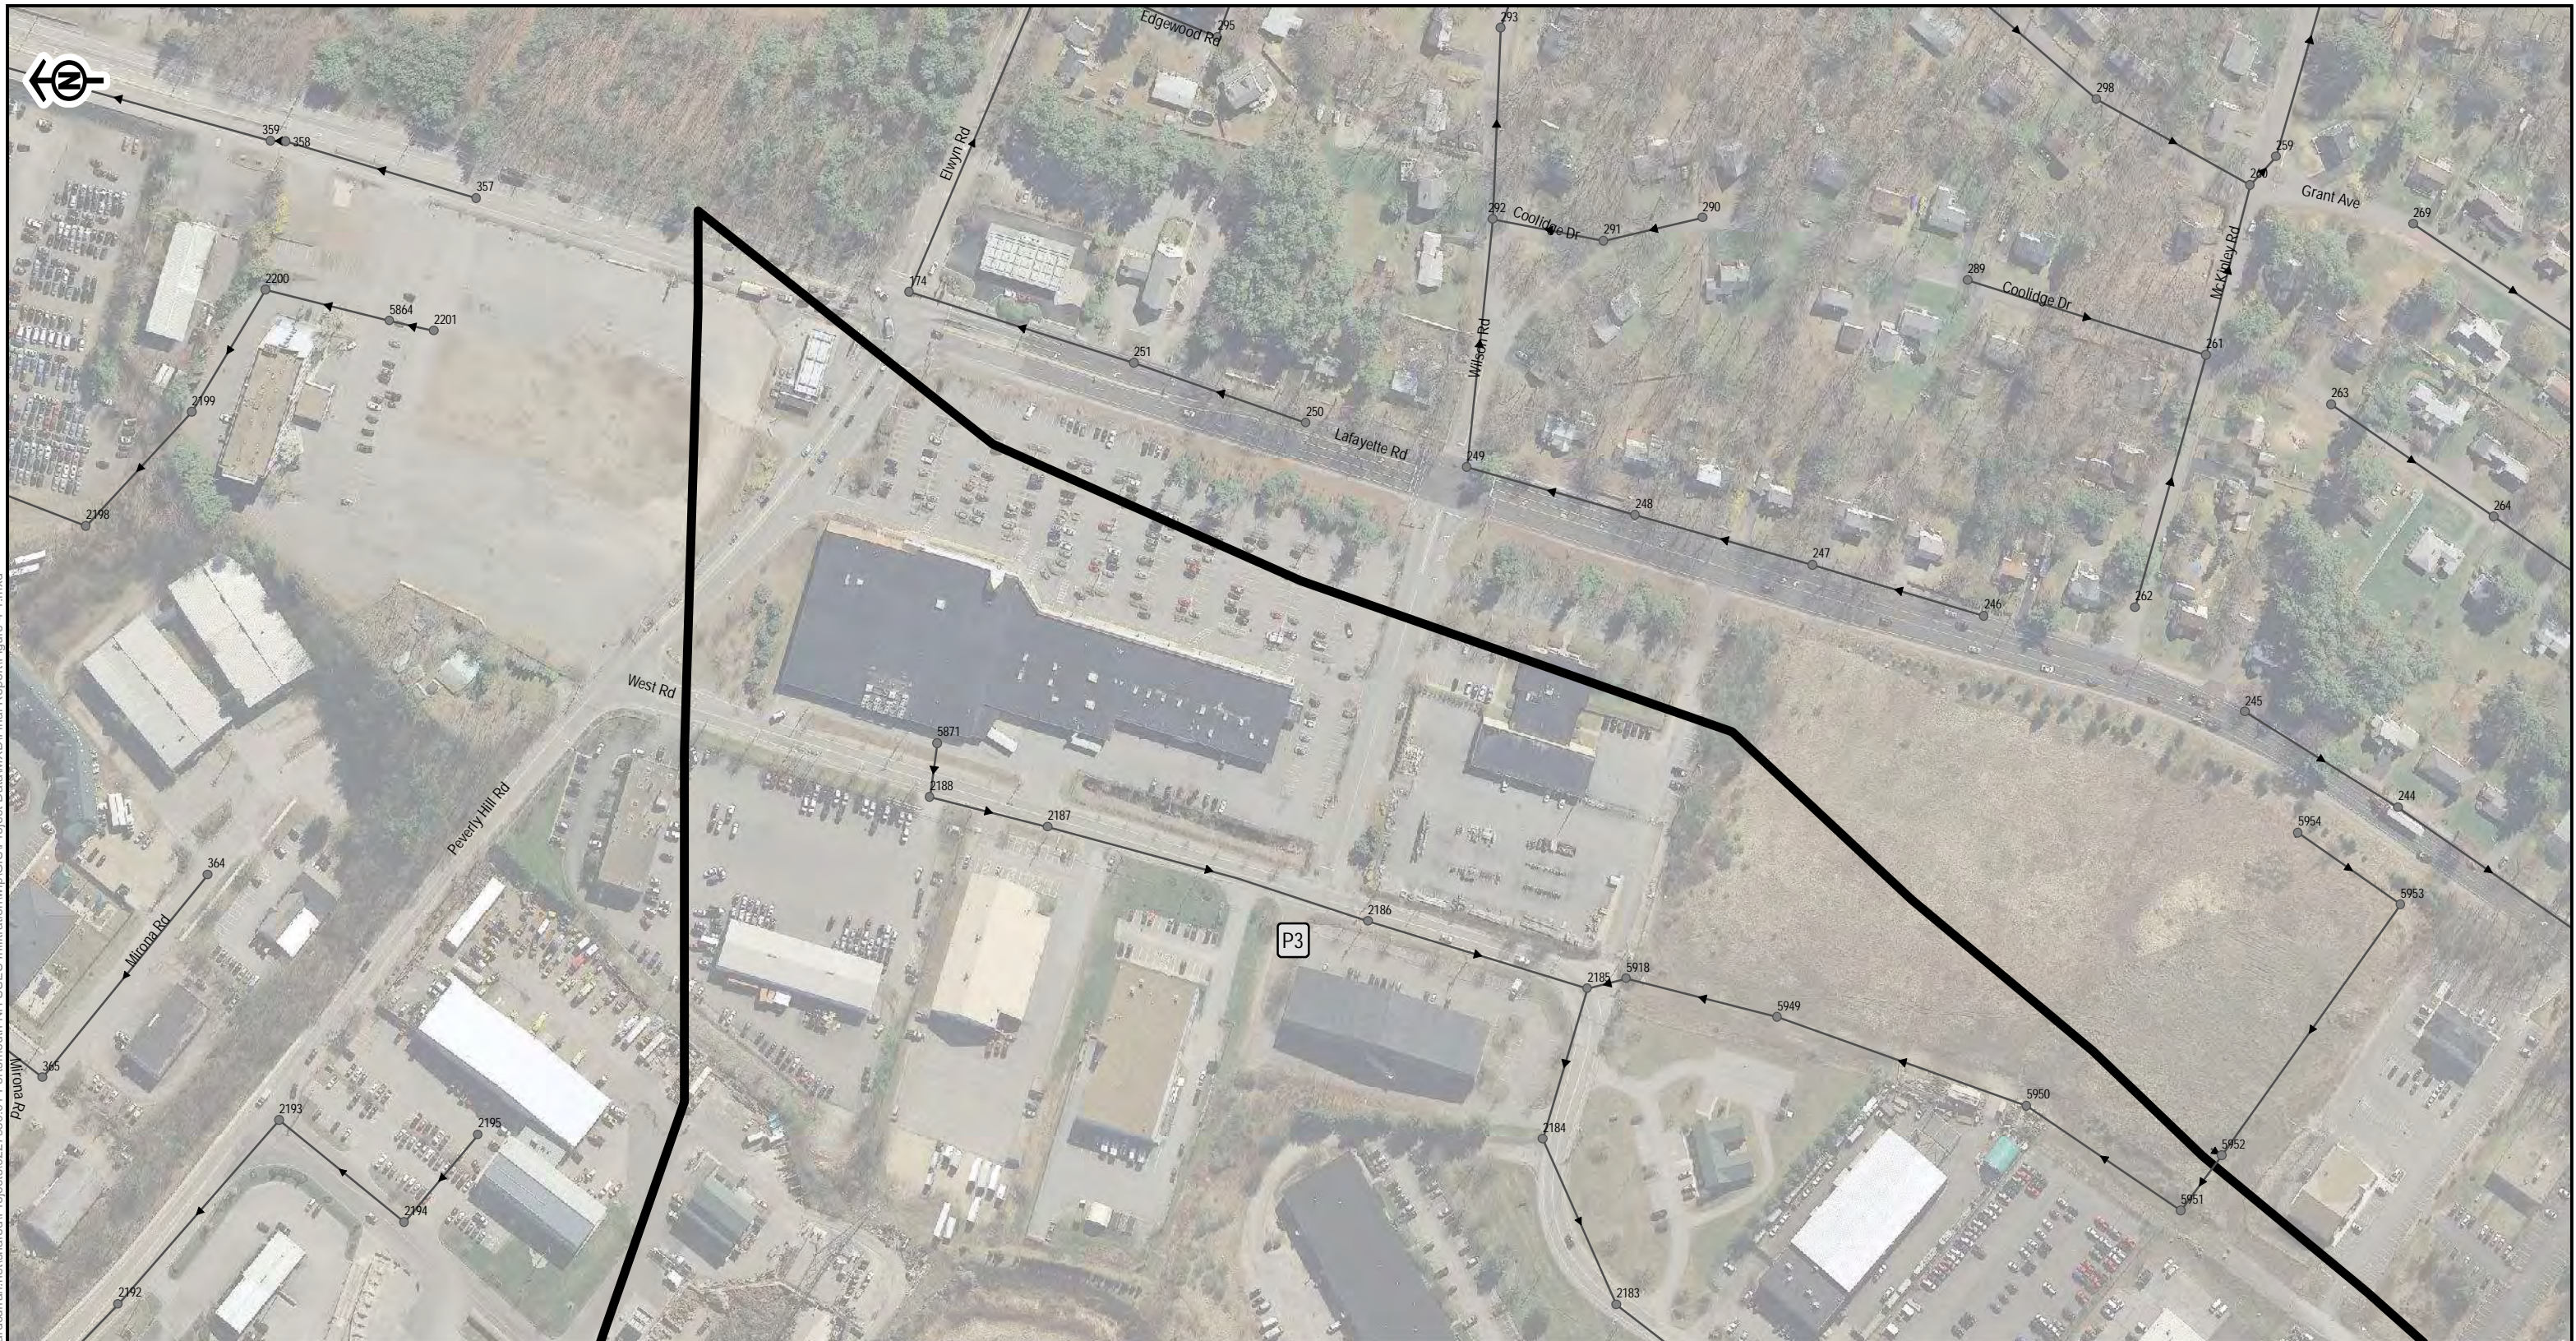
- Assets labeled in italic text reflect those with higher rehabilitation priority
- Symbology does not reflect actual position of defect and/or recommended repair.
- Refer to recommended rehabilitation tables for detailed quantities and location(s) of defects.
- Not for construction.

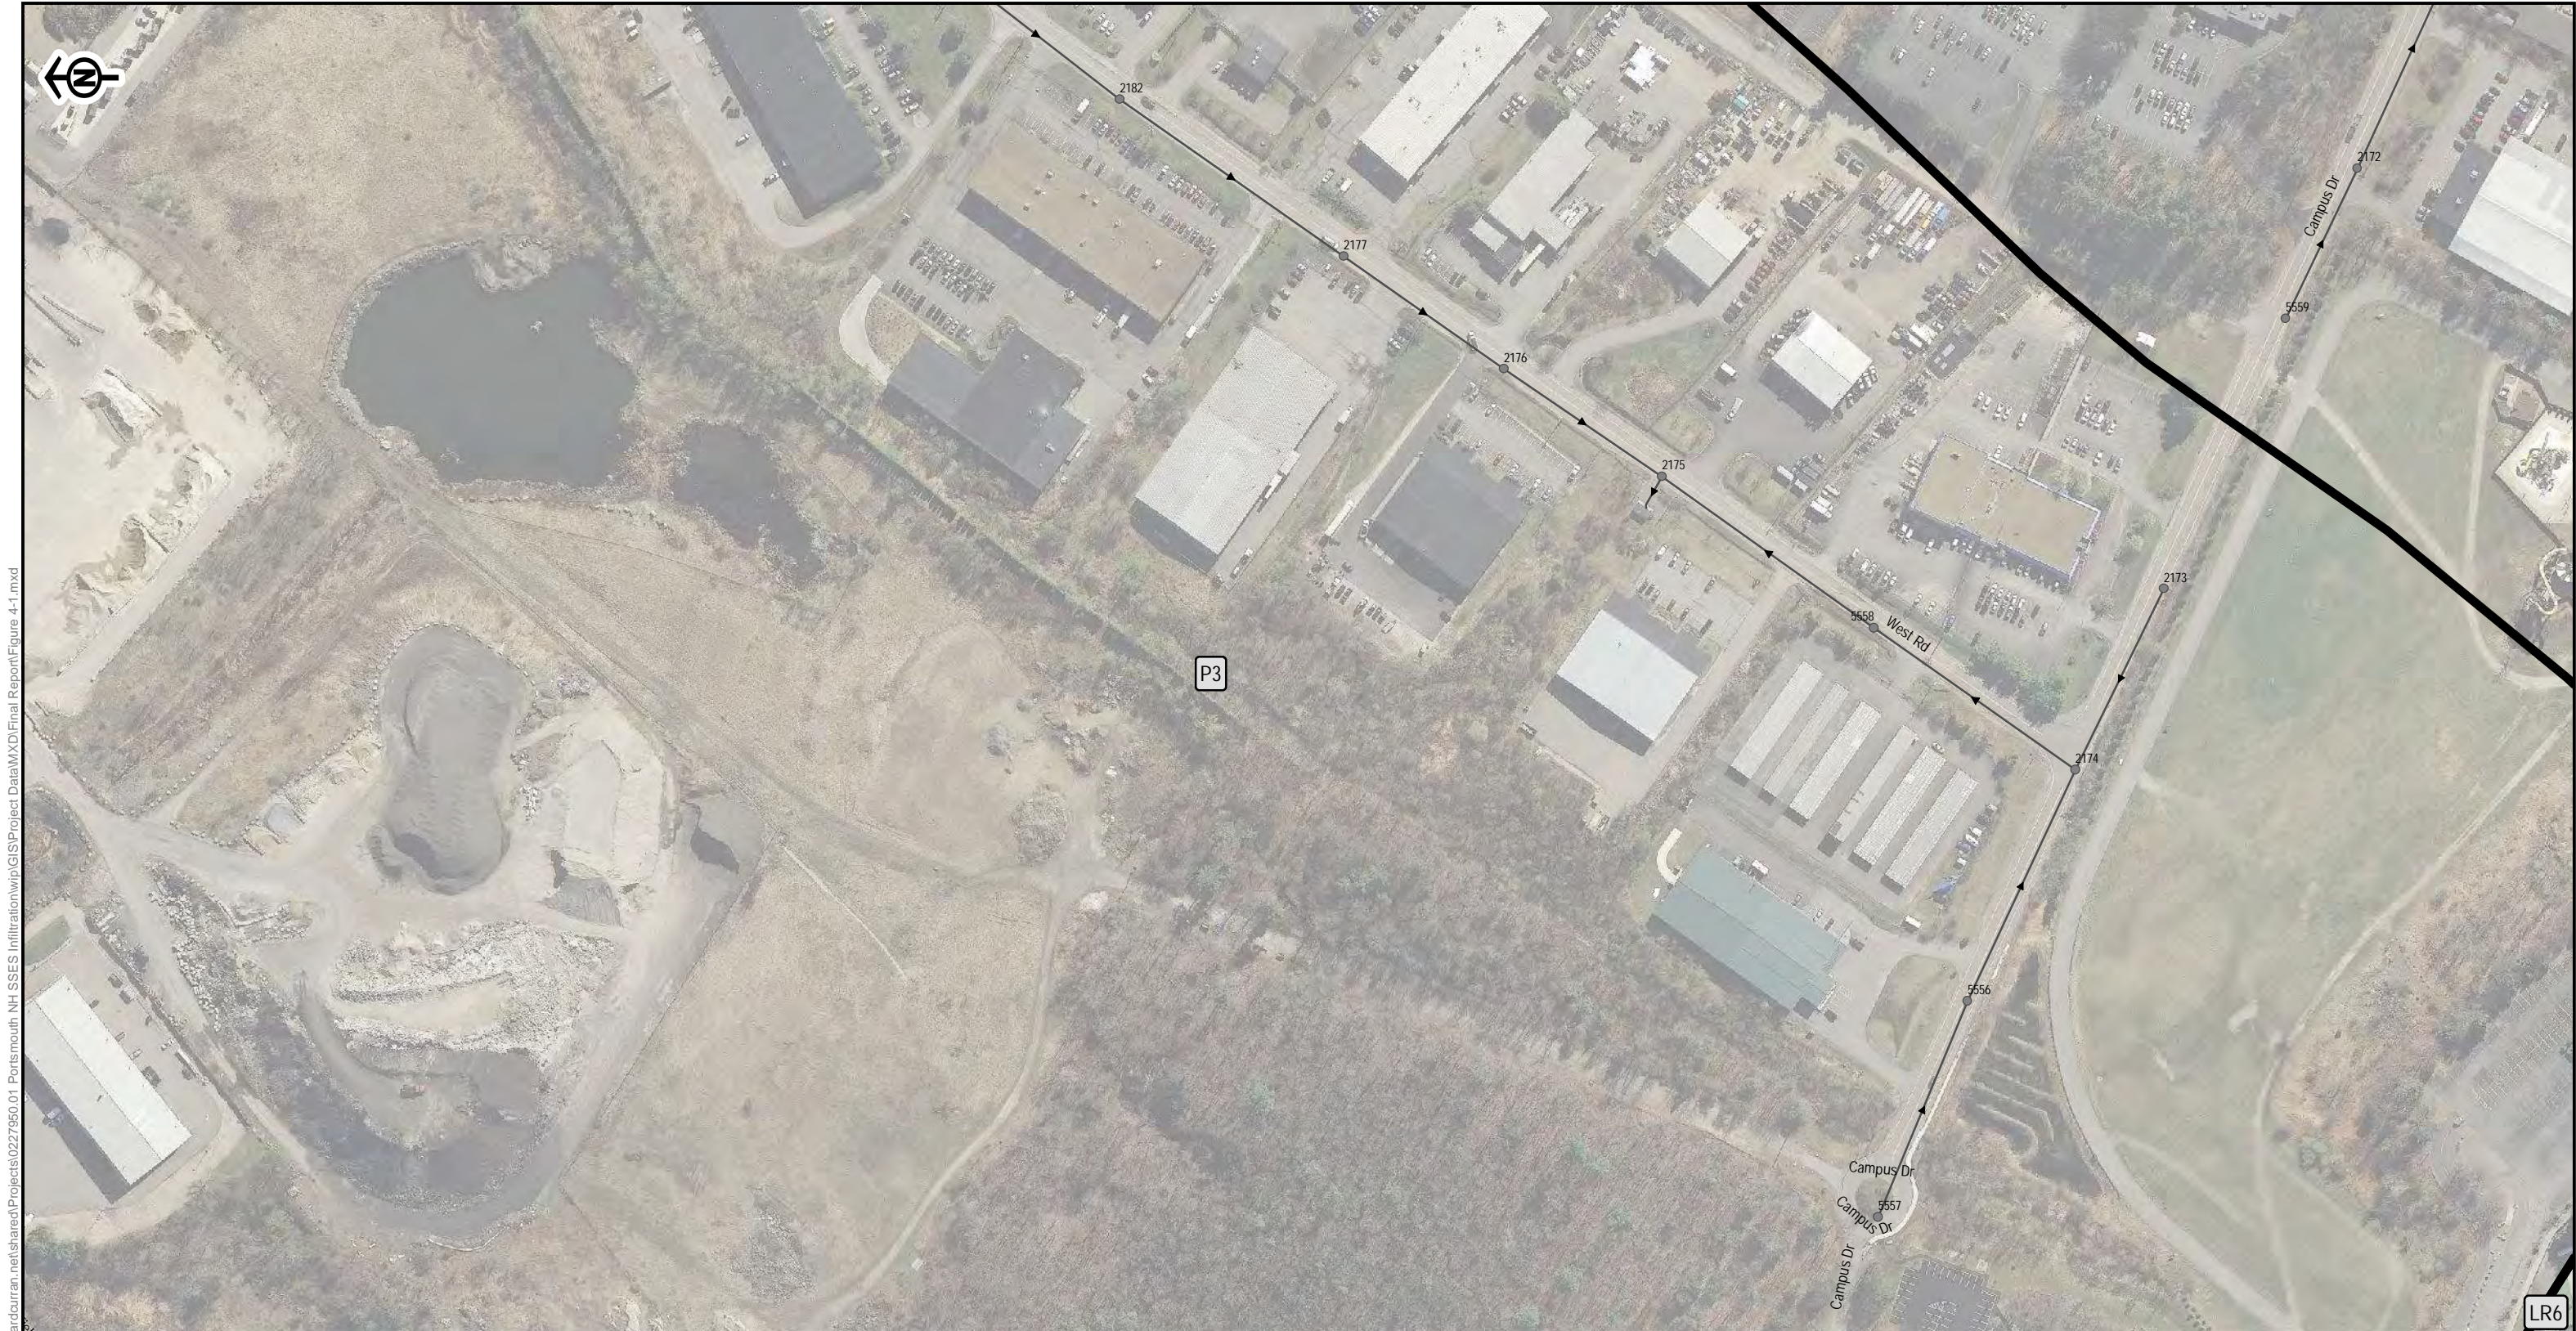
### Figure 4-1: Recommended Pipeline Rehabilitation

- Assets labeled in italic text reflect those with higher rehabilitation priority
- Symbology does not reflect actual position of defect and/or recommended repair.
- Refer to recommended rehabilitation tables for detailed quantities and location(s) of defects.
- Not for construction.
